Re: Motors Liquidation Company- Ley Creek PCB Dredgings Site (Registry # 7-34-044)  
NYSDEC Administrative Order on Consent Index # D-7-0008-97-06  
2009 Annual OM&M Inspection Report

**October 2009 OM&M Inspection Report**

Re: Ley Creek PCB Dredgings Site  
October 2009 OM&M Inspection

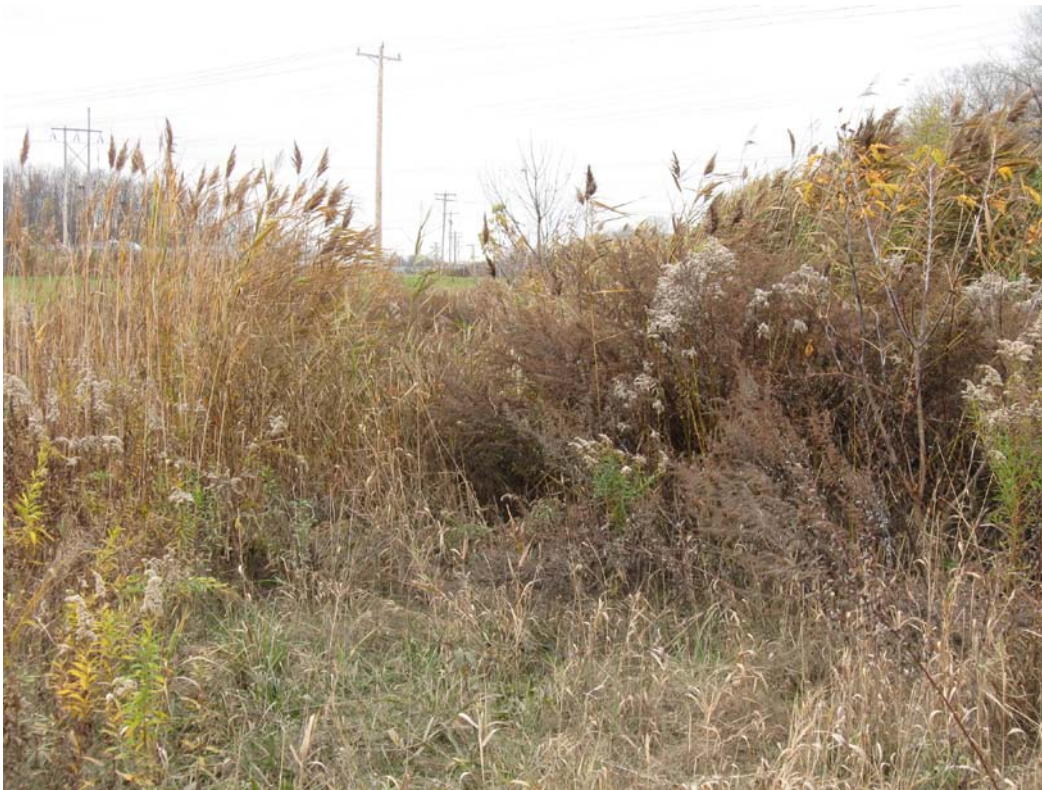
9. Mowing required?	<b>X</b>		Photographs 3 and 6.
<b>Access Road</b>	<b>Visually inspect conditions.</b>			
	1. Areas of settlement?		<b>X</b>

Photograph 3: Eastern section of Service Road.

High grass was observed along the service road (O'Brien & Gere 2009).	Grass will be mowed as part of routine spring maintenance activities.	To be performed in spring 2010.
The sign for monitoring well OBG-2 was observed to be bent (O'Brien & Gere 2009).	The sign will be repaired concurrent with routine spring maintenance activities.	To be performed in spring 2010.
A tree was observed to be growing in the security fence (O'Brien & Gere 2009).	The tree will be cut down concurrent with routine spring maintenance activities.	To be performed in spring 2010.

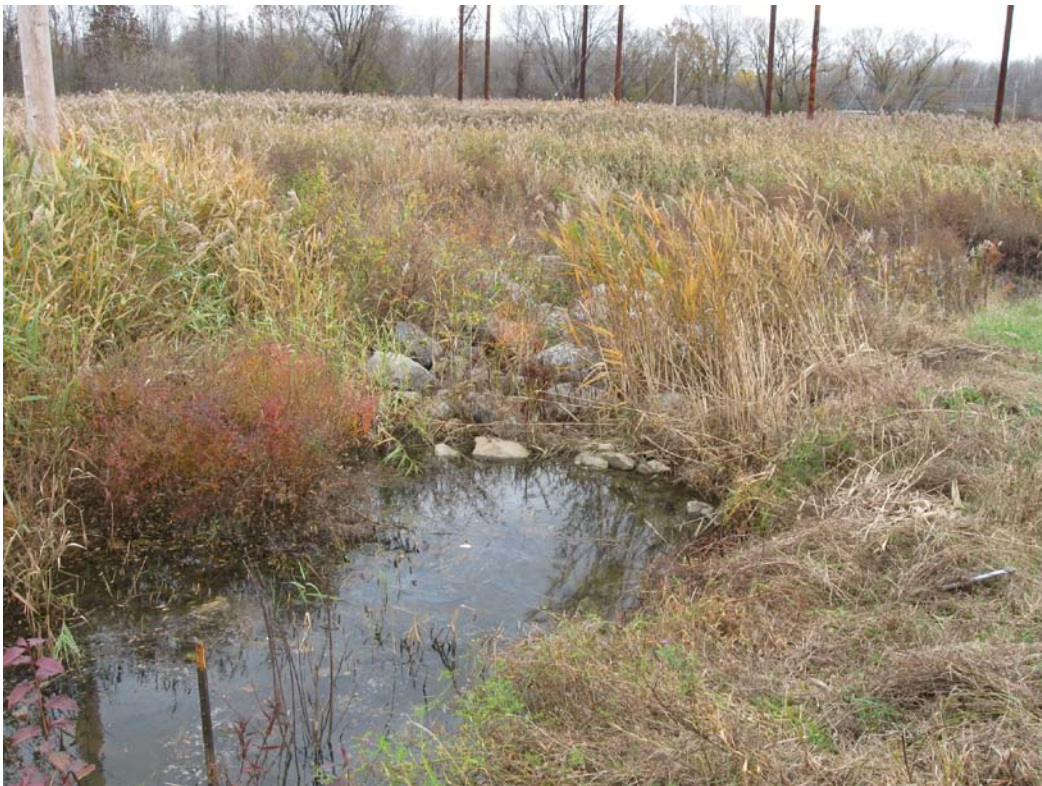
1. Accumulation of debris?	<b>X</b>		At all catch basins. Photographs 4, 8, 10, & 14.
	2. Excessive scouring?		<b>X</b>	
	3. Areas of damage?		<b>X</b>	
Ground Water Wells	<b>Visually inspect conditions.</b>

Photograph 4: View of CB-04. Plugged.

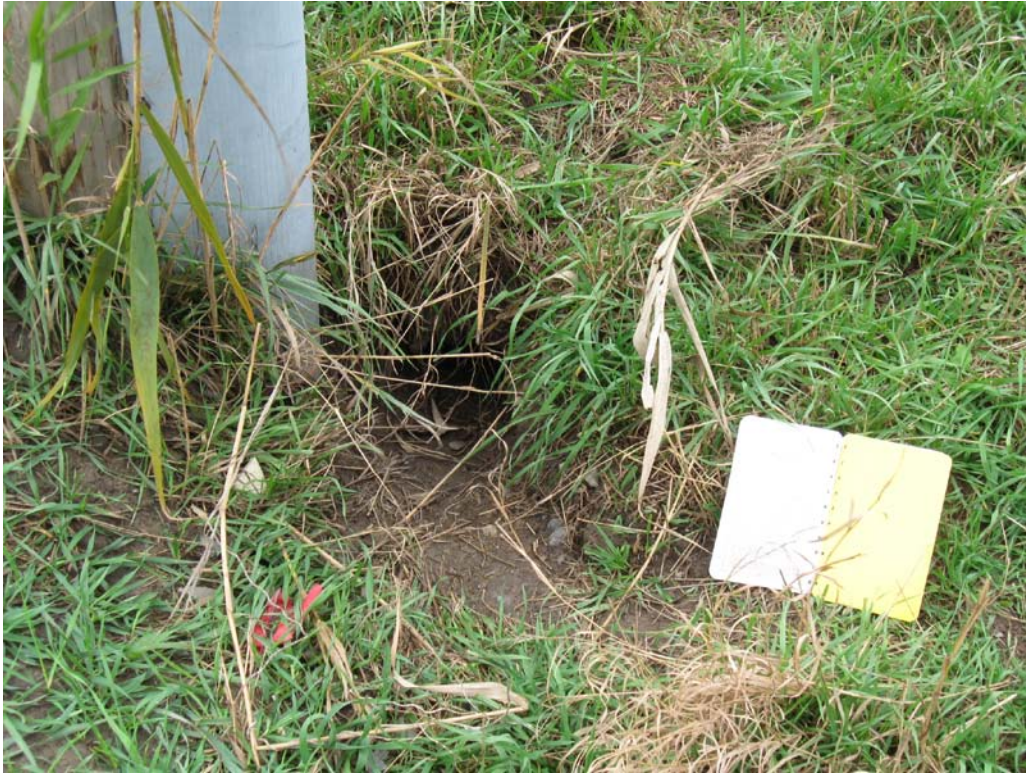
6. Presence of burrowing animals?	<b>X</b>		7 holes between CB-3 & CB-4. Photographs 5 and 7.
	7. Areas of damage?		<b>X</b>	
	8. Drainage problems?		<b>X</b>

Photograph 5: Animal burrow near utility pole.

Issue	Recommended Action	Status
Conduct an assessment of actions to control burrowing animals at the site (e.g., removal of burrowing animals). Where needed, topsoil should be placed in holes and seed and fertilizer applied (USEPA 2007).	A New York State licensed trapper will trap burrowing animals from the site.	To be performed in spring 2010.
Replace grates in catch basins with trash racks to minimize clogging (USEPA 2007).	Evaluation of engineering controls being conducted to minimize clogging at CB-1, CB-2, and CB-3. CB-5/004 receives minimal flow and CB-4/003 does not generally clog with debris.	Evaluated in August 2007. A piece of wire mesh with an attached cable connected to a post was placed on each of the four active catch basins at Ley Creek to aid in debris removal.
Soil covering MW-12 and MW-13 due to burrowing animal (O'Brien & Gere 2007).	A New York State licensed trapper will trap burrowing animals from the site. Material covering and around the monitoring wells will be placed back in the burrow and additional topsoil and seed placed, if necessary. If excess material is generated, it will be properly characterized and disposed.	Material replacement and seeding completed in September 2007. Trapping to be performed in spring 2010.

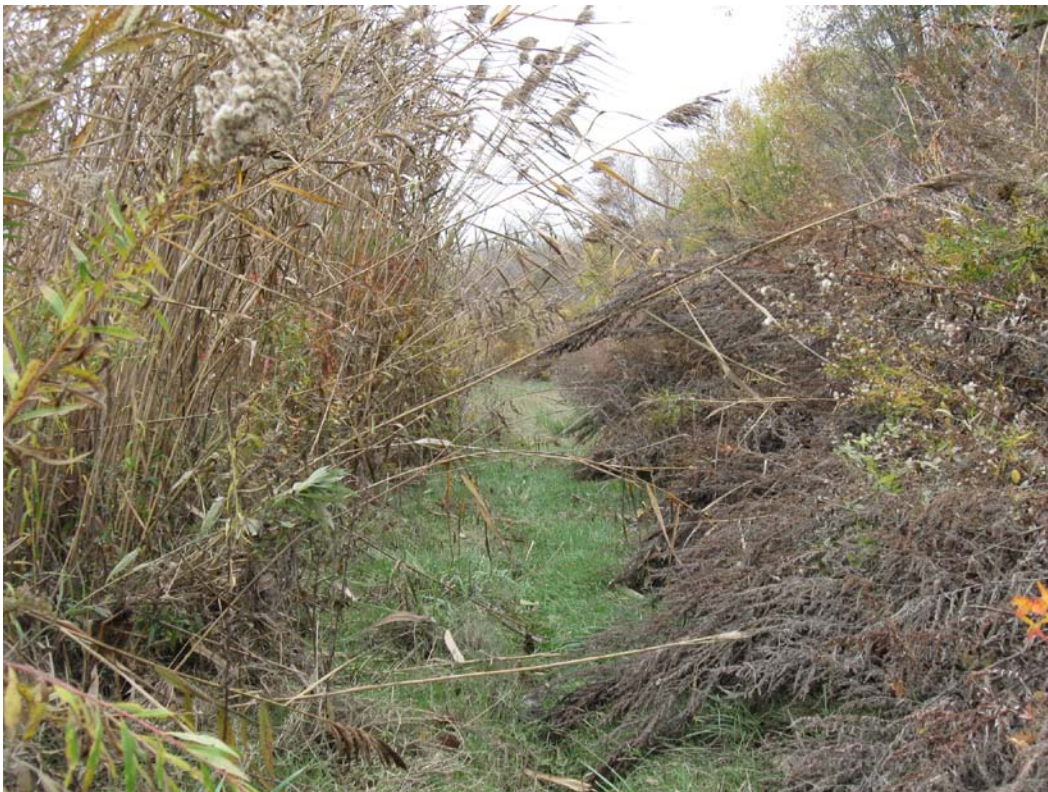
Photograph 6: Service Road between CB-03 and CB-04.

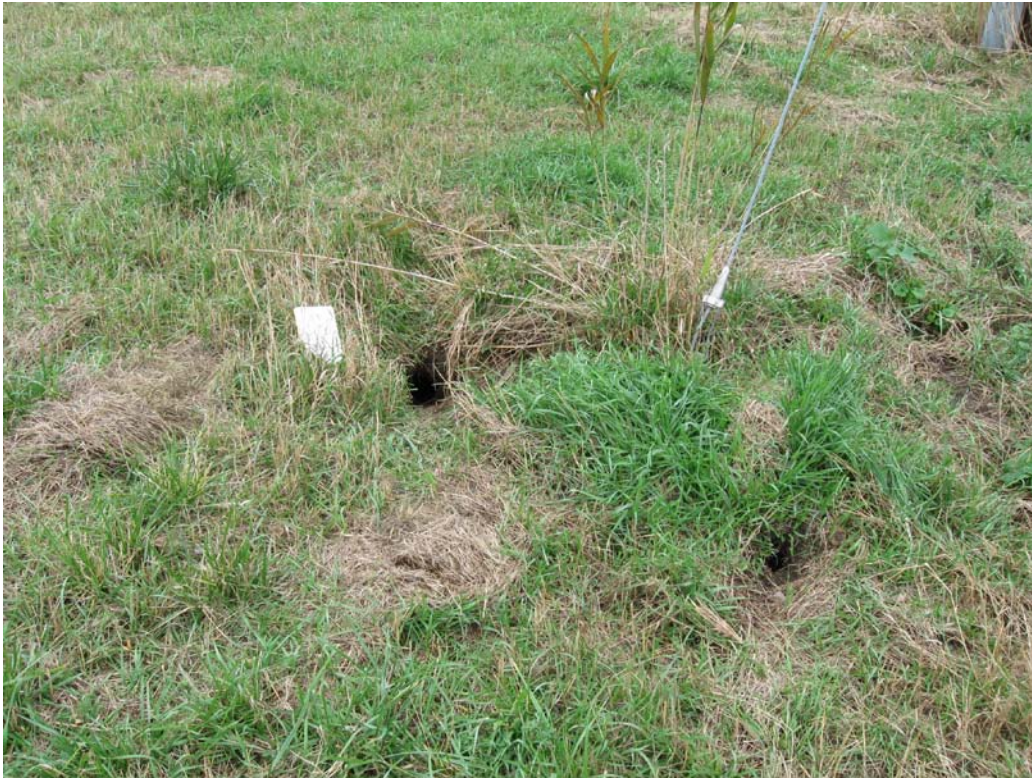
Photograph 7: Animal burrows near utility pole.

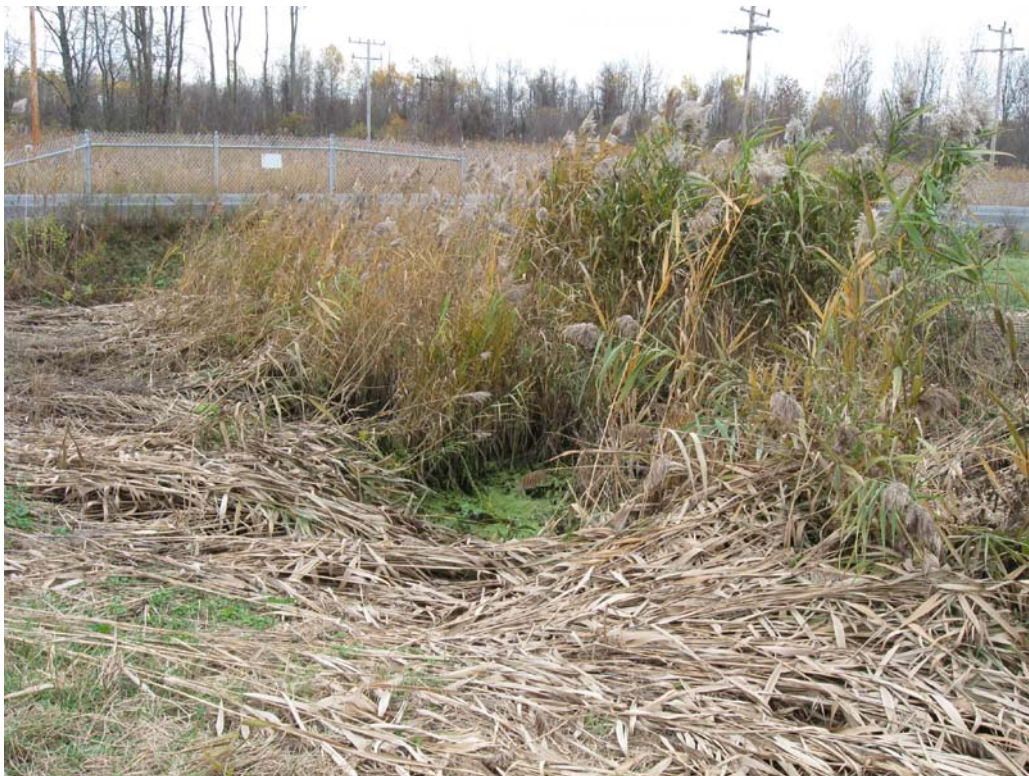
Photograph 8: View of CB-03. Not overflowing, but plugged.

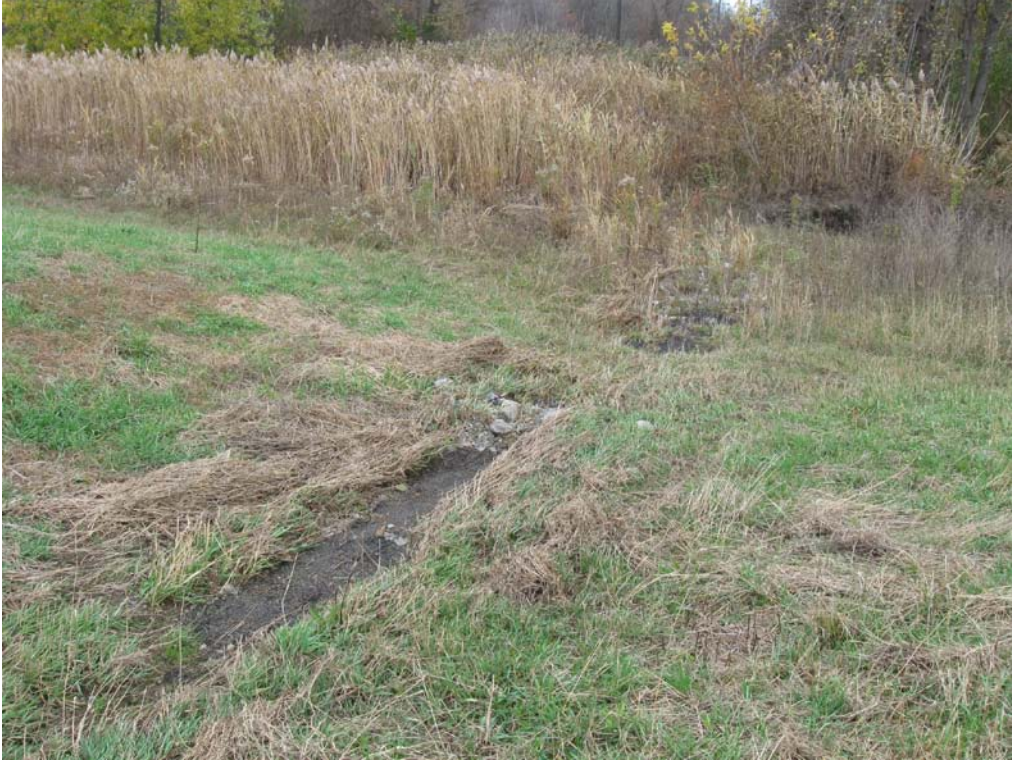
Item	Task	Response		Comments
		Yes	No	
<b>Vegetative Cover</b>	<b>Visually inspect surface conditions.</b>			
	1. Areas of settlement?		<b>X</b>	
	2. Areas of erosion?	<b>X</b>		Overflow surface at CB-03. Photograph 9.

3. Areas where geotextile visible due to erosion?	<b>X</b>		Overflow surface at CB-03. Photograph 9.
	4. Areas of slope instability?		<b>X</b>	
	5. Lack or thinning vegetation?		<b>X</b>

Photograph 9: View of scoured section of CB-03 overflow channel.

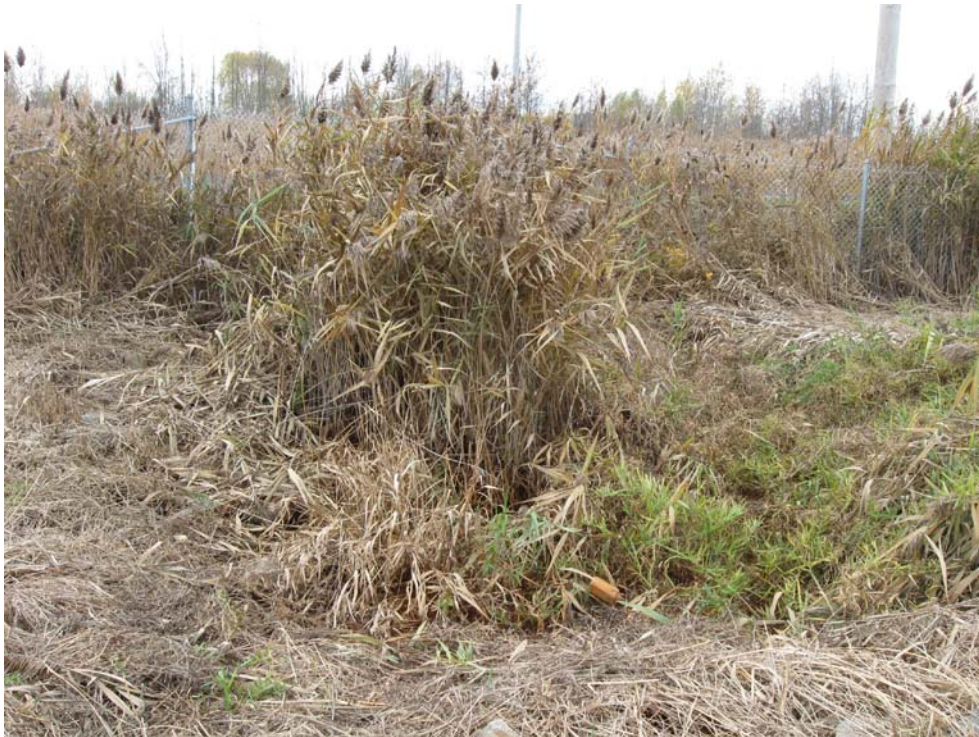
Photograph 10: View of CB-02. Plugged and over grown.

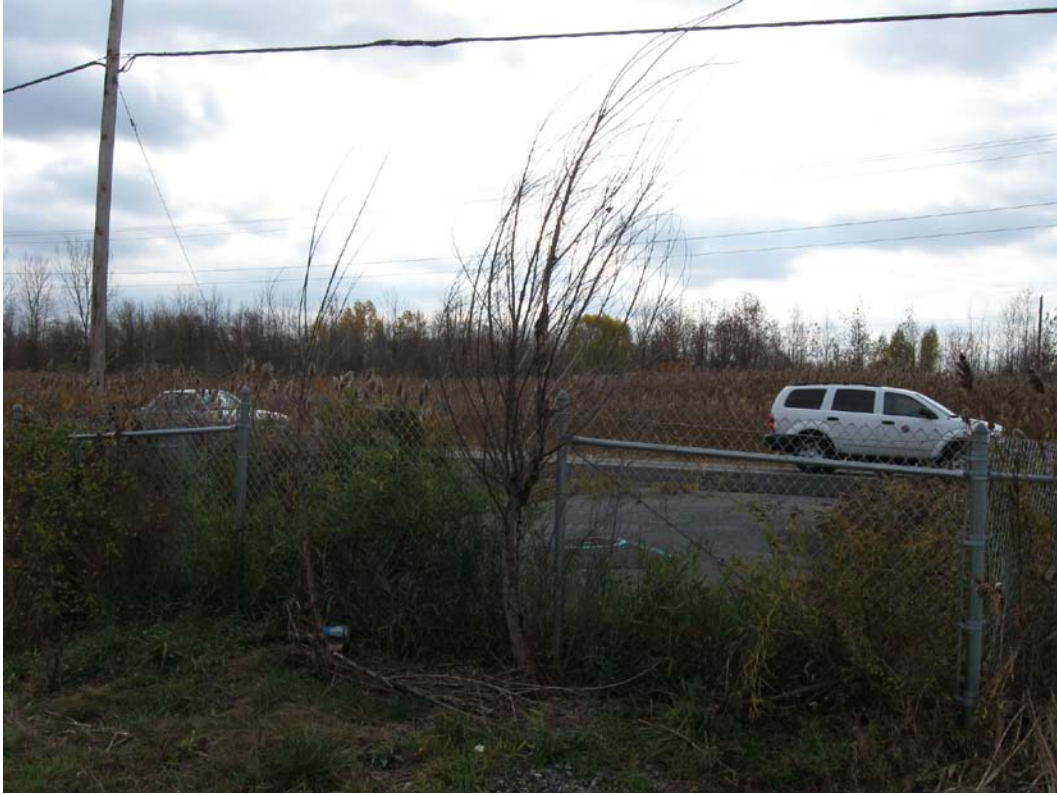
1. Signs intact?	<b>X</b>		
	2. Fence breached?		<b>X</b>	
	3. Access gates locked?	<b>X</b>		
	4. Areas of damage?		<b>X</b>	
<b>Note any additional comments.</b>				
Observation of burrowing animal holes seems to be increasing.				
Tree growing in the security fence. Photograph 13.				
The 15-foot width of wetland and the 5-foot width of buffer south of the service road looks well established.				
Bent monitoring well sign (OBG-2) from 2008 has not been corrected.

Photograph 13: Tree along fence west of CB-02.

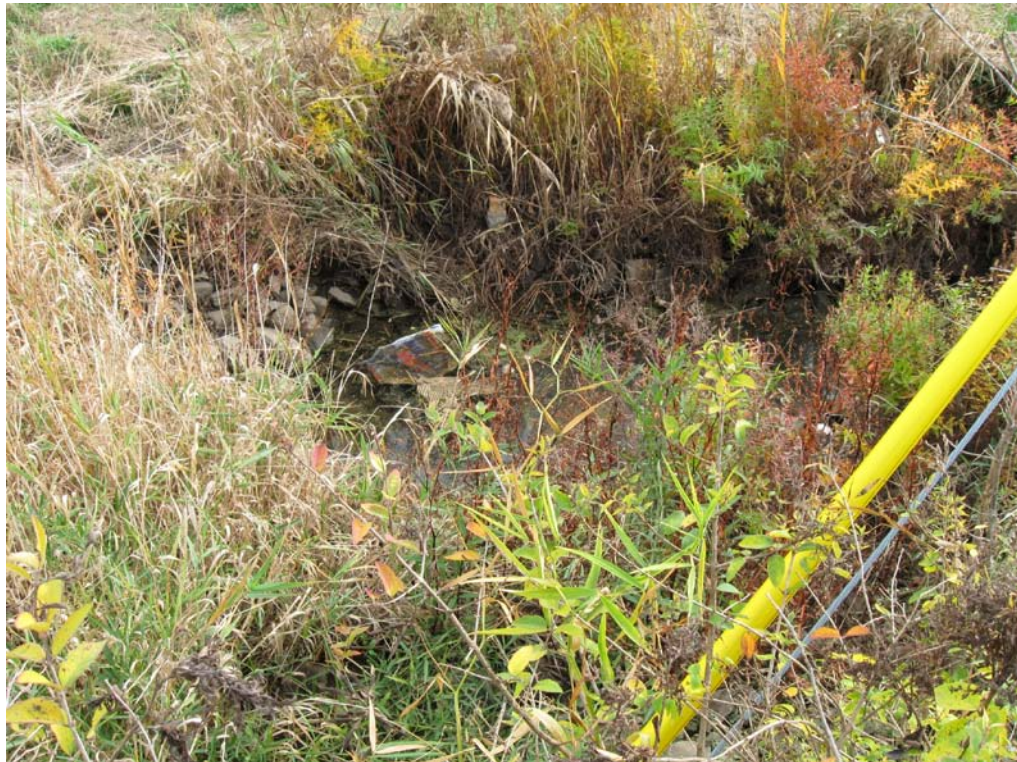
Photograph 14: View of CB-01. Plugged.

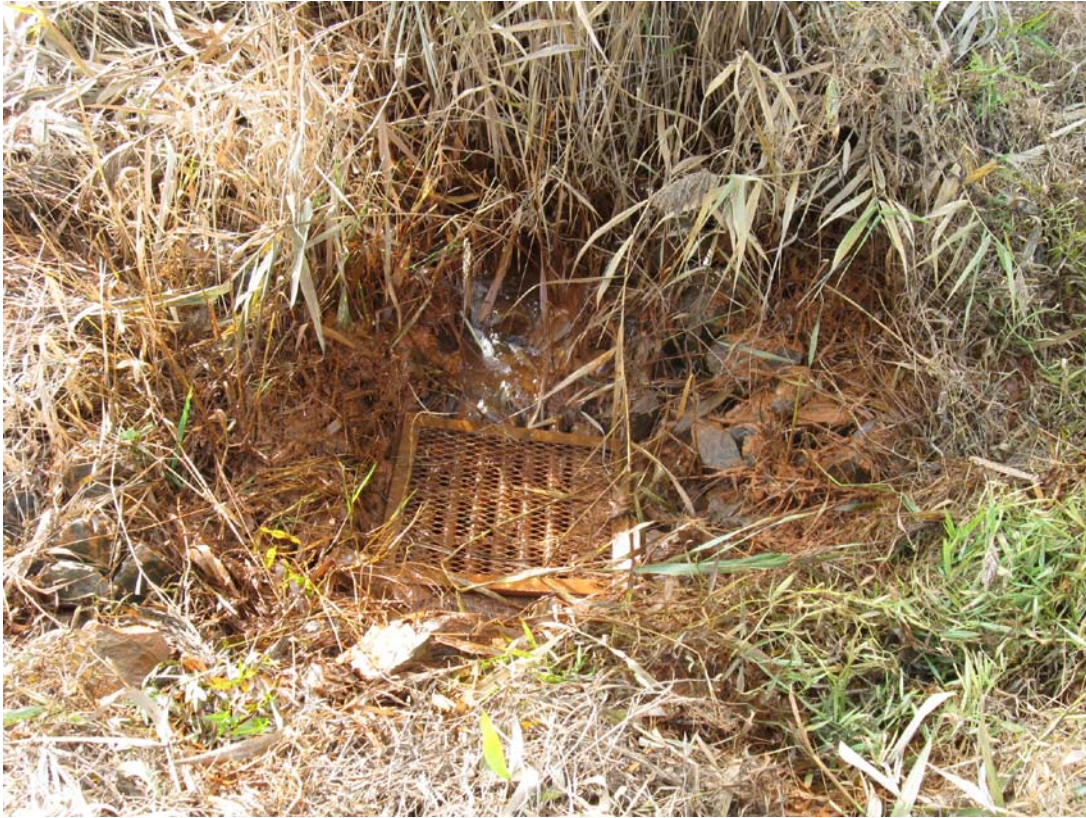
Photograph 15: View of CB-02 after cleaning.

- Catch basins plugged (CB-1, CB-2, CB-3 and CB-4) (Figures 1, 3 and 5 and Photographs 4, 8, 10 and 14). Debris was removed from the catch basins later the same day of the site inspection (Photographs 15, 16, and 17).

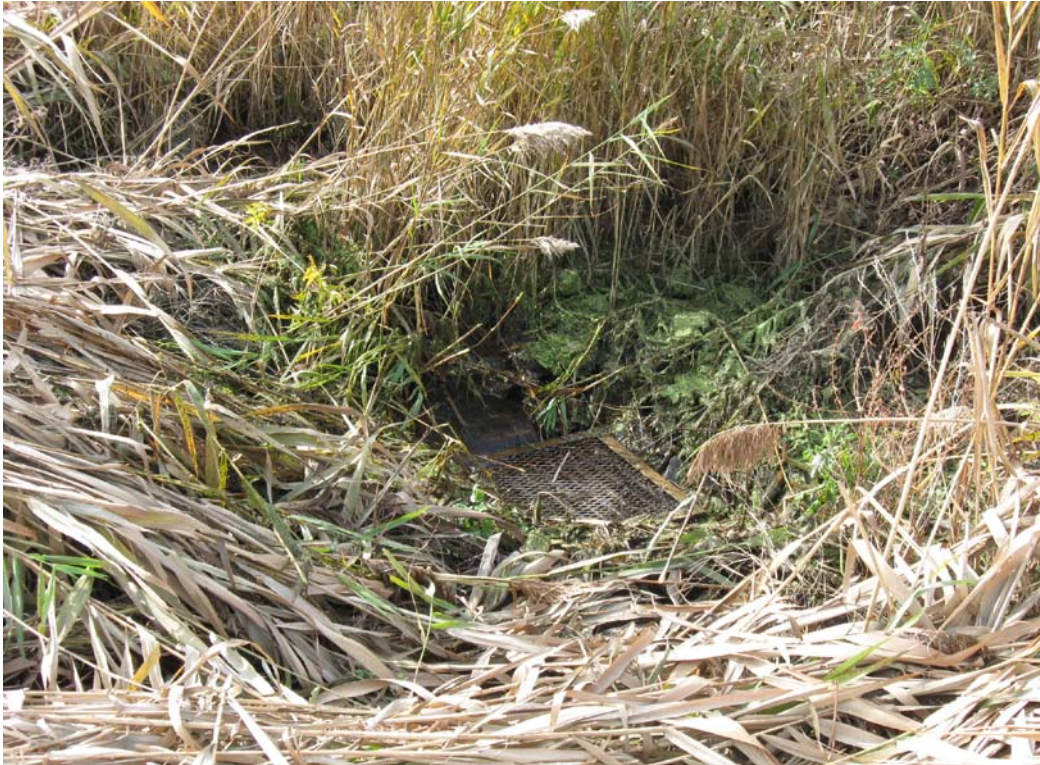
Photograph 16: View of CB-03 after cleaning.

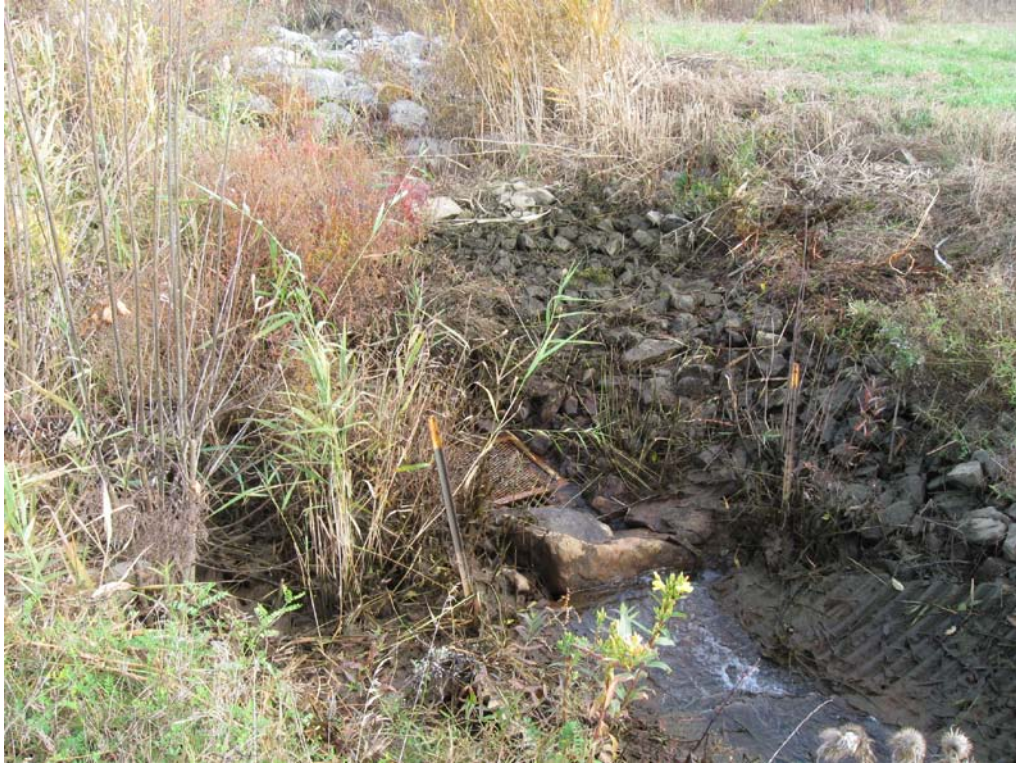
Photograph 17: View of CB-04 after cleaning.
