RACER Trust

Interim Corrective Action Plan (ICAP)

Buick City, Flint, Michigan

February 27, 2026

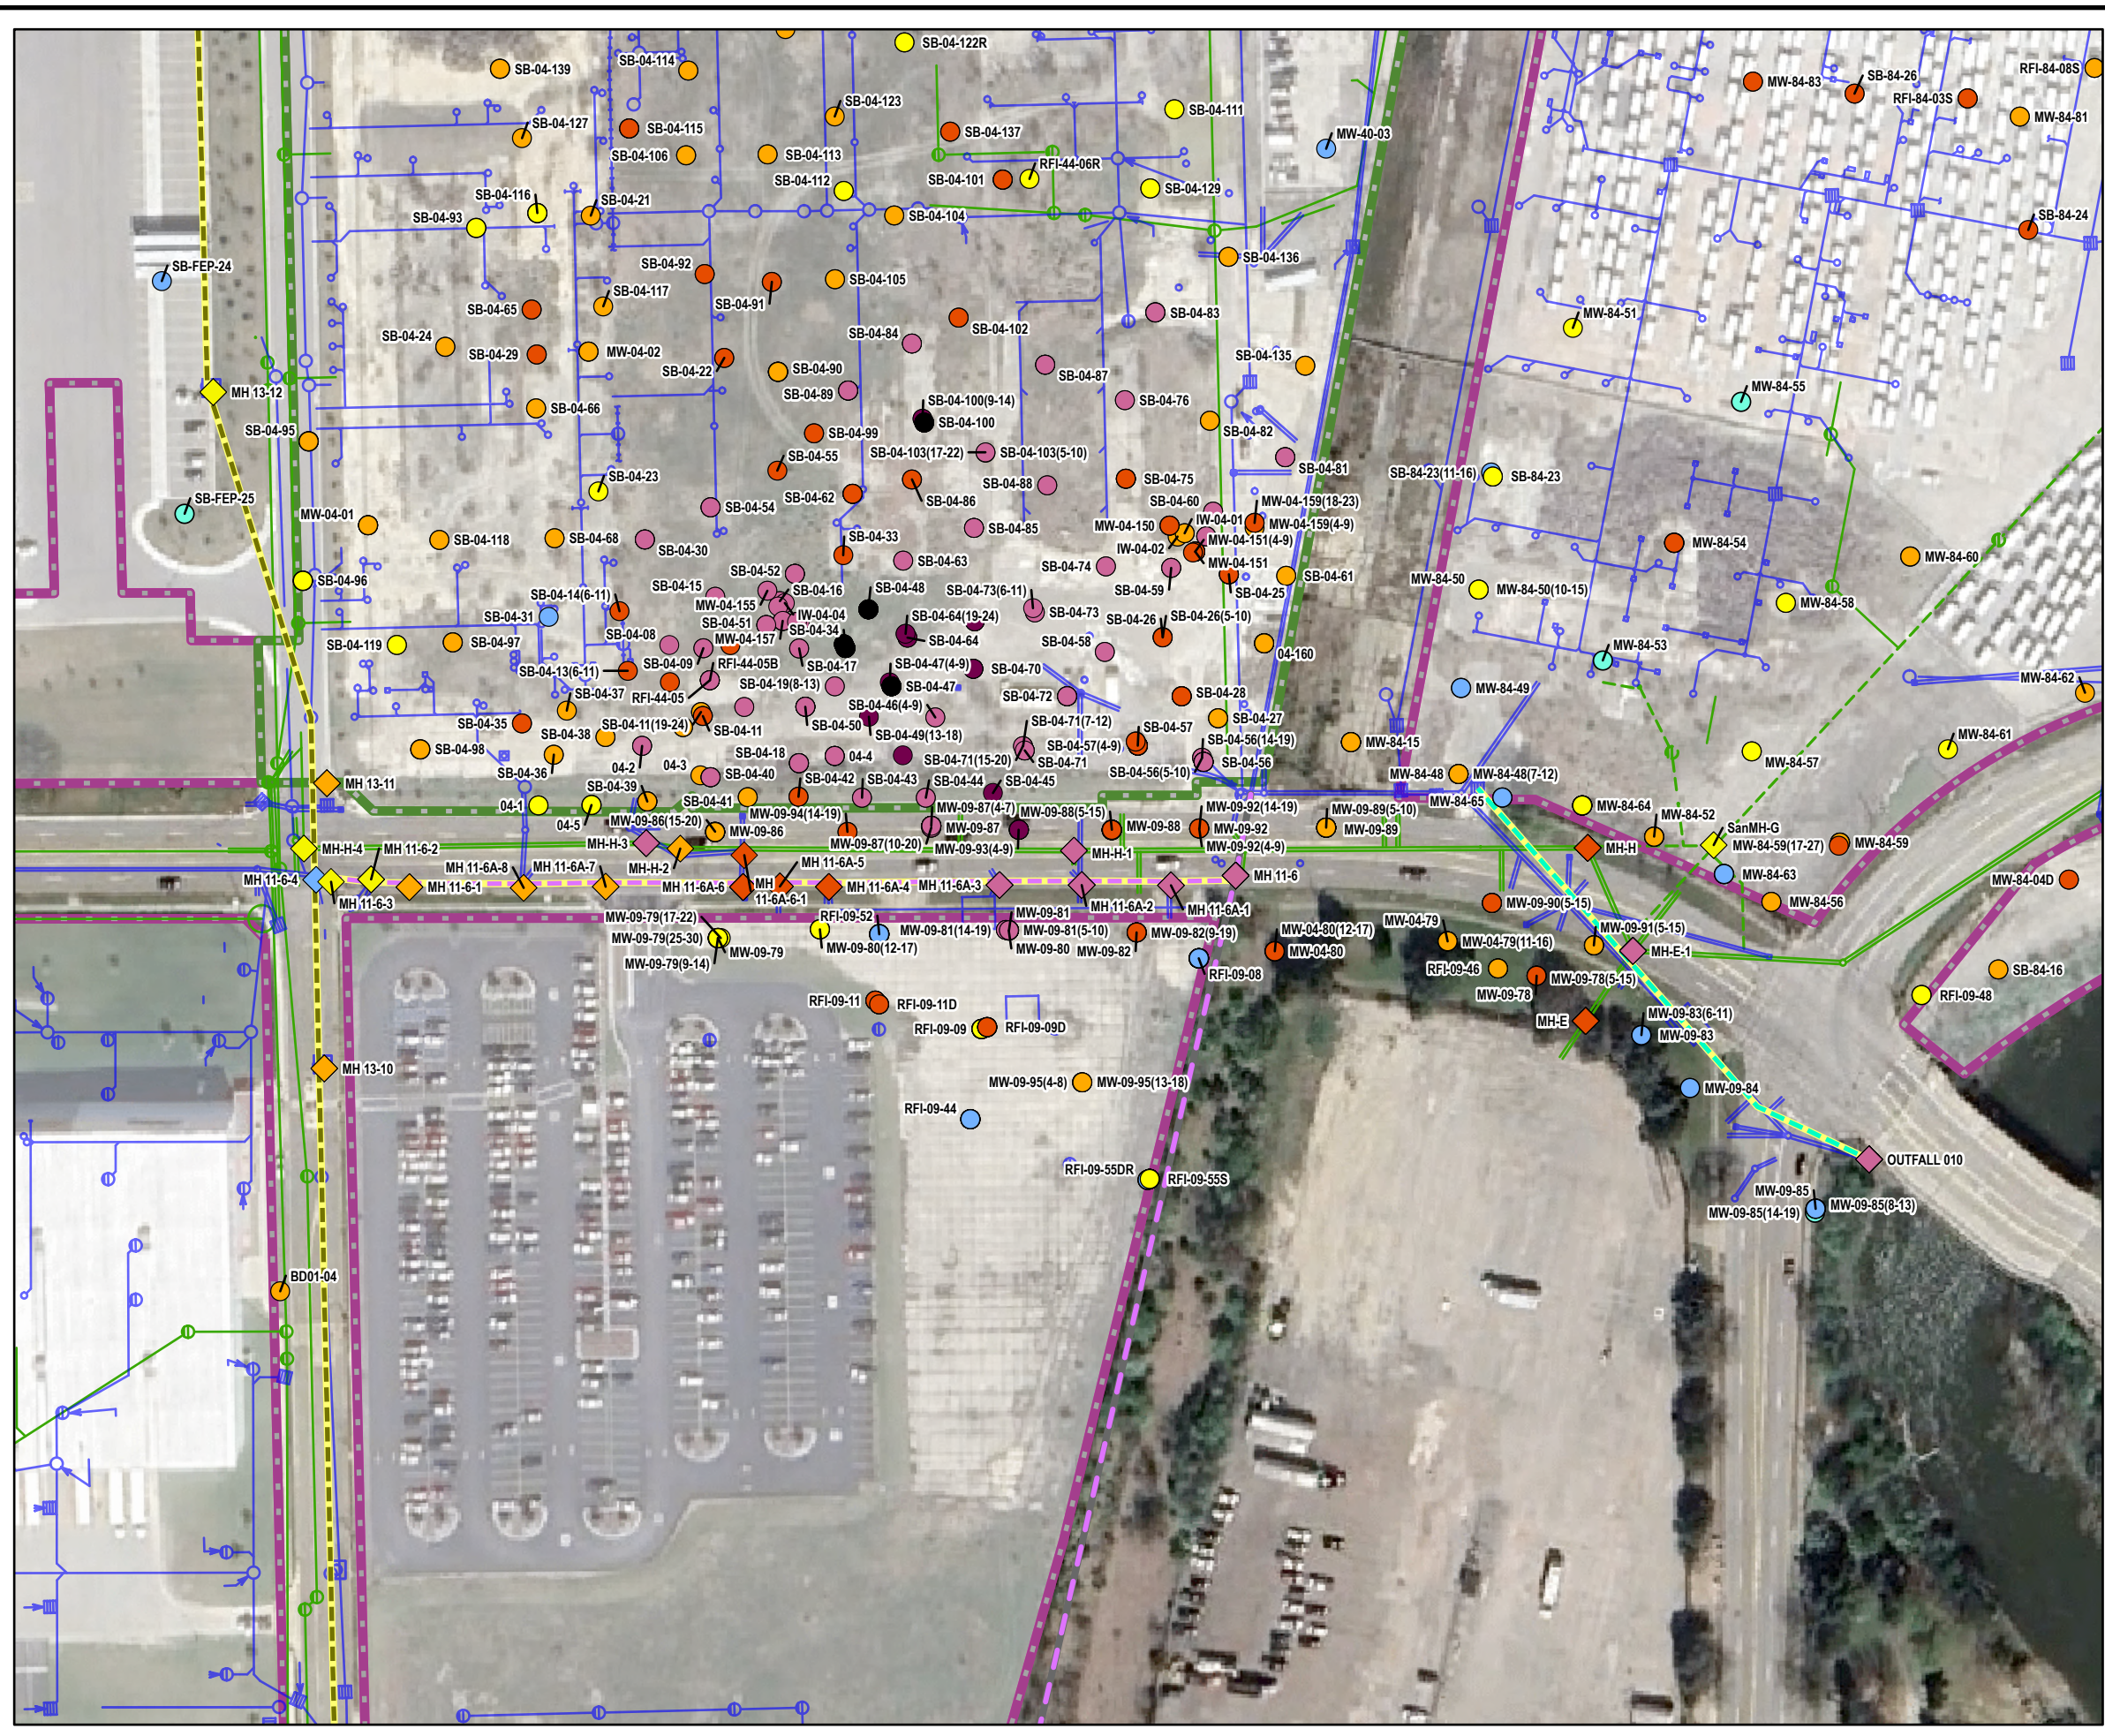
**PFOS IN GROUNDWATER AND SEWERS
 OUTFALLS 010, 011, 013**

PFOS impacted groundwater associated with a source area located north of Hamilton Ave and east of Industrial Ave is infiltrating to stormwater infrastructure associated with Outfalls 011, 013, and 010 (**Figure 1**). The objective of the proposed corrective action for Outfalls 011, 010, and 013 is to eliminate, to extent practical, infiltration of Site related PFOS impacted groundwater into nearby storm sewers (specifically stormwater infrastructure that lead to Outfalls 011, 010, and 013), nearby sanitary sewers, and stop further migration from the Hamilton Ave source area toward the Flint River. Note that corrective action for Outfall 002 is discussed in Section 5. The Outfall areas consist of the following (**Figures 2 and 3**):

The proposed corrective action for Outfalls 011, 013, and 010 is the installation of the Hamilton Ave groundwater remedy (Remedy) which is a hydraulic control system that will meet the objective of eliminating, to extent practical, infiltration of Site related PFOS impacted groundwater into nearby storm sewers (specifically stormwater infrastructure that leads to Outfalls 011, 010, and 013), nearby sanitary sewers, and stop further migration from the Hamilton Ave Source Area toward the Flint River. The Remedy will include a groundwater collection extraction system, as well as a treatment system to be located near the extraction system. The groundwater extraction system will be capable of influencing groundwater flow direction and reducing the groundwater elevation to mitigate infiltration of Site related PFOS impacted groundwater into storm sewer infrastructure connected to Outfalls 011, 010, and 013. The groundwater that is extracted will be treated in a treatment system to meet the City of Flint POTW discharge prohibitions and limits prior to discharge to the sanitary sewer. The Remedy is in the preliminary design phase; therefore, the details provided in this report are considered preliminary and subject to change as additional information is gathered and the design is advanced. An Interim Measures Work Plan that includes the basis of design and system design information for the Remedy will be submitted to EGLE for review, comment and approval.

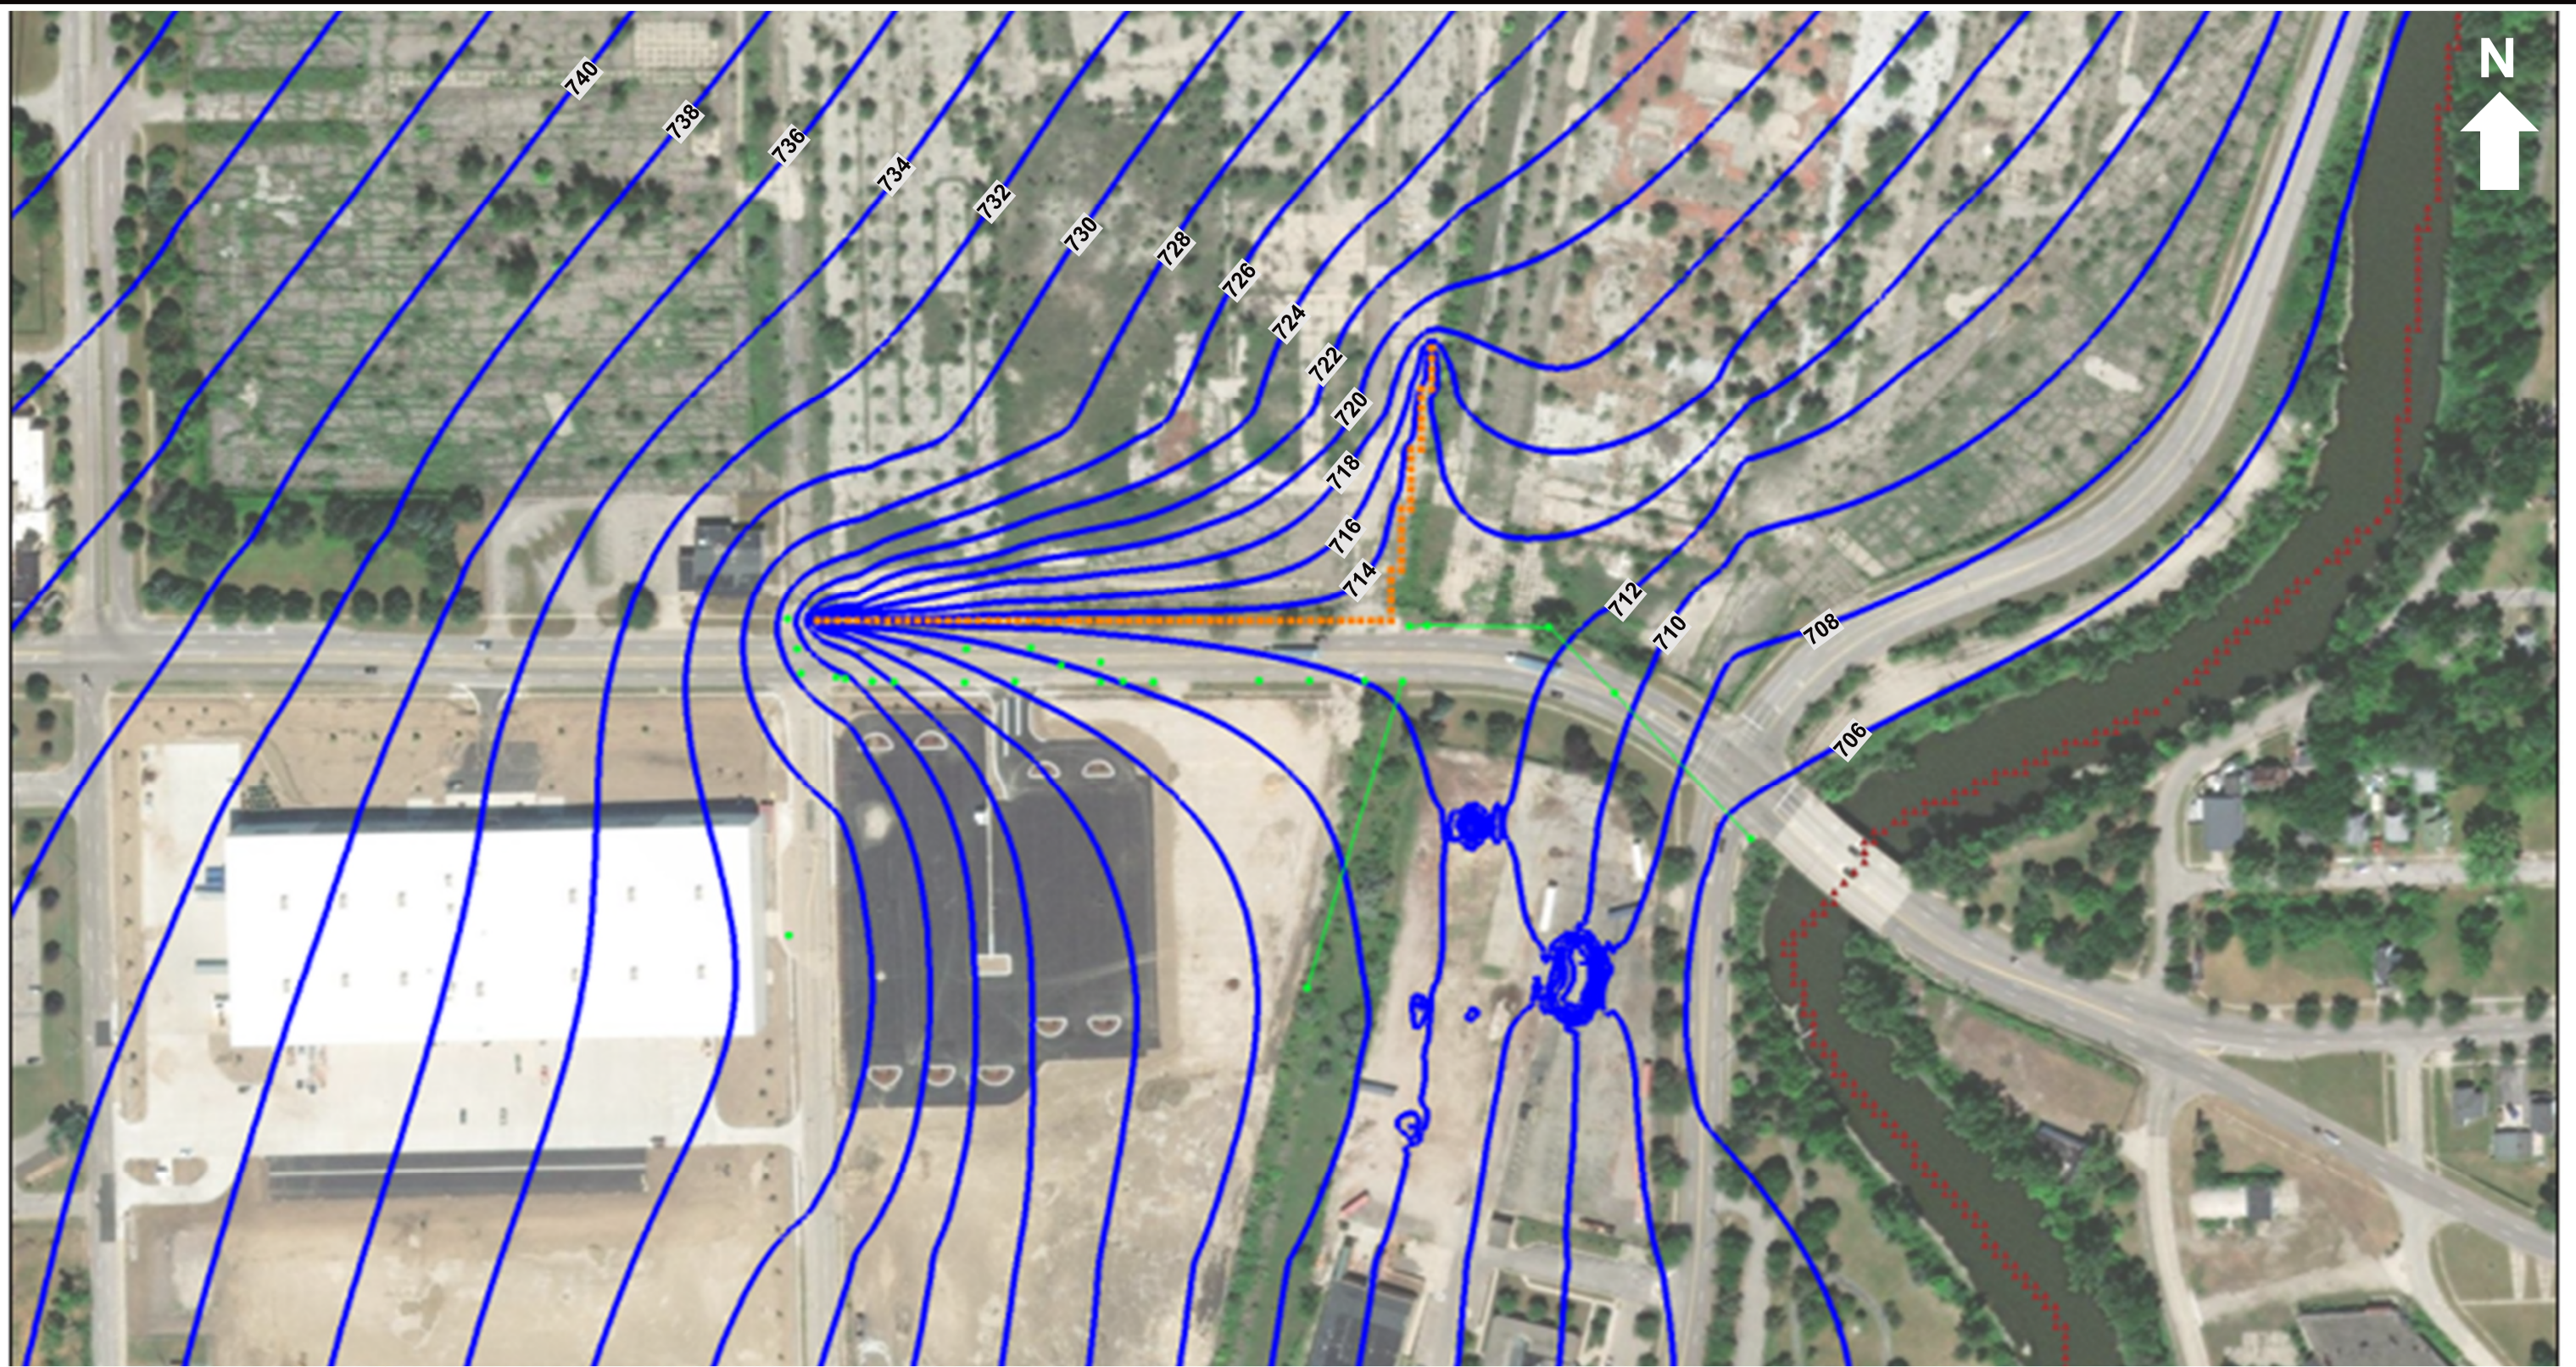
FIGURE
5

A pre-design geophysics study was completed in 2025 along the potential alignments of the collection trench to better understand potential subsurface obstructions and to inform constructability evaluations. Boring logs, test pit information, historical drawings, and historical aerial imagery was used to calibrate and ground truth the geophysical information obtained from the pre-design study. Results generally showed shallow abandoned utilities are present across the entire potential alignment of the trenches. Additionally, an approximately 250-foot-long former building foundation present along Hamilton Ave shows potential concrete obstructions as deep as 18 feet below ground surface.

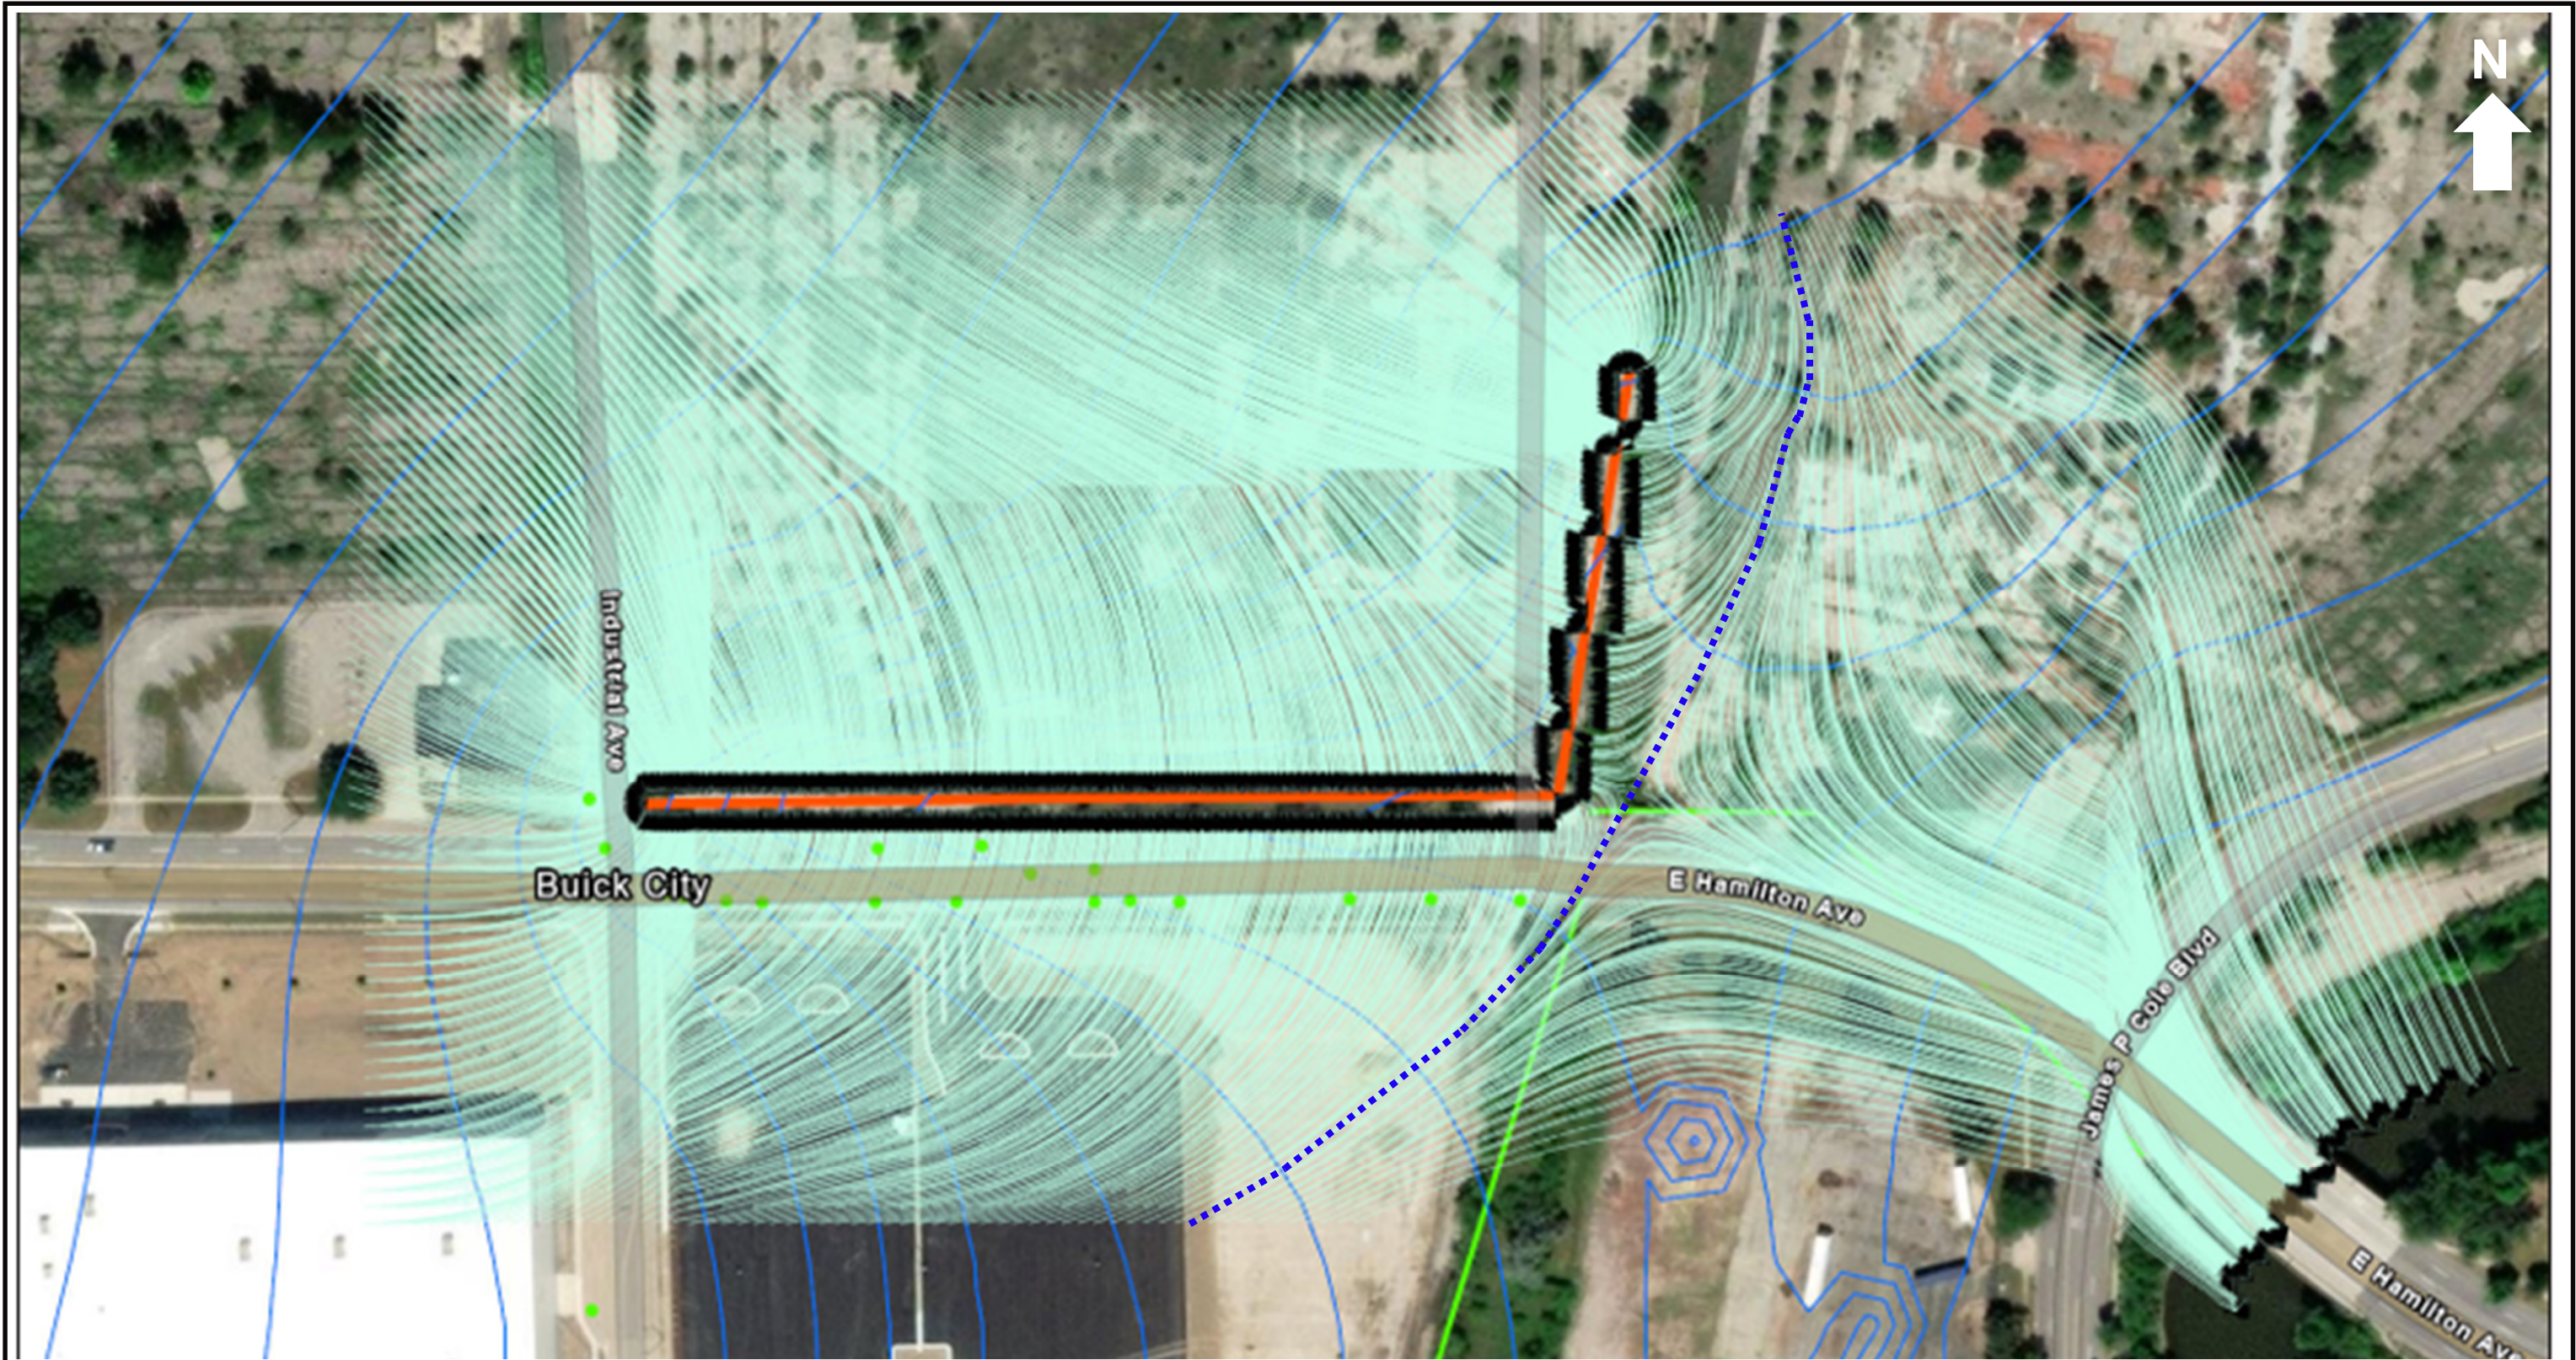
FIGURE
6

To support the design of the Remedy, a numerical groundwater flow model of the generalized local groundwater flow system at the Site was generated. The model includes Site specific water level data, boundary conditions, hydraulic conductivity distribution, and applied recharge. The groundwater flow model will be used to simulate localized groundwater flow dynamics at the Site to objectively support the design of the Remedy.

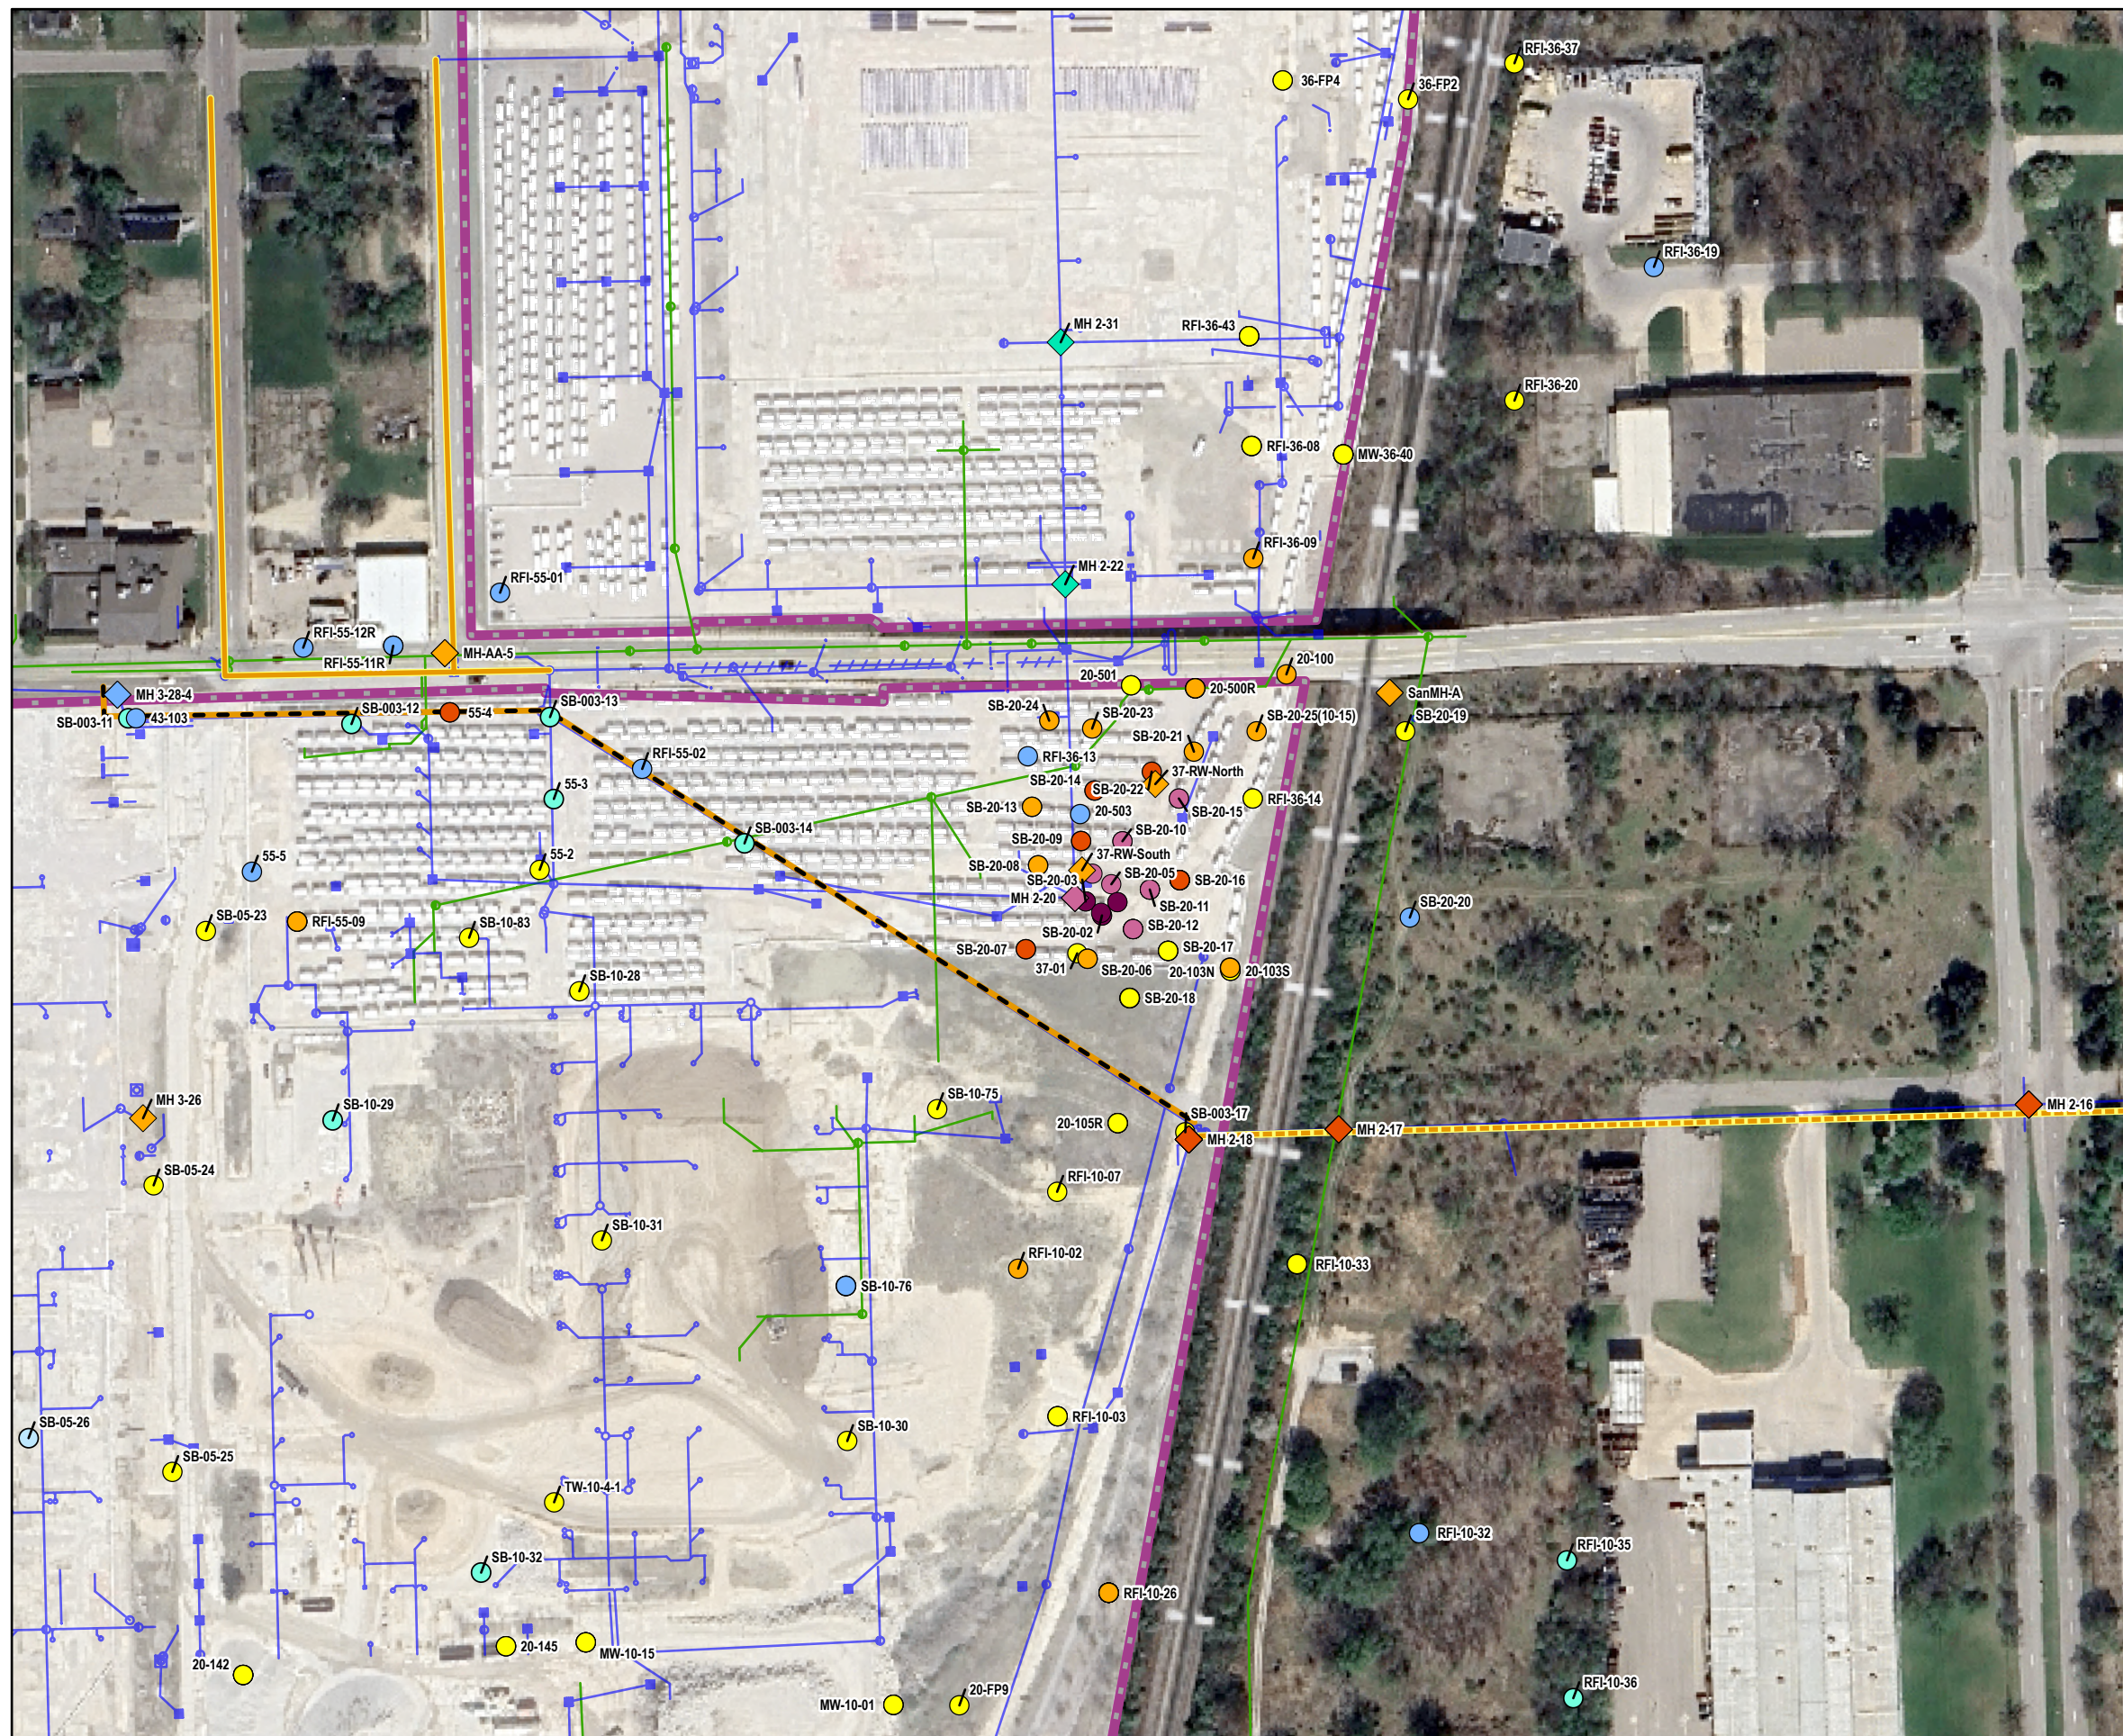
FIGURE
7

PFOS impacted groundwater associated with a source area located south of East Stewart Avenue and west of James P Cole Boulevard is infiltrating into lines and/or structures that are connected to Outfall 002 (**Figure 7**).

Proposed corrective action for Outfall 002 includes sealing MH 2-18 to stop the leak found on the joint below the outlet pipe. The 2-18 structure was replaced in 2020 with a new concrete manhole with a polypropylene lining, the main infiltration point of the structure in the lined manhole is from failed seals at the pipe penetrations entering or exiting the structure and where the polypropylene liner and RCP pipe join inside the structure. Sealing of the 54-inch diameter pipe penetrations will be done by probe injection grouting from the exterior of MH 2-18 to preserve the polypropylene lining. A highly expansive hydrophobic grout that provides compressive strength characteristics (i.e. Avanti's AV-275 Soilgrout or similar) will be used to stabilize the soils in the location and fill the voids that likely have formed from the infiltration. The purpose of the hydrophobic grout is to reduce the rate of infiltration, but small leaks may still be present. If small leaks are present following the hydrophobic grouting, they will be addressed with a low-viscosity hydrophilic grout (I.e. Avanti's AV-202LV Multigrout LV or similar) that adheres well to surfaces and will penetrate the remaining water pathways around the manhole structure. Any voids in the manhole liner, pipe penetrations, pipe joints, etc. that are large enough to be packed with oakum, shall be filled ahead of grouting and during the grouting. This is recommended to keep "free grout" from escaping before curing.

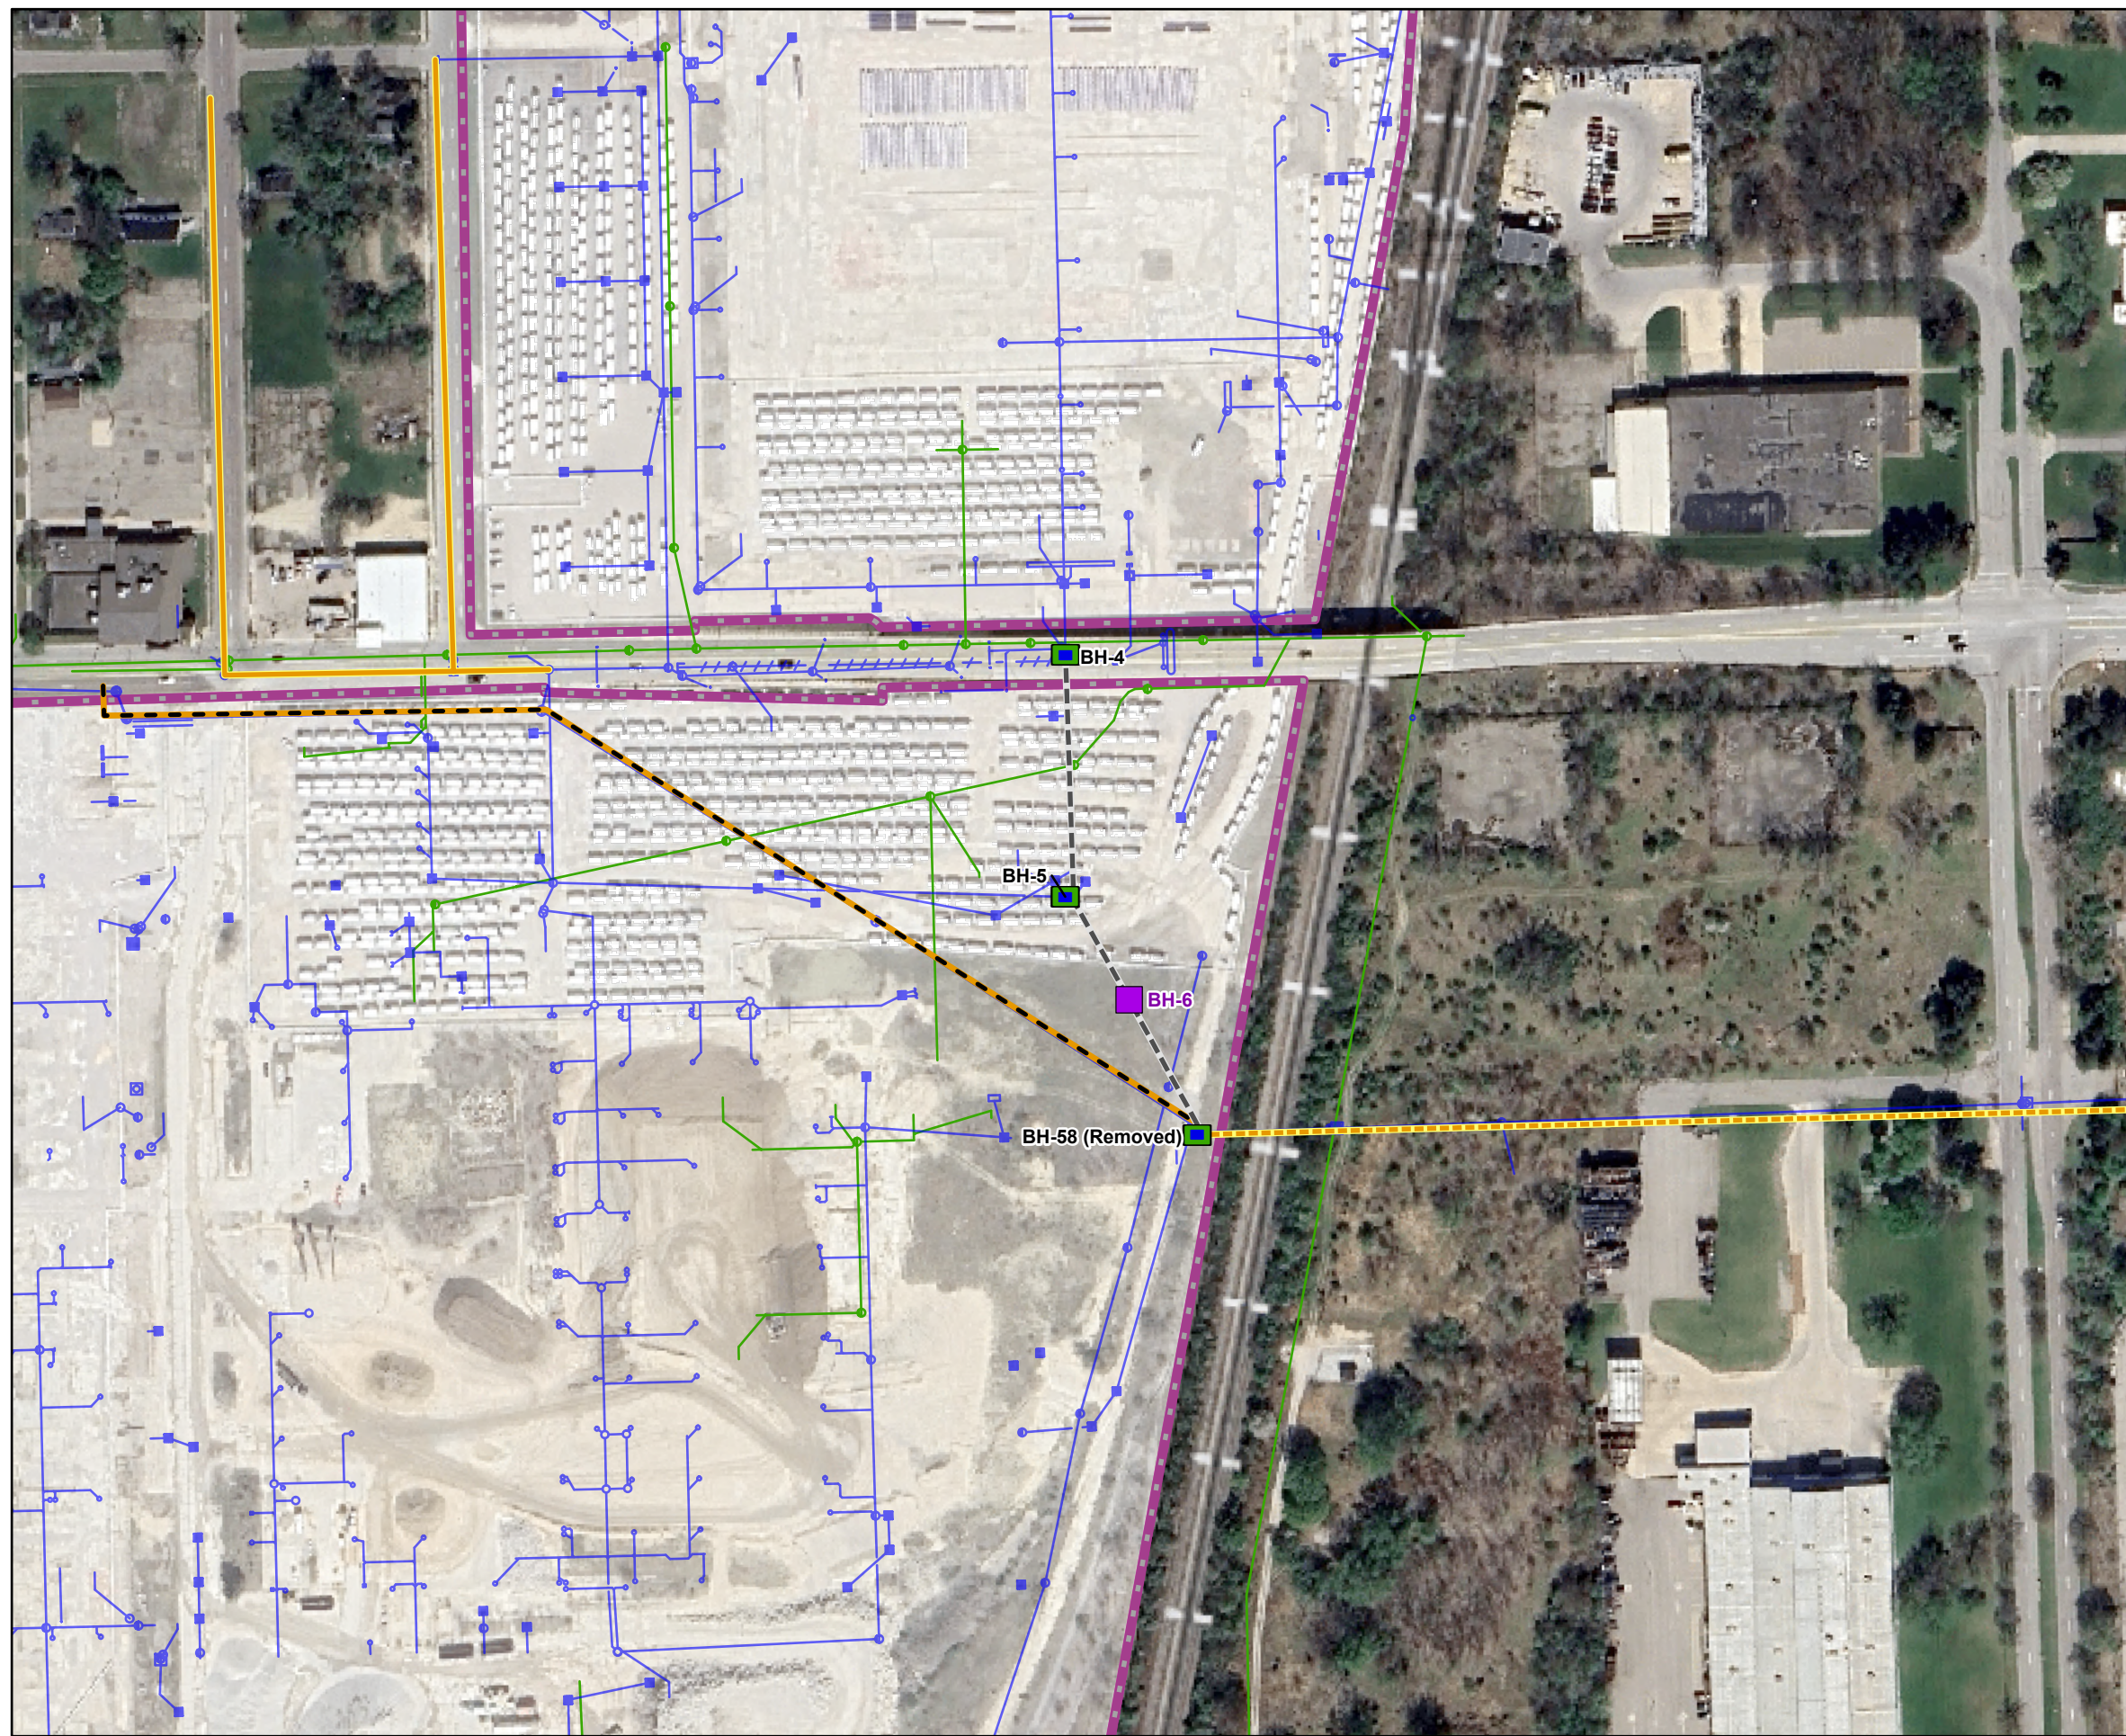
In 2020, a portion of the Outfall 003 drainage area was rerouted into the Outfall 002 storm sewer. In November 2020, as part of Site storm sewer reroute activities, the manhole structure and bulkhead previously installed at MH 2-18 were removed and a new manhole structure was installed at MH 2-18. A new sealed storm sewer was installed from Stewart Avenue to MH 2-18 to convey the upgradient flow through the Site. Between January 2021 and April 2022, grout was injected at MH 2-18 due to infiltration at a connection joint. An inspection inside MH 2-18 on November 11, 2022 showed a leak in the joint below the outlet pipe and a leak at the joint downgradient of MH 2-18. Locations of IMs are included on **Figure 8**.

Prior to completing the repair, MH 2-18 will be pumped down to inspect the leakage and confirm the conditions and that the proposed approach is appropriate. While the MH 2-18 structure is pumped down and accessible, the on-Site lined section of the Outfall 002 storm sewer and the first downgradient pipe joint will also be inspected. The inspection of the lined portion will be done through CCTV and/or with staff crawling the line. The inspection of the first downgradient pipe joint will be done by a person following confined space safety protocols from inside the MH 2-18 structure. If the inspection identifies a change in condition that impacts the repair approach and/or identifies additional leaks that could be contributing to PFOS infiltration, RACER Trust will communicate the findings and path forward with EGLE. In addition, groundwater sampling of select wells in the vicinity of MH 2-18 will be completed prior to completing the repair in order to obtain a pre-repair snap shot of PFAS concentrations in

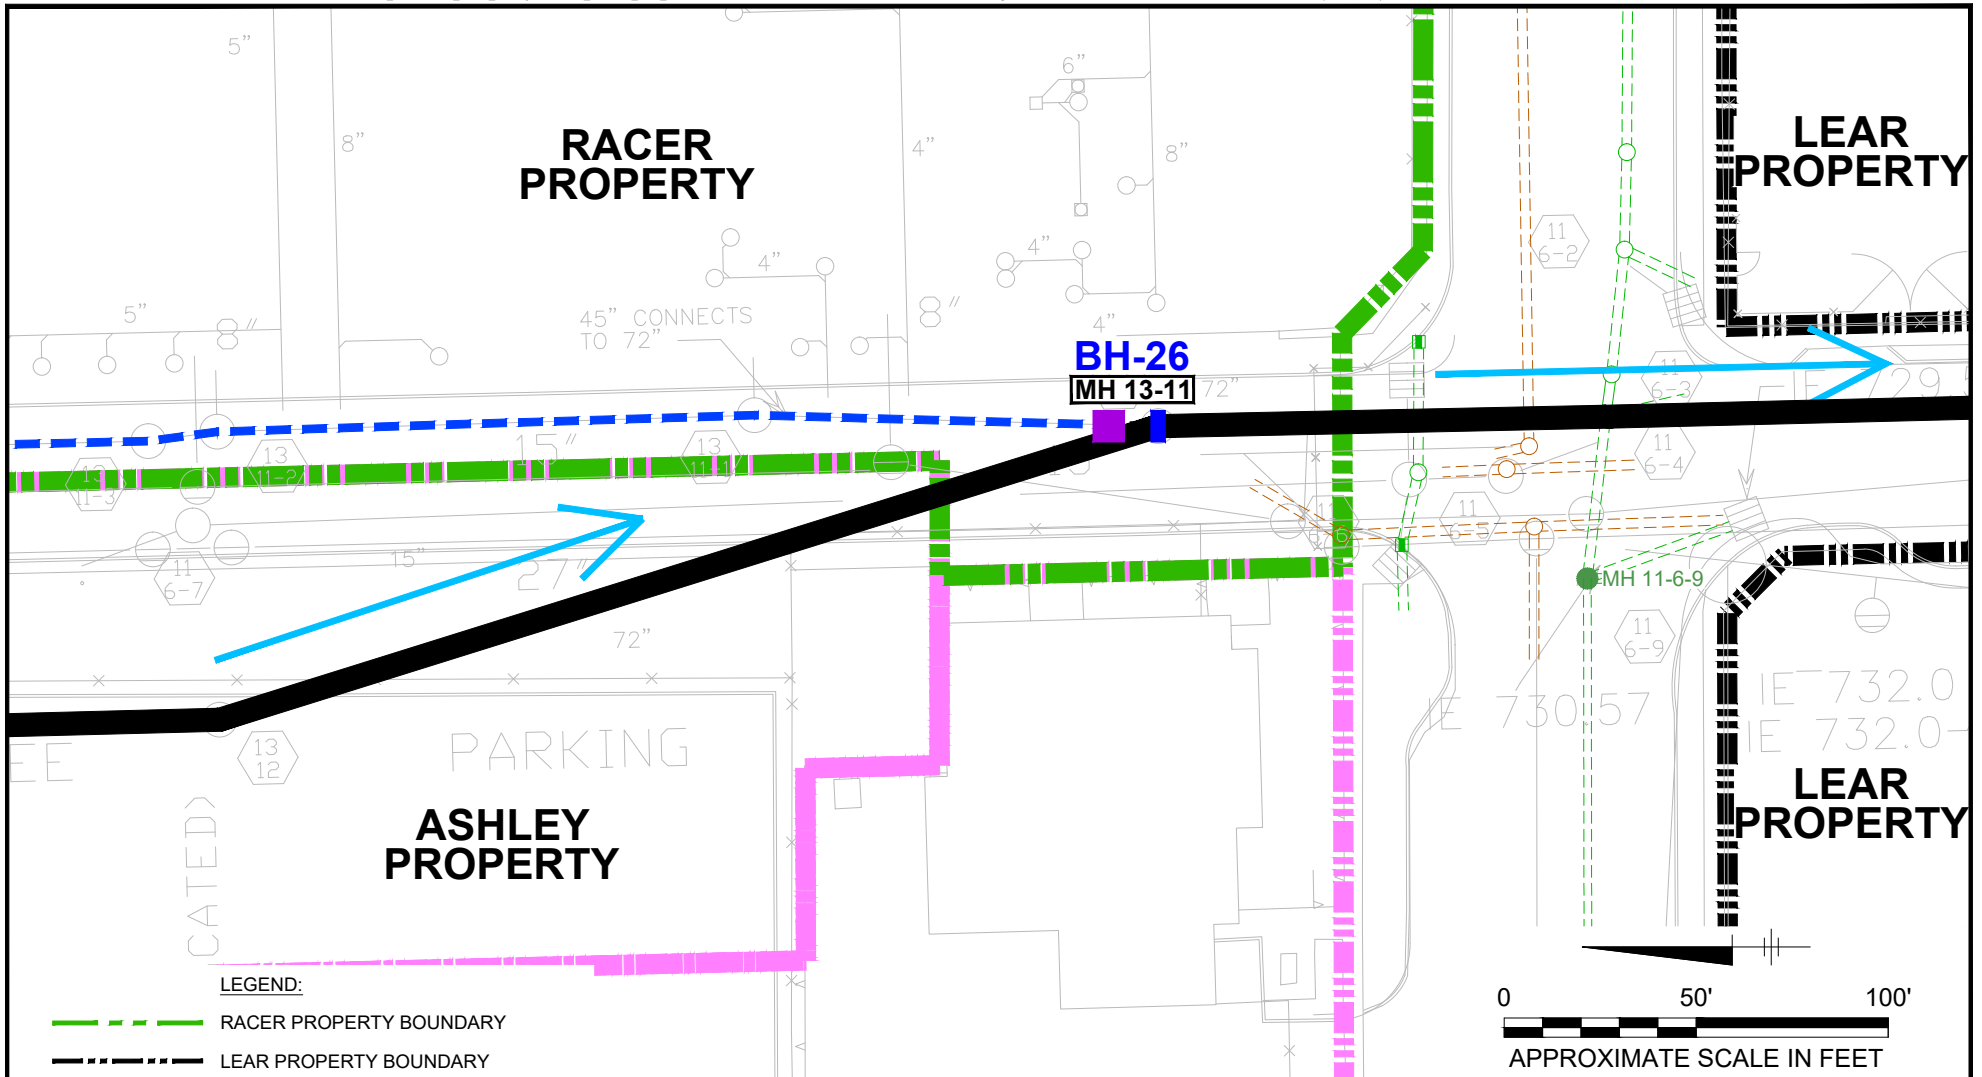
OUTFALL 013

In June 2020 a lateral was bulkheaded to address PFOS impacted groundwater infiltrating into the Outfall 013 storm sewer. The bulkhead leaked after construction and repairs were attempted; however, a physical disconnection was subsequently completed upgradient of the bulkhead in September 2021.

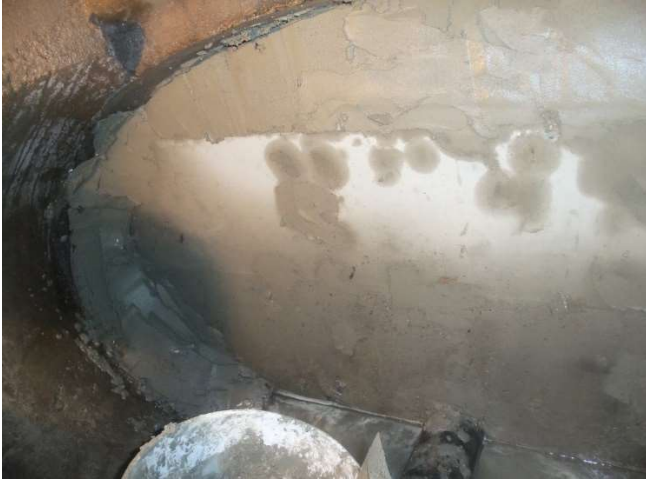
Example of grouted, sealed concrete with form removed. Flow through pipe still in place while additional curing occurs.
