RACER Trust

Interim Corrective Action Plan (ICAP)

Buick City, Flint, Michigan

February 27, 2026

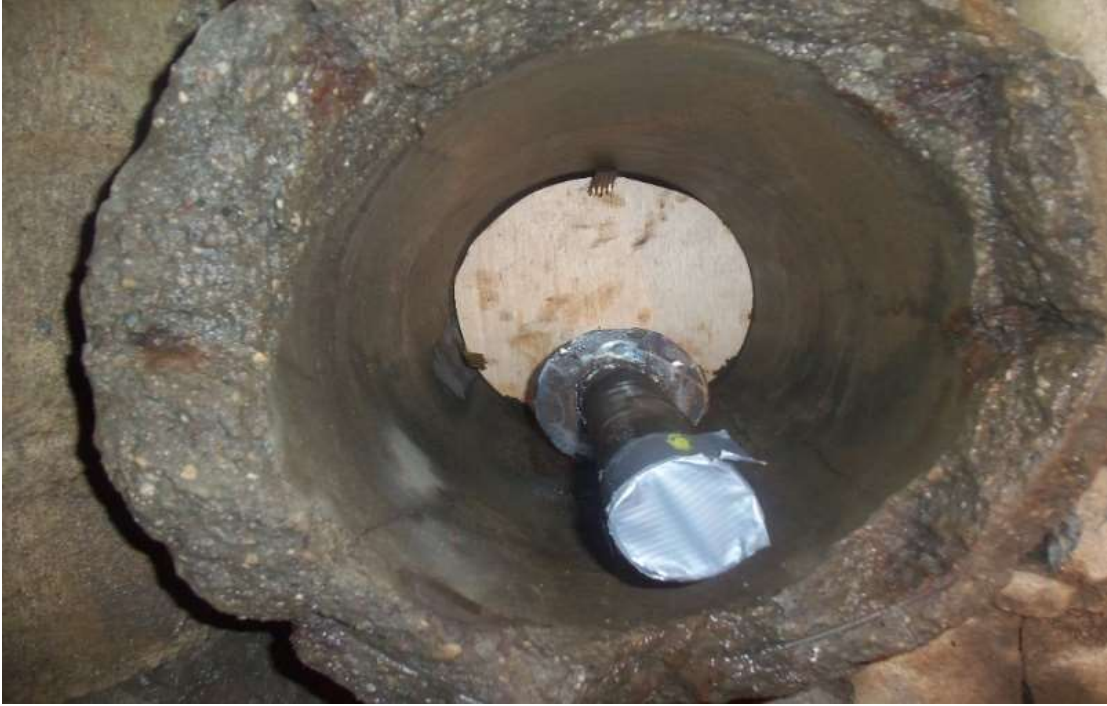
Example of plug on 24" line with flow through pipe still in place

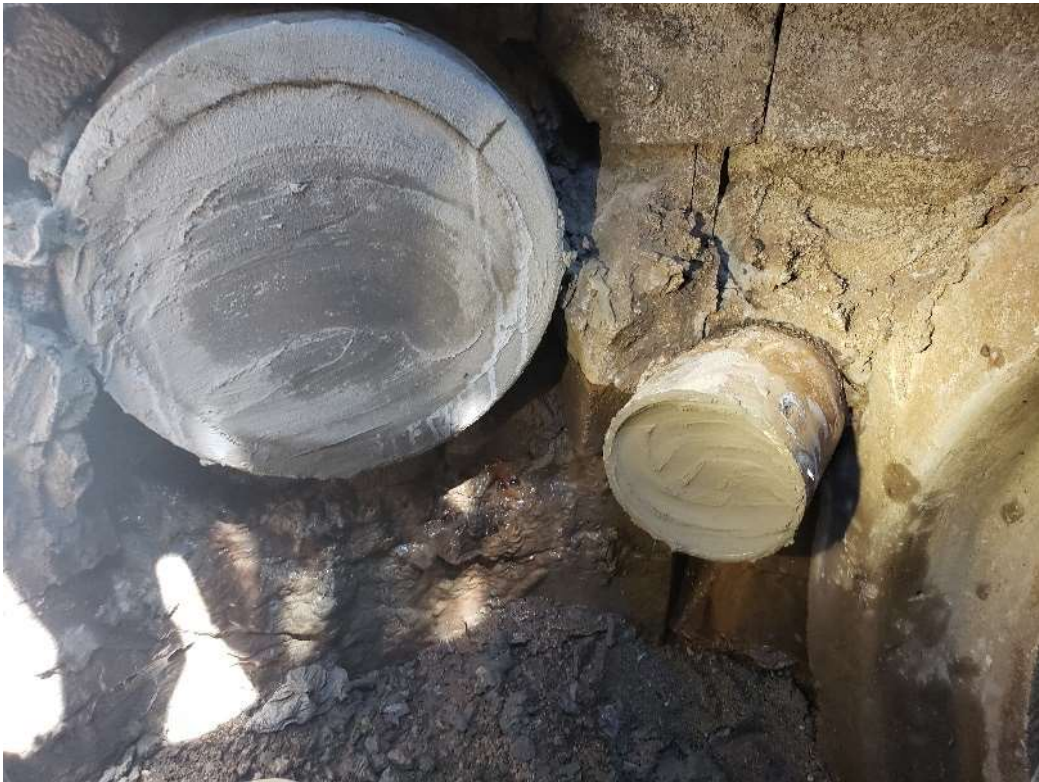
Two sealed plugs in laterals.

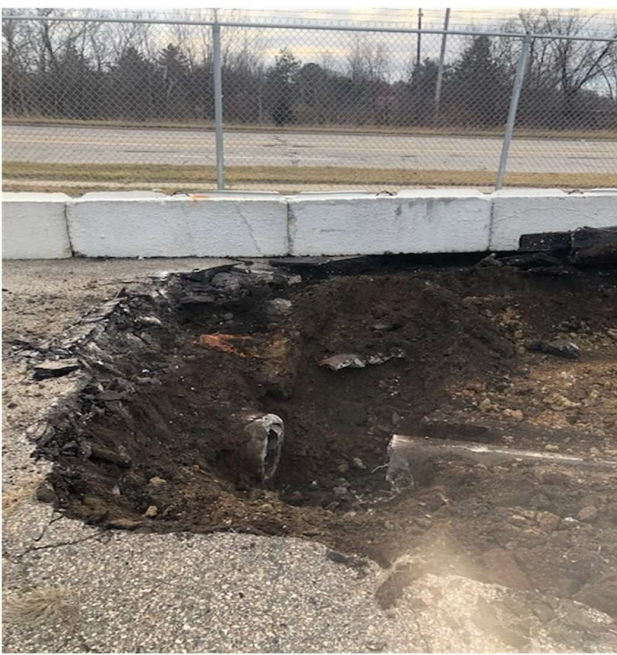
Example of disconnected line. Sewer line excavated, disconnected and temporary plugged prior to sealing

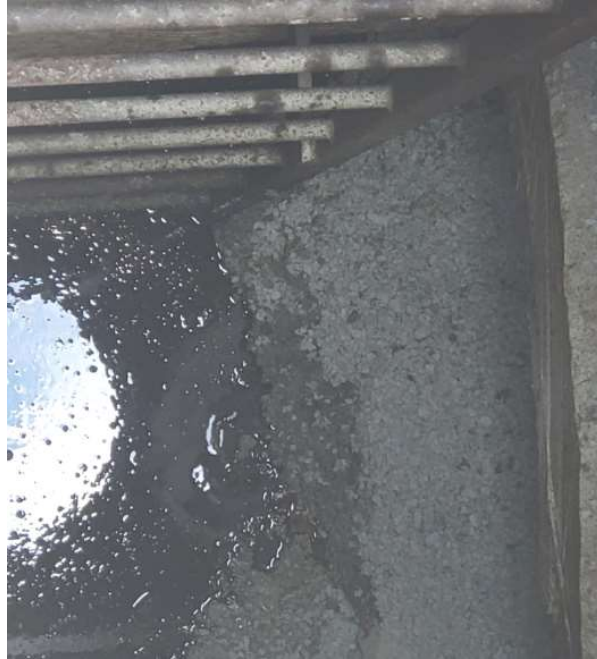
Bentonite placed in manhole prior to filling with concrete.

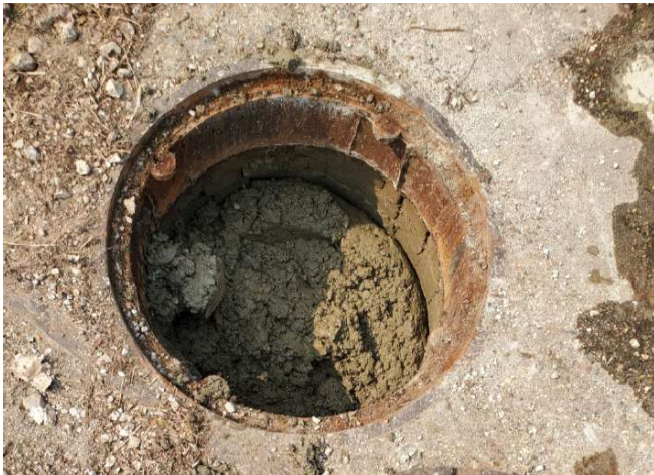
Manhole partially filled with concrete. Small pours completed to eliminate voids.

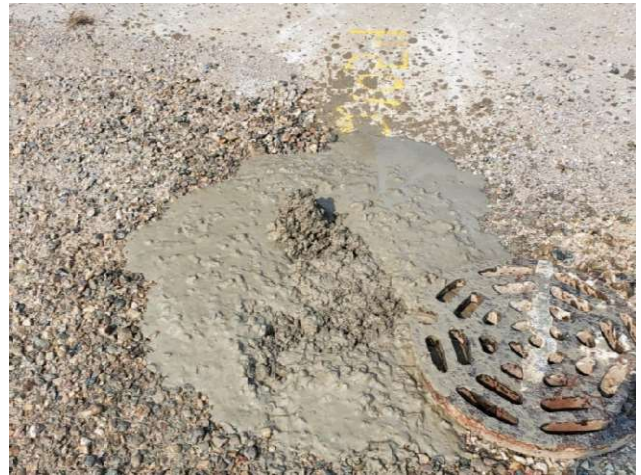
Filled manhole (on left) to grade, prior to finishing. Former cover on right.

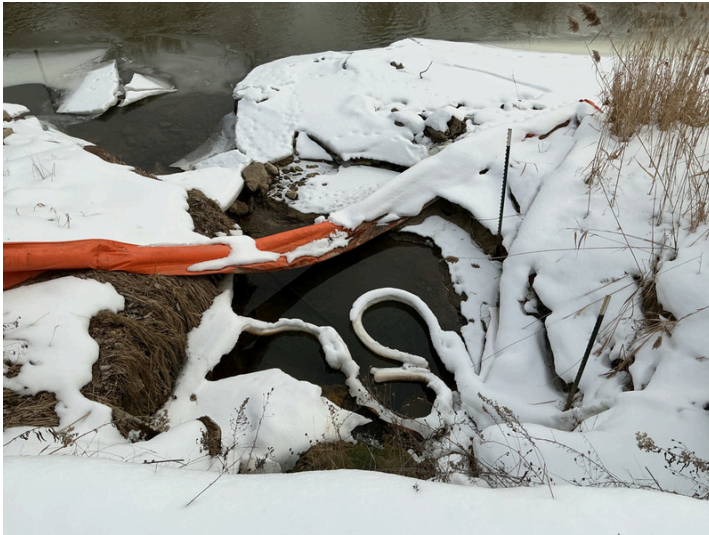
Boom Location	Outfall 5
Percent Coverage	0
Condition	CL = Clear: Water at outfall looks like the rest of the river water, FR = Frozen: Outfall area is frozen
Maintenance	None
Additional Notes

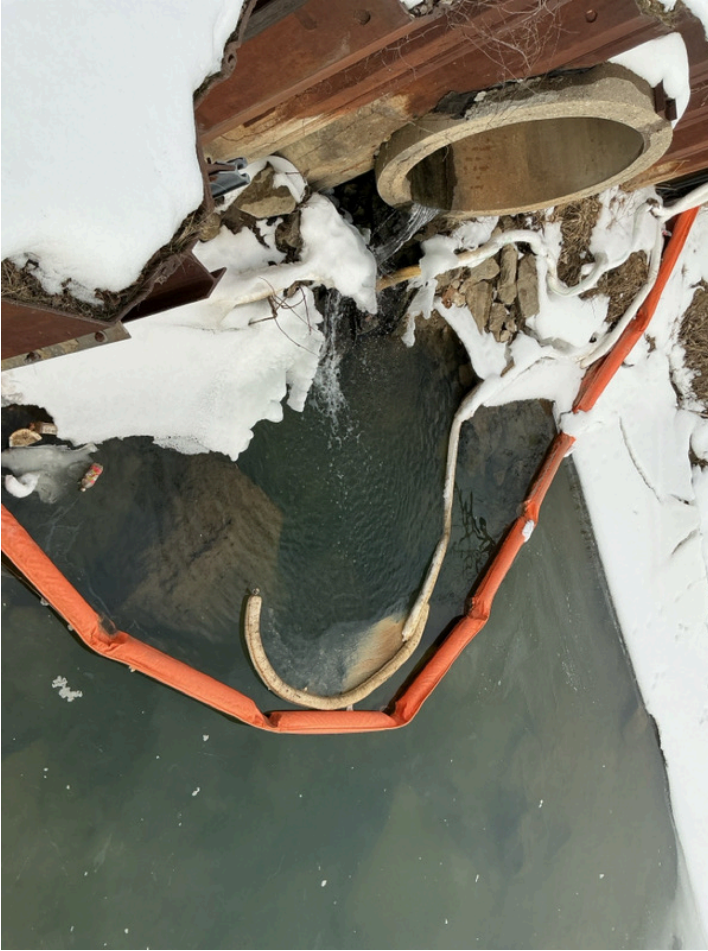
Outfall Inspections - 2. Outfall 3

Boom Location	Outfall 3
Percent Coverage	8
Condition	EO = Emulsified Oil: Oil is white or cream colored either floating on surface or soluble in water, FO = Foam: Collection of minute bubbles forming a frothy mass, FR = Frozen: Outfall area is frozen, TR = Trash: Trash either coming out of discharge point or within booms at river
Maintenance	Absorbent booms need to be replaced when outfall area thaws
