RE: *October 17, 2013 Inspection Letter* Dated December 6, 2013  
Coldwater Road Landfill  
1245 East Coldwater Road, Flint, MI  
MID 005 356 860 / Consent Order No. 64-05-92

RACER TRUST  
 COLDWATER ROAD  
 LANDFILL FACILITY  
 FLINT, MICHIGAN

**4TH QUARTER 2013  
 SPARSE VEGETATION LOCATION  
 MAP**

**4TH QUARTER 2013  
BURROW LOCATION  
MAP**

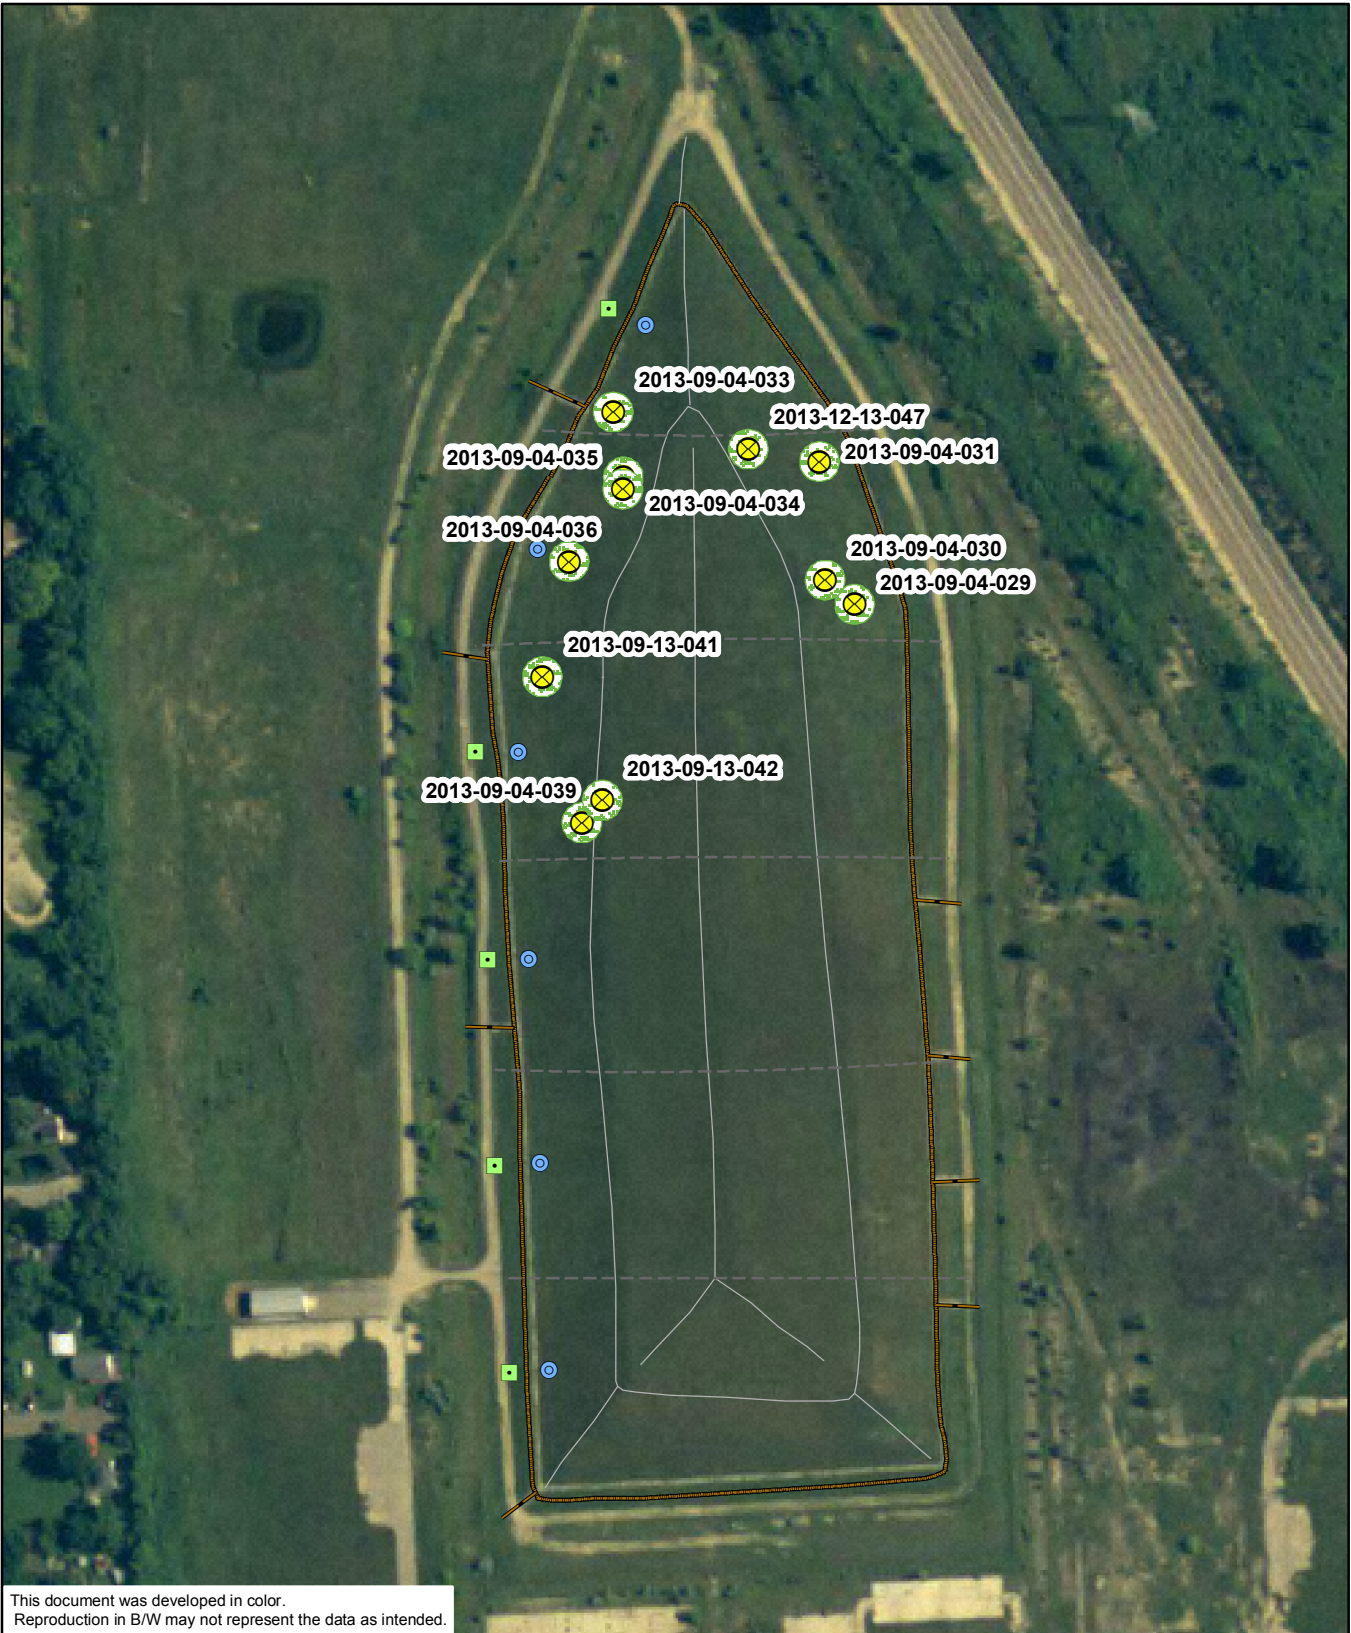
**Response:** O'Brien & Gere raked and spread grass seed over the areas with sparse vegetation and will continue to monitor the areas and spread additional grass seed as needed. The attached figure titled: 4<sup>th</sup> Quarter 2013 Sparse Vegetation Location Map and vegetation photo-log provide the location and photographs of the sparsely vegetated former animal burrow areas. Several of the areas had already been seeded, but the seed was just starting to sprout at the time of the MDEQ's inspection. Each area will be seeded or re-seeded as necessary in the early spring to re-establish the vegetative cover in these areas.

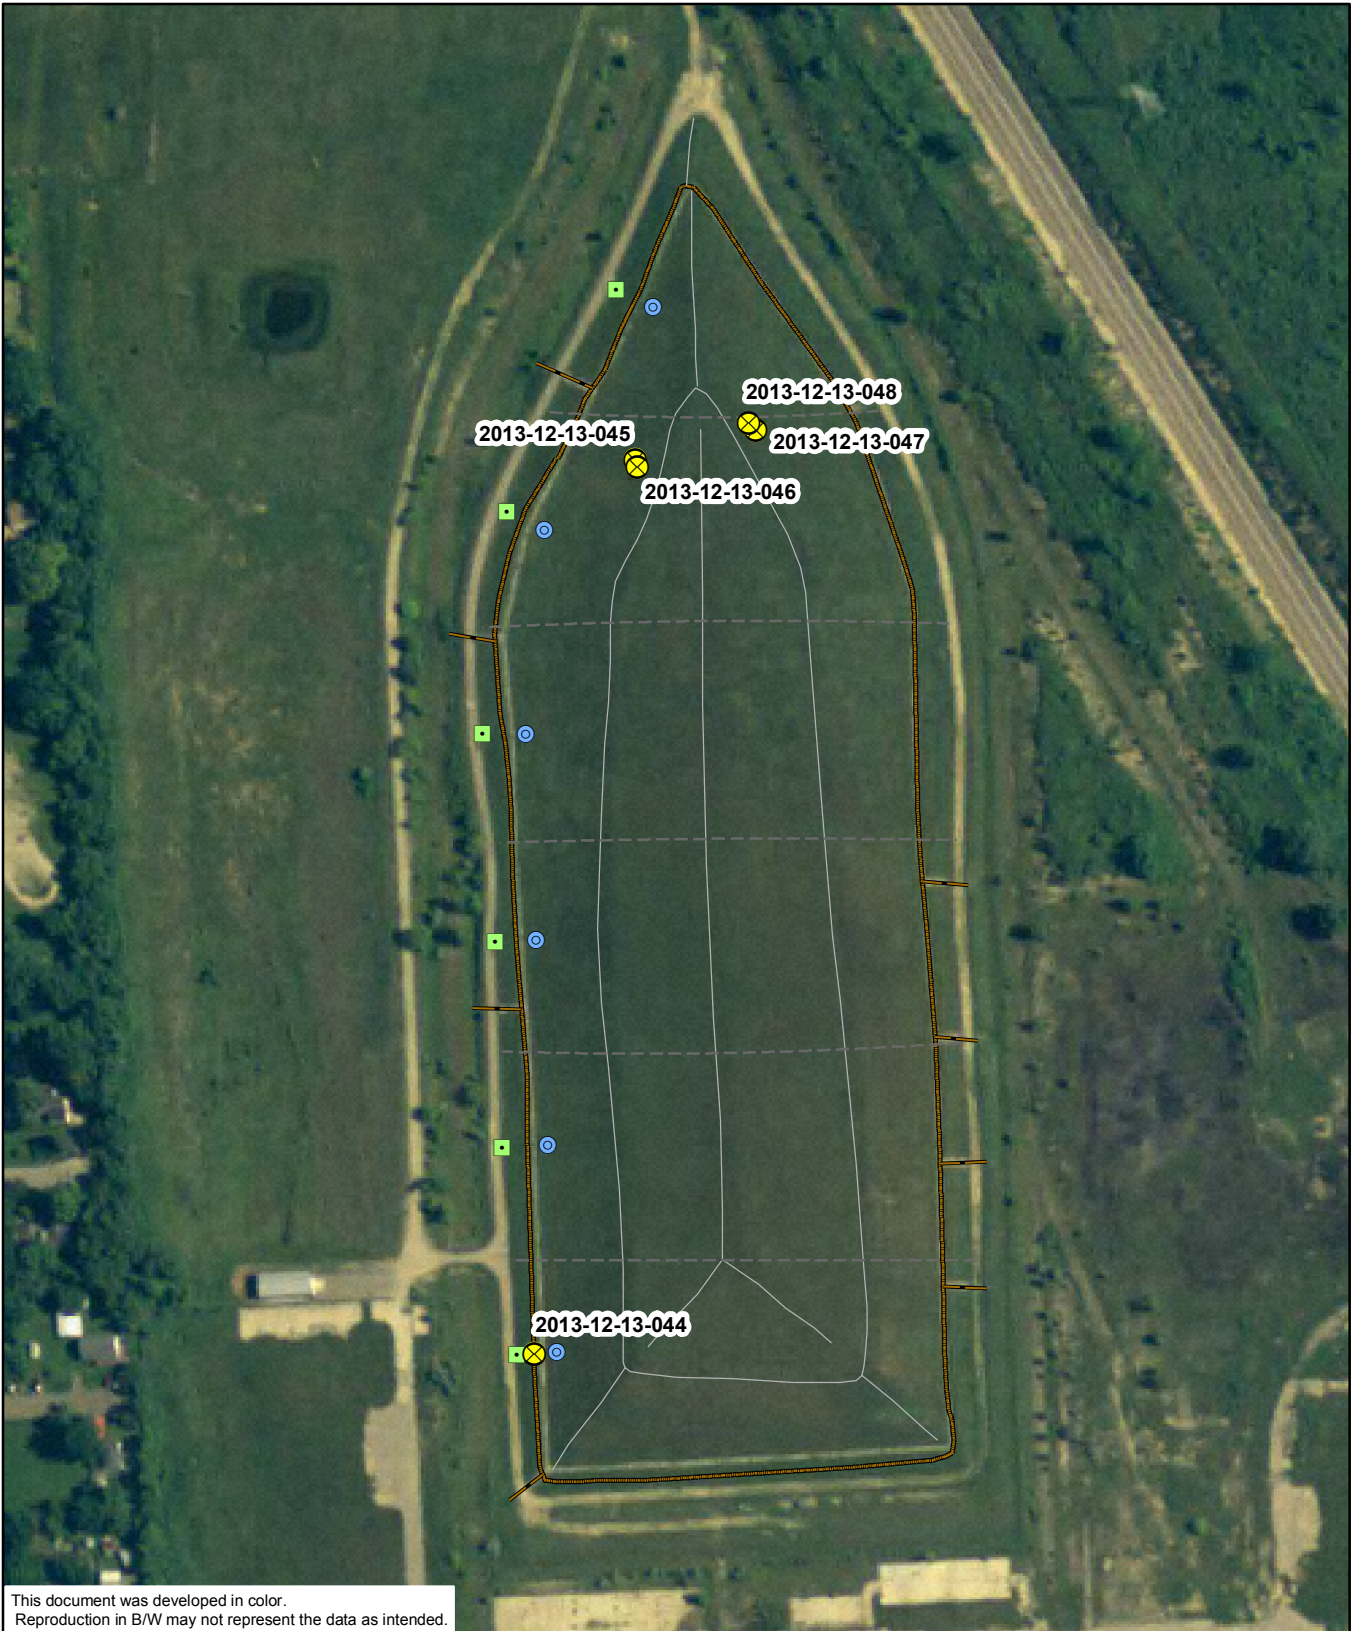
**Response:** O'Brien & Gere used a survey quality handheld global positioning system (GPS) unit to locate the cited animal borrows. The attached figure titled: 4<sup>th</sup> Quarter 2013 Burrow Location Map and animal burrow photo-log from the fourth quarter 2013 quarterly report provides the location of the animal burrows and photo documentation for the burrows discovered during the 4<sup>th</sup> quarter 2013. The photo-log contains the information pertaining to the length, depth and diameter of each animal burrow and provides a statement of whether the liner system appears to have been damaged (states: "No signs of liner damage," or would provide observations pertaining to potential liner damage if geonet, liner or clay was observed in the spoils from the animal burrow). The animal burrow figure and photo-log will continue to be included as part of the progress reports.

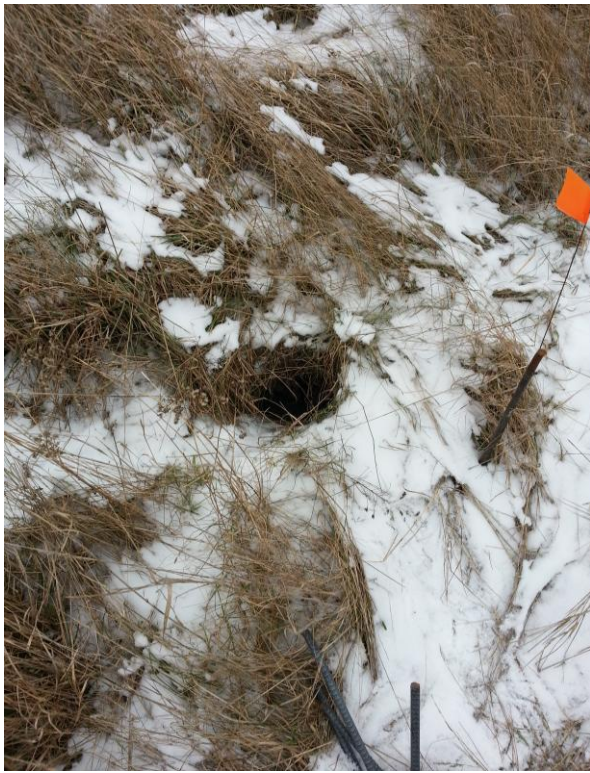
<b>LOCATION:</b> B1 – Middle of Slope		<b>APPROX. LENGTH:</b> 5+ ft	<b>APPROX. DEPTH:</b> 1.5 ft	<b>APPROX. DIAMETER:</b> 8 inch
<b>DATE FOUND:</b> 10/17/13	<b>DATE CLOSED:</b> 12/13/13

<b>NOTES:</b> <b>ID: 2013-12-13-045</b> PRE repair photo of burrow entry. Trap set up for eight weeks. Trapped animal at exit burrow. The distance between the entry (045) and exit (046) was approximately eight feet. No signs of liner damage.				
<b>LOCATION:</b> B1 – Middle of Slope		<b>APPROX. LENGTH:</b> 5+ ft	<b>APPROX. DEPTH:</b> 1.5 ft	<b>APPROX. DIAMETER:</b> 8 inch
<b>DATE FOUND:</b> 10/17/13	<b>DATE CLOSED:</b> 12/13/13

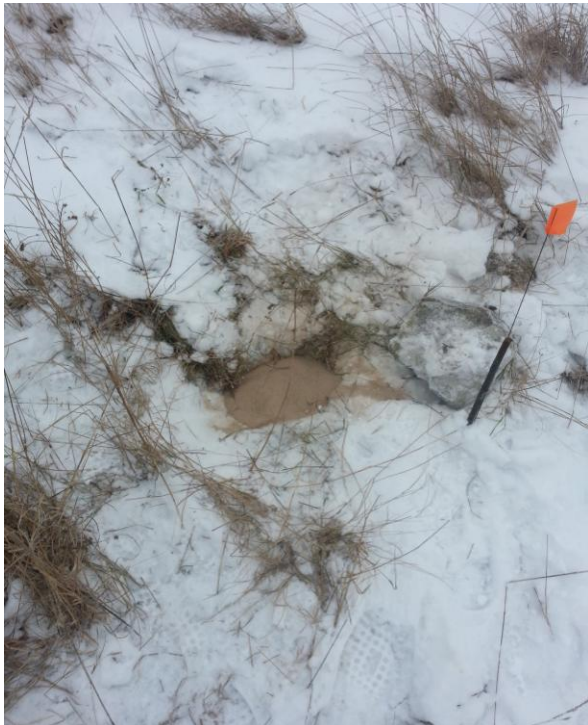
<b>NOTES:</b> POST repair photo of burrow entry. Filled in burrow. Will spread grass seed in the spring.

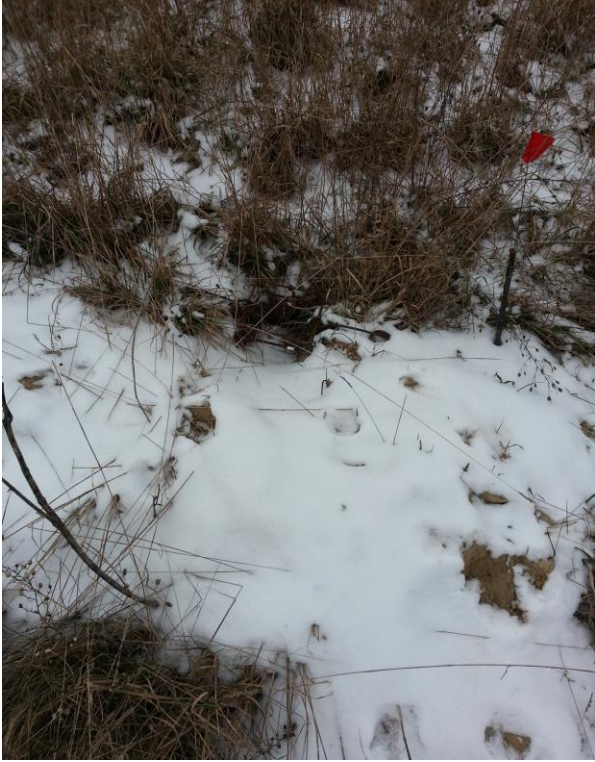
<b>LOCATION:</b> B3 – Top of Slope		<b>APPROX. LENGTH:</b> 5+ ft	<b>APPROX. DEPTH:</b> 1.5 ft	<b>APPROX. DIAMETER:</b> 8 inch
<b>DATE FOUND:</b> 10/17/13	<b>DATE CLOSED:</b> 12/13/13

<b>NOTES:</b> <b>ID: 2013-12-13-047</b> PRE repair photo of burrow entry. Trap set up for eight weeks. Trap moved by animal three times and reset. No activity for 4 weeks. No animal trapped. The distance between the entry and exit was approximately thirteen feet. No signs of liner damage.				
<b>LOCATION:</b> B3 – Top of Slope		<b>APPROX. LENGTH:</b> 5+ ft	<b>APPROX. DEPTH:</b> 1.5 ft	<b>APPROX. DIAMETER:</b> 8 inch
<b>DATE FOUND:</b> 10/17/13	<b>DATE CLOSED:</b> 12/13/13

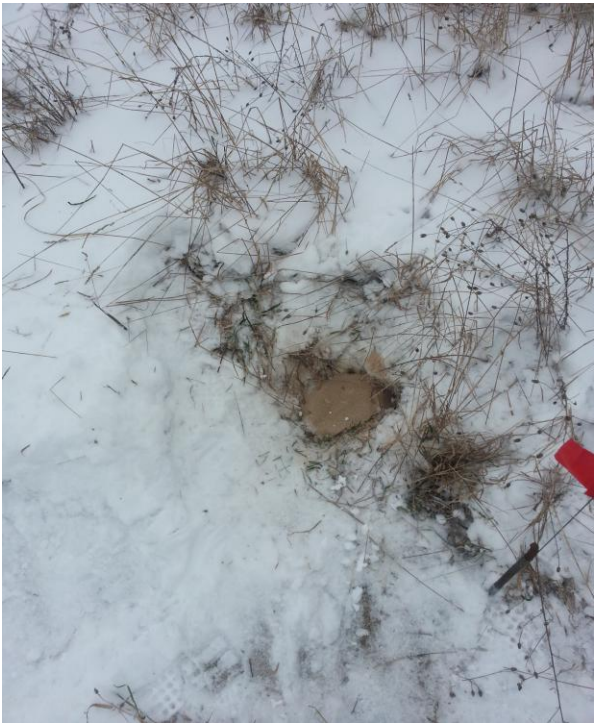
<b>NOTES:</b> POST repair photo of burrow entry. Filled in burrow. Will spread grass seed in the spring.

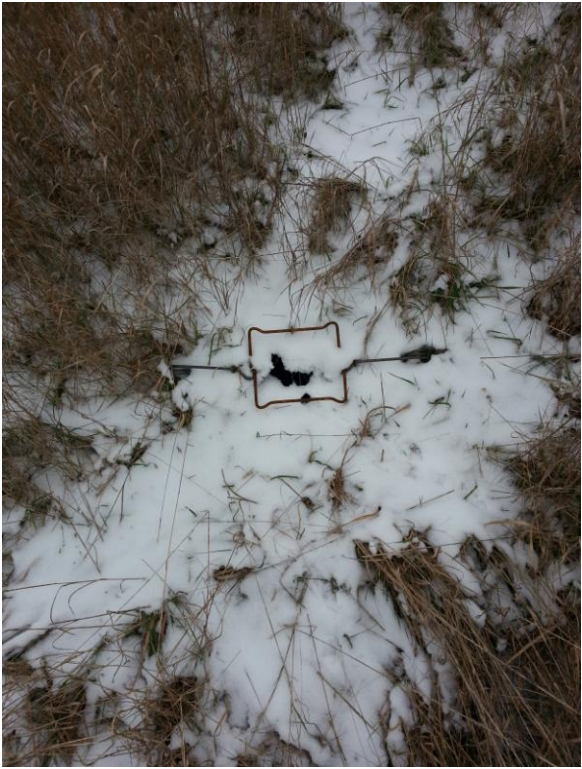
<b>LOCATION:</b> B3 – Top of Slope		<b>APPROX. LENGTH:</b> 5+ ft	<b>APPROX. DEPTH:</b> 1.5 ft	<b>APPROX. DIAMETER:</b> 6 inch
<b>DATE FOUND:</b> 10/17/13	<b>DATE CLOSED:</b> 12/13/13

<b>NOTES:</b> <b>ID: 2013-12-13-048</b> PRE repair photo of burrow exit. Trap set up for eight weeks. Trap moved by animal three times and reset. No activity for 4 weeks. No animal trapped. The distance between the entry and exit was approximately thirteen feet. No signs of liner damage.				
<b>LOCATION:</b> B3 – Top of Slope		<b>APPROX. LENGTH:</b> 5+ ft	<b>APPROX. DEPTH:</b> 1.5 ft	<b>APPROX. DIAMETER:</b> 6 inch
<b>DATE FOUND:</b> 10/17/13	<b>DATE CLOSED:</b> 12/13/13

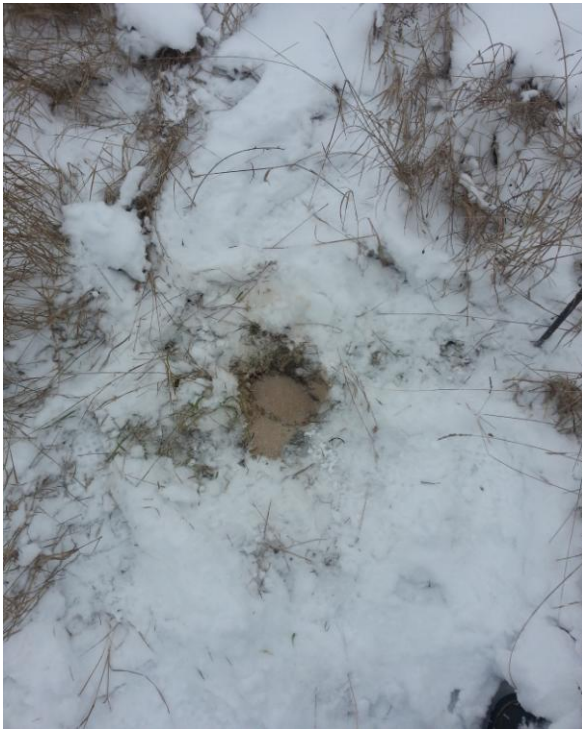
<b>NOTES:</b> POST repair photo of burrow exit. Filled in burrow. Will spread grass seed in the spring.
