**Landfill Inspection Report
Coldwater Road Landfill
Flint, Michigan
MID 005 356 860**

**RACER TRUST
Detroit, Michigan**

February 2020

**Landfill Inspection
Coldwater Road Landfill
MID 005 356 860**

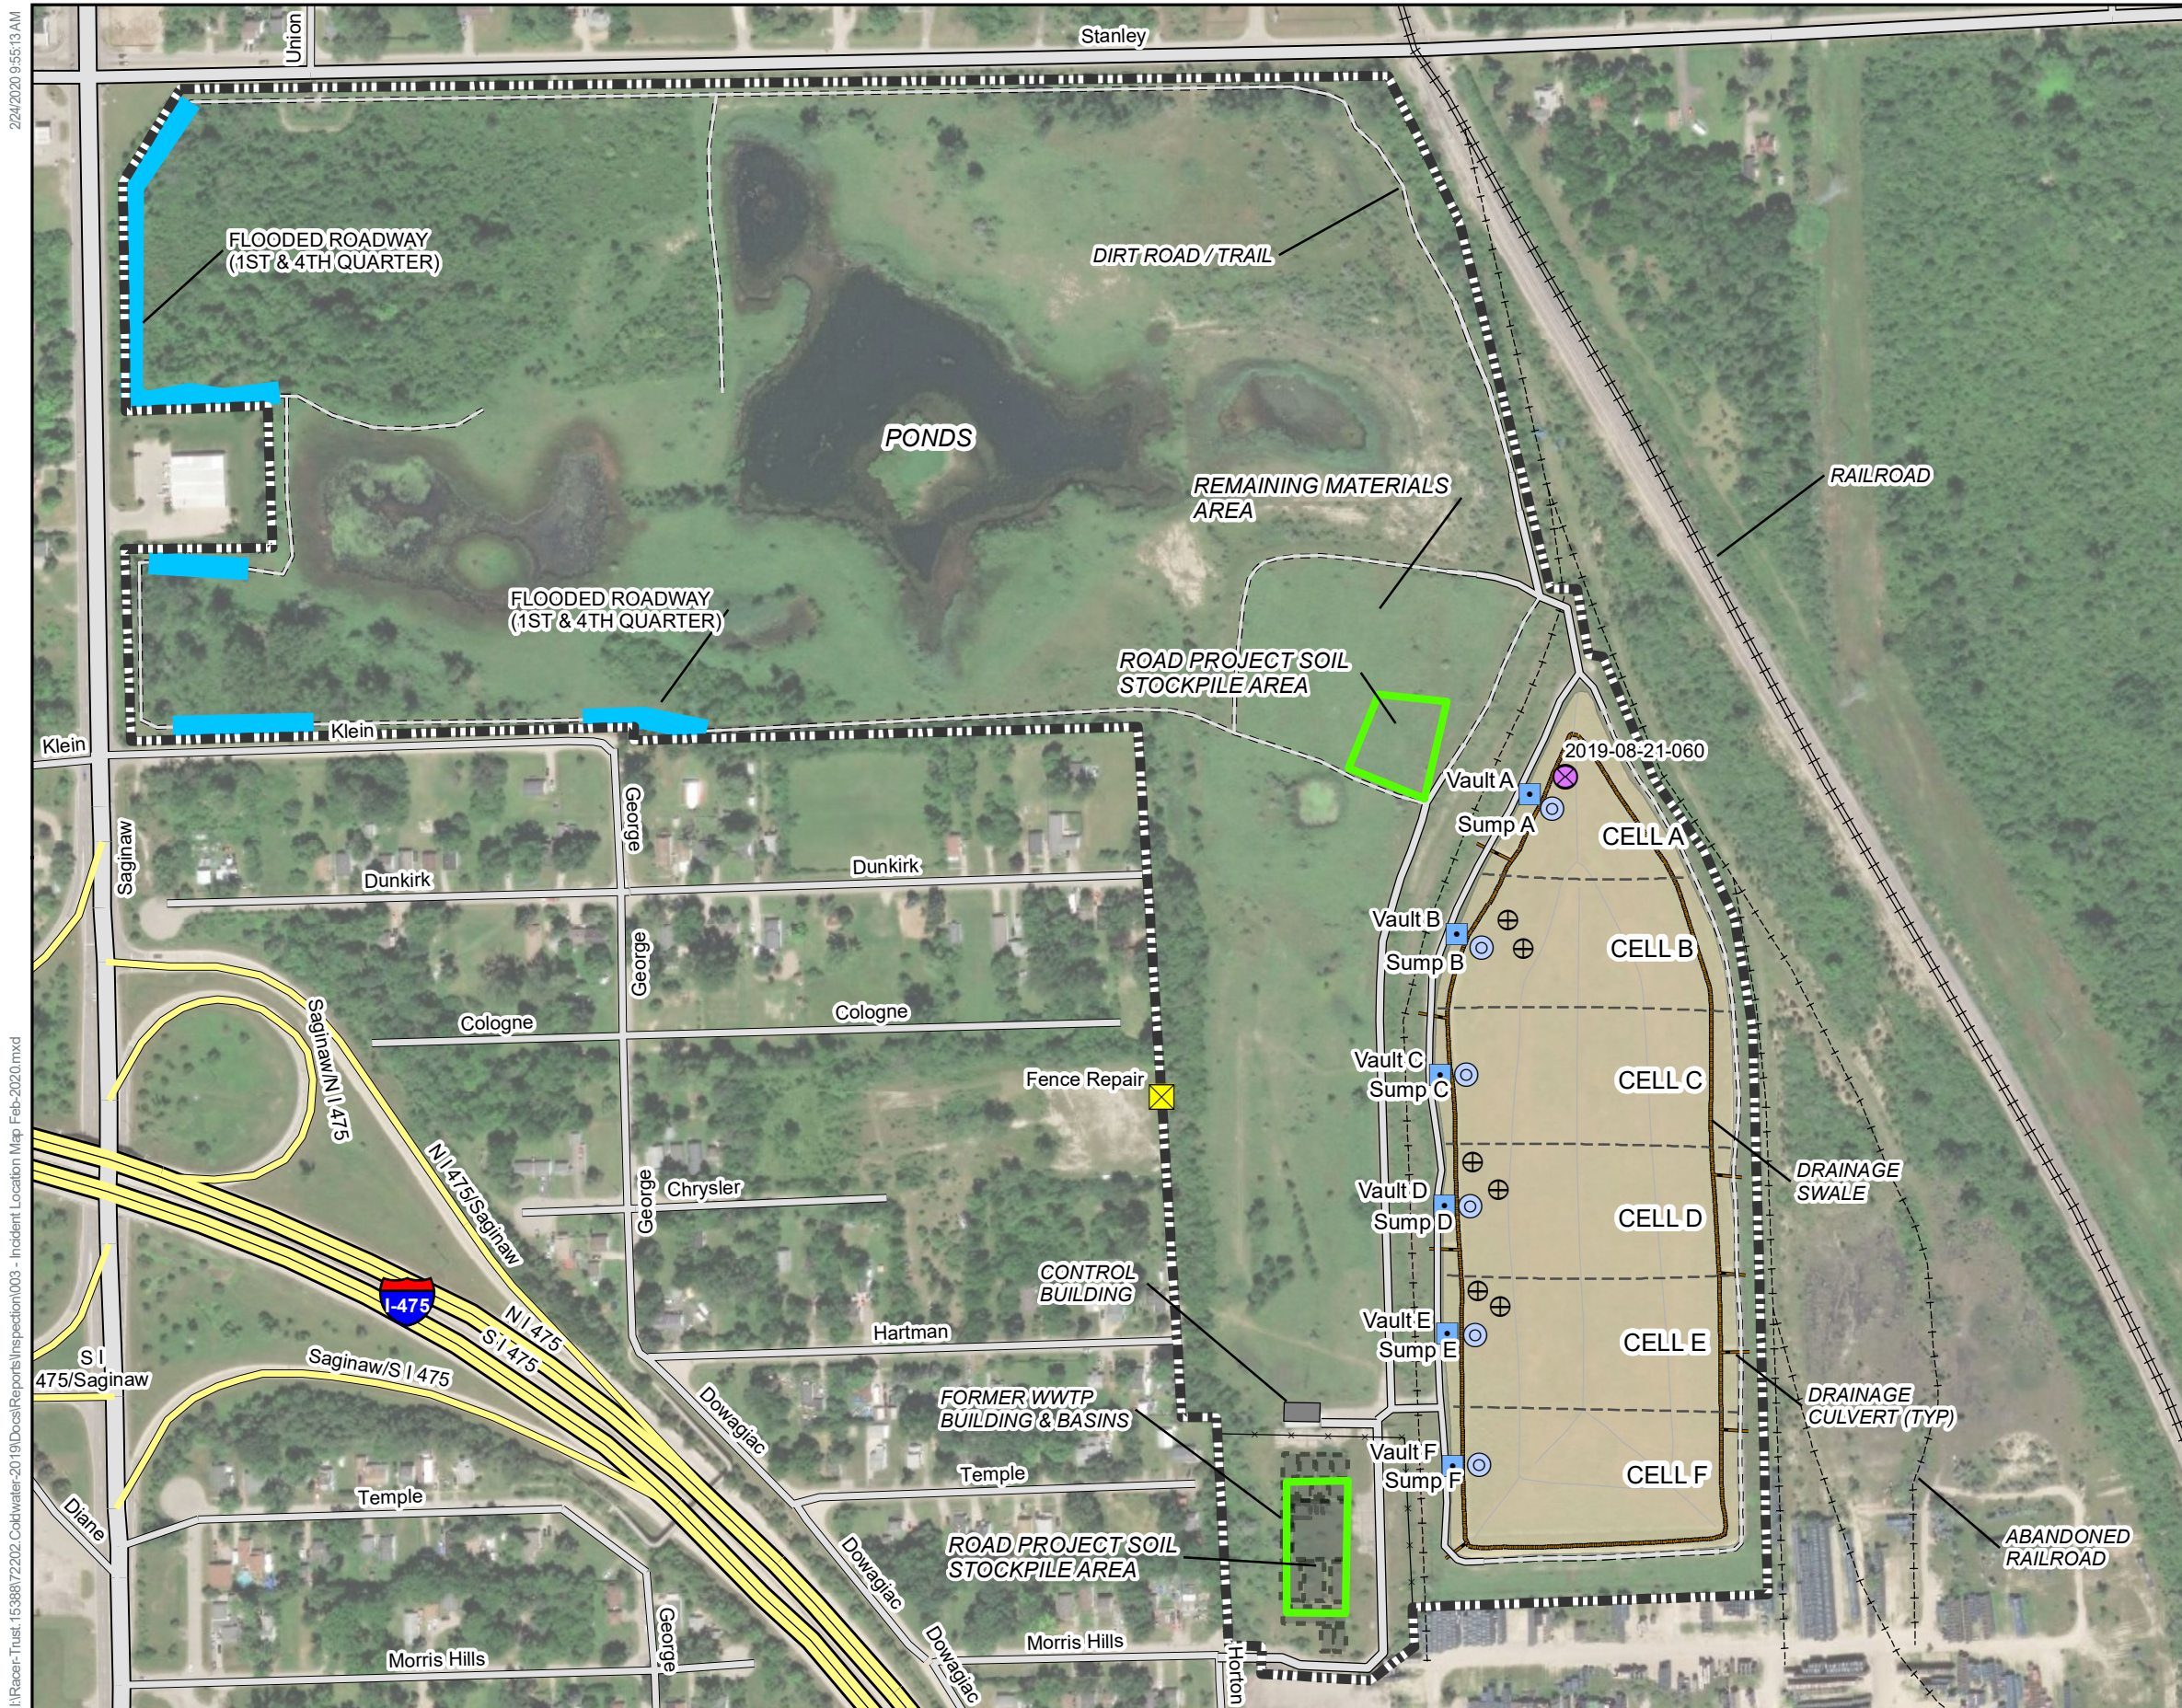
**2019
INCIDENT LOCATION
MAP**

Mole activity was observed during the 1st through 4th quarter inspections at Cell B, Cell D, and Cell E. The mole activity is noted on [Figure 3](#). It was not confirmed whether the mole mounds observed were new activity or signs of previous activity. Mole traps were set along the trails where located.

One animal burrow was identified and closed in the 3rd quarter. The animal burrow was photographically documented (before and after repair), and the approximate size and configuration of the burrow was documented and included in the Quarterly Status Report.

The burrow was deemed inactive and filled in. The burrow was filled using methods approved by the Michigan Department of Environment, Great Lakes, and Energy (EGLE), which included measuring the approximate length (1.5 feet), depth (3 inches), and diameter (4 inches). No signs of liner damage were observed during the inspection and repair of the animal burrow. A log of burrow activity throughout the year is maintained at the landfill. The log contains information on the date that a burrow was identified, response activities, and the date the burrow was filled and seeded. The animal burrow located during the quarterly inspection is noted on [Figure 3](#).

During the 1st quarter and 4th quarter inspections the access road west and south of the ponds had areas of ponded water. The wet sections of road were avoided until the road was dry.

During the 2nd quarter, 3rd quarter, and 4th quarter, one previously repaired hole along the west perimeter fence had been reopened. The hole was repaired during the site inspections [Figure 3](#).
