**CONESTOGA-ROVERS  
& ASSOCIATES**

## MEMORANDUM

DATE: April 27, 2007

RE: **Review of Historical Development and Filling Activities  
GM Former Willow Run Assembly Plant - Ypsilanti, Michigan - Update**

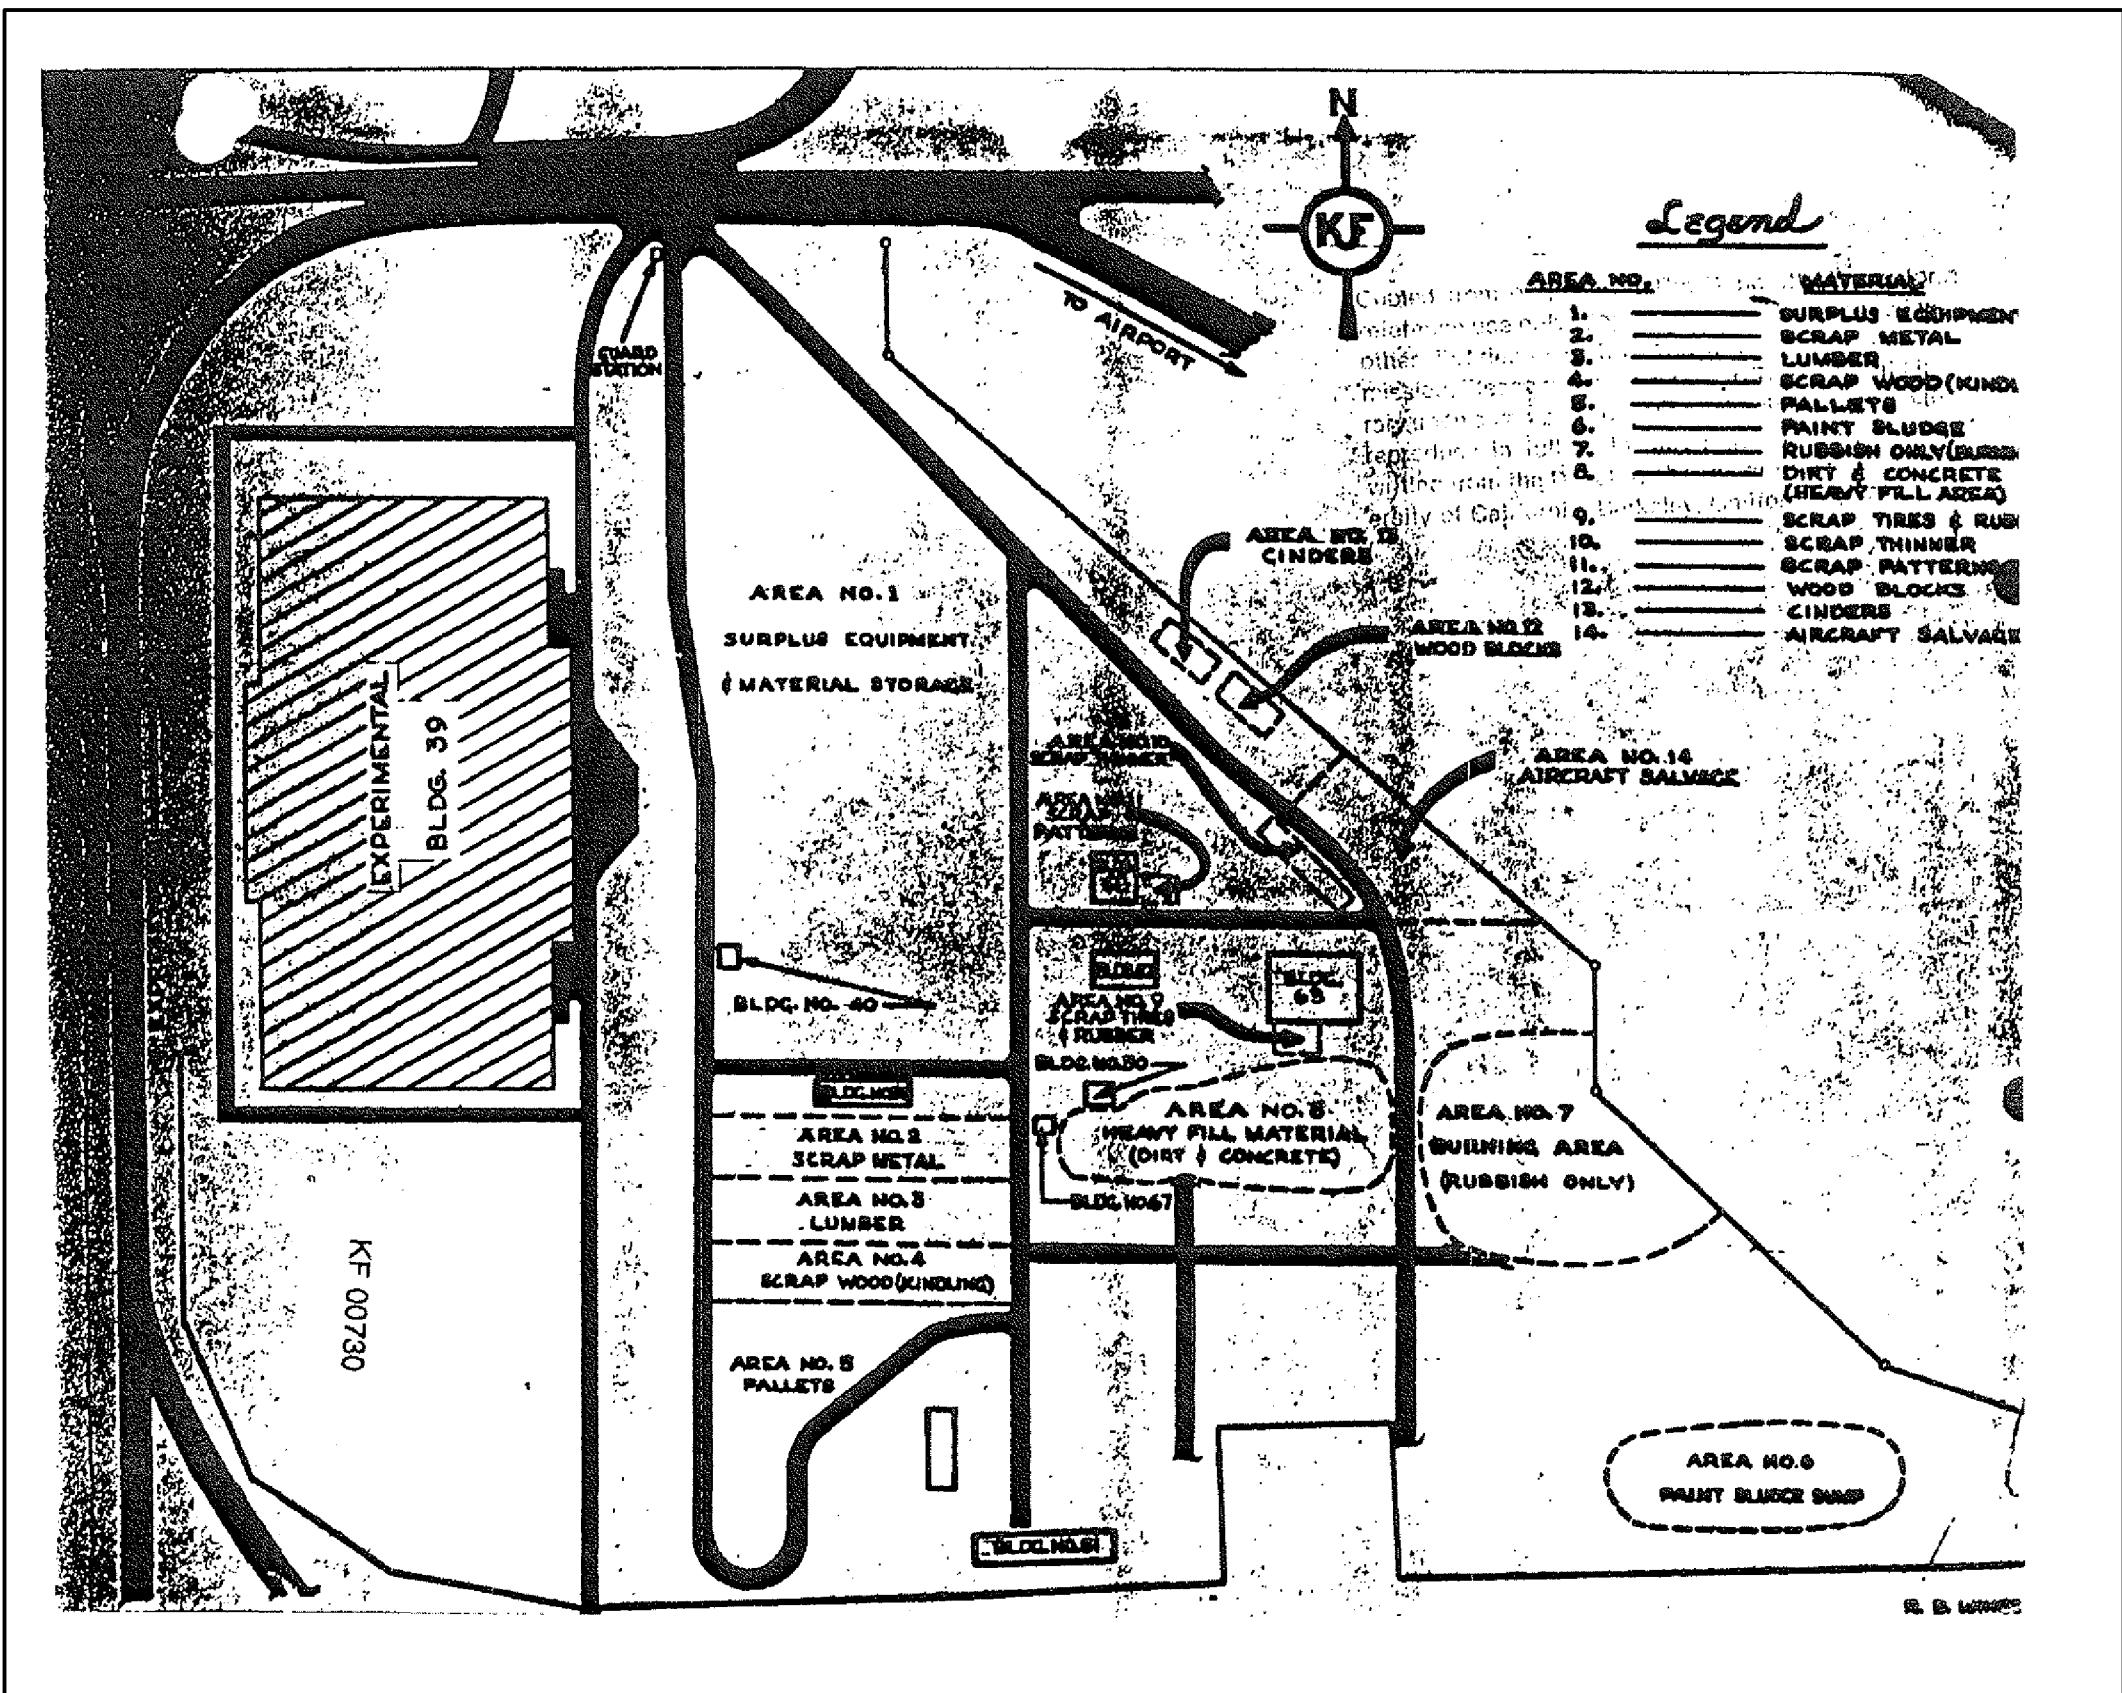
figure 2

- K-F Inter-office correspondence dated July 13, 1951 discusses the movement of scrap and salvage material to the south yard. The correspondence provided a figure detailed where scrap and salvage materials were located on the Site and the adjacent areas. The figure is included as Figure 2.

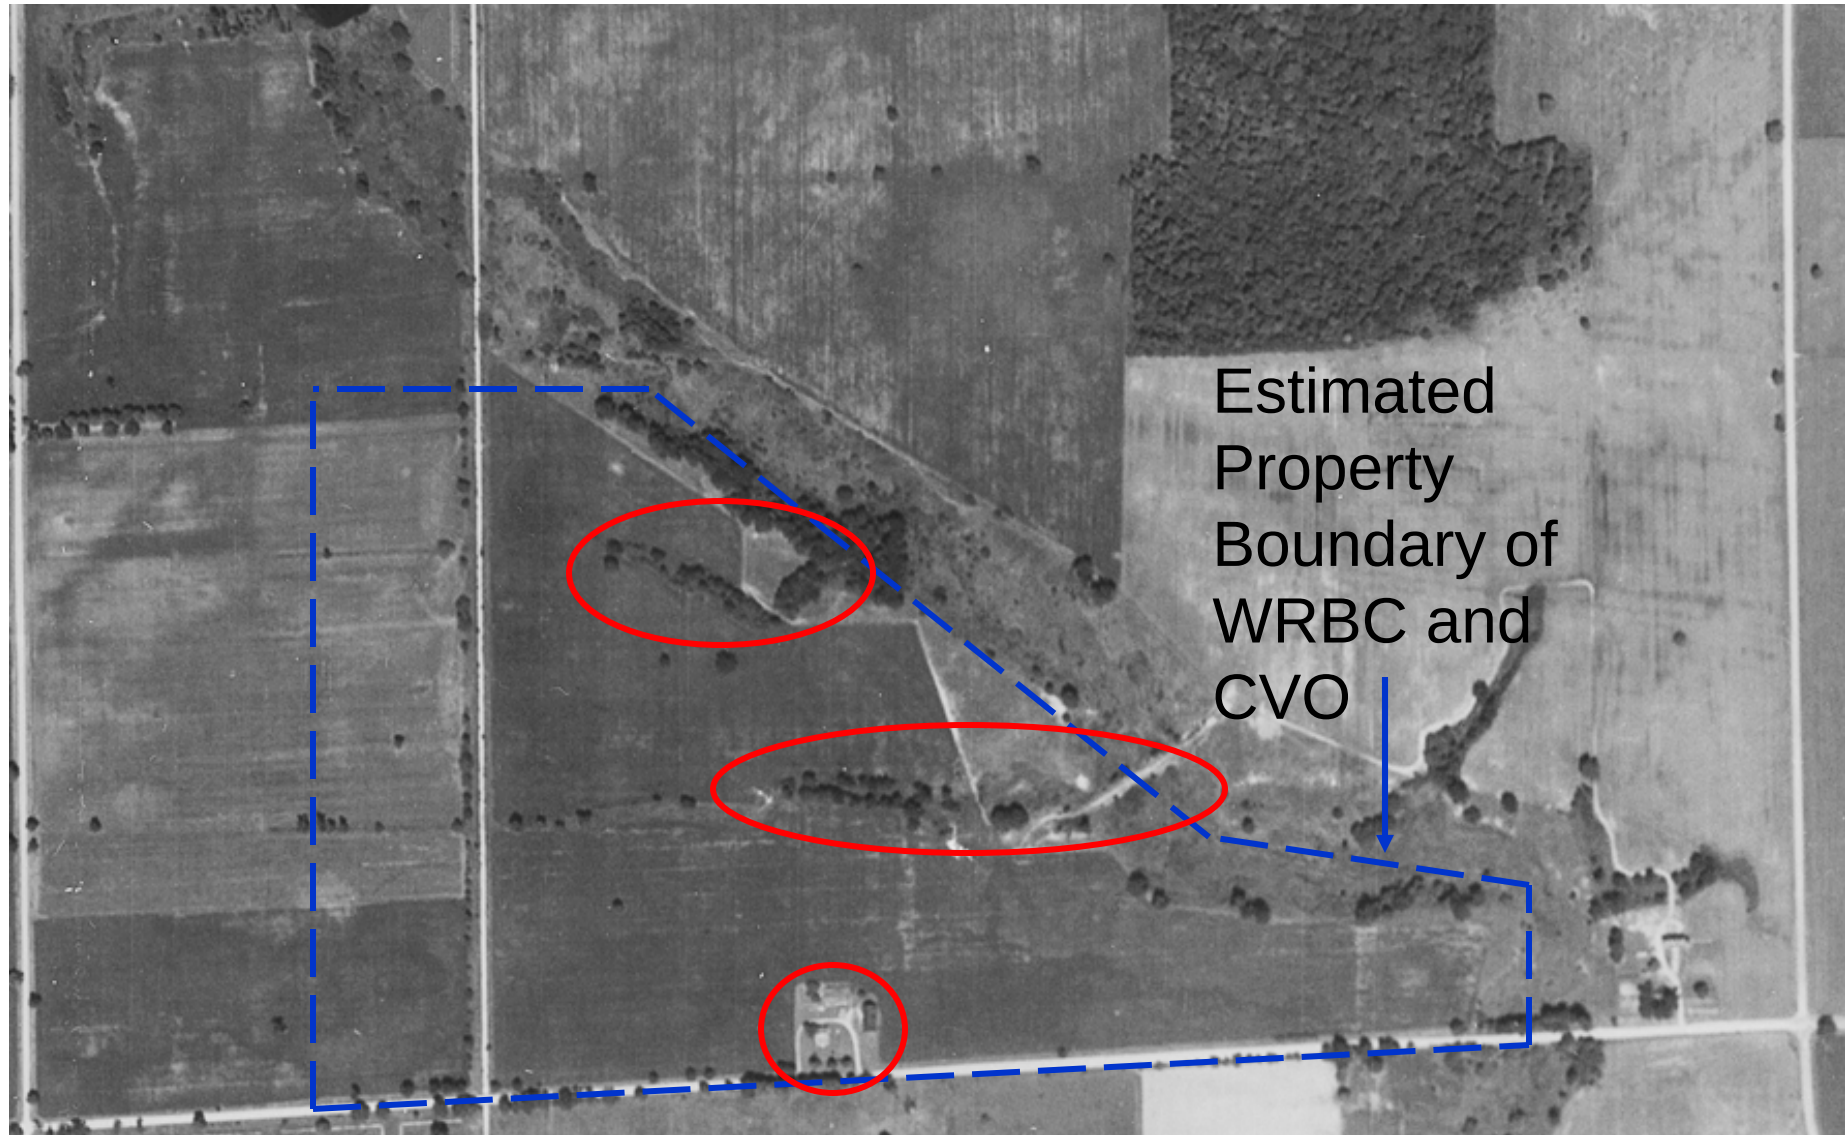
# 1937/ Ford/ Not Developed

- 1937: The 1937 aerial photograph shows the entire area as farmland with Willow Run Creek and its associated floodplain. Observed adjacent to the north of the future CVO location is a tributary (a.k.a. South Culvert) of the Willow Run Creek. Further northwest is another tributary (a.k.a. North Culvert) of the Willow Run Creek. A small building and a silo that appear to be agriculture related are adjacent to the west boundary of the current CVO property.
- 1940: The 1940 aerial photograph is relatively unchanged from the 1937 aerial photograph, although the North and South Culverts are more easily seen.
- 1943: Three 1943 aerials were located. They are labeled 1943 A, B, and C to easily correlate the written description to the appropriate aerial photographs. Photograph 1943A is a cropped enlargement of 1943B to see more detail on the CVO portion of the property.

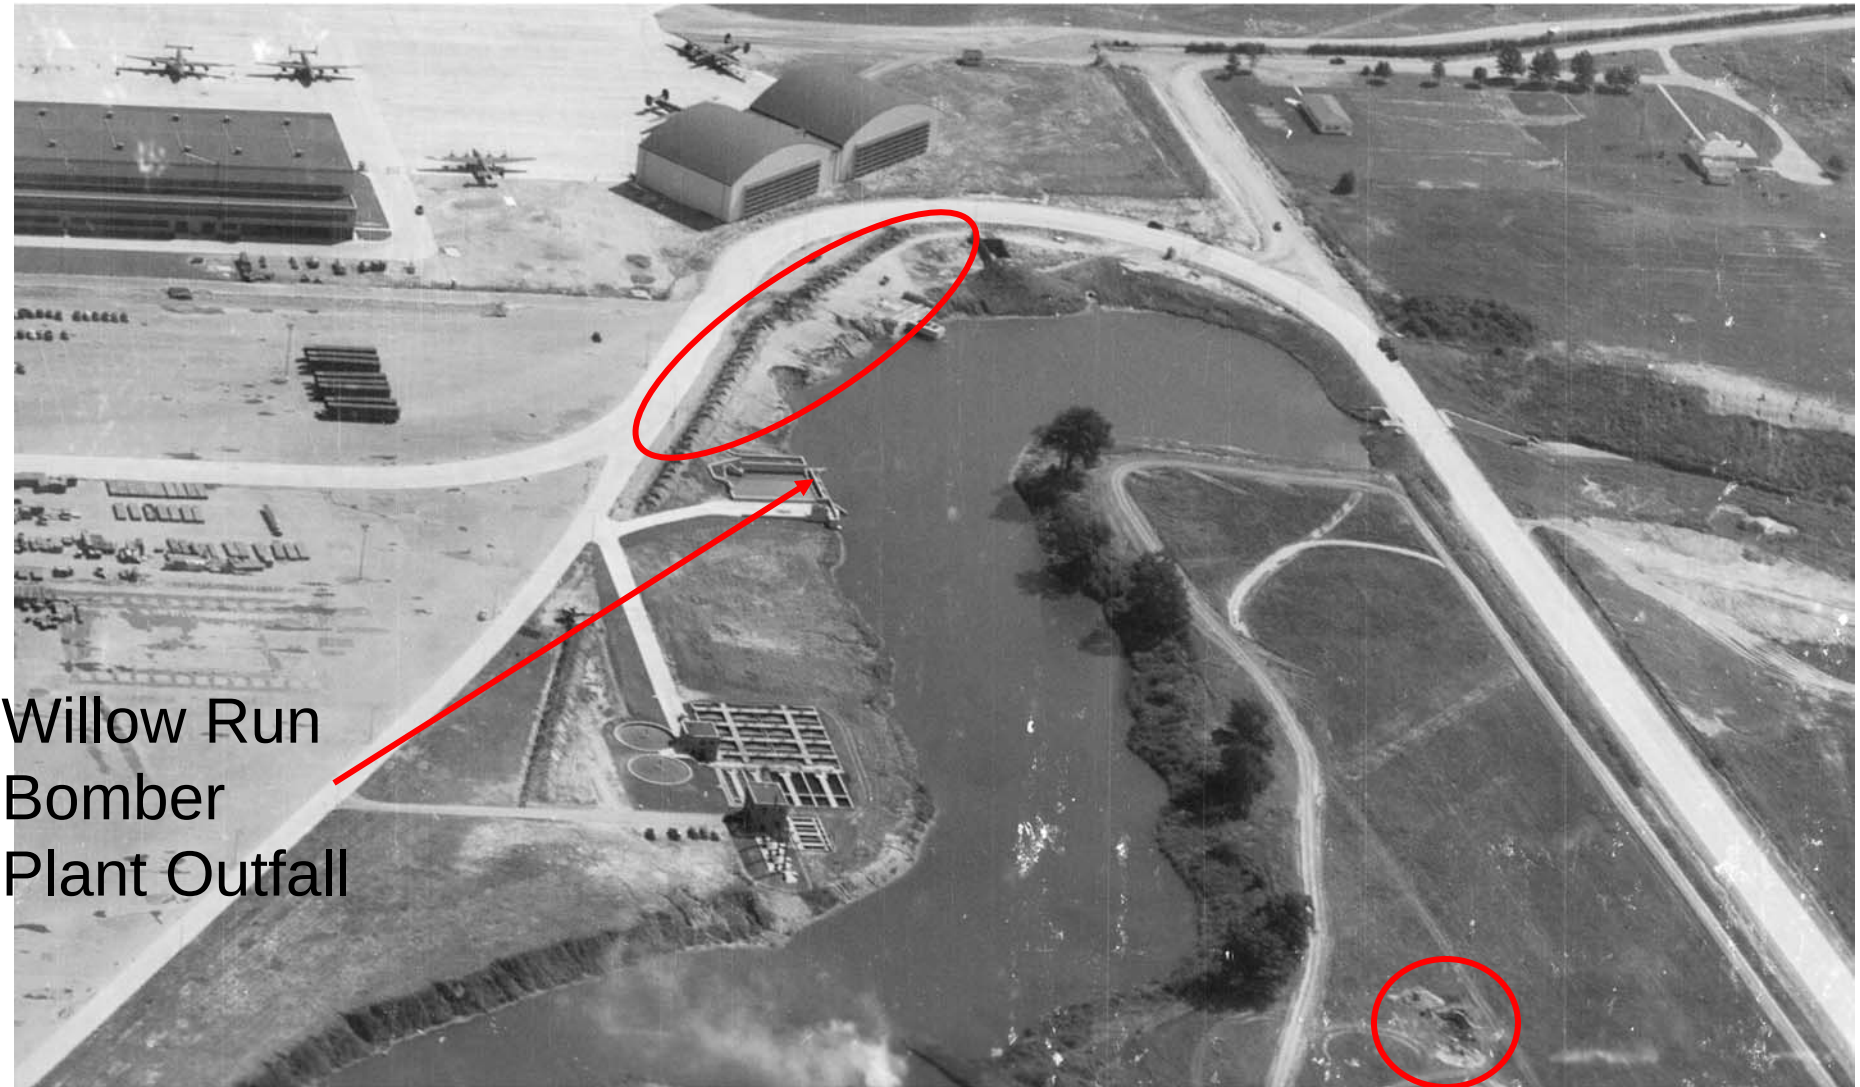
# 1943A/ USDPCA/ Ford

1943A - A cropped enlargement of 1943B this aerial photograph depicts the CVO area and shows Tyler Pond and the dam at Tyler Road in place. Tyler Pond is the discharge point for the wastewater treatment facilities associated with the airport and bomber production facility. The bomber production plant and airport facilities were built as part of the war effort in 1941. To the north of Tyler Pond the Willow Run Airport parking lot and hanger areas and the wastewater treatment facility are present. An area on the north bank of Tyler pond appears to be disturbed. The area south of Tyler Pond still appears undeveloped although there is evidence of activity, such as single track dirt roads. An excavated pit and associated soil pile is evident at a location just northeast of where the Haulaway Building is now located. The pit is darker in color than the surrounding vegetation indicating that it may contain liquid. This location corresponds to the location of Potential Area of Concern (PAOC) 23.

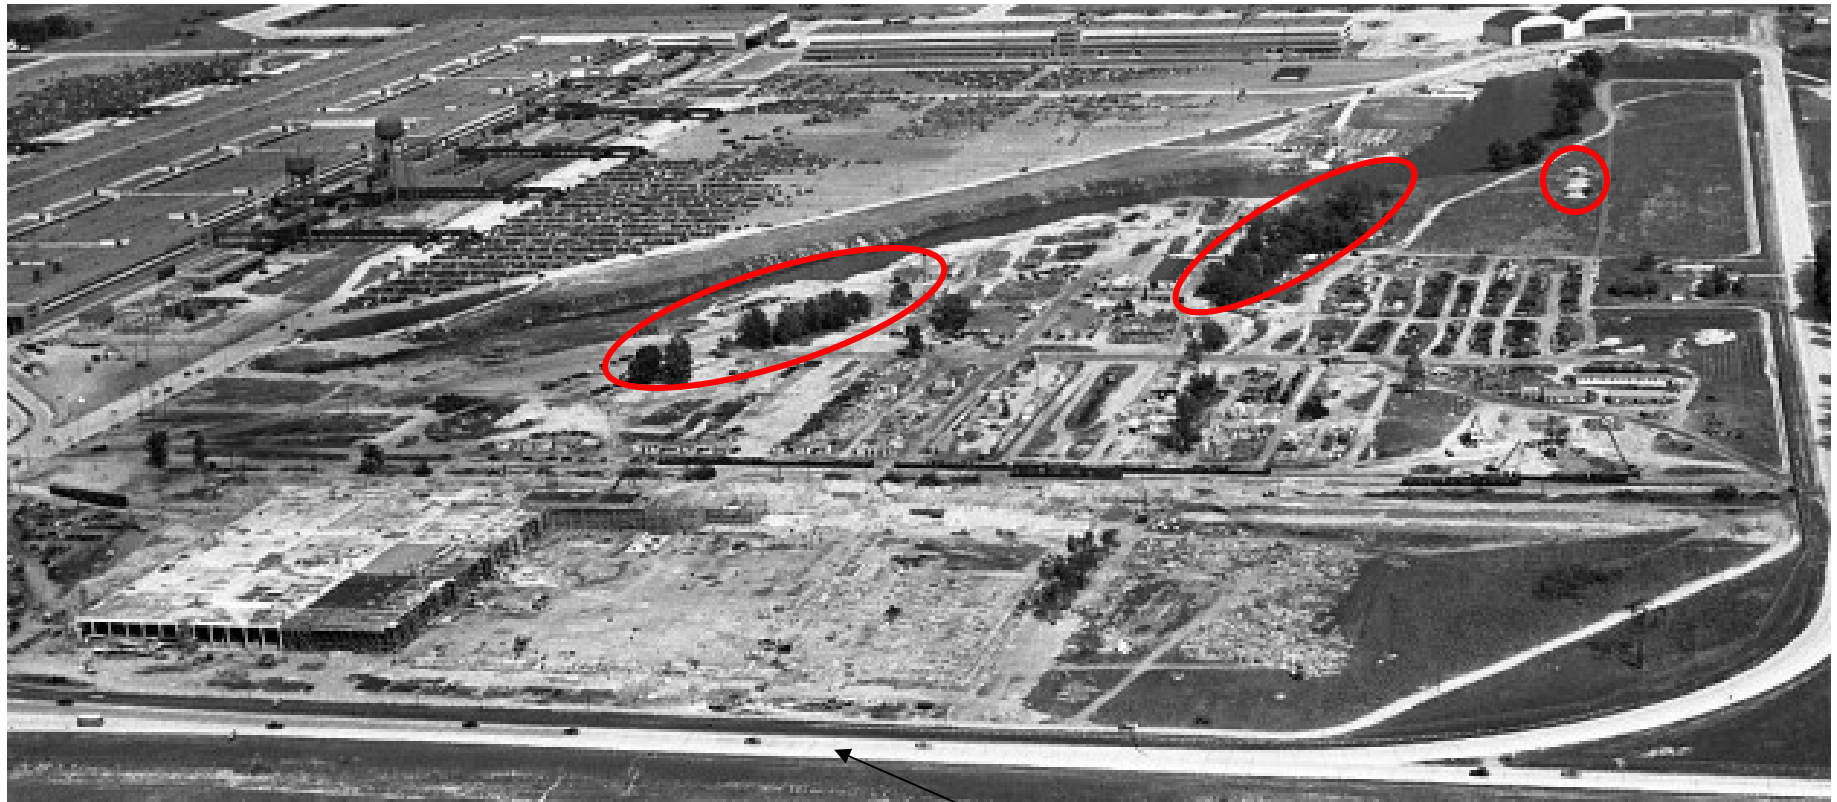
# 1943B/ USDPCA/ Ford

1943B - A 1943 aerial photograph shows the Willow Run Airport, a portion of the Willow Run Bomber Plant, and what are now the WRBC and CVO properties. This aerial photograph, thought to have been taken in mid-1943 at an oblique angle facing east, shows a small area of soil disturbance near the excavated pit identified in the 1943 aerial described above. More of the single track dirt road identified in the first 1943 aerial photograph is evident in this aerial photograph. The South Culvert with a tributary that enters Tyler Pond is visible. Vegetation and trees are observed along the banks of the South Culvert area. The western portion of the Site appears to be used for storage of materials and equipment and what appears to be several small buildings. According to historical information reviewed, these buildings are the Ford office, B&D office, John Miller office, Donald Miller office, the incinerator and Brush Repair office. More single track dirt roads are evident on the western portion of the Site. The North Culvert area observed in the 1937 and 1940 is evident although it appears that some trees in the area along Tyler Pond have been removed. Along Wiard Road, a large building is under construction. According to historical information reviewed, this building was used as a storage warehouse for the bomber plant. What appear to be construction materials are stored adjacent to the warehouse.

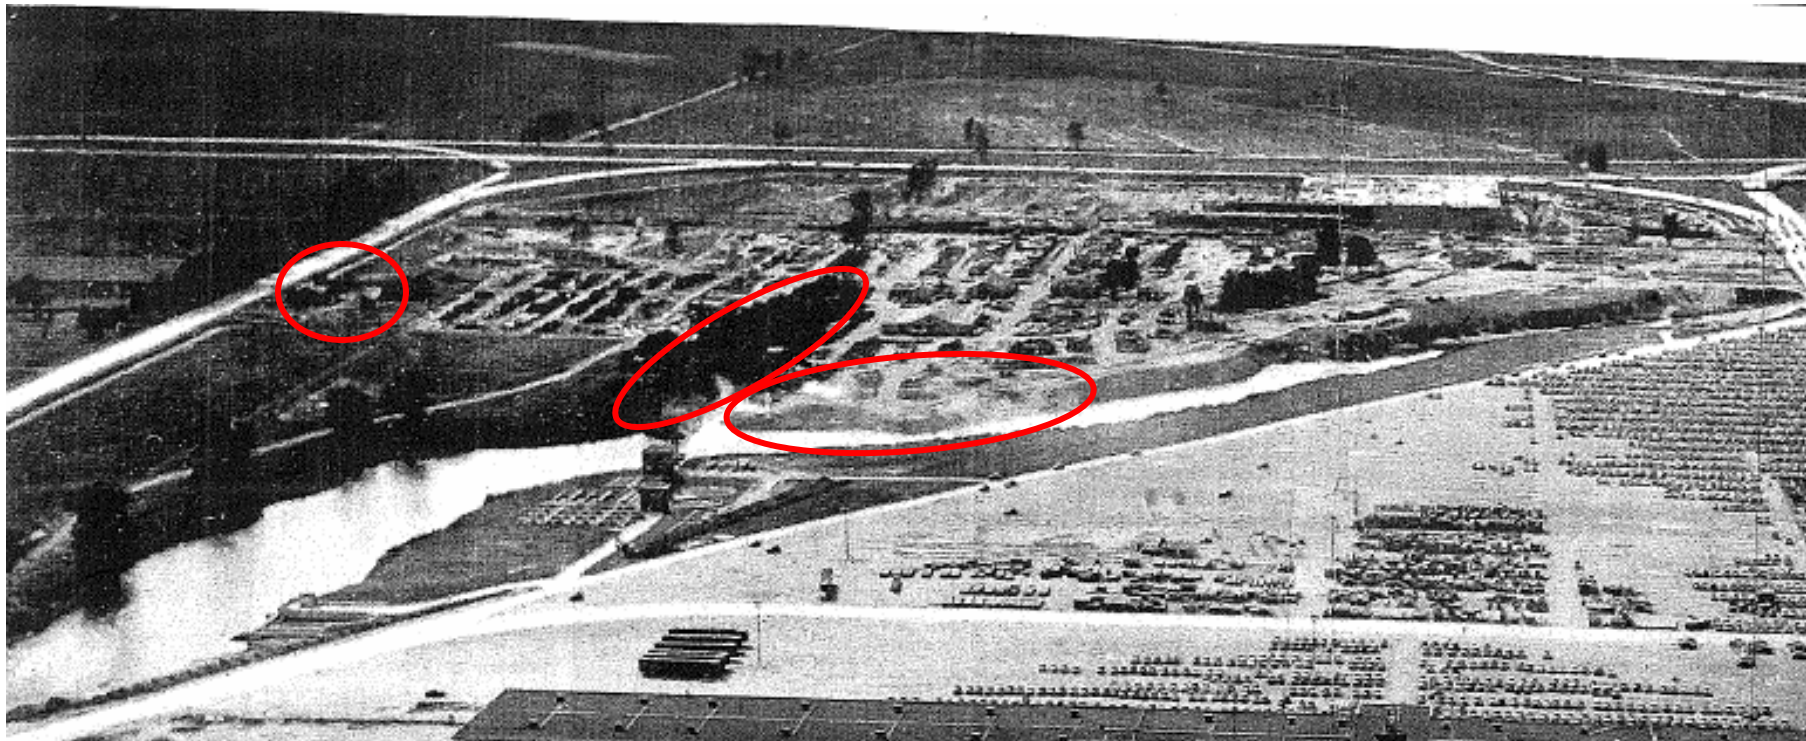
# 1943C/ USDPCA/ Ford

1943C - A third 1943 aerial photograph thought to have been taken in 1943 has a view to the west and shows a portion of the Site and the adjacent areas to the west and north. Within the CVO footprint the dirt track road identified in the previous 1943 aerial photographs is evident along the north edge of the property. Adjacent to the west of CVO are the small building and silo, which were identified in the 1937 and 1940 aerial photographs. As previously identified in the second 1943 aerial photograph, further to the north, northwest, and west are the storage areas for materials and equipment and the several small buildings. The South Culvert is evident in this aerial photograph. North of the South Culvert is a sloped area, without vegetation along the bank of Tyler Pond. Since there is no boat traffic or public access to the pond, this disturbance is suspicious from an environmental perspective. Although it does not appear to be related to any Site construction activity in 1943, the pond was constructed in 1942 and did not fill up until 1943. A review of 1943 aerial photographs indicates that several areas on the both banks of Taylor Pond lack vegetation.

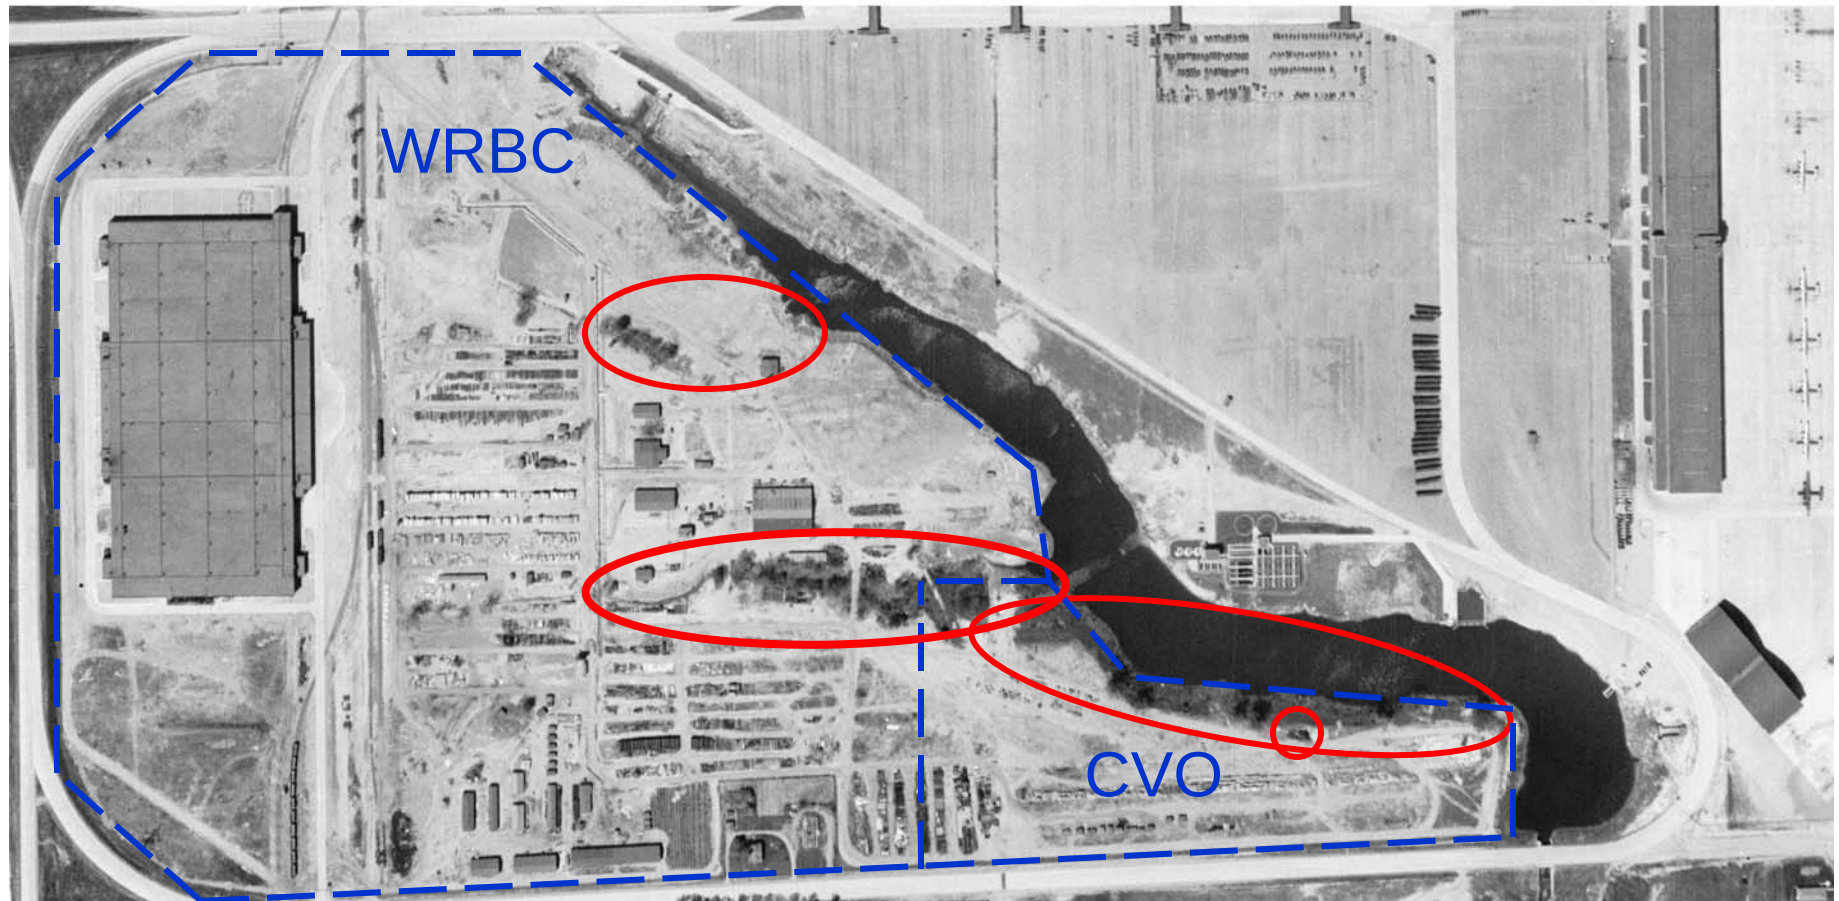
# 1944/ USDPCA/ Ford

- 1944: The 1944 aerial photograph shows substantial de-vegetated areas and material storage activities on the entire Site. The pit observed in the 1943 aerial photographs is not visible in this aerial photograph although an additional pit appears to be present along the north side of the CVO area. The bank along Tyler Pond between Outfall # 11 and #14 appears to be vegetated. The CVO area appears to be used for storage of material and additional dirt track roads are evident. The several small buildings previously identified in 1943 aerial photographs on the WRBC property are clearly evident in this photograph. Much of the materials stored north of the South Culvert have been removed. While de-vegetated areas are visible throughout the Site, the South Culvert remains vegetated. The warehouse observed in the 1943 aerial photographs along Wiard Road has been completed. What appear to be railroad tracks are evident adjacent to the east of the building. The construction materials stored adjacent to the building have been removed.

| EFFORT/EVENTS | COMPLETED BY | OWNER/OPERATOR | DATE |
|---|---|---|---|
| Aerial Photo: There is substantial soil disturbance and material storage activities on the Site. The pit observed in the 1943 aerial photographs is not observed in this aerial photograph. The areas adjacent to the north, west and northwest of the Site appear to be used for storage of materials and equipment. | | " | September 24, 1944 |

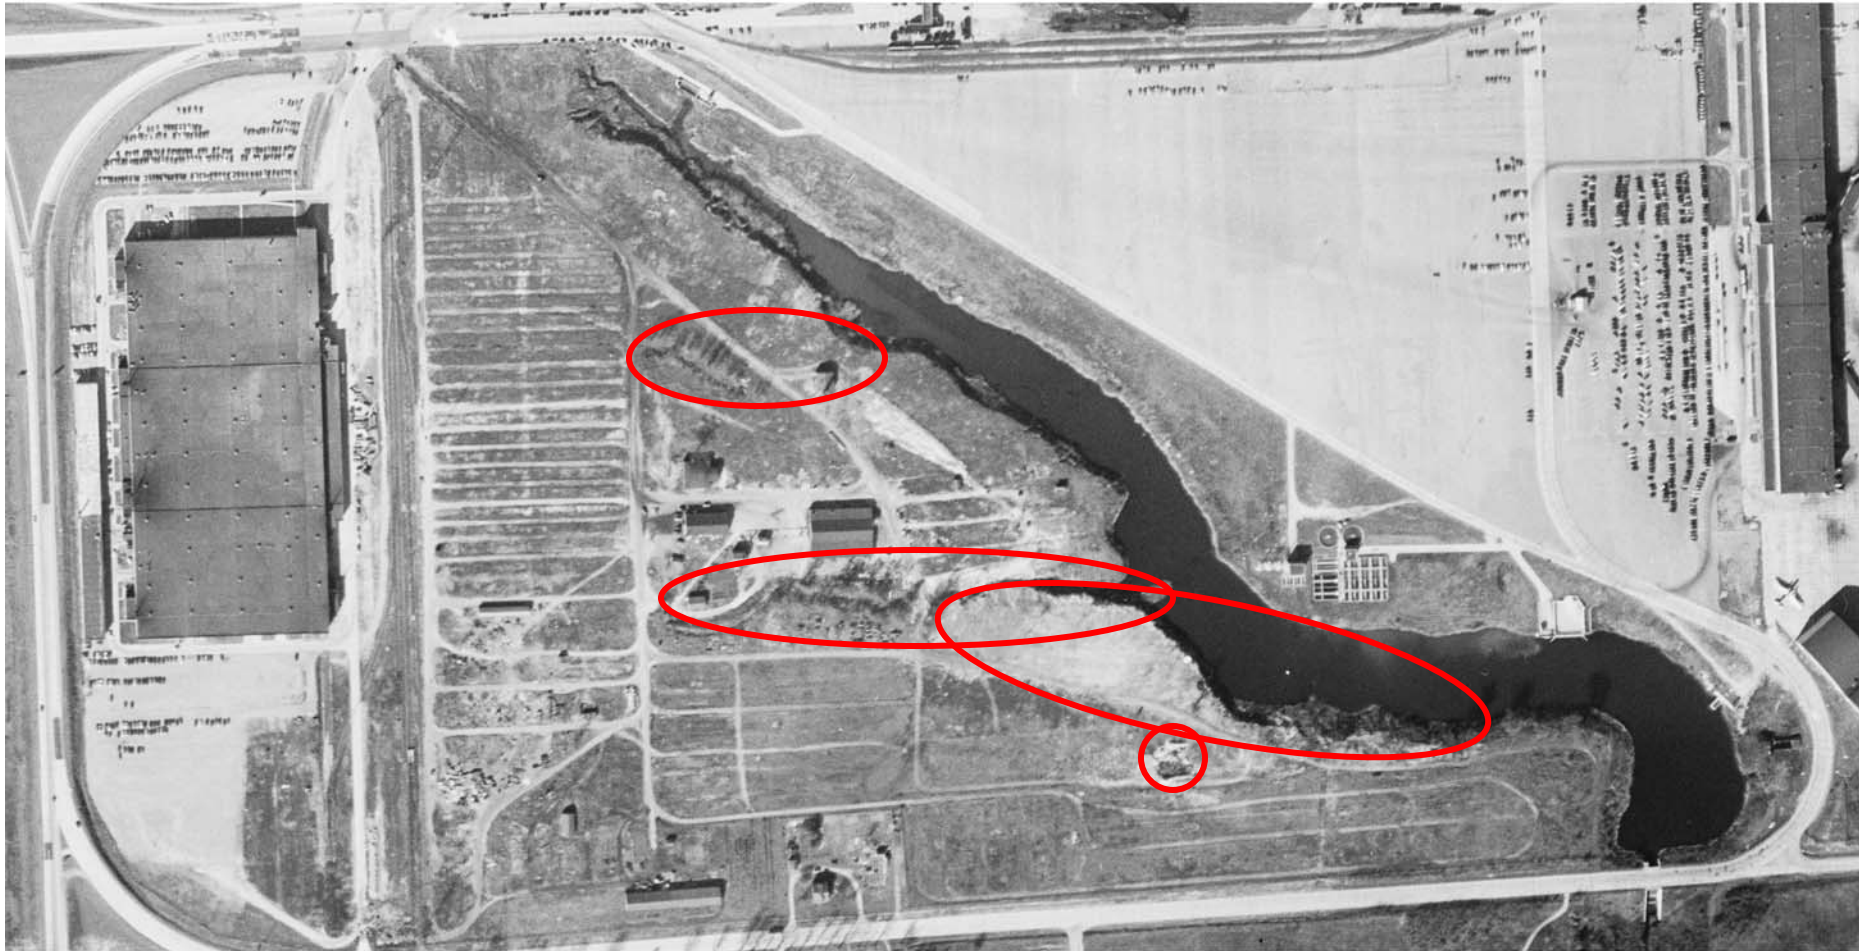
1949/ KF/ KF

- 1949: Vegetation appears to be growing on the Site with the exception of a de-vegetated area observed along the south shore of Tyler Pond from the Outfall #11 area to the east near Outfall #12. The de-vegetated area stops approximately 150 feet east of Outfall #12. The eastern most portion of this area corresponds to the location of PAOC 18. The excavated pit initially identified in the 1943 aeriels and some piles of material are apparent at a location just northeast of where the Haulaway Building is now located. The pit is dark in color, indicating that it may contain liquid. This location corresponds to the location of PAOC 23. A series of dirt track roads appear on the Site. Most of the vegetation and trees observed in the 1943 aerial photograph have been removed from the South Culvert. The majority of the stored equipment and material observed in the 1944 aerial photograph has been removed. The mouth of the tributary for the South Culvert appears to be widened from the 1944 photograph.

| EFFORT/EVENTS | COMPLETED BY | OWNER/OPERATOR | DATE |
|---|---|---|---|
| Aerial Photo: A soil disturbance is approximately 150 feet east of where Outfall #12 is located. The eastern most portion of this area corresponds to the location of Remediation Area #2. The excavated pit initially identified in the 1943 aerials and some piles of material are apparent at a location just northeast of where the Haulaway Building is now located. The pit is dark in color indicating that it may contain liquid. This location corresponds to the location of Remediation Area #1. The majority of the equipment and material stored on the Site observed in the 1944 aerial photograph has been removed. | | Kaiser Fraser - O/O | October 27, 1949 |

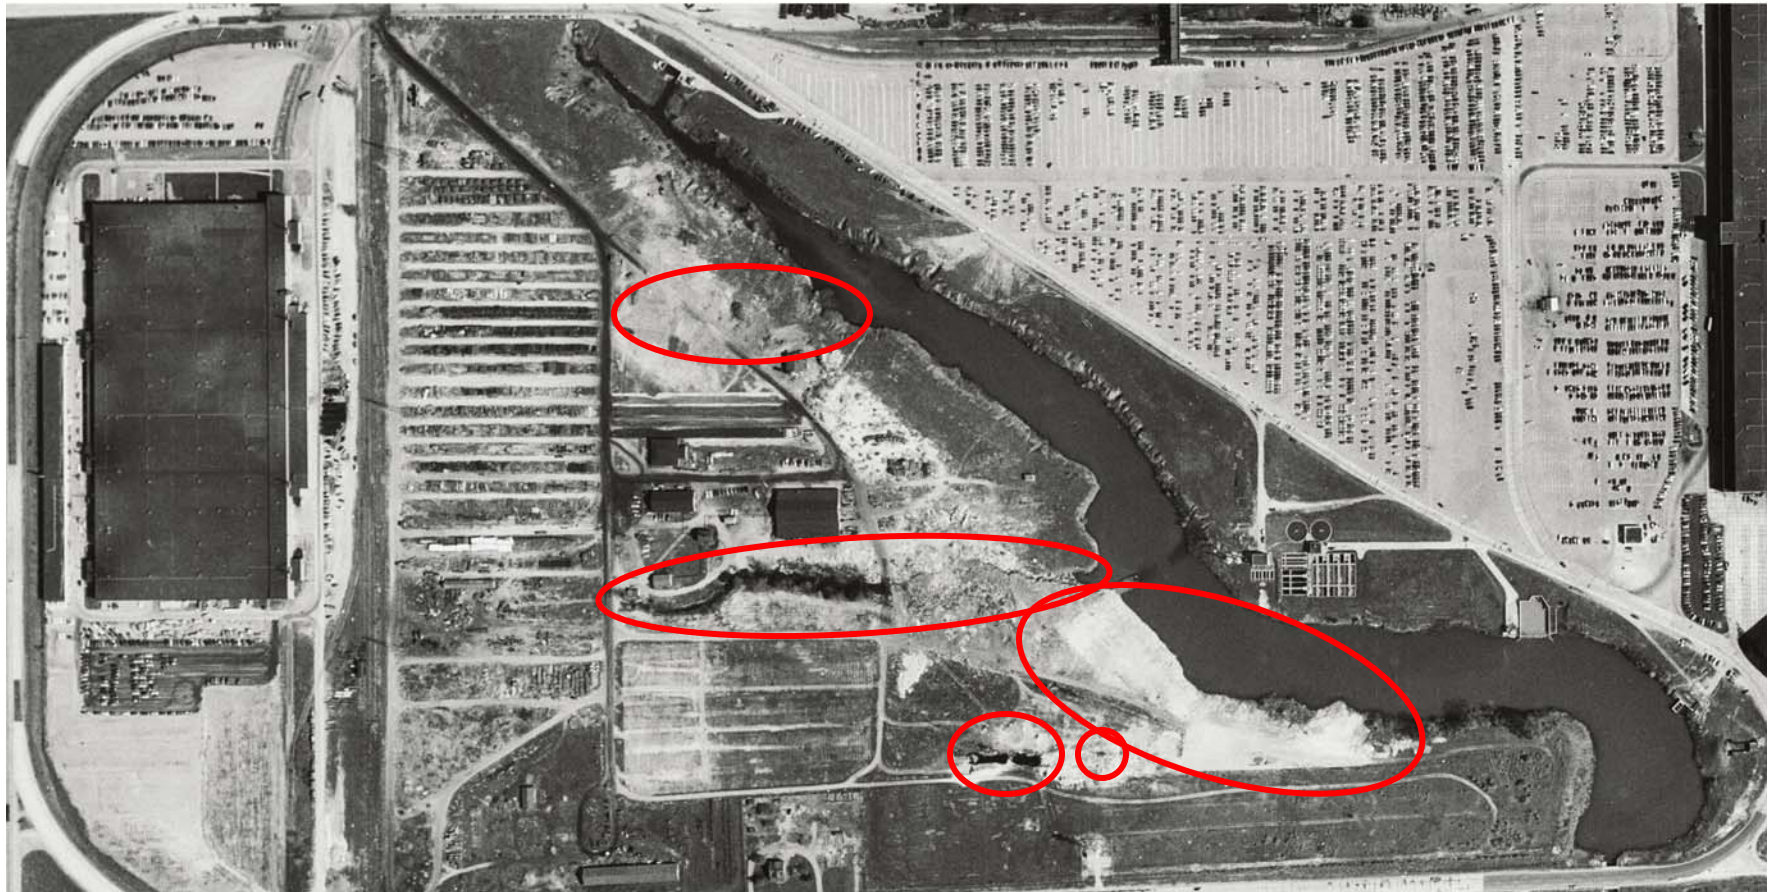
# 1952/ KF/ KF

- 1952: The 1952 aerial photograph shows that the area south and west of Tyler Pond (WRBC) was again being used as a materials storage area. There are many areas of substantial soil disturbance activities along the south shore of Tyler Pond from the Outfall #11 area to just east of the Outfall #12 area at the same location as identified in the 1949 photo. The South Culvert appears to be partially filled-in as compared to the 1949 photograph. While remnants of the excavated pit identified in the 1949 photo is present, there is evidence of two additional pits directly west of the pit identified in the 1944 photo. The east end of the pits was located at the northwest corner of where the Haulaway Building is located and extends approximately 150 feet directly west.

These pits are dark in color, indicating that they may have contained liquid. These pits were constructed between 1949 and 1952.

| EFFORT/EVENTS | COMPLETED BY | OWNER/OPERATOR | DATE |
|---|---|---|---|
| Aerial Photo: The Site and adjacent areas are being used as material storage areas. The South Culvert appears to be partially filled-in as compared to the 1949 photograph. While remnants of the excavated pit identified in the 1949 photo is present, there is evidence of two additional pits directly west of the pit. The east end of the pits was located at the northwest corner of where the Haulaway Building is located and extends approximately 150 feet directly west. These pits are dark in color indicating that they may have contained liquid. These pits were constructed between 1949 and 1952. | | " | May 1, 1952 |

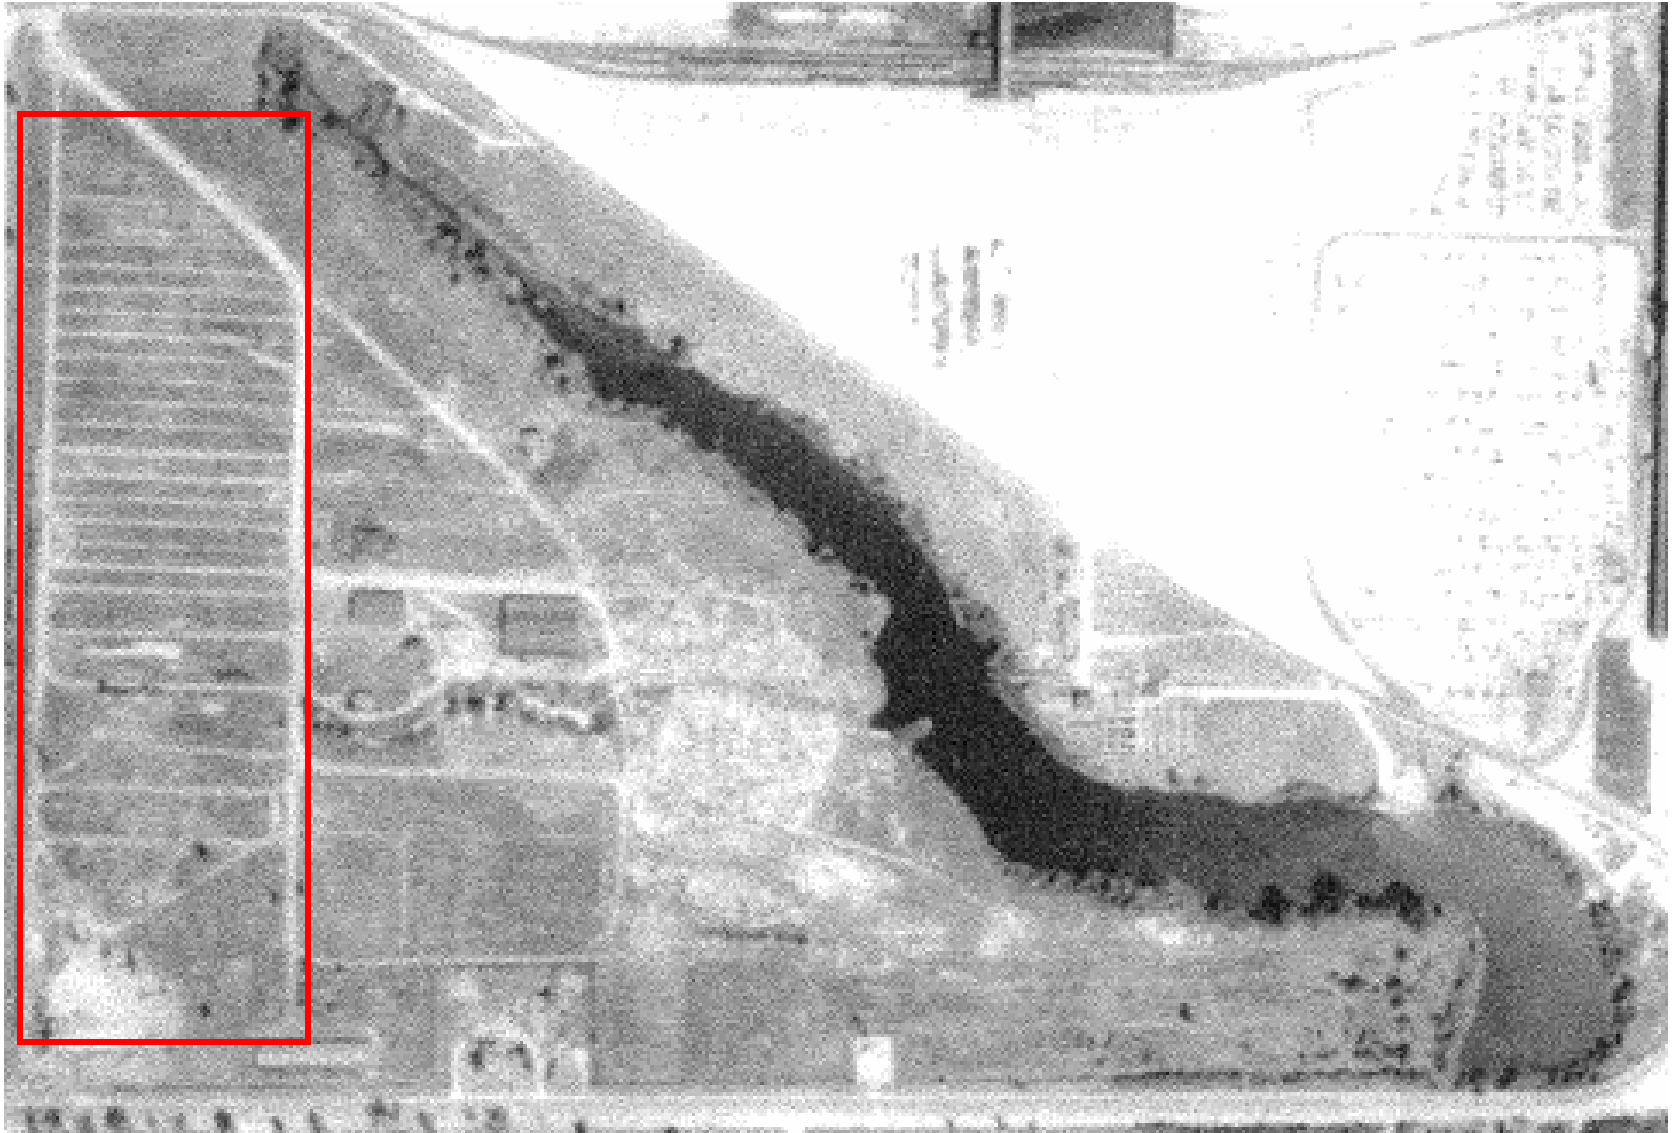
# 1955A/ GM/ GM

1955: Two 1955 aerals were located. In 1955A the materials stored on the WRBC property as observed in the 1952 aerial photograph have been removed.

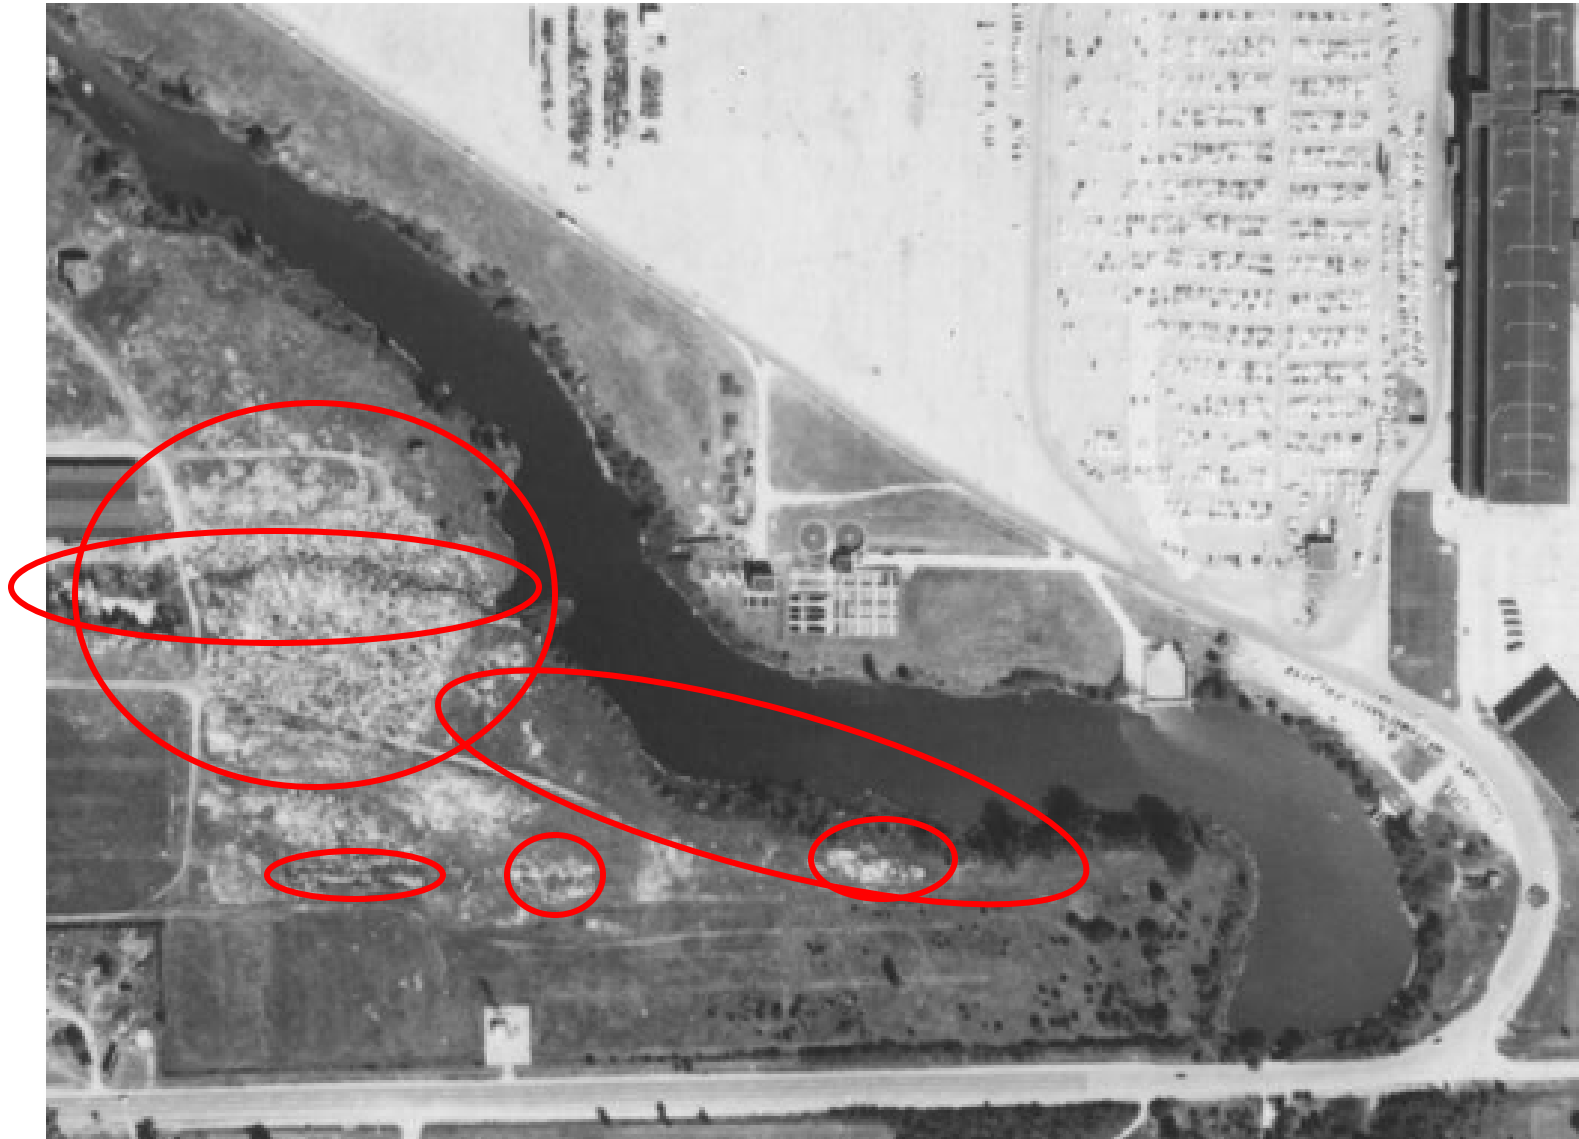
# 1955B/ GM/ GM

More detail is visible in the 1955B photograph. The 1955 aerial photographs indicate that the land use south of Tyler Pond remains unchanged from the 1952 aerial photograph. The land south of Tyler Pond remains undeveloped but significant fill activities continued northwest of Outfall #11 where the South Culvert was located. It appears that vegetation covers most of the area between Outfalls #11 and #12, indicating that minimal disturbance of the soils has occurred in 1954 and 1955. Some remnants of fill or excavation activities are noticeable to the south and southwest of Outfall #12, which is the location of the current top of the hill/fence line.

Remnants of the pit identified in the 1949 drawing are still noticeable in the 1955 photo. It appears that the pit has been filled in from the sides of the pit, or the liquid level in the pit had dropped. This is based on the observation that the pit appeared to cover less surface area. It is possible that this area may have been used to dump liquids based on the disturbance around the pit. The pits identified in the 1952 photo to the west of previously identified pit in the 1949 photo are still present but it appears that the liquid levels have decreased.
