**CONESTOGA-ROVERS  
& ASSOCIATES**

## MEMORANDUM

DATE: April 27, 2007

RE: **Review of Historical Development and Filling Activities  
GM Former Willow Run Assembly Plant - Ypsilanti, Michigan - Update**

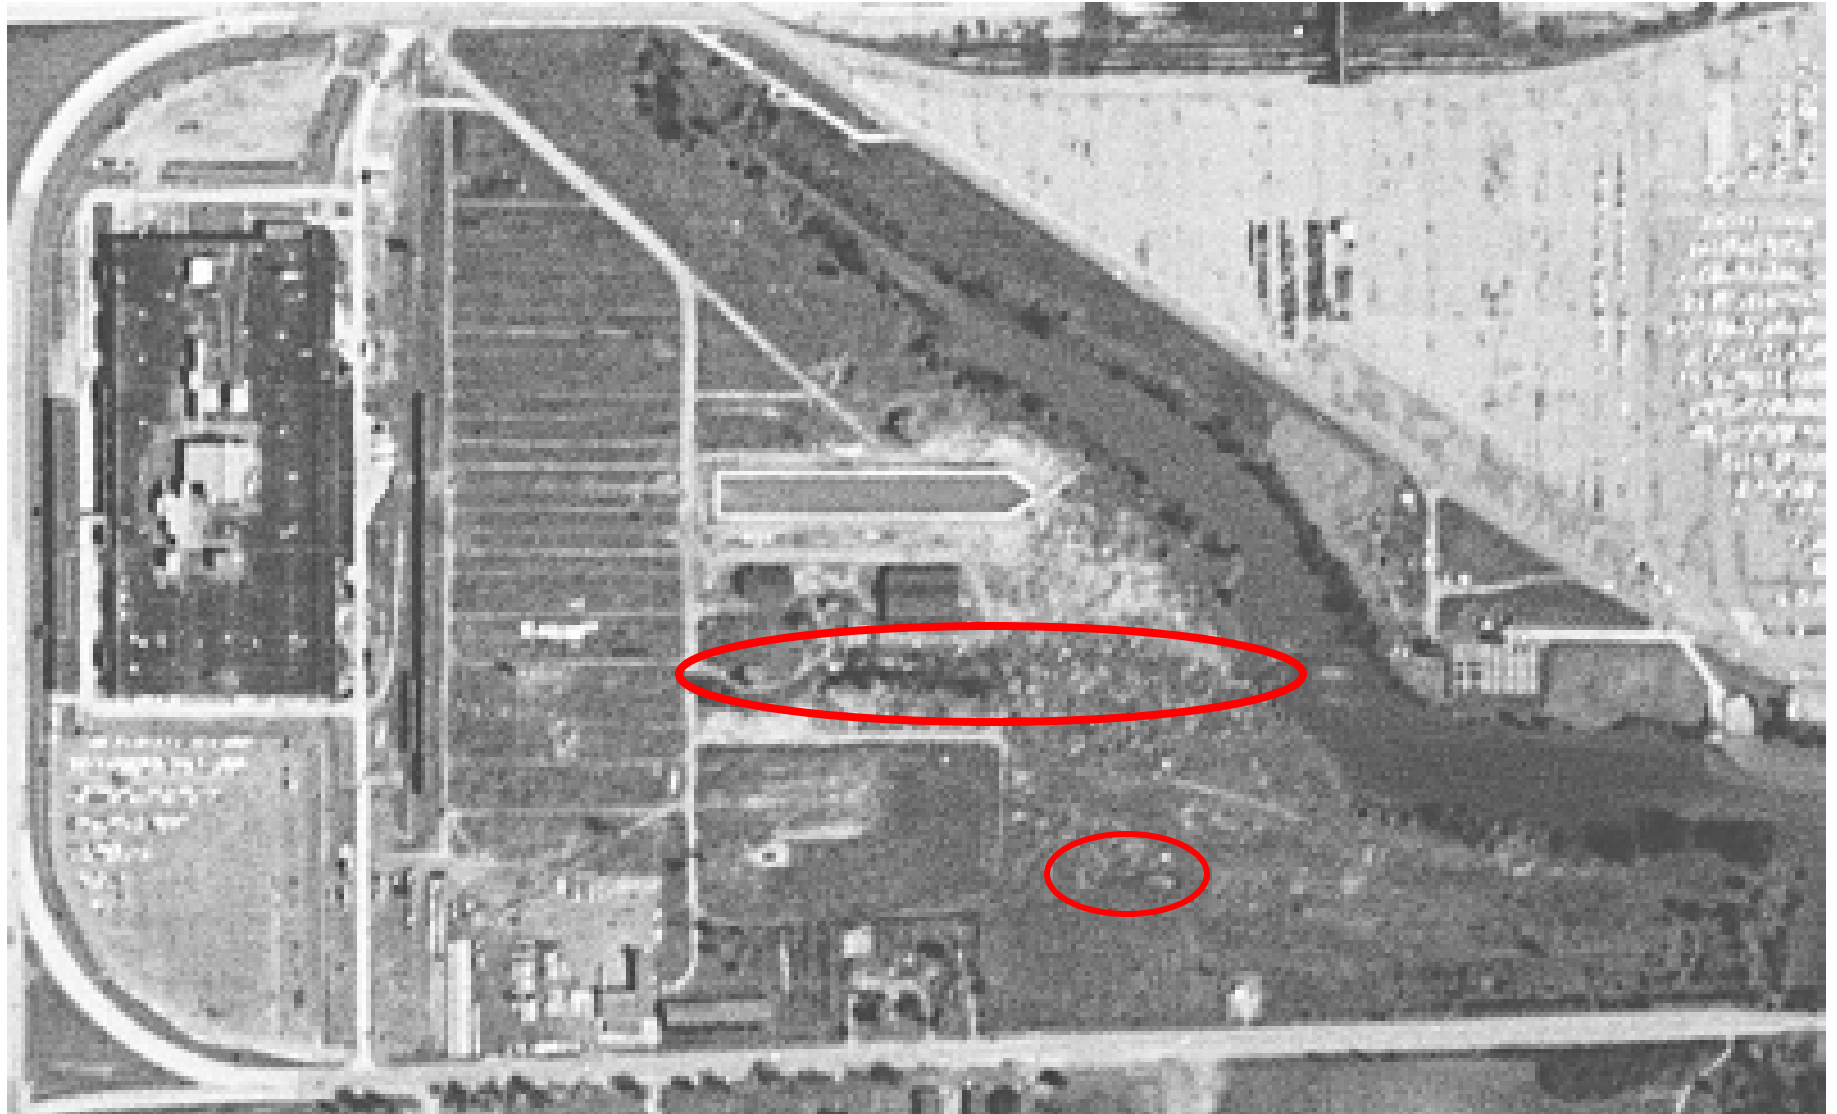
1956/ GM/ GM

1956: The 1956 photo is similar to the 1955 aerial photograph, although the 1956 aerial photograph is grainier than the 1955 aerial photograph. The aeration basin is evident northwest of the former South Culvert. No other significant changes are noticeable. It appears that the long pits may still be present. The amount of vegetation at the Site appears to be increasing. The graininess of the photo limits the level of discernable detail.

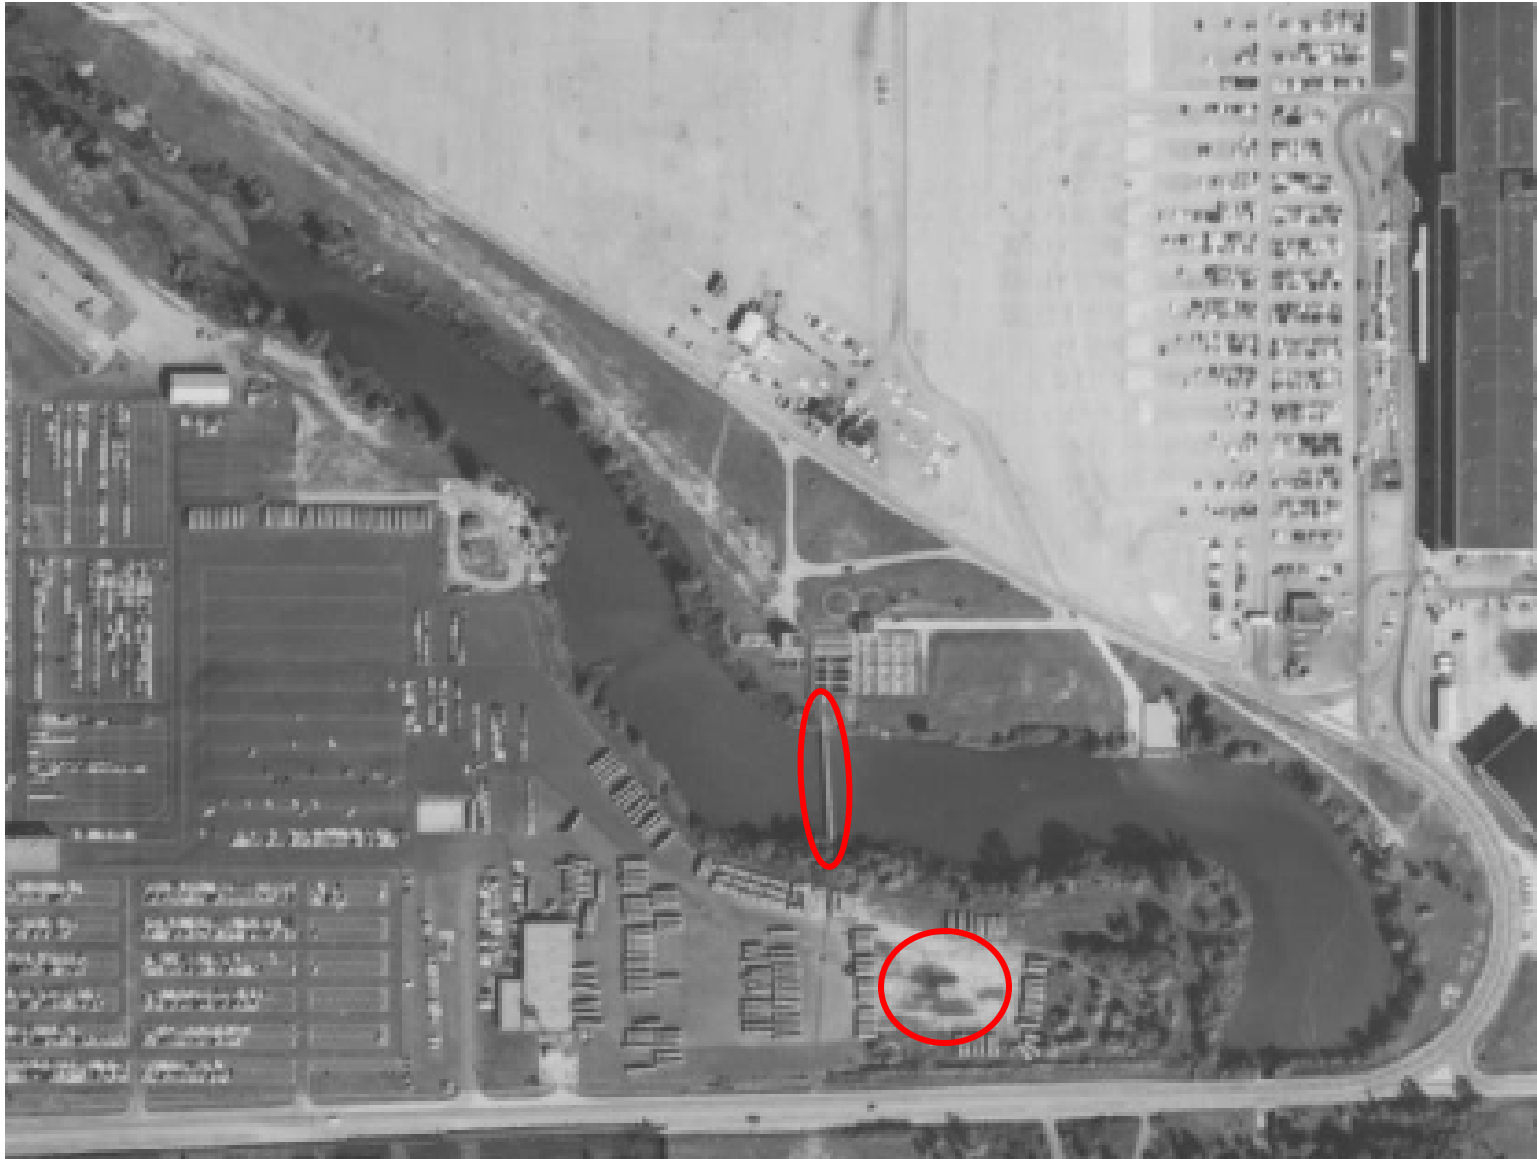
# 1963/ GM/ GM

1963: The 1963 aerial photograph shows that the CVO area had been significantly developed. The Haulaway Building has been constructed and all of the area to the west of a line running south of the pipe trestle crossing Tyler Pond is paved. The area to the east of a line running south of the pipe trestle still appears to be unpaved but approximately 60% of the area is being used to store truck trailers. Staining is visible in the eastern area where truck trailers are stored. There is no evidence of any recent soil disturbances along the south side of Tyler Pond near Outfall #11 or to the east of that location.

| EFFORT/EVENTS | COMPLETED BY | OWNER/OPERATOR | DATE |
|---|---|---|---|
| Aerial Photo: Hydraulic gradient/flow direction of groundwater potentially modified by installation of storm sewer lines between the original Haulaway Bldg. and Tyler Road. | -- | " | September 29, 1963 |

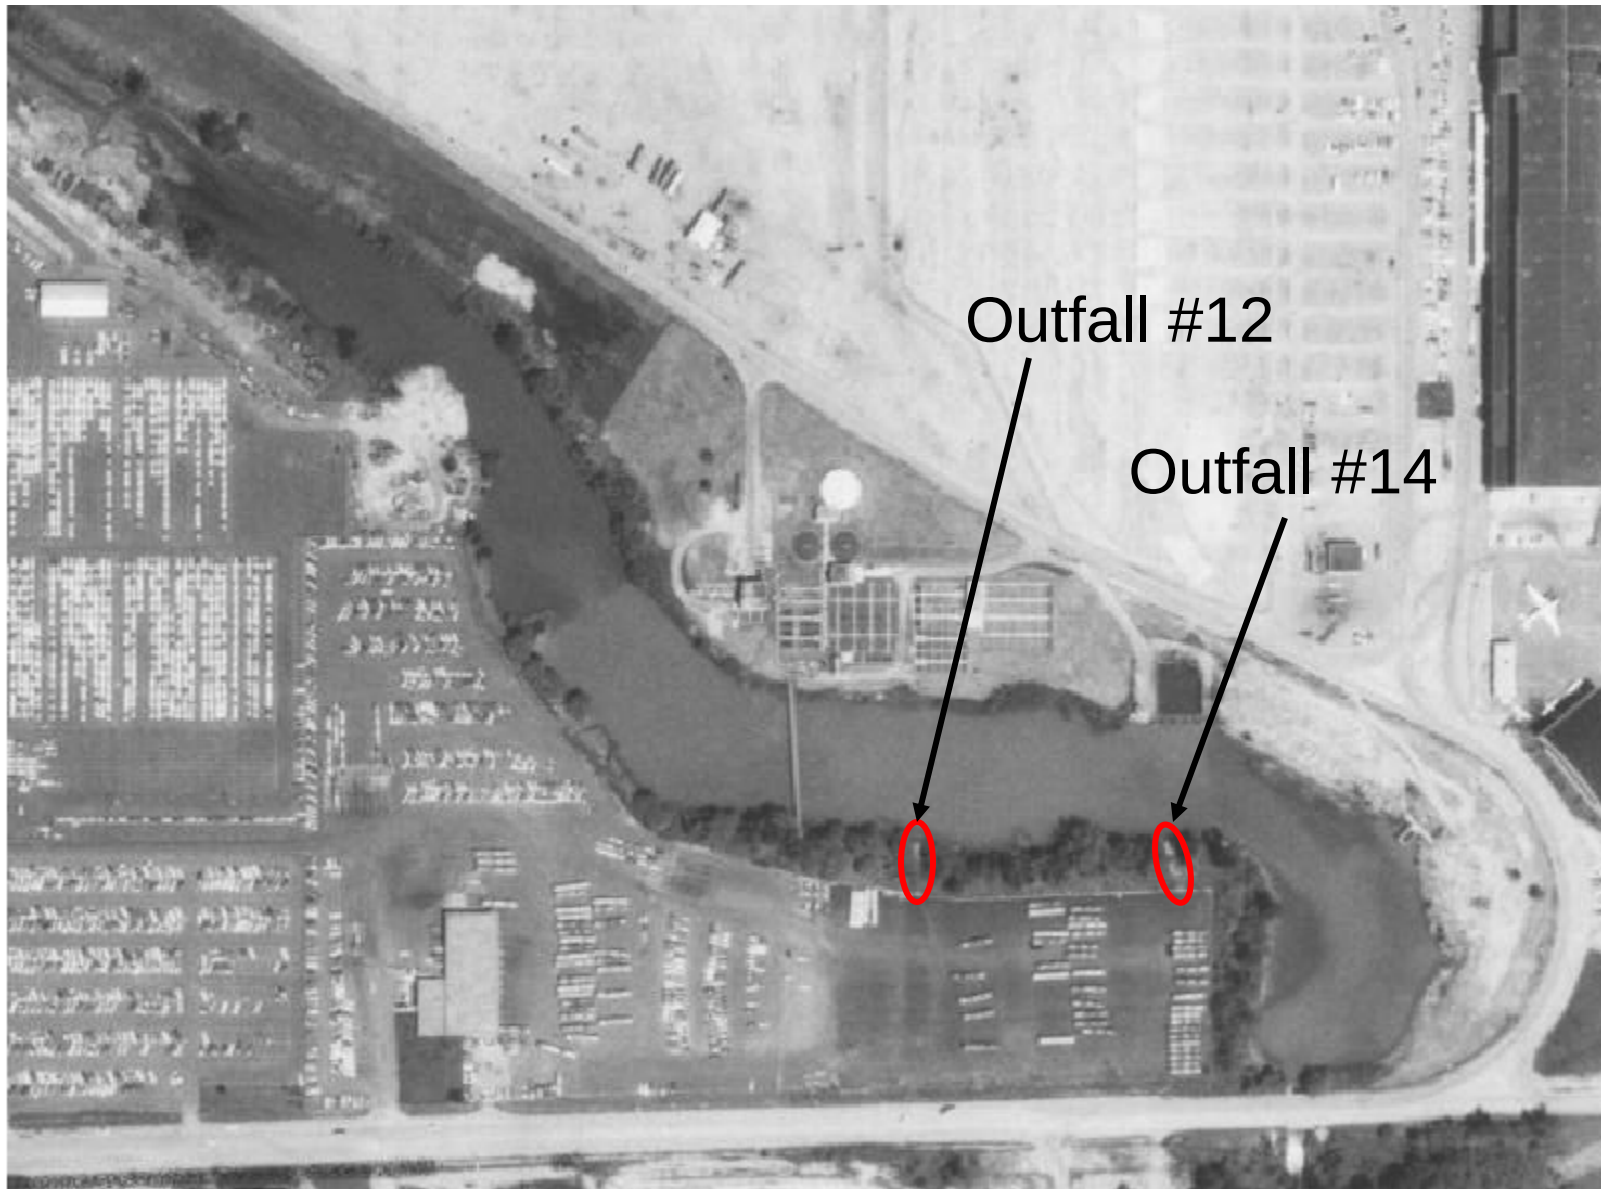
# 1969/ GM/ GM

1969: The 1969 aerial photograph shows that the entire CVO area is paved consistent with the paved area that exists today. There is evidence that the south shore of Tyler Pond is disturbed in the vicinity of Outfalls #12 and #14. These outfalls were likely installed when the eastern half of the parking lot was paved. The eastern half of the parking area appears to be used for parking truck trailers. The western half appears to be used for parking trailers and cars.

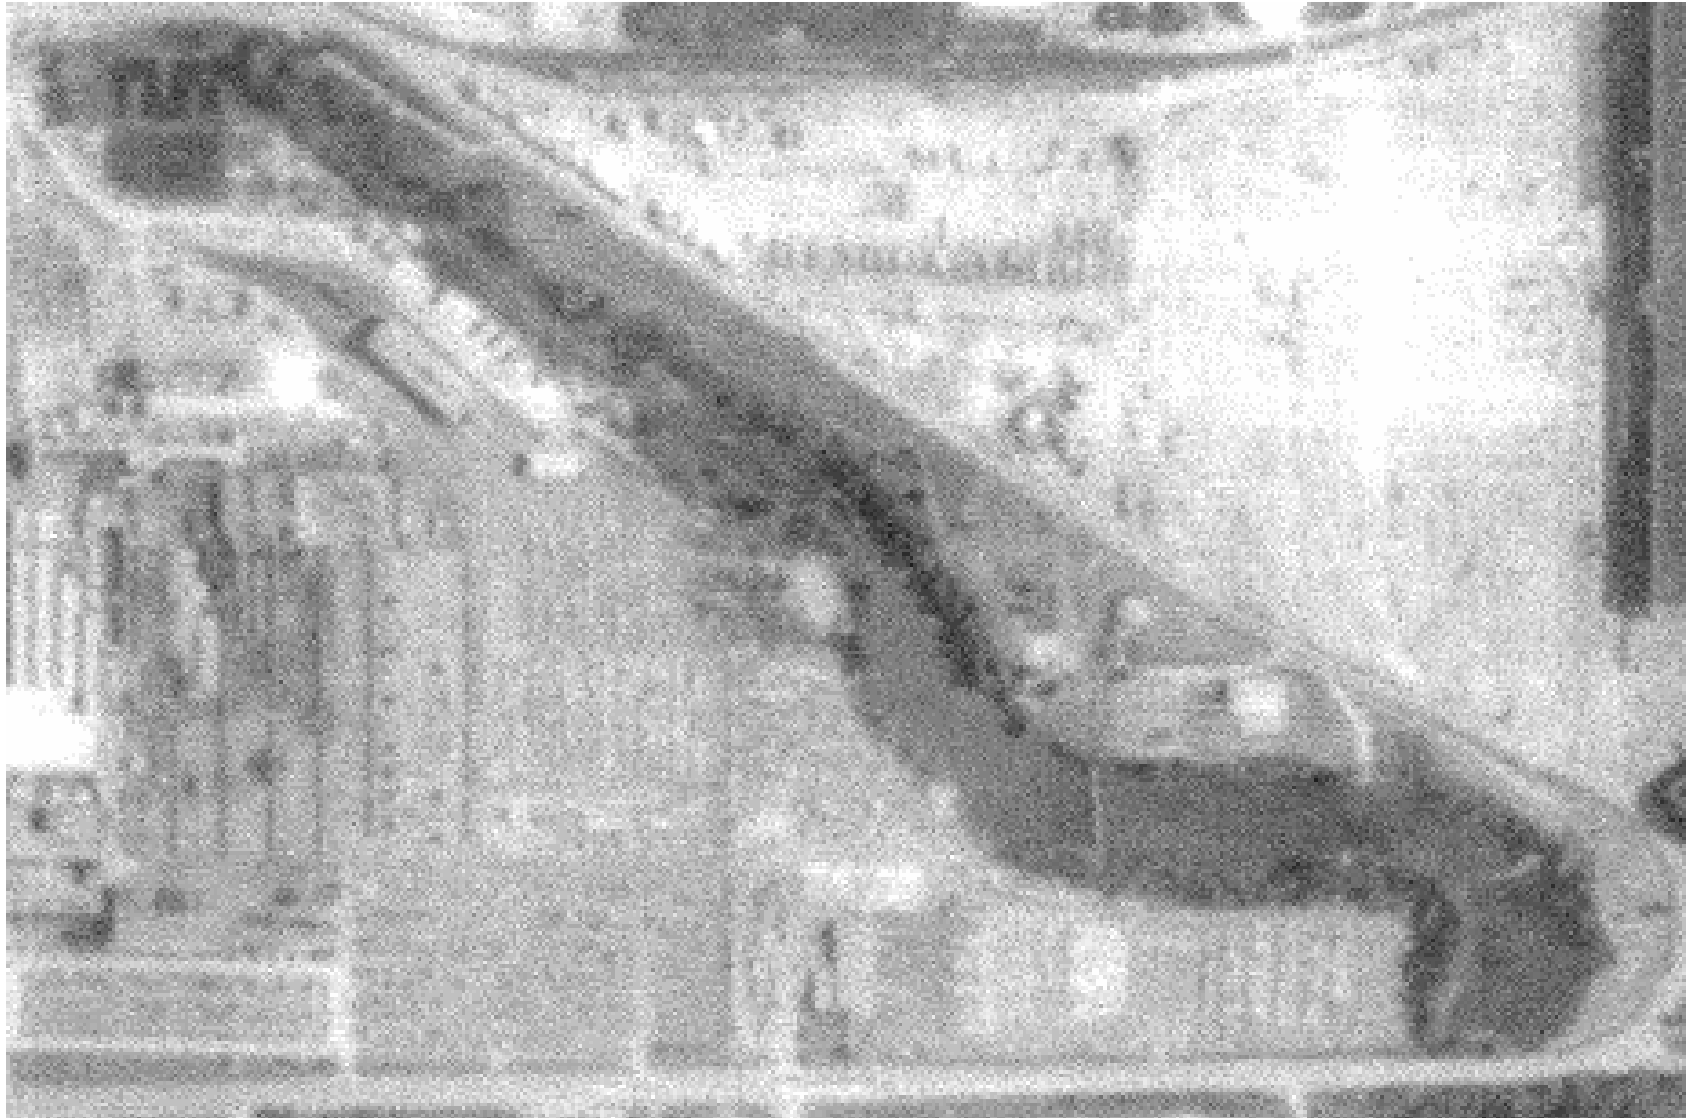
1978/ GM/ GM

1978: The 1978 aerial photograph is of poor quality and covers a larger area than previous photos, both of which minimize the noticeable details. This photo shows only one pipe trestle crossing Tyler Pond.

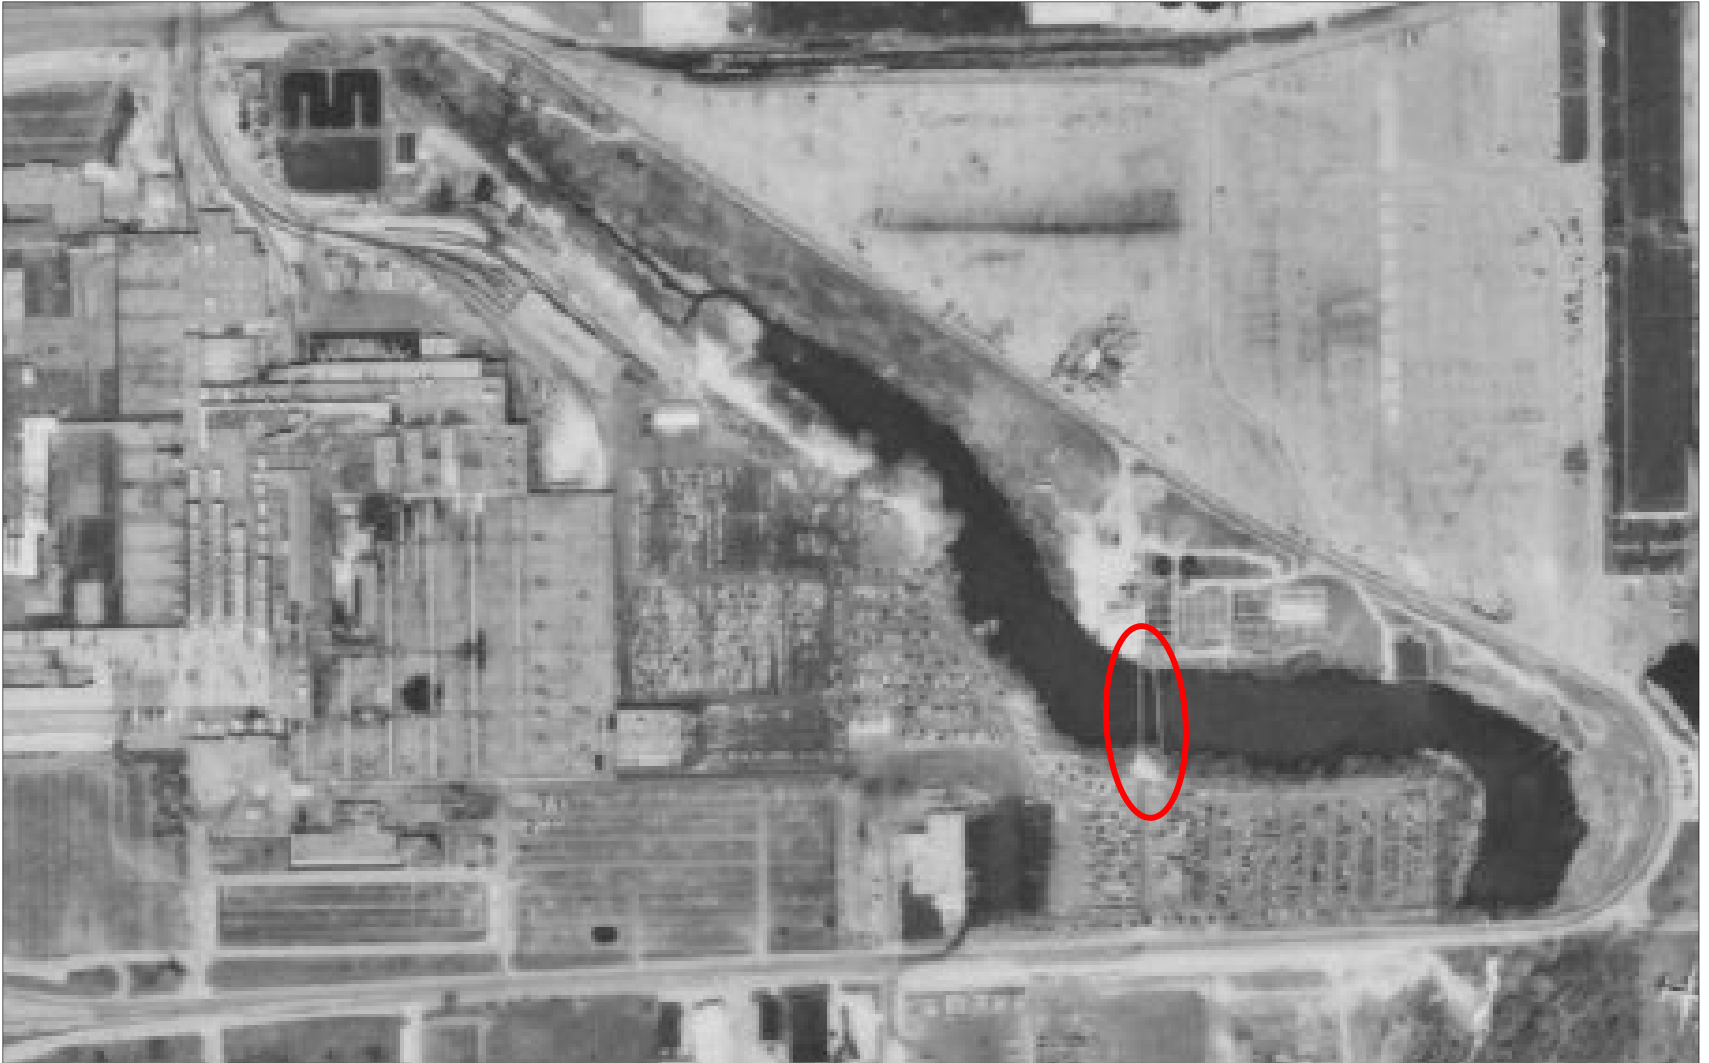
# 1980/ GM/ GM

1980: The 1980 aerial photograph covers even more area per square inch than the 1978 aerial photograph but the quality is better. This photo shows two pipe trestles crossing Tyler Pond. The second pipe trestle is located to the west of the original trestle. There is evidence of recent

soil disturbance activities to the south of the new pipe trestle. This would likely be related to the installation of the new sanitary sewer lines associated with the new pipe trestle. The north side of the parking area appears to have been disturbed compared to the 1969 aerial photograph. This may be associated with the installation of the new sewer line that was installed in the mid-1970s to capture the stormwater and direct it to the treatment plant at the northwest end of Tyler Pond. The entire parking area appears to be fully utilized for parking vehicles. The photo does not contain enough detail to make observations regarding the south bank of Tyler Pond.

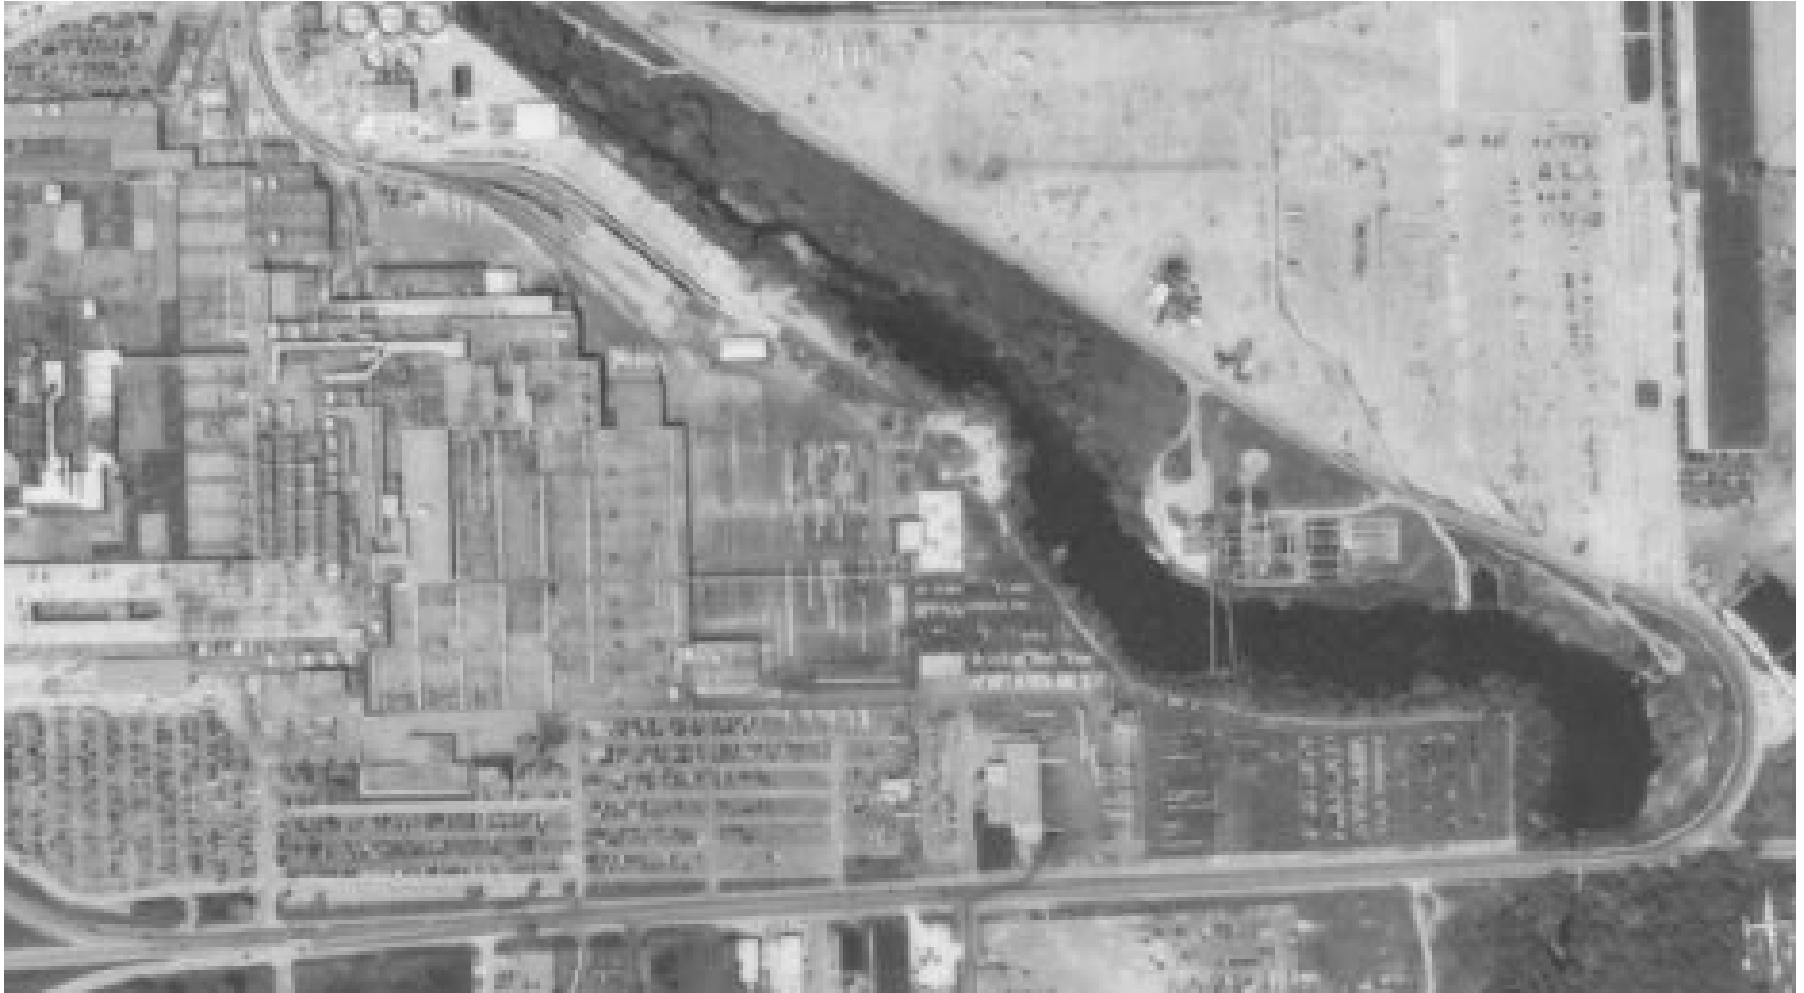
# 1985/ GM/ GM

- 1985: The 1985 aerial photograph quality and scale are similar to the 1980 aerial photograph. The 1985 aerial photograph is essentially unchanged from the 1980 aerial photograph with the Site well developed. A building is evident to the northwest of the Haulaway Building. The south bank of Tyler Pond is vegetated.

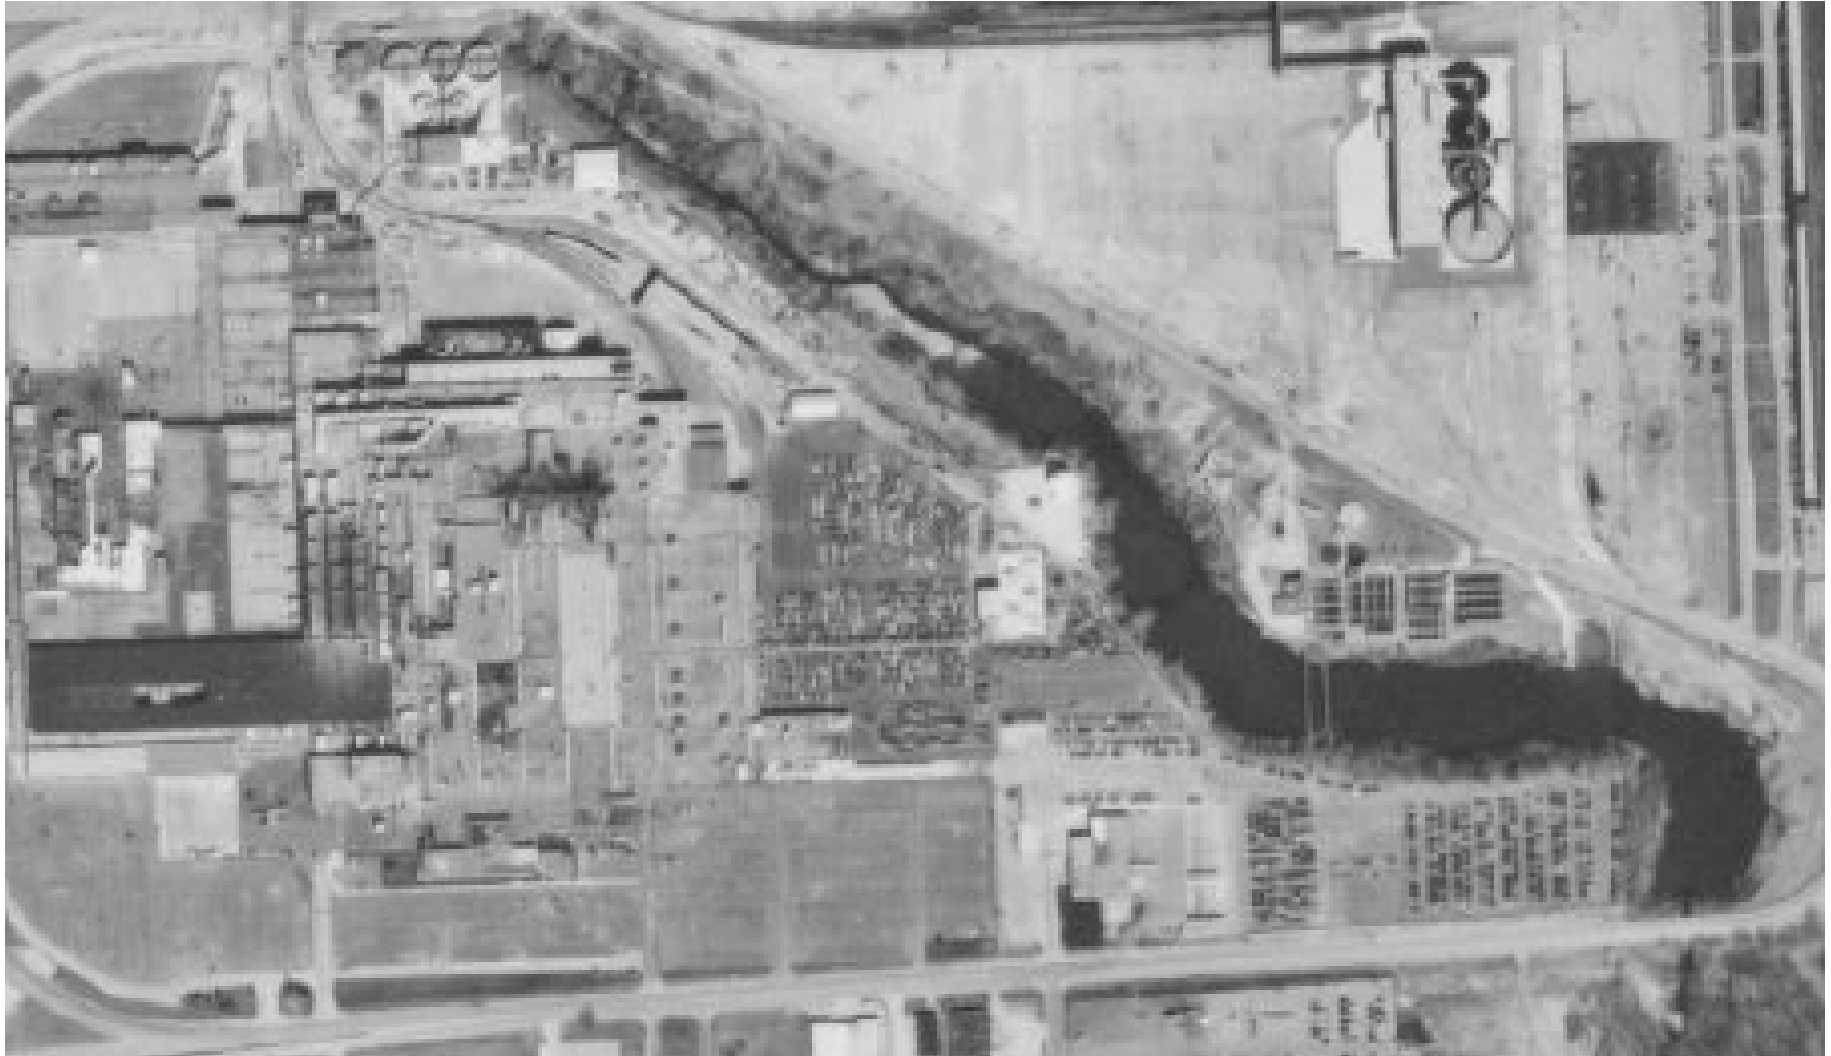
# 1990/ GM/ GM

- 1990: The 1990 aerial photograph is essentially unchanged from the 1985 aerial photograph.
- 1994: The 1994 aerial photograph is very blurry, but essentially unchanged from the 1990 aerial photograph.

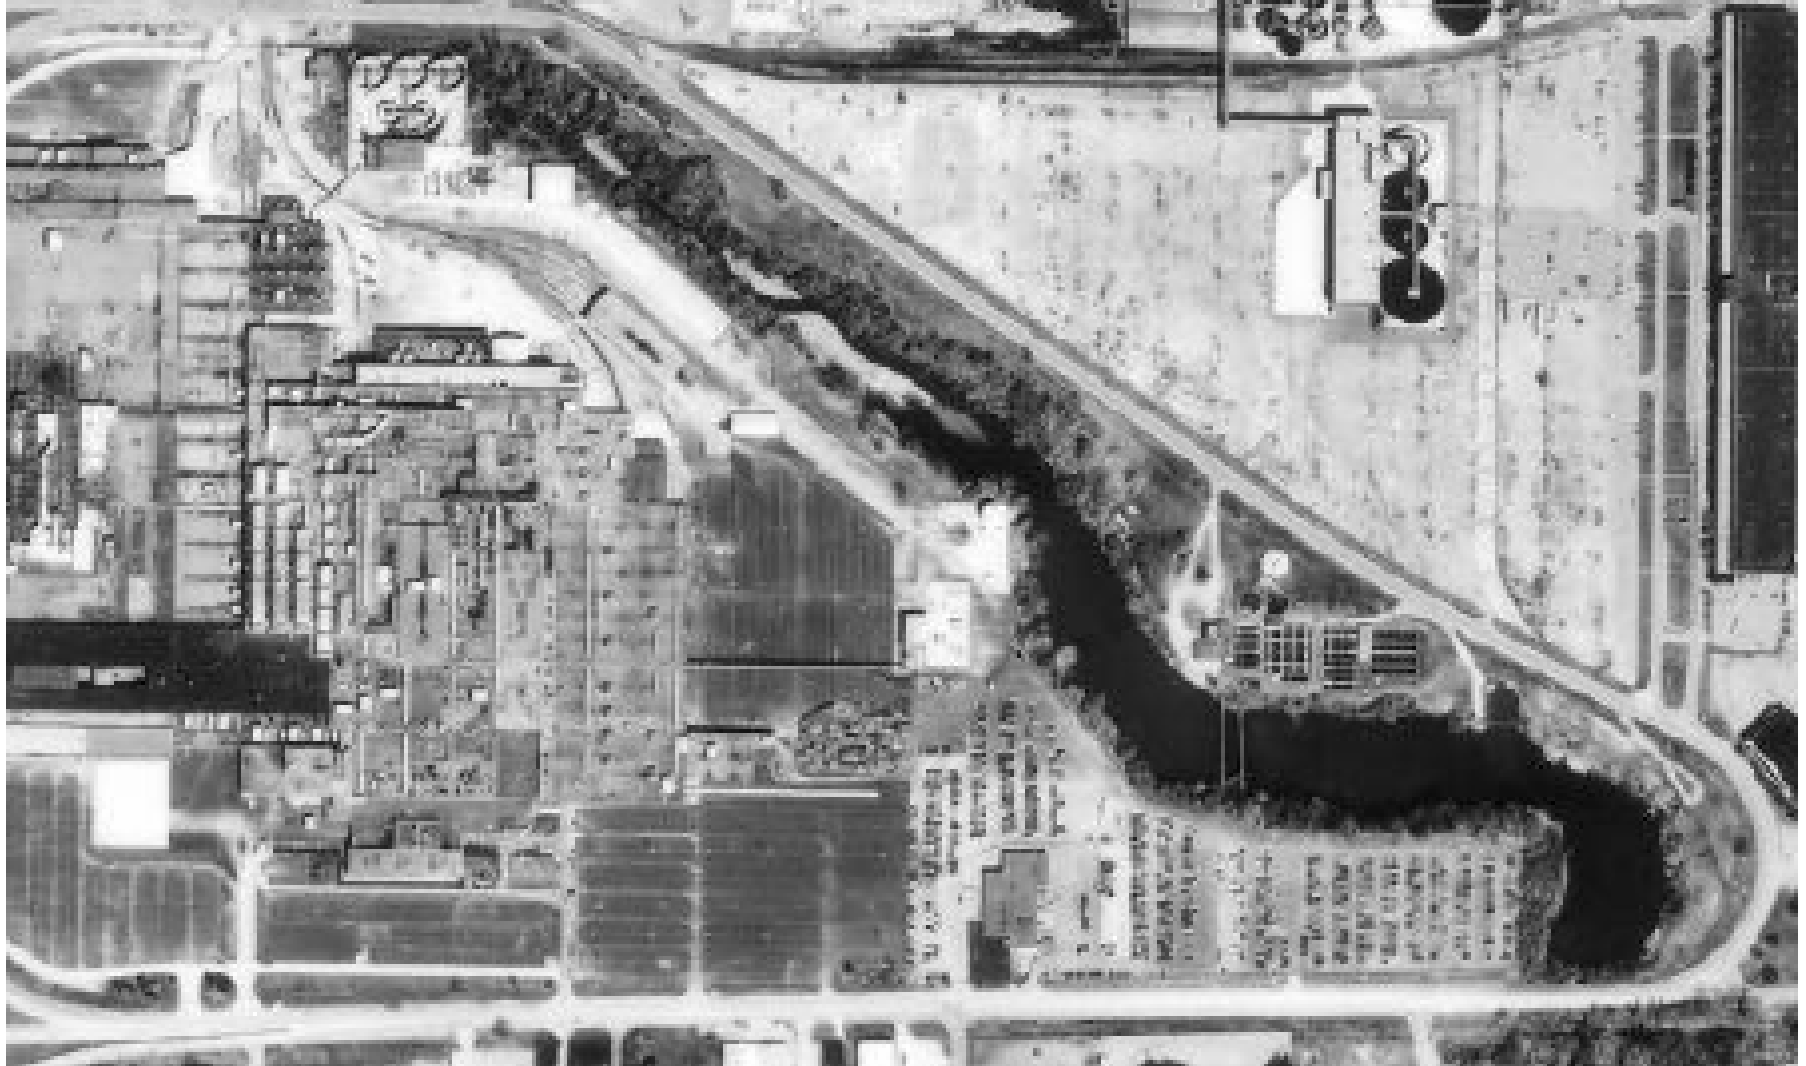
# 1995/ GM/ GM

- 1995: The 1995 aerial photograph quality and scale are similar to the 1985 aerial photograph. The photo is very clear but with a large scale (zoomed out). The 1995 aerial photograph is essentially unchanged from the 1990 and 1994 aerial photographs.

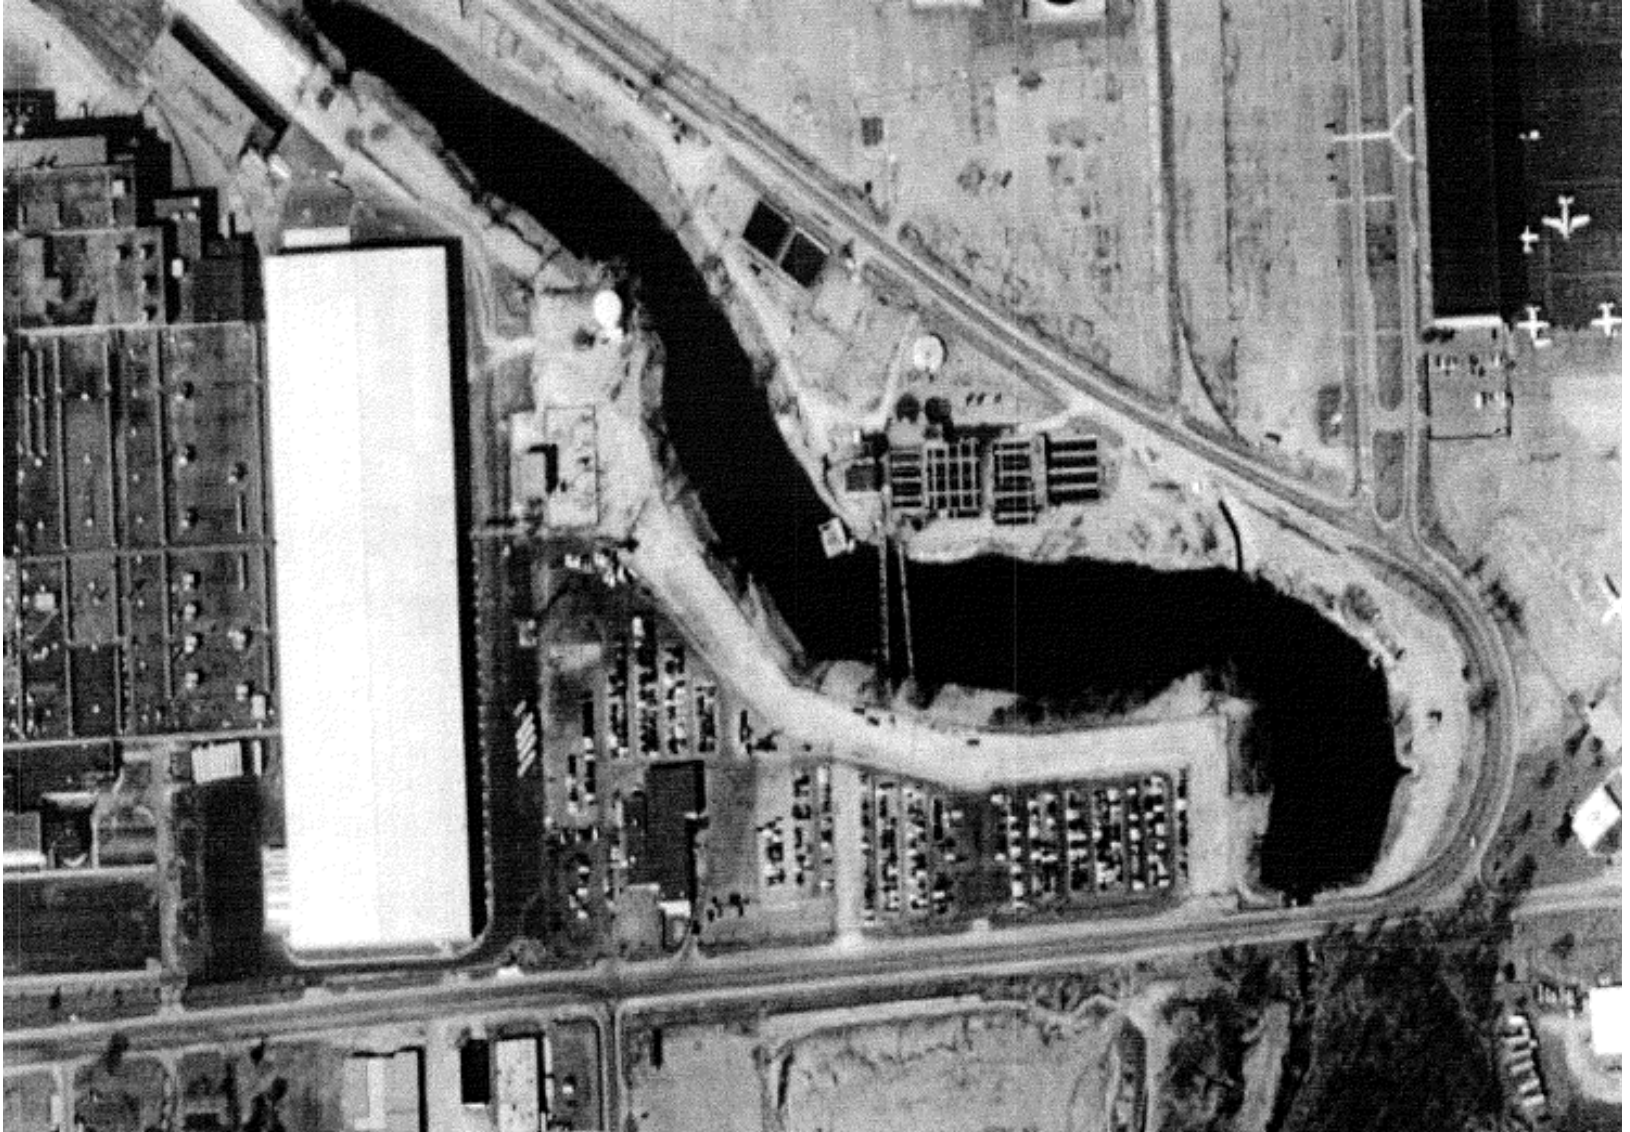
1998/ GM/ GM

- 1998: The 1998 aerial photograph shows some significant changes to the Site. The north and east sides of the parking area include a corridor area along the south shore of Tyler Pond. Several areas of the south bank along Tyler Pond have been cleared of vegetation. This corridor and the cleared areas of the shoreline are related to the remediation of Tyler Pond.

| EFFORT/EVENTS | COMPLETED BY | OWNER/OPERATOR | DATE |
|---|---|---|---|
| Aerial Photo: Hydraulic gradient/flow direction modified by dredging operations to remediate PCB sediments in former creek bottom. | -- | " | 1998 |
