April 15, 2022

RACER Pontiac North Campus – 2021 Property Inspection Report

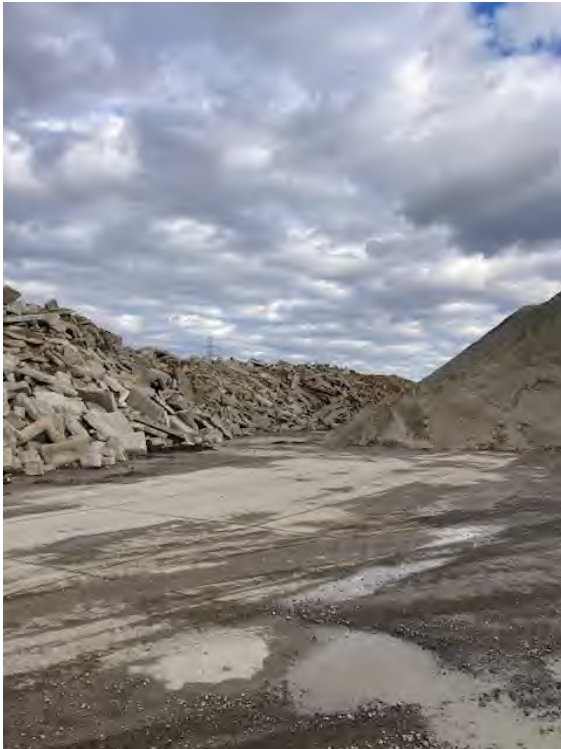
**Photograph: 3**

**Description:** Material piles present in the central portion of the property, facing east.

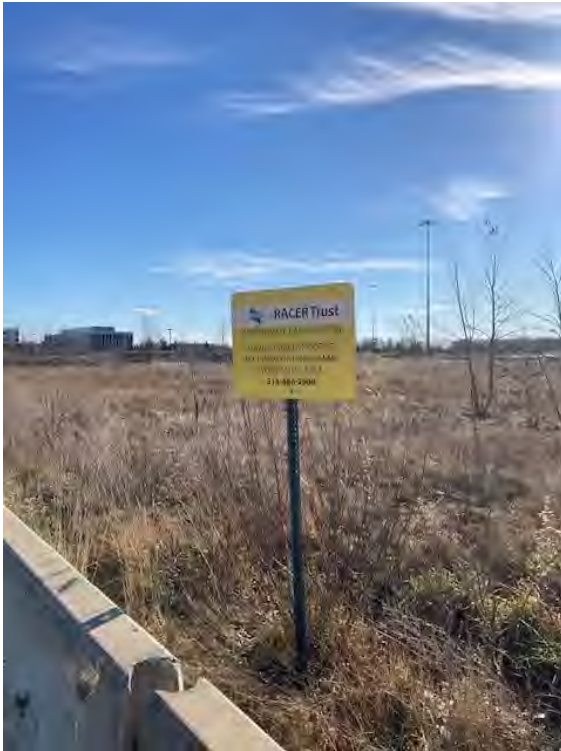
**Photograph: 3**

**Description:** Marker observed in one of the PCB cap areas at the property.

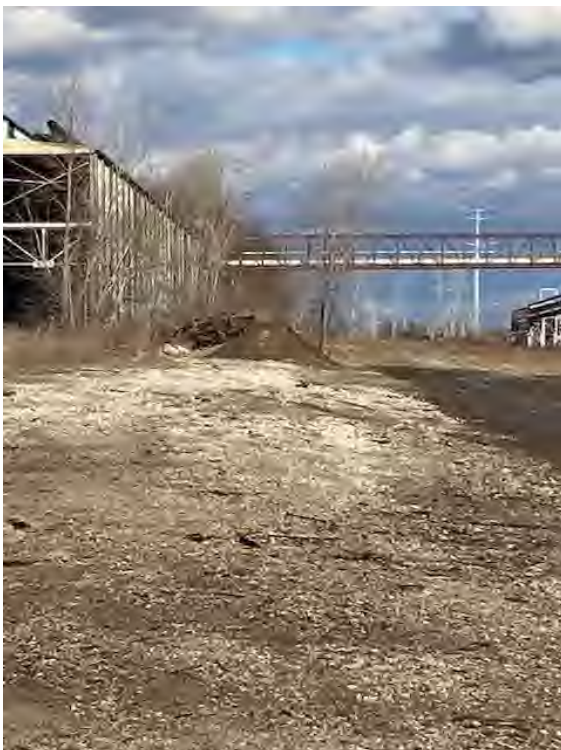
**Photograph: 2**

**Description:** Small soil pile observed in southern portion of property near Tatro property, facing north.

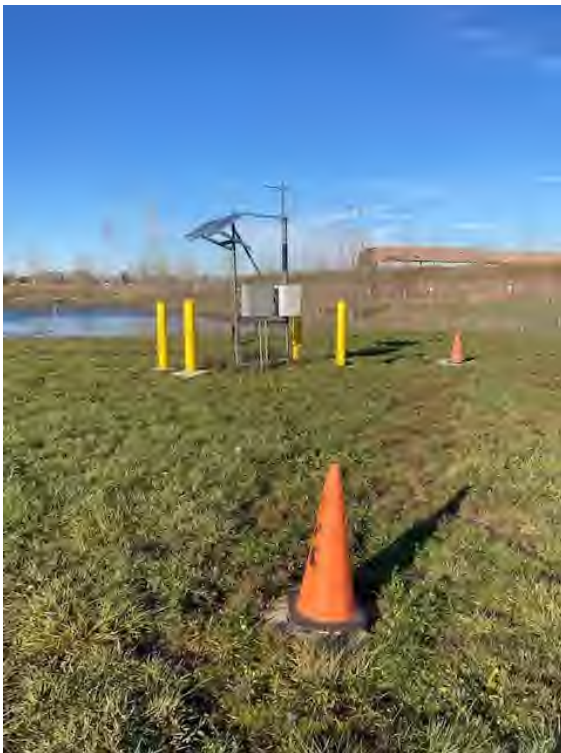
**Photograph: 4**

**Description:** Montcalm seep system in the northwestern portion of the property, facing west.

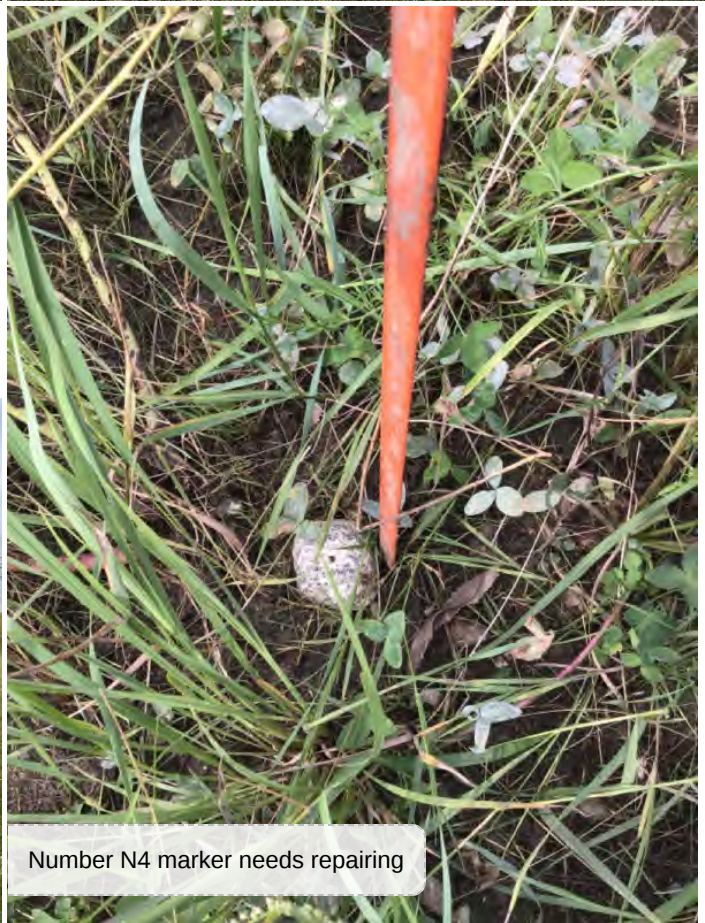
- Nine of the ten permanent monuments to define elevations are intact and legible. N-4 marker is damaged, and needs reset and resurveyed.
  - Measured elevations of the ten permanent monument markers indicate that no significant erosion has occurred, and that sufficient cap material is present above the impacted material

Number N4 marker needs repairing

- In summary, no current conditions warrant corrective measures, with the exception of resetting and re-surveying marker N-4
- USPS West Yard South TSCA Cap (AOI W-1)

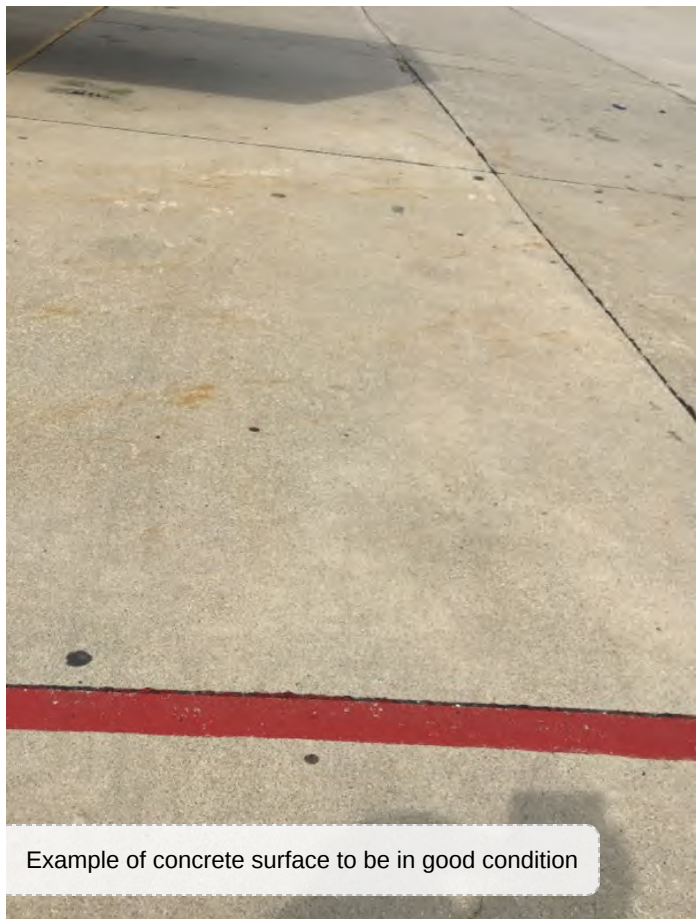
Example of concrete surface to be in good condition
