RE: Windiate Park/Dixieland Subdivision Landfill, Genesee County, Michigan (Site ID No. 25000689)  
FILE: 15388/68490 - Soil Cover Inspection Report

## WINDIATE PARK SOIL COVER MAINTENANCE CHECKLIST

Inspection Date: May 24, 2018

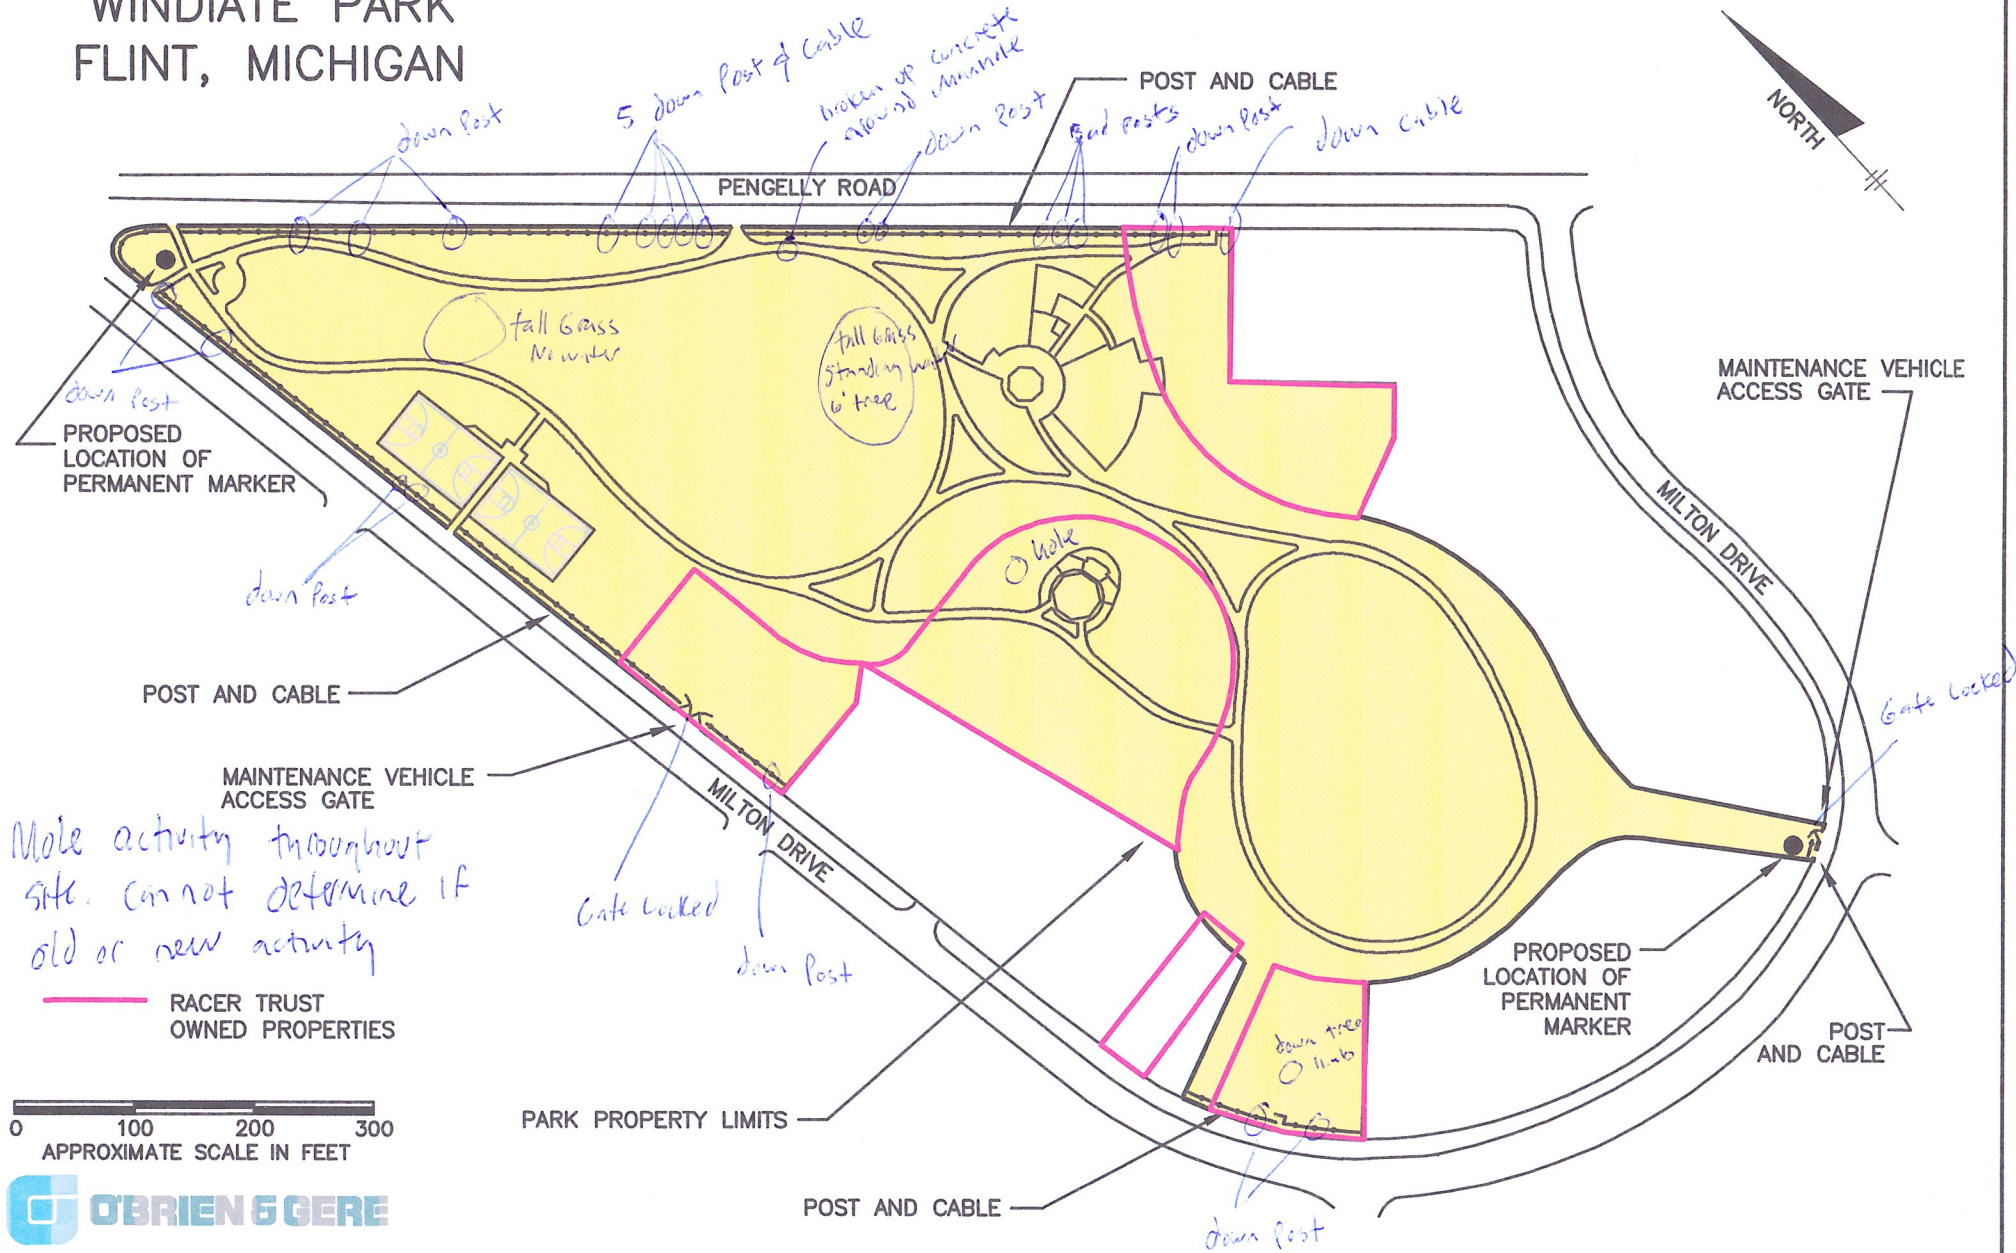
# INSPECTION MAP

During the inspection the soil cover was observed to be in good condition and no soil cover repairs are necessary at this time. However, it should be noted that on the City of Flint owned parcel, an area was observed where water has ponded after rain events. Please refer to the attached inspection sheet and map for further details.

| Inspected Item: | Comments: |
|---|---|
| <i>GRASS/VEGETATIVE LAYER</i> | Acceptable. No maintenance required at this time. One area was observed with standing water, tall grass and tall woody plants. |
| <i>POST &amp; CABLE / VEHICLE GATES</i> | Acceptable. Twenty-two damaged posts were observed during the site inspection (either partially down or completely down). Two sections of down cable were observed. The south and west maintenance vehicle access gates were locked. |

Add additional soil to area where water has ponded.
