# Memorandum

**Subject: Sequence of Events  
RACER Stanley Road Site, Flint Michigan**

This memorandum presents a sequence of events for RACER's Stanley Road Site (Site), in Flint Michigan, with a specific focus on identifying exceedances and wastes that were present at the Site.

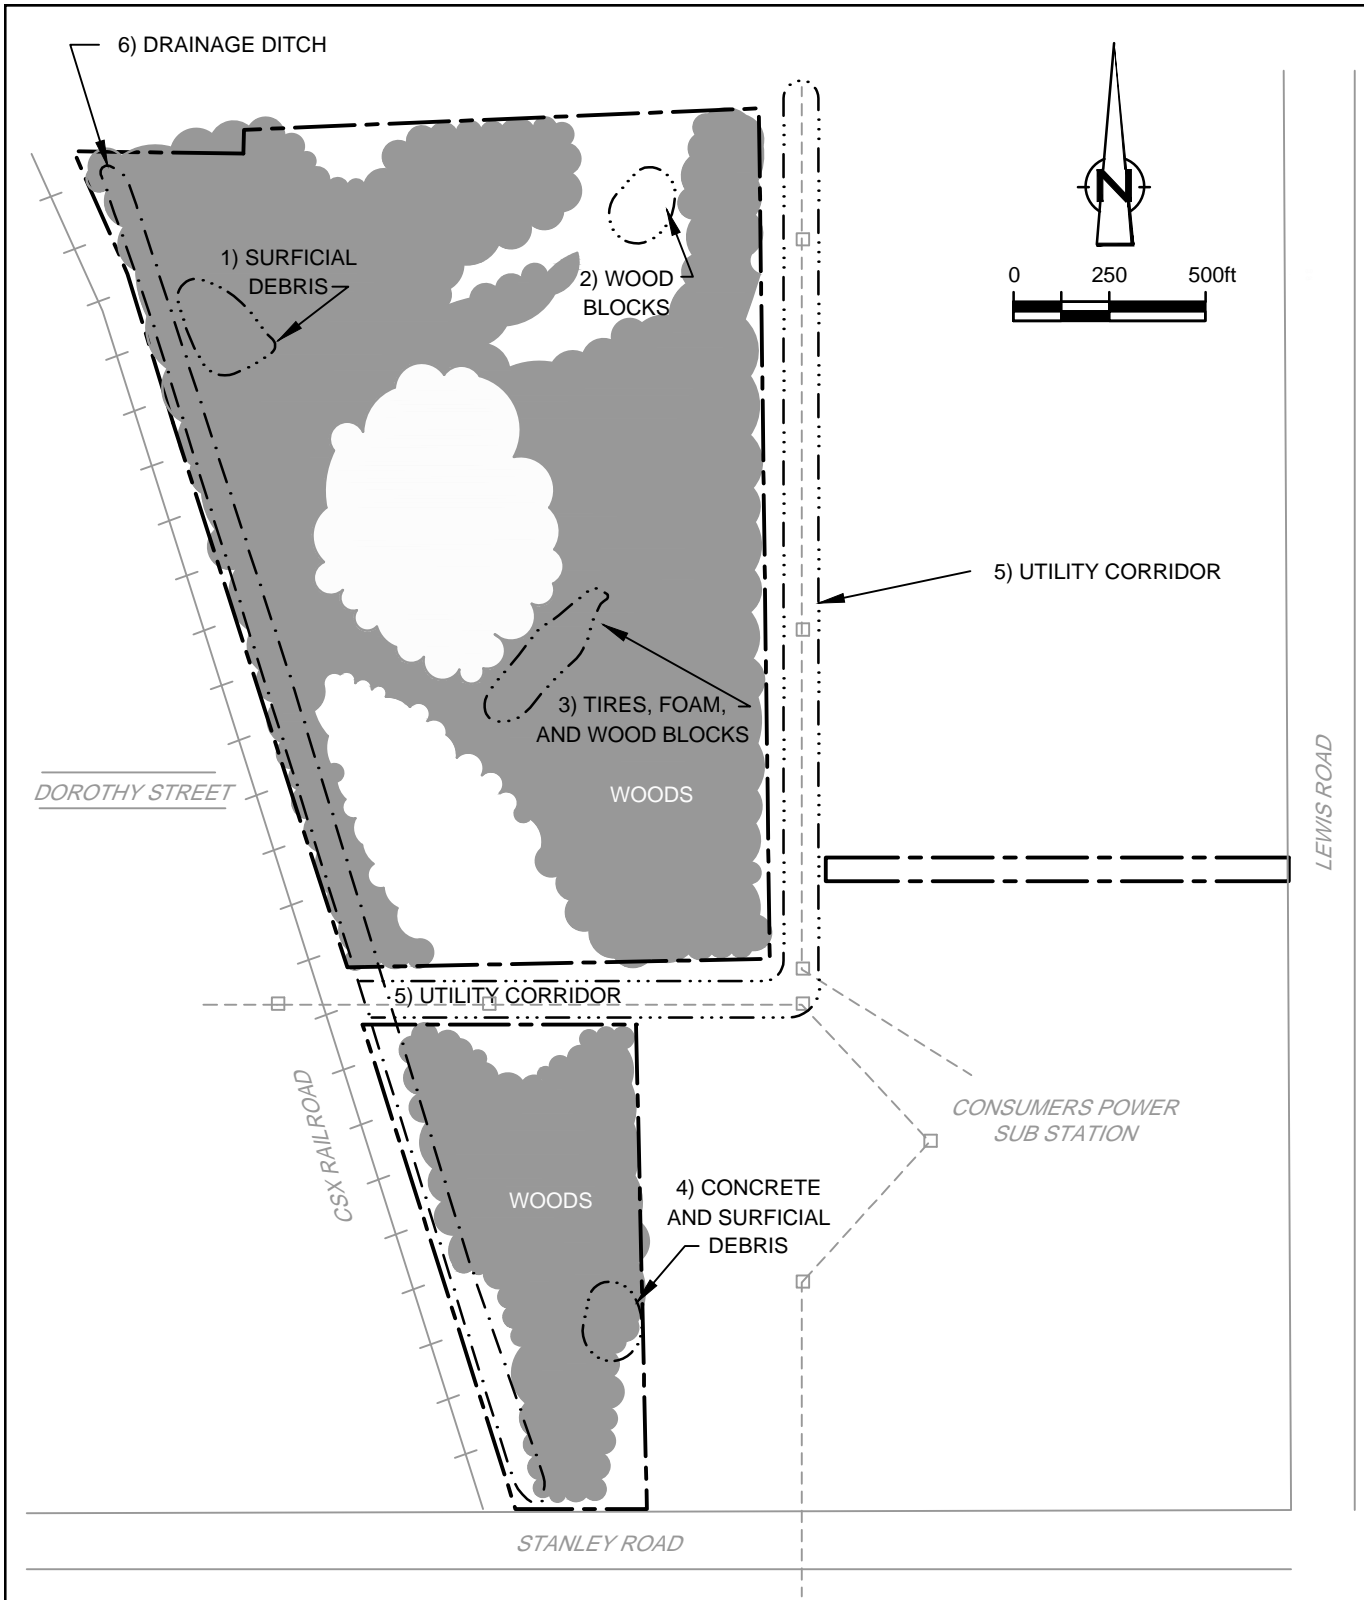
figure 3  
**PAOC LOCATIONS**  
**MOUNT MORRIS DUMP SITE**  
*Genesee County, Michigan*

- 1997 - 1998 GMC purchased land (Specific date unknown).
- Nov. 1998 CRA conducted a Phase I Environmental Site Assessment (May 1999) on behalf of REALM a subsidiary of GMC, for areas other than DA1 and DA2, which identified the following potential areas of concern (PAOCs) as shown in Figure 3:

- PAOC-1 – Potential Disposal Area No. 1 – surficial debris was identified in the area
  - PAOC-2 – Potential Disposal Area No. 2 – surficial debris including wood blocks was identified in the area

- PAOC-3 – Potential Disposal Area No. 3 – surficial debris including tires, foam rubber, and wood blocks was identified in the area
  - PAOC-4 – Potential Disposal Area No. 4 – surficial debris including concrete was identified in the area.

- PAOC-5 – Utility Corridor – transmission lines have historically been treated with herbicides
  - PAOC-6 – Drainage Ditches – stormwater runoff from historical disposal area may be impacted

- Feb. 1999 CRA conducted a Phase II ESA (May 1999) on behalf of REALM a subsidiary of GMC in areas other than DA1 and DA2
- Potential Area of Concern (PAOC) No. 1 - Lead in soil was detected at 20 mg/kg, which is above the Michigan Part 201 Residential Drinking Water Protection Criteria (DWPC) of 1.0 mg/kg and below the Michigan Part 201 Residential Direct Contact Criteria (DCC) of 400 mg/kg. No other RCRA metals, TCL VOCs, TCL SVOCs, and PCBs were detected in the soil sample at concentrations above the Michigan Part 201 Residential DWPC or DCC.

- PAOC No. 2 - Lead in soil was detected at 4 mg/kg, which is above the DWPC of 1.0 mg/kg and below DCC of 400 mg/kg. No other RCRA metals, TCL VOCs, TCL SVOCs, and PCBs were detected in the soil sample at concentrations above the Michigan Part 201 Residential DWPC or DCC. No TCL VOCs, TCL SVOCs, RCRA Metals or PCBS were detected in groundwater above Michigan Part 201 Residential Drinking Water Criteria (DWC) or DCC

- PAOC No. 3 - Lead in soil was detected at 11 mg/kg, which is above the DWPC of 1.0 mg/kg and below the DCC of 400 mg/kg. No other parameters (other RCRA metals, TCL VOCs, TCL SVOCs, and PCBs) were detected in the soil sample at concentrations above the DWPC or DCC. Lead in groundwater was detected at 440 ug/L and mercury in groundwater was detected at 3.0 ug/L, which were above DWC, 4.0 ug/L and 2.0 ug/L, respectively. No other RCRA metals, TCL VOCs, TCL SVOCs, or PCBs were detected in groundwater above DWC or DCC.

- PAOC No. 4 - Lead in soil was detected at 160 mg/kg, which is above the DWPC of 1.0 mg/kg and below the DCC of 400 mg/kg. No other RCRA metals, TCL VOCs, TCL SVOCs, and PCBs were detected in the soil sample at concentrations above the DWPC or DCC.

- PAOC No. 5 – Five surface soil samples were collected and analyzed for herbicides along the utility corridor. There were no exceedances of criteria
- PAOC No. 6 – Silver in sediment was detected at 650 ug/kg which is above the Ontario sediment quality criteria (OSQC) of 500 ug/kg, cadmium in sediment was detected at 660 ug/kg which is above the OSQC of 600 ug/kg, and arsenic was detected at 6,300 ug/kg which is above the OSQC of 6,000 ug/kg. No other parameters (other RCRA metals, TCL VOCs, TCL SVOCs, and PCBs) were detected in the soil sample at concentrations above the DWPC or DCC. No TCL VOC, TCL SVOCs, RCRA metals, herbicides, or PCBs were detected in surface water above U.S. EPA MCLs.
