**Landfill Inspection Report
Coldwater Road Landfill
Flint, Michigan
MID 005 356 860**

**RACER TRUST
Detroit, Michigan**

February 2016

RE: 2015 Annual Landfill Inspection Report
Coldwater Road Landfill, Flint, Michigan
MID 005 356 860
FILE: 15388 /60794/rep

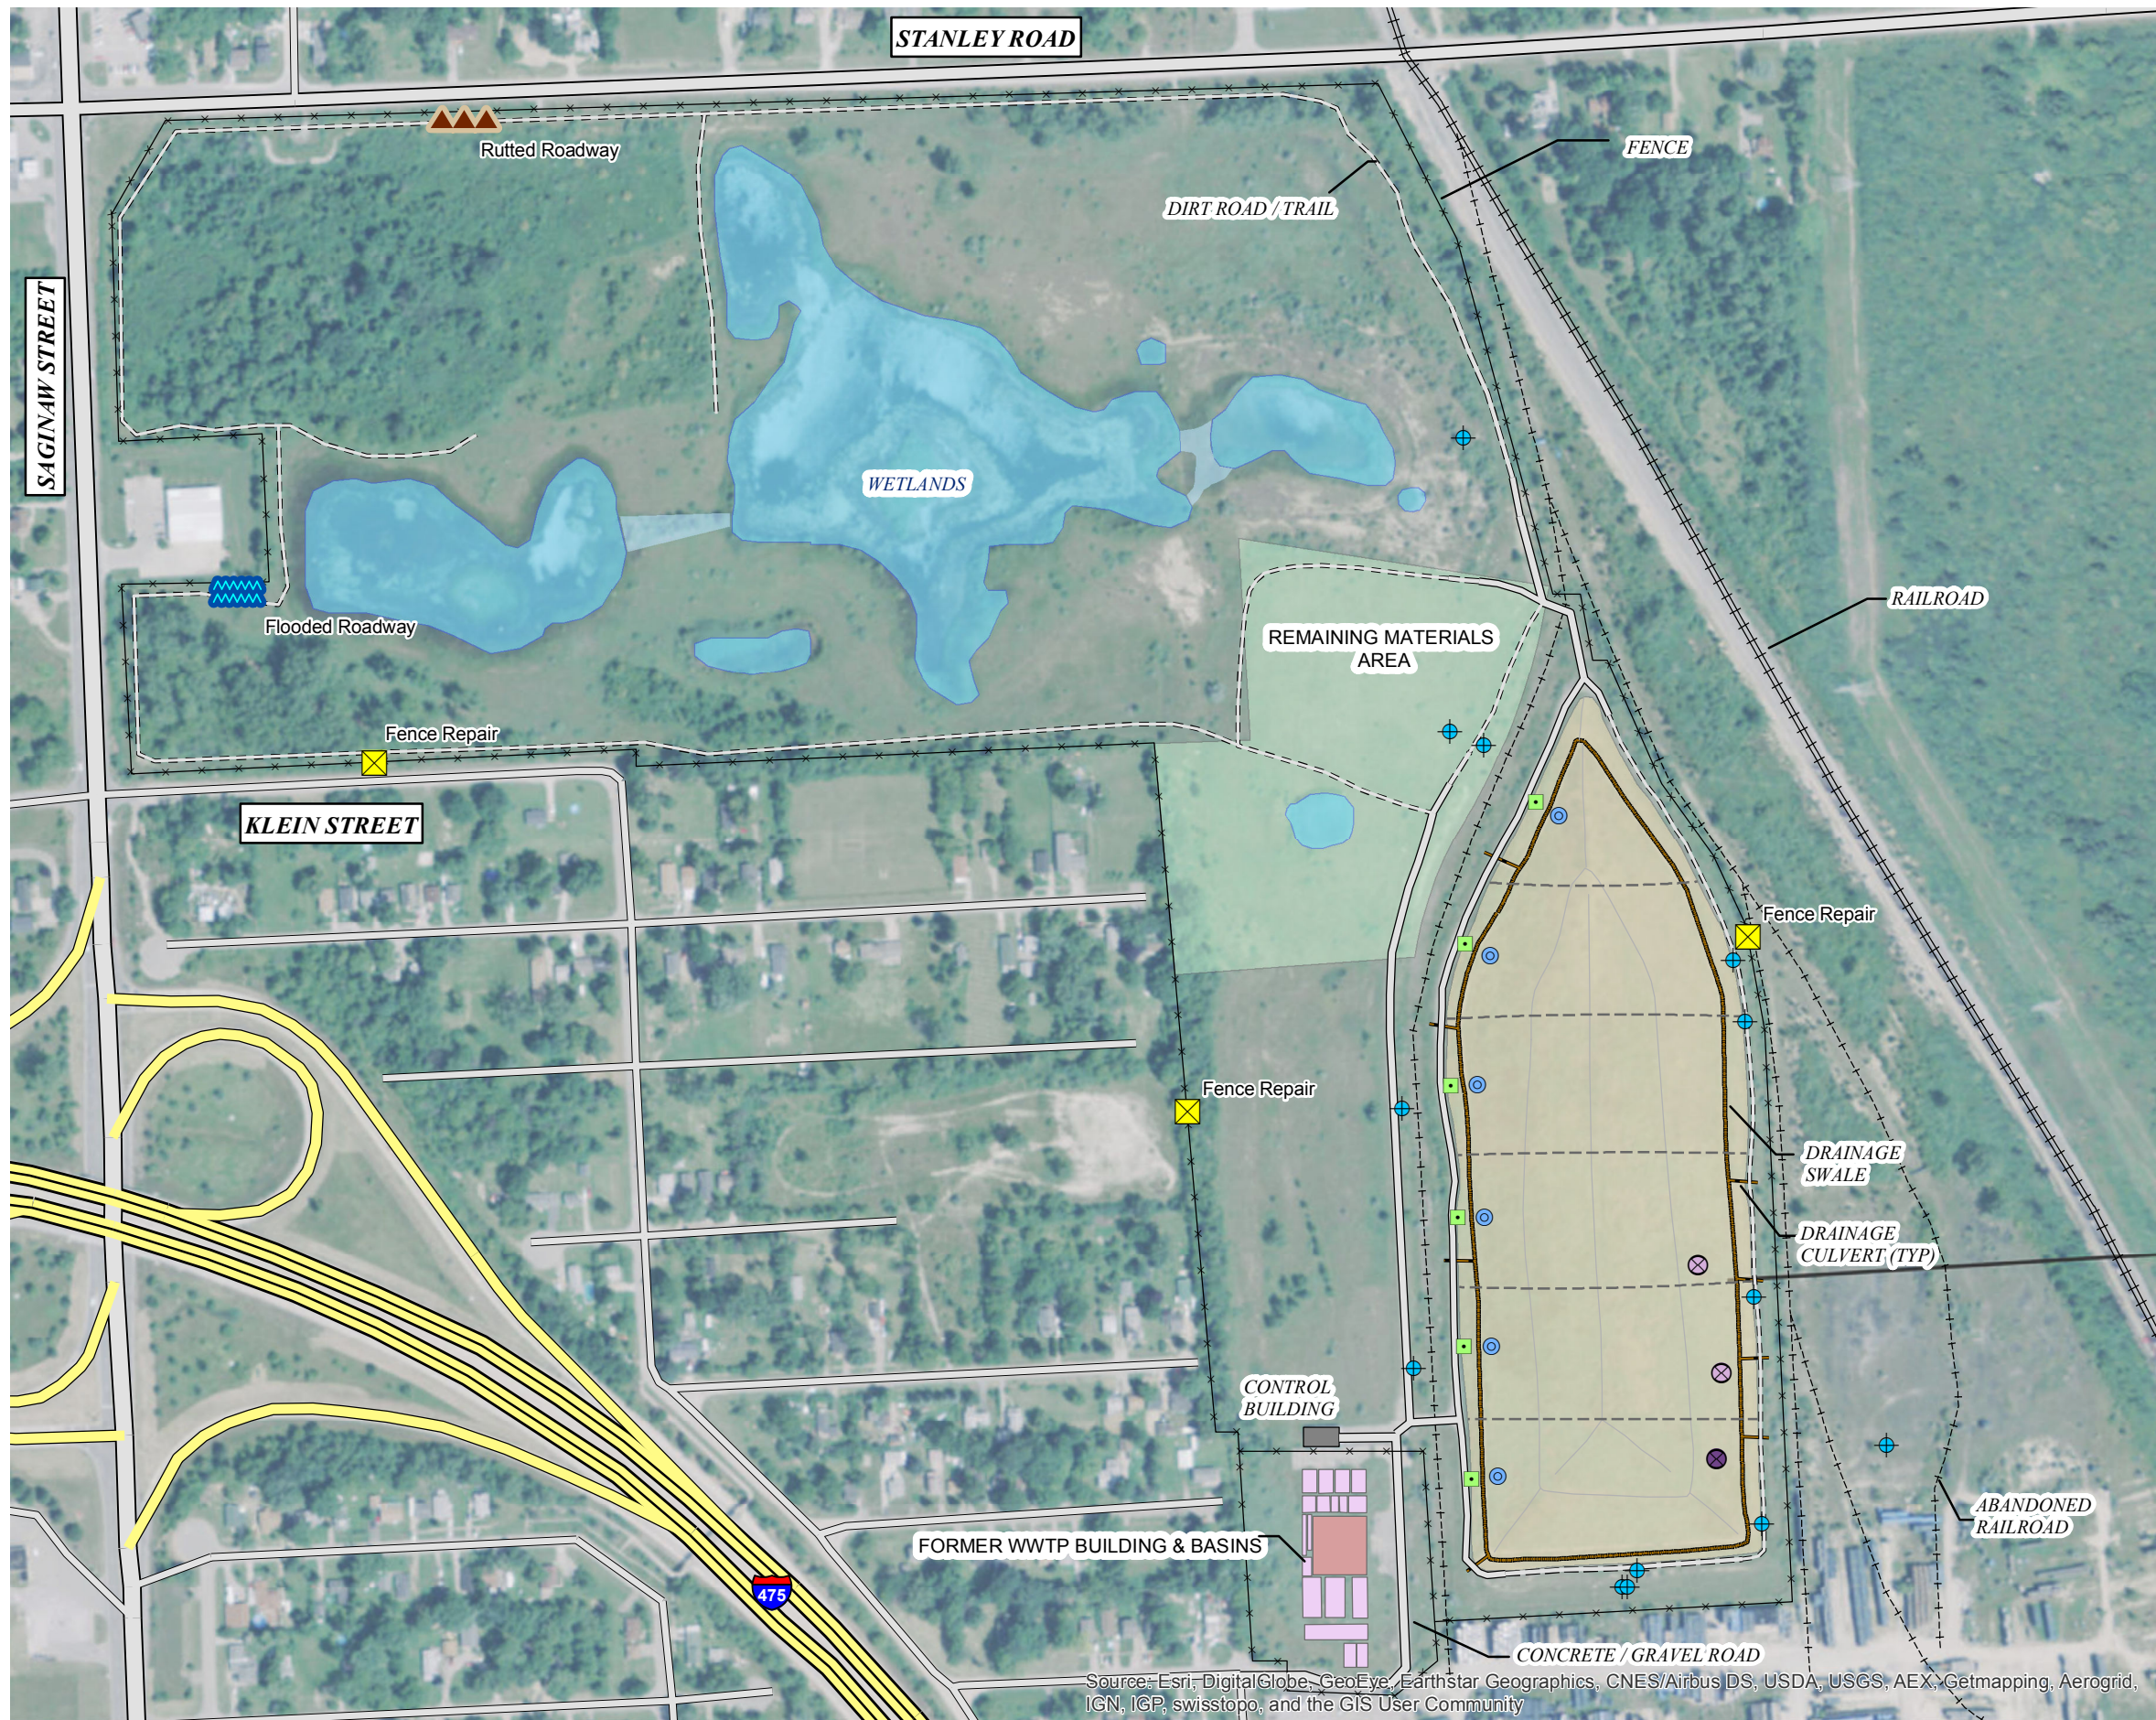
**2015
INCIDENT LOCATION
MAP**

Three animal burrows were identified and closed throughout the year. The animal burrows were photographically documented (before and after repair), and the approximate size and configuration of the burrows were documented and included in the Quarterly Status Reports.

The landfill access and perimeter roads were inspected for sufficient gravel and proper drainage during the quarterly inspections. Shallow ruts in the road were observed along the north perimeter road during the 1st quarterly inspection. During the 2nd quarterly inspection the roadway near the northwest catch basin was flooded. The shallow ruts were repaired on August 4, 2015. The wet section of road was avoided until the road was dry. No other problems to the access roads were observed during 2015.

Damage to the site perimeter fence was noted at three locations during the 3rd and 4th quarterly inspections. During the 3rd quarter inspection, one previously repaired hole was reopened along the west perimeter fence. During the 4th quarter inspection, two previously repaired hole were reopened along the west and southwest perimeter fence, and one hole was located along the east perimeter fence.

The holes in the perimeter fence were repaired on September 24, 2015 and December 17, 2015.

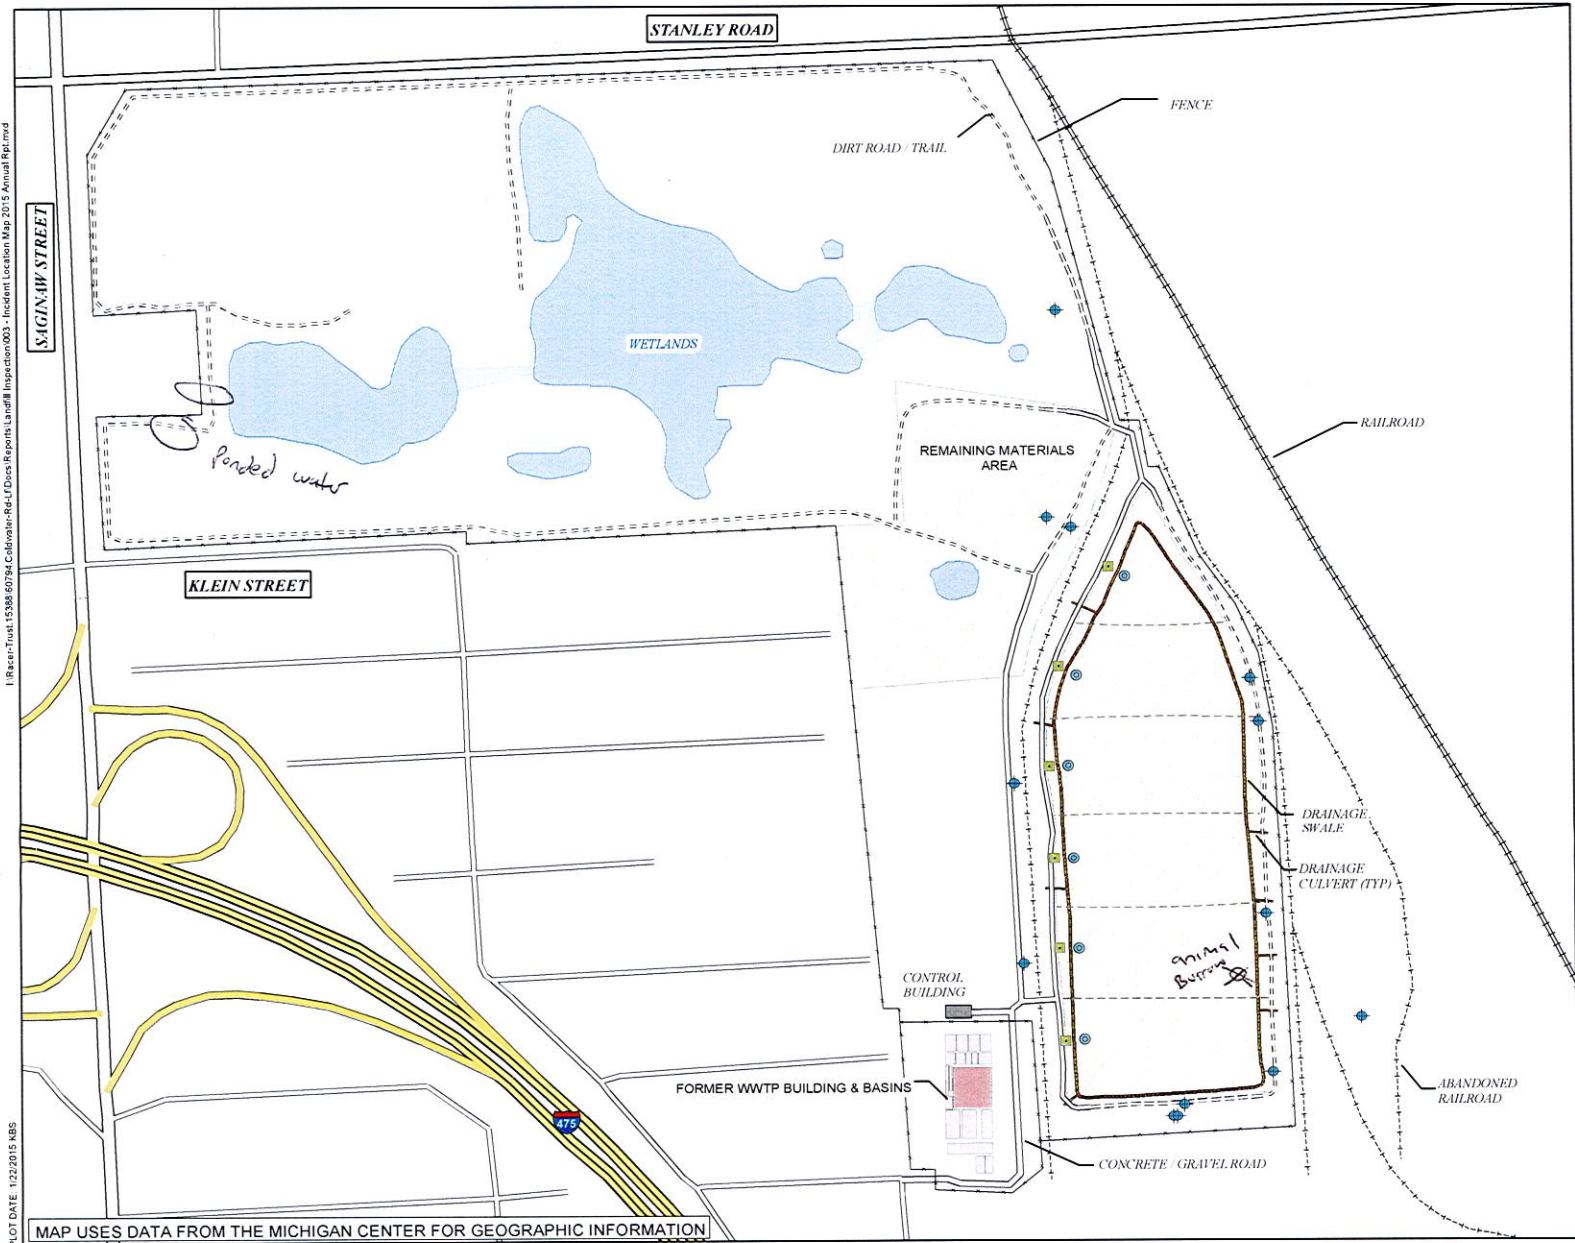
FIGURE 1

Area of Inspection	Animal Burrows?	Soil Erosion	Slope Failures?	Ponding?	Washouts?	Liner damage or exposure?	If yes to any, describe issue, location, and actions taken	Date Corrected
Cell A	No	No	No	No	No	No		
Cell B	Yes	No	No	No	No	No	animal burrow cell B3	7/29/15
Cell C	No	No	No	No	No	No		
Cell D	No	No	No	No	No	No		
Cell E	No	No	No	No	No	No		
Cell F	No	No	No	No	No	No		
Berms	No	No	No	No	No	No

Area	Sufficient gravel present?	Proper drainage present?	If no, describe issue, and actions taken	Date Corrected
Roads located approx. west of landfill	Yes	Yes		
Roads located approx. east of landfill	Yes	Yes		
Roads located approx. north of wetlands	No	OK. Ruts along north perimeter Road	Will repair later in quarter once tractor pented	Required 8/4/15
Roads located approx. south of wetlands	Yes	Yes		
Roads located approx. west of wetlands	Yes	Ponded water Yes		
Roads located approx. east of wetlands	Yes	Yes

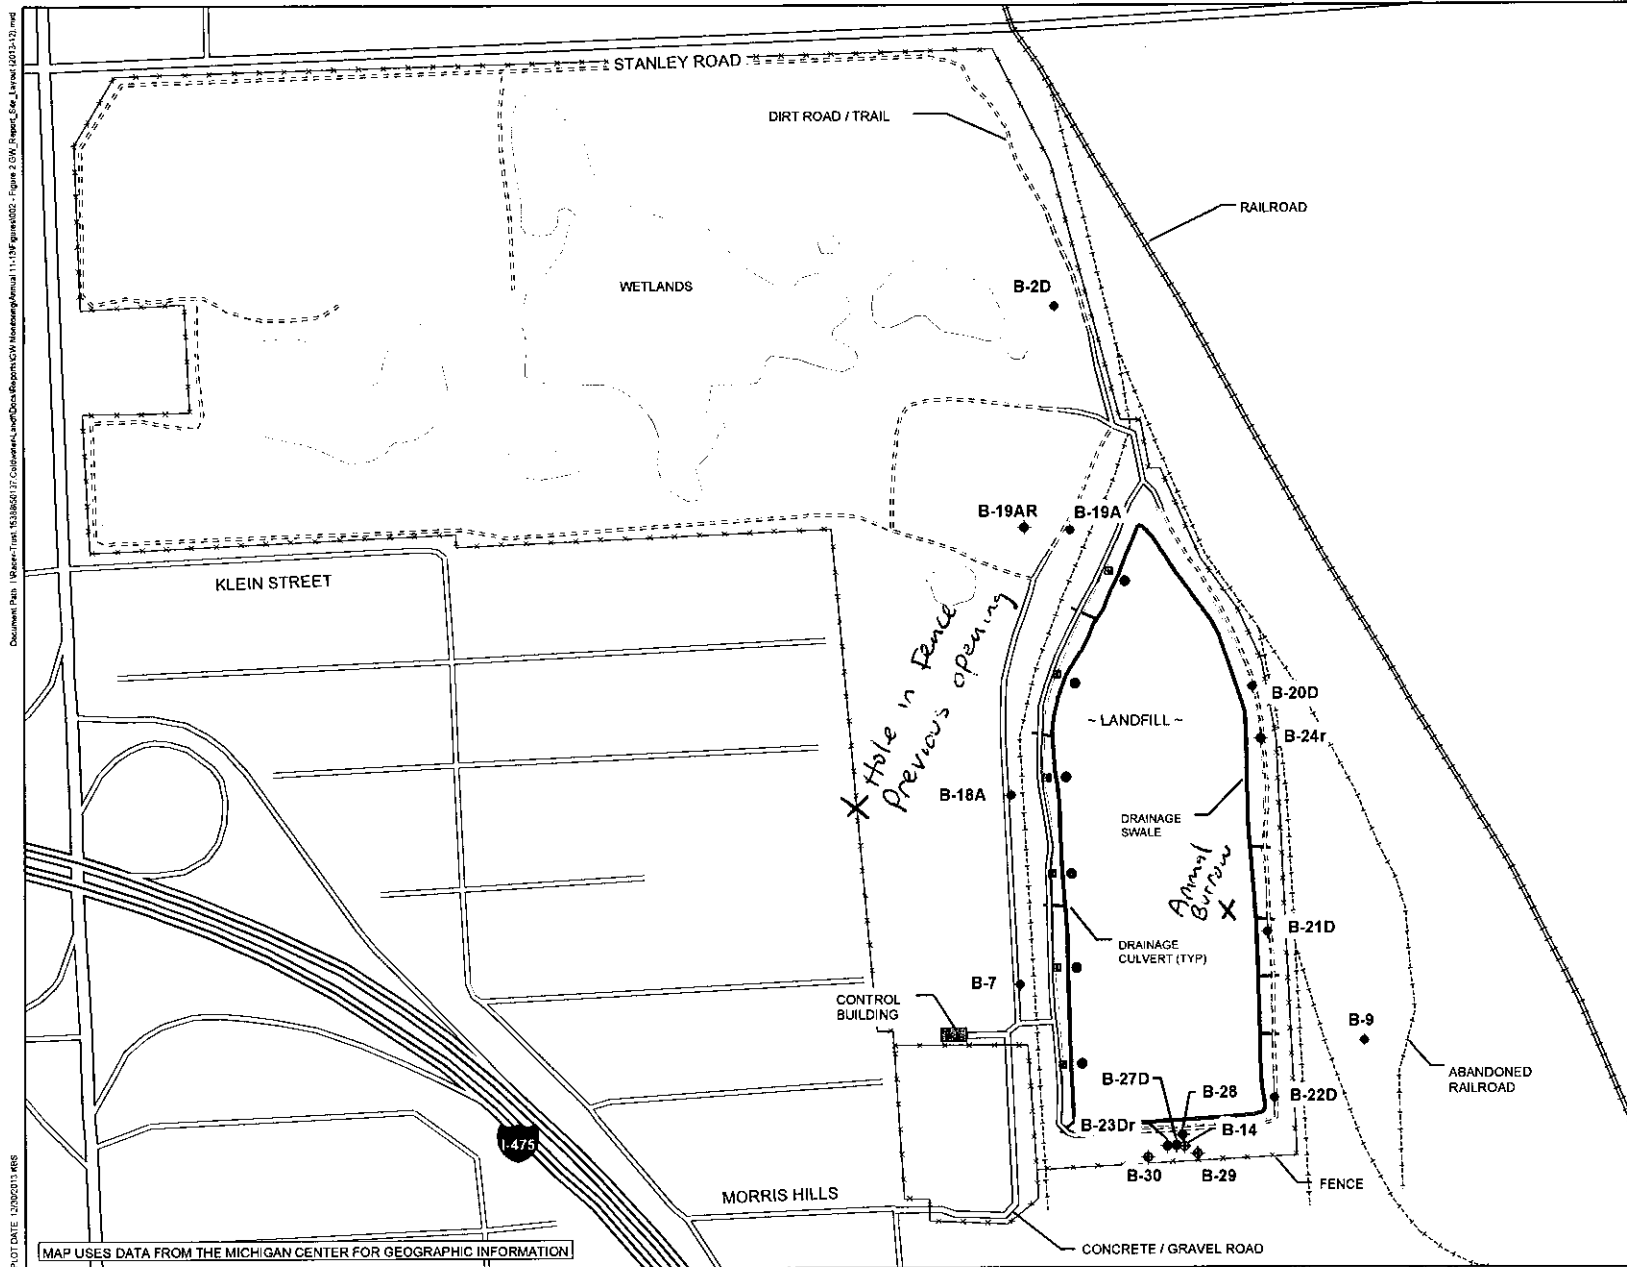
FIGURE 2

Area of Inspection	Animal Burrows?	Soil Erosion	Slope Failures?	Ponding?	Washouts?	Liner damage or exposure?	If yes to any, describe issue, location, and actions taken	Date Corrected
Cell A	No	No	No	No	No	No	—	—
Cell B	No	No	No	No	No	No	—	—
Cell C	No	No	No	No	No	No	—	—
Cell D	No	No	No	No	No	No	—	—
Cell E	9/24/15 one burrow	No	No	No	No	No	we set trap and knee groundhog and back filled hole.	9/24/15
Cell F	No	No	No	No	No	No	—	—
Berms	No	No	No	No	No	No	—	—

Area	Any damage present?	Signs of unauthorized entry?	Broken or damaged locks on gates?	"Trespassing Prohibited" and "Private Property" Signs Posted?	If yes to any, describe issue, and actions taken	Date Corrected
Fences along north property line	No	No	No	Yes	—	—
Fences along south property line	No	No	No	Yes	—	—
Fences along west property line	9/24/15 No one hole	west property line near AMA No	No	Yes	deer run through hole - some are hitting fence as they come through hole repair hole 9/24/15	
Fences along east property line	No	No	No	Yes	—	—

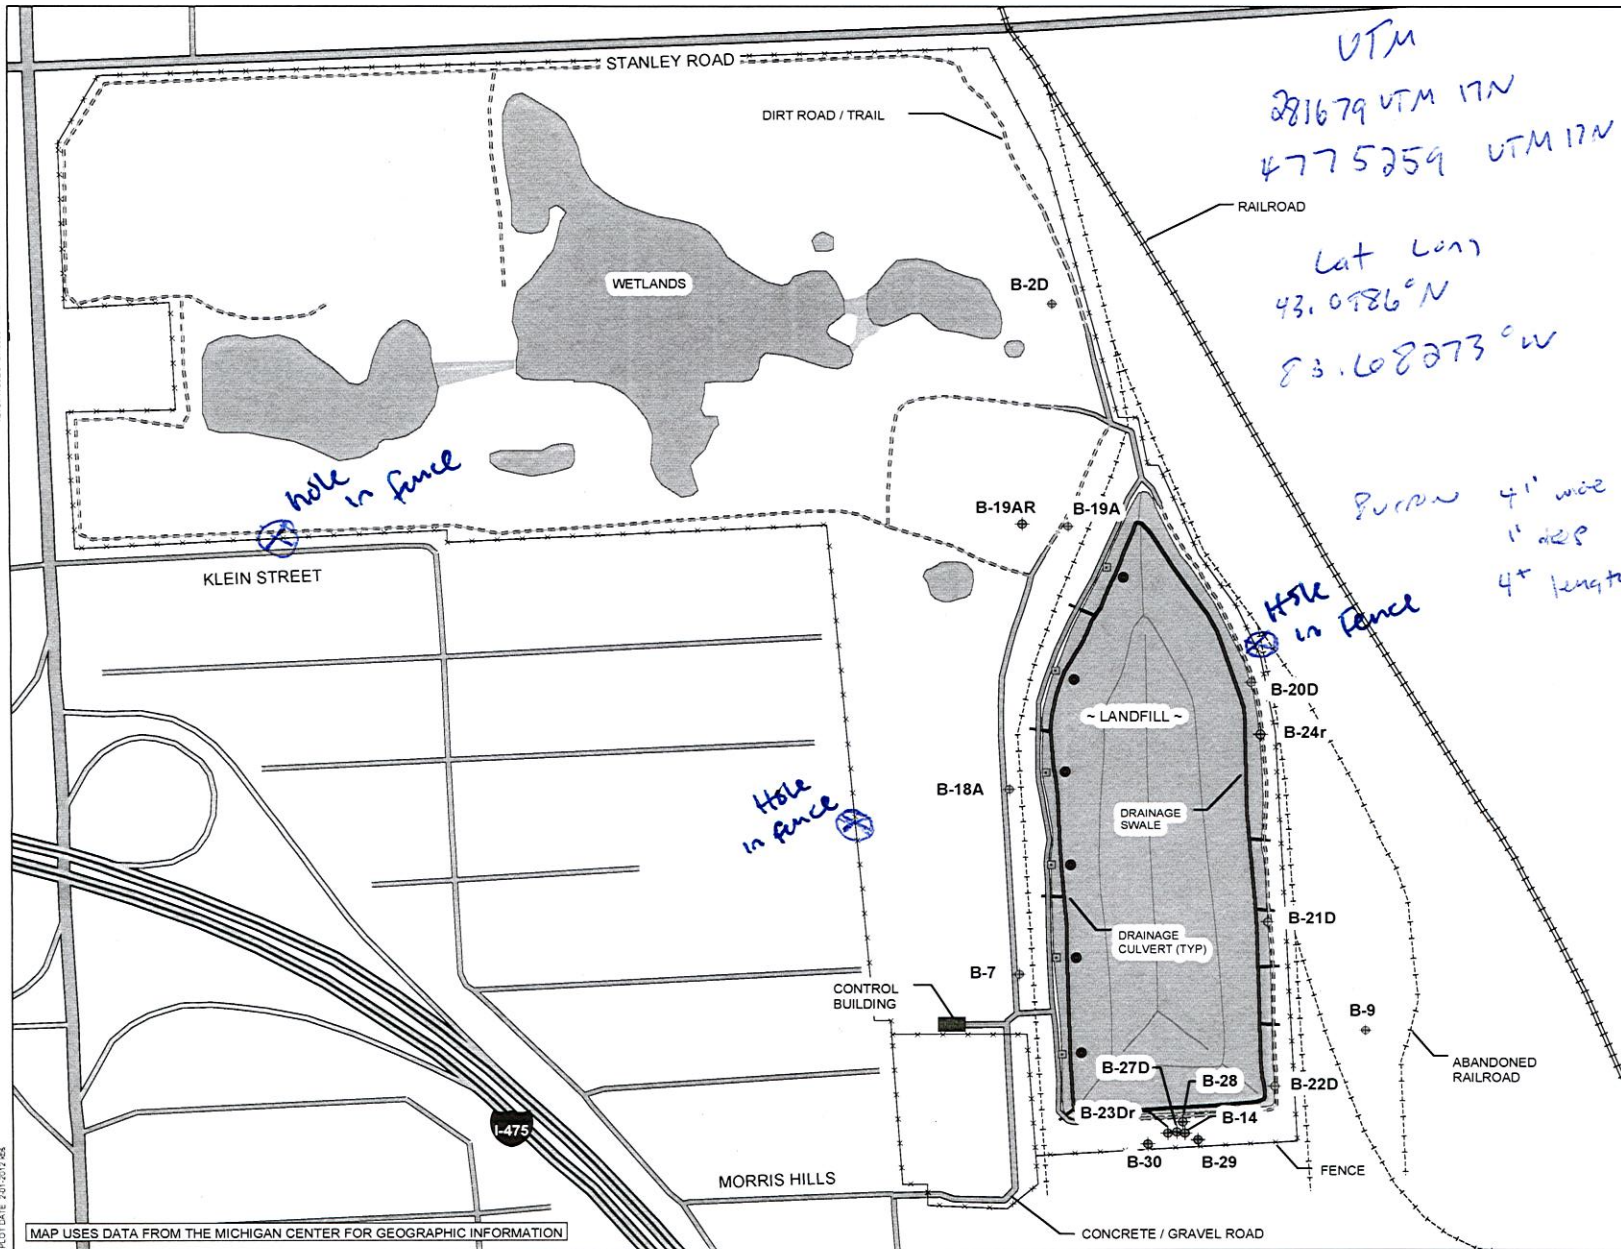
Area of Inspection	Animal Burrows?	Soil Erosion	Slope Failures?	Ponding?	Washouts?	Liner damage or exposure?	If yes to any, describe issue, location, and actions taken	Date Corrected
Cell A	No	No	No	No	No	No		
Cell B	No	No	No	No	No	No		
Cell C	No	No	No	No	No	No		
Cell D	No	No	No	No	No	No		
Cell E	No	No	No	No	No	No		
Cell F	Yes ^{one}	No	No	No	No	No	set trap, no activity in two days	12/17/15
Berms	No	No	No	No	No	No

Area	Any damage present?	Signs of unauthorized entry?	Broken or damaged locks on gates?	"Trespassing Prohibited" and "Private Property" Signs Missing?	If yes to any, describe issue, and actions taken	Date Corrected
Fences along north property line	No	No	No	Yes		
Fences along south property line	No	No	No	Yes		
Fences along west property line	2 openings Yes	opened for deer path	No	Yes	Previous hole reopened	resecured fence 12/17/15
Fences along east property line	hole in fence Yes	opened for deer path	No	Yes	closed opening in fence	12/17/15
