**Remediation and Liability Management Company Inc.**

Re: Ley Creek PCB Dredgings Site (Registry # 7-34-044)  
NYSDEC Order on Consent Index # D-7-0008-97-06  
2006 Annual OM&M Inspection Report

## O'BRIEN & GERE

Re: Ley Creek PCB Dredgings Site  
2006 OM&M Wetland Evaluation

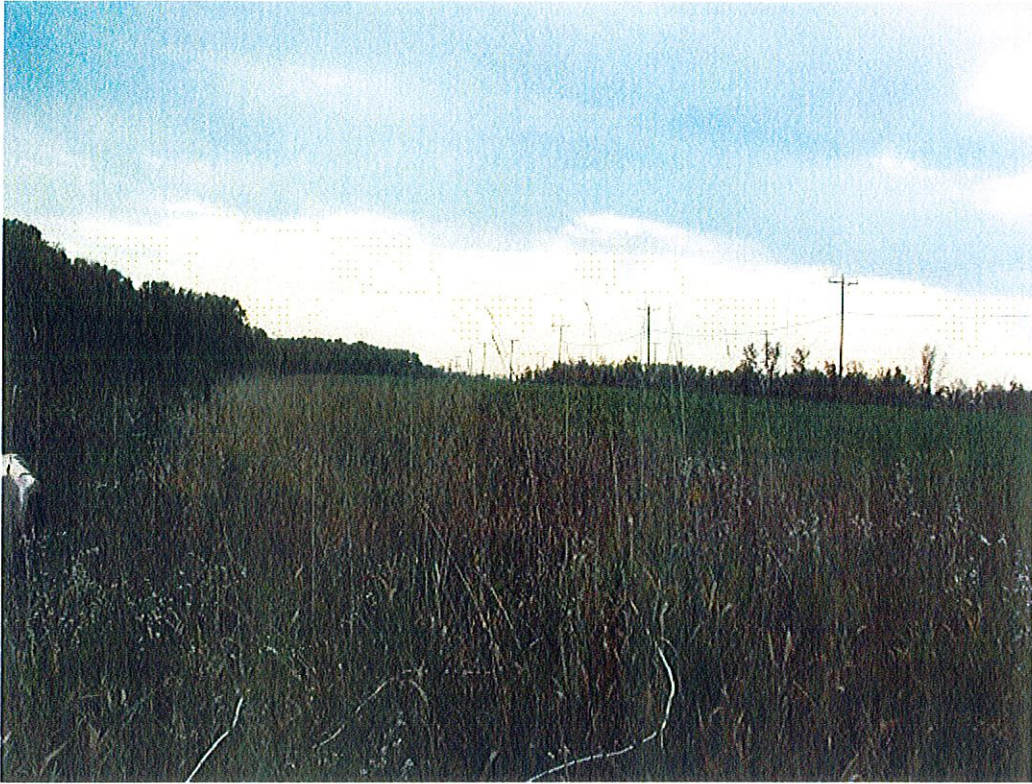
Sample Plot #1 did not meet the target ground cover percentage. Plot #1 had a total desirable ground cover of 50% (reed canary grass). The co-dominant species in Plot #1 is Lathco flat pea (*Lathyrus sylvestris*). Lathco flat pea was a component of the seed mix used to stabilize and vegetate the main site area. The presence of this species in Plot #1 is likely a result of this species encroaching into the wetland area from the main site area. Lathco flat pea is not included on the USFWS wetland indicator listings and is therefore a non-indicator (NI) species with regards to wetlands.

Photo 1: Looking east at area of restored wetland evaluation Plot #1.  
Date photo taken: 10/3/2006

- Additional seeding of herbaceous wetland species (reed canary grass) is recommended in the emergent portion of the wetland as indicated on Figure 1 and 2, and should be performed in Spring 2007. Mowing of the current vegetation and discing of the ground surface prior to the seeding of this area is also recommended. Fertilizer 6-44-12 should be applied at a rate of 300 lbs per acre and FINN HST soil conditioner should be applied at a rate of 2.5 gallons per acre. Conwed HYDRO MULCH 2000 should be applied at a rate of 2,500 lbs per acre to minimize the potential of newly applied seed/fertilizer/soil conditioner being carried away during high discharge periods within Ley Creek.

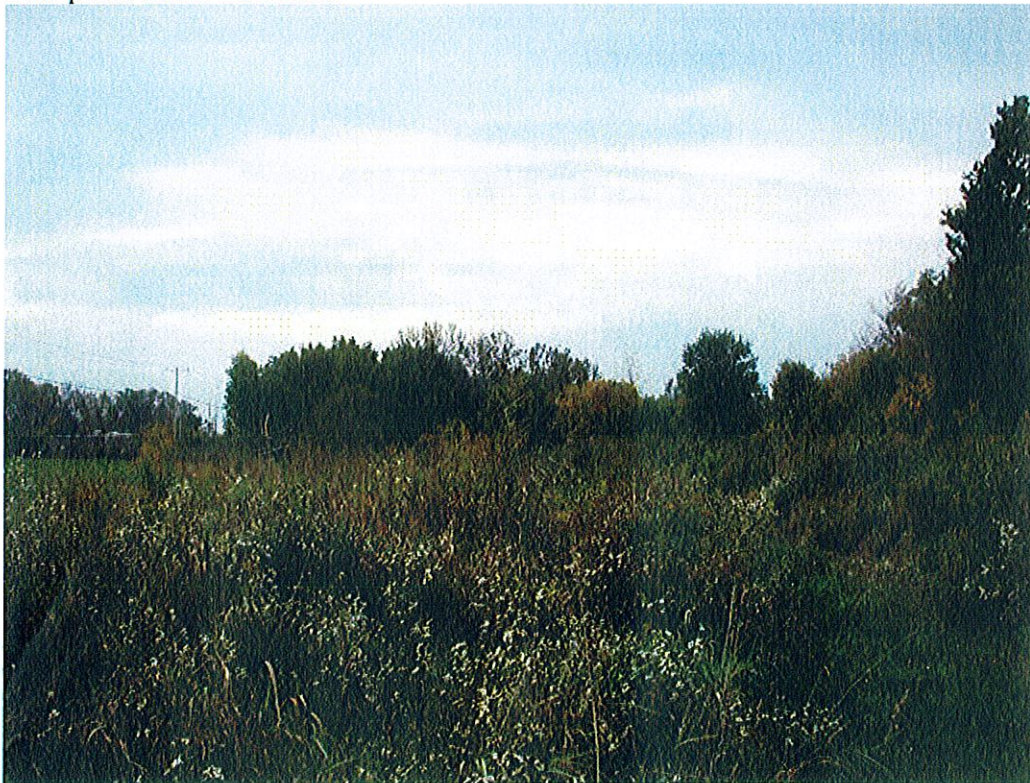
In Plot #2, reed canary grass and other desirable wetland species made up 95% of the total ground cover, with reed canary grass comprising 80% of the total in this plot. In Plot #3 reed canary grass and other desirable wetland species made up 92% of the total ground cover, with reed canary grass comprising 15% of the total in this plot. In Plot #4, reed canary grass and other desirable wetland species made up 98% of the total ground cover, with reed canary grass comprising 90% of the total in this plot.

Photo 2: Looking west at area of restored wetland evaluation Plot #2.  
Date photo taken: 10/3/2006

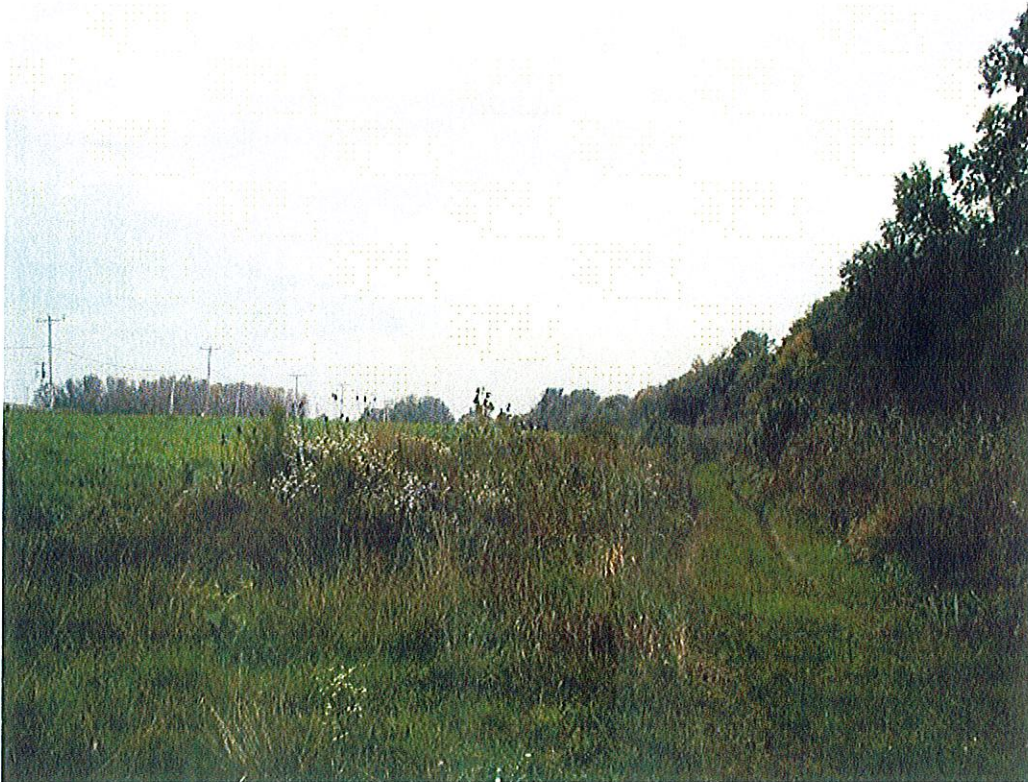
Photo 3: Looking west at area of restored wetland evaluation Plot #3.  
Date photo taken: 10/3/2006

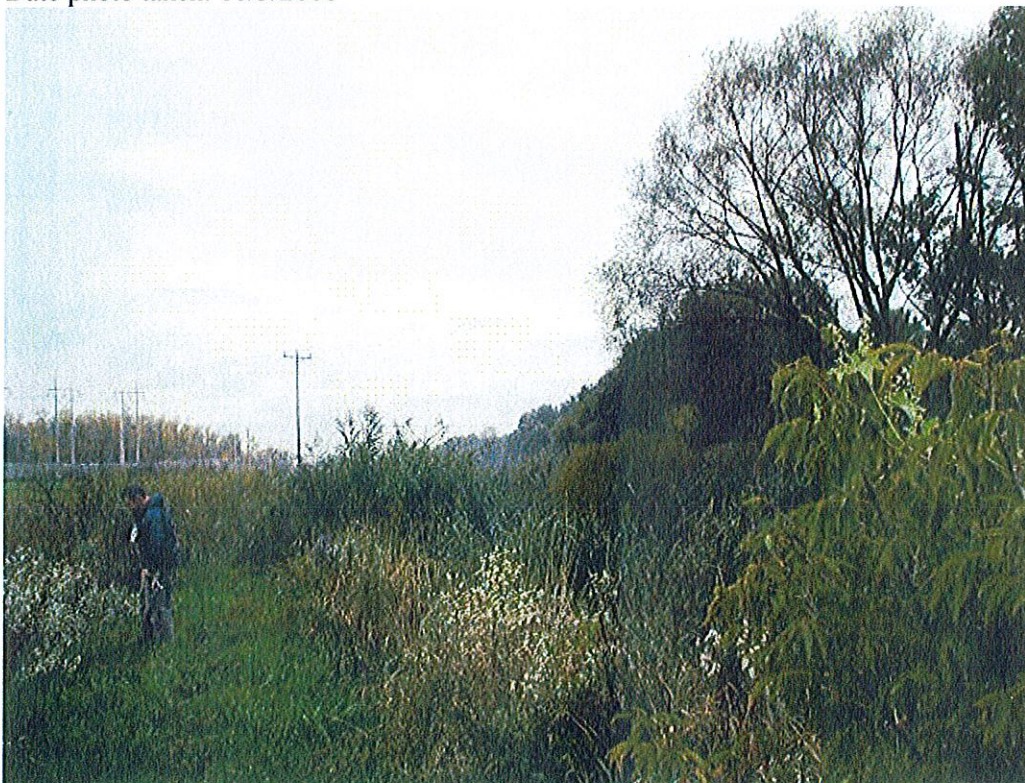
Photo 4: Looking northwest at area of restored wetland evaluation Plot #4.  
Date photo taken: 10/3/2006

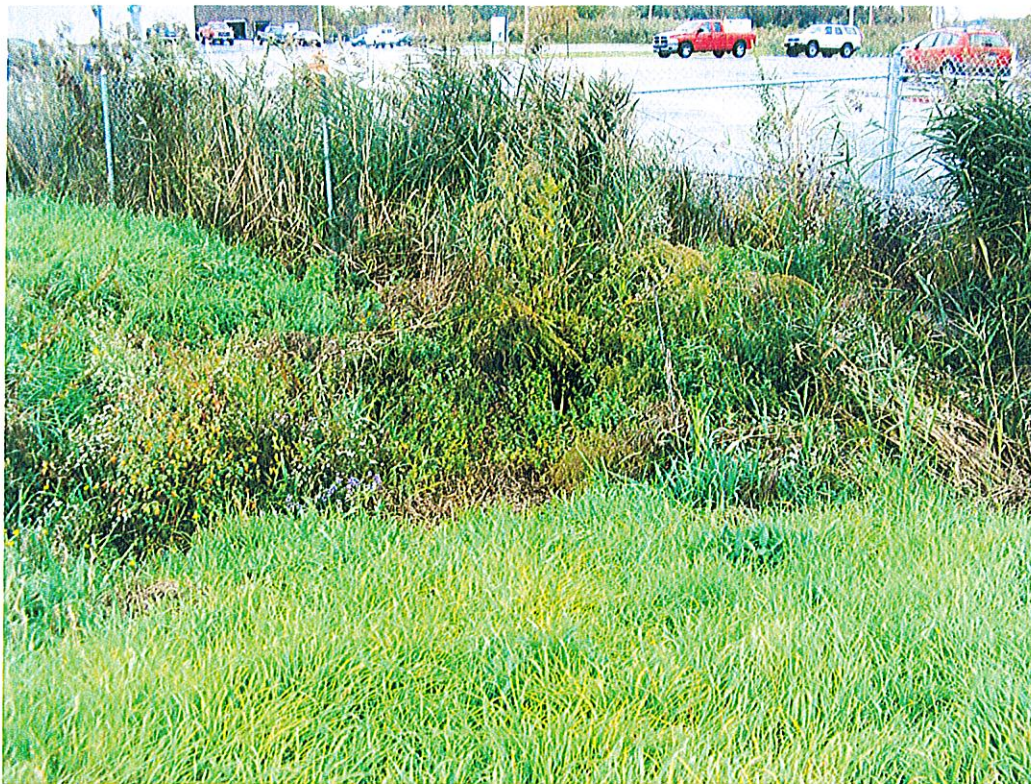
- Exposed non-woven geotextile fabric and erosion along creek bank near CB-1 outlet (Figure 1 and Photographs 17 and 18)
- Exposed erosion control fabric within CB-3 overflow spillway (Figure 3 and Photograph 11)
- Erosion at fenceline near CB-3 overflow spillway (Figure 3 and Photographs 6 and 7)
- Garbage near stone access road near western Site entrance (Figure 1)
- Soil covering MW-13 monitoring well (Figure 1 and Photograph 22)
- Access road rutting (Figures 2, 3, and 4)
- Phragmites in asphalt (Figure 2)
- Concrete rubble near Factory Avenue (Figure 3)
- Damage to asphalt (Figure 3)
- Significant vegetation growth along Factory Avenue site perimeter fence and within area around catch basins (Figures 1, 3, and 5 and Photographs 2, 8, 14, and 19).

**Photograph 2:** View of vegetation around CB-1.

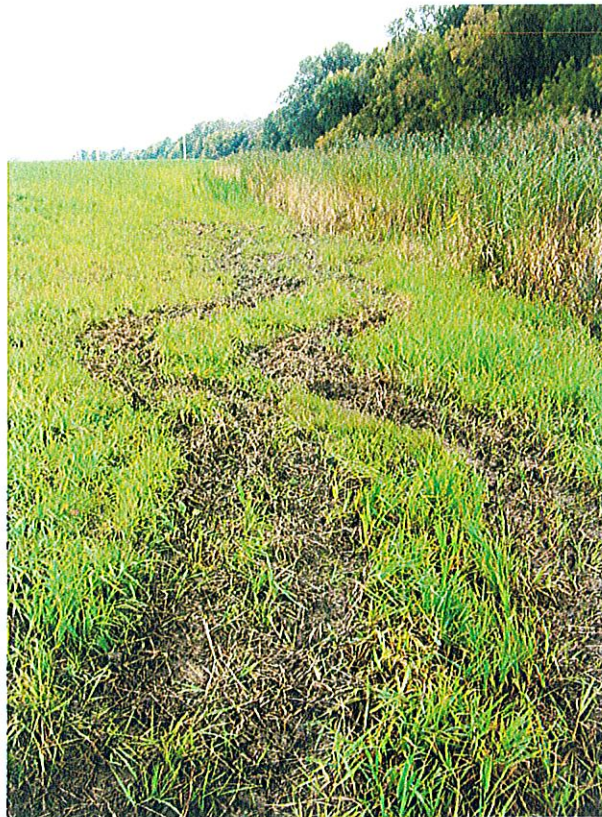
**Photograph 4:** View of repaired erosion area near OBG-20D.

Areas that were repaired prior to the inspection to address erosion areas (Figures 3 and 4 and Photographs 4, 10, and 13) that were observed during the August 2006 inspection should be monitored during subsequent inspections to evaluate vegetation establishment.

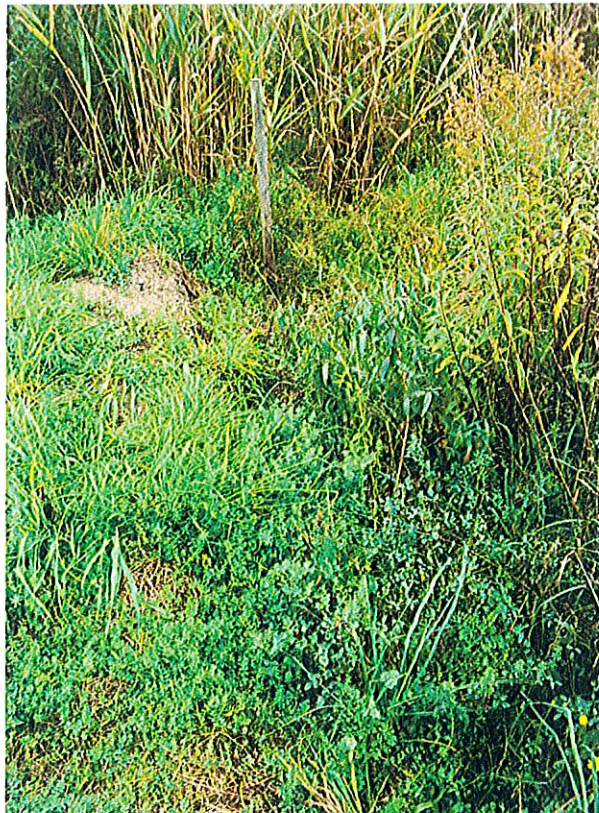
**Photograph 6:** View of erosion channel near CB-3 along fenceline.

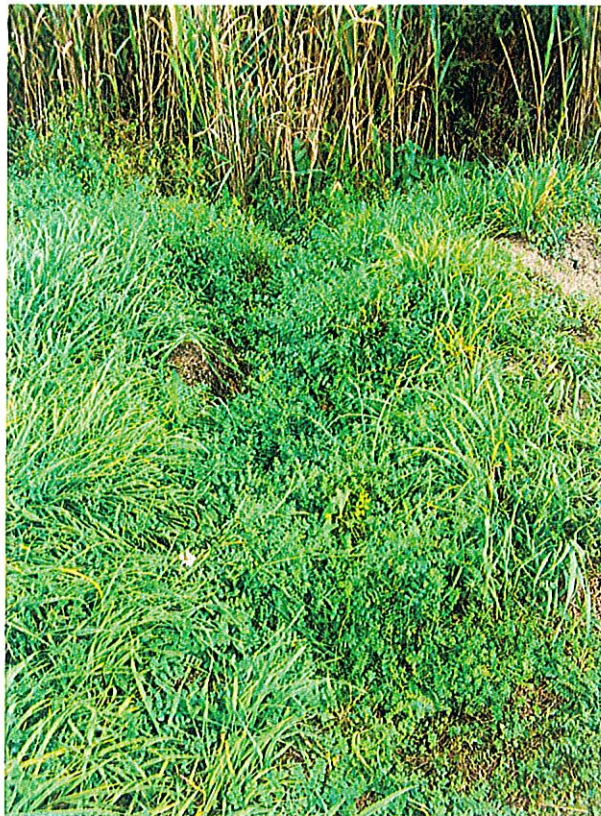
**Photograph 7:** View of erosion channel near CB-3 along fenceline.

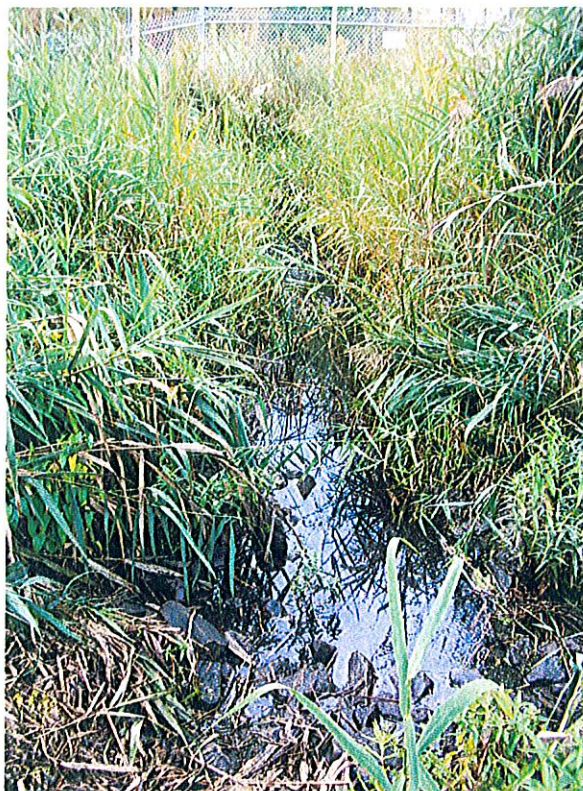
**Photograph 8:** View looking at CB-3 (clogged grate).

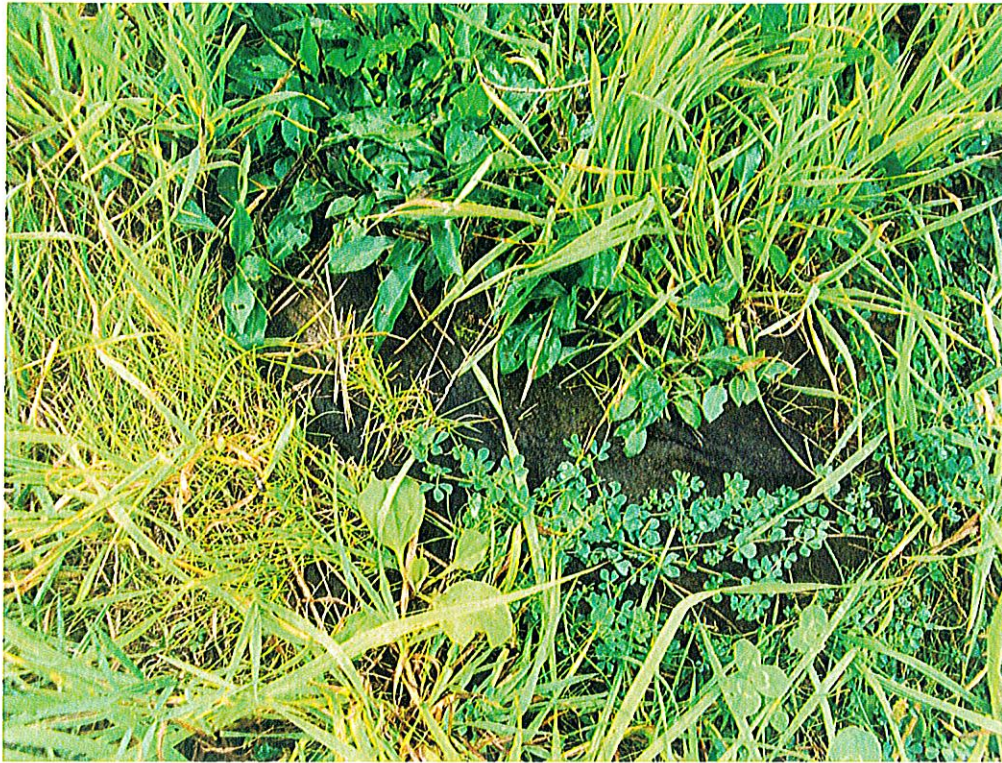
**Photograph 9:** Non-woven geotextile exposed due to erosion within CB-3 overflow spillway.

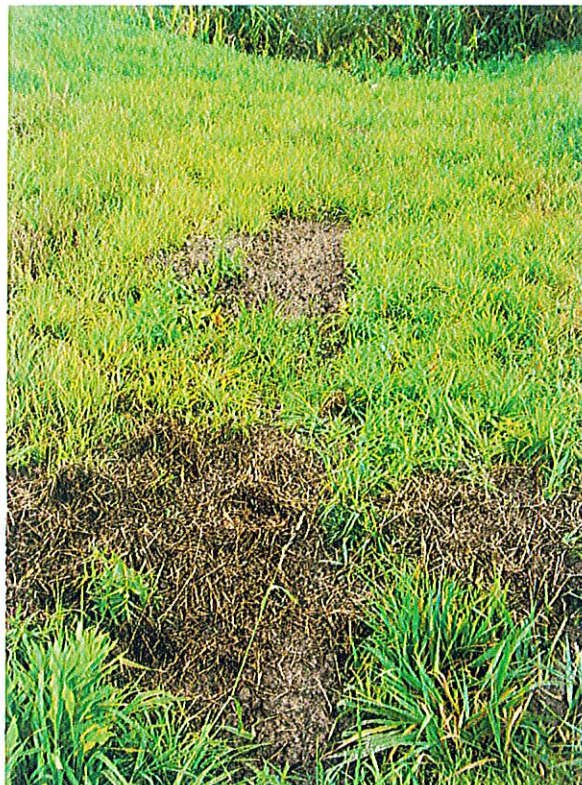
**Photograph 10:** View of repaired erosion areas within CB-3 overflow spillway.

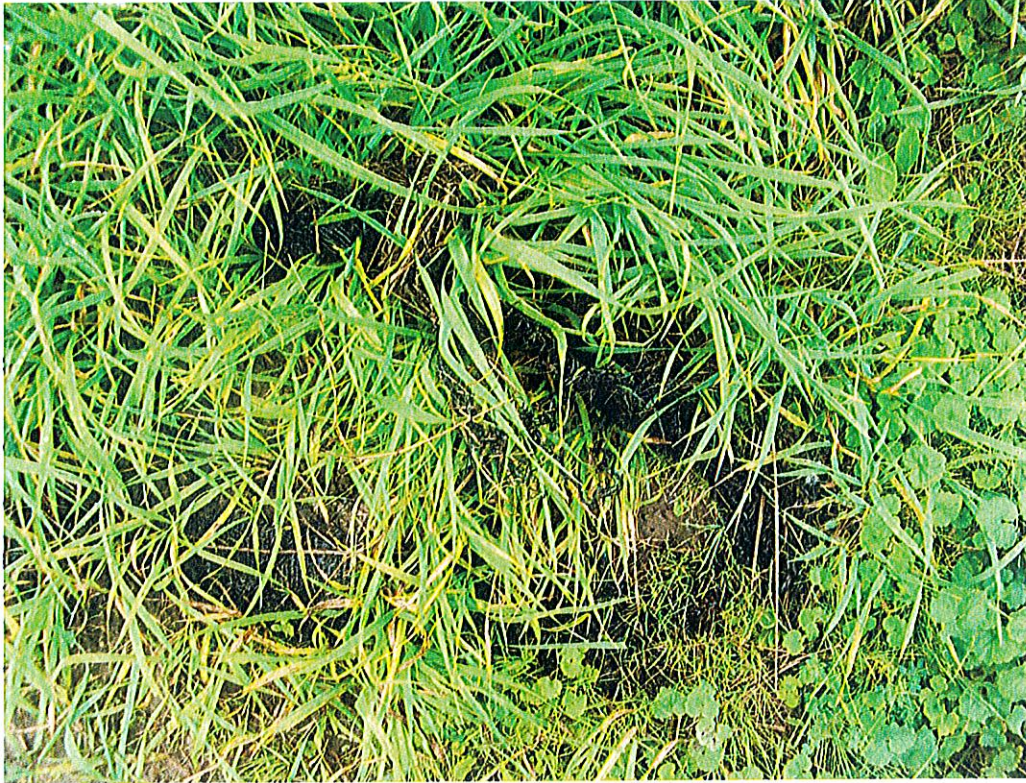
**Photograph 11:** View of exposed erosion control fabric within CB-3 overflow spillway.

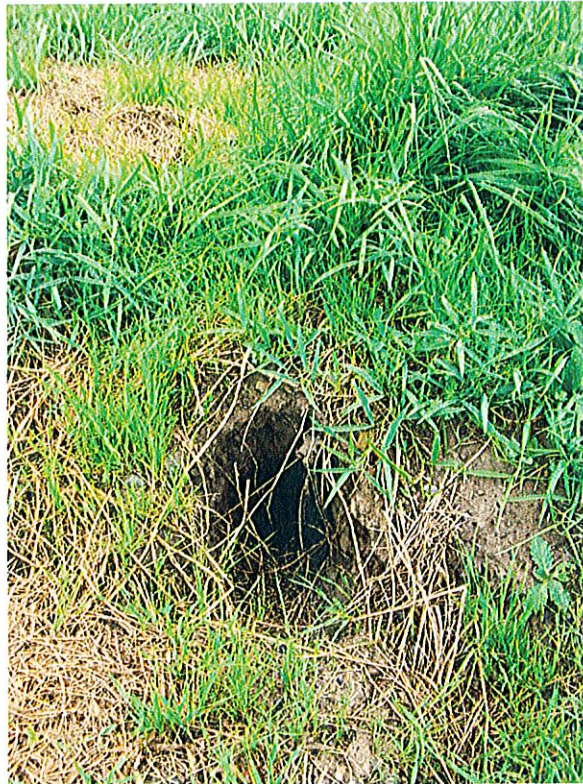
6. Presence of burrowing animals?	<b>X</b>		Figures 1, 3, and 5 - Photographs 12 and 20
	7. Areas of damage?	<b>X</b>		Figures 3 and 5 - Photographs 10 and 4 (areas repaired)

**Photograph 12:** View of burrowing animal hole at crest of CB-2 overflow spillway slope.

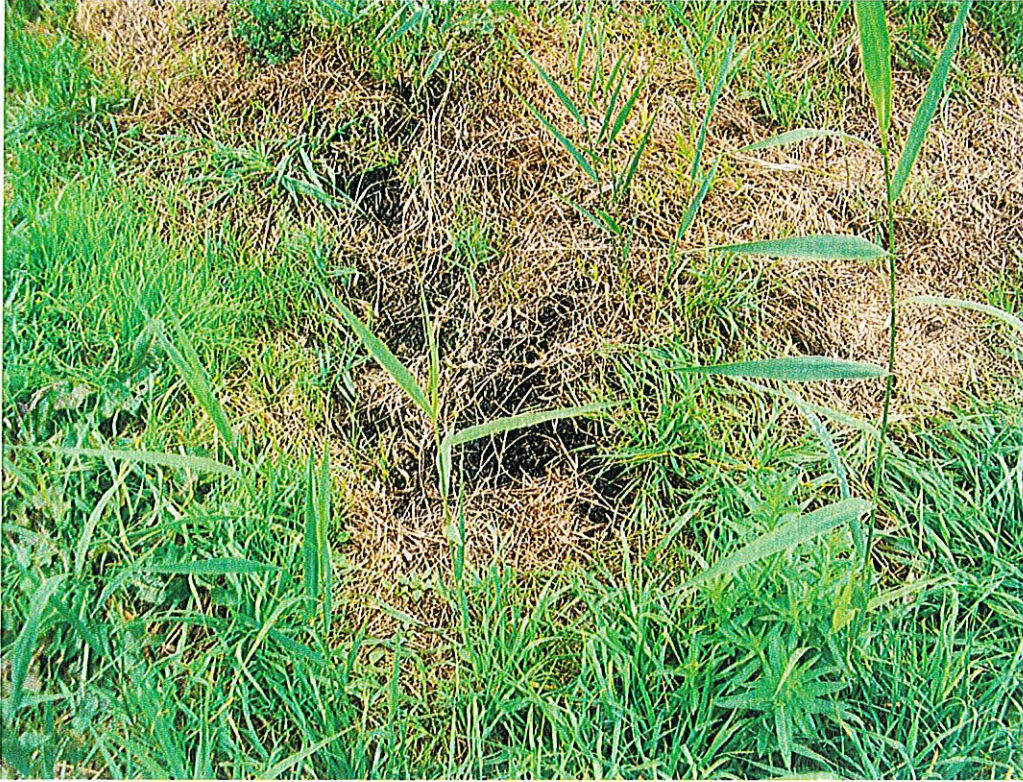
**Photograph 13:** View of repaired erosion areas within CB-2 overflow spillway.

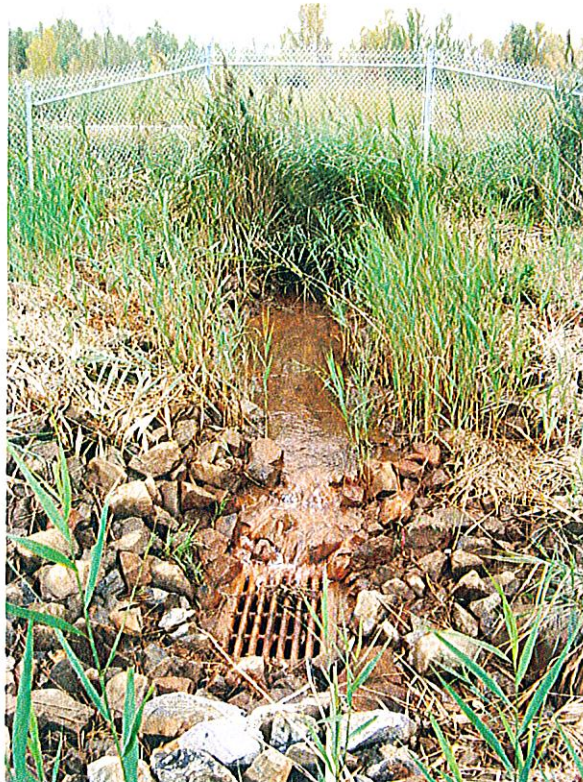
**Photograph 14:** View of CB-2.

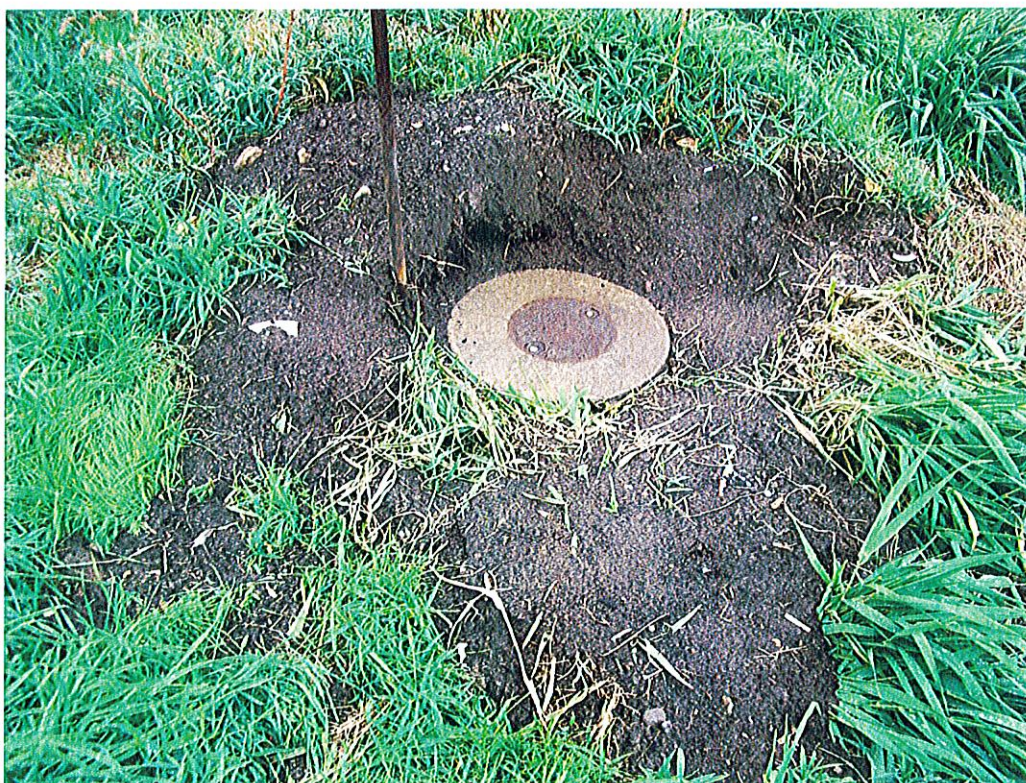
**Photograph 16:** View of exposed soil near around MW-12.

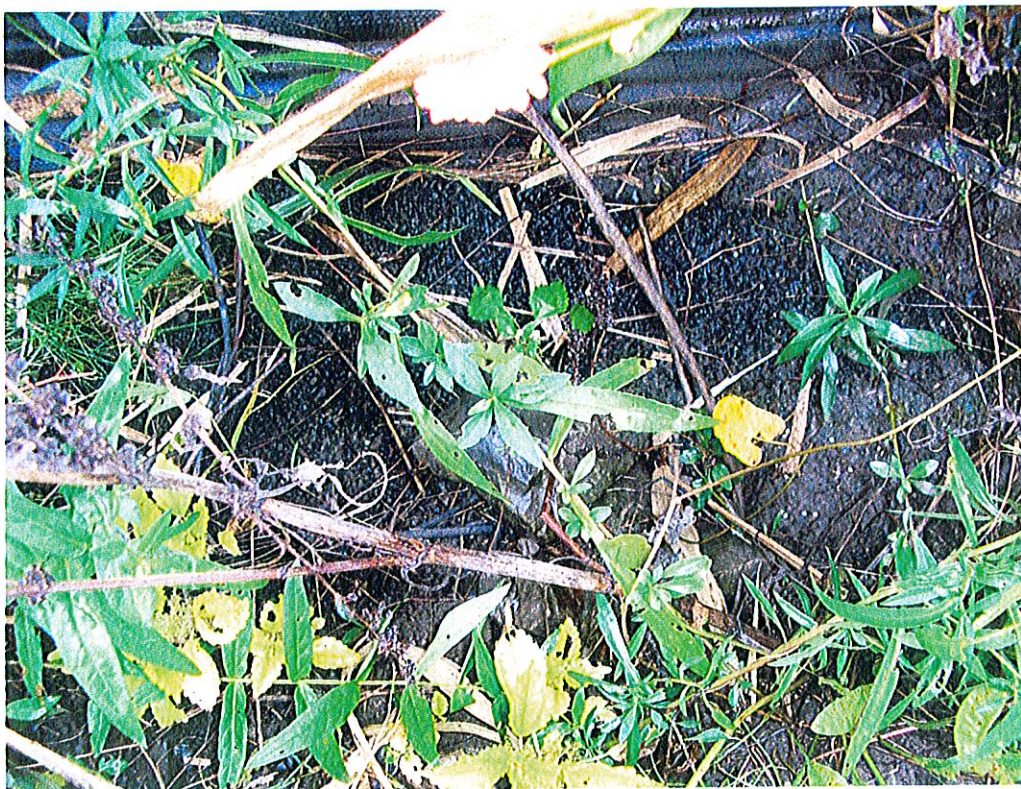
**Photograph 17:** View of exposed non-woven geotextile fabric along creek bank near CB-1 outlet.

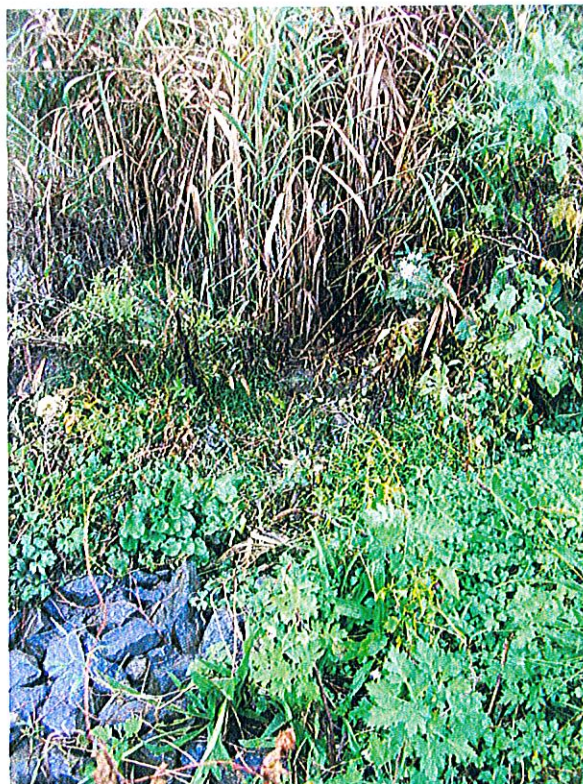
**Photograph 18:** View of erosion near outlet of CB-1 at Ley Creek bank.

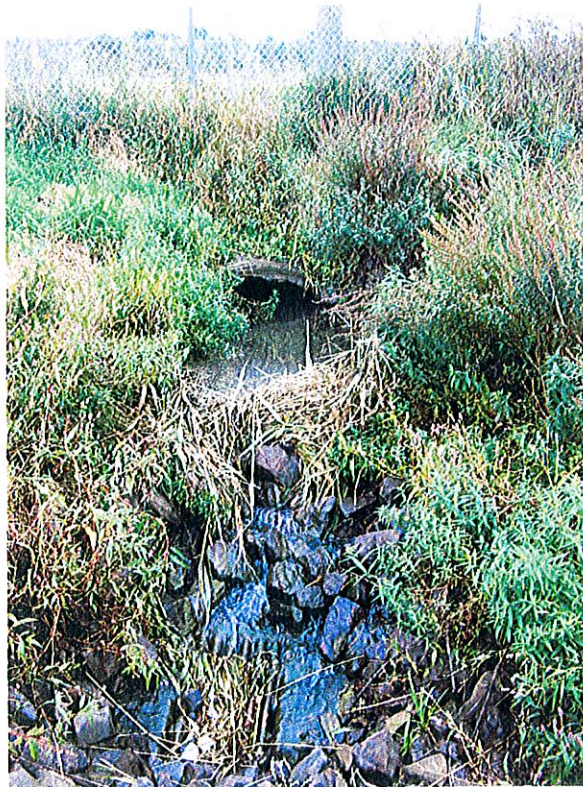
**Paragraph 19:** View looking at CB-1.

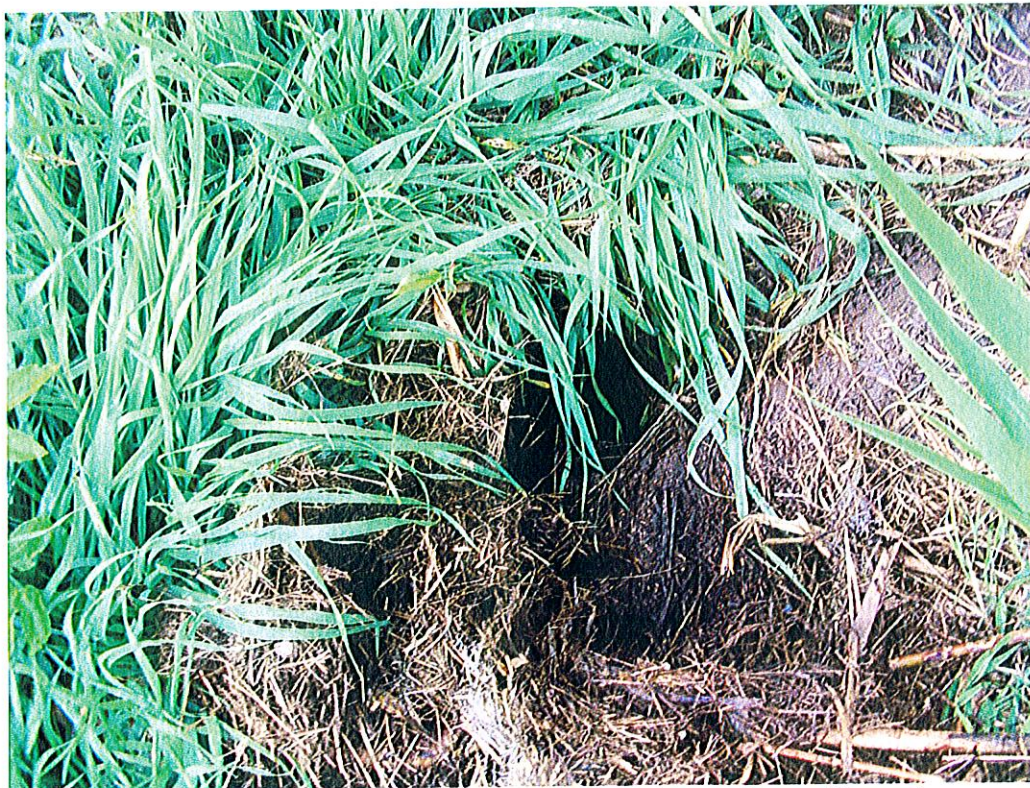
**Photograph 20:** View of burrowing animal hole at crest of CB-21 overflow spillway slope.

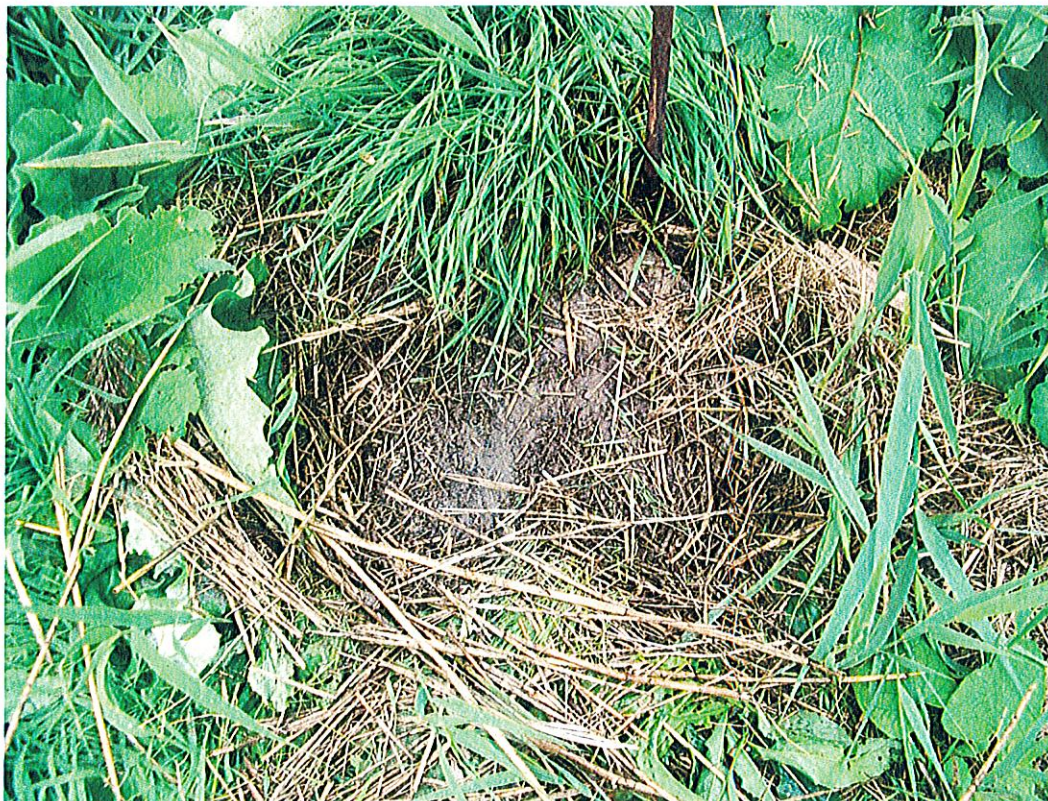
**Photograph 22:** View looking at MW-13 covered with soil.
