Re: Ley Creek PCB Dredgings Site (Registry # 7-34-044)
NYSDEC Order on Consent Index # D-7-0008-97-06
Operation, Maintenance, and Monitoring

Re: Ley Creek PCB Dredgings Site
June 2007 OM&M Inspection

JUNE 2007
OM&M INSPECTION
PARTIAL SITE PLAN

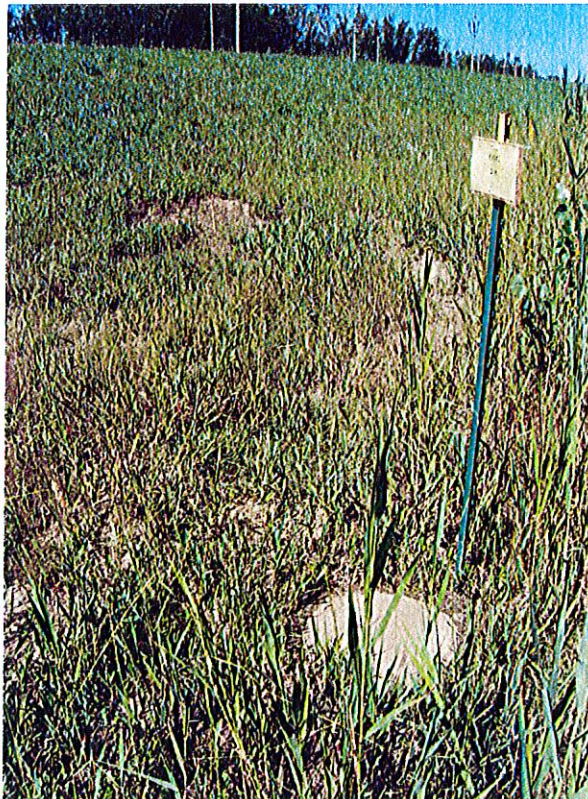
Establishment of vegetation in the areas that were repaired in the 2006 construction season to address erosion (Figures 3 and 4 and Photograph 4) has improved, but requires additional monitoring until fully established.

Photograph 4: View of area near OBG-26S, which was re-seeded in Fall of 2006.

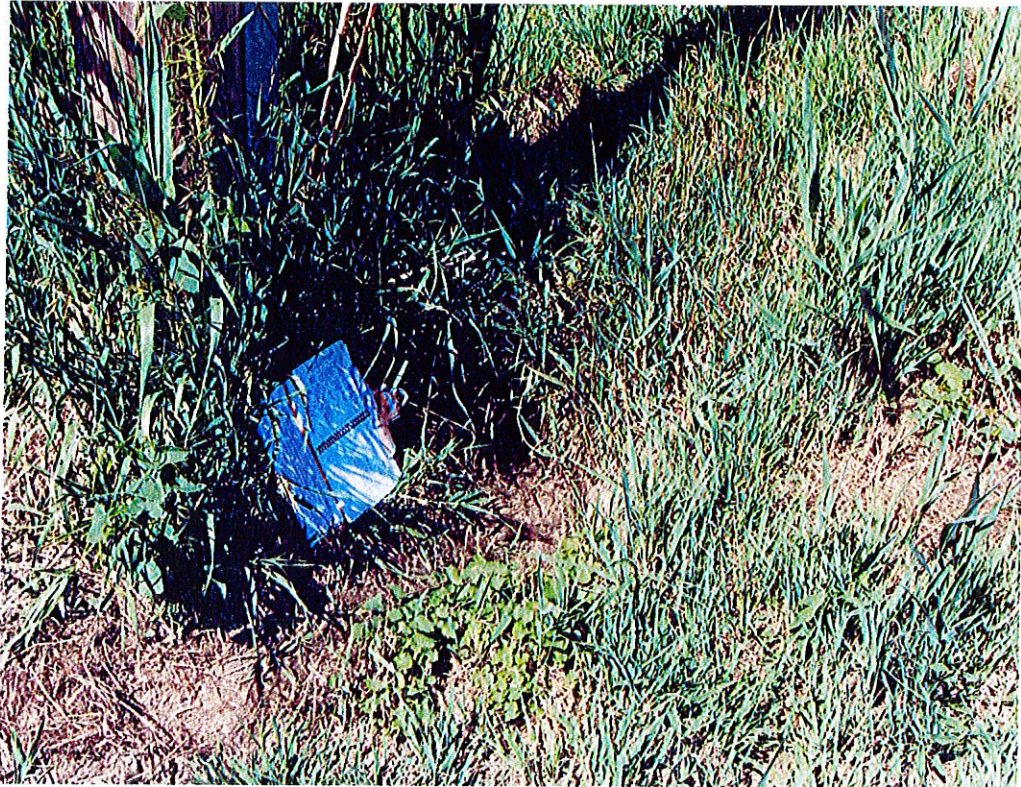
- Animal burrow in vegetative cover (Figures 1, 2, and 4 and Photographs 5, 10 and 14)
- Exposed erosion control fabric within CB-3 overflow spillway (Figure 3 and Photograph 7)
- Lack of vegetation within CB-3 overflow spillway (Figure 1, 2, and 3 and Photograph 6, 11, and 12)
- Soil covering MW-12 and MW-13 monitoring well due to animal burrow (Figures 1 and 2 and Photographs 10 and 15)
- Phragmites in asphalt (Figure 1 and 2 and Photograph 16)
- Garbage near Factory Avenue (Figure 3)

Photograph 5: Burrowing animal hole along fenceline southeast of OBG-21D.

Issue	Action to be completed	Targeted Schedule
Conduct an assessment of actions to control burrowing animals at the site (e.g., removal of burrowing animals). Where needed, topsoil should be placed in holes and seed and fertilizer applied (USEPA 2007).	A New York State licensed trapper will trap burrowing animals from the Site in the areas noted in the June 2007 OM&M inspection report.	Fall 2007
Repair pavement depression with like asphalt (USEPA 2007).	Depression will be repaired.	October 2007
Future OM&M inspection reports should be immediately provided to the oversight agencies. The reports should note any previously reported deficiencies, which have not been addressed as well as include a schedule for the implementation of all needed corrective measures (USEPA 2007).	Purpose of this letter.	Completed.
Replace grates in catch basins with trash racks to minimize clogging (USEPA 2007).	Evaluation of engineering controls being conducted to minimize clogging at CB-1, CB-2, and CB-3. CB-5/004 receives minimal flow and CB-4/003 does not generally clog with debris.	Evaluation - August 2007 Implementation dependent on evaluation results

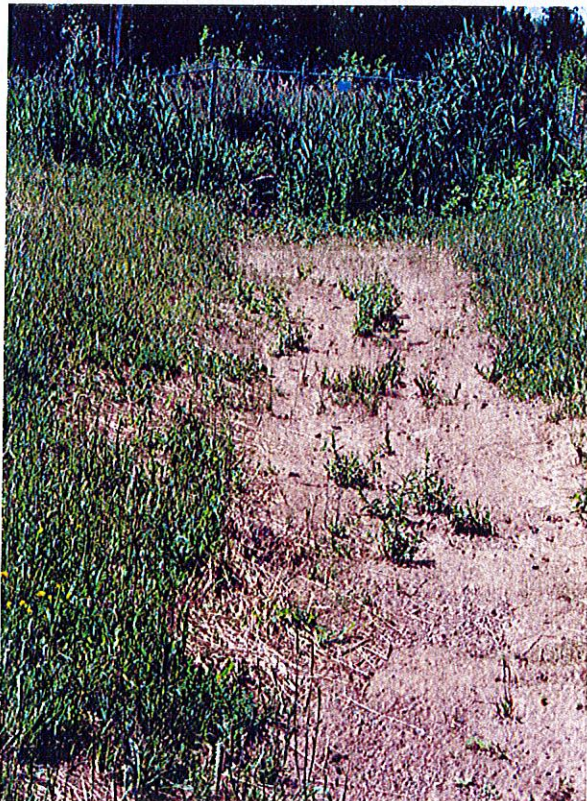
Photograph 6: Newly placed topsoil in CB-3 overflow spillway without vegetation establishment.

Exposed erosion control fabric within CB-3 overflow spillway (O'Brien & Gere 2007).	Topsoil and seed will be placed.	September 2007
Lack of vegetation within CB-3 overflow spillway (O'Brien & Gere 2007).	Additional topsoil and seed will be placed.	September 2007
Soil covering MW-12 and MW-13 due to burrowing animal (O'Brien & Gere 2007).	A New York State licensed trapper will trap burrowing animals from areas. Material covering and around the monitoring wells will be placed back in the burrow and additional topsoil and seed placed, if necessary. If excess material is generated, it will be properly characterized and disposed.	Fall 2007
Implement repair by placing additional crushed stone and improve drainage of the stone access road by constructing small drainage channels to convey ponded water from the road to Ley Creek. This could be performed by removal of less than 1 foot of vegetative cover material with subsequent replacement of crushed stone.	Additional stone was placed within these areas. In lieu of construction of drainage channels, the areas with historical rutting will be monitored in future inspections.	Future OM&M inspections

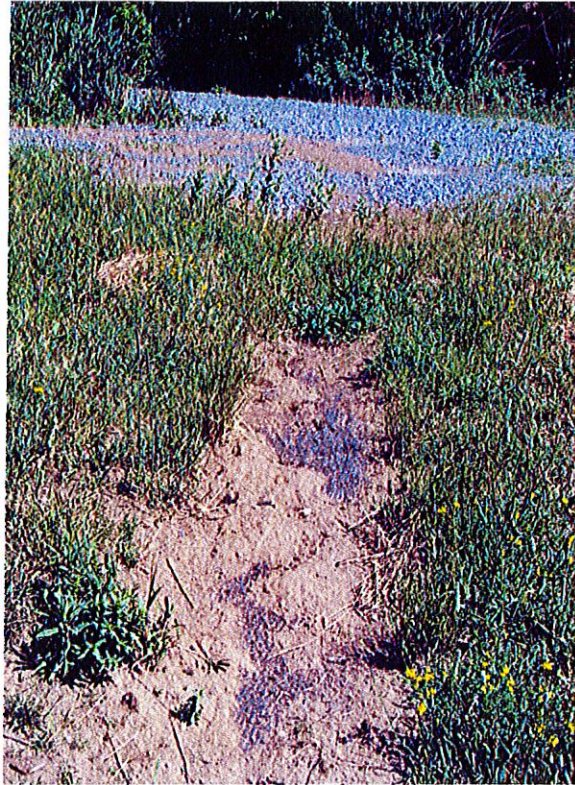
Photograph 7: View of eroded topsoil with visible erosion control fabric.

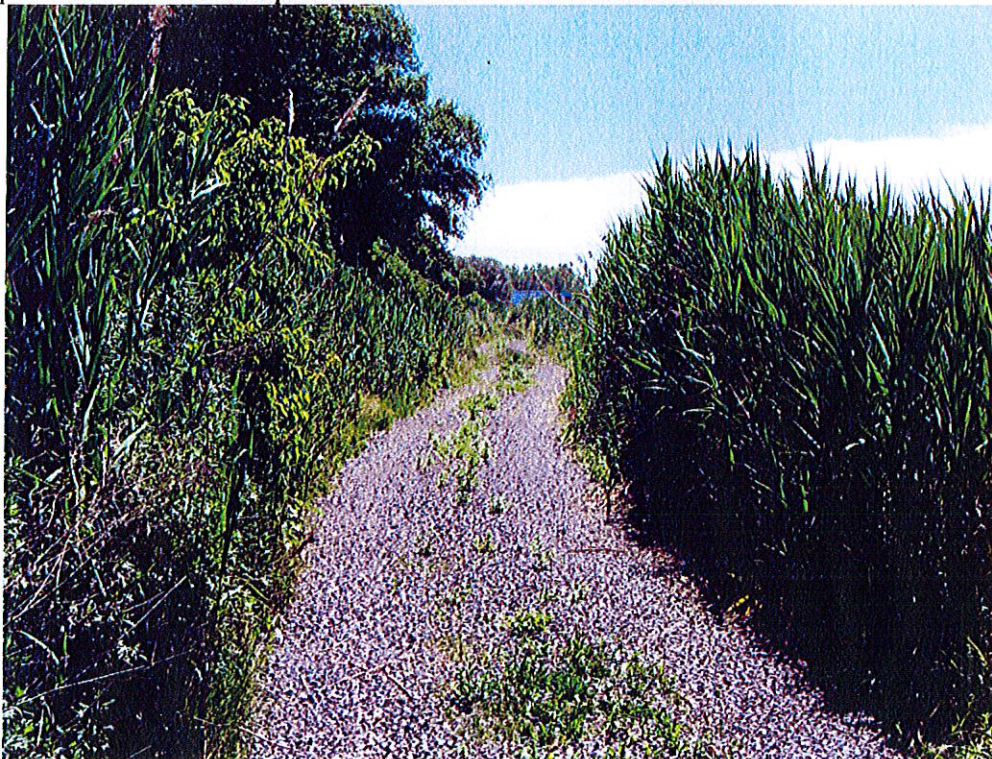
Photograph 8: View looking east from CB-3 outlet at repaired access road.

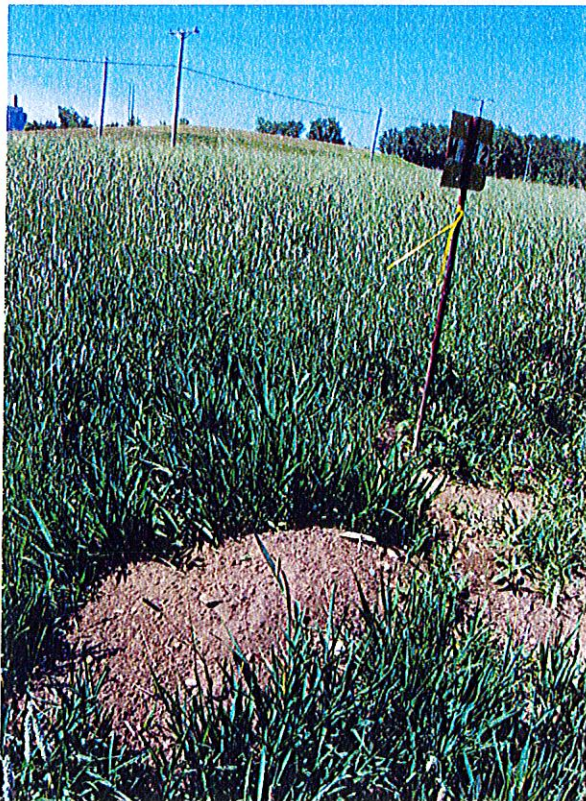
Photograph 10: View of burrowing animal hole near MW-12.

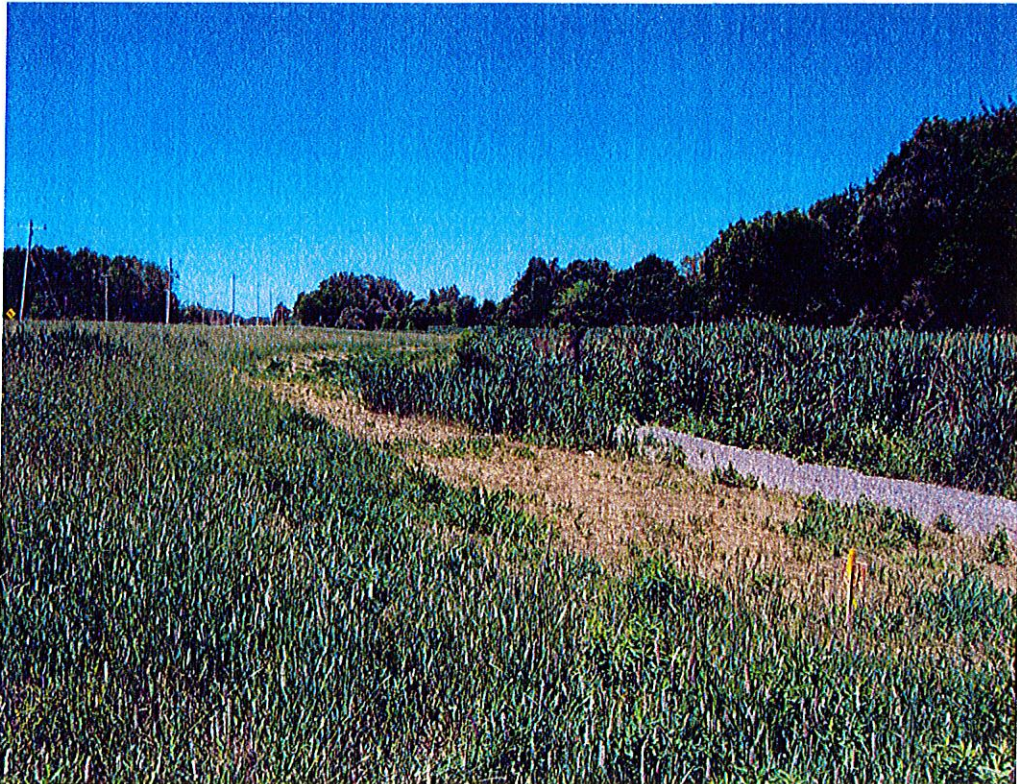
Also attached is a copy of the wetland vegetation mix that was placed by Royal Environmental, Inc. on May 25, 2007. The wetland area seeded is noted on Figures 1 and 2 and Photographs 11 and 12. This area will be inspected by O'Brien & Gere as part of the wetland inspection to be performed in Late Summer/Early Fall 2007.

Photograph 11: View looking west from eastern extent of re-seeded wetland area.

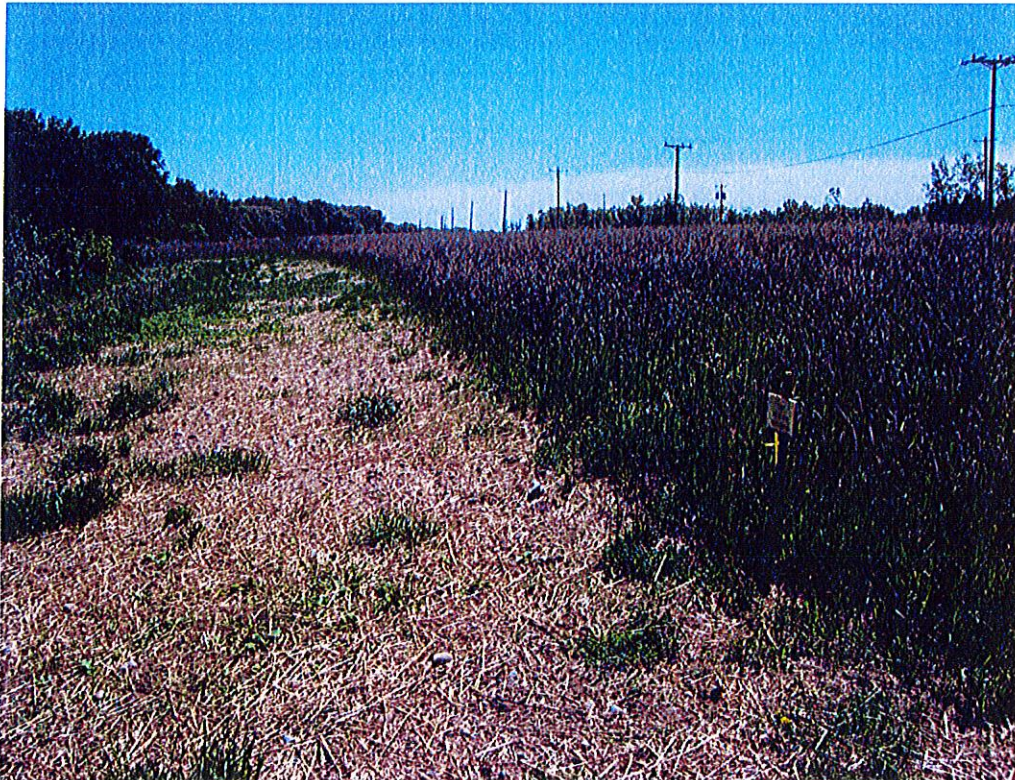
Photograph 12: View looking east from western extent of re-seeded wetland area.

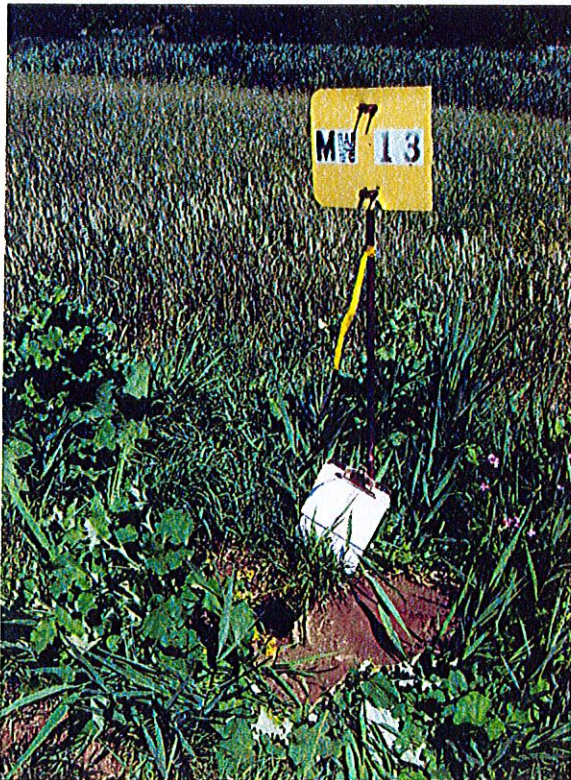
Photograph 14: View looking at burrowing animal hole at MW-13.

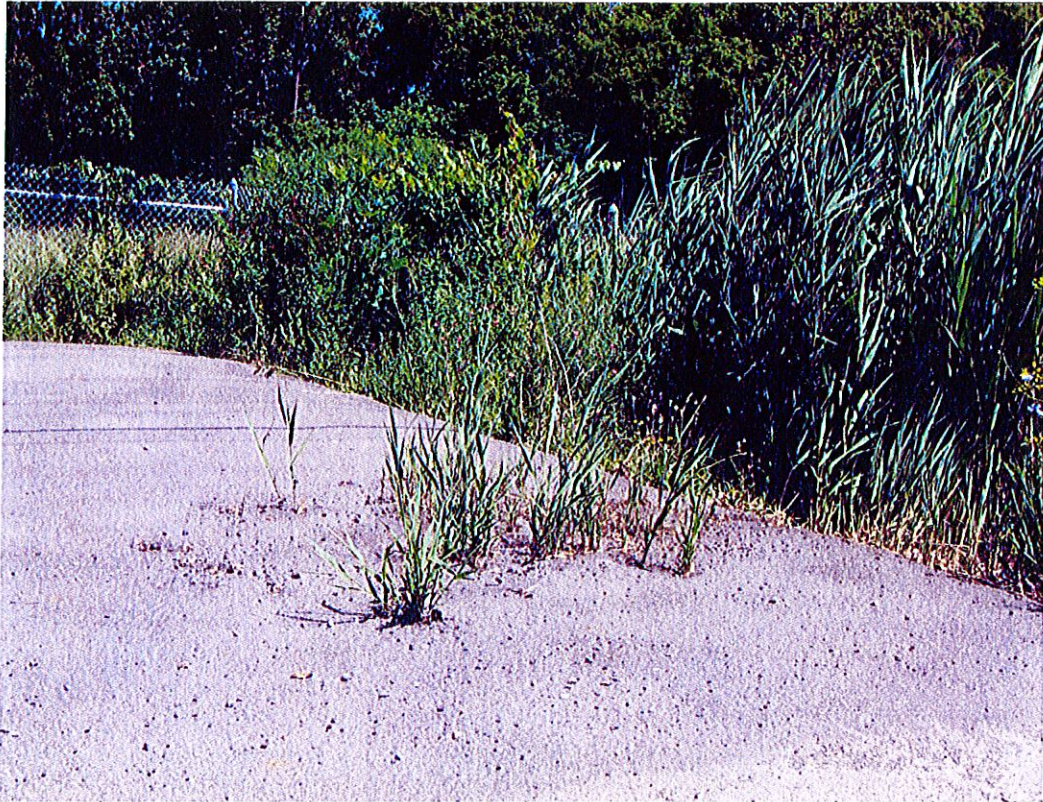
Photograph 15: View of phragmites in pavement access drive.

Phragmites in asphalt (O'Brien & Gere 2007).	Herbicide will be applied to the areas.	September 2007
