Re: Ley Creek PCB Dredgings Site (Registry # 7-34-044)
NYSDEC Order on Consent Index # D-7-0008-97-06
2003 Annual OM&M Inspection Report

Re: Ley Creek PCB Dredgings Site
June 2003 OM&M Inspection

LEY CREEK PCB DREDGINGS SITE
SYRACUSE, NEW YORK
SITE REMEDIATION PROJECT

JUNE 2003
OM&M INSPECTION
PARTIAL SITE PLAN

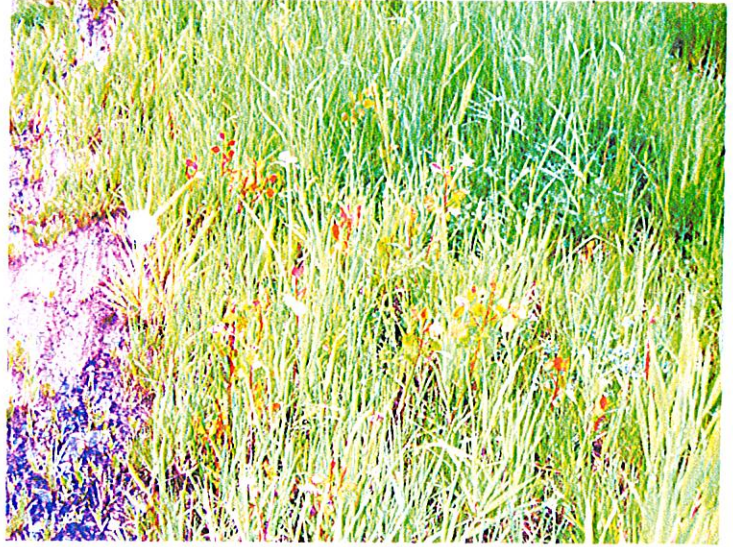
- Tree establishment: (Photographs 2 and 25. Figures 1, 3, 4, and 5.) Tree saplings were observed in several areas within the seeded wetlands along the stone access road.

Photograph 2 - View of trees in wetland area

- Remove the debris around catch basin CB-1 and catch basin CB-3 grate
- Repair area of excessive scouring by removal of rip-rap, placement of compacted crushed stone to meet surrounding grade, and replacement of rip-rap
- Mow/trim the vegetation around all catch basins, monitoring wells, utility poles, guy wires, and along the fence line require mowing
- Remove the trees from the wetland area
- Remove vegetation from the stone access road turnaround.

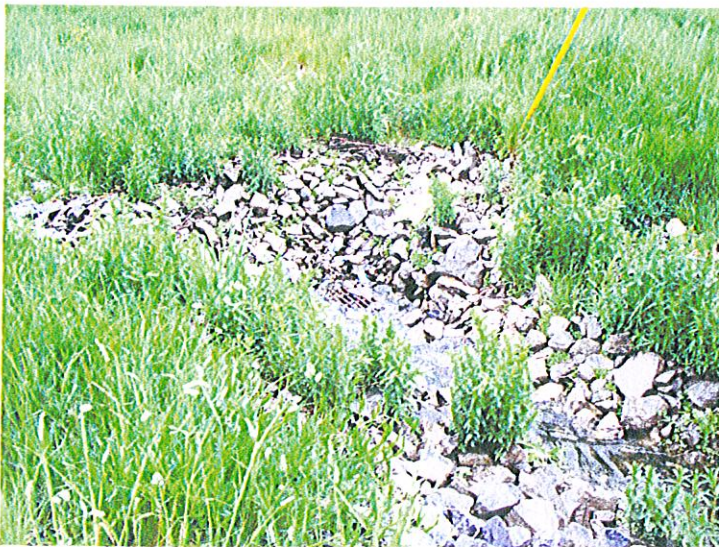
- Debris accumulation: (Photographs 3 and 13. Figures 1 and 3.) Debris was accumulated around the catch basin CB-1 and the grate for catch basin CB-3 was partially blocked, thus restricting flow.

Photograph 3 - View of CB-1 with some trash accumulation.

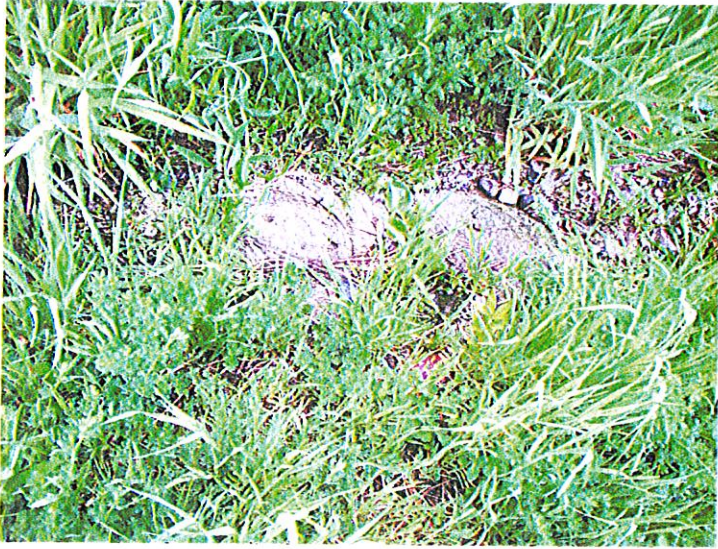
- Vegetative cover erosion: (Photographs 5, 6, 7, 8, 17, 19, 20, and 32. Figures 1, 3, and 5). Several areas of erosion of the vegetative cover were observed. In general, these areas were within the overflow spillways.

Photograph 5 - View of geotextile visible near outlet of CB-1.

- Apply seed and fertilizer to areas that received topsoil earlier this year
- Repair the damaged site security fence
- Repair eroded areas of the vegetative cover by placement of topsoil and subsequent application of seed and fertilizer
- Remove the woodchucks from the Site, place topsoil in the hole, and apply seed and fertilizer
- Repair the eroded areas and the areas of poor drainage of the stone access road by placement of additional crushed stone
- Improve drainage of the stone access road by constructing small drainage channels to convey ponded water from the stone access road to Ley Creek. This could be

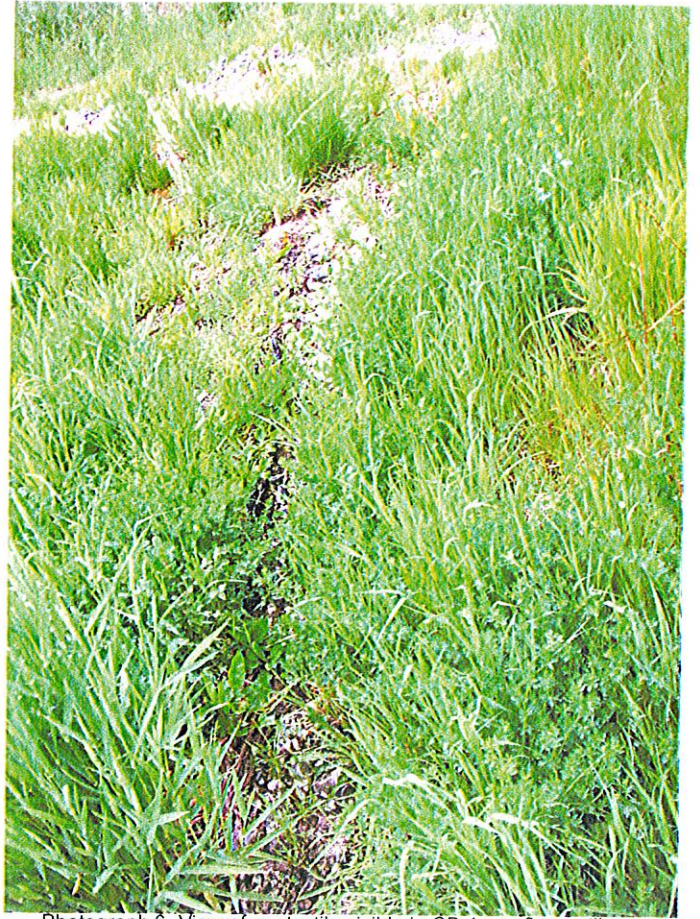
Photograph 6 -View of geotextile visible in CB-1 overflow spillway

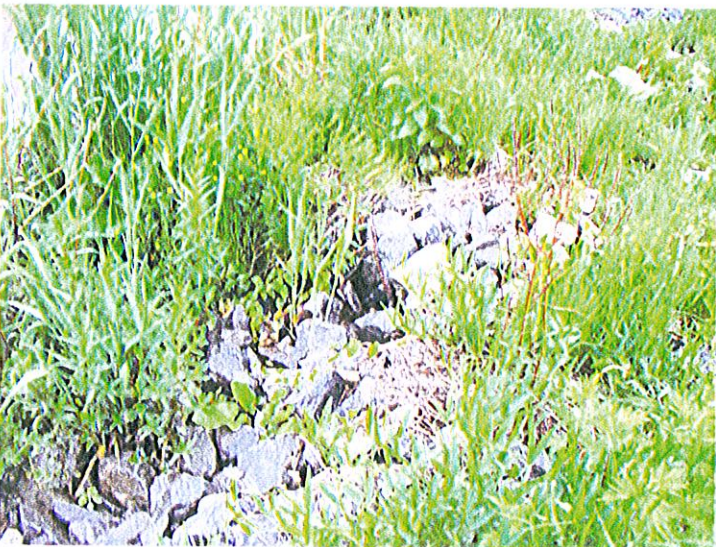
Photograph 7 - View of eroded area near east of outlet for CB-1.

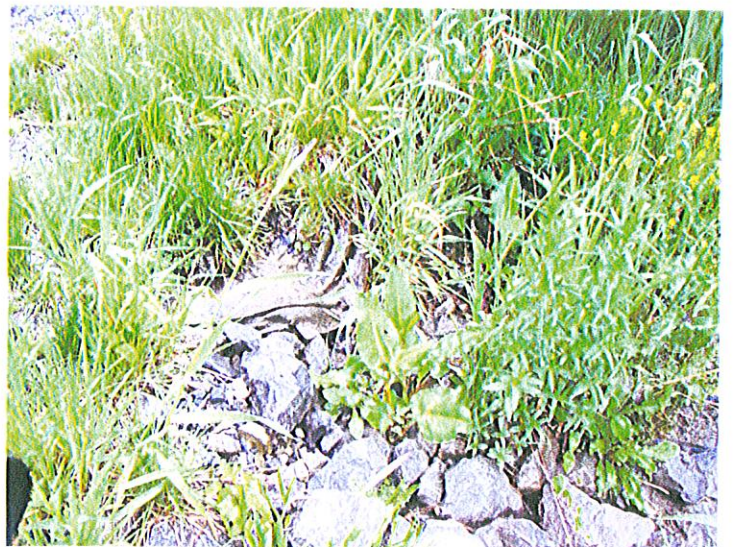
Photograph 8 - View of eroded area west of CB-1 outlet.

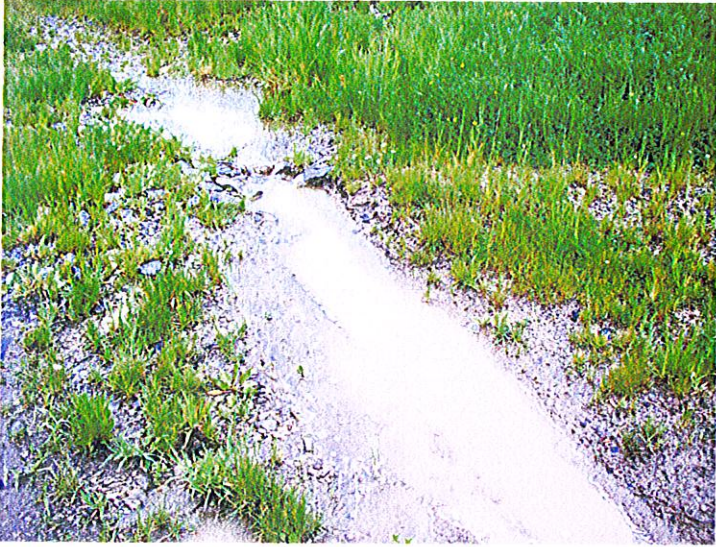
- Stone access road erosion: (Photograph 9 and 14. Figures 1 and 3.) Erosion of a section of the stone access road near the outlet of catch basin CB-3 was observed.

Photograph 9 - View of eroded access road near the CB-1 outlet.

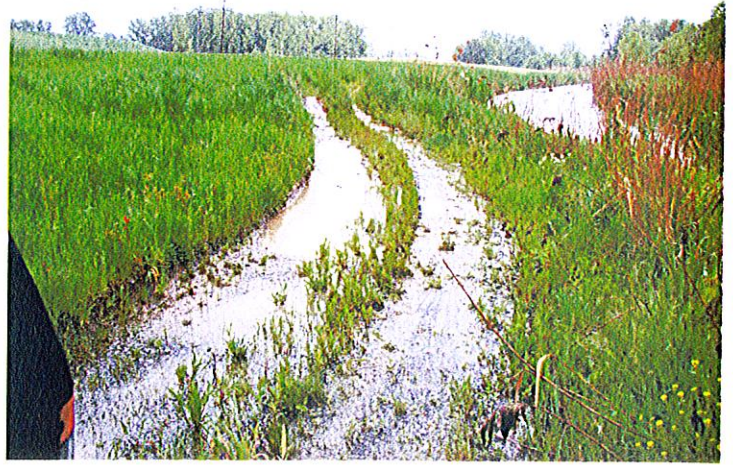
- Stone access road drainage: (Photographs 10, 11, 15, 16, 23, and 24. Figures 2, 3, and 4.) Several areas of the stone access road were observed to have poor drainage, which was characterized by ponded water being visible within the stone access road.

Photograph 10 - View of standing water in access road.

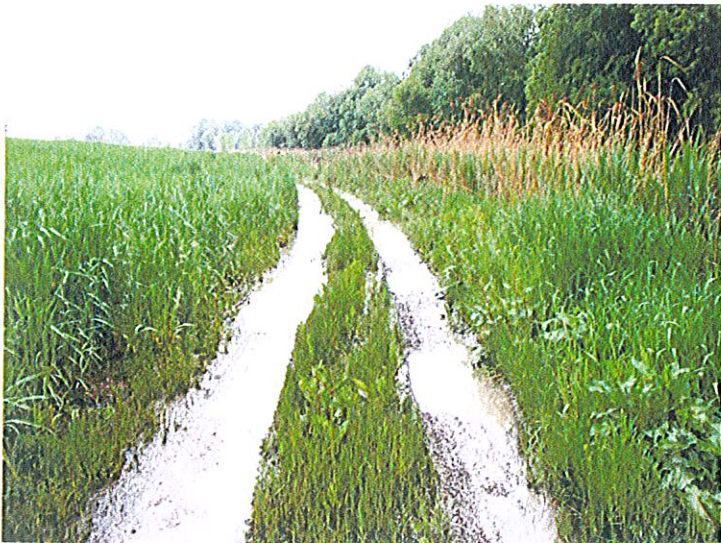
Photograph 11 - View of standing water in access road.

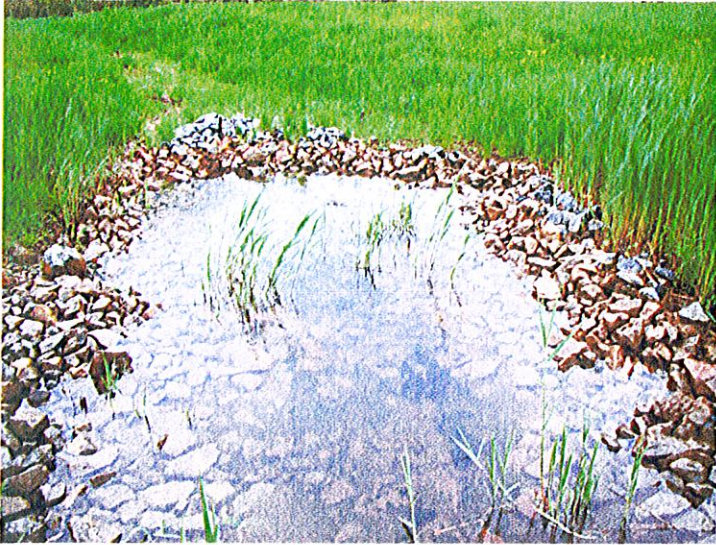
Photograph 13 - View of grate blockage for CB-2.

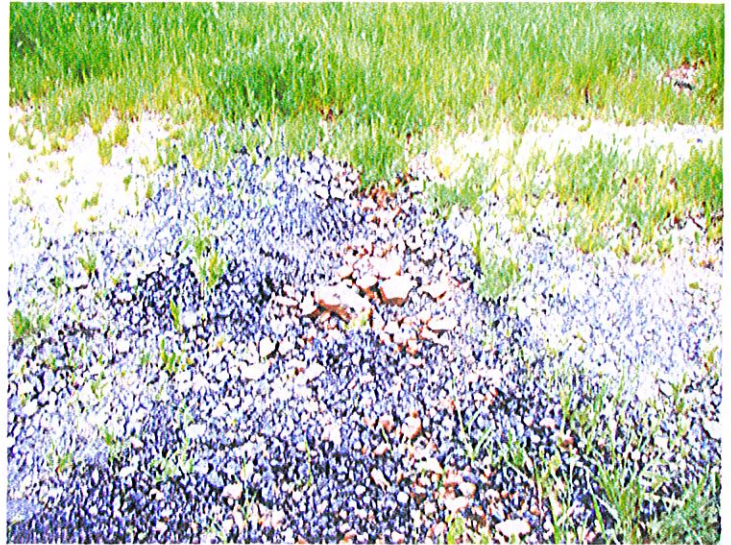
Photograph 14 - View of eroded area in access road.

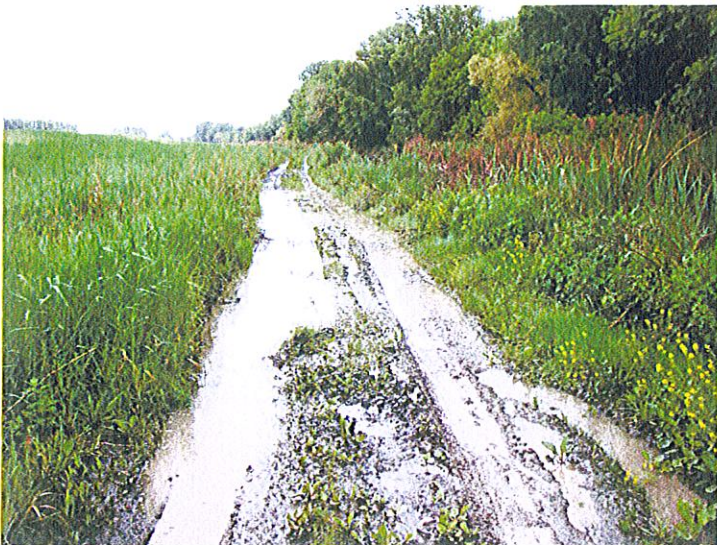
Photograph 15 - View of standing water in access road.

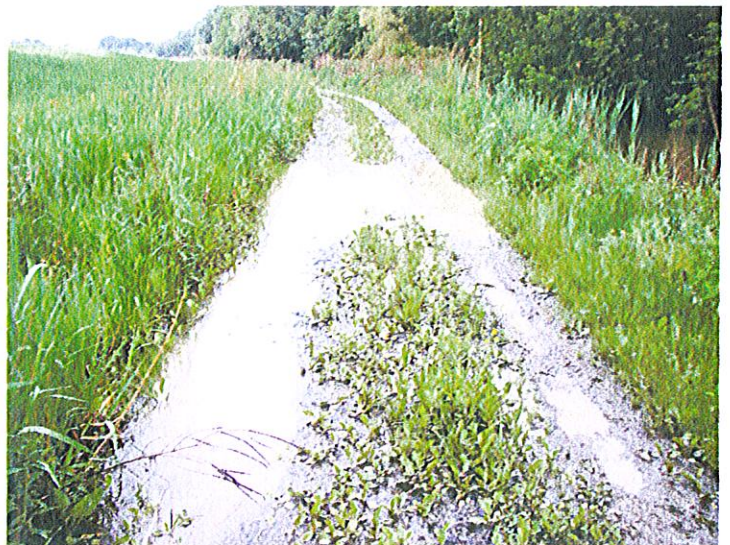
Photograph 16 - View of standing water in access road.

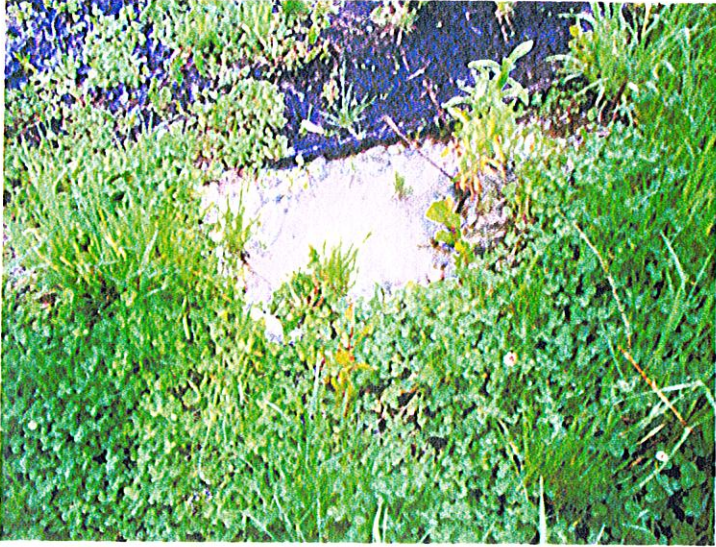
Photograph 17 - View of geotextile visible in CB-3 overflow spillway.

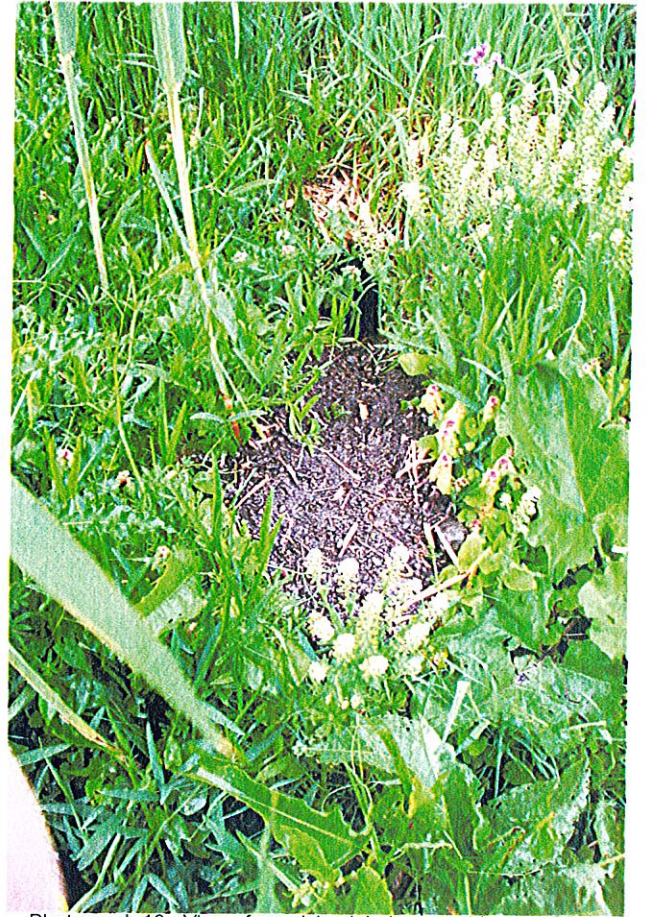
- Burrowing animals: (Photographs 18 and 28. Figures 3 and 5.) A woodchuck hole was observed in the area of catch basin CB-3 and catch basin CB-5/004 during the site inspection.

Photograph 18 - View of woodchuck hole west side near CB-3.

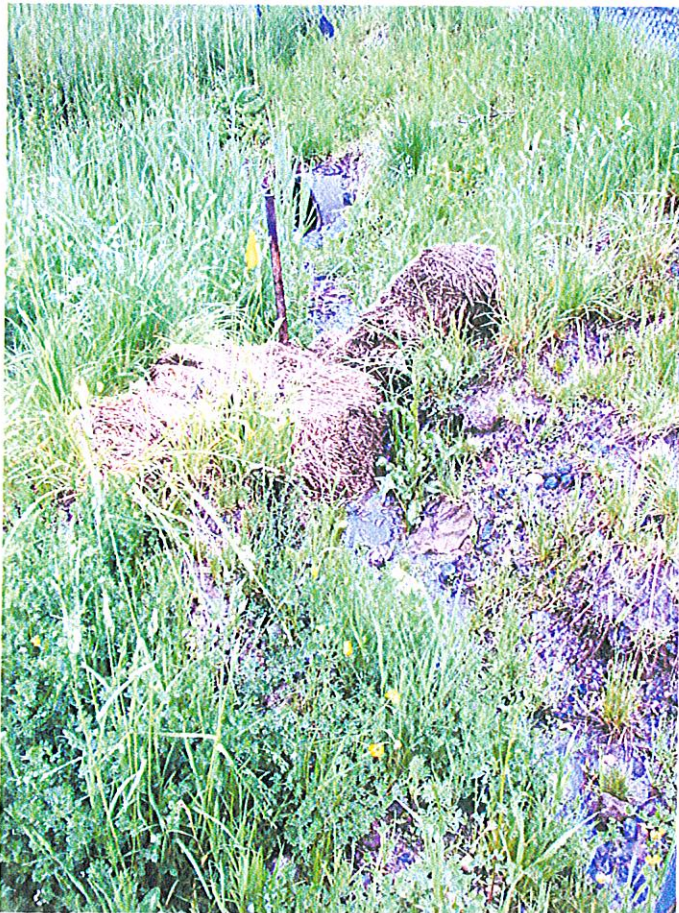
Photograph 19 - View of erosion channel near CB-3.

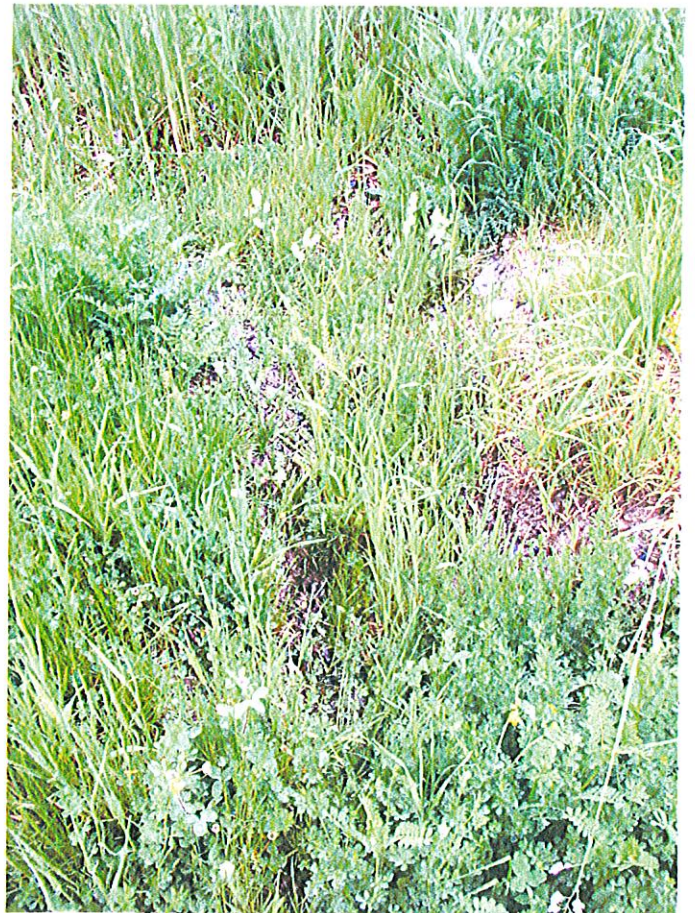
Photograph 20 - View of erosion channel near CB-3.

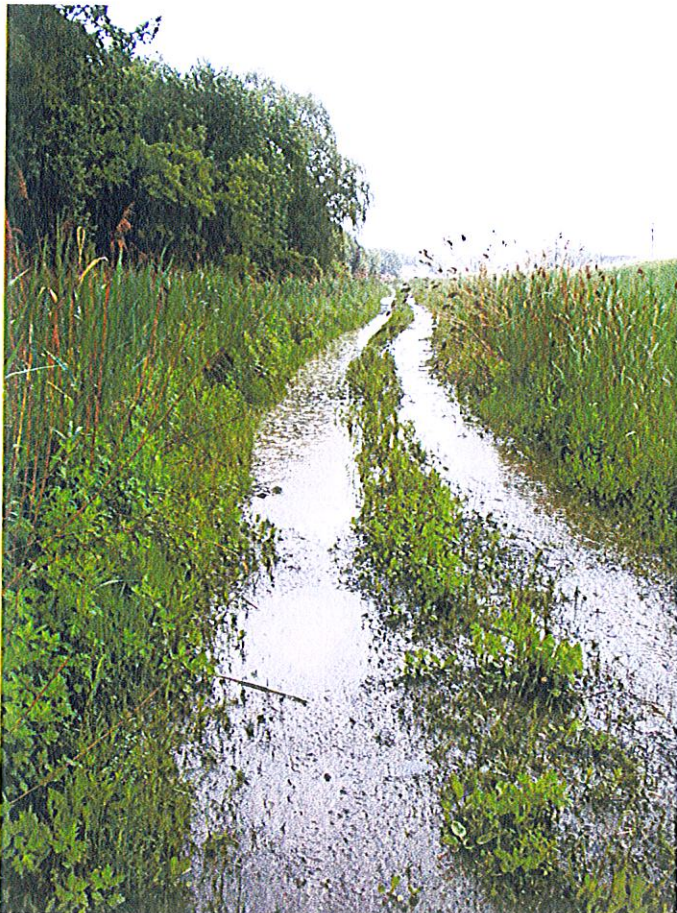
Photograph 23 - View of standing water in access road.

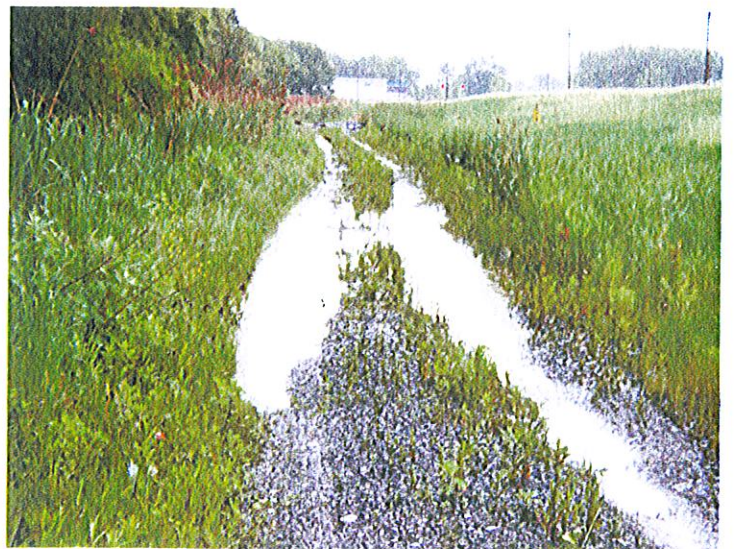
Photograph 24 - View of standing water in access road.

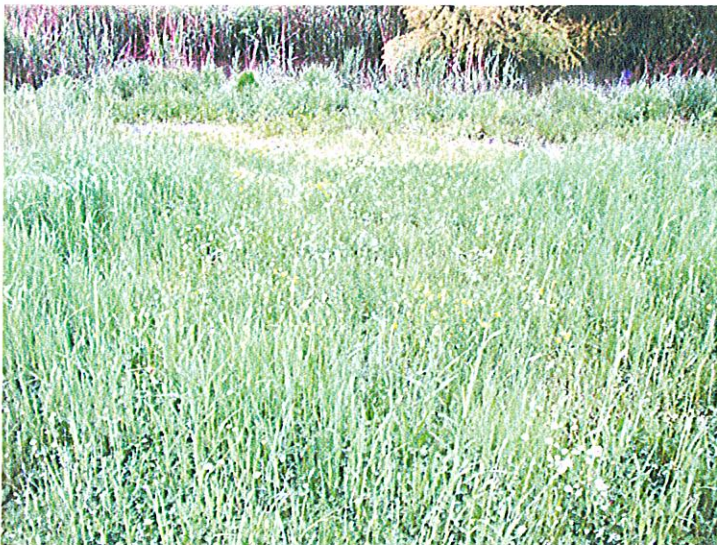
- Vegetation within stone access road: (Photograph 27. Figure 5.) A significant amount of vegetation was observed within the stone access road turnaround at the eastern end of the Site.

Photograph 27 - View of vegetation in access road turnaround.

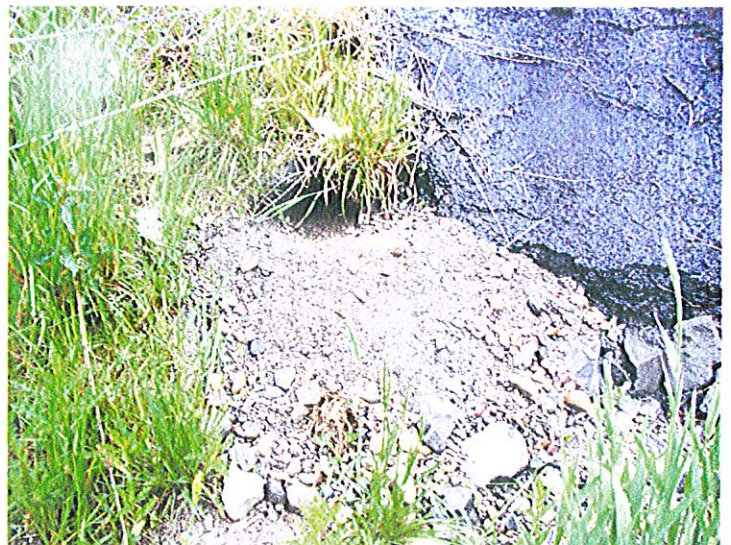
Photograph 28 - View of woodchuck hole near CB-5/004.

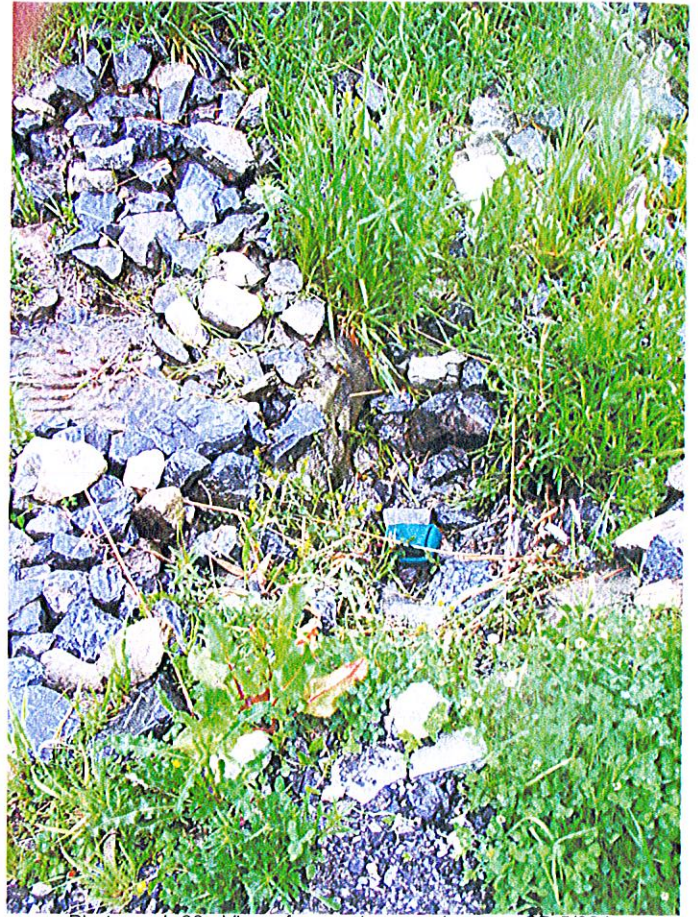
- Excessive scouring: (Photograph 30. Figure 5.) The excessive scouring that was observed in the August 2002 inspection requires repair.
- Area requiring mowing: The vegetation around the catch basins, monitoring wells, utility poles, guy wires, and along the fence line require mowing.

Photograph 30 - View of excessive scouring near CB-5/004.

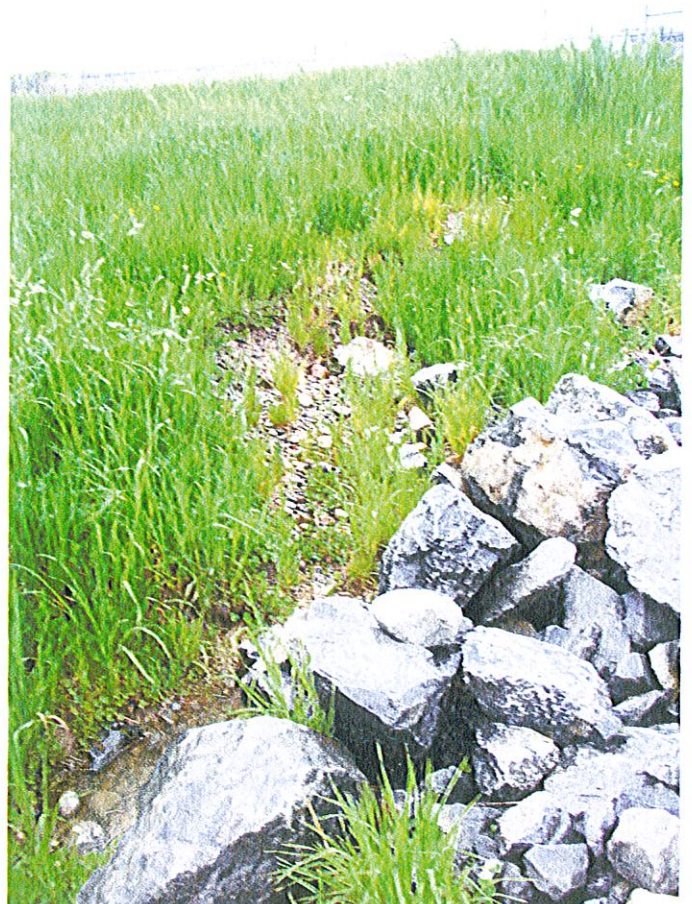
Photograph 32 - View of erosion in CB-4/003 overflow spillway.

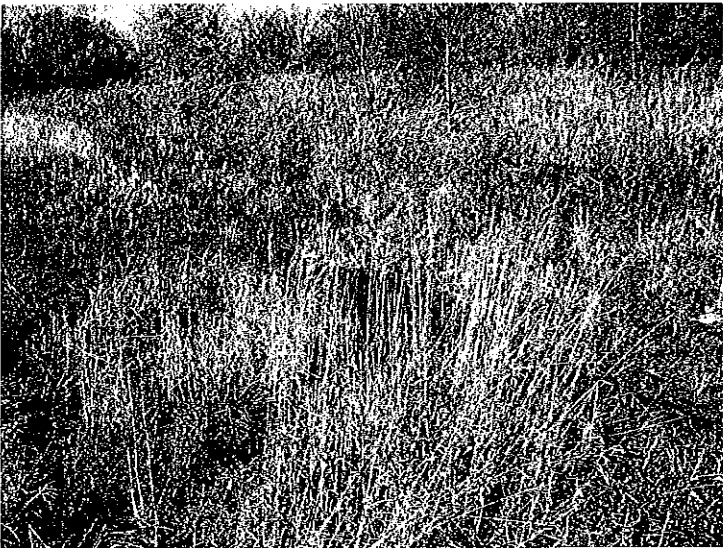
Photograph 3- View of flooding in access road near CB-1 outlet at Ley Creek

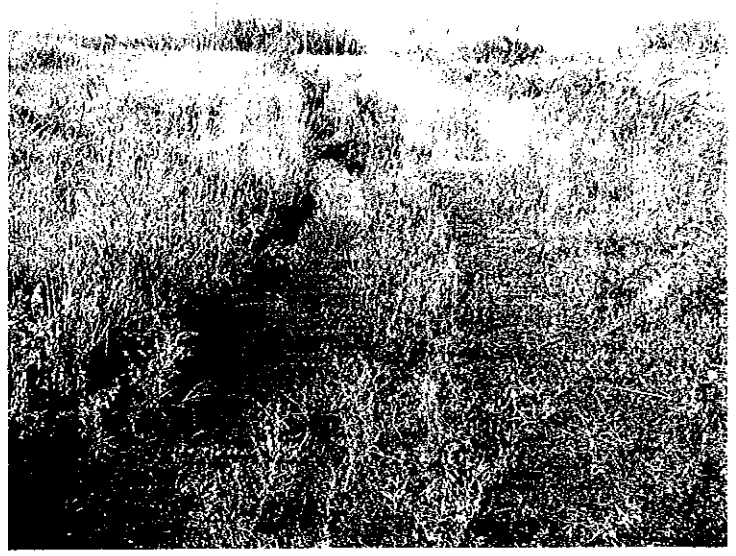
- Burrowing animals: (Figure 3.) A woodchuck hole observed in the June 2003 inspection, in the area of catch basin CB-3, requires repair
- Stone access road drainage: (Photograph 6. Figure 2.) One area of the stone access road observed during the June 2003 inspection to have rutting and poor drainage, which was characterized by ponded water being visible within the stone access road, requires repair

Photograph 6- View of rutting in stone access road

- Remove the woodchuck(s) from the Site, place topsoil in the hole, and apply seed and fertilizer
- Repair the areas of rutting of the stone access road by placement of additional crushed stone and improve drainage of the stone access road by constructing small drainage channels to convey ponded water from the stone access road to Ley Creek. This could be performed by removal of less than 1 foot of vegetative cover material with subsequent replacement of crushed stone

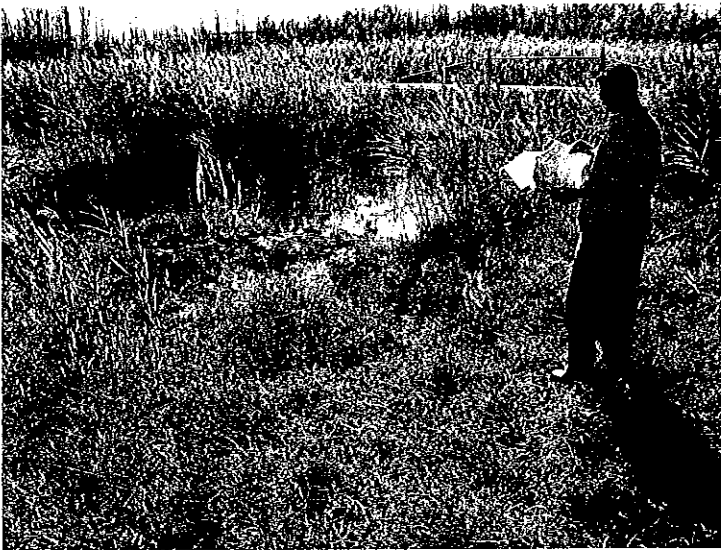
Photograph 7- View of CB-2 with ponded water due to grate blockage

- Remove the debris around catch basin CB-1 and catch basin CB-2 grate
- Repair the area of excessive scouring by removal of rip-rap, placement of compacted crushed stone to meet surrounding grade, and replacement of rip-rap

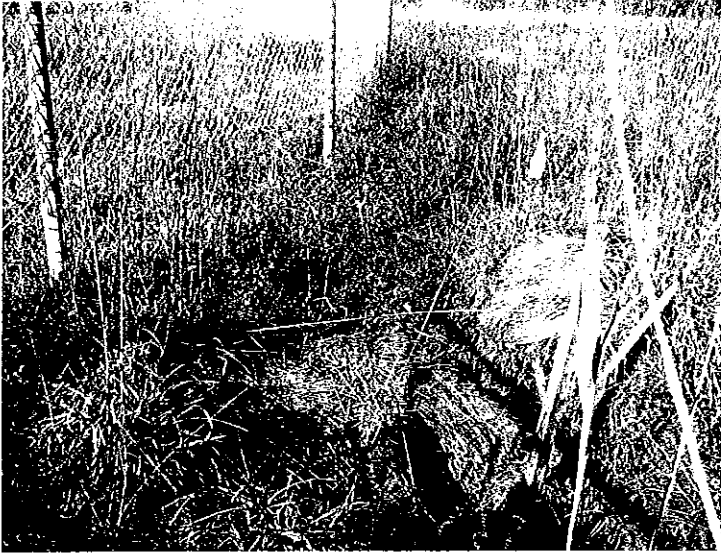
- Vegetative cover erosion: (Photograph 9. Figure 3). One area of erosion of the vegetative cover was observed

Photograph 9- View of erosion channel near CB-3

- Repair the damaged site security fence
- Repair eroded areas of the vegetative cover by placement of topsoil and subsequent application of seed and fertilizer

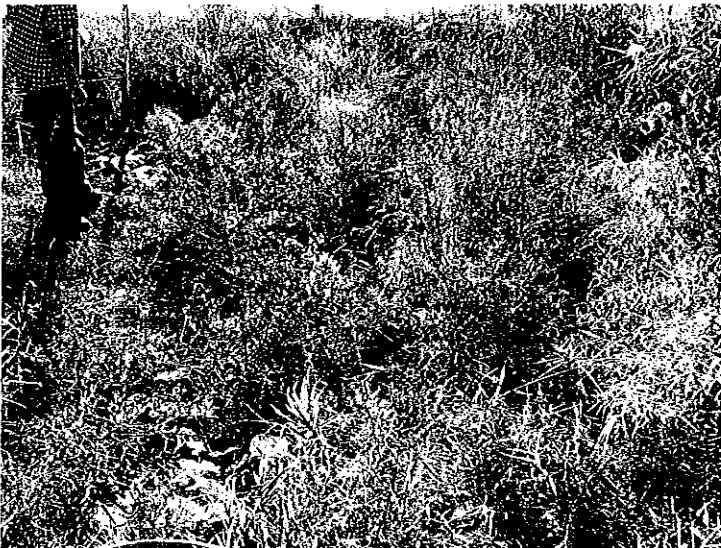
- Excessive scouring: (Photograph 15. Figure 5.) The excessive scouring that was observed in the August 2002 inspection requires repair
- Area requiring mowing: The vegetation around the catch basins, monitoring wells, utility poles, guy wires, and along the fence line requires mowing

Photograph 15- View looking at scoured area south of CB-5/004
