July 12, 2022

RE: *Quarterly Status Report – April 2022 – June 2022*
Coldwater Road Landfill
1245 East Coldwater Road, Flint, MI
MID 005 356 860

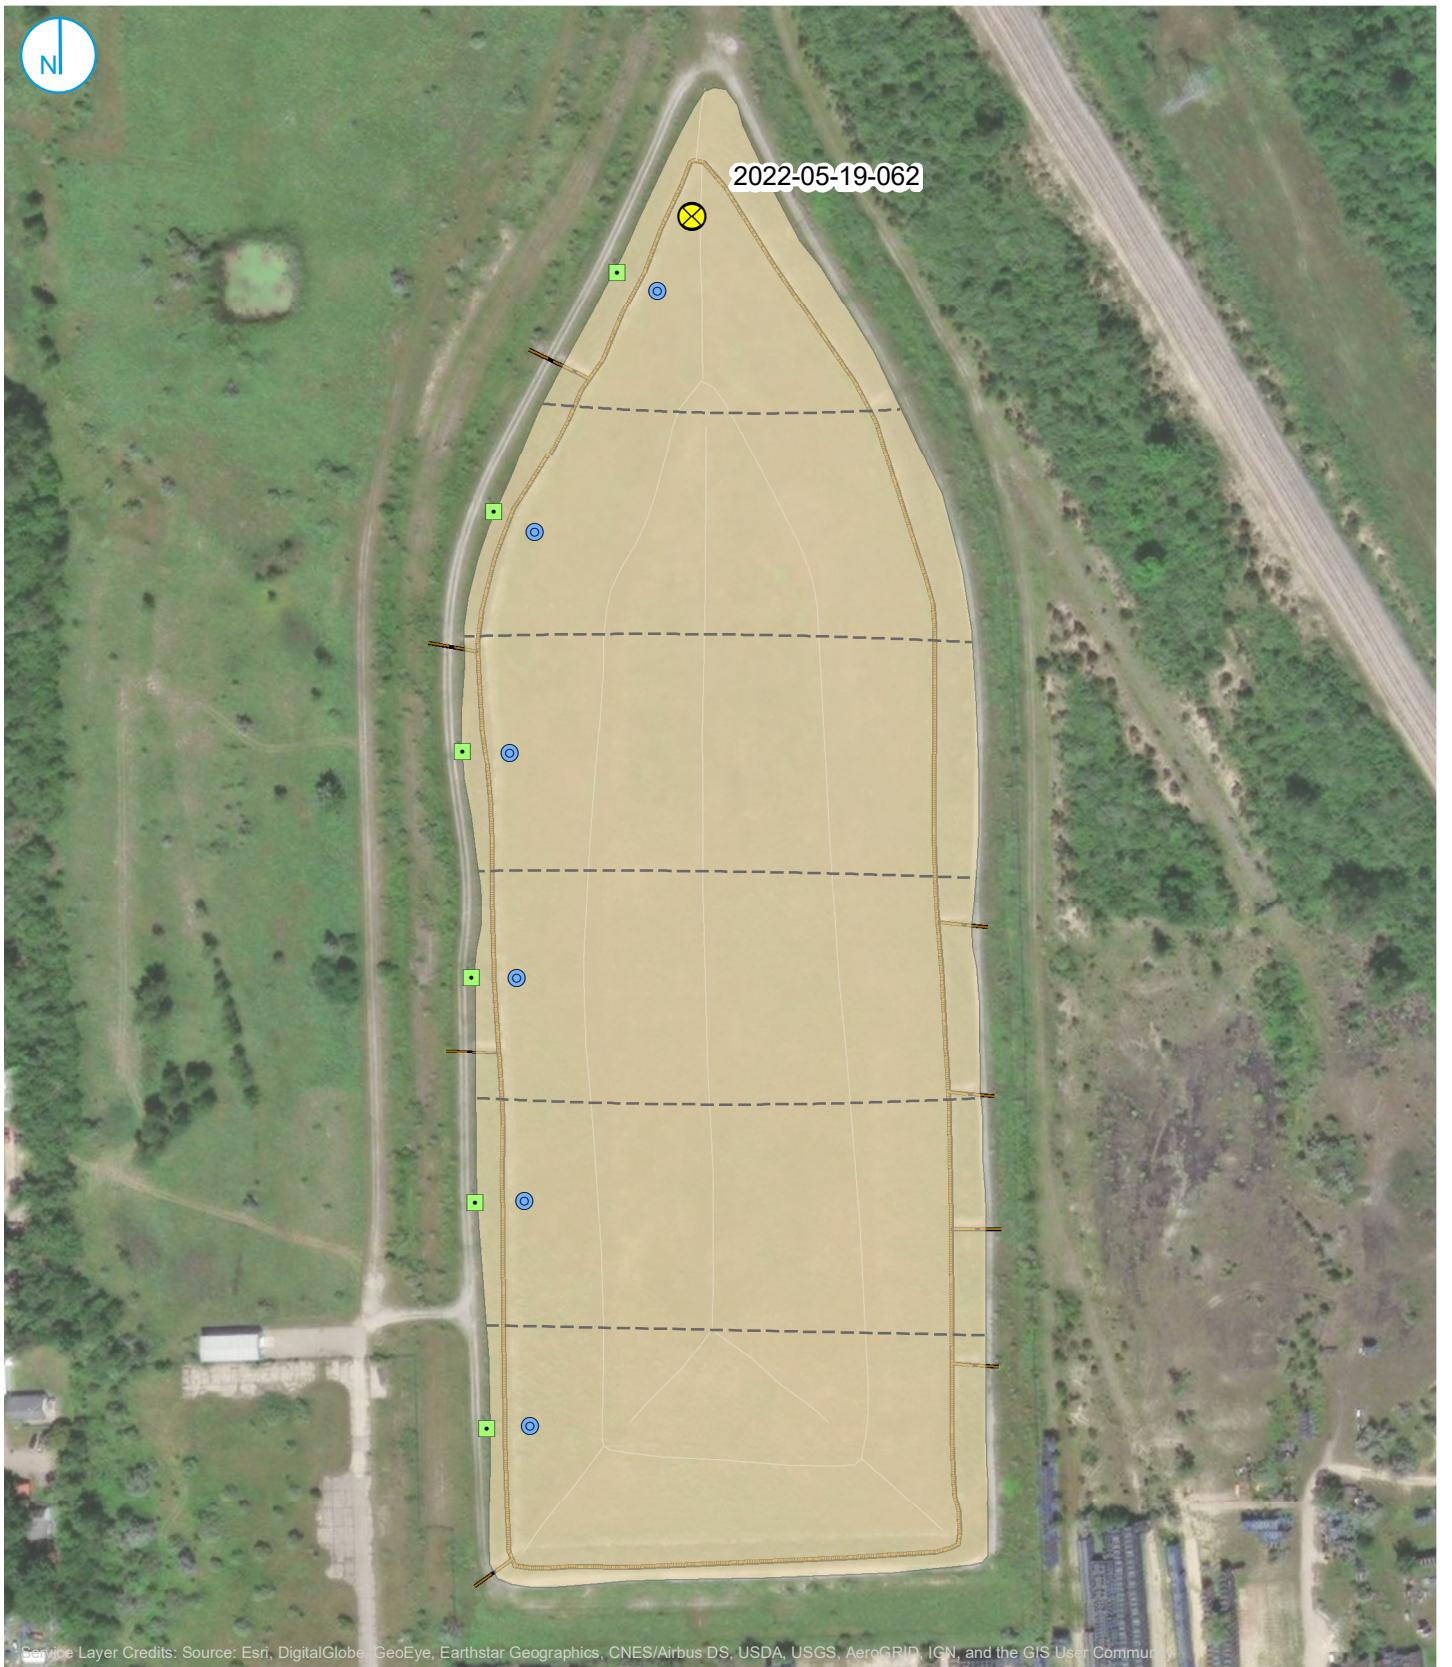
FIGURE 01

- » Observed one potentially active animal burrow on March 25, 2022 and a trap was set on March 31, 2022. The animal burrow was found to not be active and was closed out on May 19, 2022. See attached photo log and figure for further details.

**2ND QUARTER 2022
BURROW LOCATION MAP**

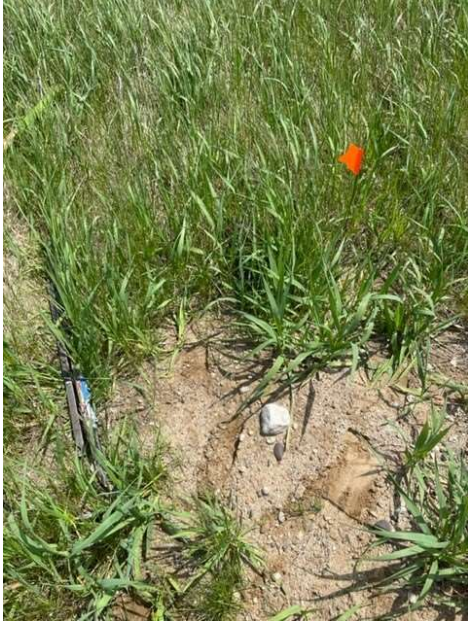
LOCATION: Cell A1		APPROX. LENGTH: 44 inches	APPROX. DEPTH: 18 inches	APPROX. DIAMETER: 5 inches
DATE FOUND: 3/31/22	DATE CLOSED: 5/19/22

NOTES: ID: 2022-05-19-062 PRE repair photo. Trap set for forty-nine days. Checked multiple days. No activity. No signs of liner damage.				
LOCATION: Cell A1		APPROX. LENGTH: 44 inches	APPROX. DEPTH: 18 inches	APPROX. DIAMETER: 5 inches
DATE FOUND: 3/31/22	DATE CLOSED: 5/19/22
