January 13, 2025

RE: *Semiannual Status Report – July 2024 – December 2024*  
*Coldwater Road Landfill*  
*1245 East Coldwater Road, Flint, MI*  
*MID 005 356 860*  
FILE: 1088190/1940107203/Docs

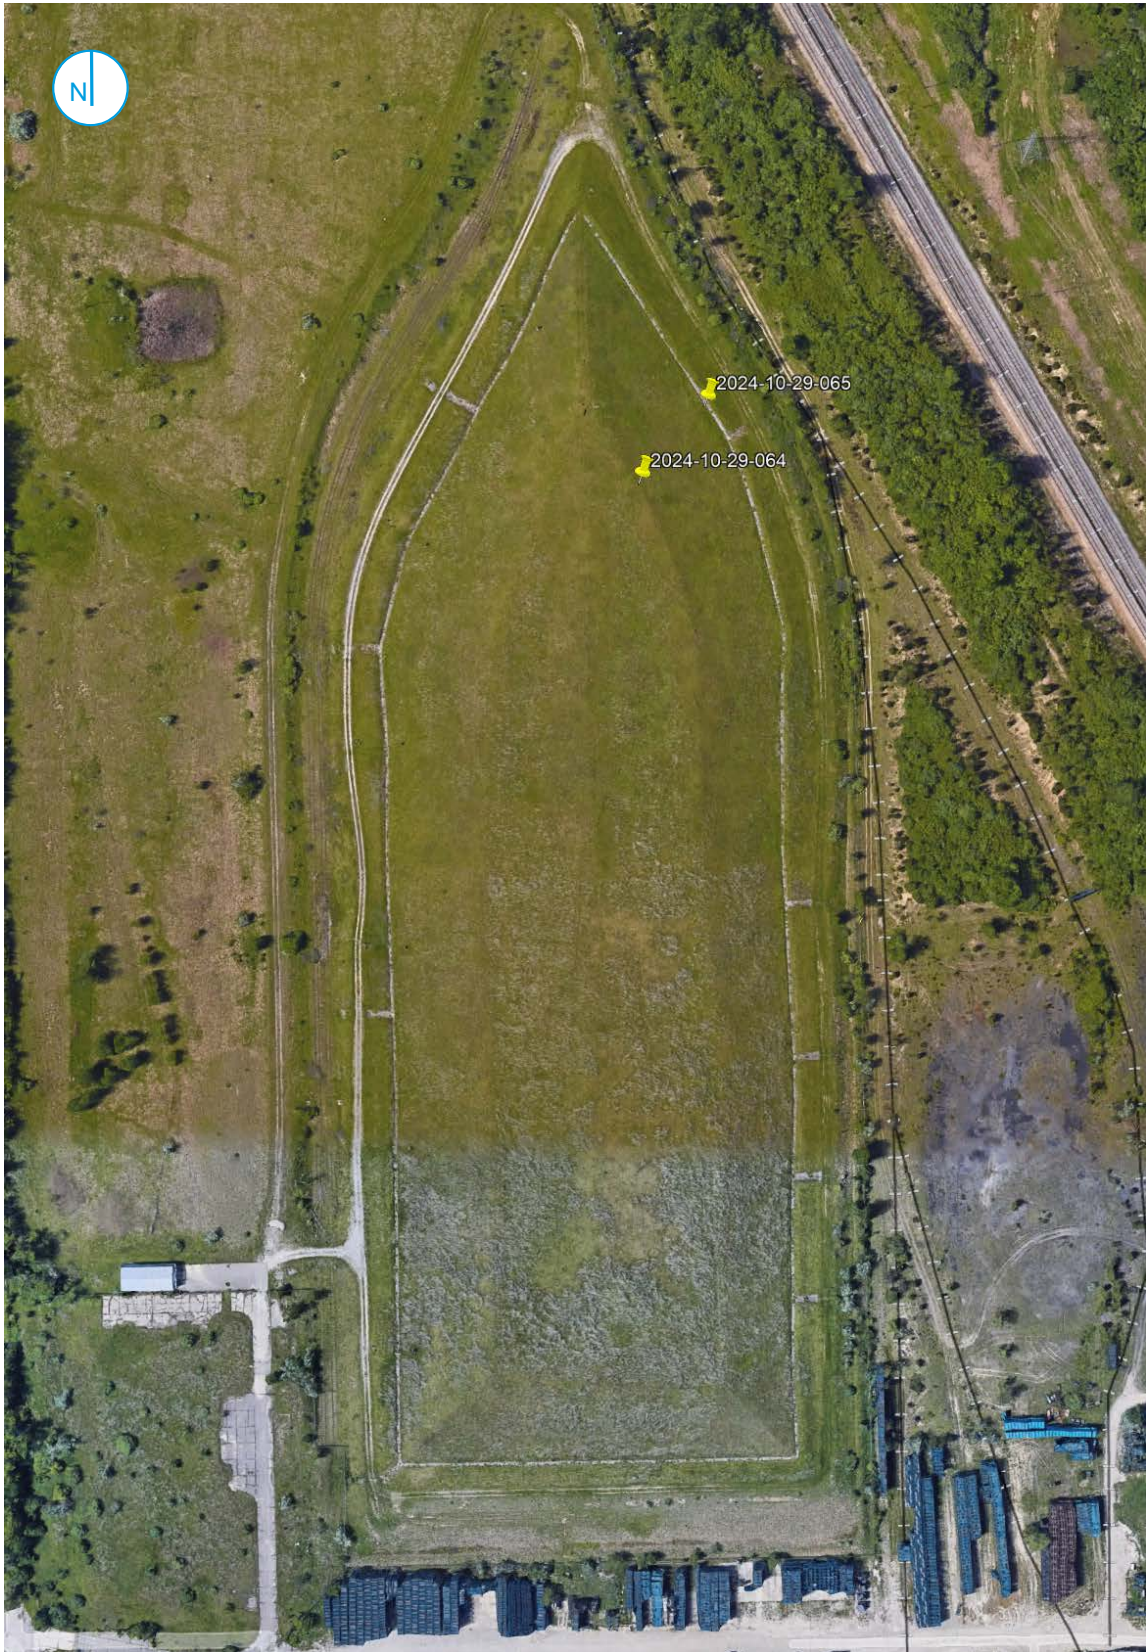
**FIGURE 01**

- » Observed two potentially active animal burrow on October 17, 2024. A trap was set at each animal burrow. A groundhog was trapped at one of the burrows and the other burrow was found to be inactive. The animal burrows were backfilled and closed out on October 29, 2024, and a photo log and figure are included as an appendix to this report.

**4TH QUARTER 2024  
BURROW LOCATION MAP**

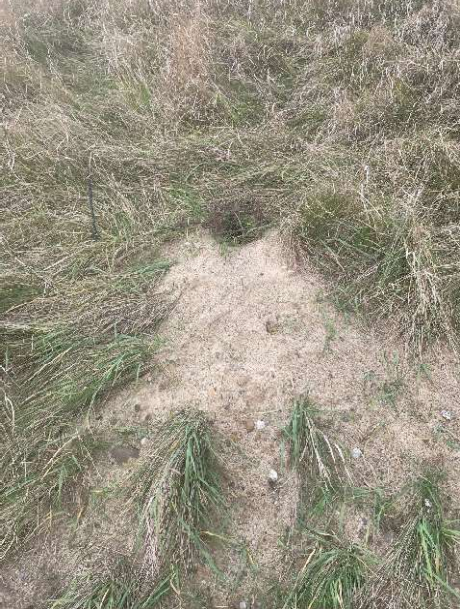
<b>LOCATION:</b> Cell A2		<b>APPROX. LENGTH:</b>  2.5 feet	<b>APPROX. DEPTH:</b>  1.5 feet to the left	<b>APPROX. DIAMETER:</b>  6 inches
<b>DATE FOUND:</b> 10/17/24	<b>DATE CLOSED:</b> 10/29/24

<b>NOTES:</b> ID: 2024-10-29-064  PRE repair photo. Trap set for eleven days. No activity. No signs of liner damage.				
<b>LOCATION:</b> Cell A2		<b>APPROX. LENGTH:</b>  2.5 feet	<b>APPROX. DEPTH:</b>  1.5 feet to the left	<b>APPROX. DIAMETER:</b>  6 inches
<b>DATE FOUND:</b> 10/17/24	<b>DATE CLOSED:</b> 10/29/24

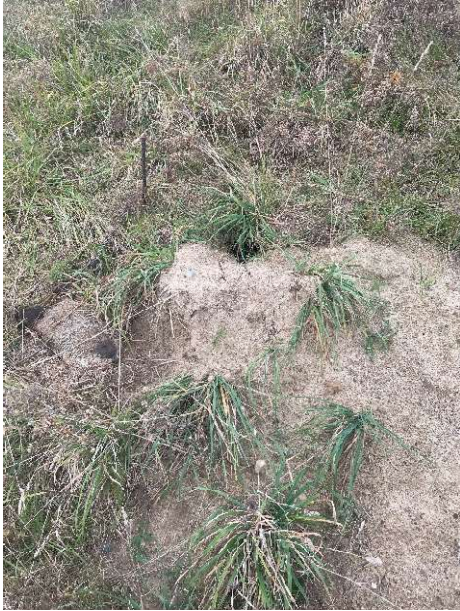
<b>LOCATION:</b> Cell A2		<b>APPROX. LENGTH:</b> 1 foot, 8 inches to left	<b>APPROX. DEPTH:</b> 1 foot	<b>APPROX. DIAMETER:</b> 6 inches
<b>DATE FOUND:</b> 10/17/24	<b>DATE CLOSED:</b> 10/29/24

<b>NOTES:</b> ID: 2024-10-29-065  PRE repair photo. Trap set for eleven days. Trapped ground hog. No signs of liner damage.				
<b>LOCATION:</b> Cell A2		<b>APPROX. LENGTH:</b> 1 foot, 8 inches to left	<b>APPROX. DEPTH:</b> 1 foot	<b>APPROX. DIAMETER:</b> 6 inches
<b>DATE FOUND:</b> 10/17/24	<b>DATE CLOSED:</b> 10/29/24
