## Memorandum

**Re: PCB Excavation**

GHD Services Inc. (GHD) is providing this summary on behalf of Revitalizing Auto Communities Environmental Response (RACER) Trust of the excavation of PCB impacted soil located in the southern portion of the Site at the former PCC-Validation (Site) facility located in Pontiac, Michigan.

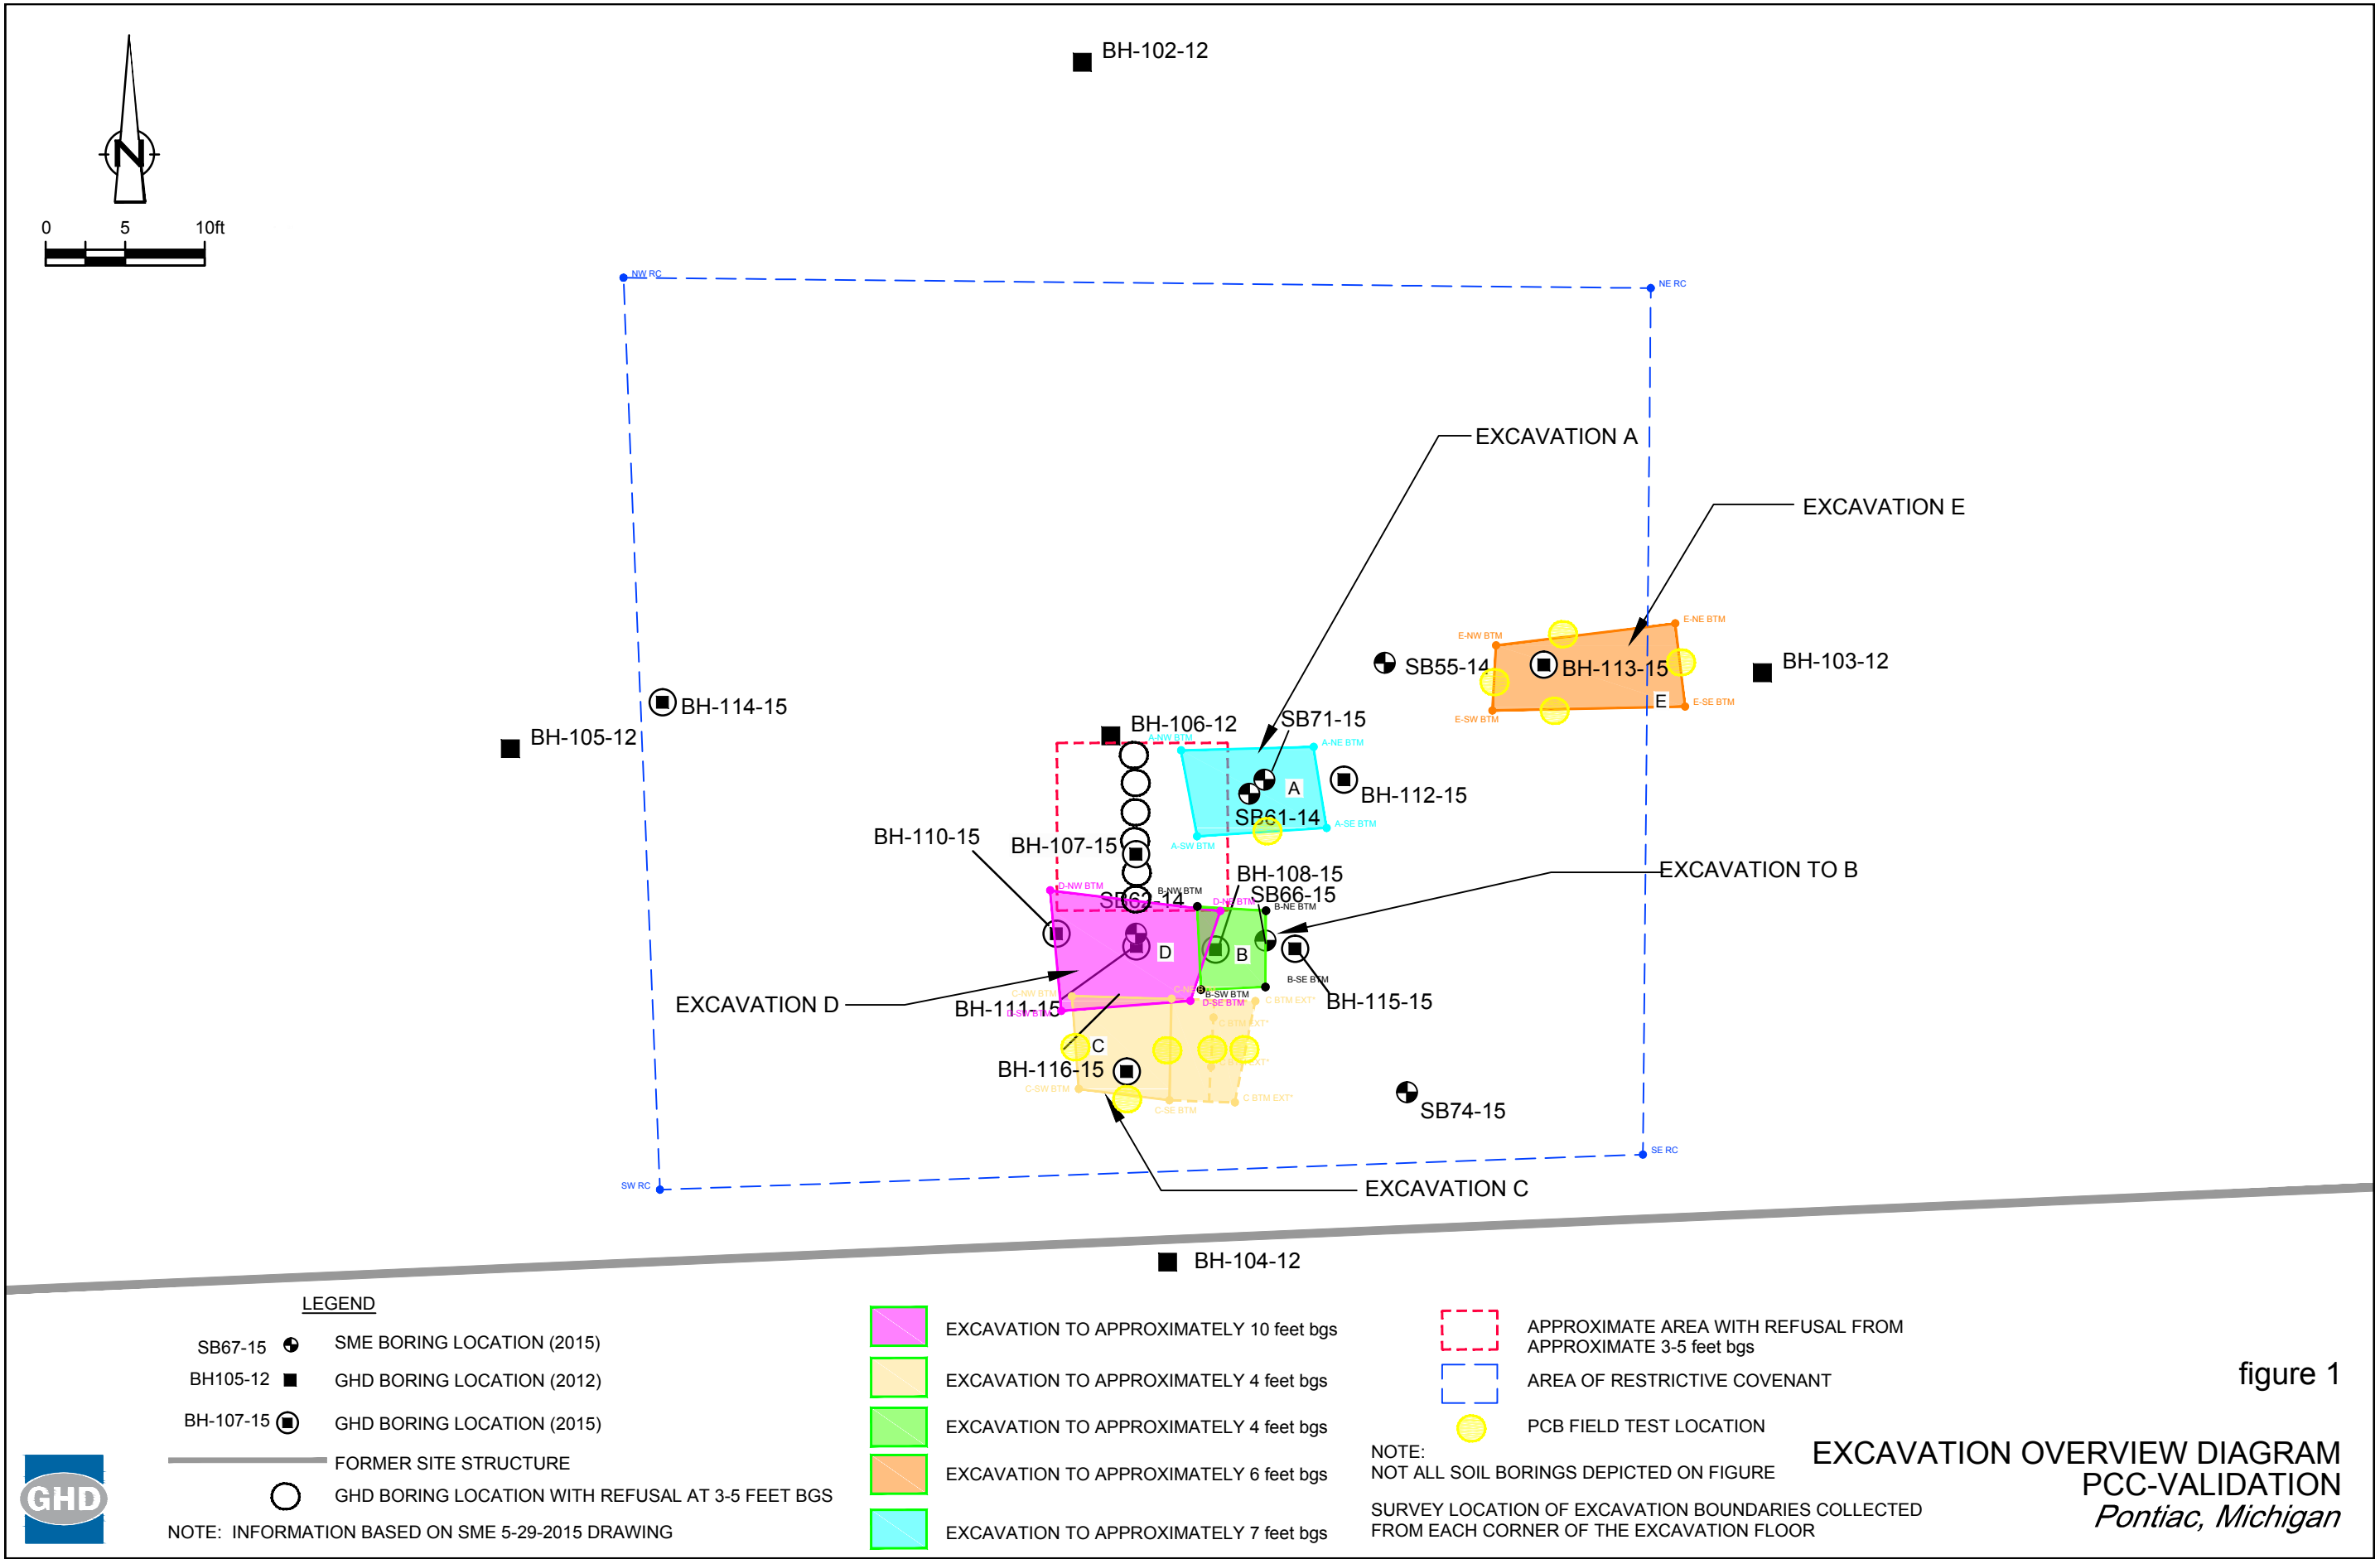
- ) Prior to excavation, five areas (A, B, C, D, and E) were surveyed and flagged (figure 1). Ground surface elevations were collected from the five areas.

- ) Based on the positive field test kit at the eastern sidewall of excavation C, an additional 3.5 feet of sidewall was over-excavated. Re-tested sidewall samples of the over excavated eastern sidewall was negative (<50 PPM). See figure 1 for over-excavated sidewall area.

Figure 1 provides a map with excavation boundaries (surveyed from floor of excavation corners) and field test sample locations. See Table 1 for a sample key and test kit results summary. See Table 2 for a summary of excavation elevations. A photographic log of excavations and field test kits are provided in Attachment 1.

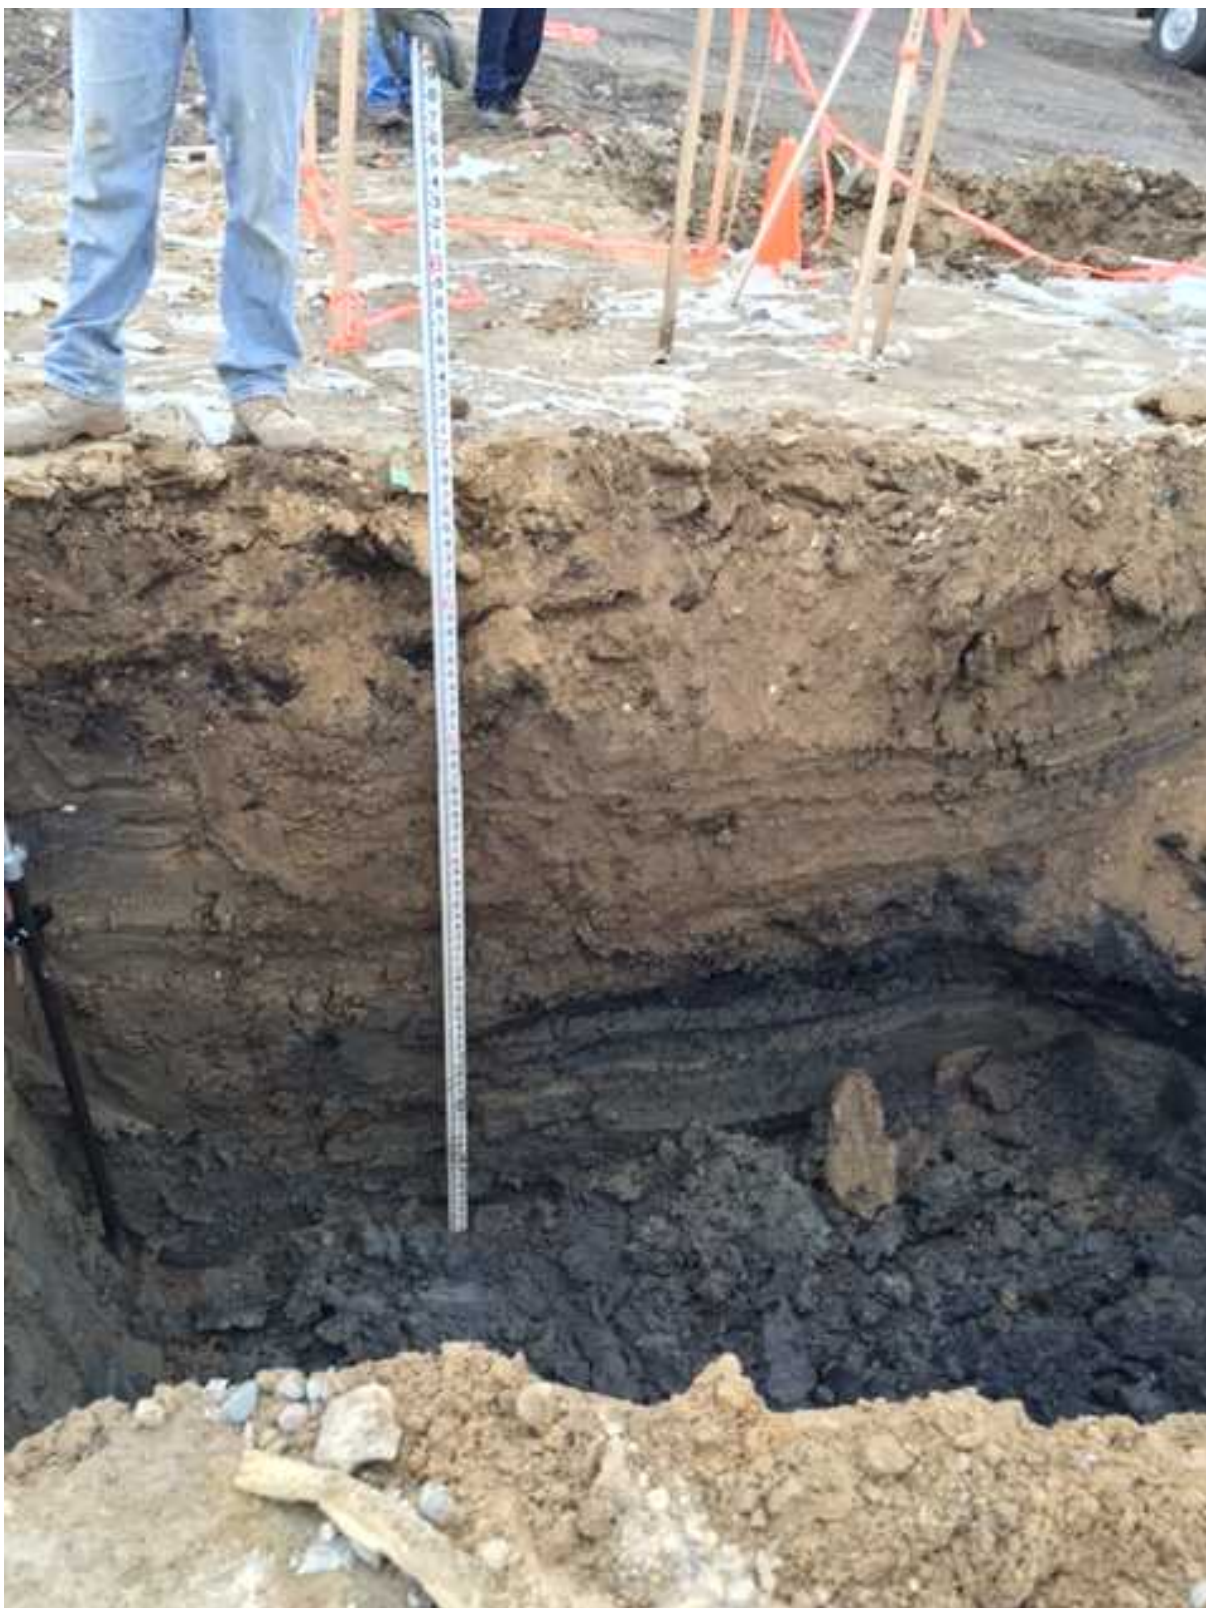
Excavation A facing North sidewall

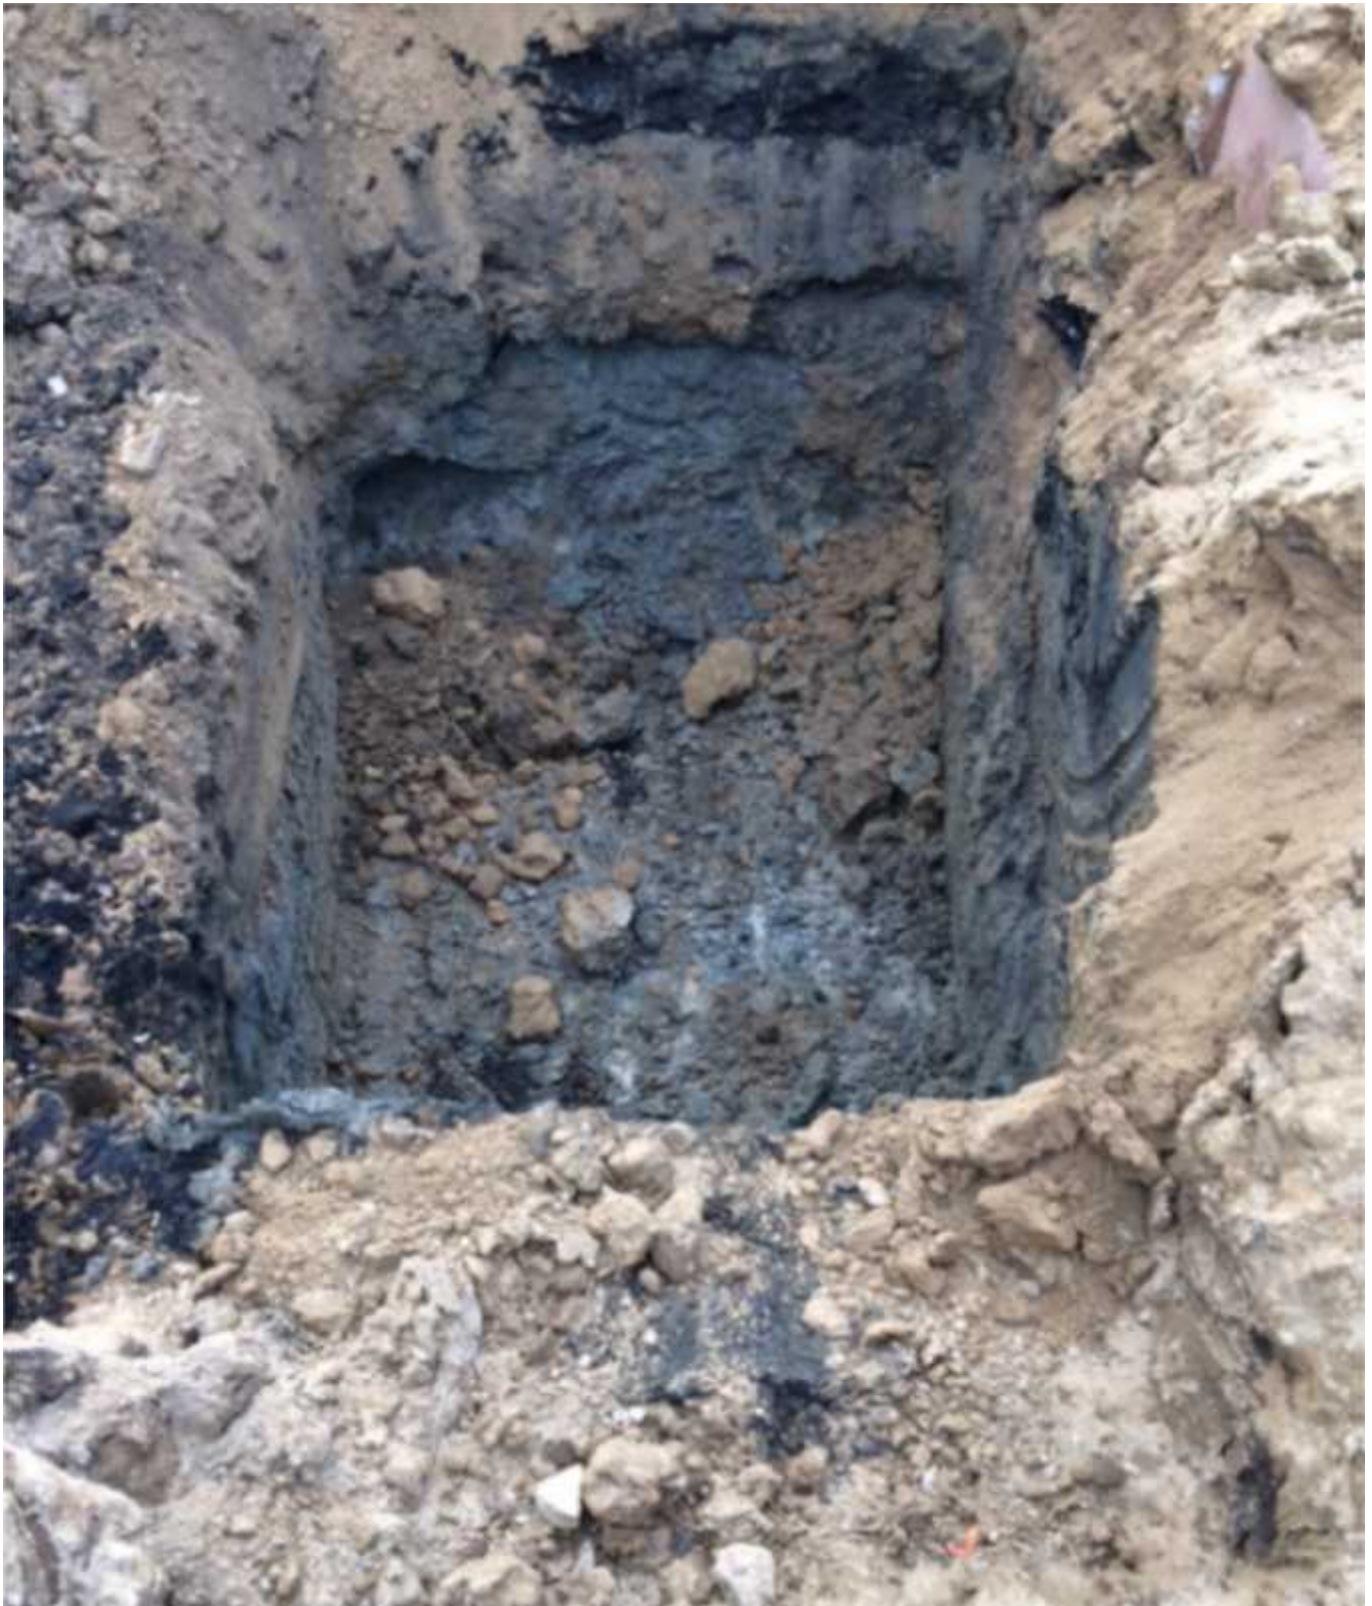
Excavation B facing East sidewall

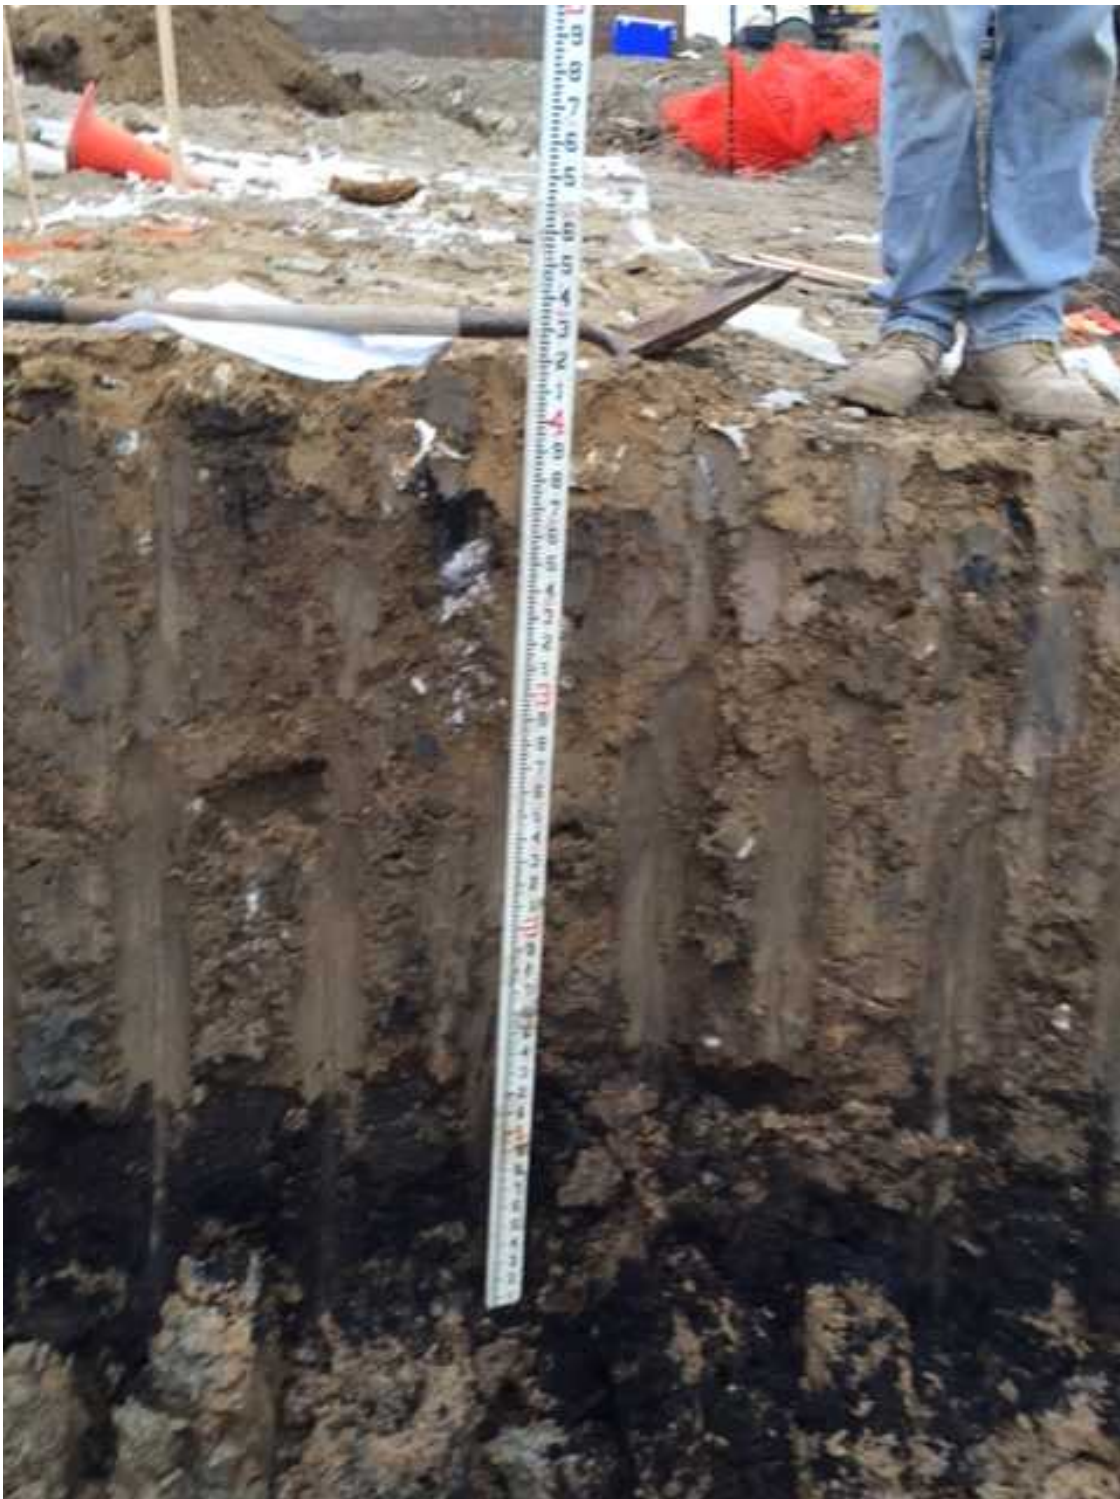
- ) Field test kits (to 50 PPM) were used to verify the northern, southern, eastern and western sides of excavation E.
- ) All field tests kits were negative (<50 PPM) except the eastern sidewall of excavation C.

Excavation C facing east sidewall at 0 foot over excavation

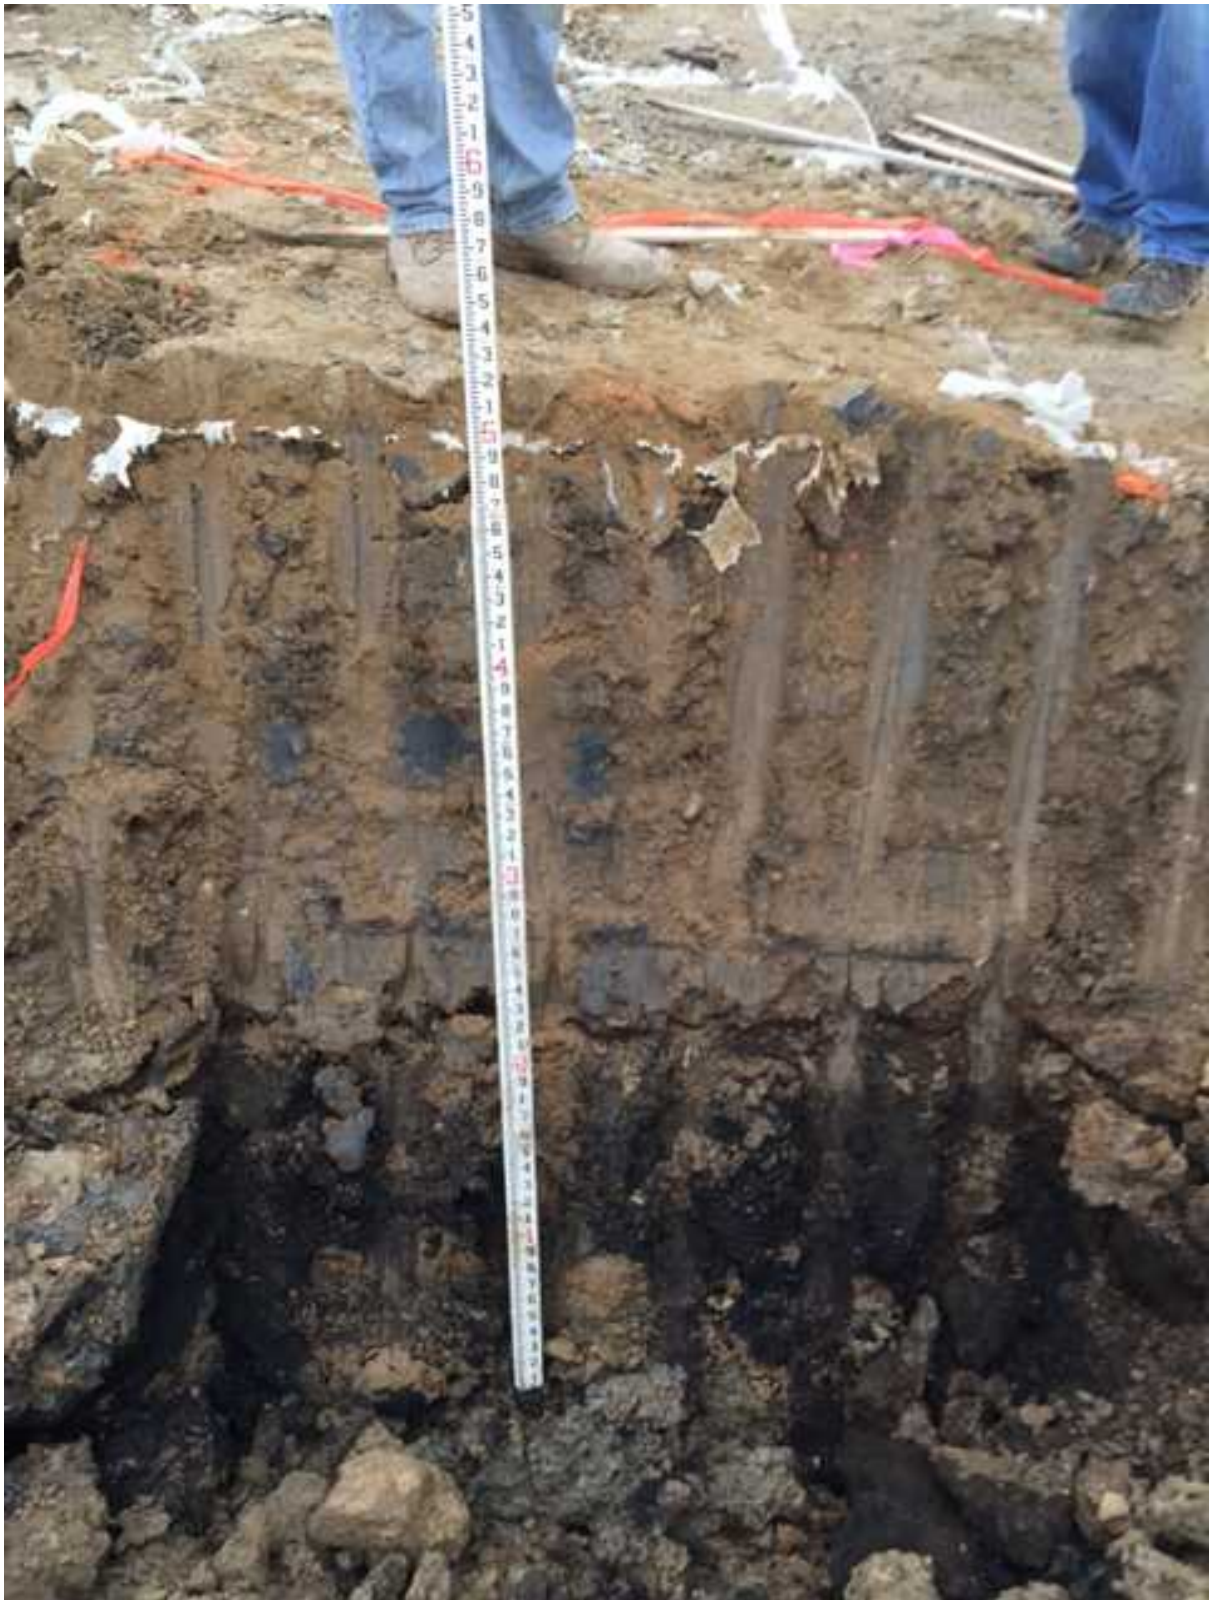
Excavation C facing east sidewall at 1.5 foot over excavation

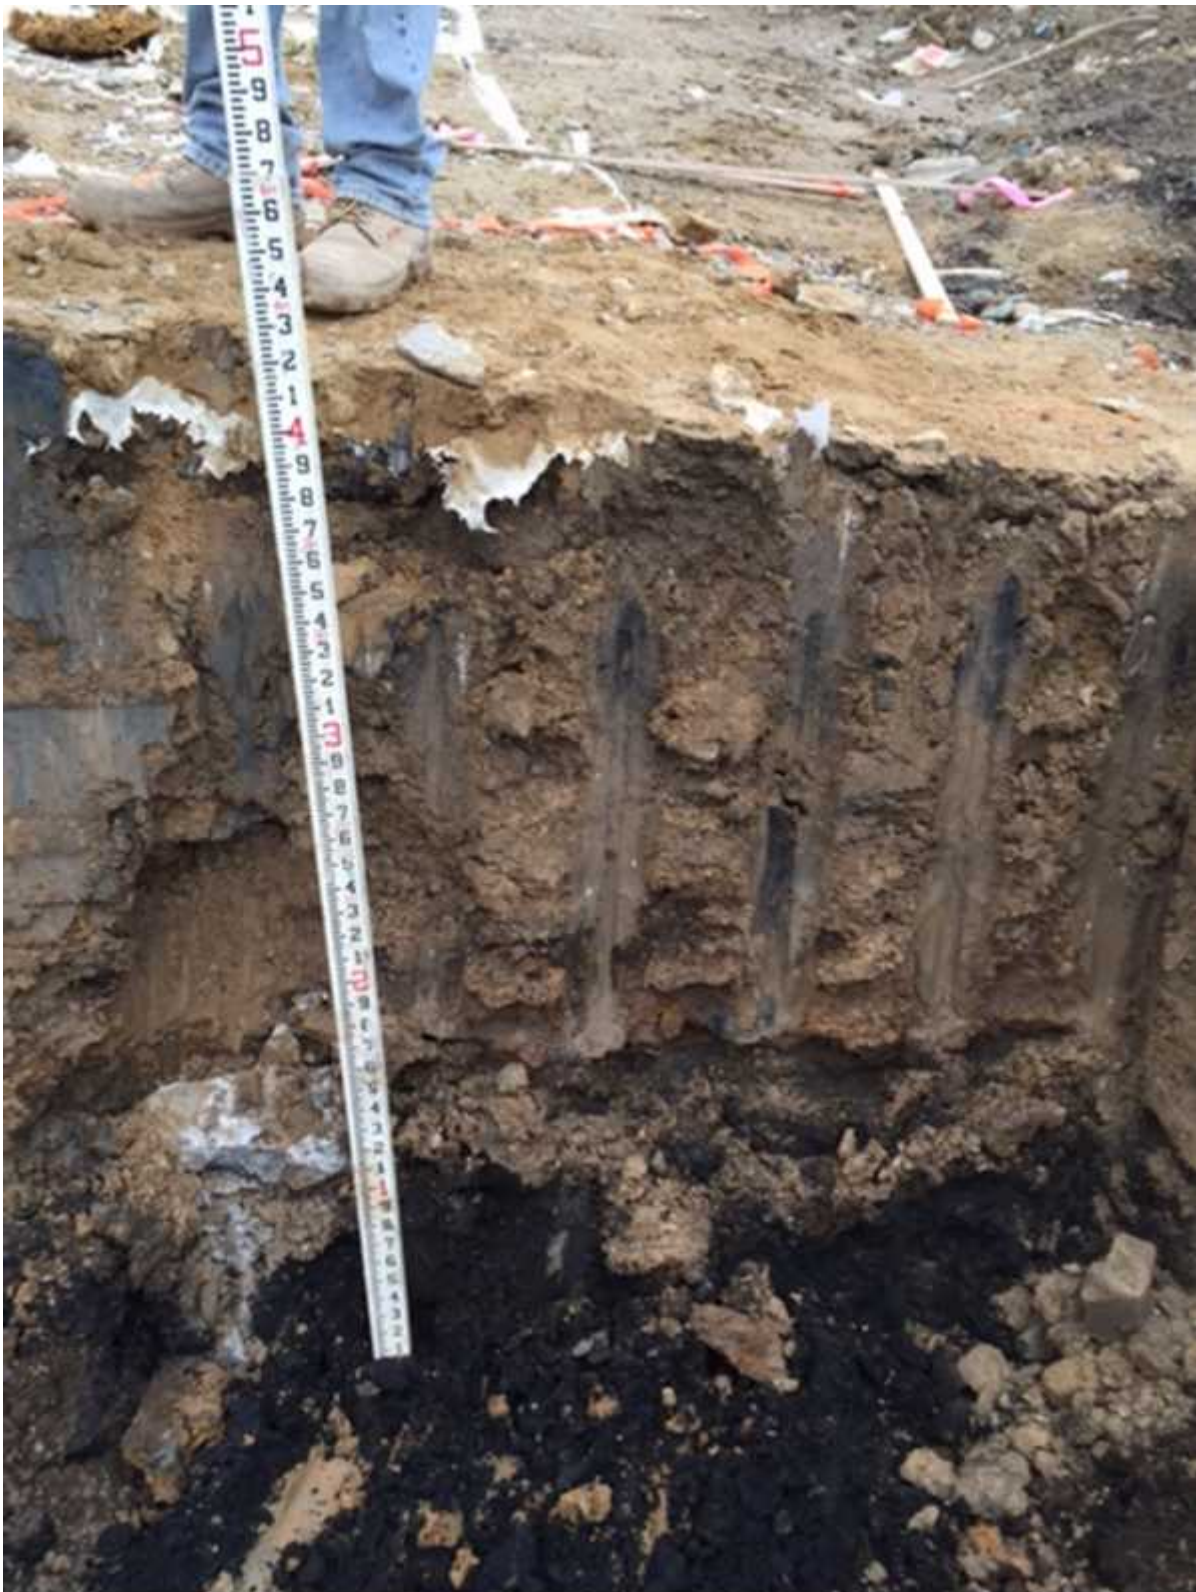
Excavation C facing east sidewall at 3.5 foot over excavation

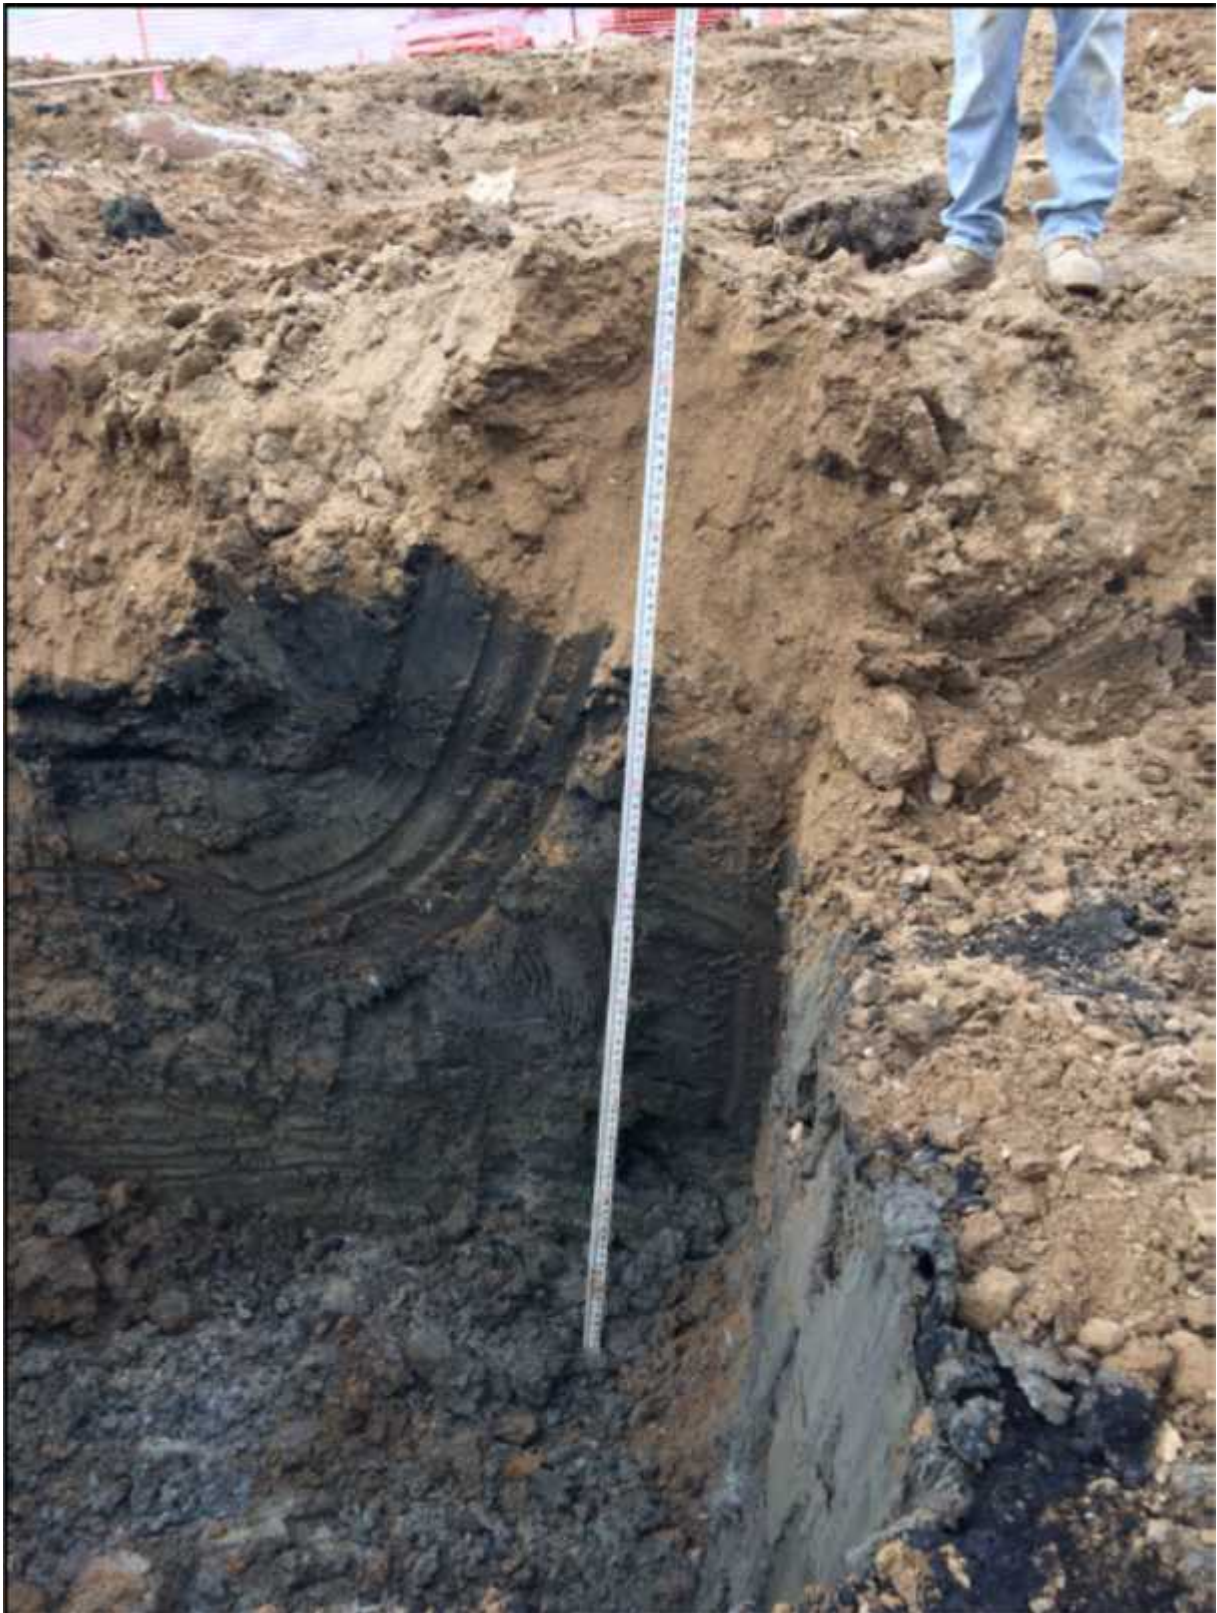
Excavation D facing Northeast corner

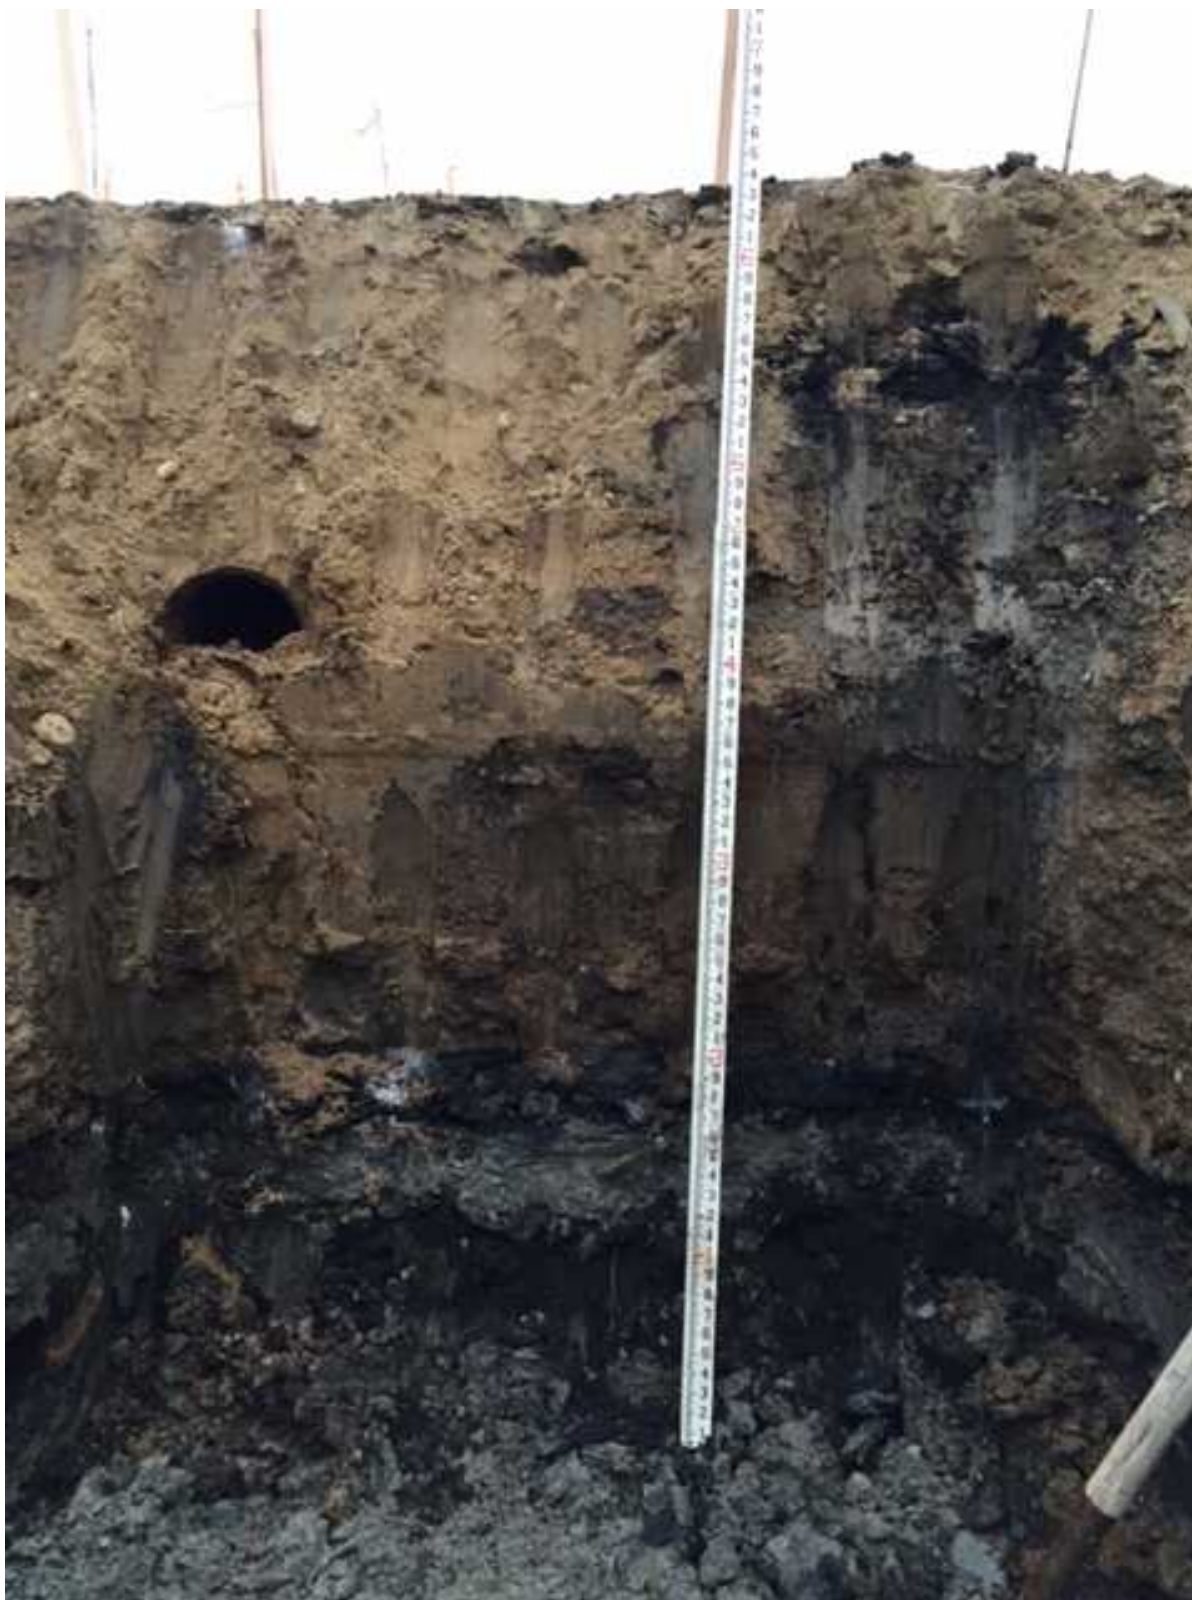
Excavation E facing West sidewall

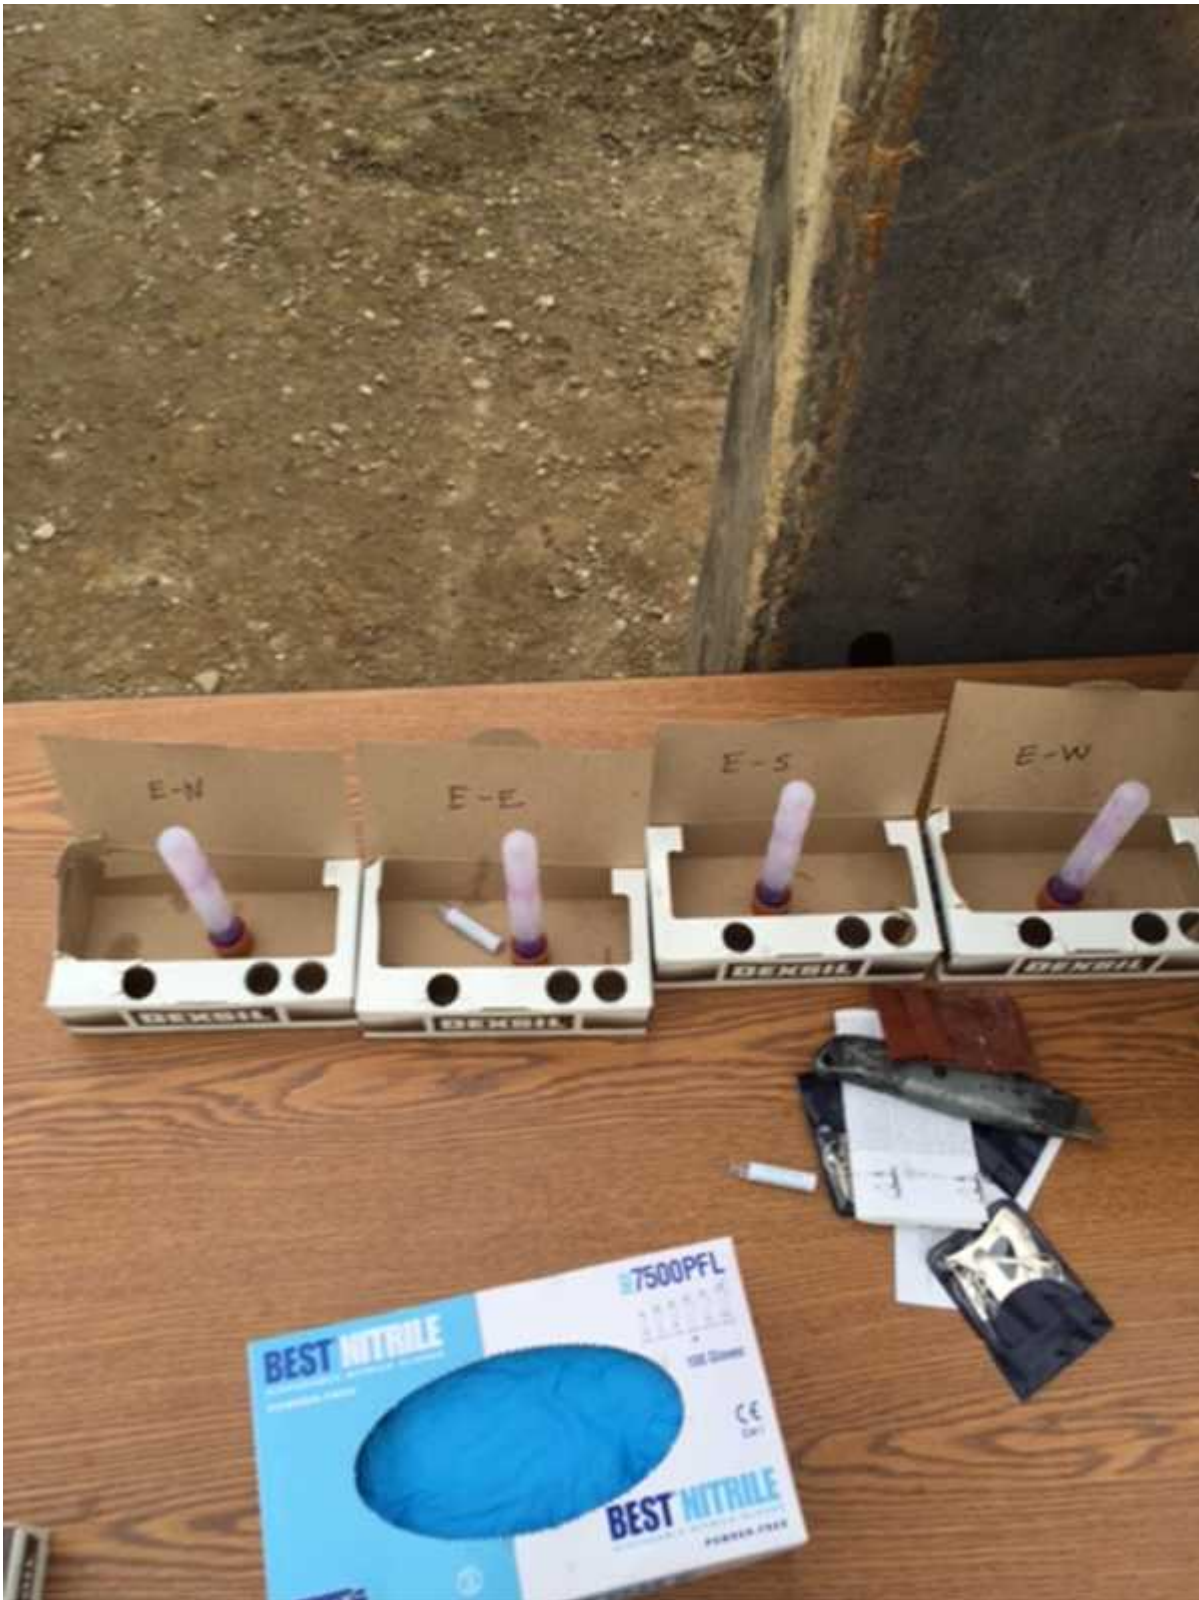
Field test kit results for excavation E – North, South, East and West sidewalls

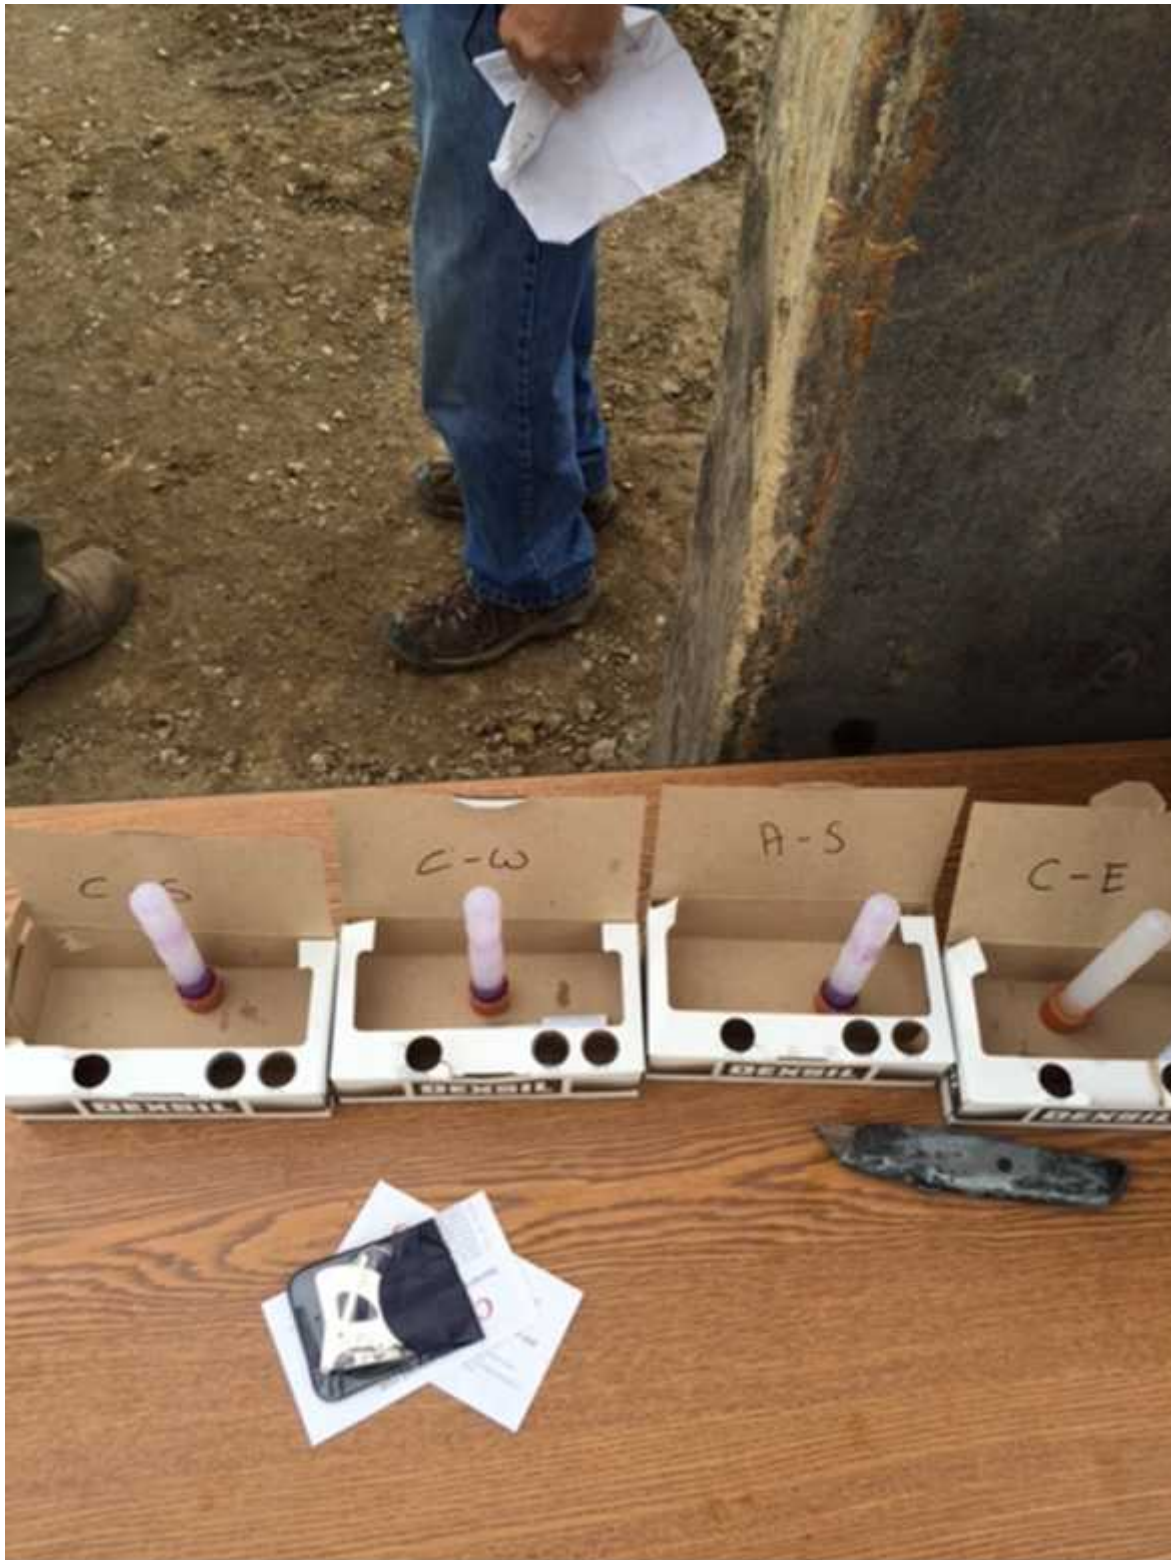
Field test kit results for excavation C – South, East (0 foot over excavation) and West sidewalls & Excavation E – South Sidewall
