## Memorandum

**Re: PCB Excavation**

GHD Services Inc. (GHD) is providing this summary on behalf of Revitalizing Auto Communities Environmental Response (RACER) Trust of the excavation of PCB impacted soil located in the southern portion of the Site at the former PCC-Validation (Site) facility located in Pontiac, Michigan.

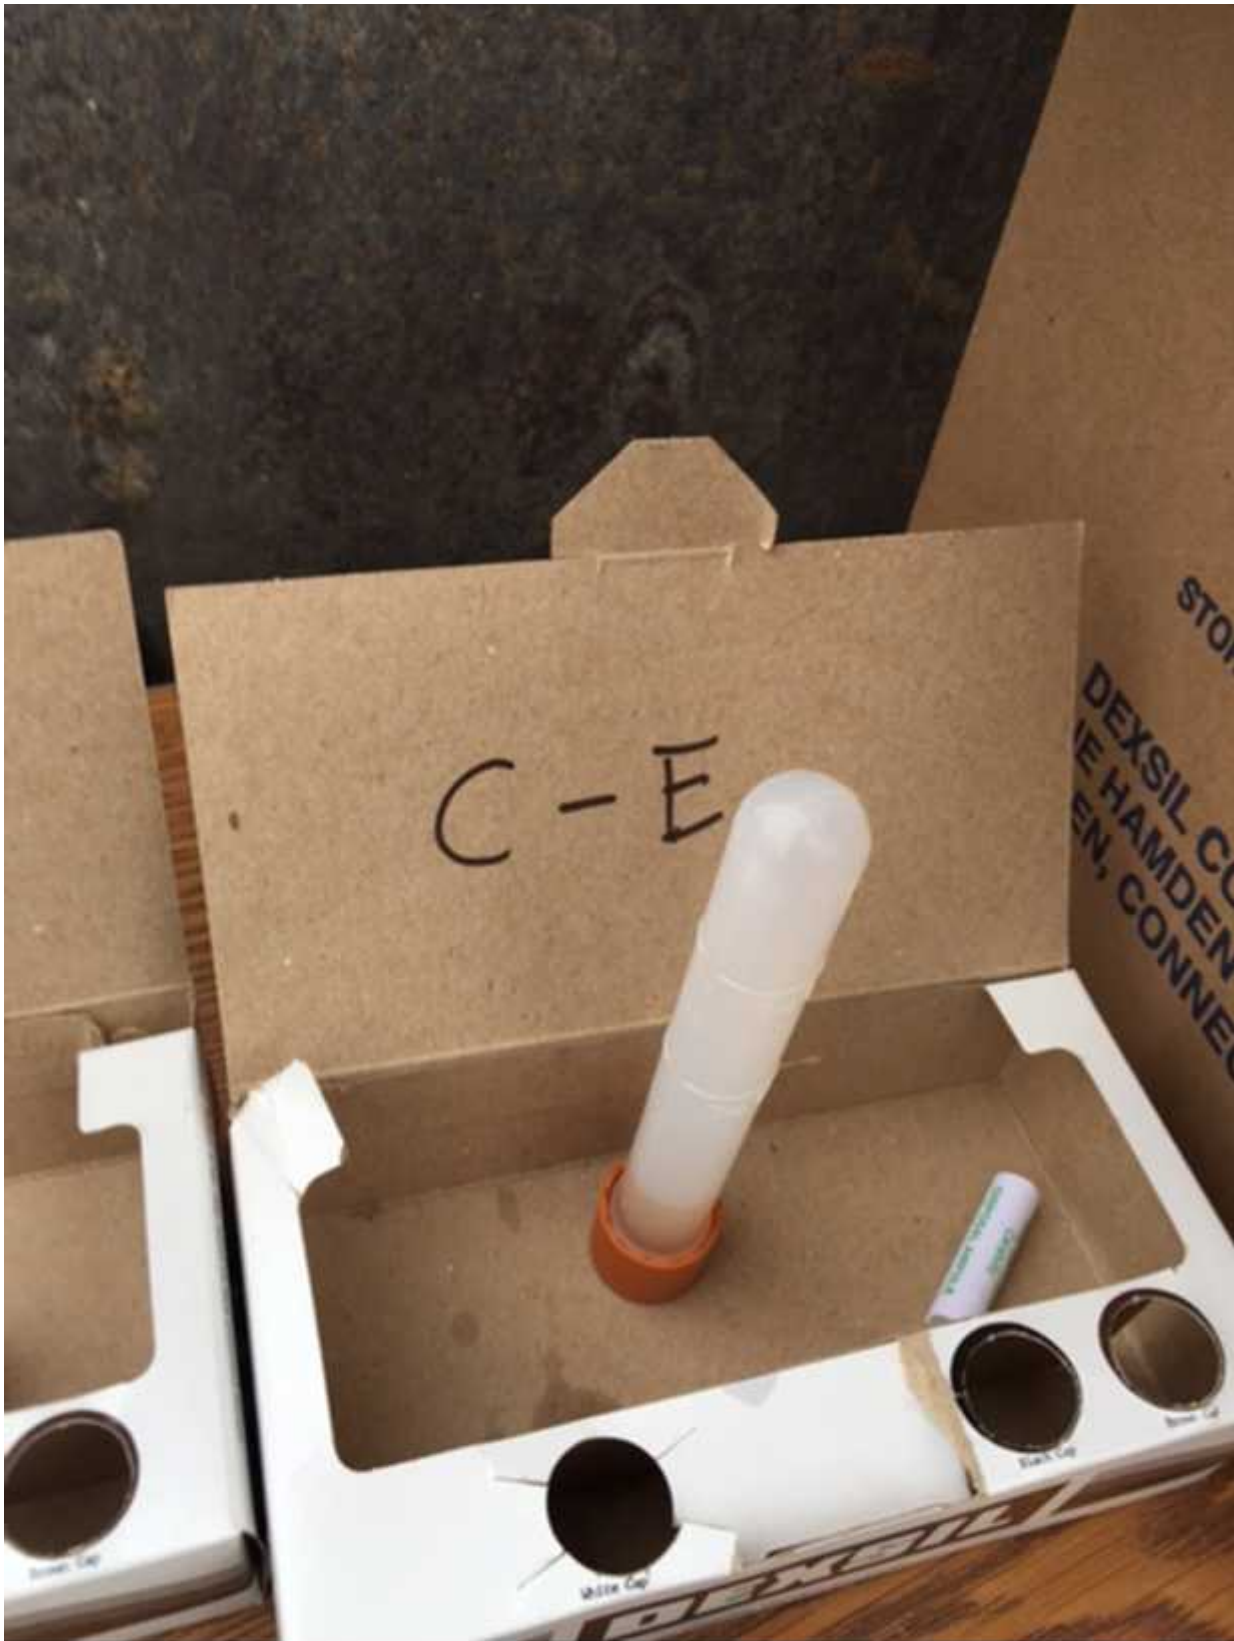
| Sample ID<br>(For Lab Analysis) | Location<br>Description | Soil Boring and Depth<br>Historic PCB Impacts<br>Encountered (Ft BGS) | Depth Soil Sample Collected<br>for Test Kit/Laboratory<br>Analysis (Ft BGS) | Field Test<br>Kit Results | PCB Lab<br>Analytical Results<br>(PPM) | | Notes |
|---|---|---|---|---|---|--|---|
| NA | East Sidewall | BH116-15 (2-4) | (2-4) | >50 PPM*** | NA | | |

(Close-up photo) Field test kit results for excavation C – East 0 feet over excavated sidewall

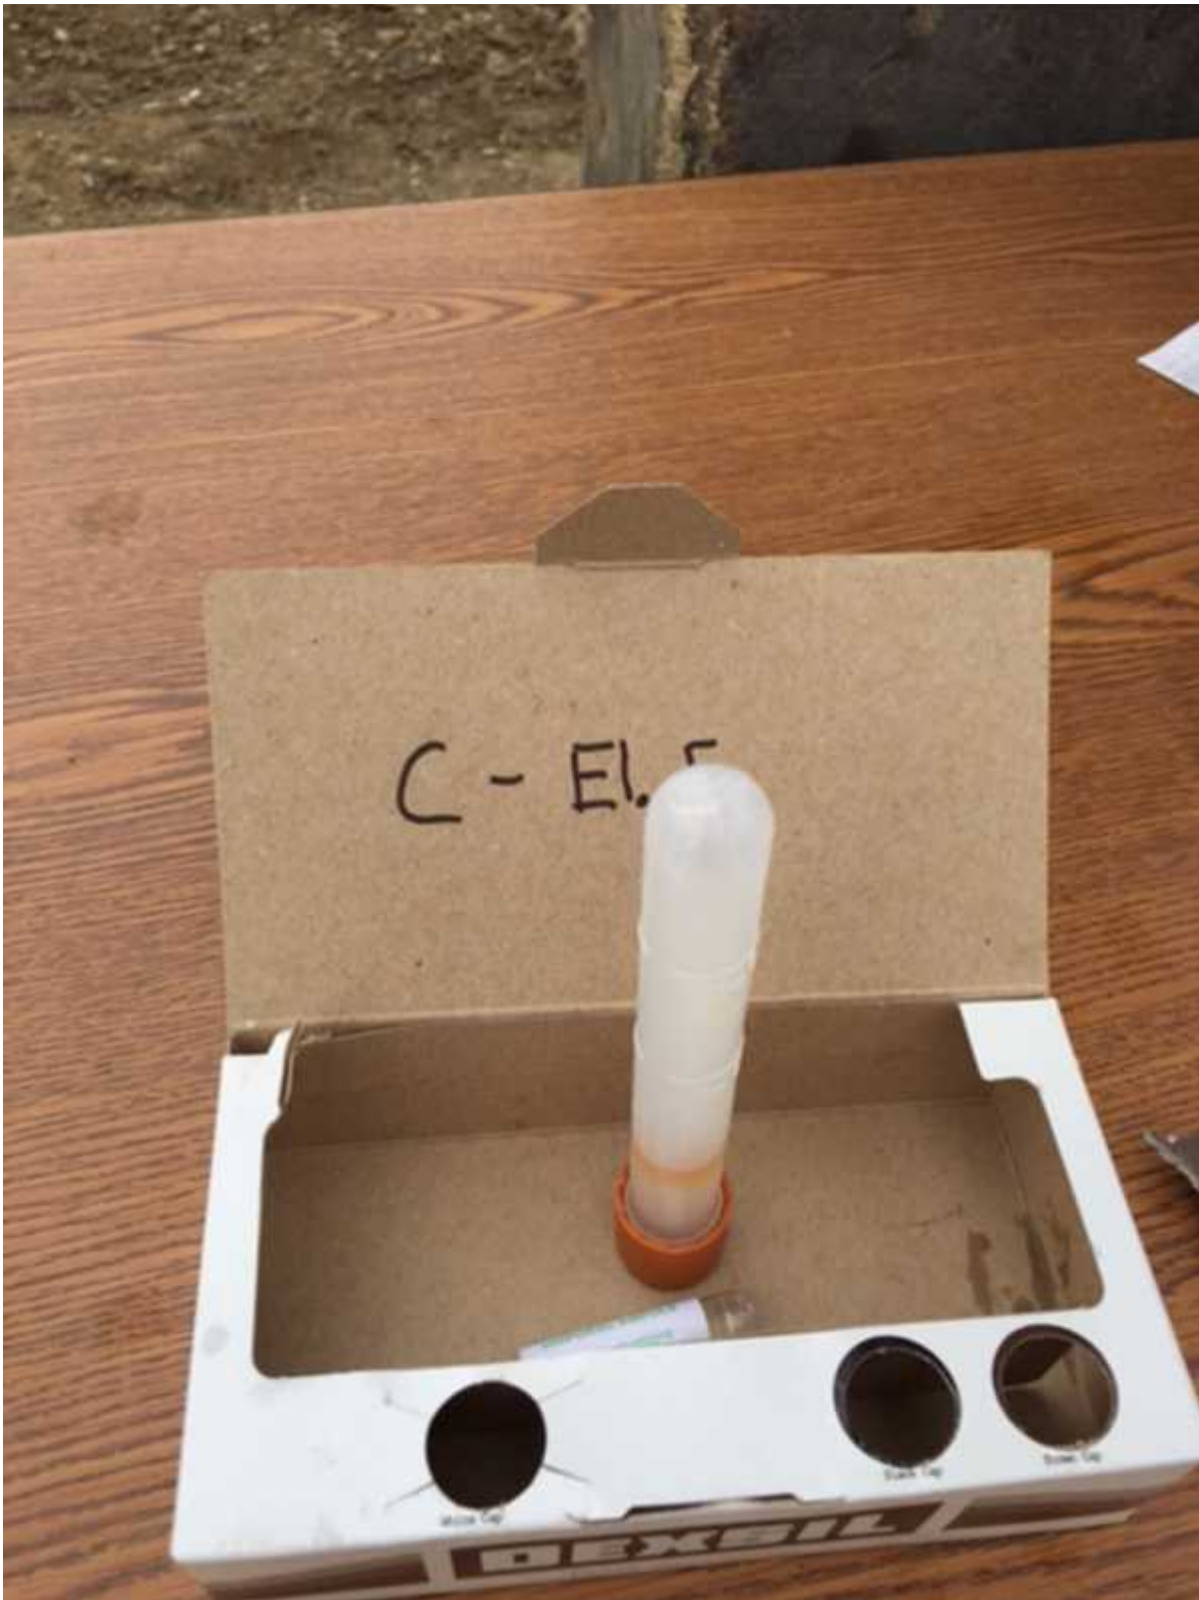
| Sample ID<br>(For Lab Analysis) | Location<br>Description | Soil Boring and Depth<br>Historic PCB Impacts<br>Encountered (Ft BGS) | Depth Soil Sample Collected<br>for Test Kit/Laboratory<br>Analysis (Ft BGS) | Field Test<br>Kit Results | PCB Lab<br>Analytical Results<br>(PPM) | | Notes |
|---|---|---|---|---|---|--|---|
| NA | East Sidewall + 1.5* | BH116-15 (2-4) | (2-4) | >50 PPM*** | NA | | |

Field test kit results for excavation C – East 1.5 feet over excavated sidewall

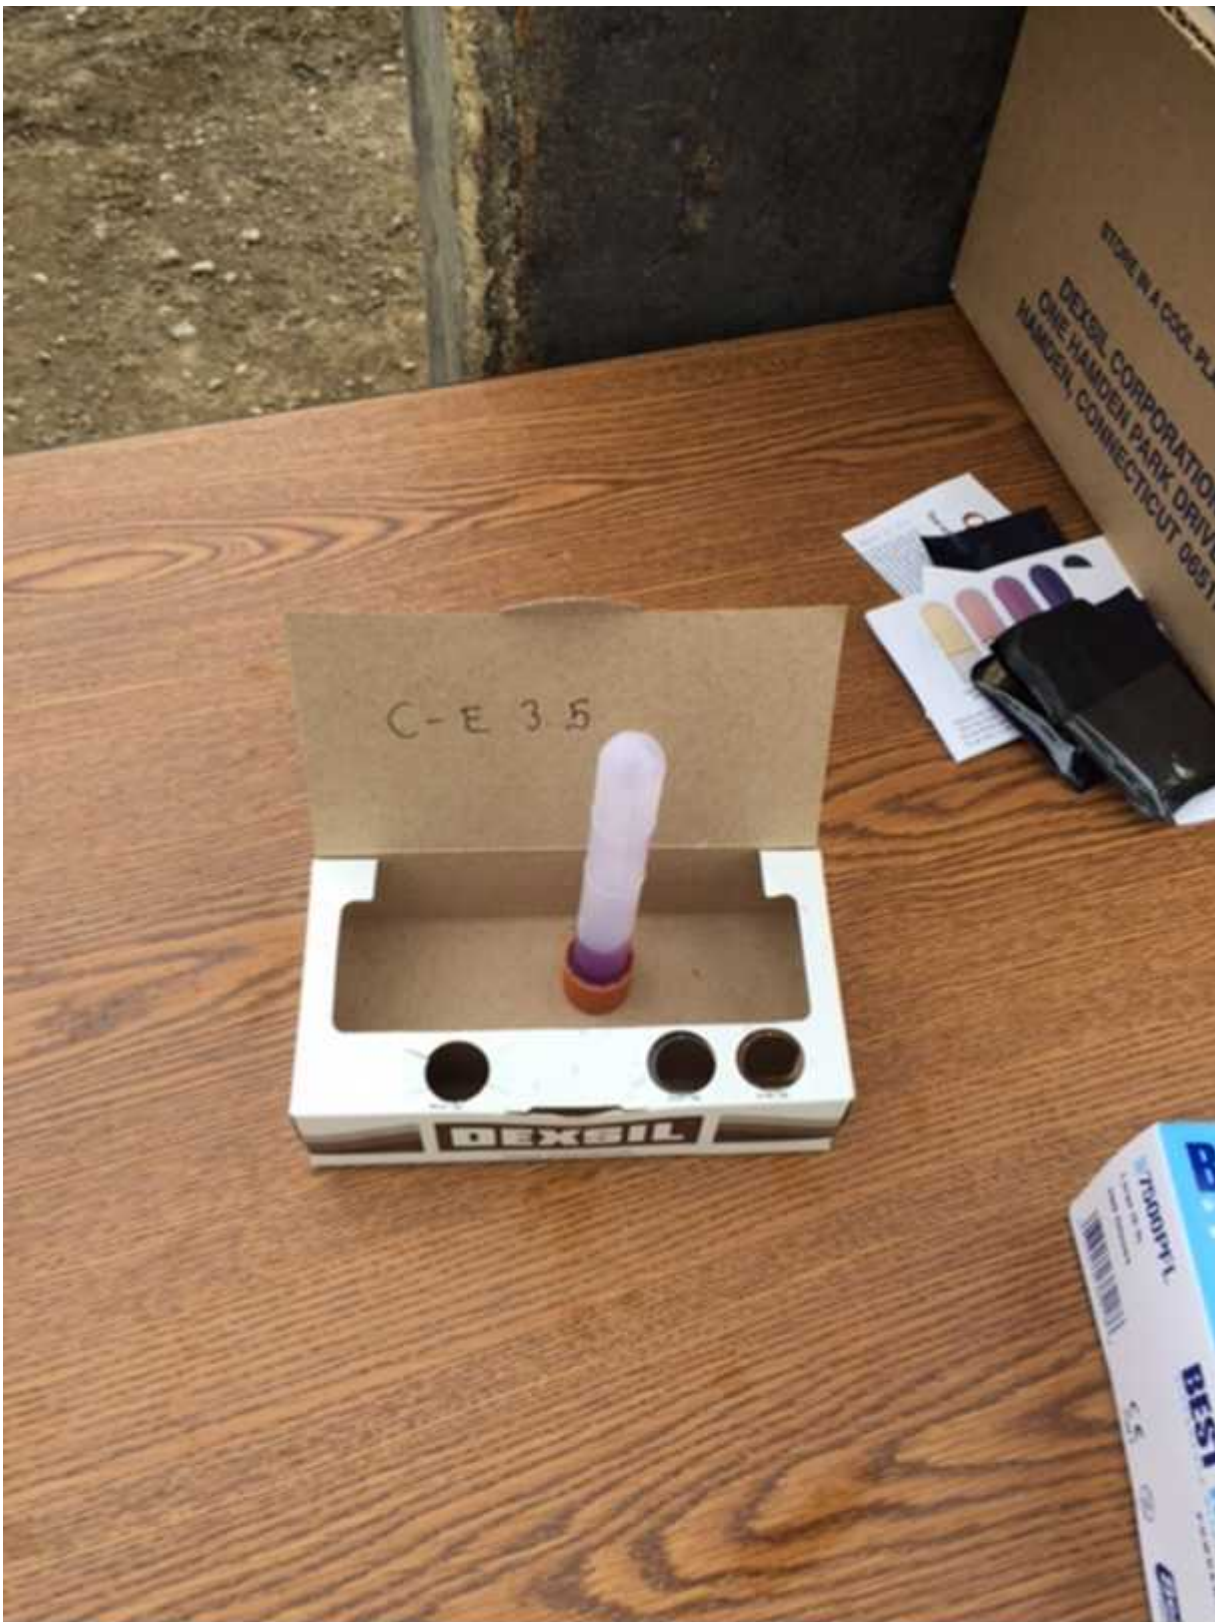
| Sample ID<br>(For Lab Analysis) | Location<br>Description | Soil Boring and Depth<br>Historic PCB Impacts<br>Encountered (Ft BGS) | Depth Soil Sample Collected<br>for Test Kit/Laboratory<br>Analysis (Ft BGS) | Field Test<br>Kit Results | PCB Lab<br>Analytical Results<br>(PPM) | | Notes |
|---|---|---|---|---|---|--|---|
| SO-17322-100915-MC-009 | East Sidewall +3.5** | BH116-15 (2-4) | (2-4) | <50 PPM | 0.081 | | |

Field test kit results for excavation C – East 3.5 feet over excavated sidewall
