2016 ANNUAL REPORT – FINAL REPORT

**Landfill Inspection Report
Coldwater Road Landfill
Flint, Michigan
MID 005 356 860**

**RACER TRUST
Detroit, Michigan**

February 2017

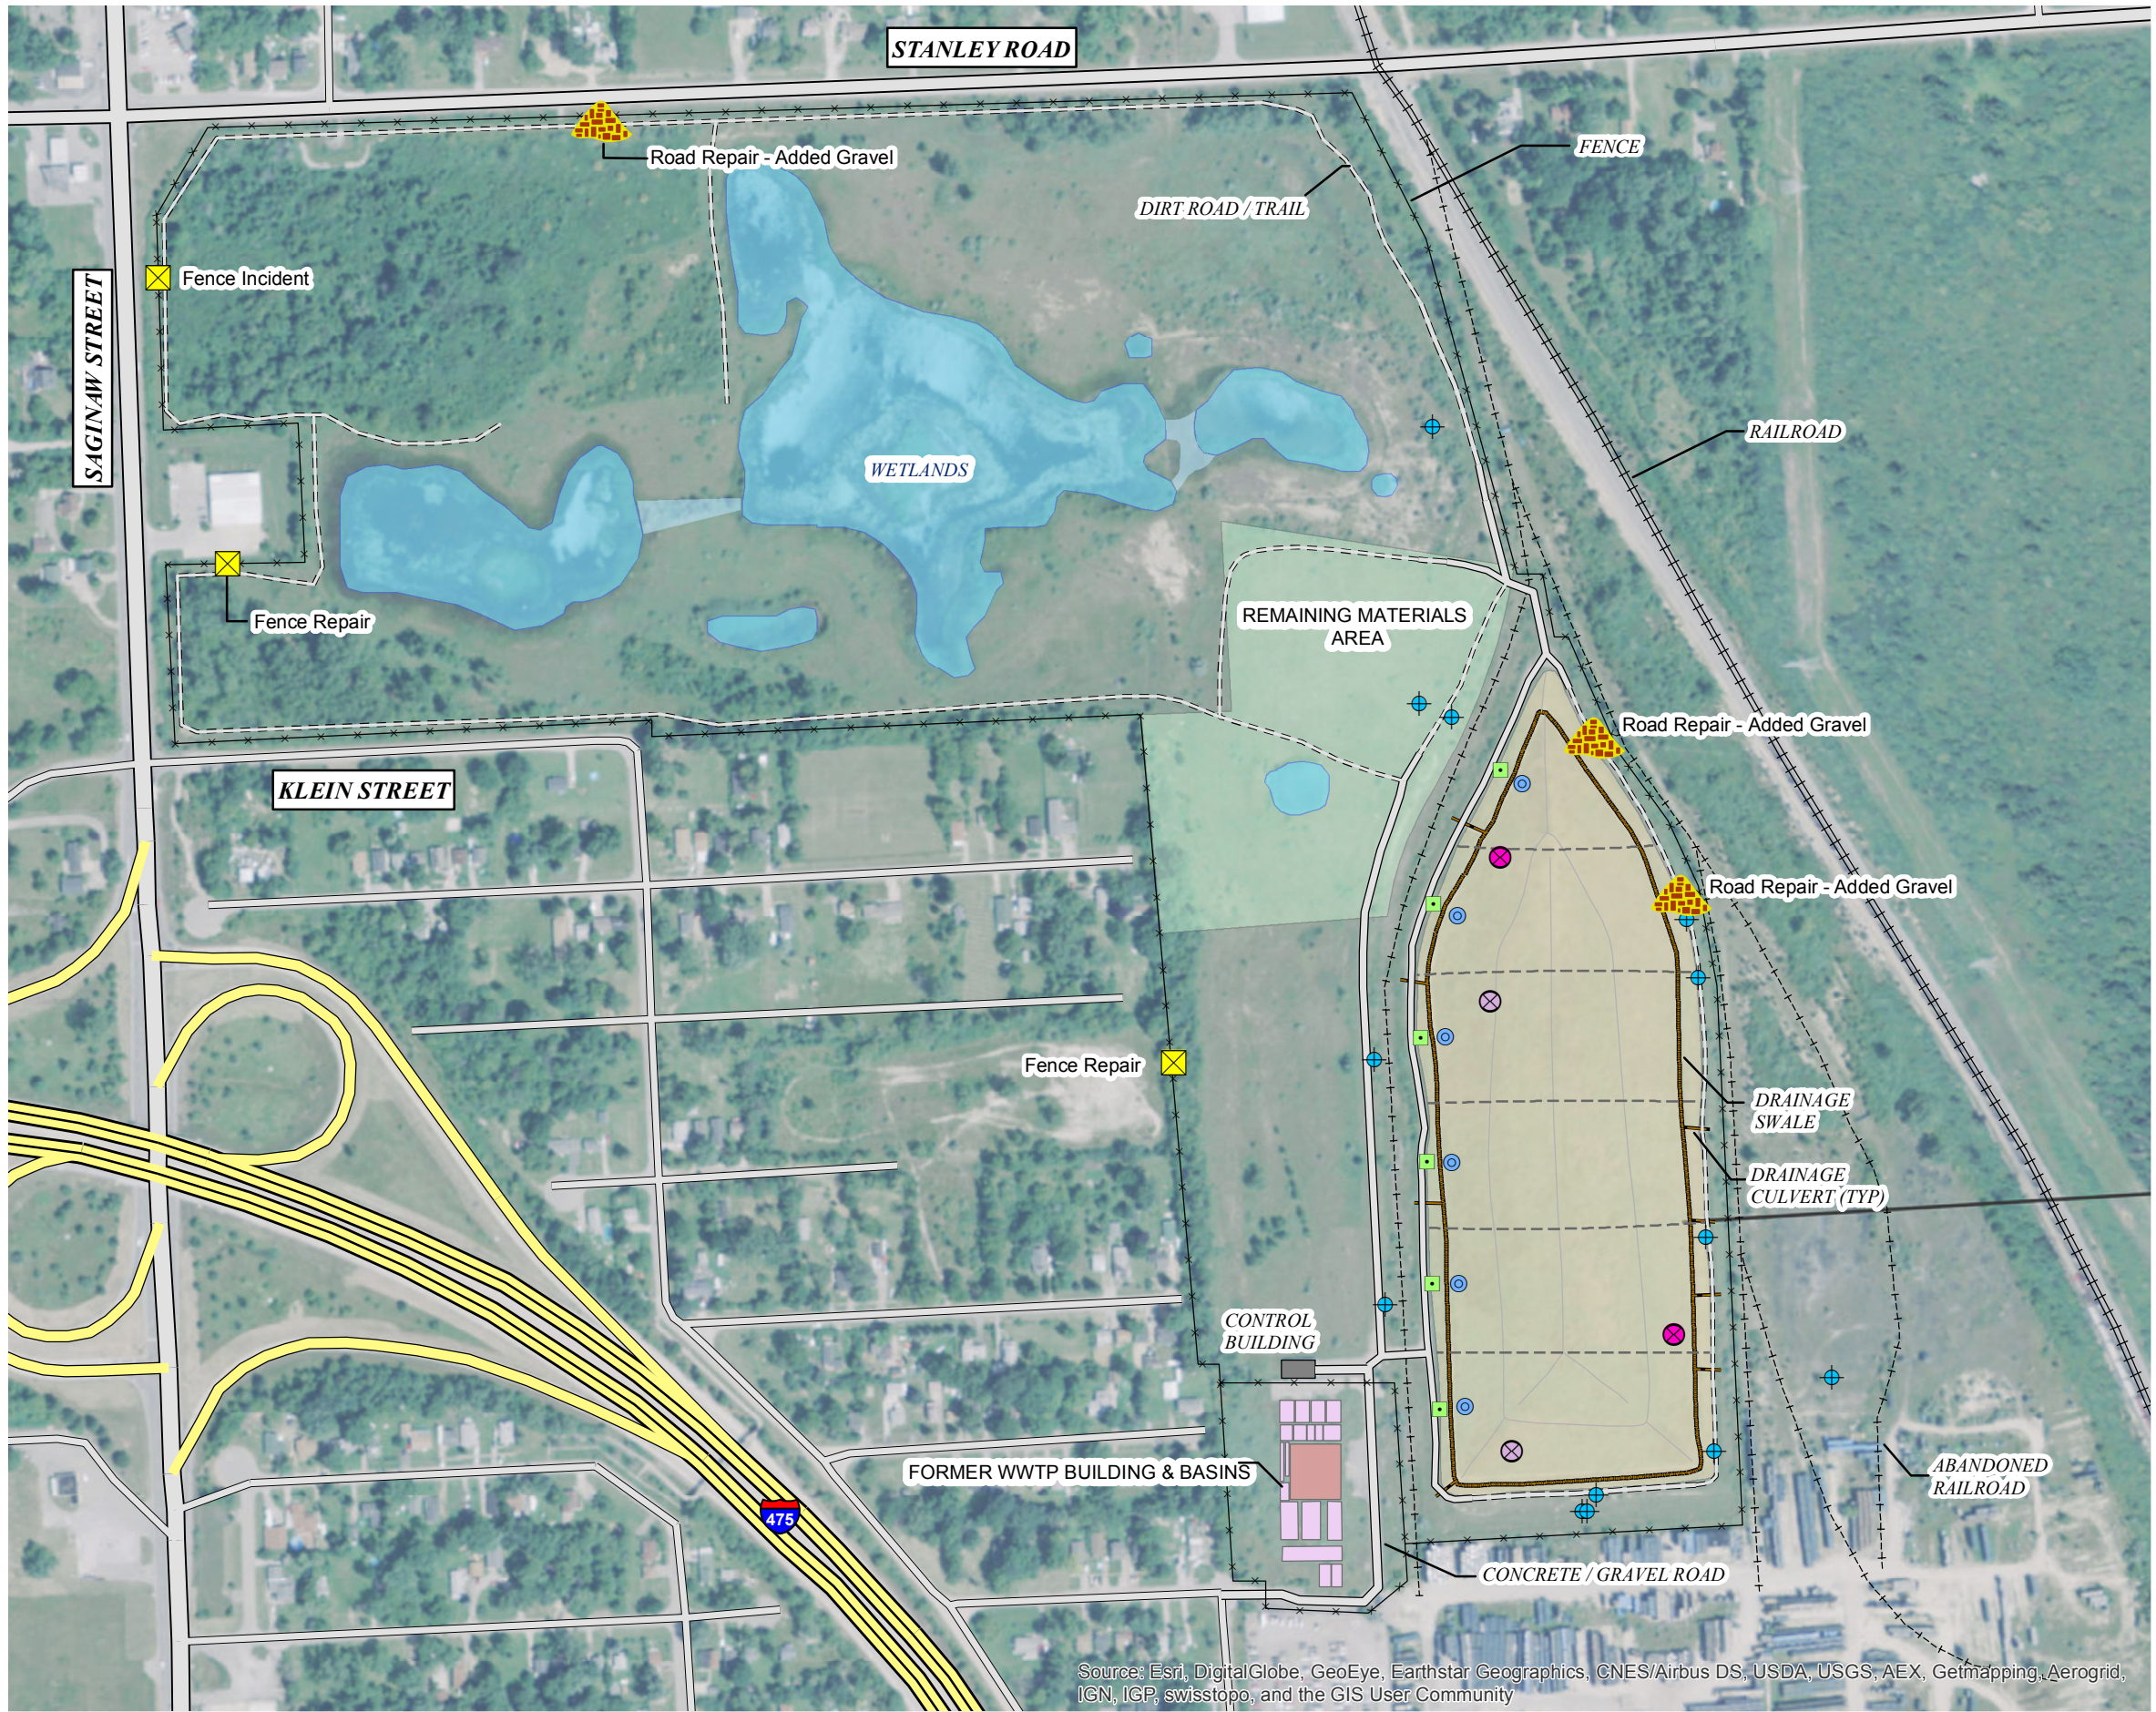
**2016
INCIDENT LOCATION
MAP**

Four animal burrows were identified and closed throughout the year. The animal burrows were photographically documented (before and after repair), and the approximate size and configuration of the burrows were documented and included in the Quarterly Status Reports.

Damage to the site perimeter fence was noted at three locations during the 3rd and 4th quarterly inspections. During the 3rd quarter inspection, one hole was observed along the west perimeter fence near the Dollar General and an approximately 40-foot section of fence was knocked down along the west perimeter fence on Saginaw Road. During the 4th quarter inspection, one previously repaired hole was reopened along the west perimeter fence.

Traps were set at the opening of each of the animal burrows. Animals were either trapped or the burrow was deemed inactive and filled in. The burrows were filled using methods approved by the Michigan Department of Environmental Quality (MDEQ). Animal burrows located during the quarterly inspections are noted on [Figure 3](#). A log of burrow activity throughout the year is maintained at the landfill. The log contains information on the date that a burrow was identified, response activities, and the date the burrow was filled and seeded.

The knocked down fence along Saginaw Road was propped back up by RACER maintenance during the fourth quarter 2016. The holes in the perimeter fence were repaired on January 11, 2017.

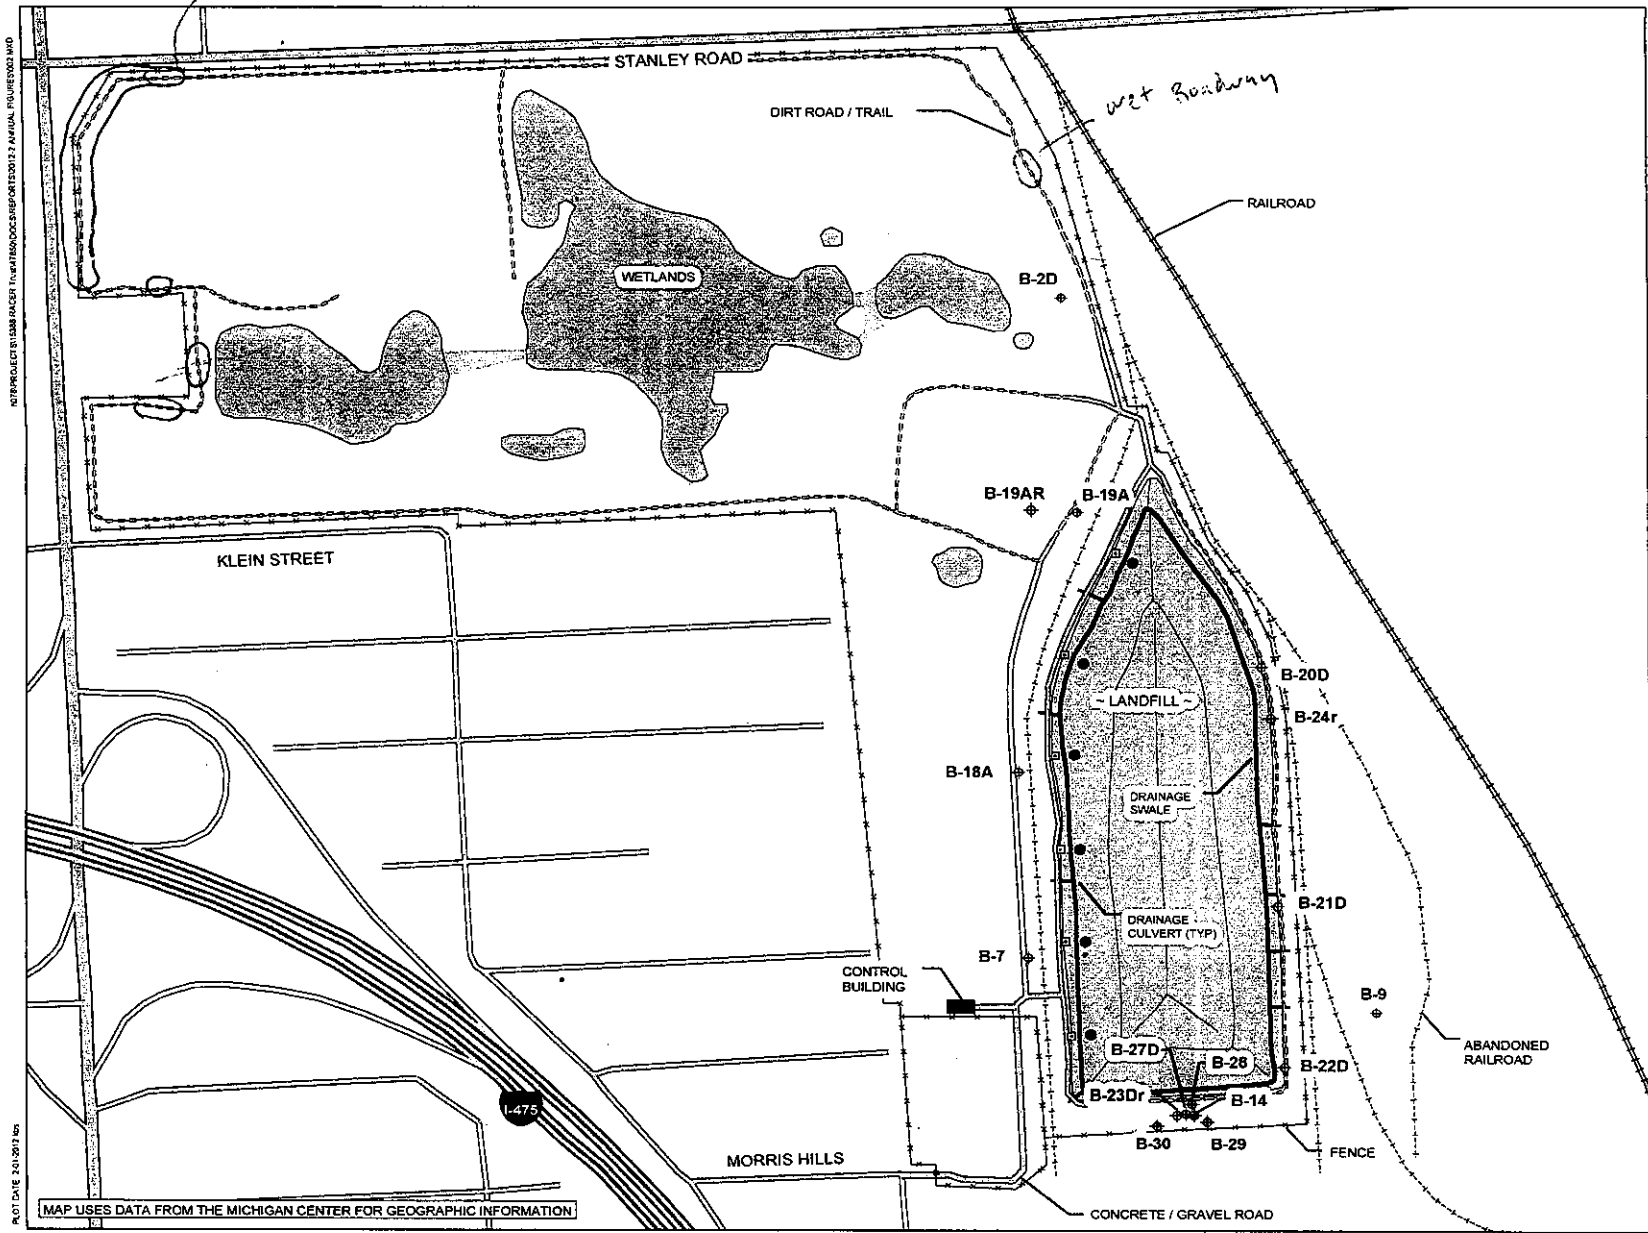
1st Qtr 2016

| Area of Inspection | Animal Burrows? | Soil Erosion | Slope Failures? | Ponding? | Washouts? | Liner damage or exposure? | If yes to any, describe issue, location, and actions taken | Date Corrected |
|---|---|---|---|---|---|---|--|---|
| Cell B | Note mounds B1 | No | No | No | No | No | | |
| Cell F | Note mounds and trails F3 | No | No | No | No | No | | |

| Area | Sufficient gravel present? | Proper drainage present? | If no, describe issue, and actions taken | Date Corrected |
|---|---|---|--|---|
| Roads located approx. west of landfill | yes | wet roadway | | |
| Roads located approx. north of wetlands | yes | wet roadway | | |
| Roads located approx. west of wetlands | yes | wet roadway | | |

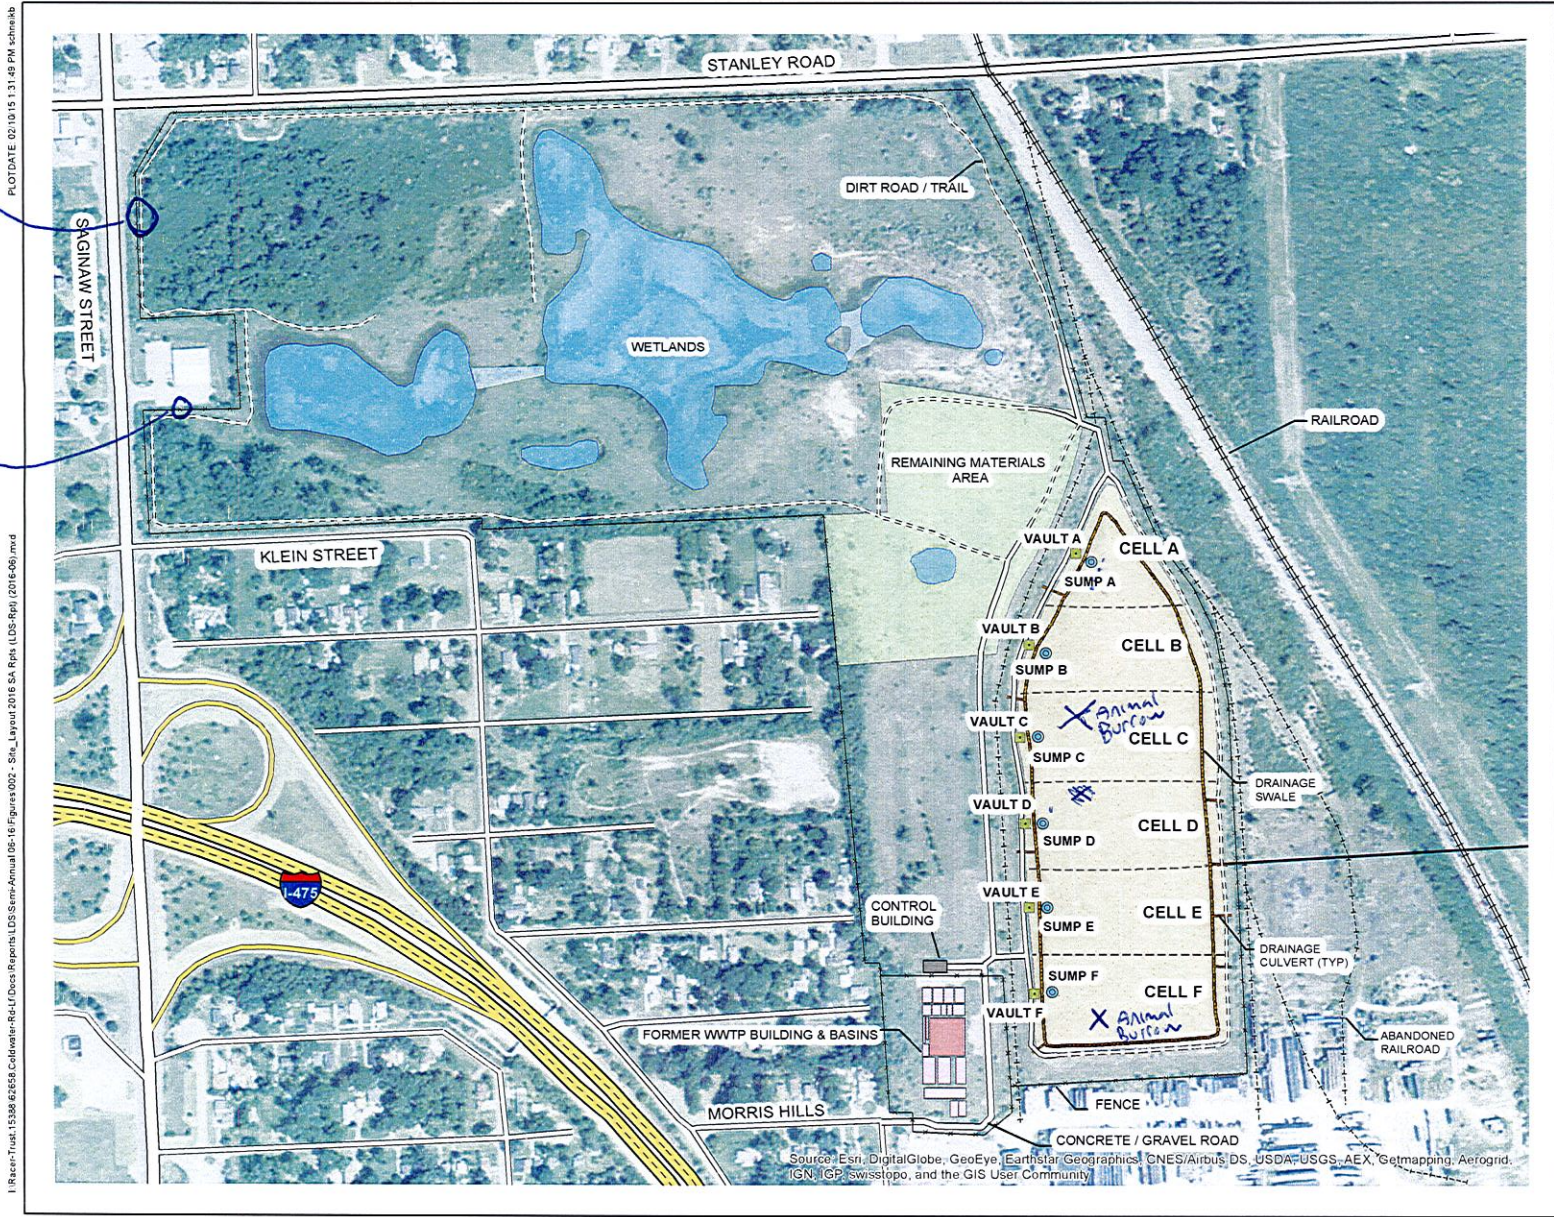
FIGURE 2

40' Fence
Hole in Fence
