**Landfill Inspection Report
Coldwater Road Landfill
Flint, Michigan
MID 005 356 860**

**RACER TRUST
Detroit, Michigan**

February 2018

RE: 2017 Annual Landfill Inspection Report
Coldwater Road Landfill, Flint, Michigan
MID 005 356 860
FILE: 15388 /64737/rep

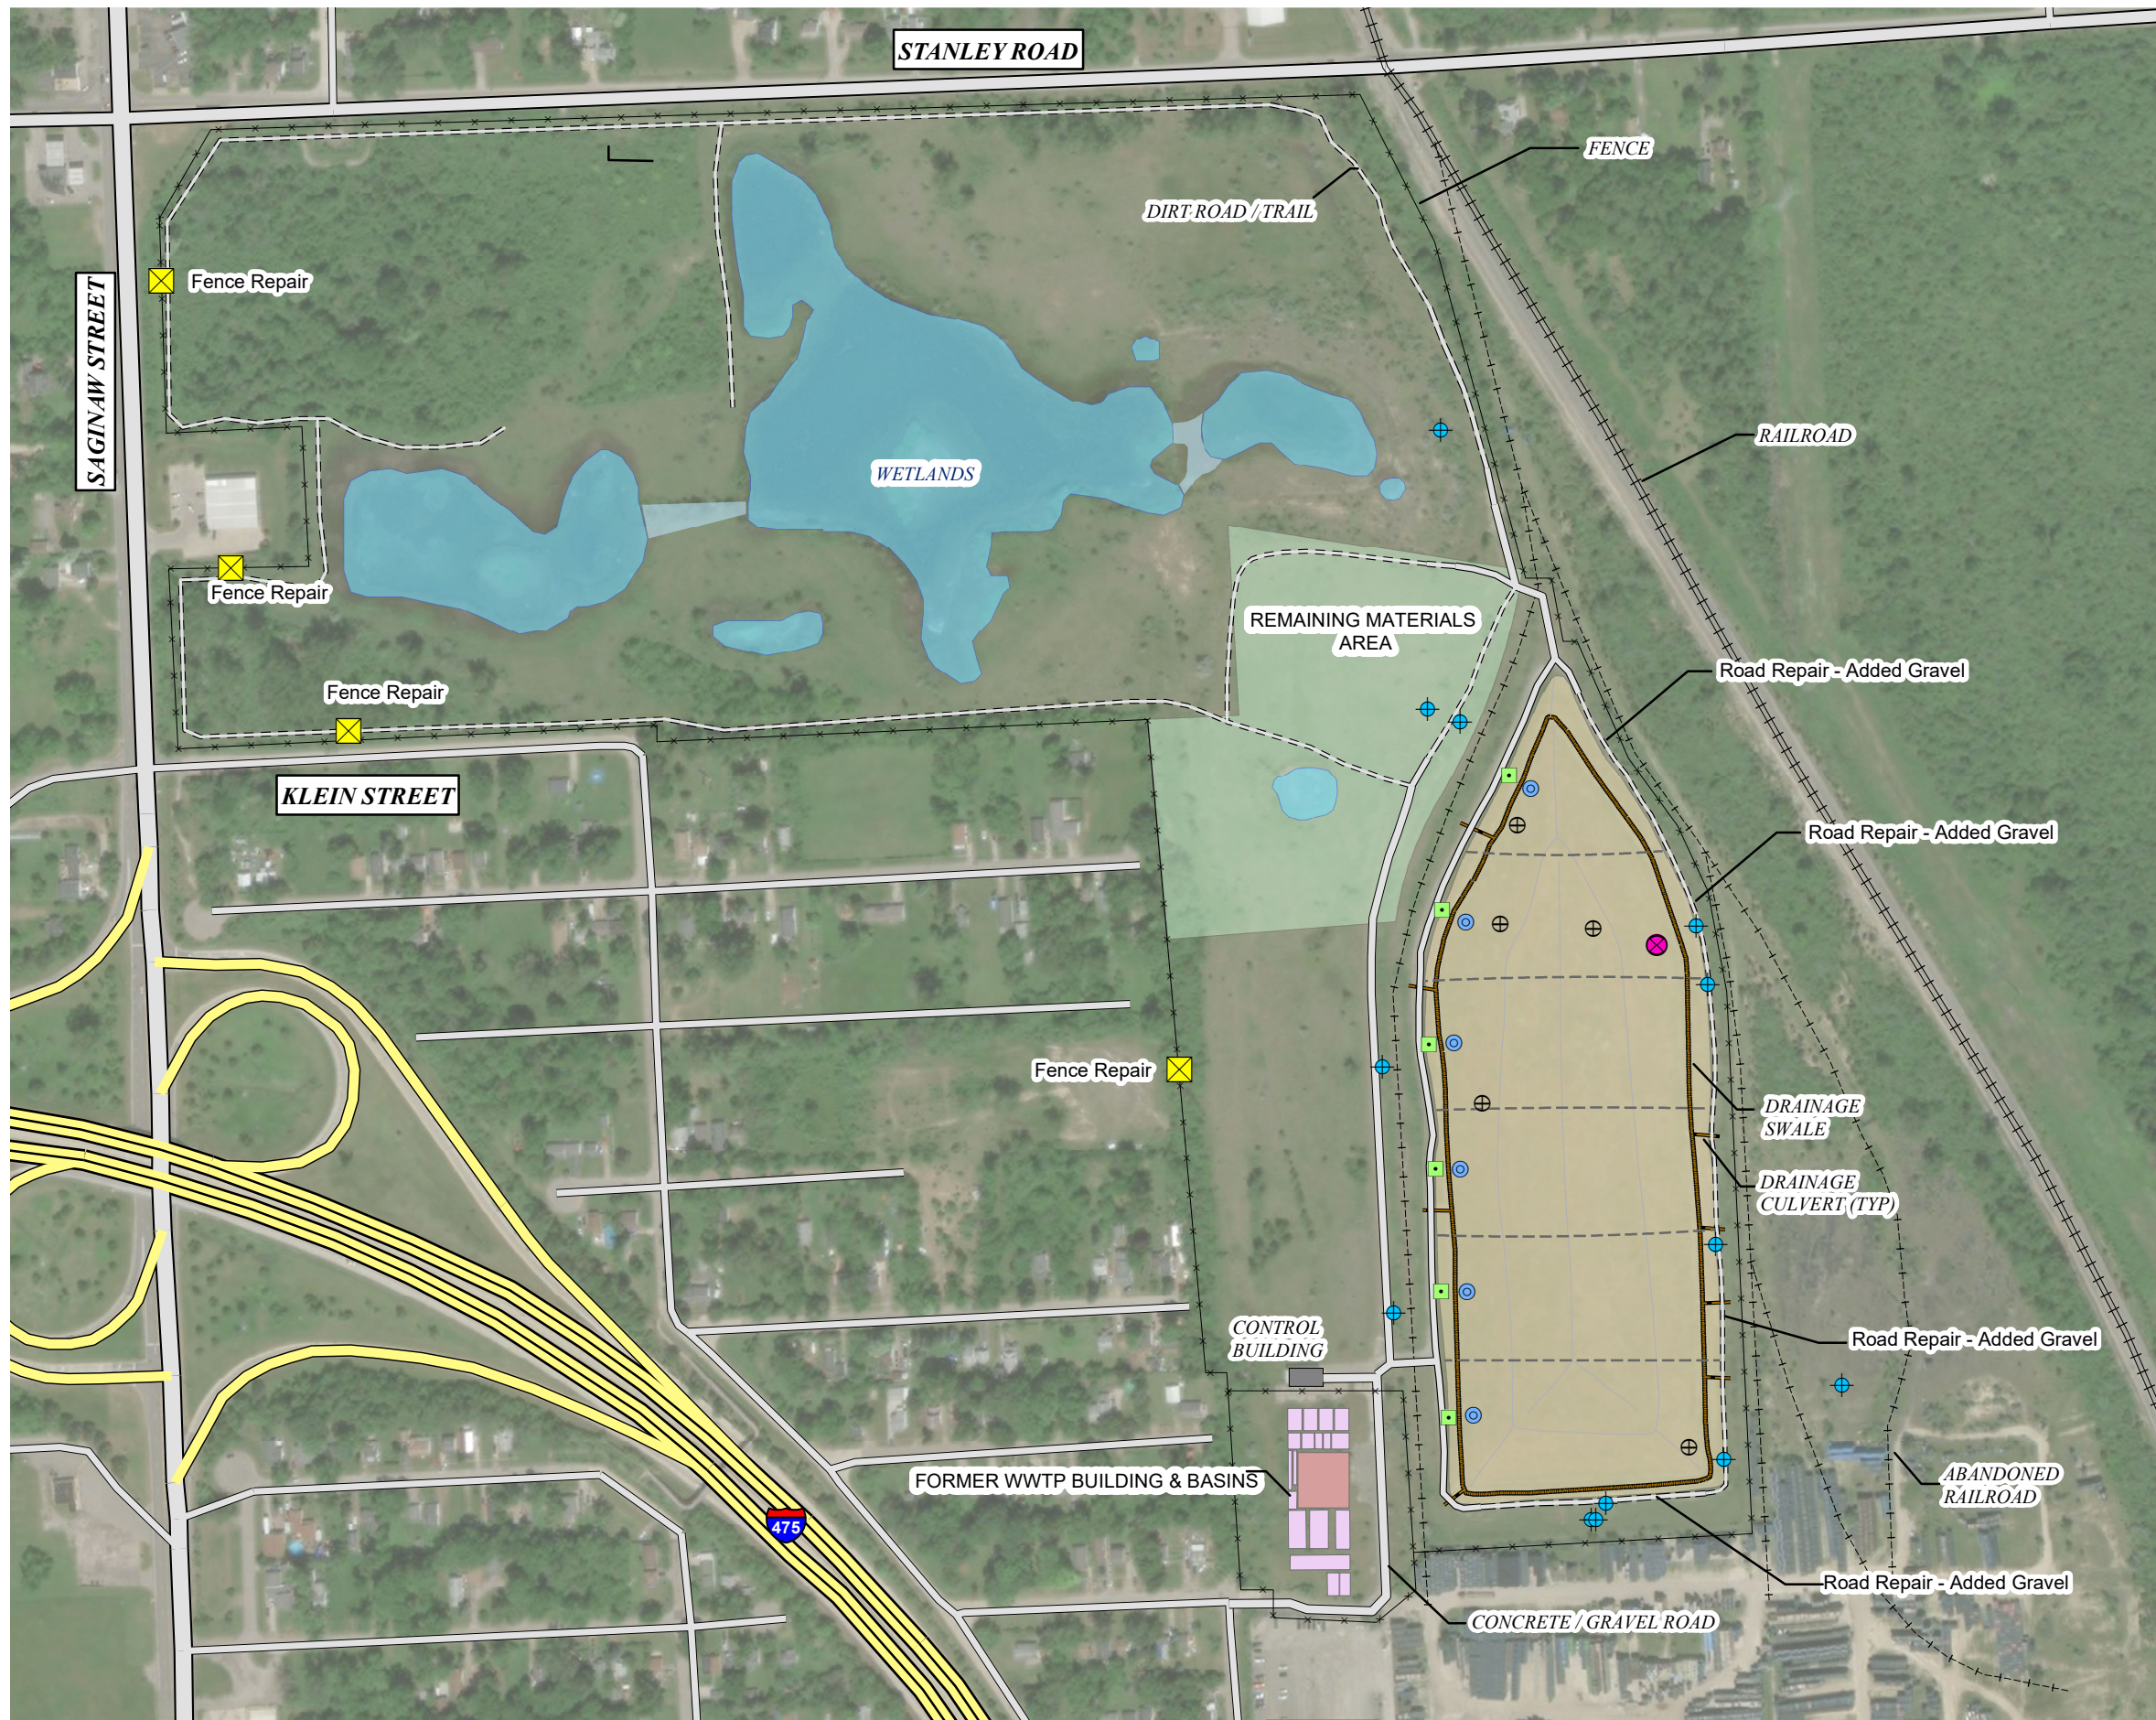
**2017
INCIDENT LOCATION
MAP**

Mole activity was observed during the 3rd and 4th quarter inspections at Cell A, Cell B, Cell D, and Cell F. Mole traps were set along the trails where located.

One animal burrow was identified and closed in the 4th quarter. The animal burrow was photographically documented (before and after repair), and the approximate size and configuration of the burrow was documented and included in the Quarterly Status Report.

A trap was set at the opening of the animal burrow. The burrow was deemed inactive and filled in. The burrow was filled using methods approved by the Michigan Department of Environmental Quality (MDEQ), which included collecting the approximate length (1ft), depth (5 inches), and diameter (4 inches). No signs of liner damage were observed during the inspection and repair of the animal burrow. A log of burrow activity throughout the year is maintained at the landfill. The log contains information on the date that a burrow was identified, response activities, and the date the burrow was filled and seeded. The animal burrow located during the quarterly inspection is noted on [Figure 3](#).

Damage to the site perimeter fence was noted at two locations during the 1st quarter and 4th quarter inspections. On January 12, 2017, a hole in the fence along the western perimeter near the Dollar General store was repaired. On December 21, 2017, a hole in the fence along Klein Street was repaired.

An approximately 40-foot section of fence was knocked down along the west perimeter fence on Saginaw Road in 2016. The knocked down fence along Saginaw Road was propped back up by RACER maintenance during the fourth quarter 2016. The knocked down section of fence was repaired on May 18, 2017 and June 6, 2017. The location of repairs can be found on [Figure 3](#).
