**2020 Annual Inspection Report**

Linden Road Landfill  
FILE: 15388/1940075236

**RACER Trust - Linden Road  
Operation and Maintenance Periodic Inspection Report  
Flint, MI**

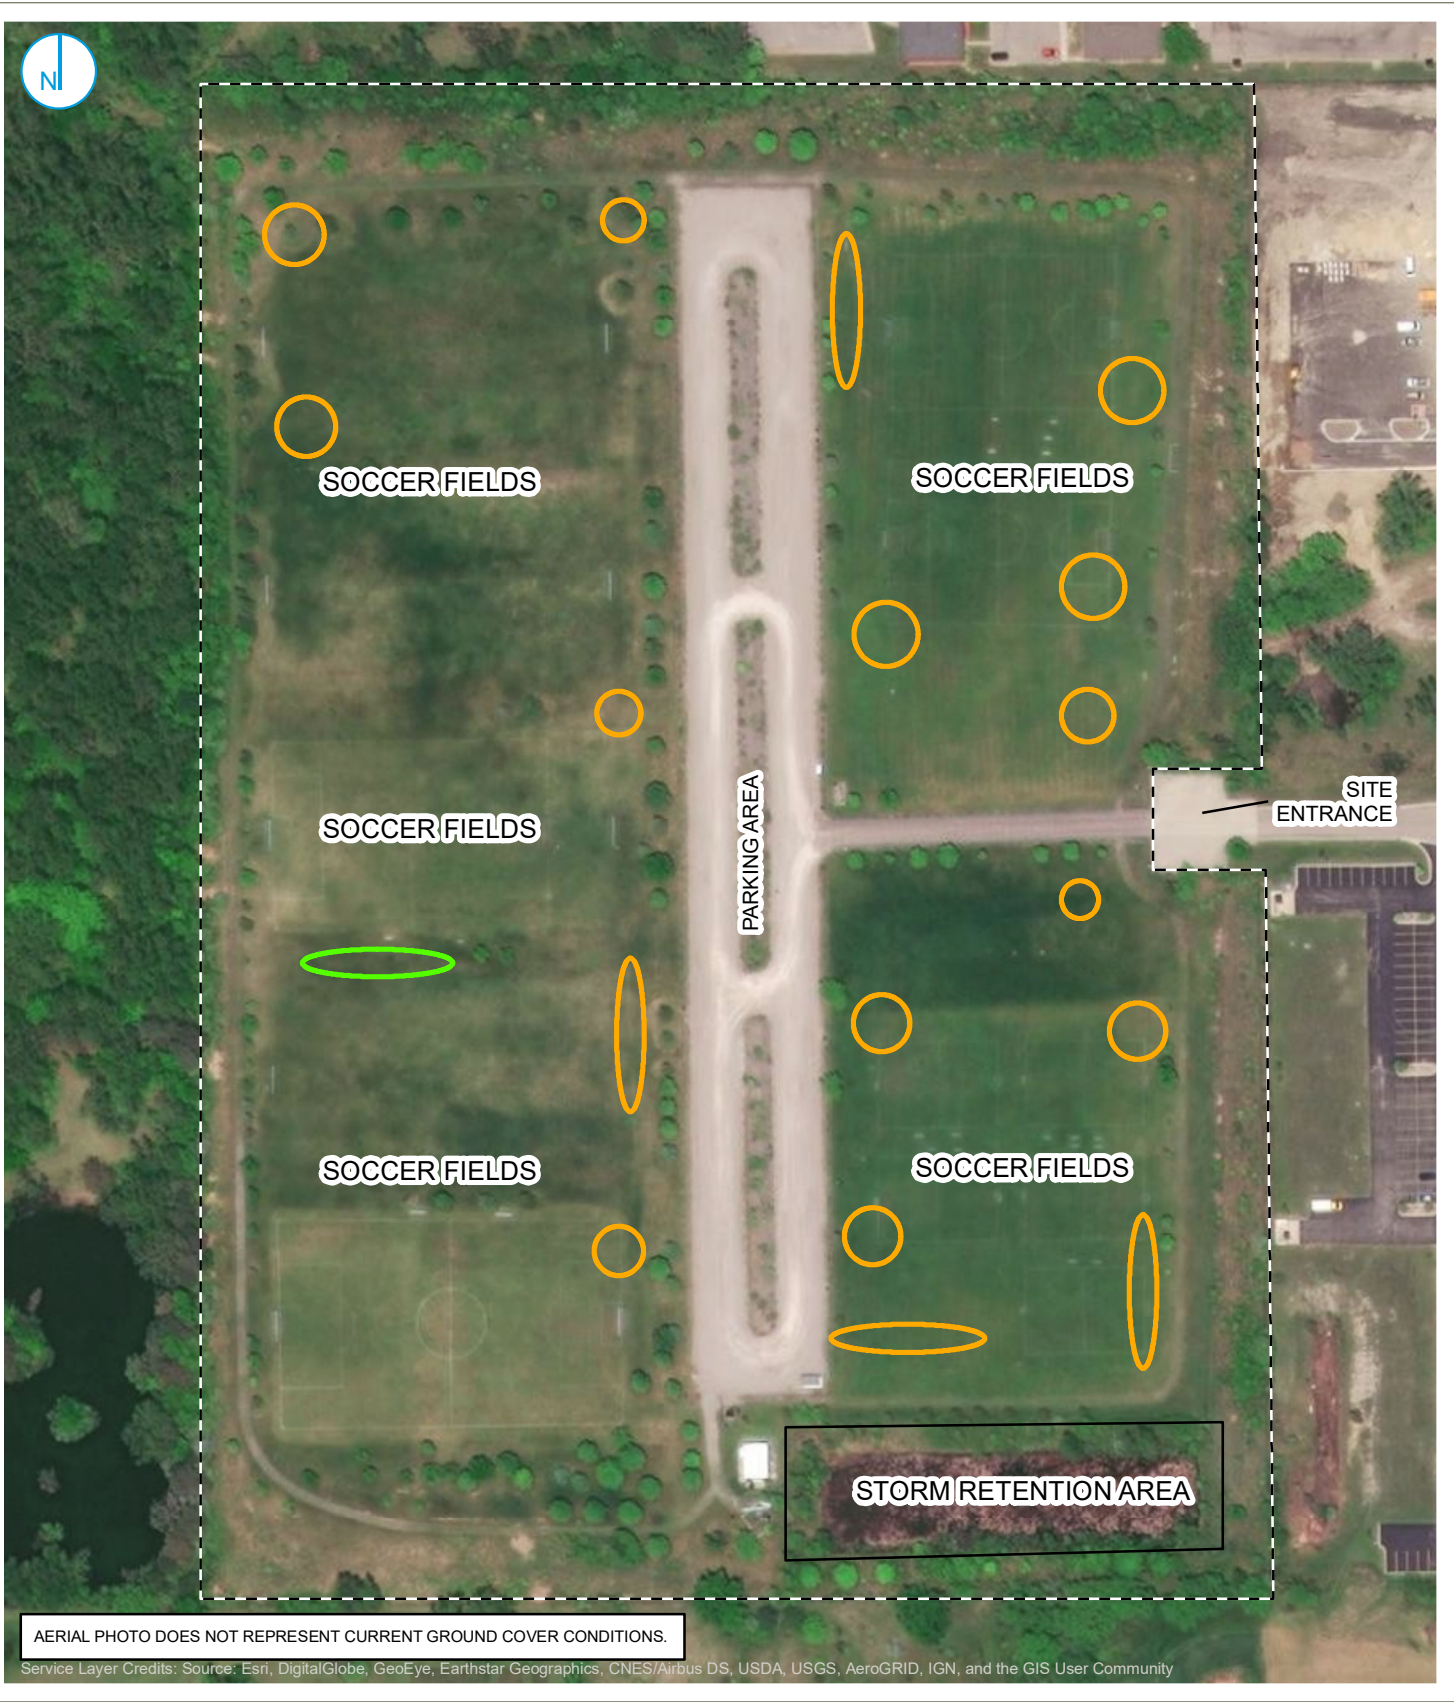
FIGURE 01

As noted in the report, moles have made tunnels and mounds in several areas. The mole activity appeared to be just below the surface and no signs of damage to the final cover or evidence of waste were observed during the inspection.

There was one area with sparse vegetation where grass seed should be spread during the next growing season in order to promote growth. Otherwise, the landfill cap is in good condition.

GENERAL DESCRIPTION OF SITE CONDITIONS:            Grass has been recently mowed. Overall vegetation is in good condition.  
One area of sparse vegetation observed between two soccer field.  
A few small areas where mole mounds were observed have sparse vegetation.

Summary of Deficiencies and/or Corrective Actions:            One area of sparse vegetation observed between two soccer field where grass seed should be planted. Mole trails observed were treated with posion mole peanuts.  
Unable to determine if mole trails were active.

Ramboll has worked with the AYSO to remove the moles by placing solar powered sonic spikes to drive the moles away. Also, during the inspection Ramboll placed poisonous mole peanuts in several tunnels to eliminate the moles and prevent further damage. Ramboll plans to continue working with the AYSO to control the moles and burrowing animals.
