**Landfill Inspection Report 2022**

# **COLDWATER ROAD LANDFILL - MID 005 356 860 LANDFILL INSPECTION REPORT**

Project name **RACER Trust Coldwater Road Landfill**  
Project no. **15388/1940102192**  
Recipient **Nicole Sanabria, Christina Hebert, & John McCabe**  
Document type **Annual Report**  
Version **1**  
Date **February 24, 2023**  
Prepared by **Kevin Schneider**  
Checked by **Clifford Yantz**  
Approved by **Clifford Yantz**  
Description **Landfill Inspection Annual Report**

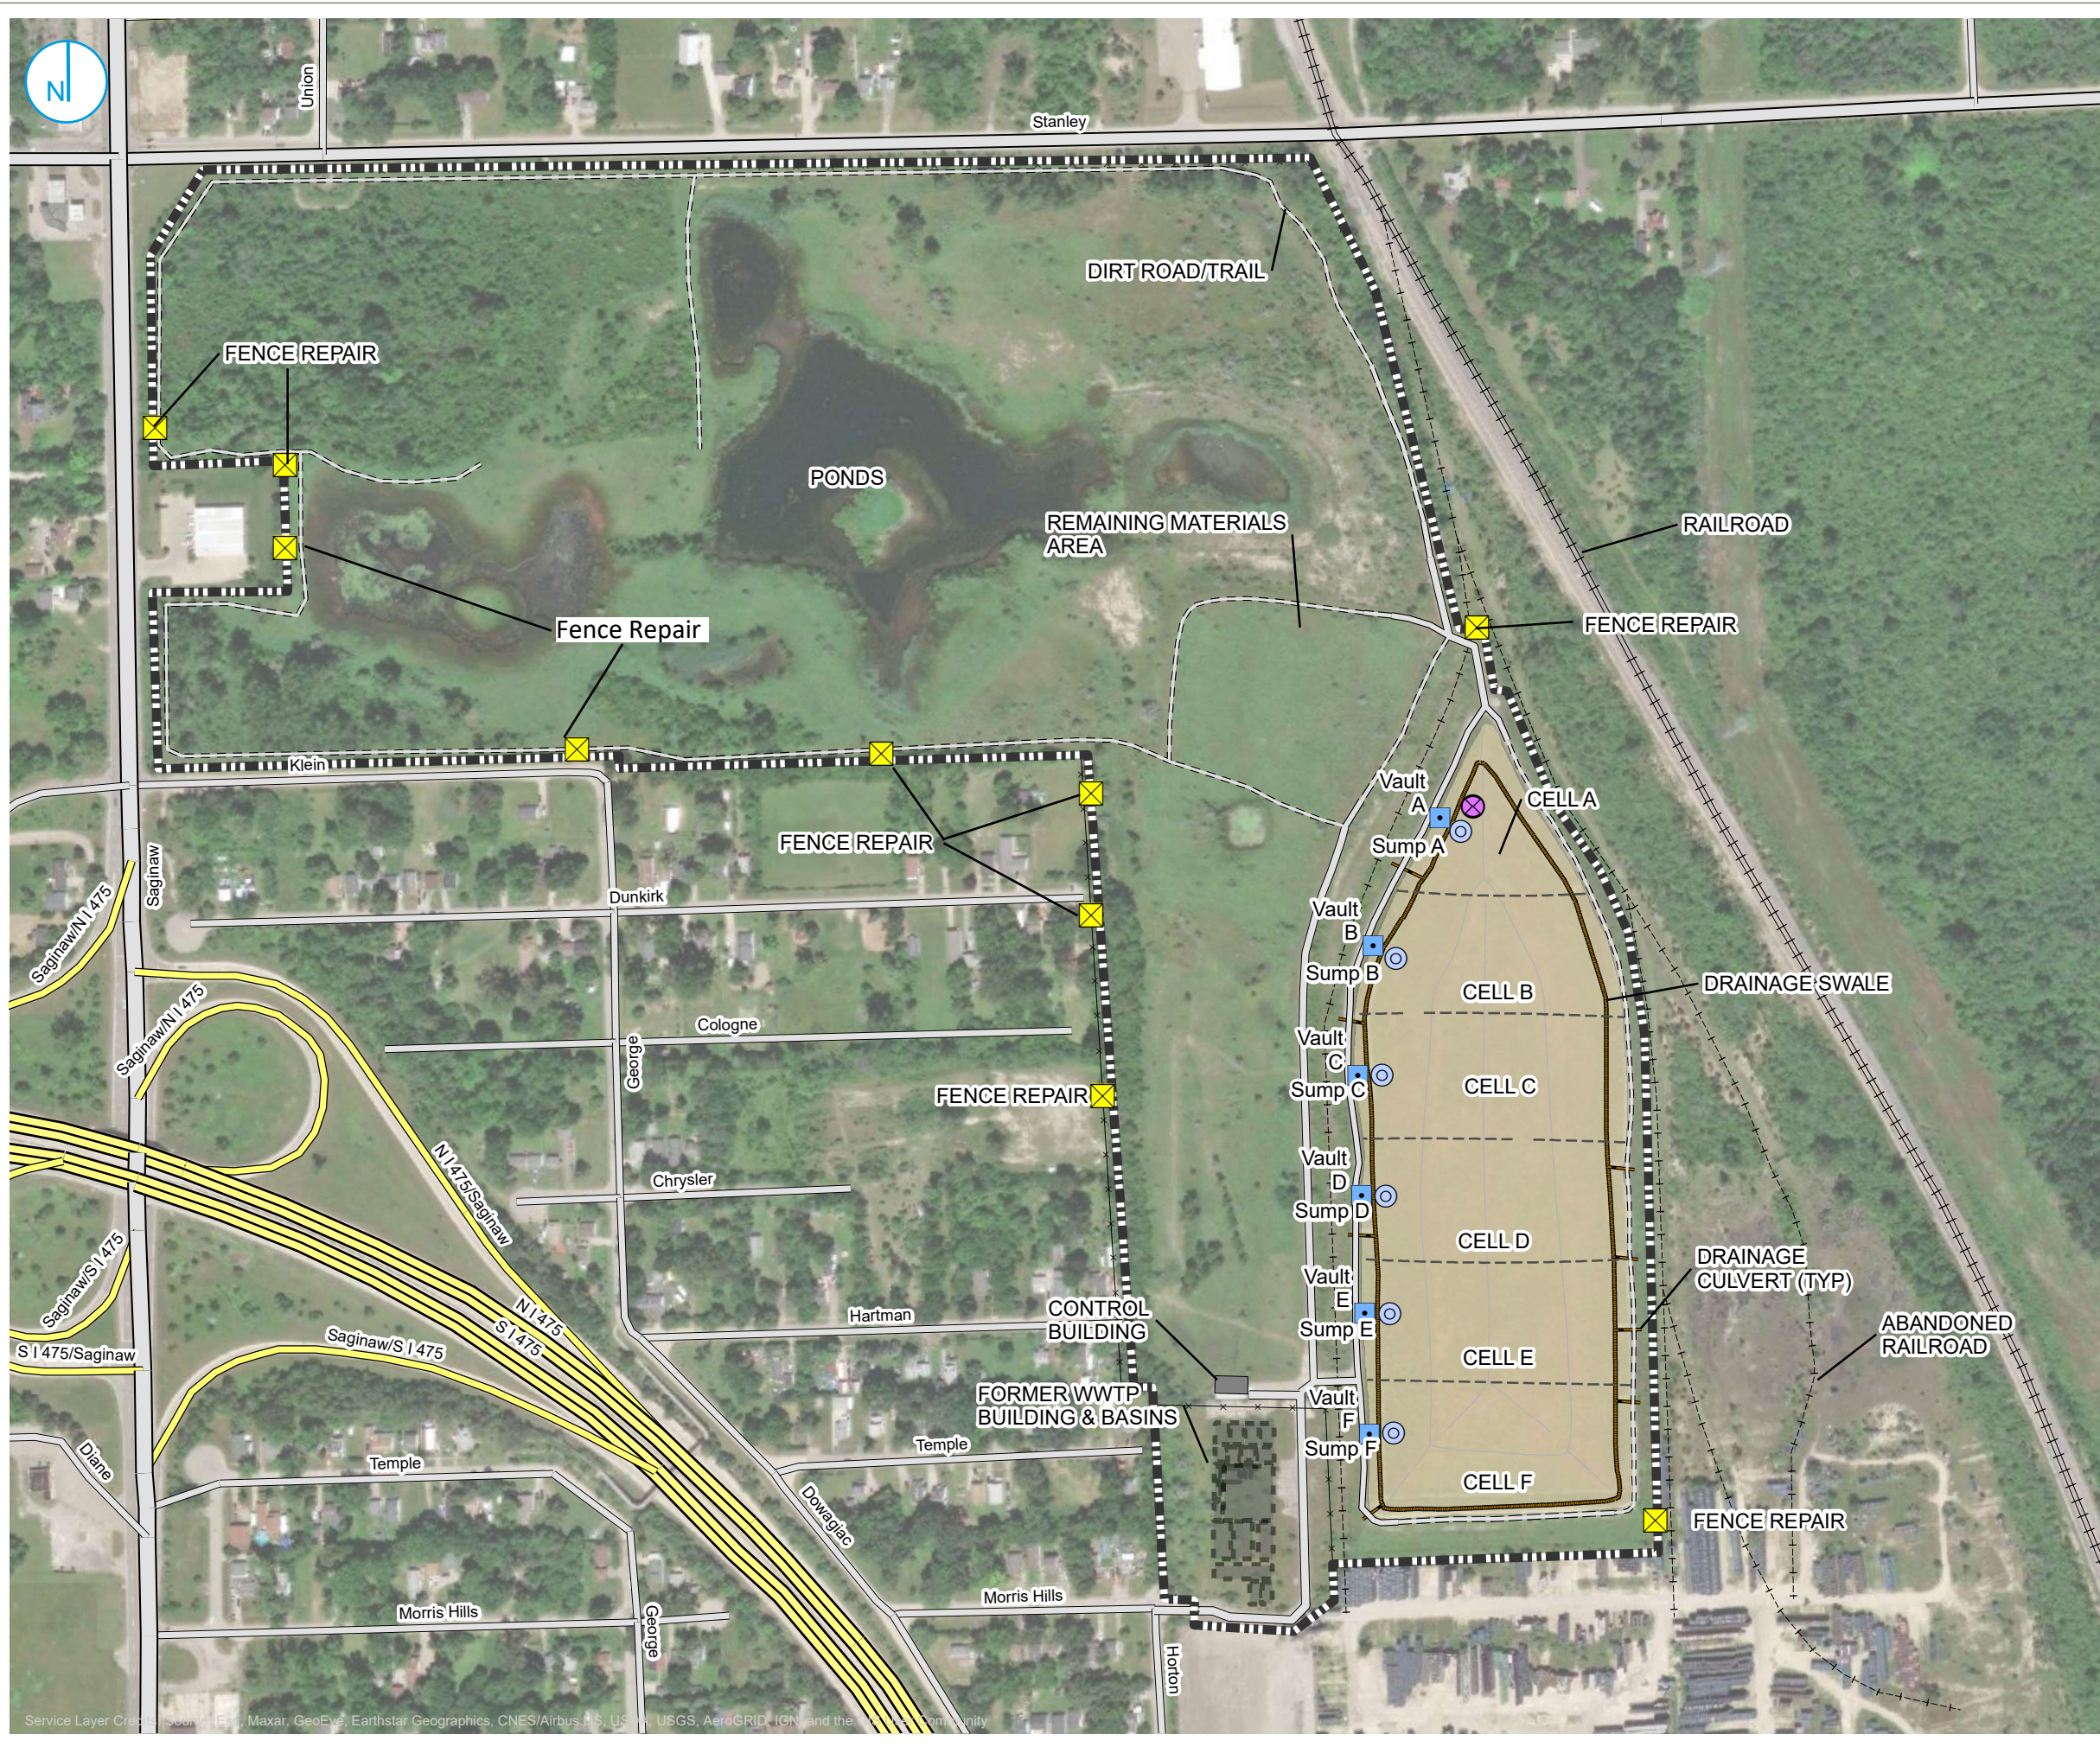
FENCE REPAIR LOCATION MAP

One potentially active animal burrow was observed on March 25, 2022 and a trap was set on March 31, 2022. The animal burrow was found to not be active and was closed out on May 19, 2022. The burrow was filled using methods approved by the Michigan Department of Environment, Great Lakes, and Energy (EGLE), which included measuring the approximate length (1.5 feet), depth (3 inches), and diameter (4 inches) and recording the location.

During the 4<sup>th</sup> quarter, holes in the fence were repaired along the western property boundary and along the southern portion of the western arm of Site. See [Figure 3](#) for the location of the fence repairs completed during the entire year.

During the 2<sup>nd</sup> quarter and 3<sup>rd</sup> quarter, holes in the fence were repaired west of the landfill cap north of Chrysler Street, west of landfill cap south of Dunkrik Road, along the western property boundary, and southeast of the landfill cap. A new section of fence was also installed north of the landfill cap to replace fence that was removed during the berm construction. At the request of EGLE a photo log and figure of the repairs was shared via email on July 22, 2022.

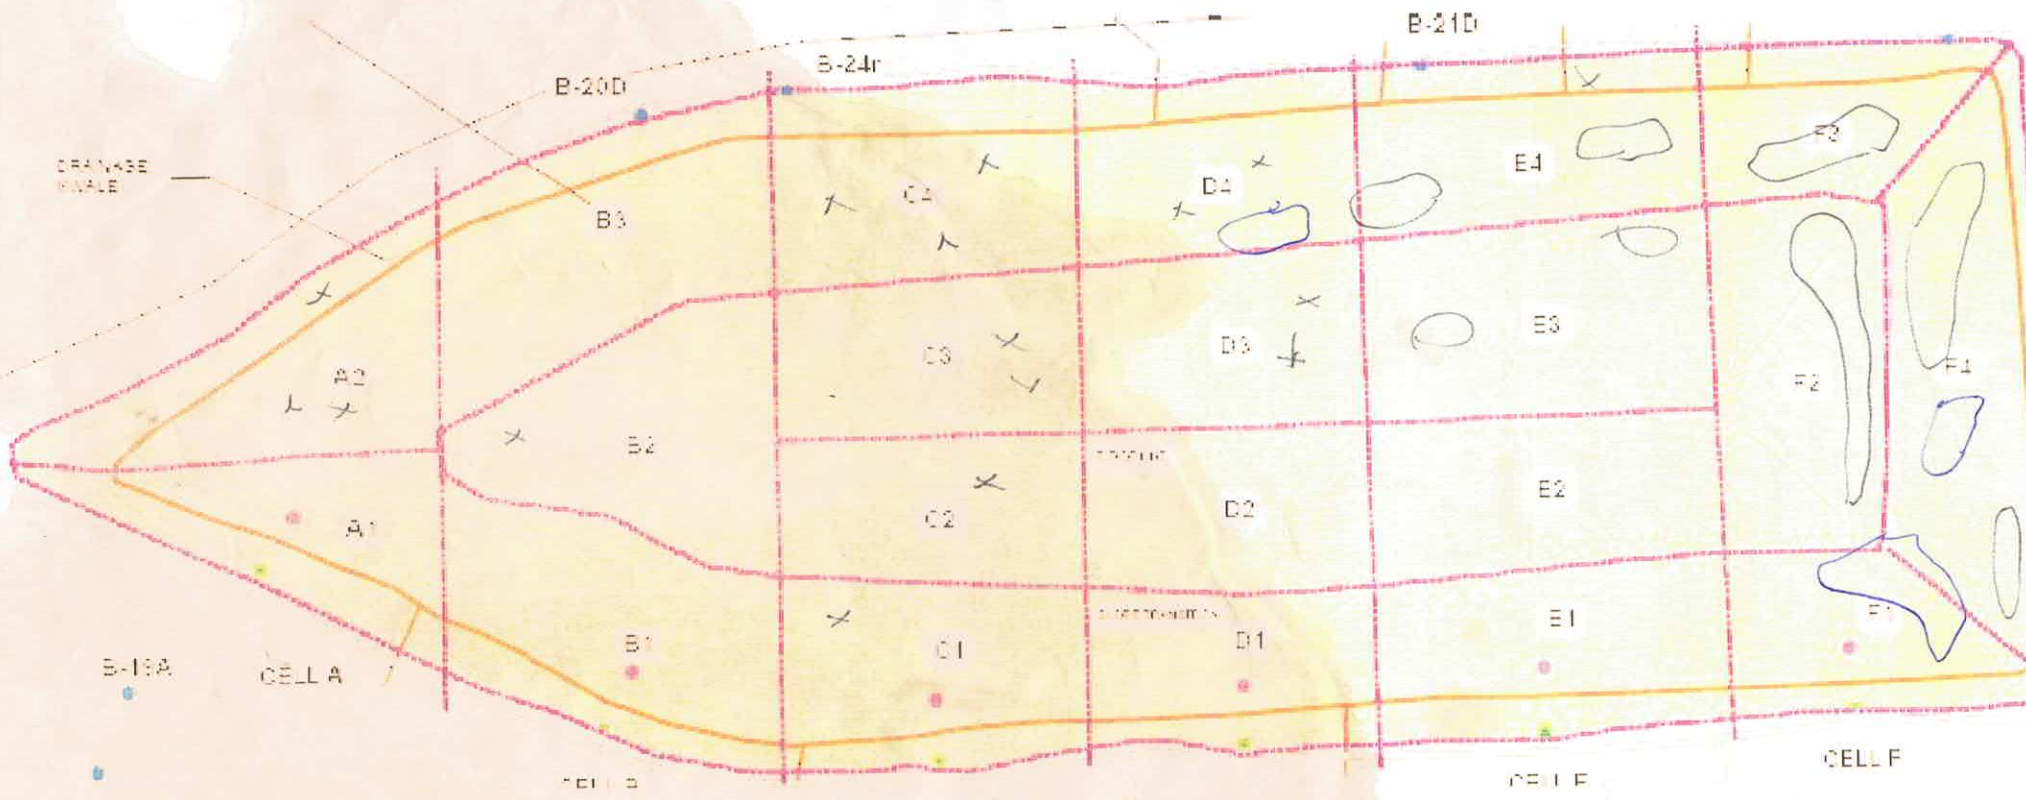
Tall shallow rooted weeds covered a portion of the southern area of the landfill cap during 2022. The weeds roots were not deep penetrating; although they did make navigating the areas where they are located more difficult. If the weeds do not get pushed down over the winter months due to snow cover and decompose during the spring, the areas with the tall weeds will be mowed down during the first 2023 Site-wide mowing event.

X woody plants  
O Tall dense shallow rooted weeds
