Re: Ley Creek PCB Dredgings Site
July 2006 OM&M Inspection

This letter documents the Operation, Maintenance, and Monitoring (OM&M) site inspection conducted on July 19, 2006 by O'Brien & Gere at the Ley Creek PCB Dredgings Site (the Site), located in Syracuse, New York. This inspection was performed in accordance with the NYSDEC-approved OM&M Manual, dated September 2001.

LEY CREEK PCB DREDGINGS SITE
SYRACUSE, NEW YORK
SITE REMEDIATION PROJECT

JULY 2006
OM&M INSPECTION
PARTIAL SITE PLAN

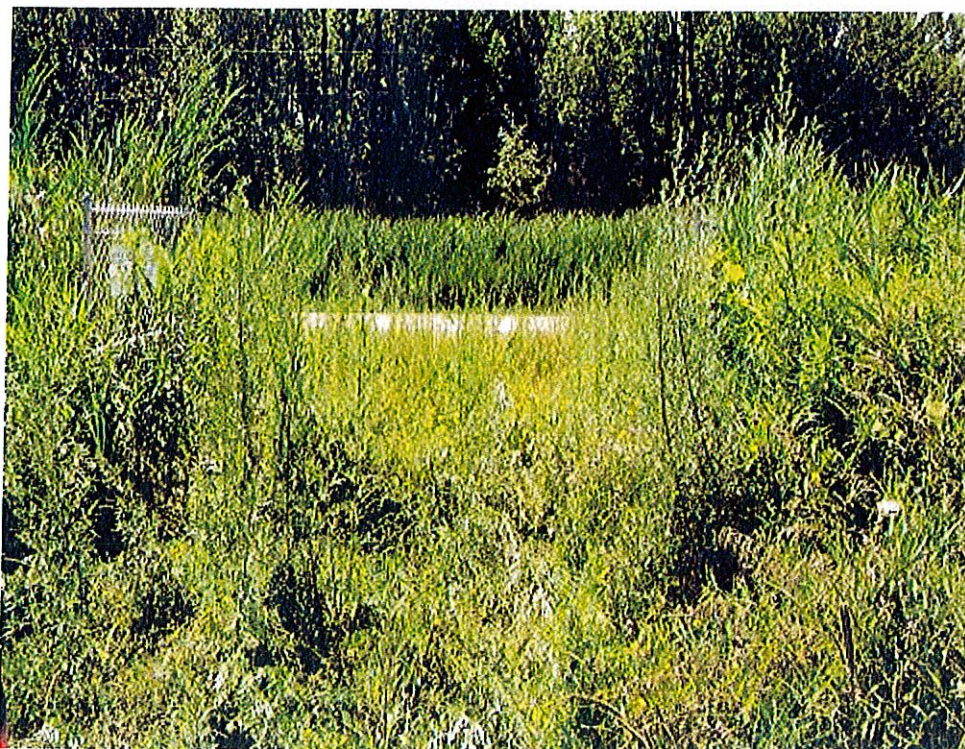
- Organic debris scattered throughout Site due to recent flooding (Photographs 4, 11, 21, and 22)
- Garbage box of used oil (Figure 4)
- Significant vegetation growth along Factory Avenue site perimeter fence and within the Site in general (Figures 1, 2, and 3, Photograph 1).

Photograph 1: Looking at west entrance gate vegetation growth.

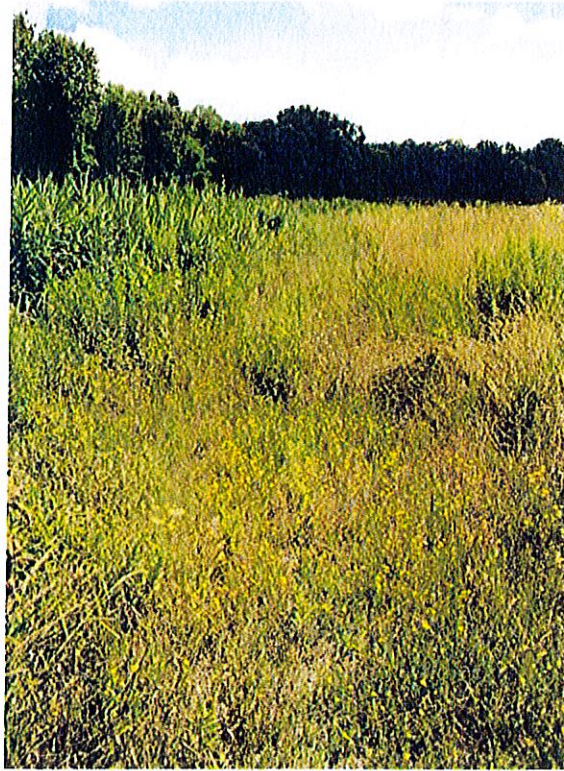
- Rutting of the stone access road (Figures 2, 3, and 4)
- Exposed erosion control fabric along overflow spillway from CB -3 (Figure 3, Photograph 20)
- A significant amount of vegetation within the stone access road throughout the Site (Photograph 3)
- Tree establishment along the fence line and between the access road and Ley Creek (Figures 1 through 5, Photographs 10 and 17)
- Vegetation through pavement/cracks in asphalt and damage to asphalt (Figure 3)
- Delineation of the wetland area with signage.

Photograph 3: View down site access road approximately 140' from west access gate.

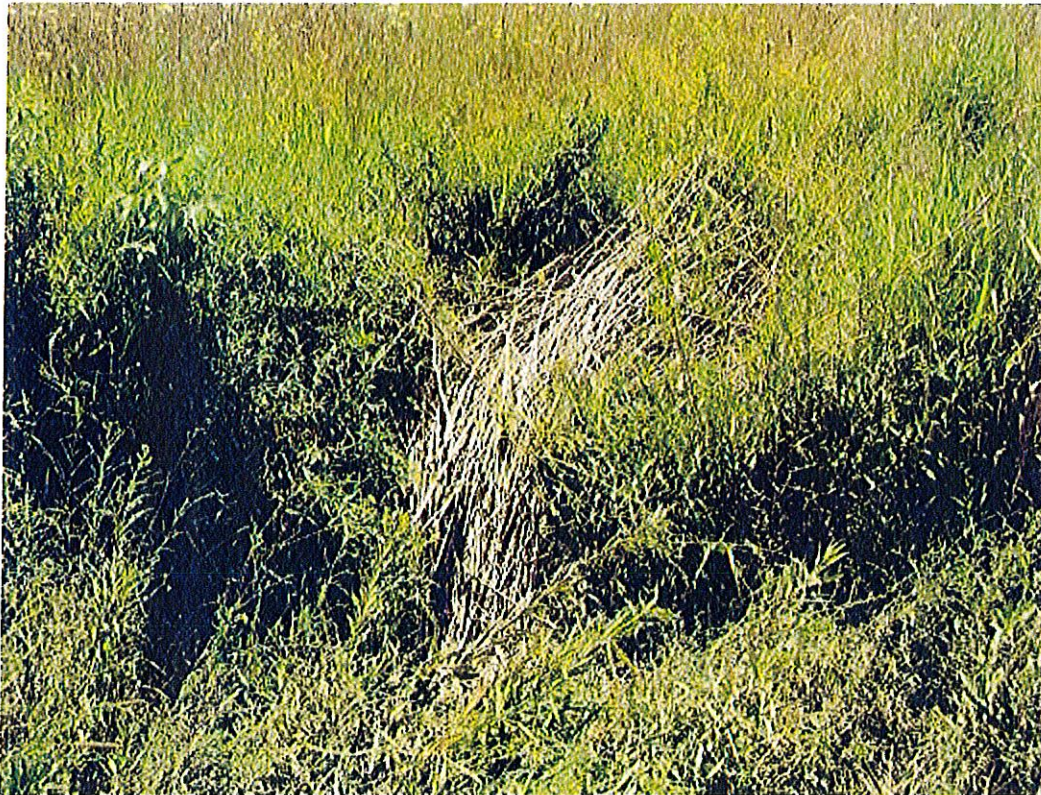
Photograph 4: Organic debris from flooding south of access road adjacent to Ley Creek.

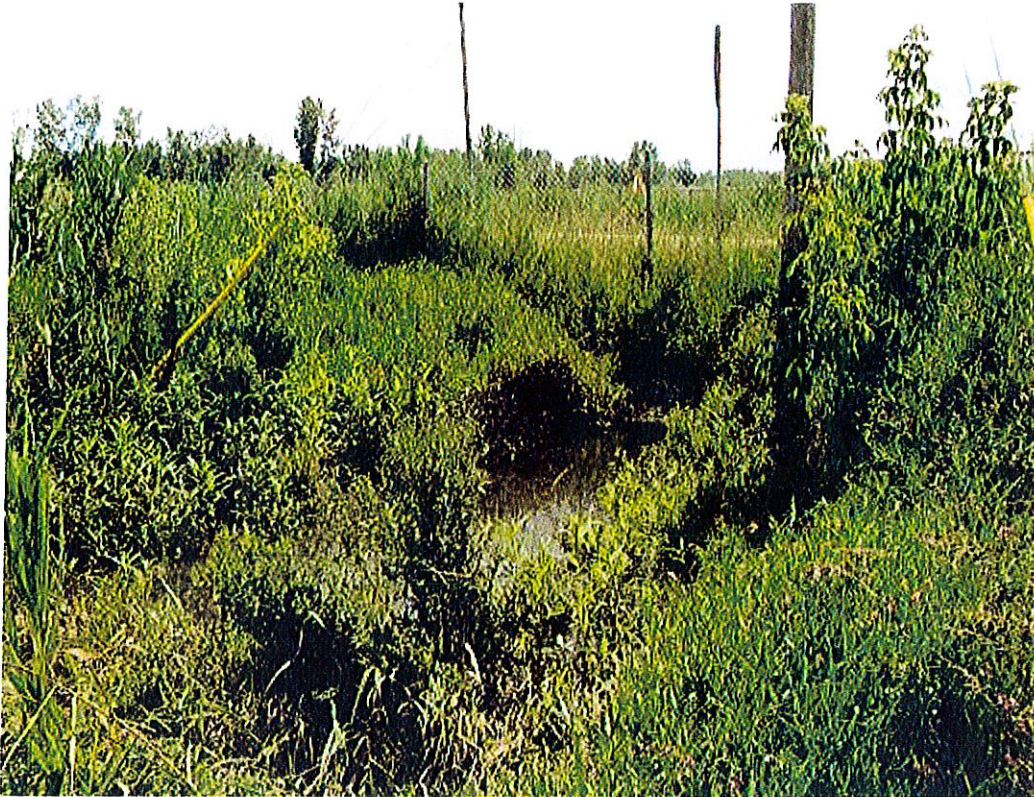
- Clogged catch basins CB-1, CB-2 and partially clogged CB-3 (Figures 1 and 3, Photographs 5, 14, and 18)
- Further tree/shrub establishment and growth, some trees approximately 2" in diameter (Figures 1 through 5, Photographs 10 and 17)

6. Presence of burrowing animals?	X		Near MW-12, refer to Photograph 13 and Figure 2.
	7. Areas of damage?		X	
	8. Drainage problems?	X		CB-1 and CB-2 plugged, CB-3 partially plugged (Figures 1 and 3, Photographs 5, 14, and 18).

Photograph 5: Stagnant water in CB-1 indicates clogging.

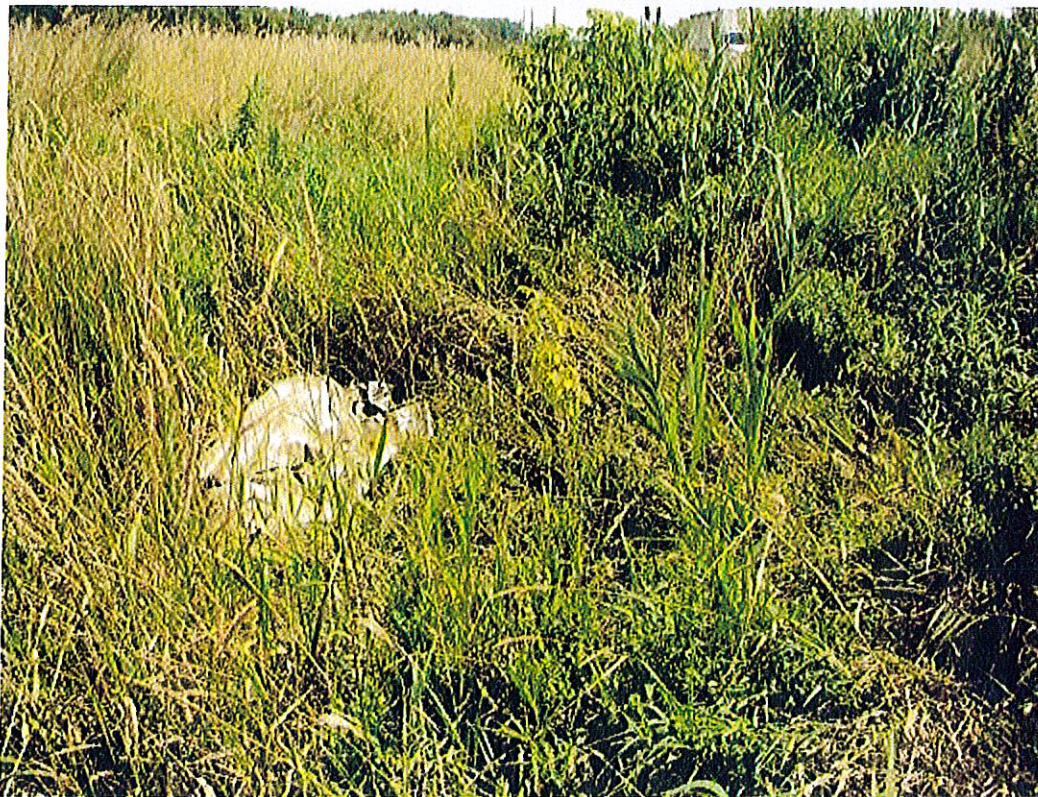
- Exposed soil with no vegetation in CB-2 overflow spillway near access road (Figure 3, Photograph 15)
- Concrete rubble near Factory Avenue (Figure 3) and garbage near CB-1 (Photograph 6)

Photograph 6: Garbage near CB-1.

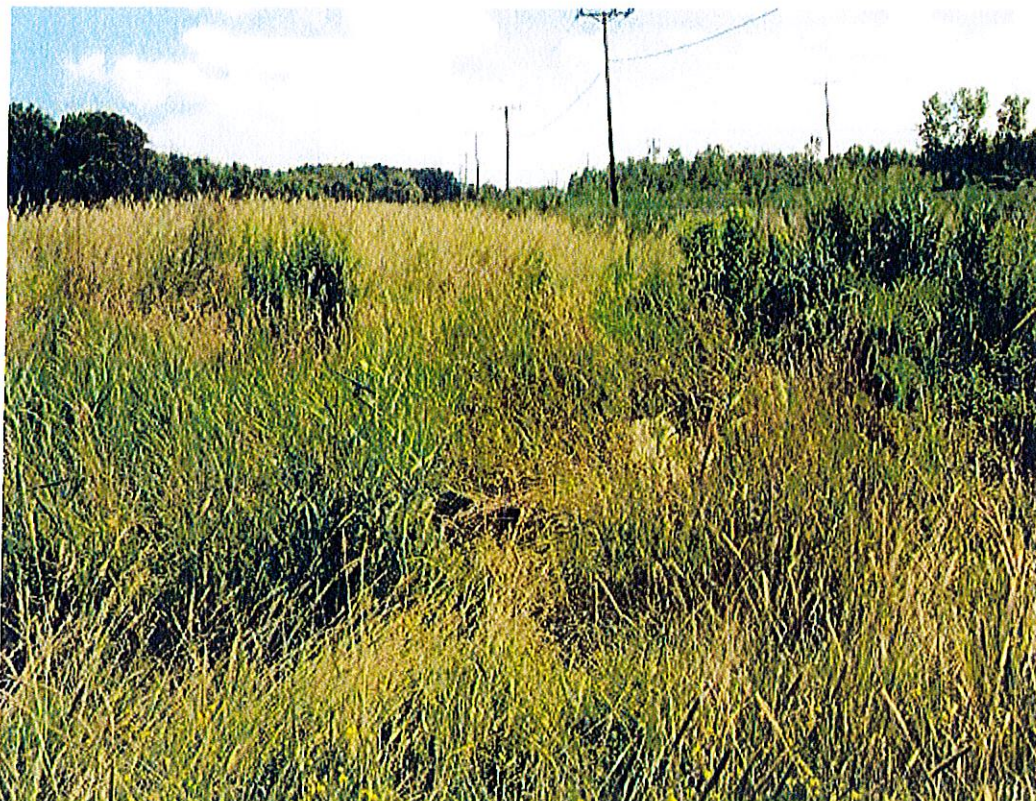
Photograph 7: View looking east of CB-1 overflow spillway showing significant vegetation.

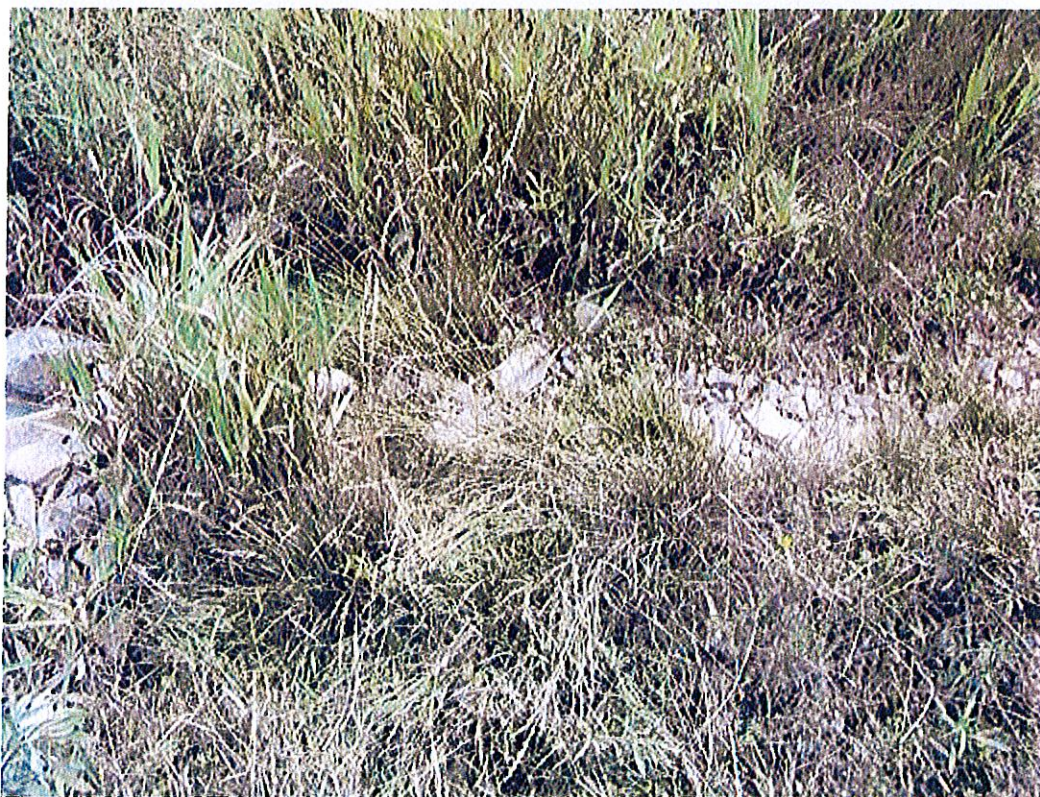
- Monitoring well OBG-3D concrete flush-mount casing shifted (Figure 5, Photograph 23)
- Erosion where CB-1 overflow spillway crosses access road (Figure 1, Photograph 8 and 9)

Item	Task	Response		Comments
		Yes	No	
Access Road	2. Areas of erosion?	X		Minimally where CB-1 overflow spillway crosses access road (Figure 1, Photograph 8 and 9).

Photograph 8: Erosion in CB-1 overflow spillway along access road.

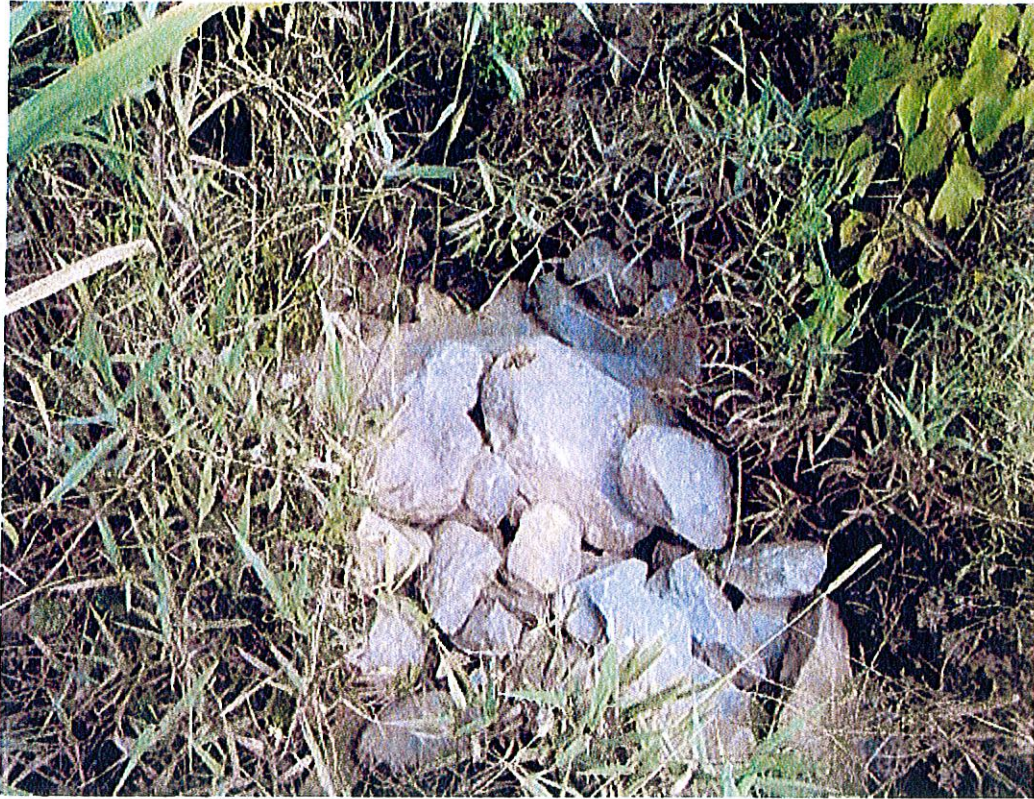
3. Areas where geotextile visible due to erosion?	X		Refer to Photographs 9 and 20, Figures 1 and 3.
	4. Areas of slope instability?		X	
	5. Lack or thinning vegetation?		X

Photograph 9: Woven geotextile exposed due to erosion where CB-1 overflow spillway crosses access road.

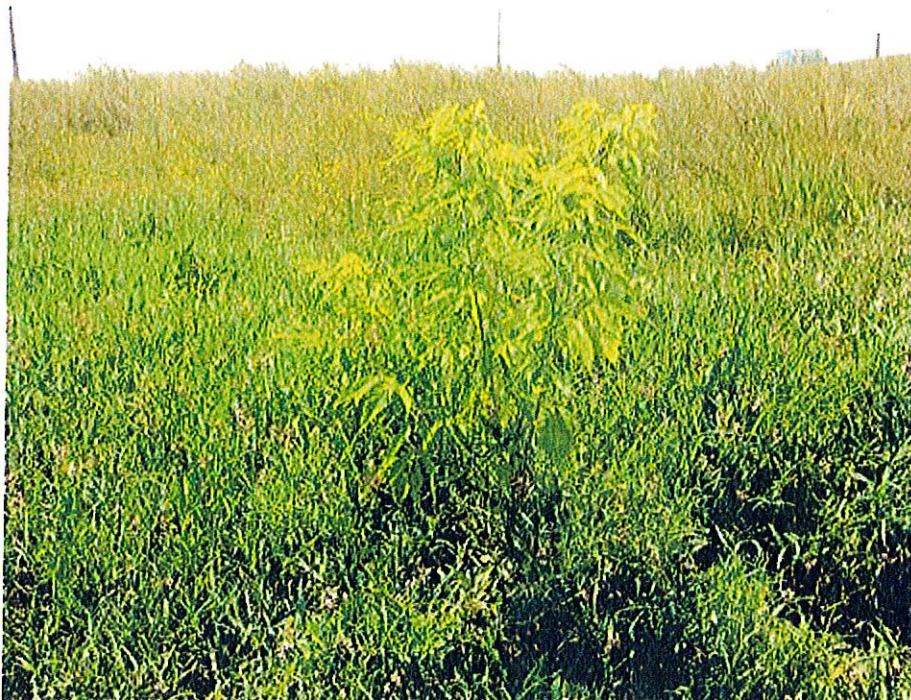
Photograph 10: Tree establishment.

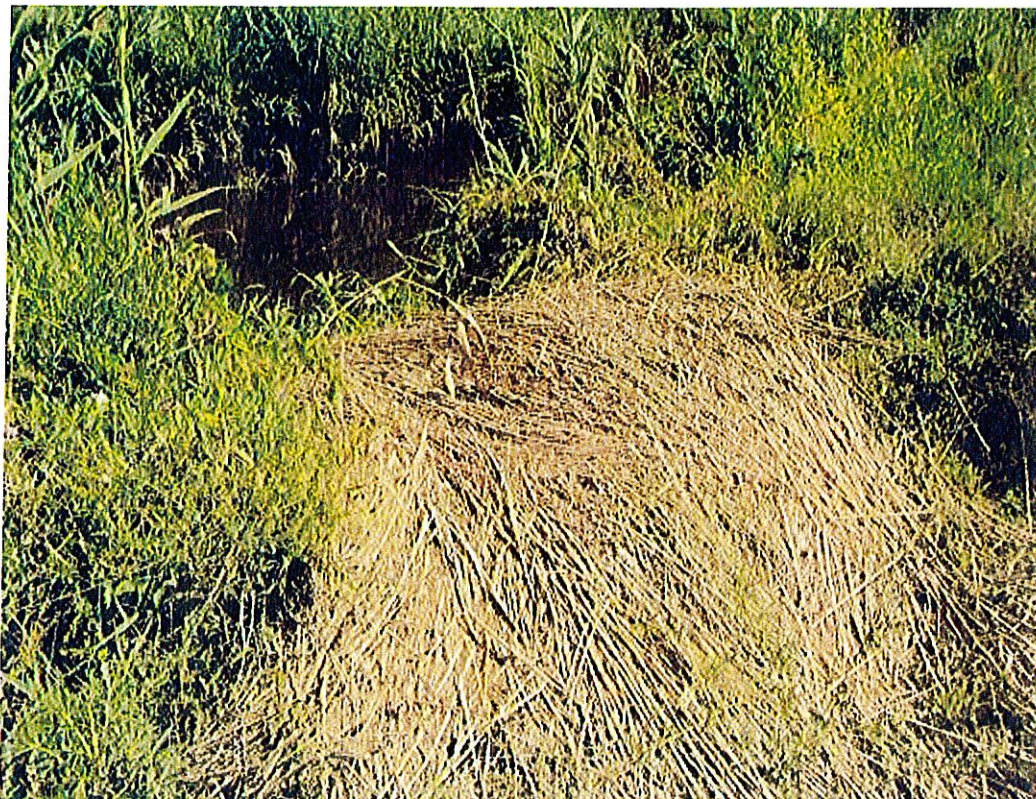
Photograph 11: View of organic debris from flooding.

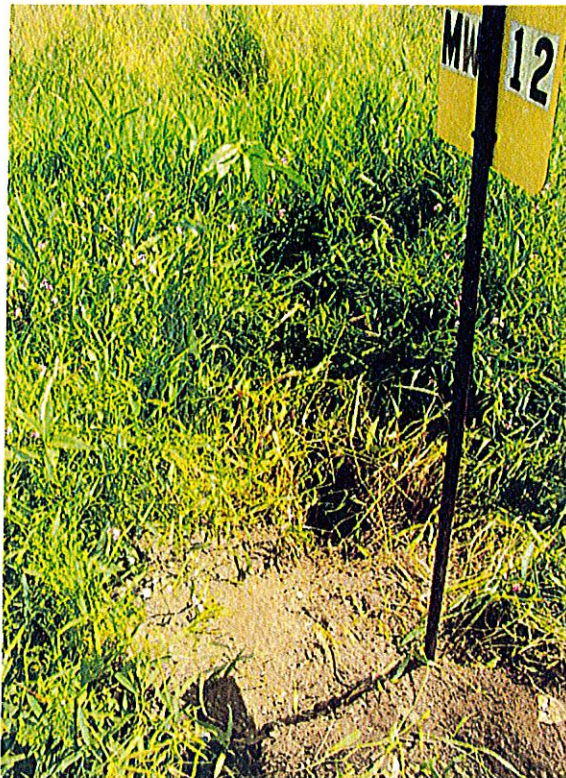
- Animal burrow in vegetative cover and buried monitoring well MW-12 (Figure 2, Photograph 13)
- Monitoring well OBG-21D lock broken and J-plug not in PVC riser (Figure 4, Photograph 21)

2. Areas of damage?	X		MW-12 buried due to adjacent burrow (Figure 2, Photograph 13).
Sanitary sewer access paths	Visually inspect conditions.			
	1. Cracks in asphalt?	X		Refer to Figure 3.

Photograph 13: View of burrow near MW-12. MW-12 buried and not identified.

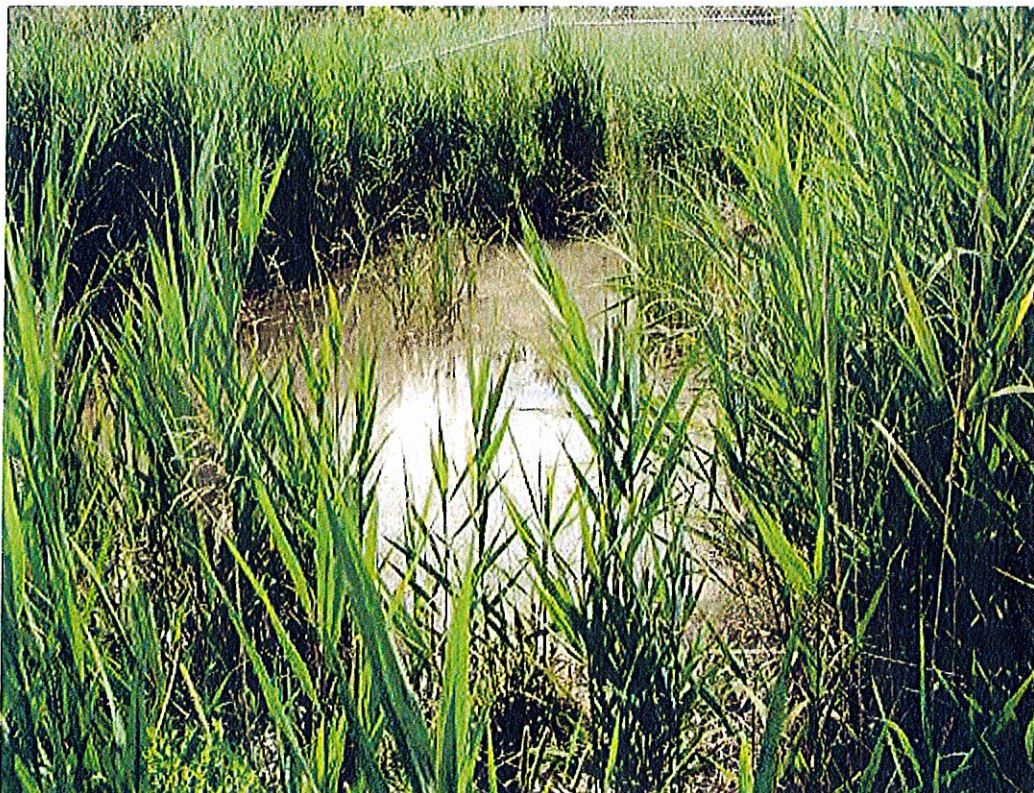
Photograph 14: Stagnant water in CB-2 indicates clogging.

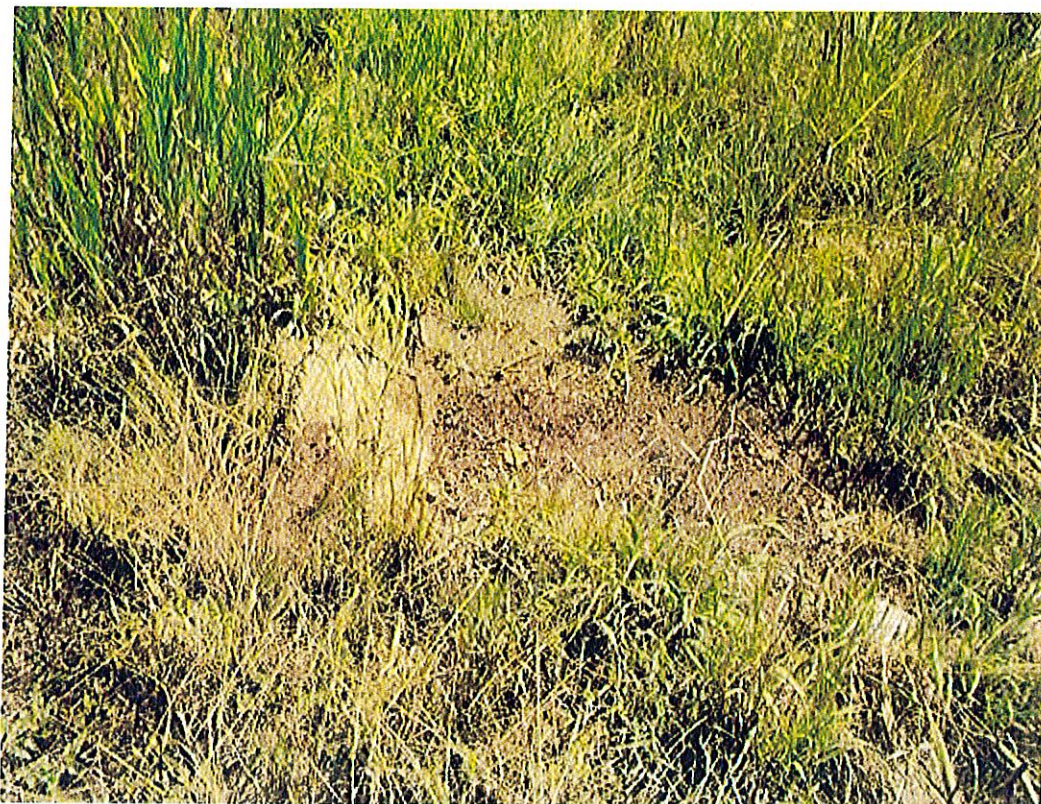
Item	Task	Response		Comments
		Yes	No	
Vegetative Cover	Visually inspect surface conditions.			
	1. Areas of settlement?		X	
	2. Areas of erosion?	X		Exposed soil with no vegetation in CB-2 overflow spillway near access road (Figure 3, Photograph 15).

Photograph 15: View of soil with no vegetation in CB-2 overflow spillway near access road.

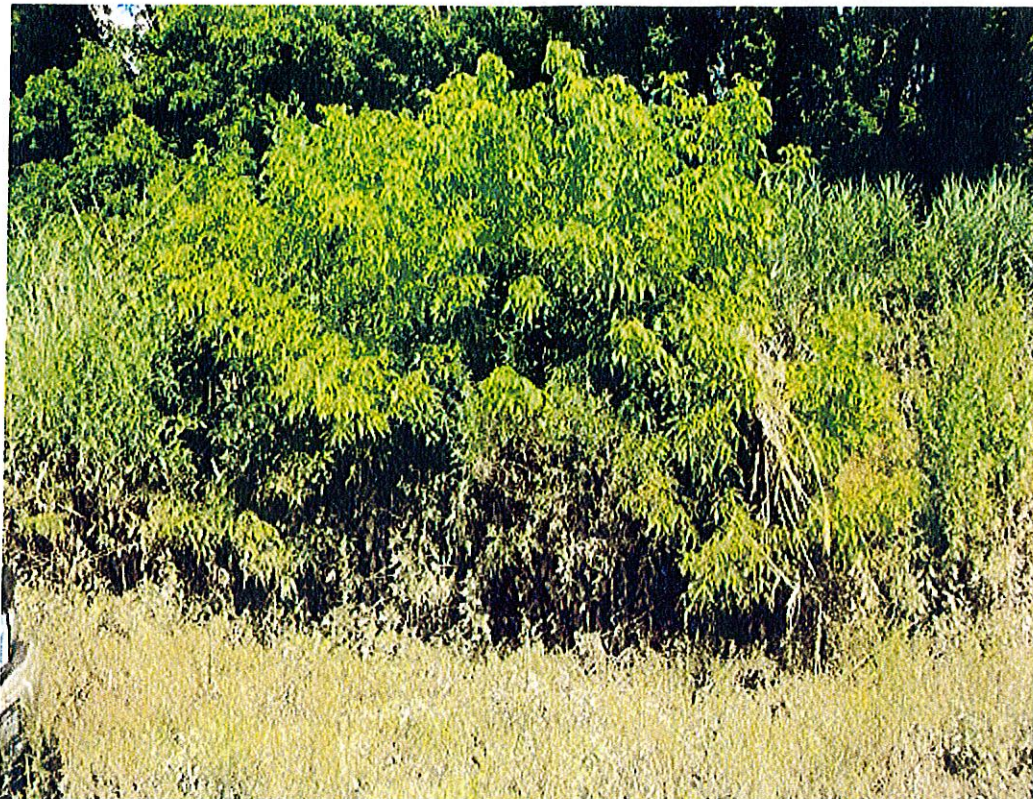
Photograph 17: Tree establishment between access road and Ley Creek.

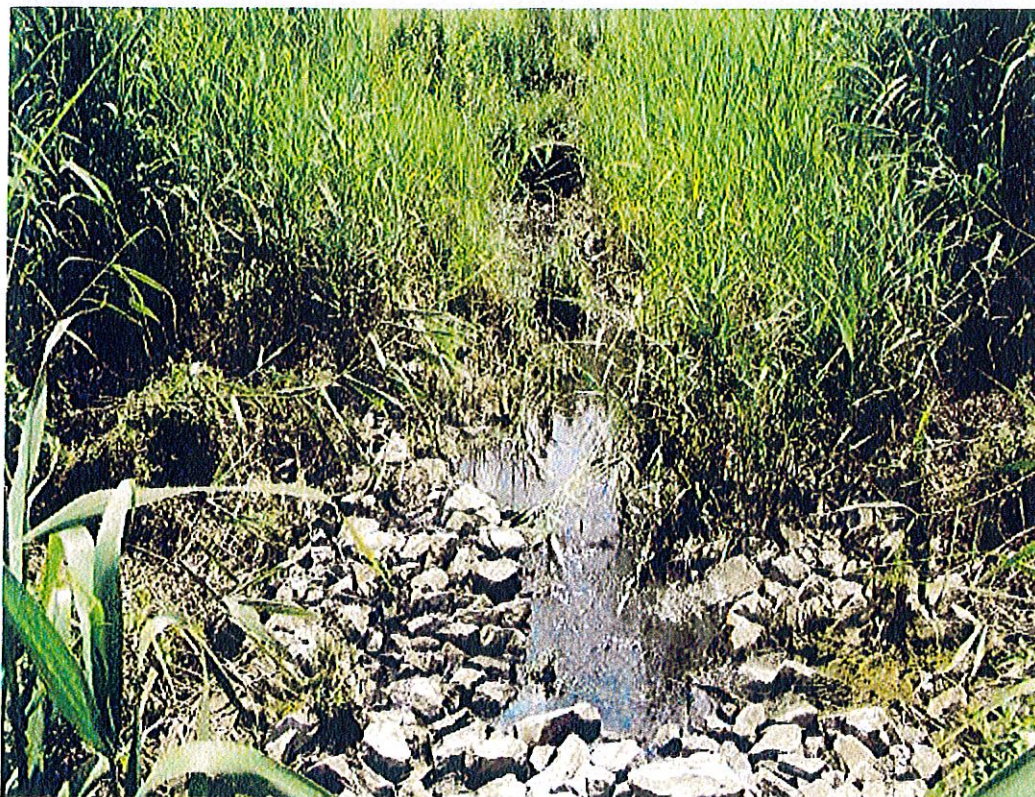
Photograph 18: CB-3 partially clogged.

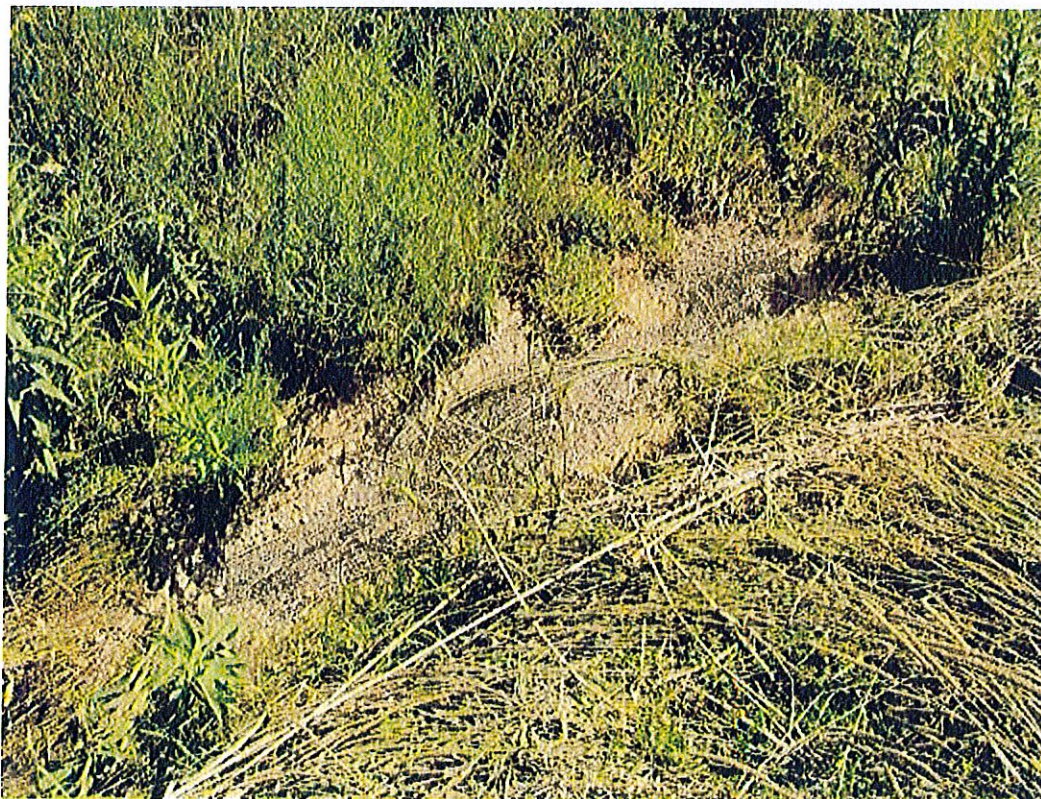
Photograph 20: Exposed geotextile fabric due to erosion along CB-3 overflow spillway.

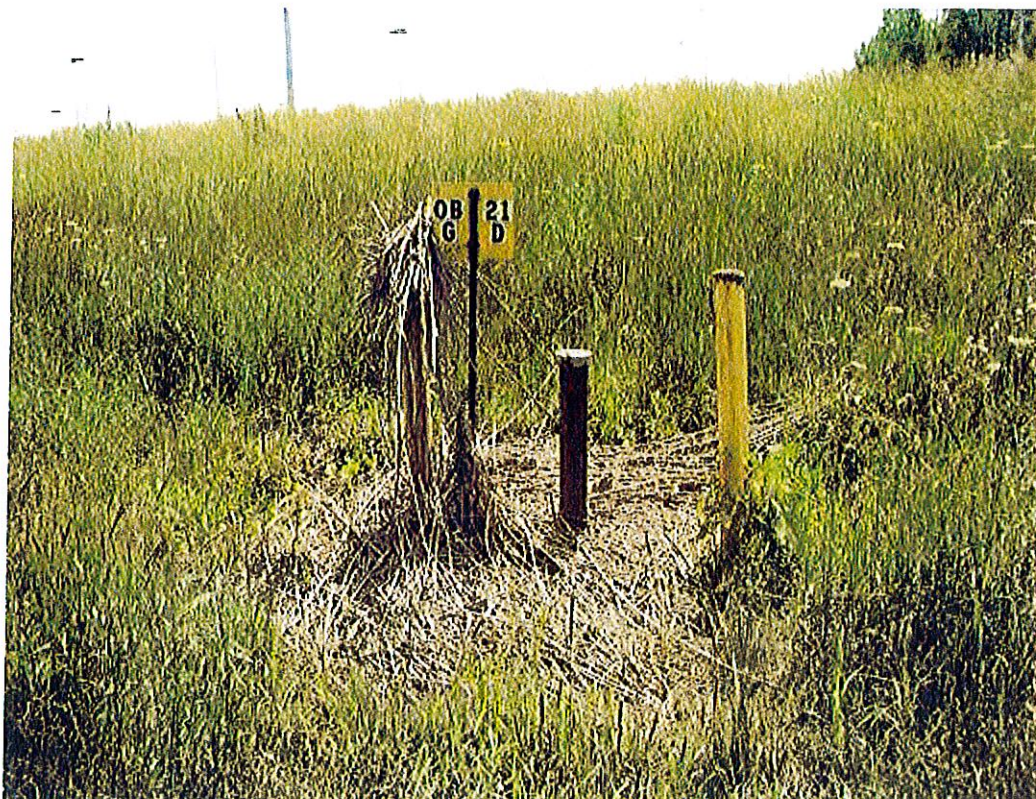
3. Areas of damage?		X	
Ground Water Wells	Visually inspect conditions.			
	1. Casings secure and locked?		X	OBG-21D lock damaged and missing J-plug (Fig. 4, Photo. 21), OBG-3D flush mount shifted (Fig. 5, Photo. 23).

Photograph 21: Organic debris from flooding around OBG-21D.

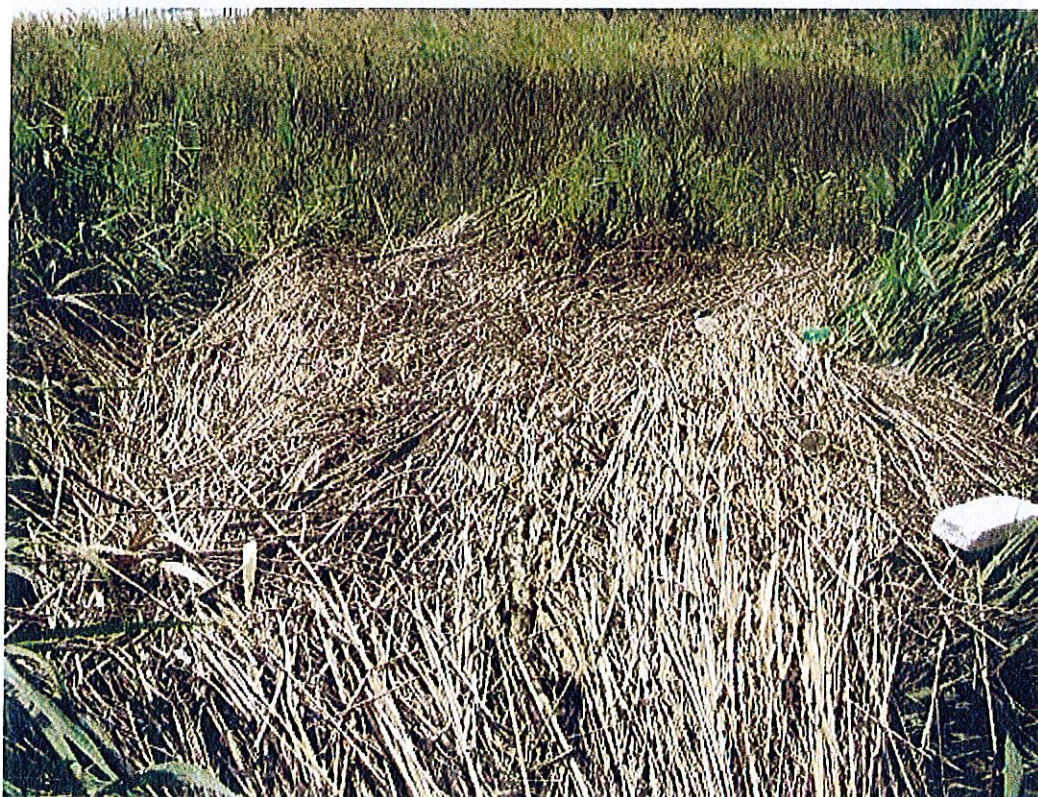
Photograph 22: Organic debris from flooding.

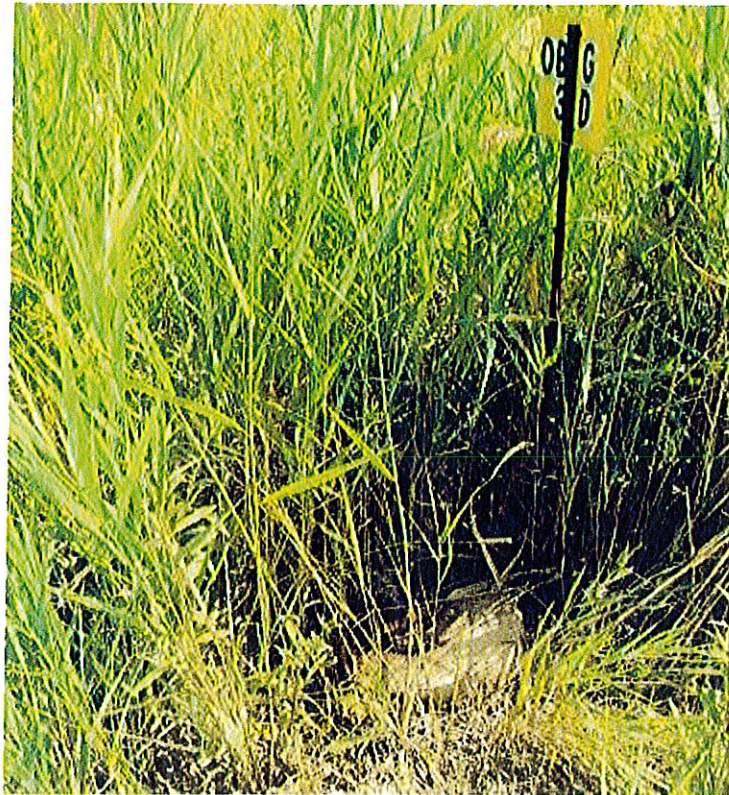
Photograph 23: OBG-3D flush mount casing appears moved.

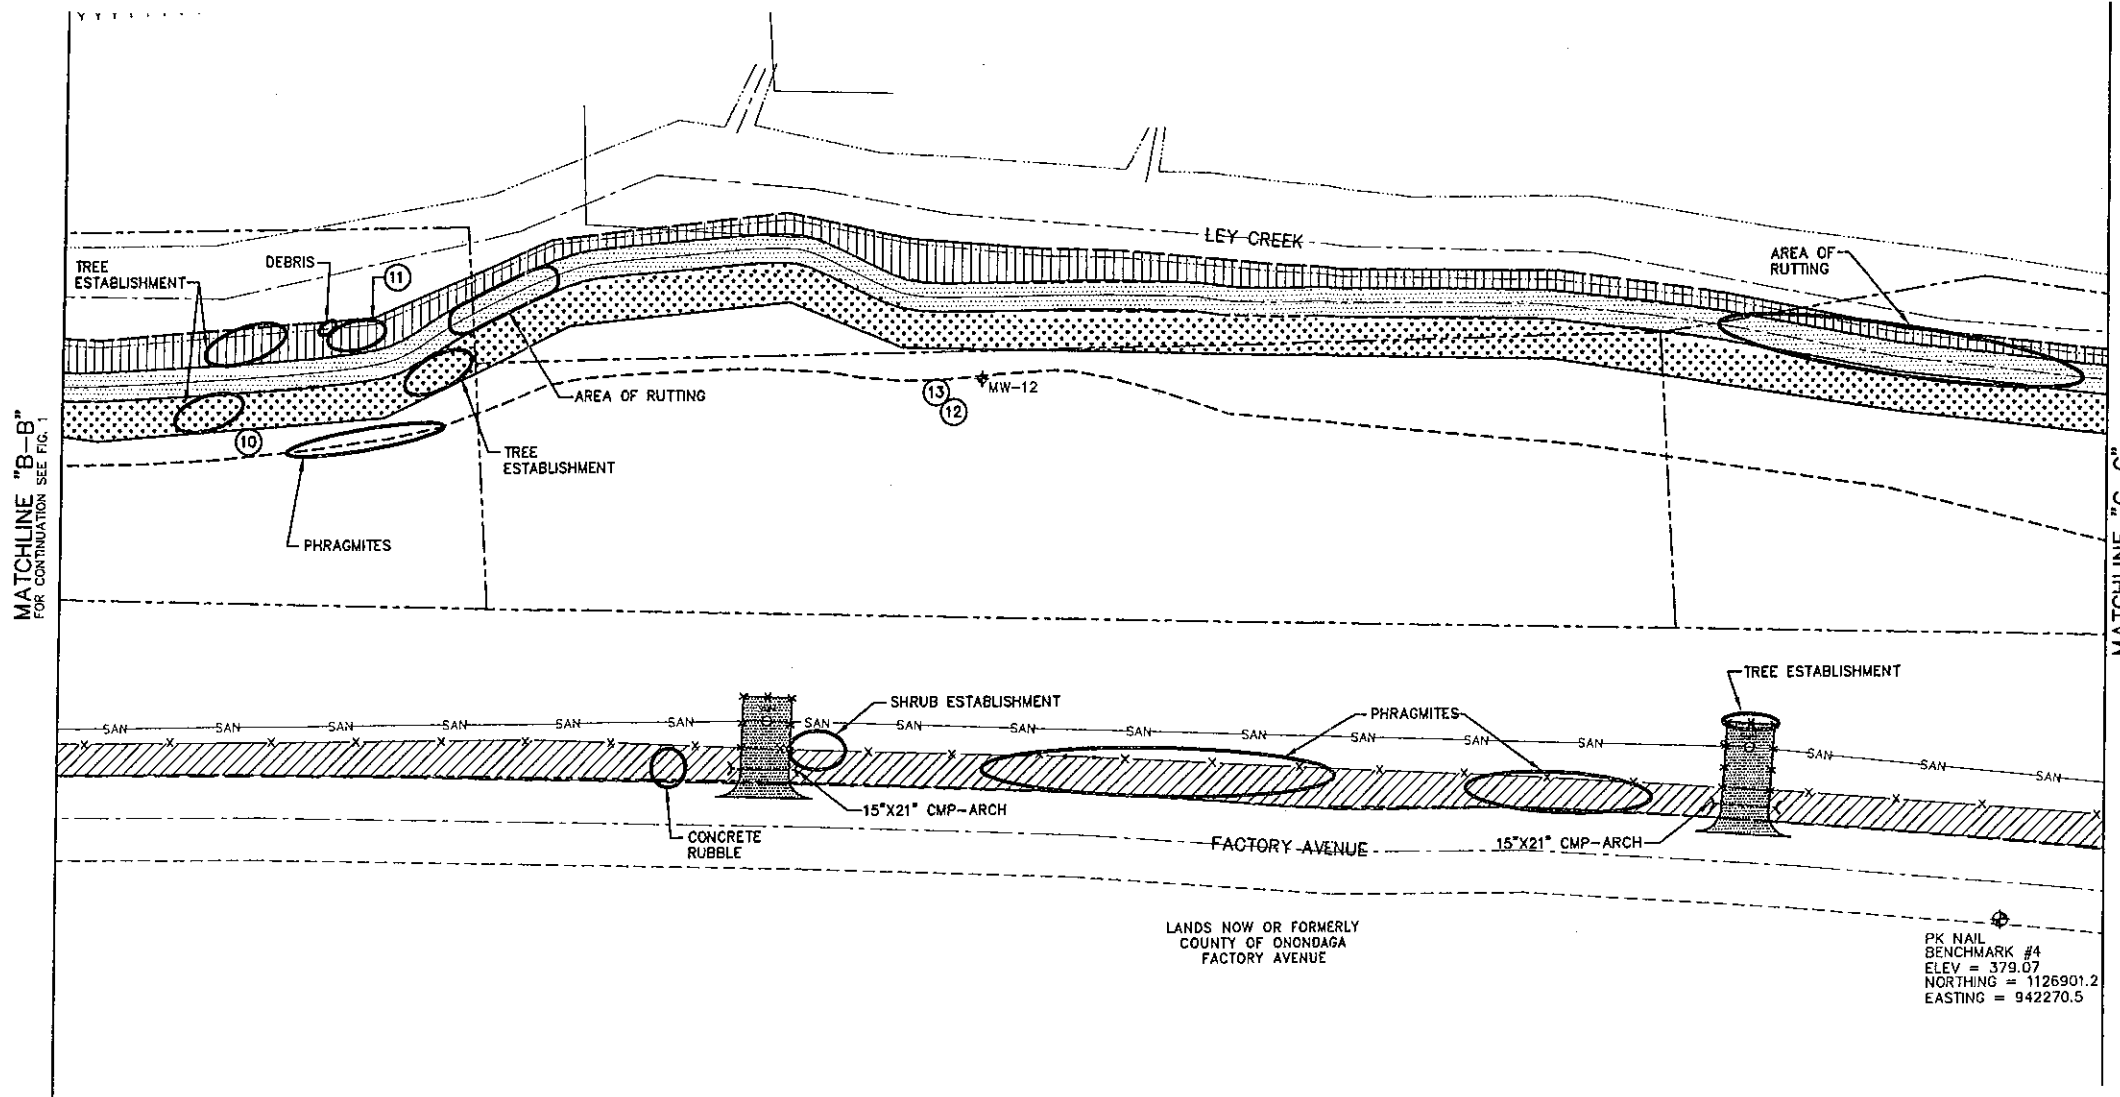
FIGURE 2

3. Areas rutted or potholes present?	X		Figures 2, 3, and 4.
	4. Areas of damage?		X	
Surface Water Drainage	Visually inspect ditches, catch basins, etc.
