Arcadis of Michigan, LLC  
28550 Cabot Drive  
Suite 500  
Novi  
Michigan 48377  
Phone: 248 994 2240  
[www.arcadis.com](http://www.arcadis.com)

Date: June 16, 2026

Subject: 2025 Exposure Barrier Inspection Report for Plant 2, Areas 2, 5-2, 5-3; Plant 3, Areas 14, 18, and 19; and Plant 6, Area 5-6  
RACER Lansing Plants, Lansing, Michigan

2025 Exposure Barrier Inspection Forms and Photograph Logs for  
Each Area

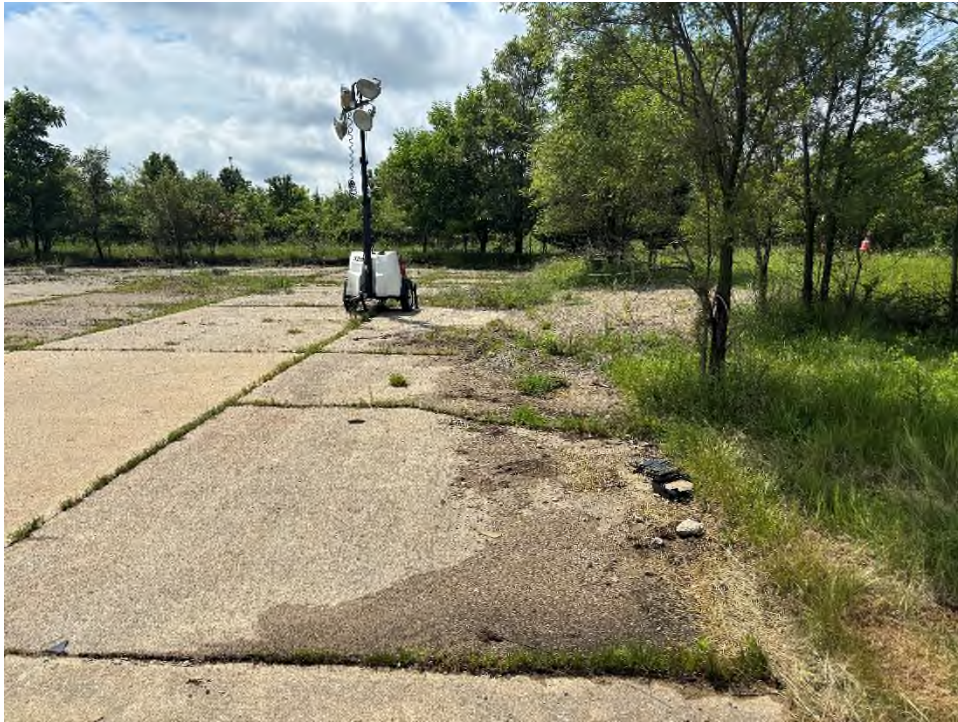
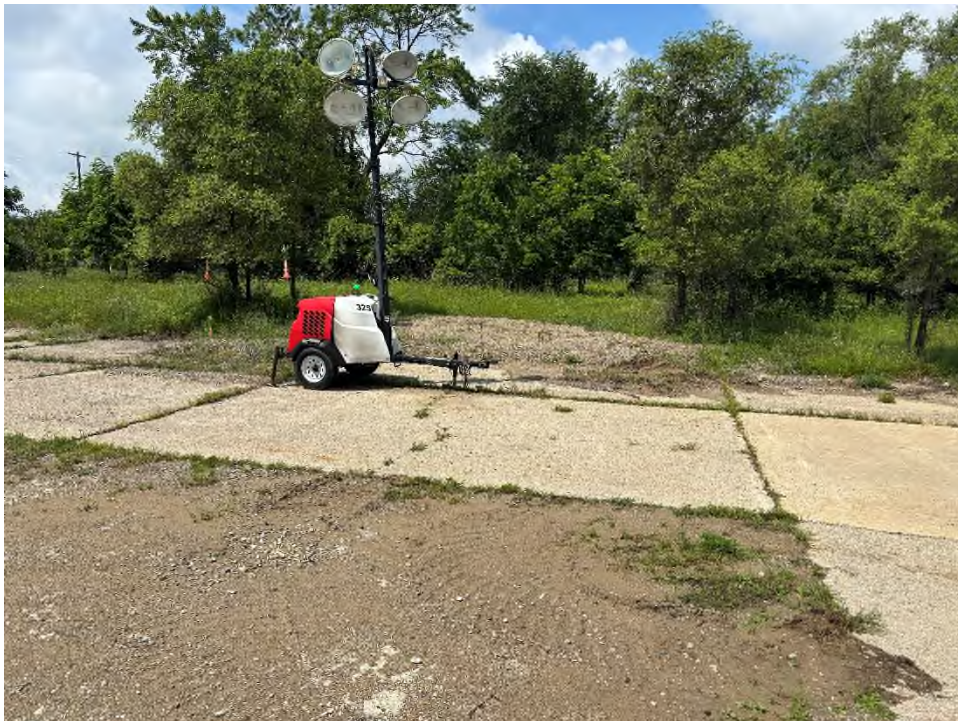
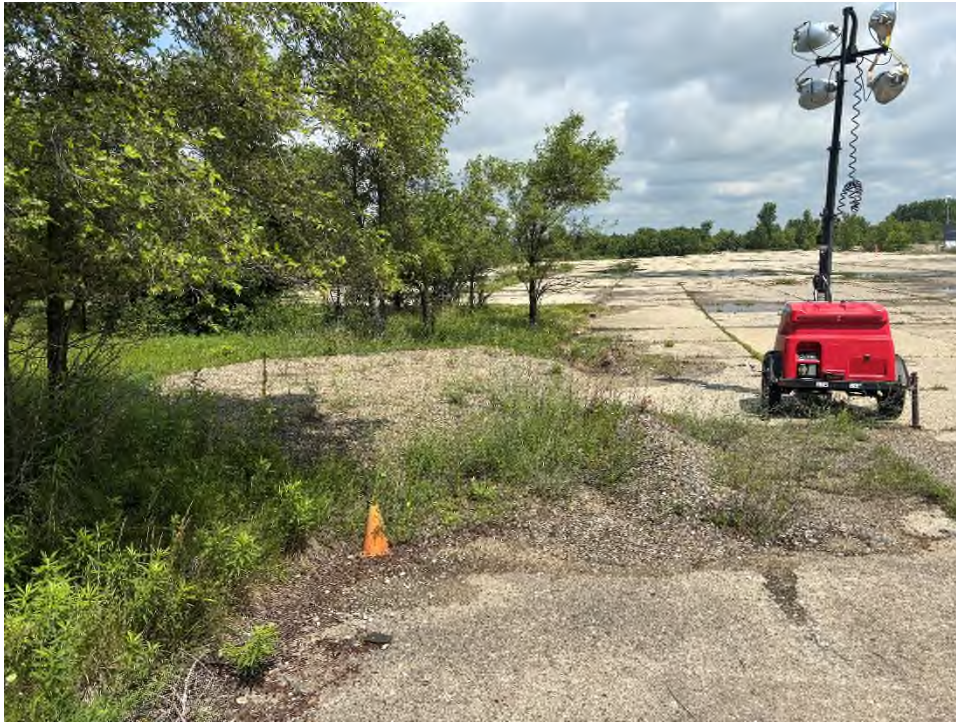
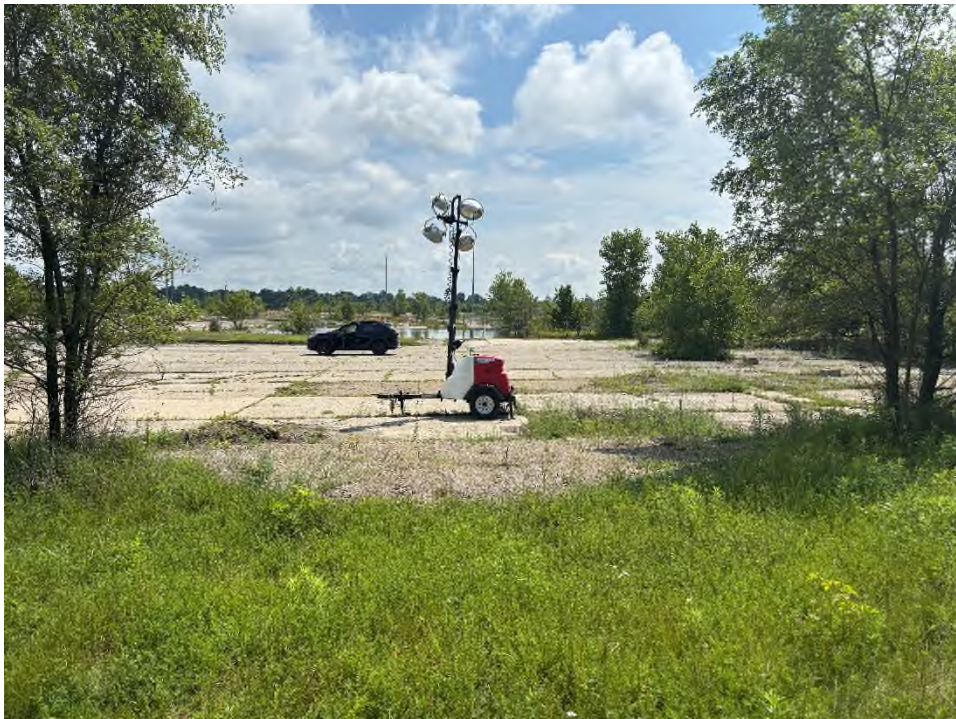
RACER Trust  
Lansing Plant 2 Area 2  
Project # 30267725

- Plant 2 Area 2 Exposure Barrier – condition was noted as satisfactory and in good condition. The exposure barrier area consists of existing concrete pavement. The concrete shows some signs of weathering and cracking, with some areas also containing short grass growth. At the time of the inspection the exposure barrier appears to be functioning adequately to prevent exposure to the underlying soil containing concentrations of arsenic that exceed Michigan Environment, Great Lakes, and Energy (EGLE) Part 201 generic Nonresidential Direct Contact Criteria (December 30, 2013). Accordingly, no corrective actions are recommended. The soils above Direct Contact Criteria for arsenic were located between existing concrete and a grassy area onsite. Therefore, in December 2023, an excavation was completed to remove impacted soils in the grassy area onsite. The existing concrete remains over the soils that were not removed during excavation and constitutes the exposure barrier area that will be visually inspected on an annual basis. The

| <b>Exposure Barrier</b> | <b>Groundcover Condition</b><br>(Describe weathering, erosion, settling, water ponding, vegetation growth, etc.) | <b>Overall Condition</b><br>(Good / Fair / Poor) | <b>Photo Notes</b><br>(Attach labelled photographs) |
|---|---|---|---|
| Plant 2 Area 2<br>Exposure Barrier | The Eastern half of the exposure barrier consists of a concrete cap. The concrete shows little cracking with short grassy growth in a few areas. The Western half of the exposure barrier consists of a gravel and dirt cap. No signs of settling, weathering, and erosion. No vegetation growing off Western half. <del>Traffic barrels and yellow plastic chain now protect barrier and flares</del> | Good | 1. See attached photo log for pictures of the area.<br>2.<br>3.<br>4. |

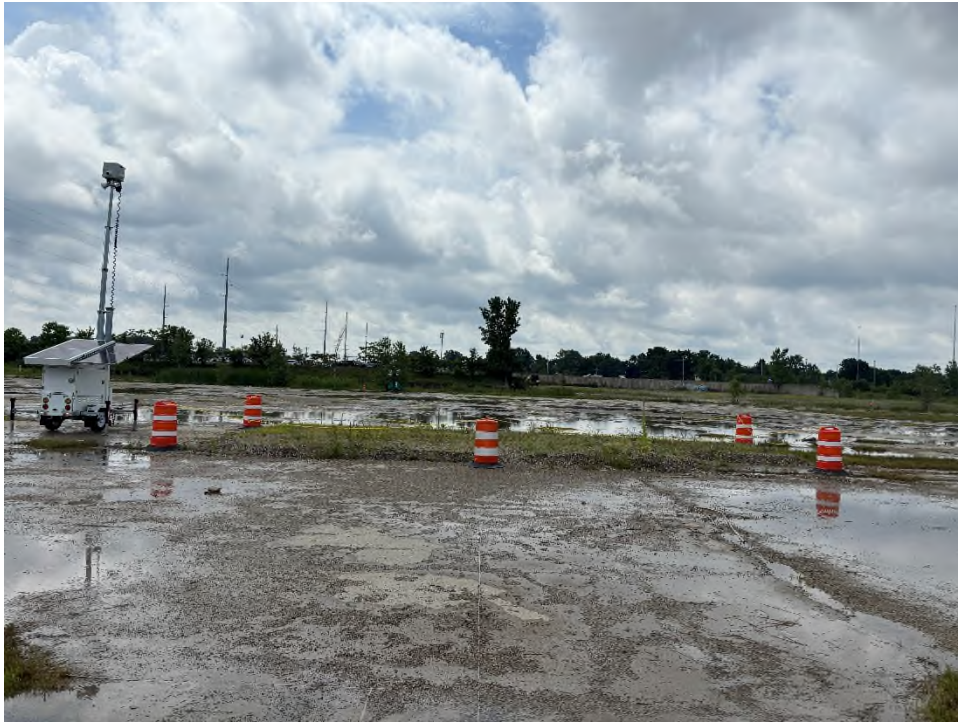
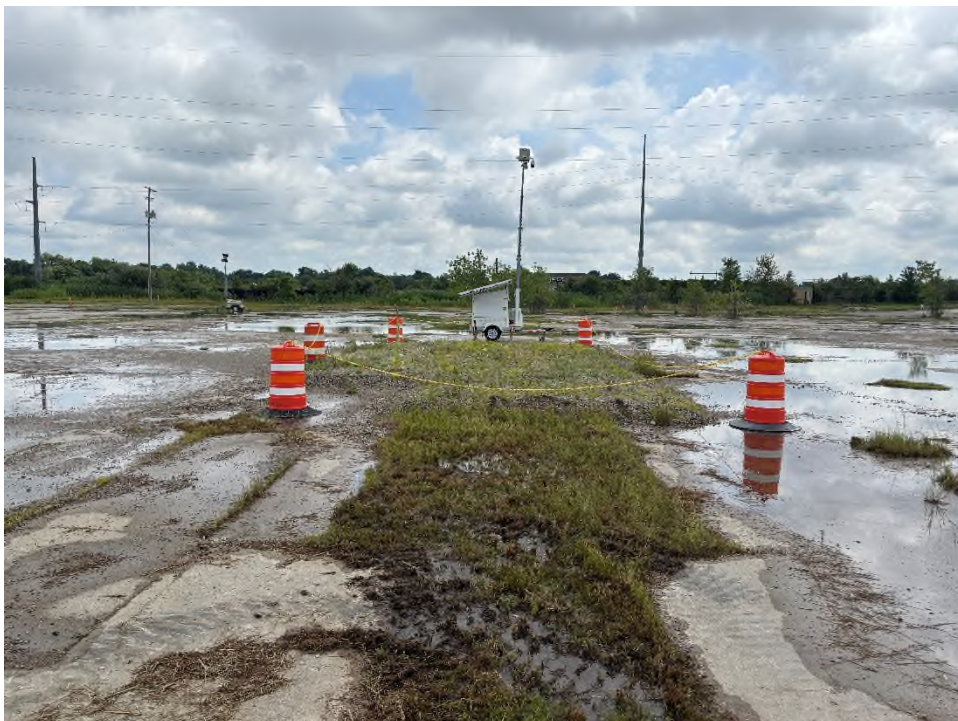
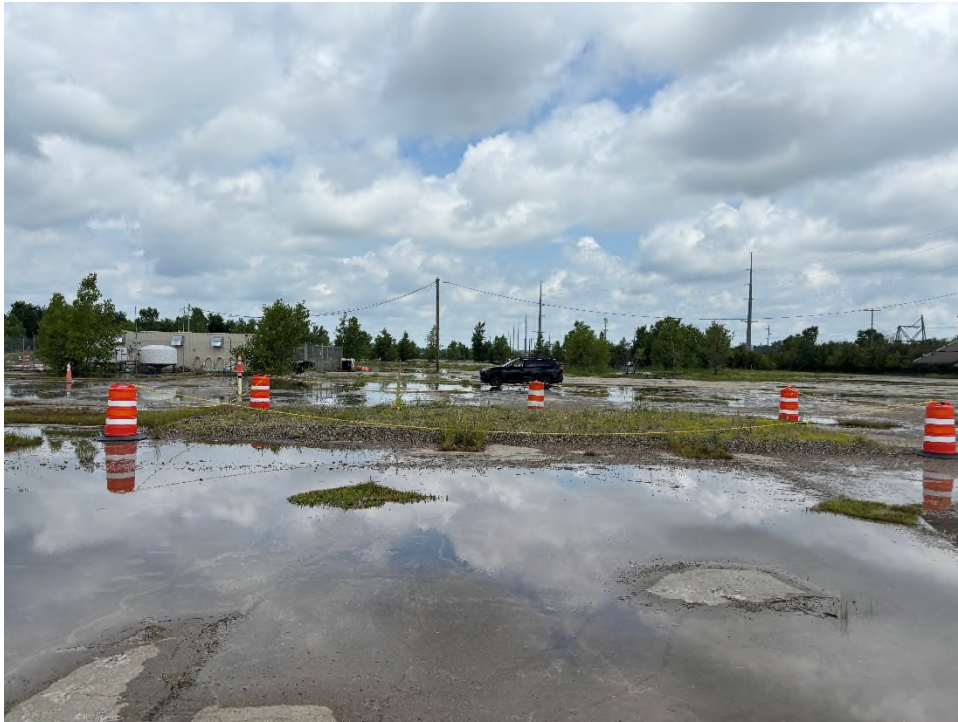
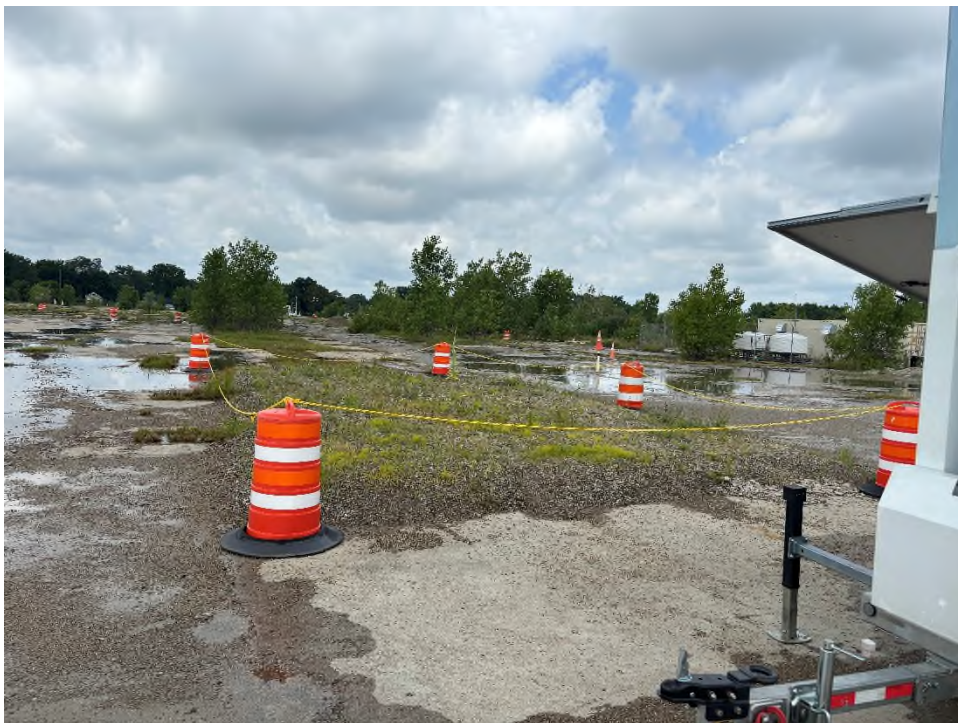
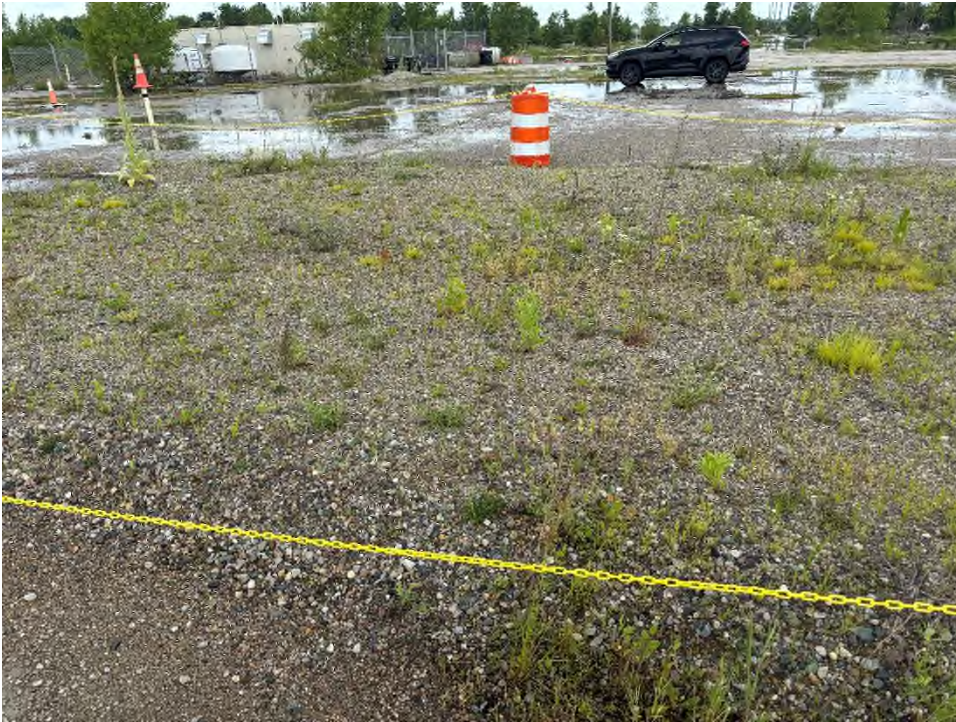
RACER Trust  
Lansing Plant 2 Area 5-2  
Project # 30267725

- Plant 2 Area 5-2 and Area 5-3 Exposure Barriers – condition was noted as satisfactory and in good condition. The exposure barriers in these areas were placed in December 2023 and consist of demarcation fabric underlying an approximate 6-inch to 1-foot layer of 22A road gravel. During inspection low lying grasses and other vegetation were observed to be growing on the majority of the exposure barrier areas. At the time of the inspection the exposure barriers appeared to be functioning adequately to prevent exposure to the underlying soil containing concentrations of benzo(a)pyrene that exceed EGLE Part 201 generic Nonresidential Direct Contact Criteria (December 30, 2013). Accordingly, no corrective actions are recommended. The exposure barrier placement activities are summarized in the *Plant 2 Area 2 Excavation and Plants 2 and 3 Exposure Barrier Placement Completion Report*, dated August 1, 2024. Due to the exposure barrier placement at Areas 5-2 and 5-3, and vehicle parking activity occurring at the Site, it was suggested that traffic barrels with yellow plastic chain link be placed around the exposure barrier areas to identify these areas and prevent vehicles from driving over the barriers. This was completed in July 2024 and was still in place during 2025 inspections.

| <b>Exposure Barrier</b> | <b>Groundcover Condition</b><br>(Describe weathering, erosion, settling, water ponding, vegetation growth, etc.) | <b>Overall Condition</b><br>(Good / Fair / Poor) | <b>Photo Notes</b><br>(Attach labelled photographs) |
|---|---|---|---|
| Plant 2 Area 5-2<br>Exposure Barrier | Most of the exposure barrier ground cover consists of a gravel and dirt cap. No signs of settling, weathering, and erosion. Low lying grasses and other vegetation now growing on majority of the cap. Traffic barrels and yellow plastic chain now protect the barrier. | Good | 1. See attached photo log for pictures of the area.<br>2.<br>3.<br>4. |

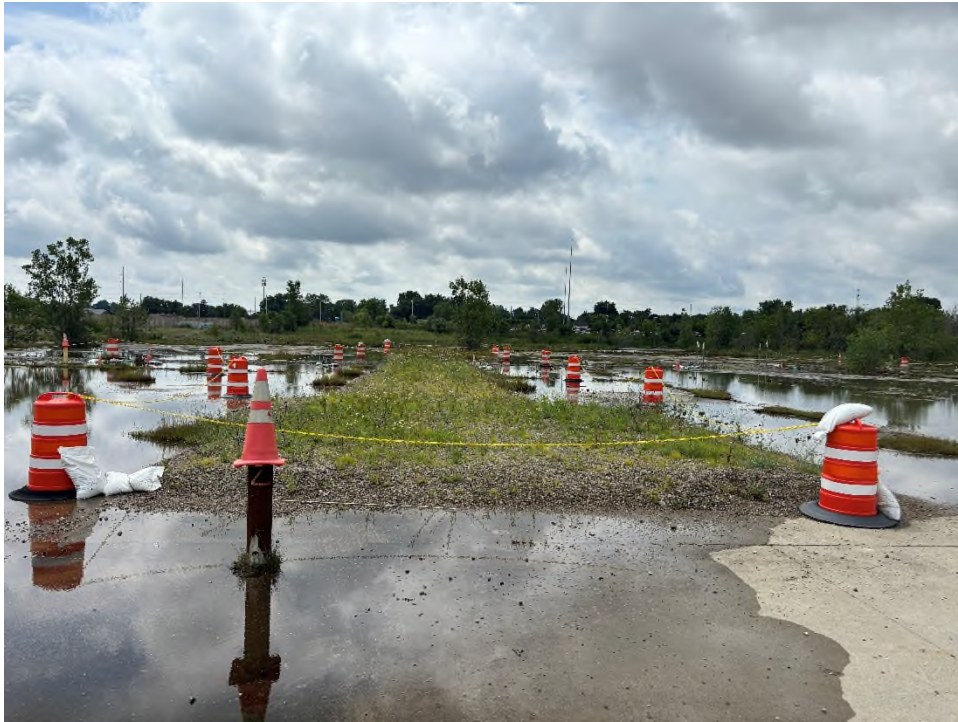
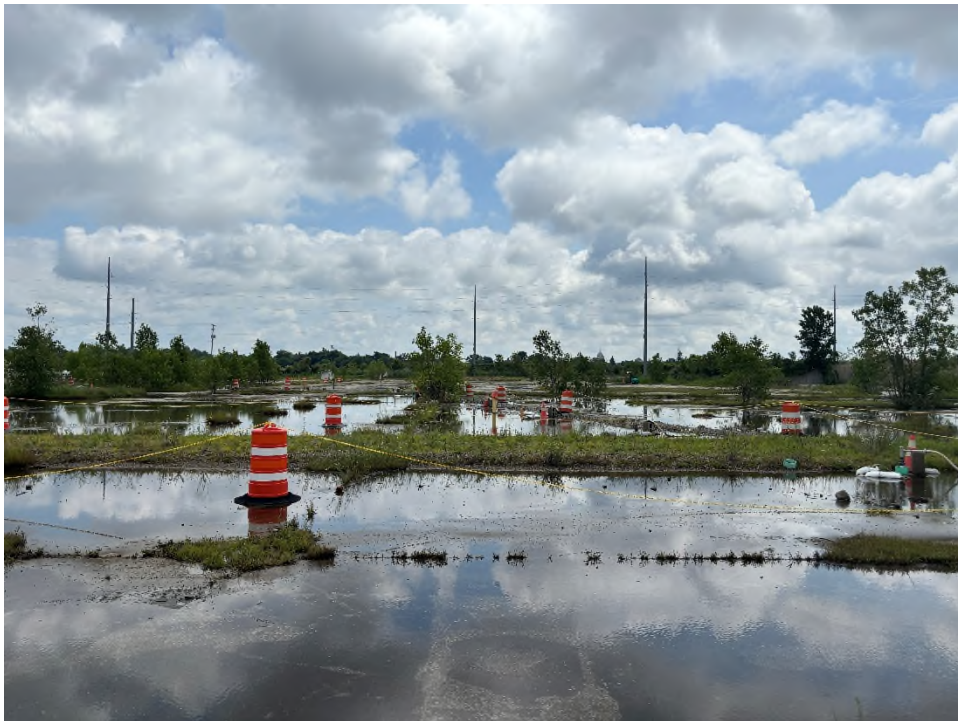
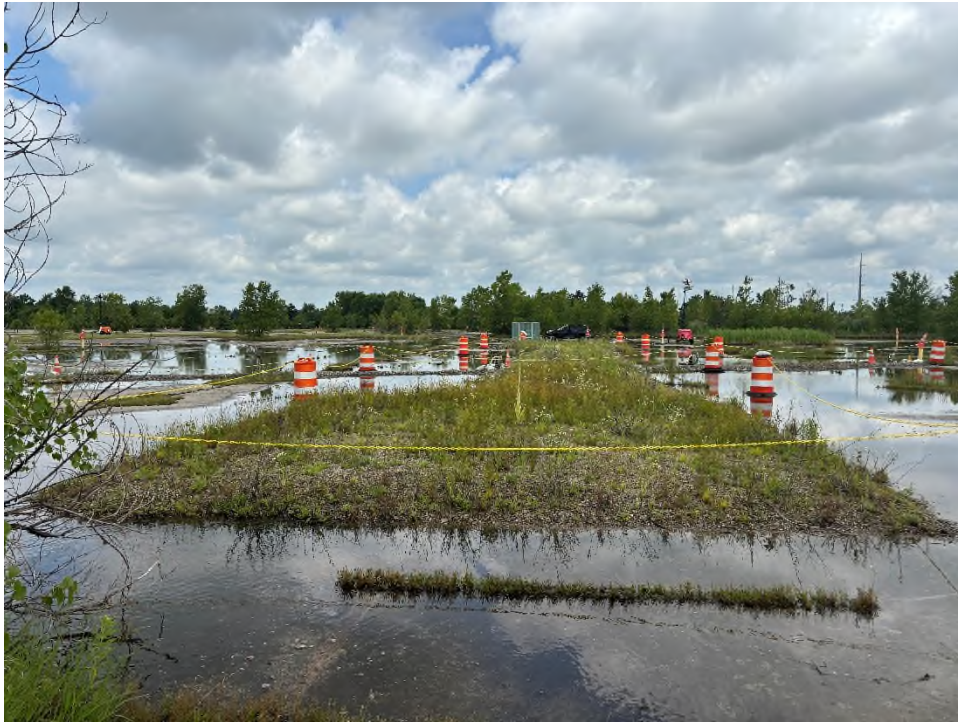
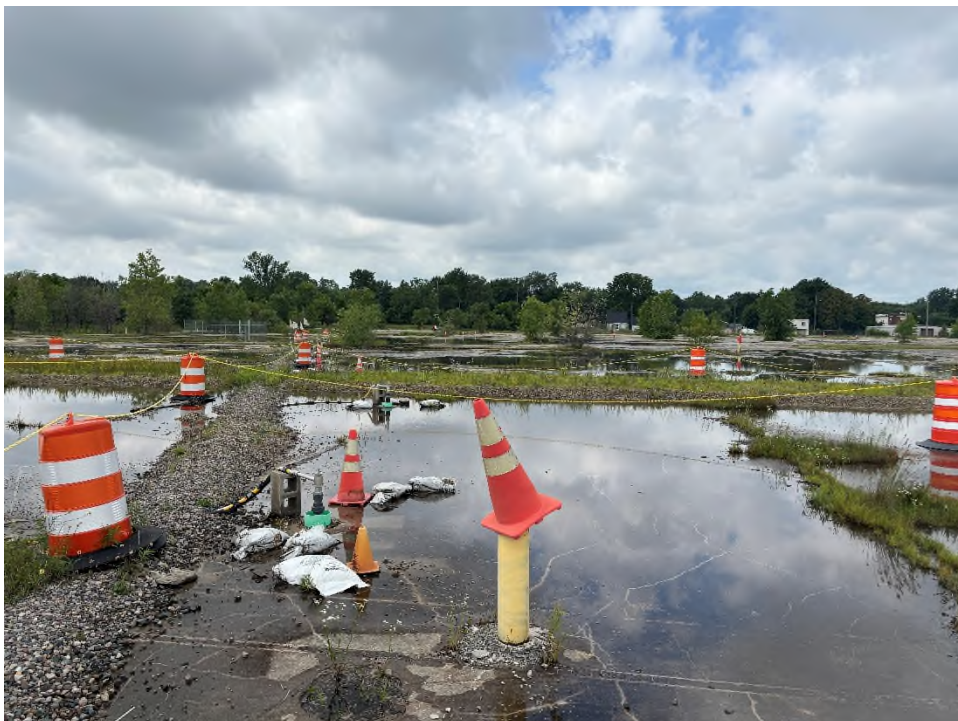
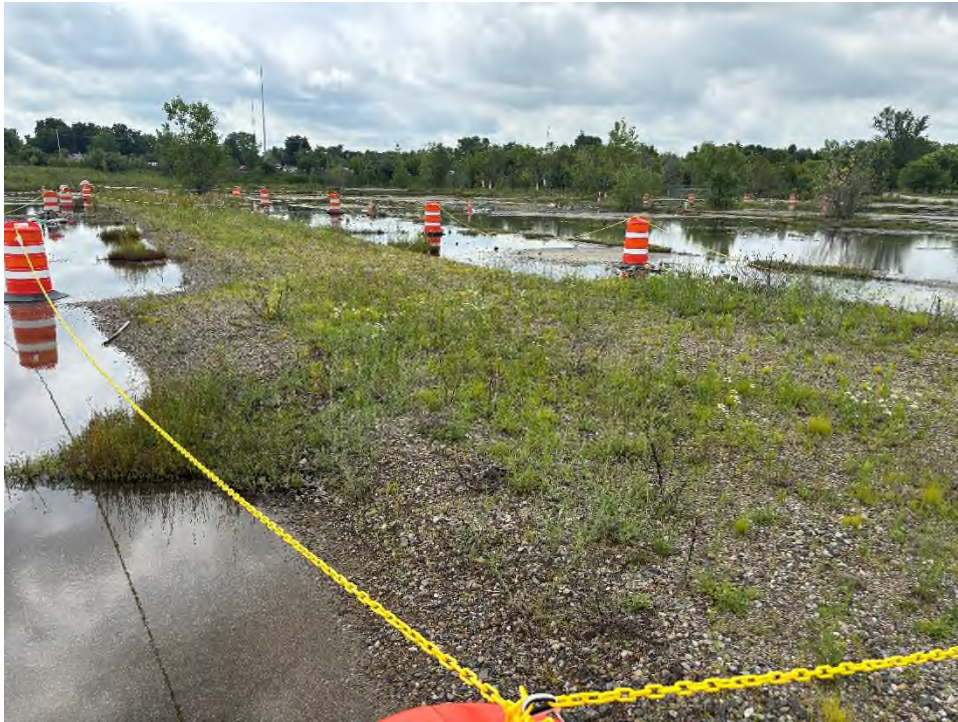
RACER Trust  
Lansing Plant 2 Area 5-3  
Project # 30267725

| <b>Exposure Barrier</b> | <b>Groundcover Condition</b><br>(Describe weathering, erosion, settling, water ponding, vegetation growth, etc.) | <b>Overall Condition</b><br>(Good / Fair / Poor) | <b>Photo Notes</b><br>(Attach labelled photographs) |
|---|---|---|---|
| Plant 2 Area 5-3<br>Exposure Barrier | Most of the exposure barrier ground cover consists of a gravel and dirt cap. No signs of settling, weathering, and erosion. Low lying grasses and other vegetation now growing on majority of the cap. Traffic barrels and yellow plastic chain now protect barrier. | Good | 1. See attached photo log for pictures of the area.<br>2.<br>3.<br>4. |

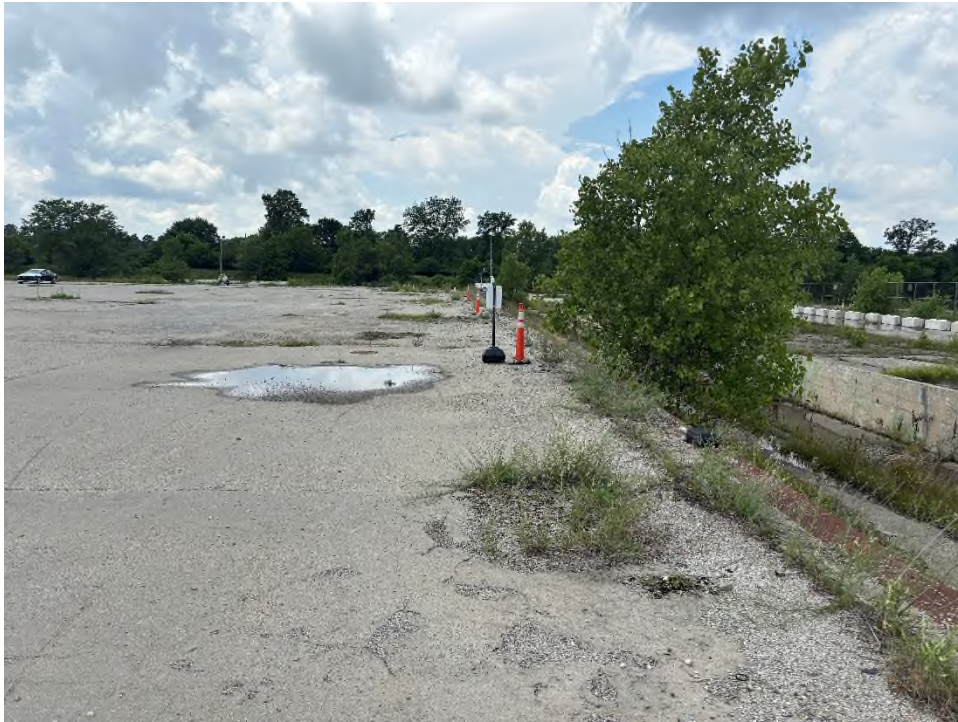
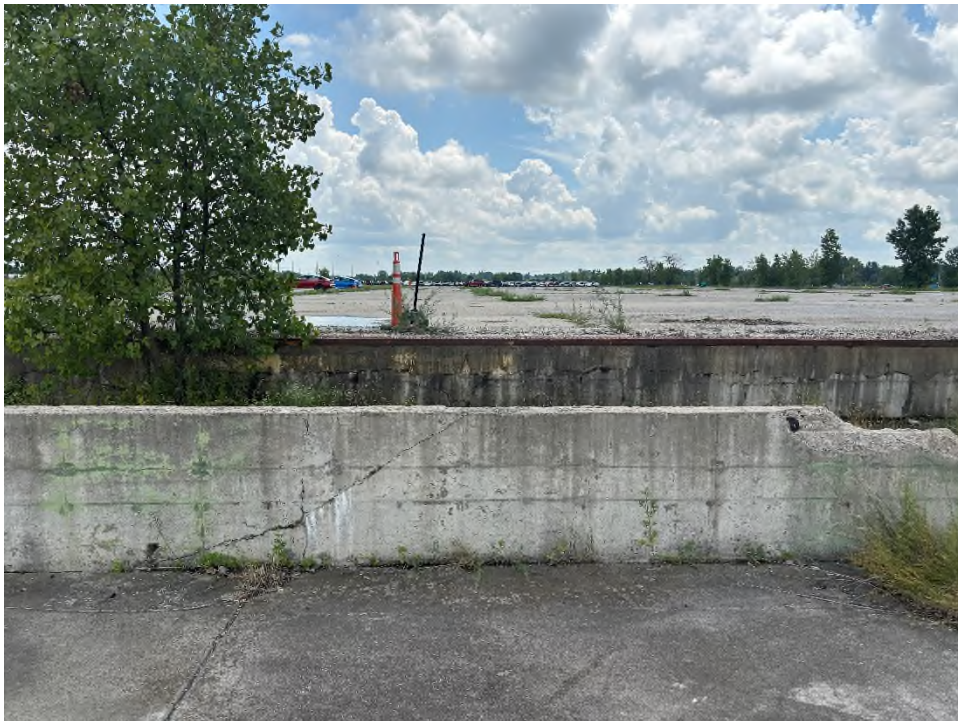
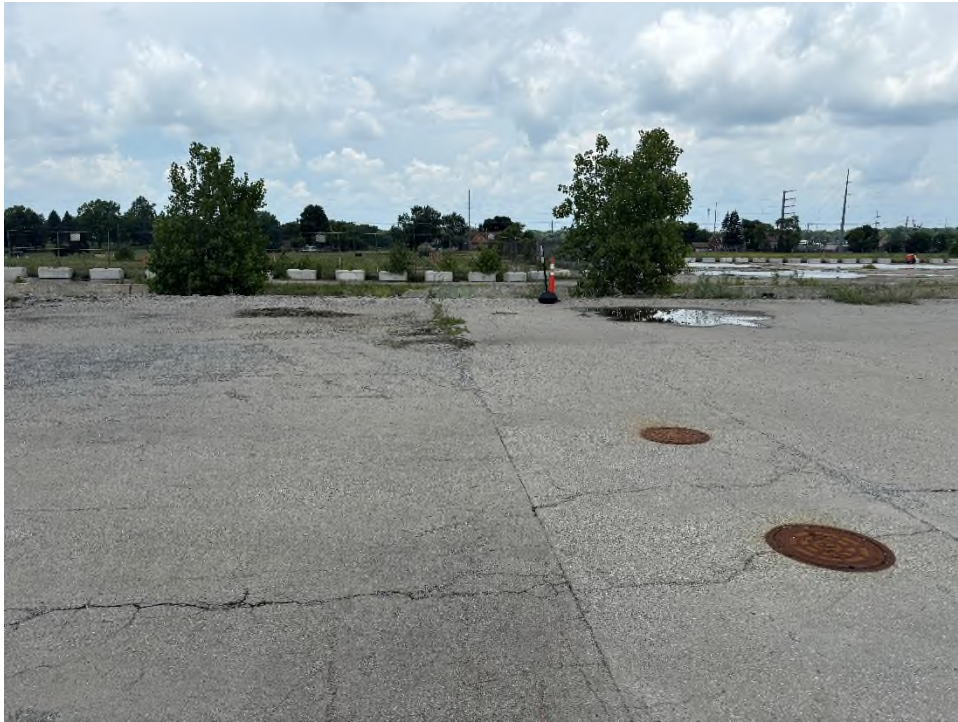
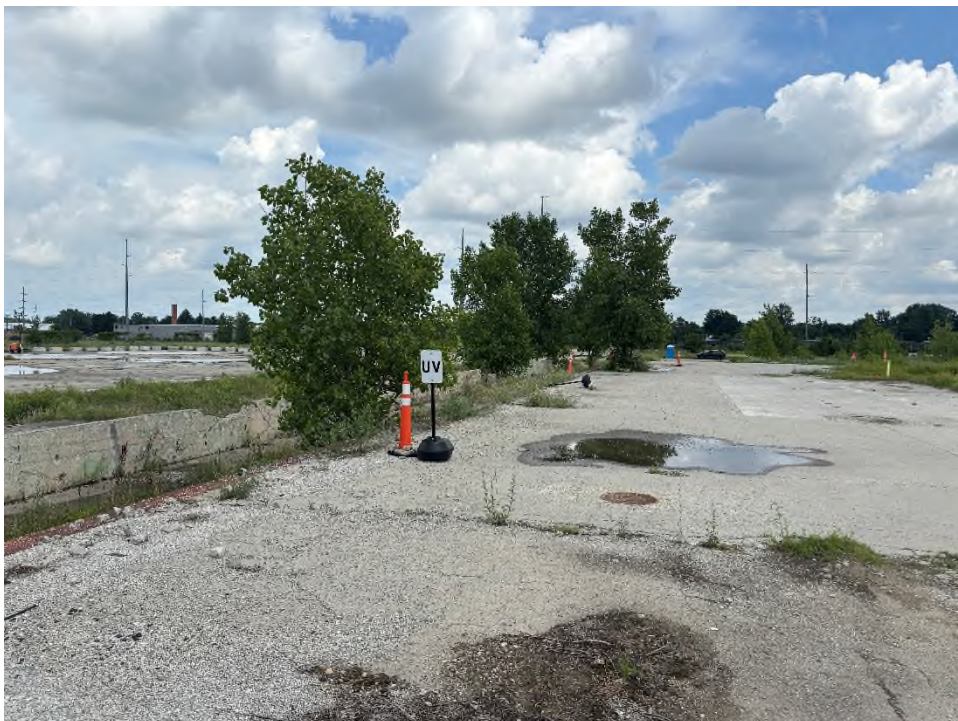
RACER Trust  
Lansing Plant 3 Area 14  
Project # 30267725

- Plant 3 Area 14 Exposure Barrier – condition was noted as satisfactory and in fair condition. The exposure barrier in this area consists of existing concrete pavement. The concrete shows some signs of weathering and cracking, with some areas also containing vegetation growth. At the time of the inspection the exposure barrier appears to be functioning adequately to prevent exposure to the underlying soil containing concentrations of cyanide that exceed EGLE Part 201 generic Nonresidential Direct Contact Criteria (December 30, 2013). Accordingly, no corrective actions are recommended.

| <b>Exposure Barrier</b> | <b>Groundcover Condition</b><br>(Describe weathering, erosion, settling, water ponding, vegetation growth, etc.) | <b>Overall Condition</b><br>(Good / Fair / Poor) | <b>Photo Notes</b><br>(Attach labelled photographs) |
|---|---|---|---|
| Plant 3 Area 14<br>Exposure Barrier | Most of the exposure barrier ground cover consists of concrete pavement. The area shows some signs of weathering and cracking. There are a couple poplar trees and some weeds growing up through the cracks. | Fair | 1. See attached photo log for<br>2. pictures of the area.<br>3.<br>4. |

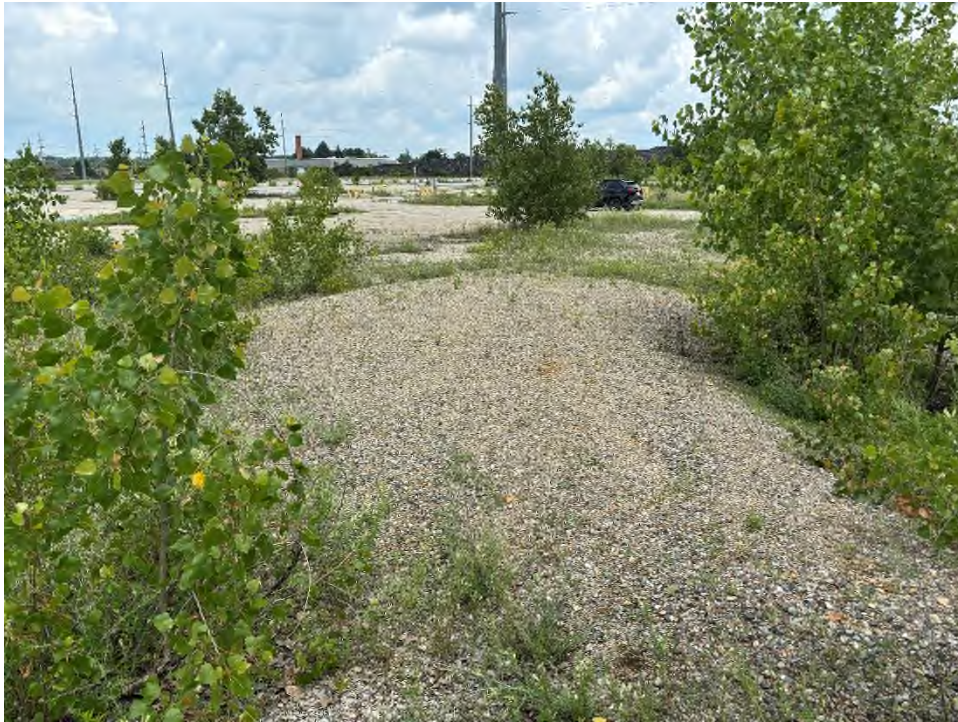
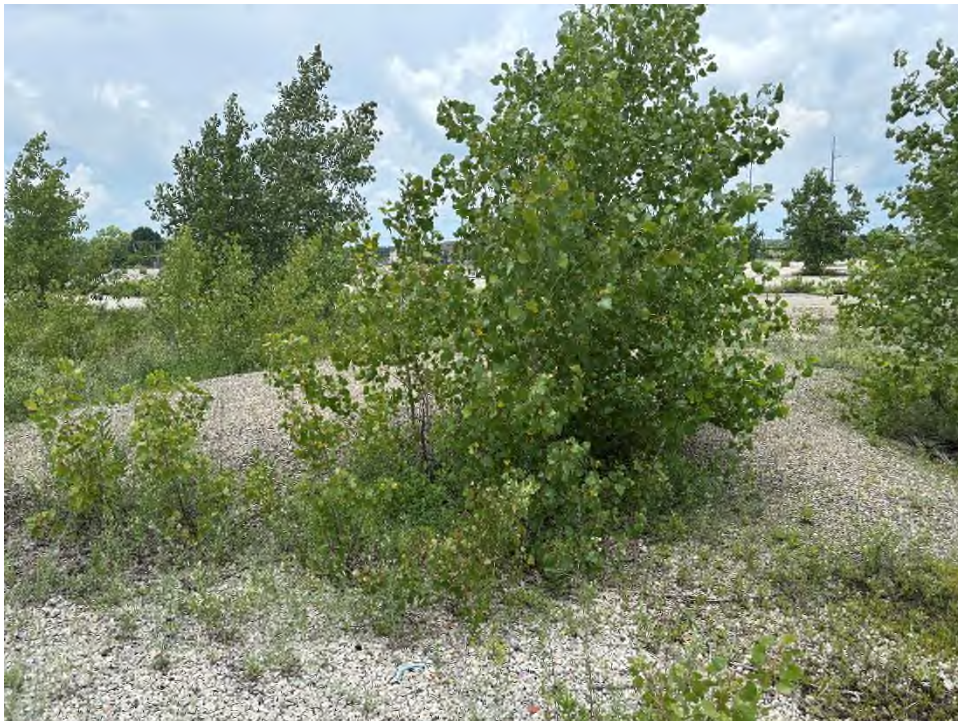
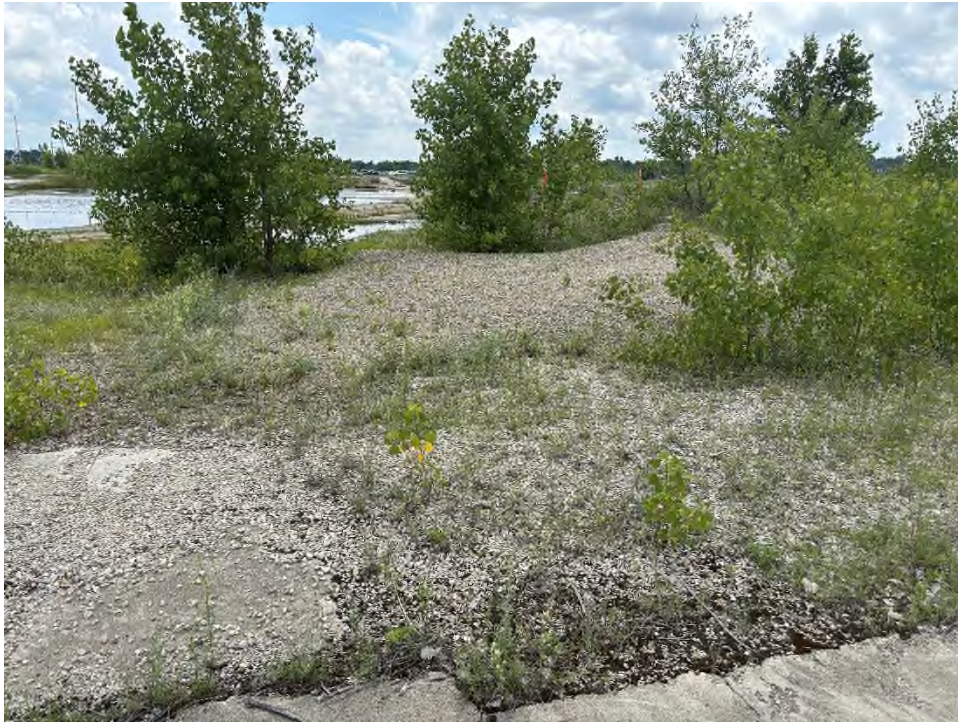
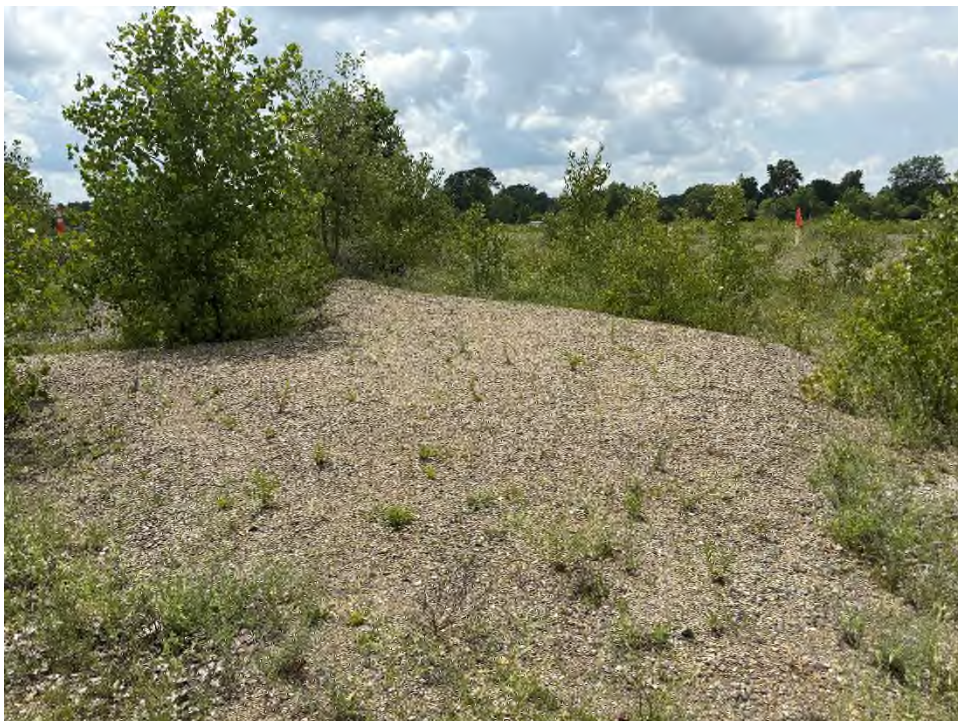
RACER Trust  
Lansing Plant 3 Area 18  
Project # 30267725

- Plant 3 Area 18 Exposure Barrier – condition was noted as satisfactory and in good condition. The exposure barrier in this area was placed in December 2023 and consists of demarcation fabric underlying a layer of 22A road gravel. During inspection no vegetation was observed to be growing in the exposure barrier areas. A few small shrubs were observed to be growing near the perimeter of the barrier. At the time of the inspection the exposure barrier appeared to be functioning adequately to prevent exposure to the underlying soil containing concentrations of benzo(a)pyrene that exceed EGLE Part 201 generic Nonresidential Direct Contact Criteria (December 30, 2013). Accordingly, no corrective actions are recommended. The exposure barrier placement activities are summarized in the *Plant 2 Area 2 Excavation and Plants 2 and 3 Exposure Barrier Placement Completion Report*, dated August 1, 2024.

| <b>Exposure Barrier</b> | <b>Groundcover Condition</b><br>(Describe weathering, erosion, settling, water ponding, vegetation growth, etc.) | <b>Overall Condition</b><br>(Good / Fair / Poor) | <b>Photo Notes</b><br>(Attach labelled photographs) |
|---|---|---|---|
| Plant 3 Area 18<br>Exposure Barrier | Most of the exposure barrier ground cover consists of a gravel and dirt cap. No signs of settling, weathering, and erosion. No vegetation growing in the gravel and dirt at this time. Few poplar shrubs growing near the perimeter. | Good | 1. See attached photo log for<br>2. pictures of the area.<br>3.<br>4. |

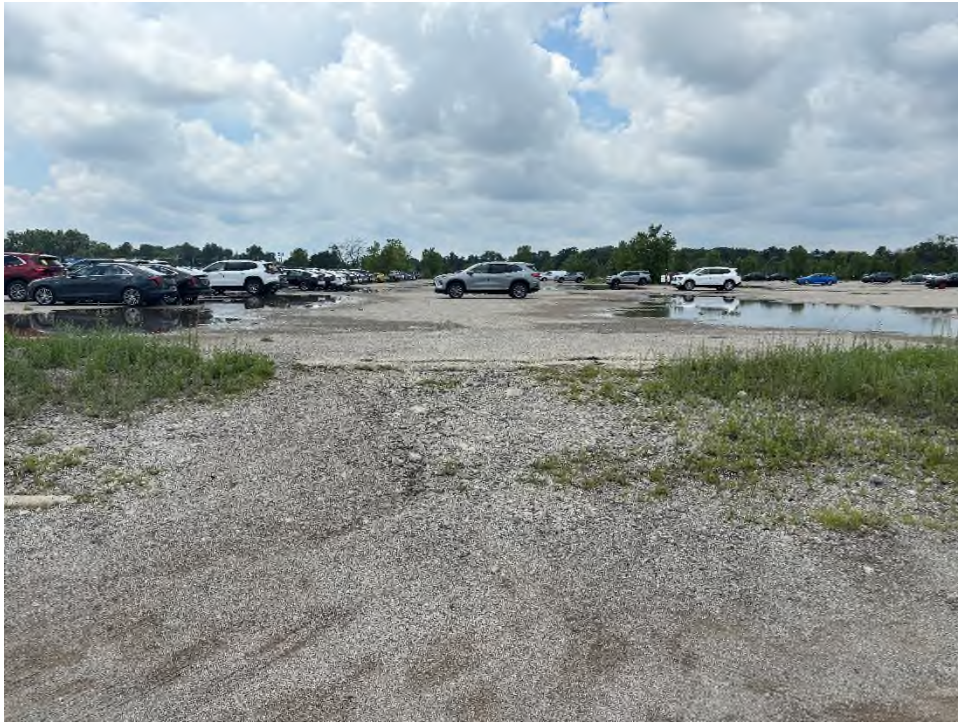
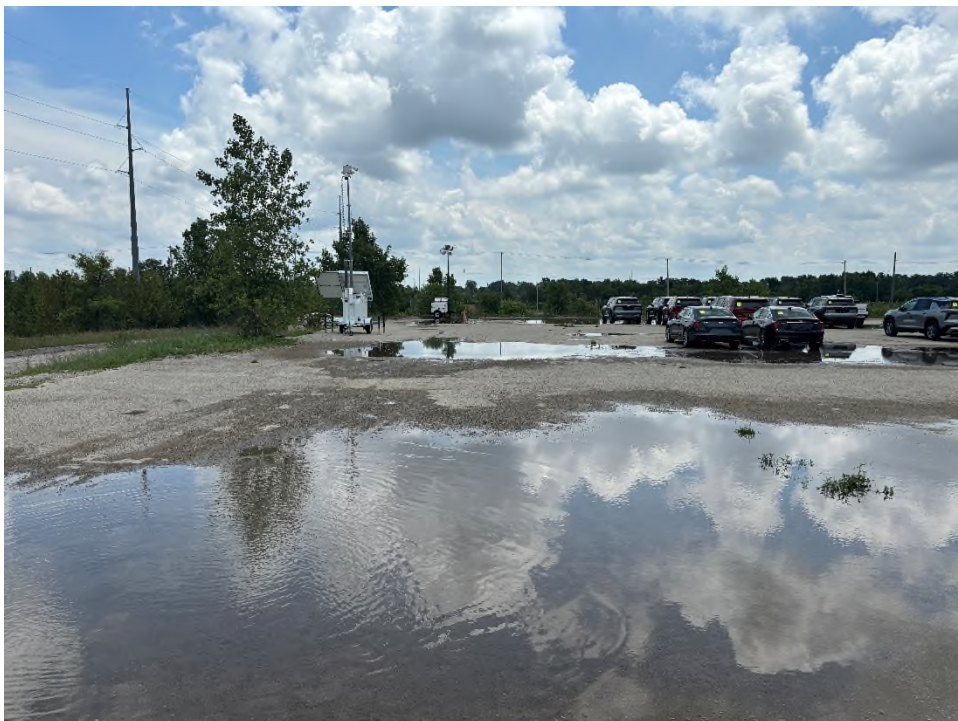
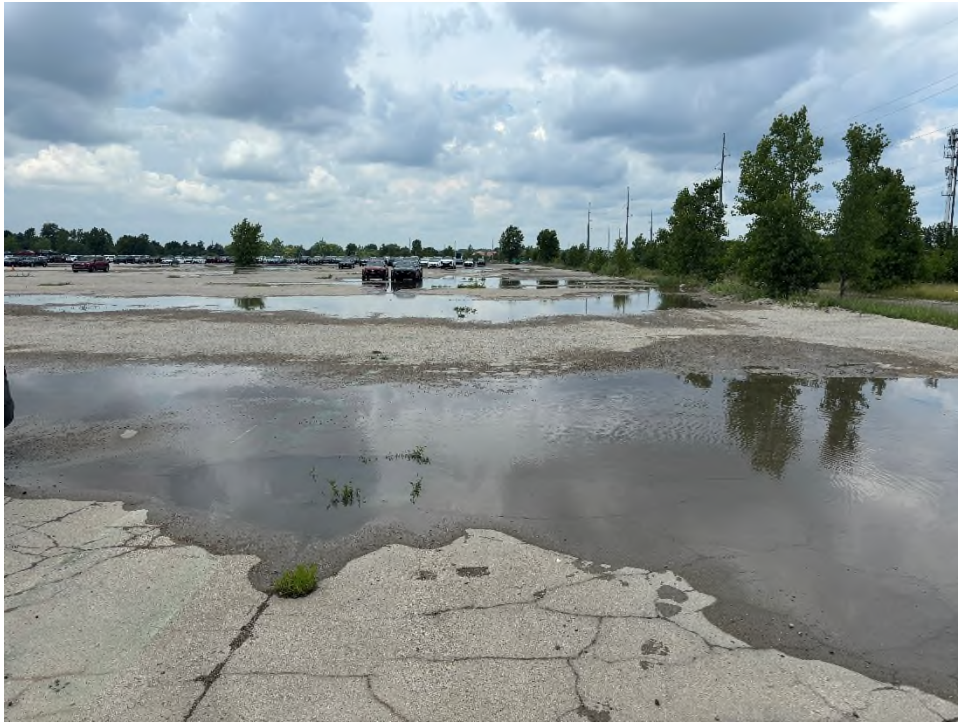
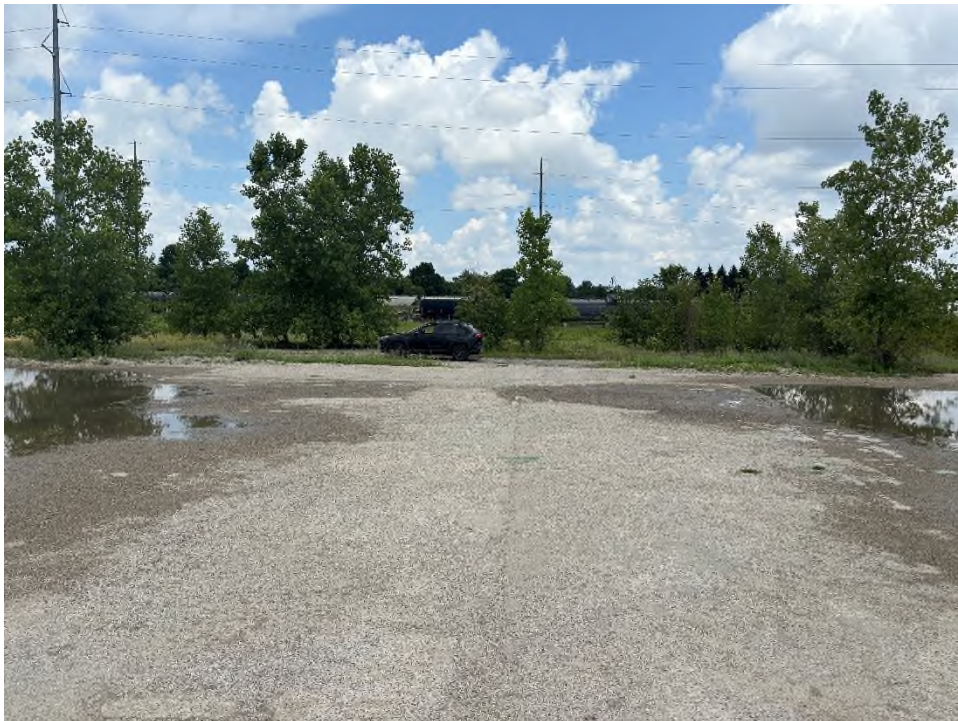
RACER Trust  
Lansing Plant 3 Area 19  
Project # 30267725

- Plant 3 Area 19 Exposure Barrier – condition was noted as satisfactory and fair condition. The exposure barrier area consists of existing concrete pavement. The concrete shows some signs of weathering and cracking. At the time of the inspection the exposure barrier appeared to be functioning adequately to prevent exposure to the underlying soil containing concentrations of arsenic that exceed EGLE Part 201 generic Nonresidential Direct Contact Criteria (December 30, 2013). Accordingly, no corrective actions are recommended.

| <b>Exposure Barrier</b> | <b>Groundcover Condition</b><br>(Describe weathering, erosion, settling, water ponding, vegetation growth, etc.) | <b>Overall Condition</b><br>(Good / Fair / Poor) | <b>Photo Notes</b><br>(Attach labelled photographs) |
|---|---|---|---|
| Plant 3 Area 19<br>Exposure Barrier | Most of the exposure barrier ground cover consists of concrete pavement. The area shows some signs of weathering and cracking. | Fair | 1. See attached photo log for<br>2. pictures of the area.<br>3.<br>4. |
