Arcadis of Michigan, LLC  
28550 Cabot Drive  
Suite 500  
Novi  
Michigan 48377  
Phone: 248 994 2240  
[www.arcadis.com](http://www.arcadis.com)

Date: June 16, 2026

Subject: 2025 Exposure Barrier Inspection Report for Plant 2, Areas 2, 5-2, 5-3; Plant 3, Areas 14, 18, and 19; and Plant 6, Area 5-6  
RACER Lansing Plants, Lansing, Michigan

2025 Exposure Barrier Inspection Forms and Photograph Logs for  
Each Area

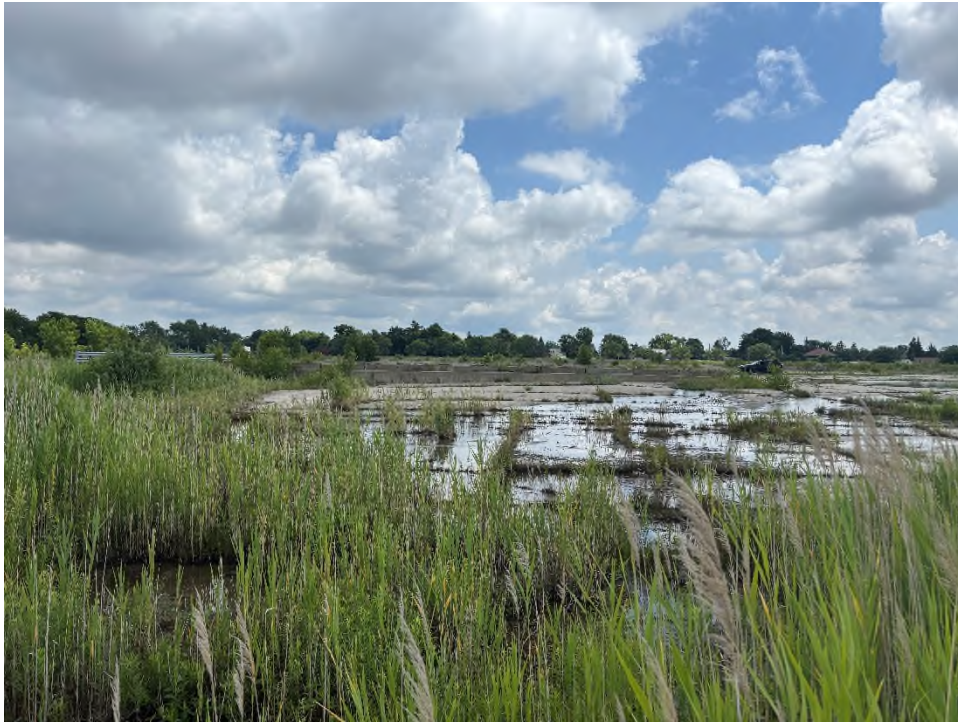
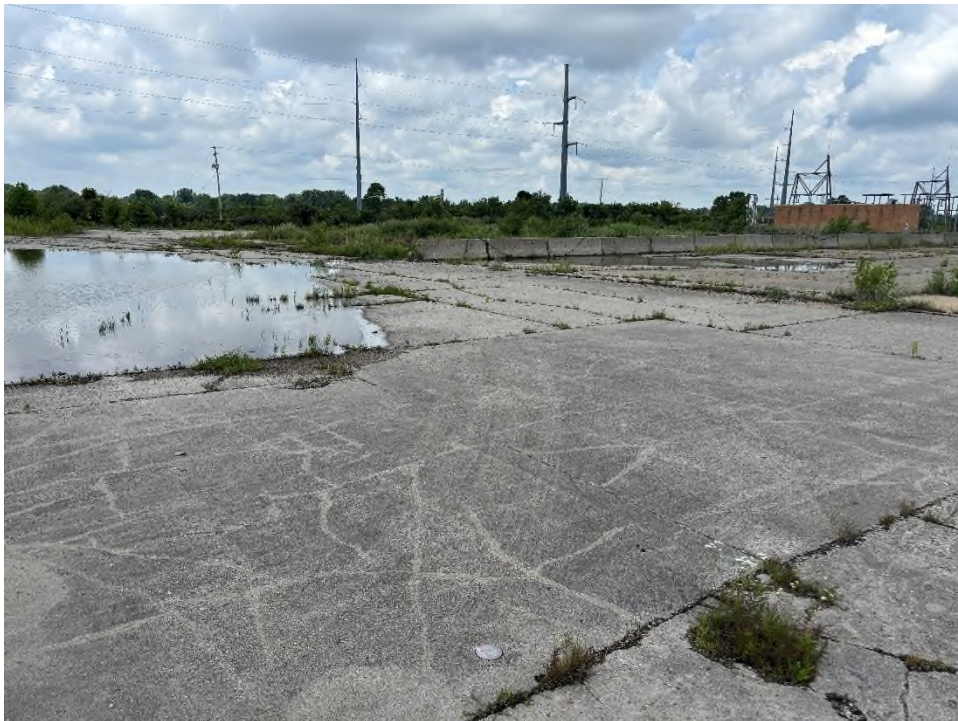
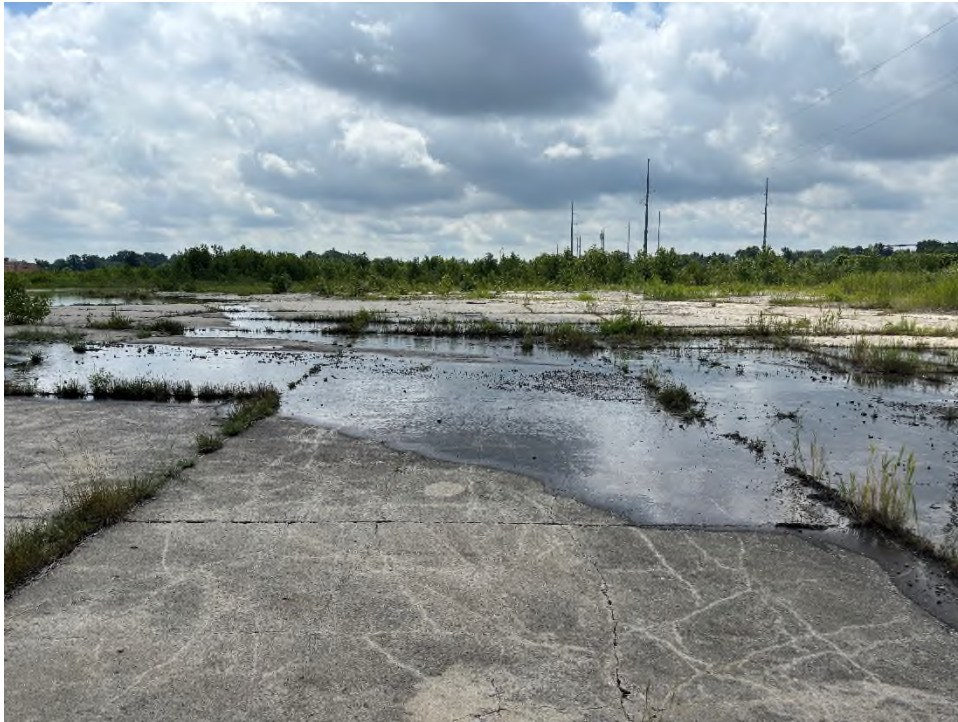
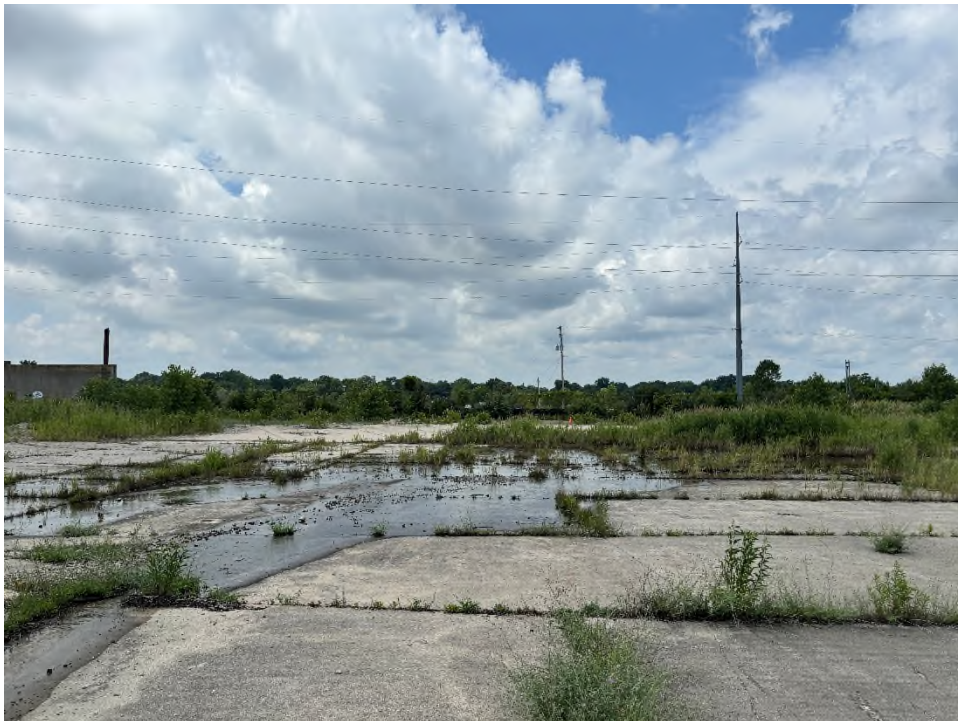
RACER Trust  
Lansing Plant 6 Area 5-6  
Project # 30267725

- Plant 6 Area 5-6 Exposure Barrier – condition was noted as satisfactory and in fair condition. The exposure barrier area consists of portions of concrete pavement as well as some areas of crushed concrete. The concrete shows some signs of weathering and cracking, with some areas also containing vegetation growth and some standing water. At the time of the inspection the exposure barrier appeared to be functioning adequately to prevent exposure to the underlying soil containing concentrations of lead that exceed EGLE Part 201 generic Nonresidential Direct Contact Criteria (December 30, 2013). Accordingly, no corrective actions are recommended. The steel markers placed in September 2023 were still present, in good condition, with the stamping on the markers legible during the 2025 inspection.

| Exposure Barrier | Groundcover Condition<br>(Describe weathering, erosion, settling, water ponding, vegetation growth, etc.) | Overall Condition<br>(Good / Fair / Poor) | Photo Notes<br>(Attach labelled photographs) |
|---|---|---|---|
| Area 5-6 Exposure Barrier | Most of the exposure barrier ground cover consists of concrete pavement with some sections containing crushed concrete. The concrete shows some signs of weathering and cracking, with some areas containing poplar tree and phragmite growth. A few areas have ponding water. | Fair. | <ol style="list-style-type: none"> <li>1. See attached photos of the area</li> <li>2.</li> <li>3.</li> <li>4.</li> </ol> |

Based on the above observations, are any corrective actions (i.e., repairs) required? The overall condition of the ground cover is fair. Brush clearing and/or mowing is recommended.

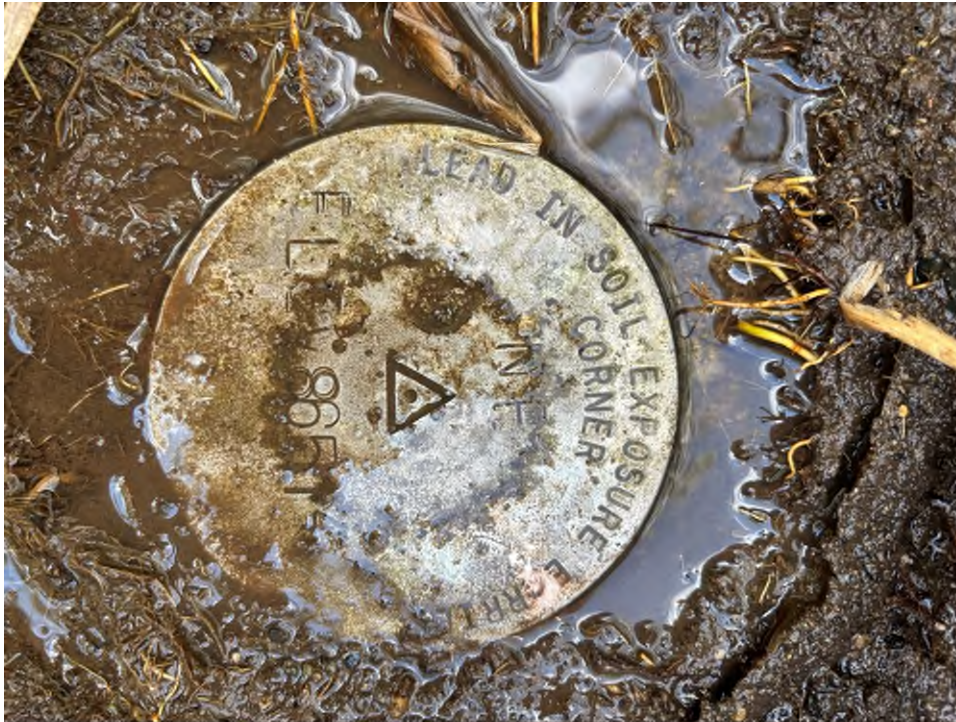
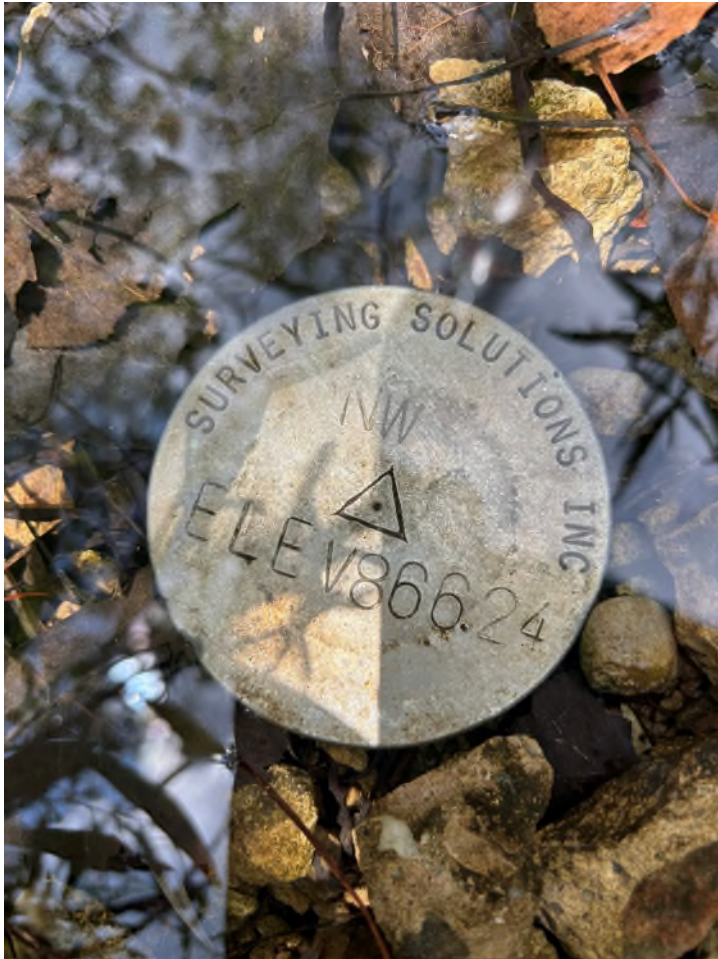
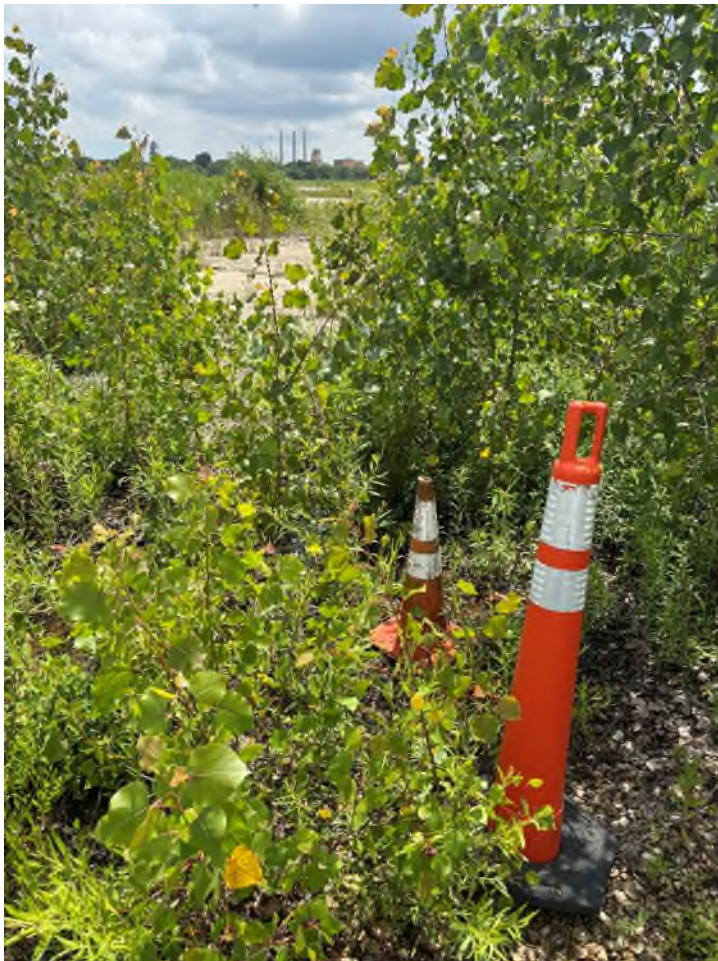
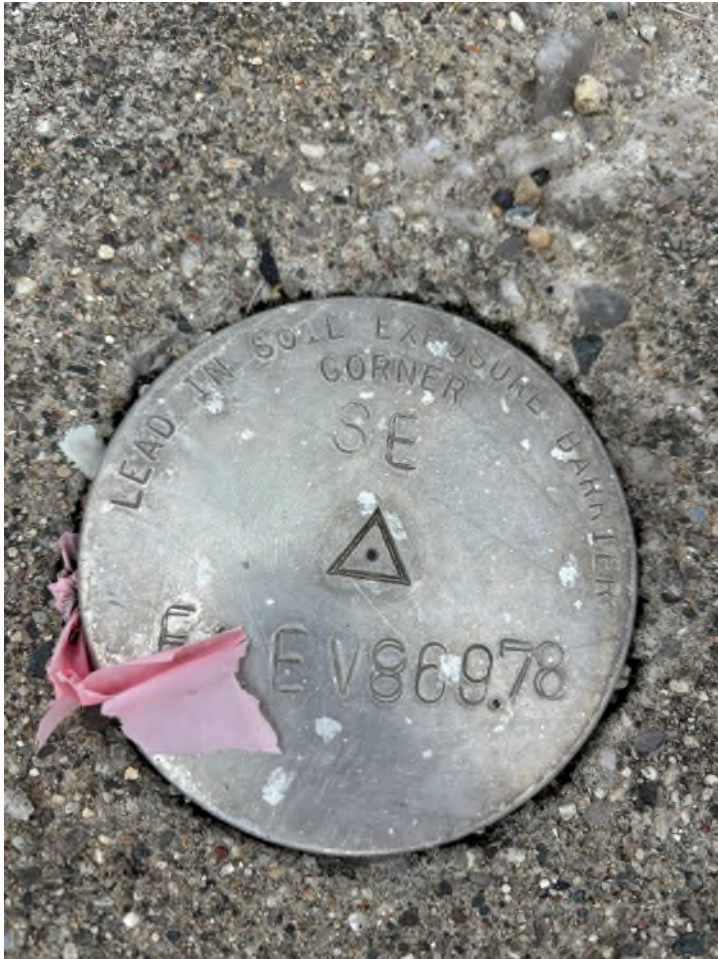
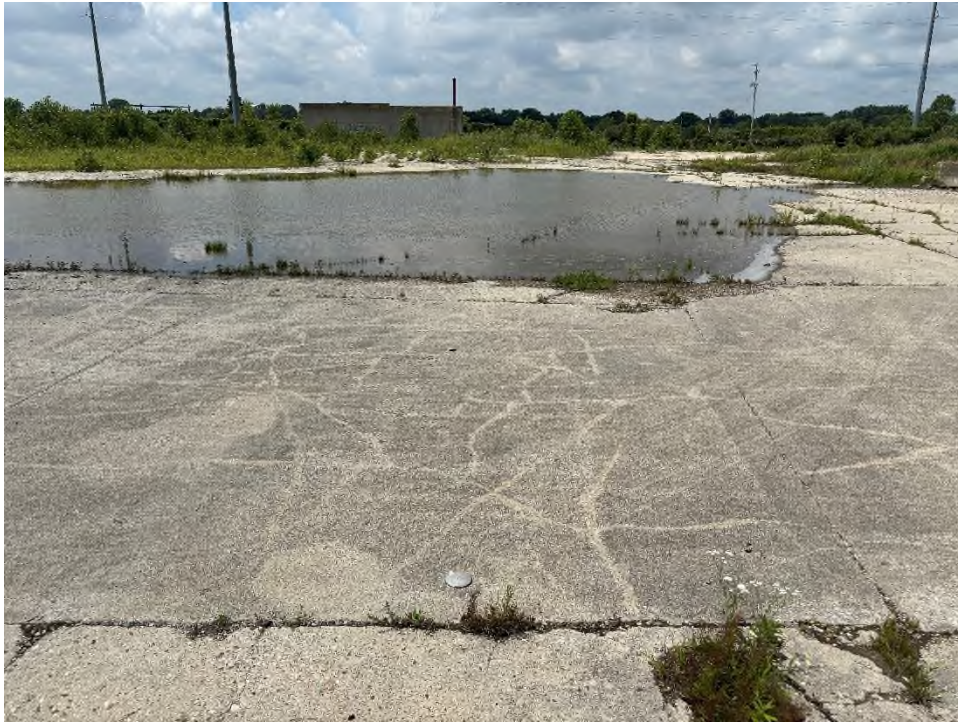
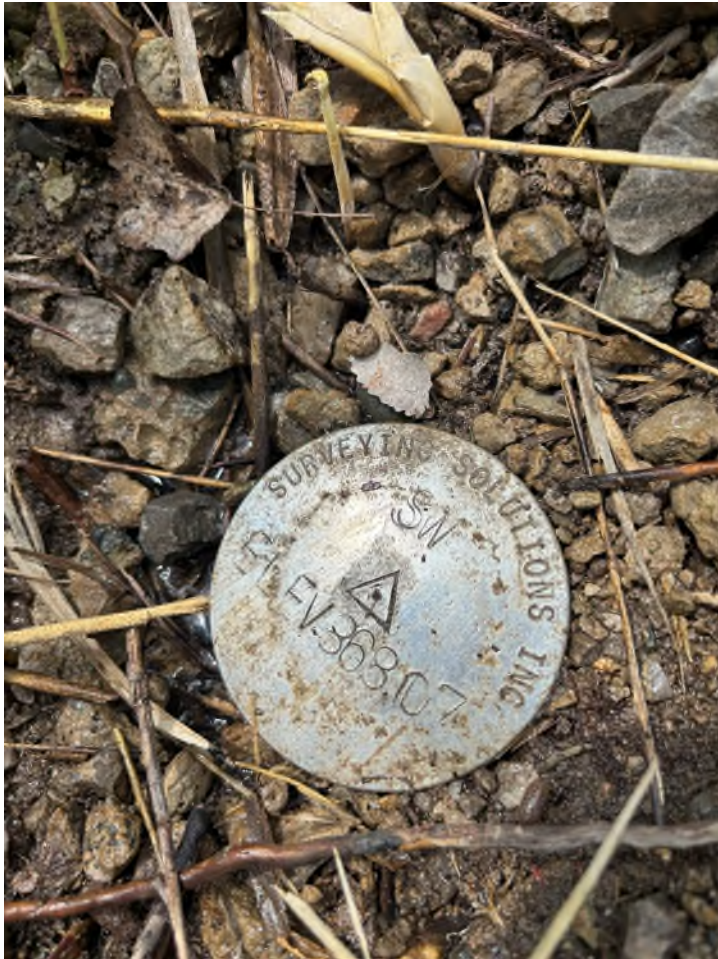
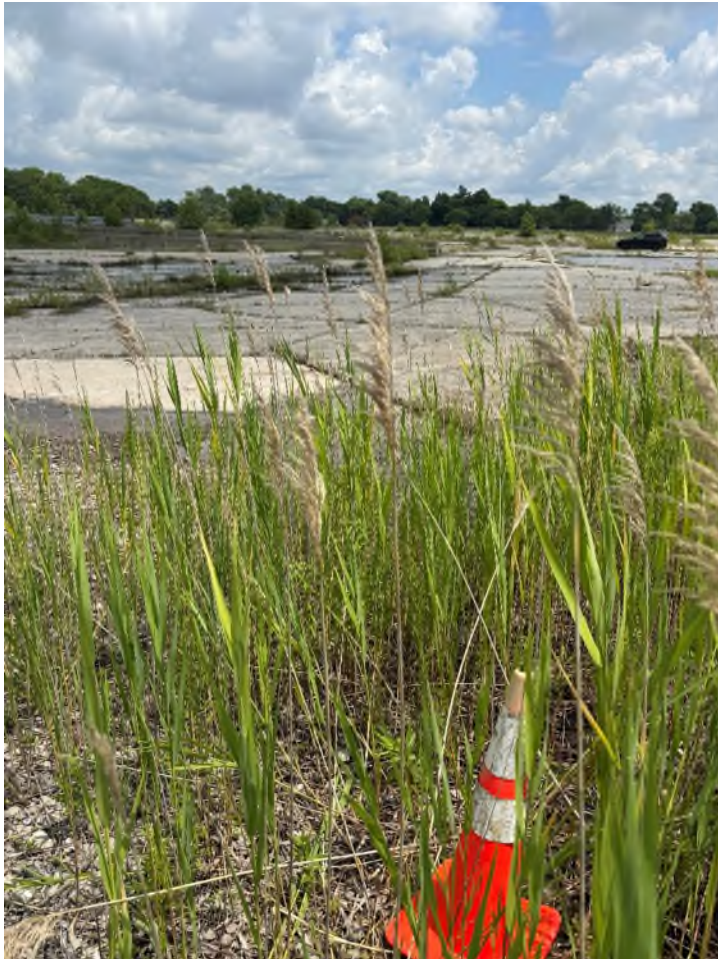
Area 5-6 Exposure Barrier corner markers are in good condition and the  
stamping is legible  
 \_\_\_\_\_  
 \_\_\_\_\_
