RE: Windiate Park/Dixieland Subdivision Landfill, Pengelly Road Site, Genesee County, Michigan  
(Site ID No. 25000689)

FILE: 15388/75088 - Soil Cover Inspection Report

# WINDIATE PARK SOIL COVER MAINTENANCE CHECKLIST

# INSPECTION MAP

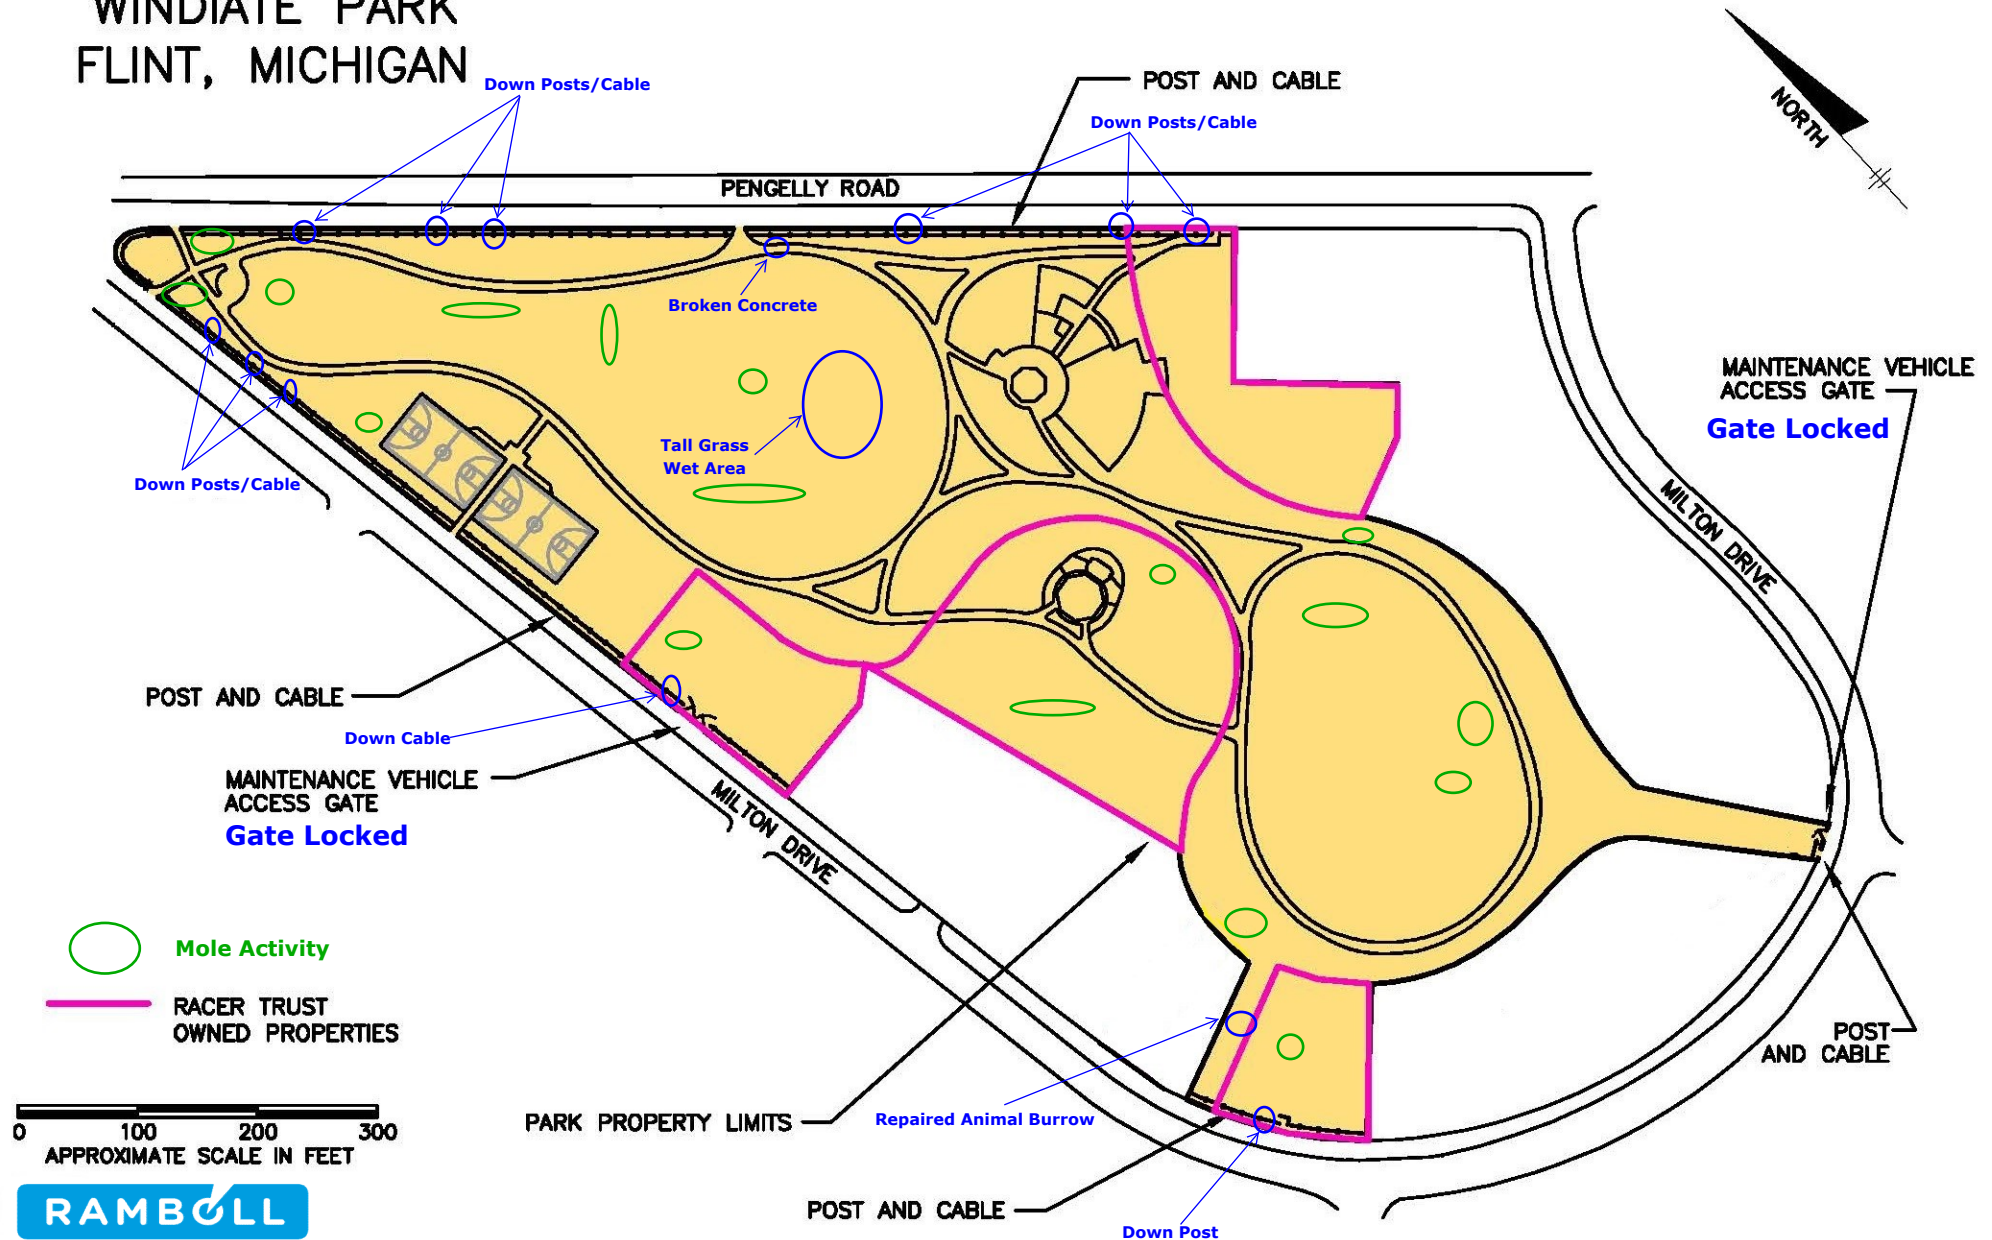
| Inspected Item: | Comments: |
|---|---|
| GRASS/VEGETATIVE LAYER | Acceptable. No maintenance required at this time. One area was observed with standing water, tall grass and tall woody plants. |
| POST & CABLE / VEHICLE GATES | Acceptable. Approximately twelve damaged posts were observed during the site inspection (either partially down or completely down). Four sections of down cable were observed. A number of new posts have recently been installed. The south and west maintenance vehicle access gates were locked. |
| OTHER OBSERVATIONS | A number of mole mounds and/or trails were observed. Unable to determine if the mounds are from recent activity or from older activity. One animal burrow was observed and appeared to be active. The animal burrow was managed on November 12, 2020 by putting dry ice down the burrow and then backfilling with soil. The area was then leveled, and grass seed was spread. One section of concrete had collapsed around manhole on sidewalk along Pengelly Road. |

Grass has been mowed

Add additional soil to area where water has ponded.
