RE: *Quarterly Status Report – July 2017 – September 2017*  
*Coldwater Road Landfill*  
*1245 East Coldwater Road, Flint, MI*  
*MID 005 356 860*

In accordance with requirements of the approved Post-Closure Care Plan, we are providing you with this Quarterly Status Report for the third quarter 2017.

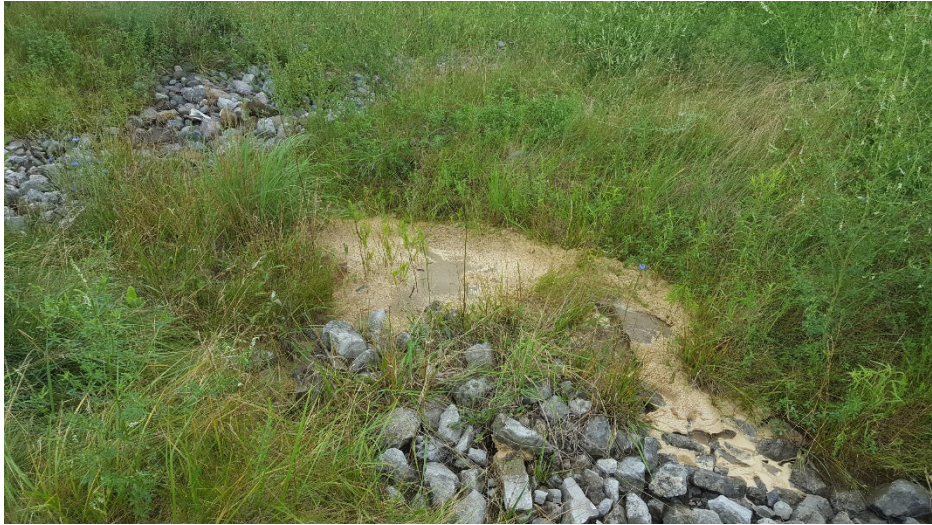
<b>CLIENT NAME:</b> RACER Trust		<b>SITE LOCATION:</b> Coldwater Rd Landfill	<b>PROJECT NO.</b> 64737
<b>PHOTO NO.</b> 1	<b>DATE:</b> 7/13/2017

- » Due possibly to a large rain event, two areas of erosion were discovered on July 13, 2017. The areas were on the east and west side of Cell E and washout (sand) was observed in the swale riprap. The area on the eastern side of Cell E had settled, and was subsequently repaired.

<b>DESCRIPTION</b> Photo of sand accumulated in riprap on eastern side of Cell E due to rain event. View looking northeast.

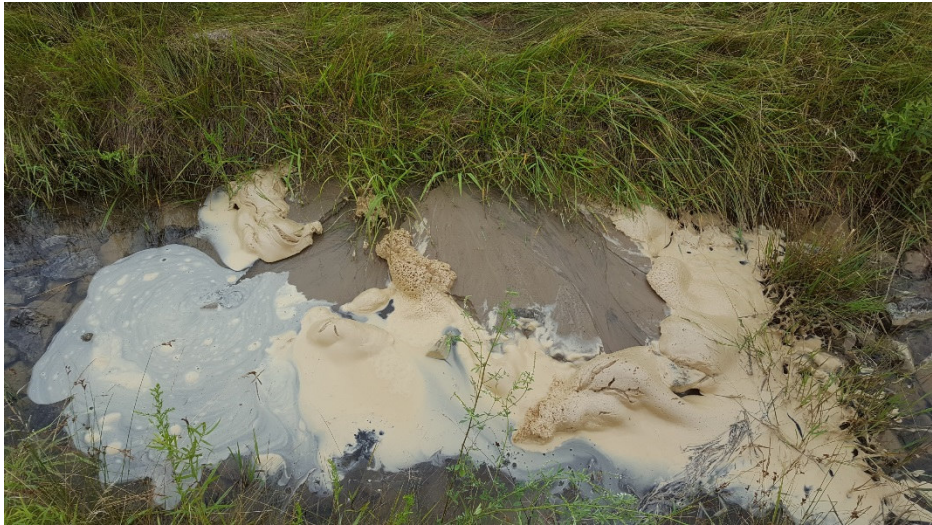
<b>CLIENT NAME:</b> RACER Trust		<b>SITE LOCATION:</b> Coldwater Rd Landfill	<b>PROJECT NO.</b> 64737
<b>PHOTO NO.</b> 2	<b>DATE:</b> 7/13/2017

<b>DESCRIPTION</b> Photo of sand accumulated in riprap on western side of Cell E due to rain event. View looking east.
