# RACER TRUST LANSING PLANTS 2, 3, & 6

#### **2021 Fourth Quarter Progress Report | January 15, 2022**

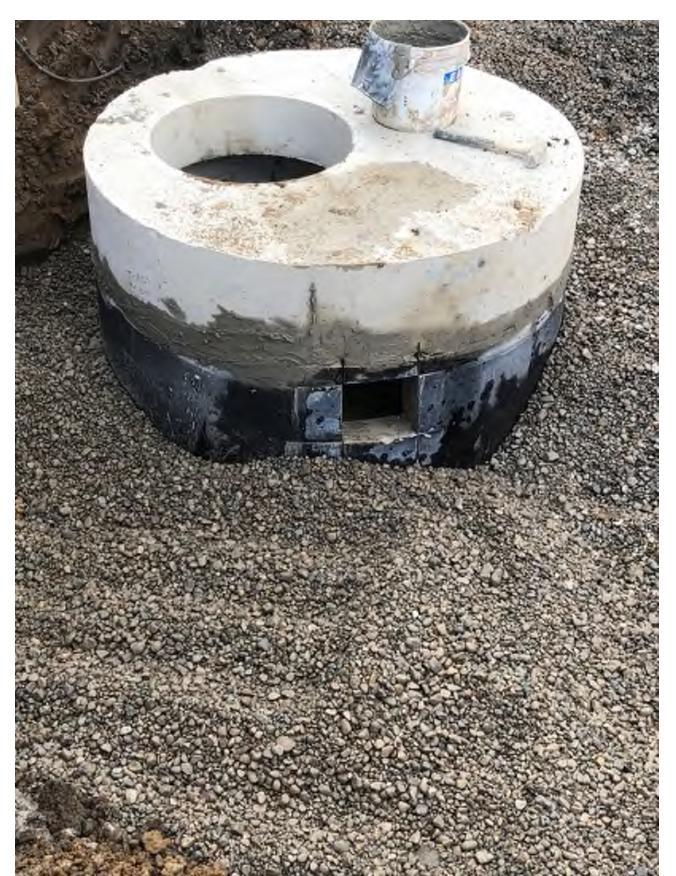
- Osborn Street catch basin was replaced in November 2021 as part of sewer modifications completed during fourth quarter 2021 to prevent infiltration of groundwater containing Perfluorooctanesulfonic acid (PFOS) into the sewer system
- Old brick catch basin wall had numerous leaking cracks that would be difficult to repair
- Replaced entire catch basin structure to mitigate leaks
- Structure replacement preserves stormwater drainage in Osborn Street with no connections to the RACER site

New catch basin structure

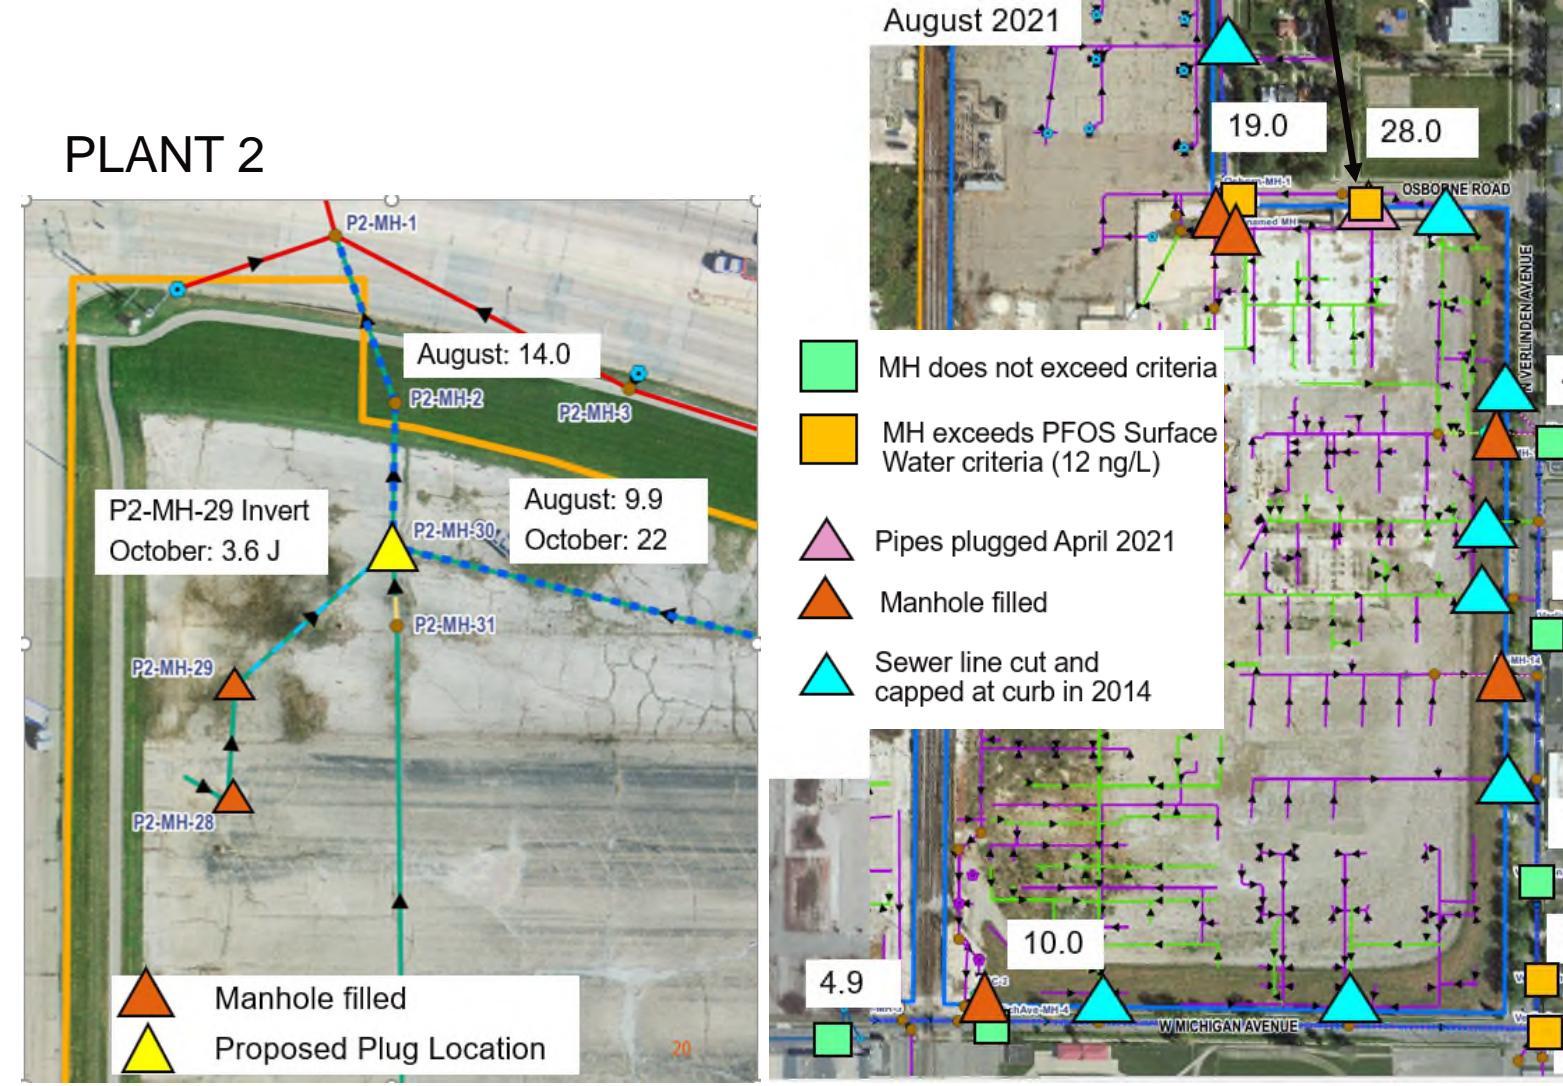
PLANT 6

- Third Quarter site wide performance monitoring of storm sewers was conducted in August and additional sampling was completed in October for P2-MH-29. Results for Perfluorooctanesulfonic acid (PFOS), the specific PFAS of concern, are depicted on figures to the right.
- Fourth Quarter site wide performance monitoring of storm sewers was conducted in December 2021. Results will be summarized in the First Quarter Progress Report.

Catch basin structure replaced

in Nov 2021

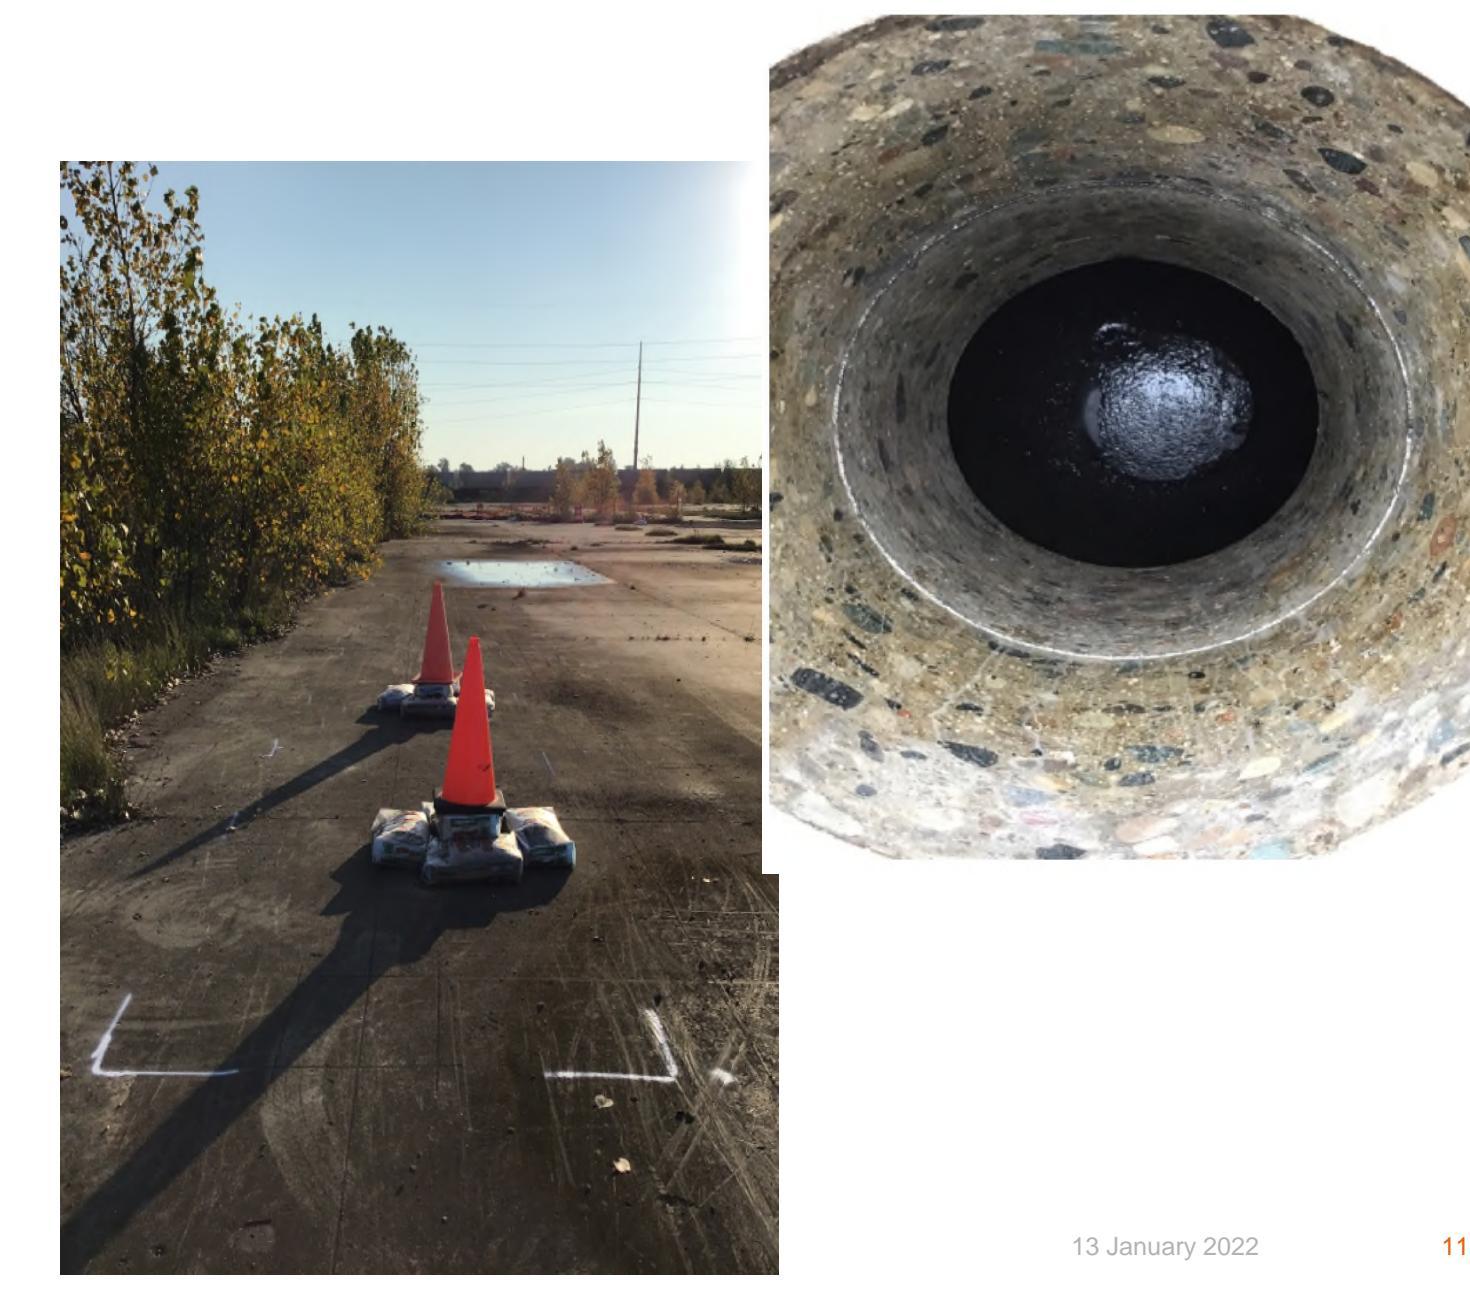
- Vault closure completed on October 12<sup>th</sup>, 2021
- Vault structure was larger than anticipated
  - 36 X 6 X 4 ft
- Approximately 12,800 gallons of water was pumped into a frac tank on-site
- A portion of the interior of the vault was pressure washed and the vault was filled with flowable fill as the cleaning water was pumped into the frac tank
- Contents of the frac tank were picked up and transported off-site for disposal on November 15, 2021
- A summary memo will be submitted to EGLE in January 2022
