2013 ANNUAL REPORT – FINAL REPORT

Landfill Inspection Report Coldwater Road Landfill Flint, Michigan MID 005 356 860

> RE: 2013 Annual Landfill Inspection Report Coldwater Road Landfill Flint, Michigan FILE: 15388/50137/rep

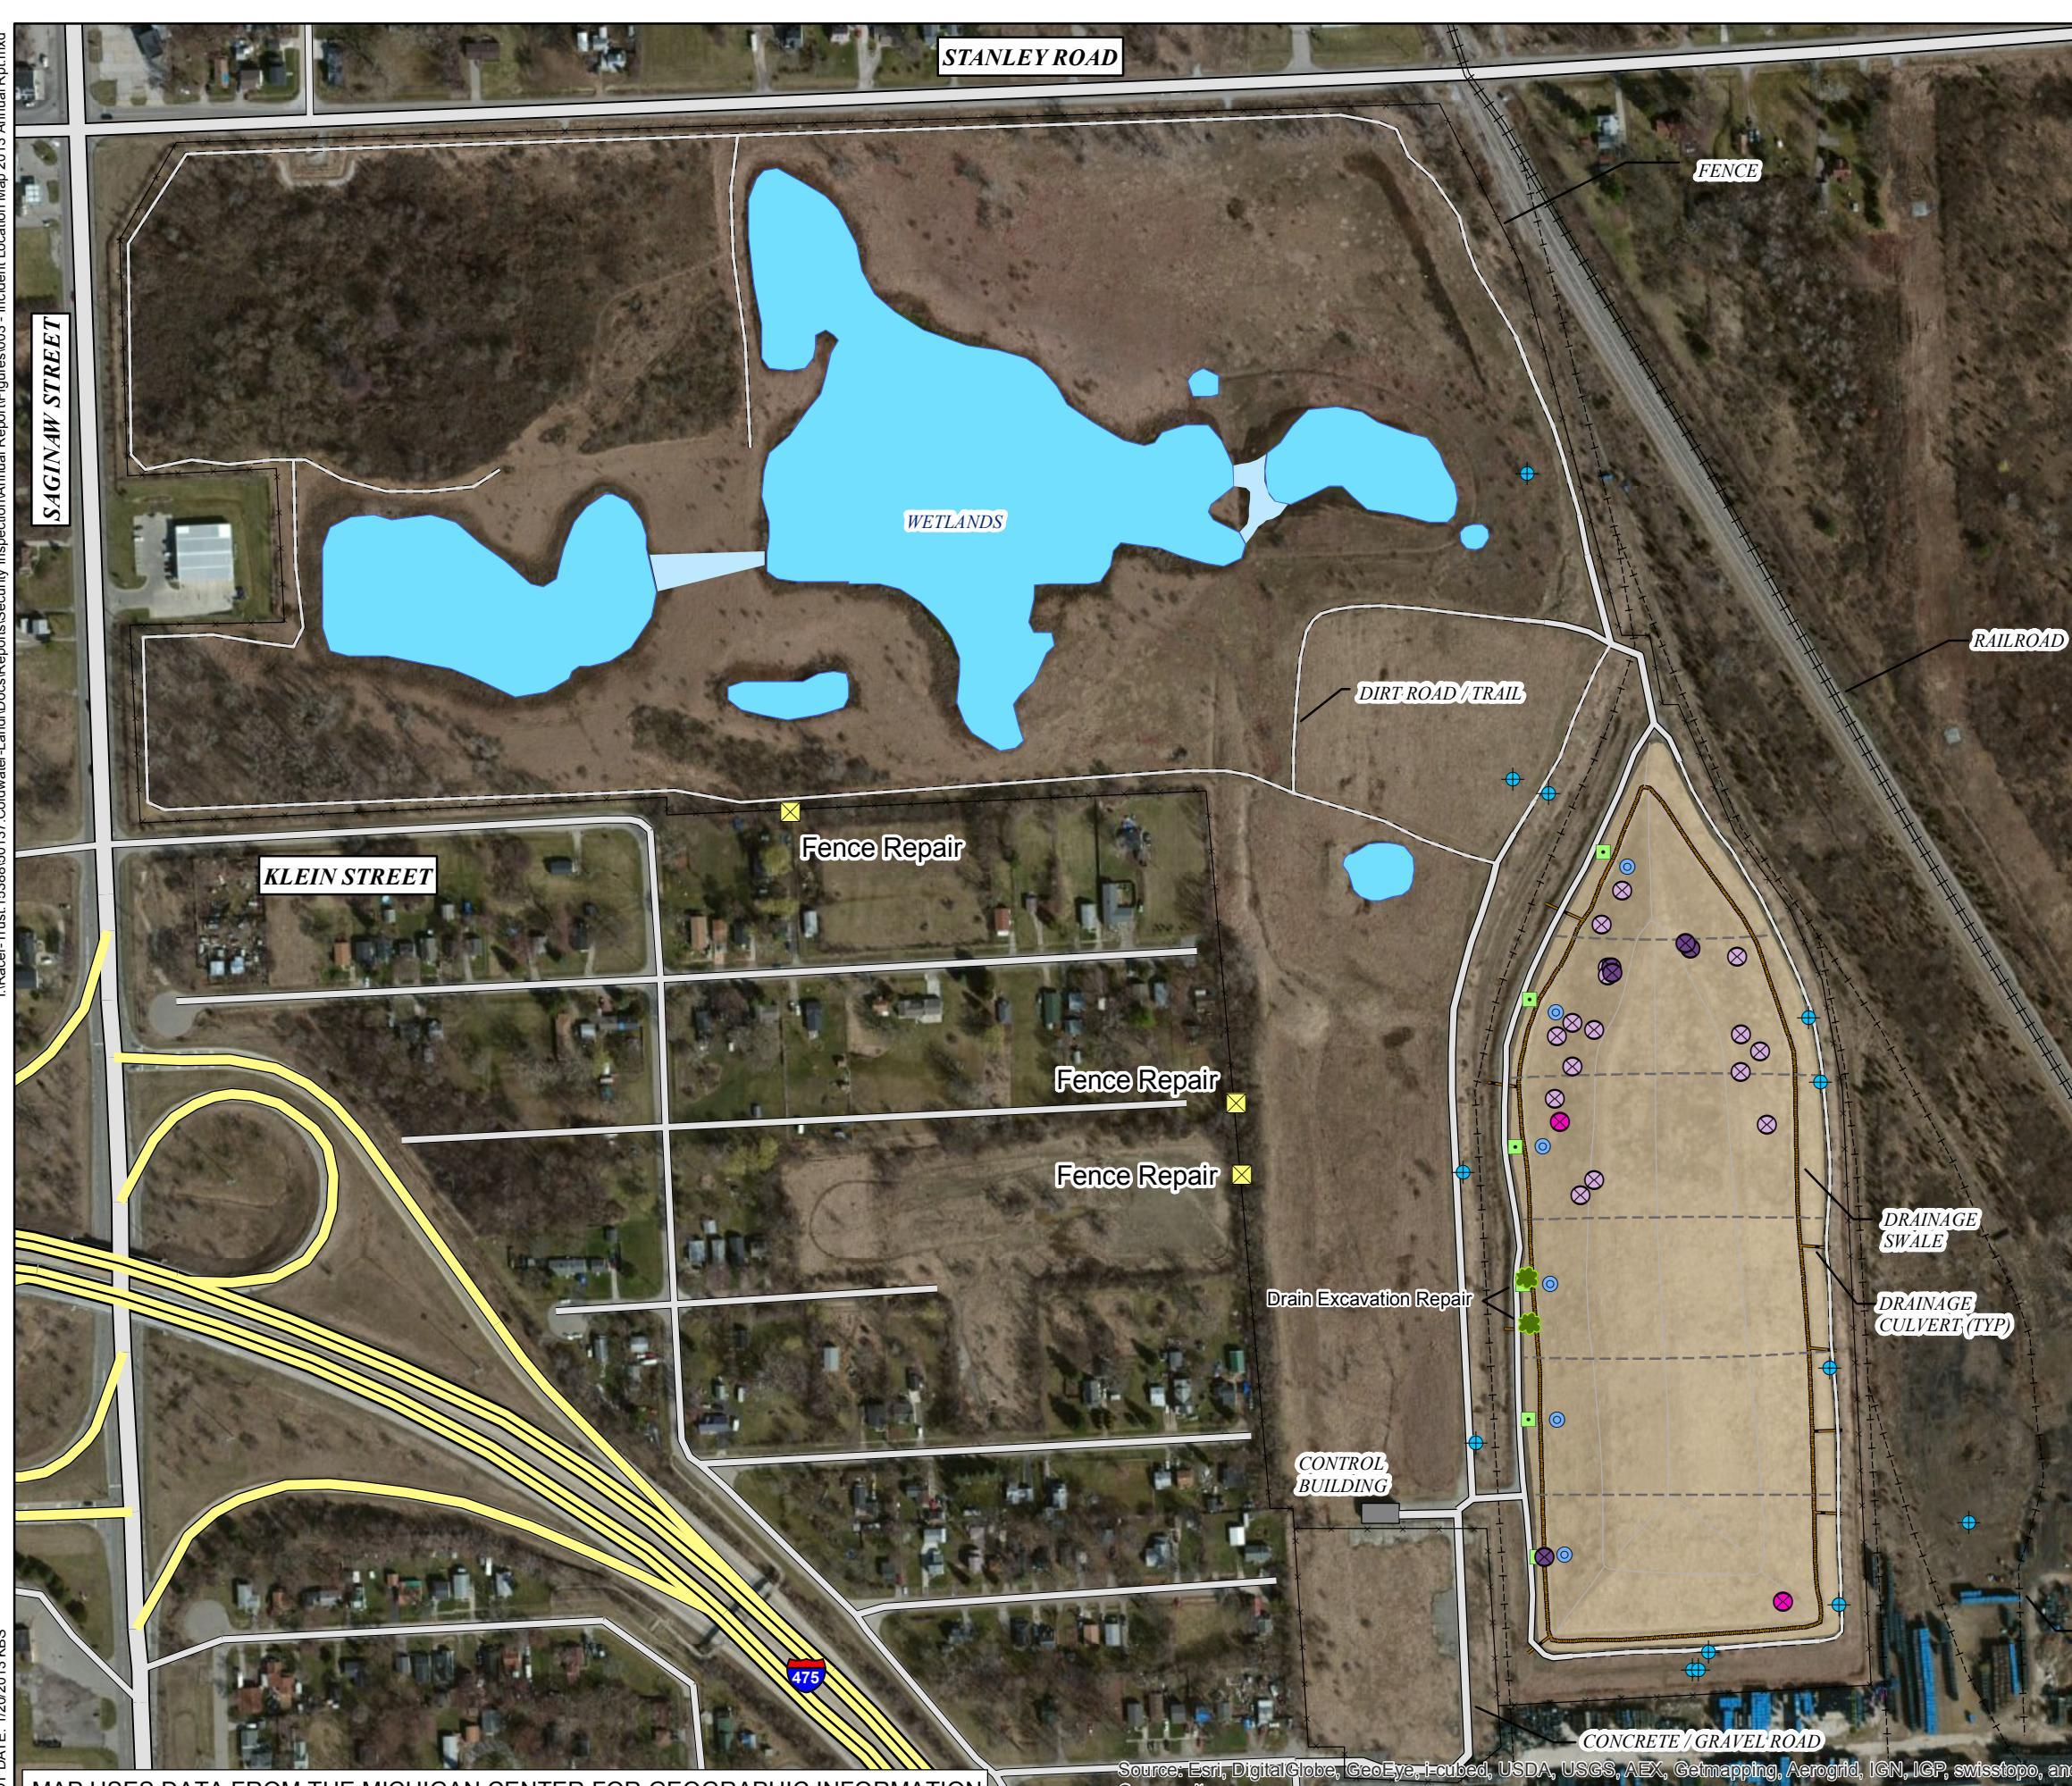
FIGURE 3

During the 1st quarter inspection two areas of erosion were observed where the drains to move water away from Cell D had been installed. Shortly after the inspection the areas were backfilled with soil or gravel, within the access road, to their original grade and seeded as appropriate.

Twenty-one animal burrows were identified and closed throughout the year. Animal burrows were photographically documented (before and after repair), and the approximate size and configuration of the burrows were documented and included in the Quarterly Status Reports.

Damage to the site perimeter fence was noted at a number of locations during the quarterly inspections. During the 1st quarter inspection, one previously repaired hole was reopened along the west perimeter fence. During the 3rd quarter inspection, two previously repaired holes were reopened along the west perimeter fence.

2013 **INCIDENT LOCATION** MAP

The holes in the perimeter fence were repaired either during the inspections or shortly thereafter.

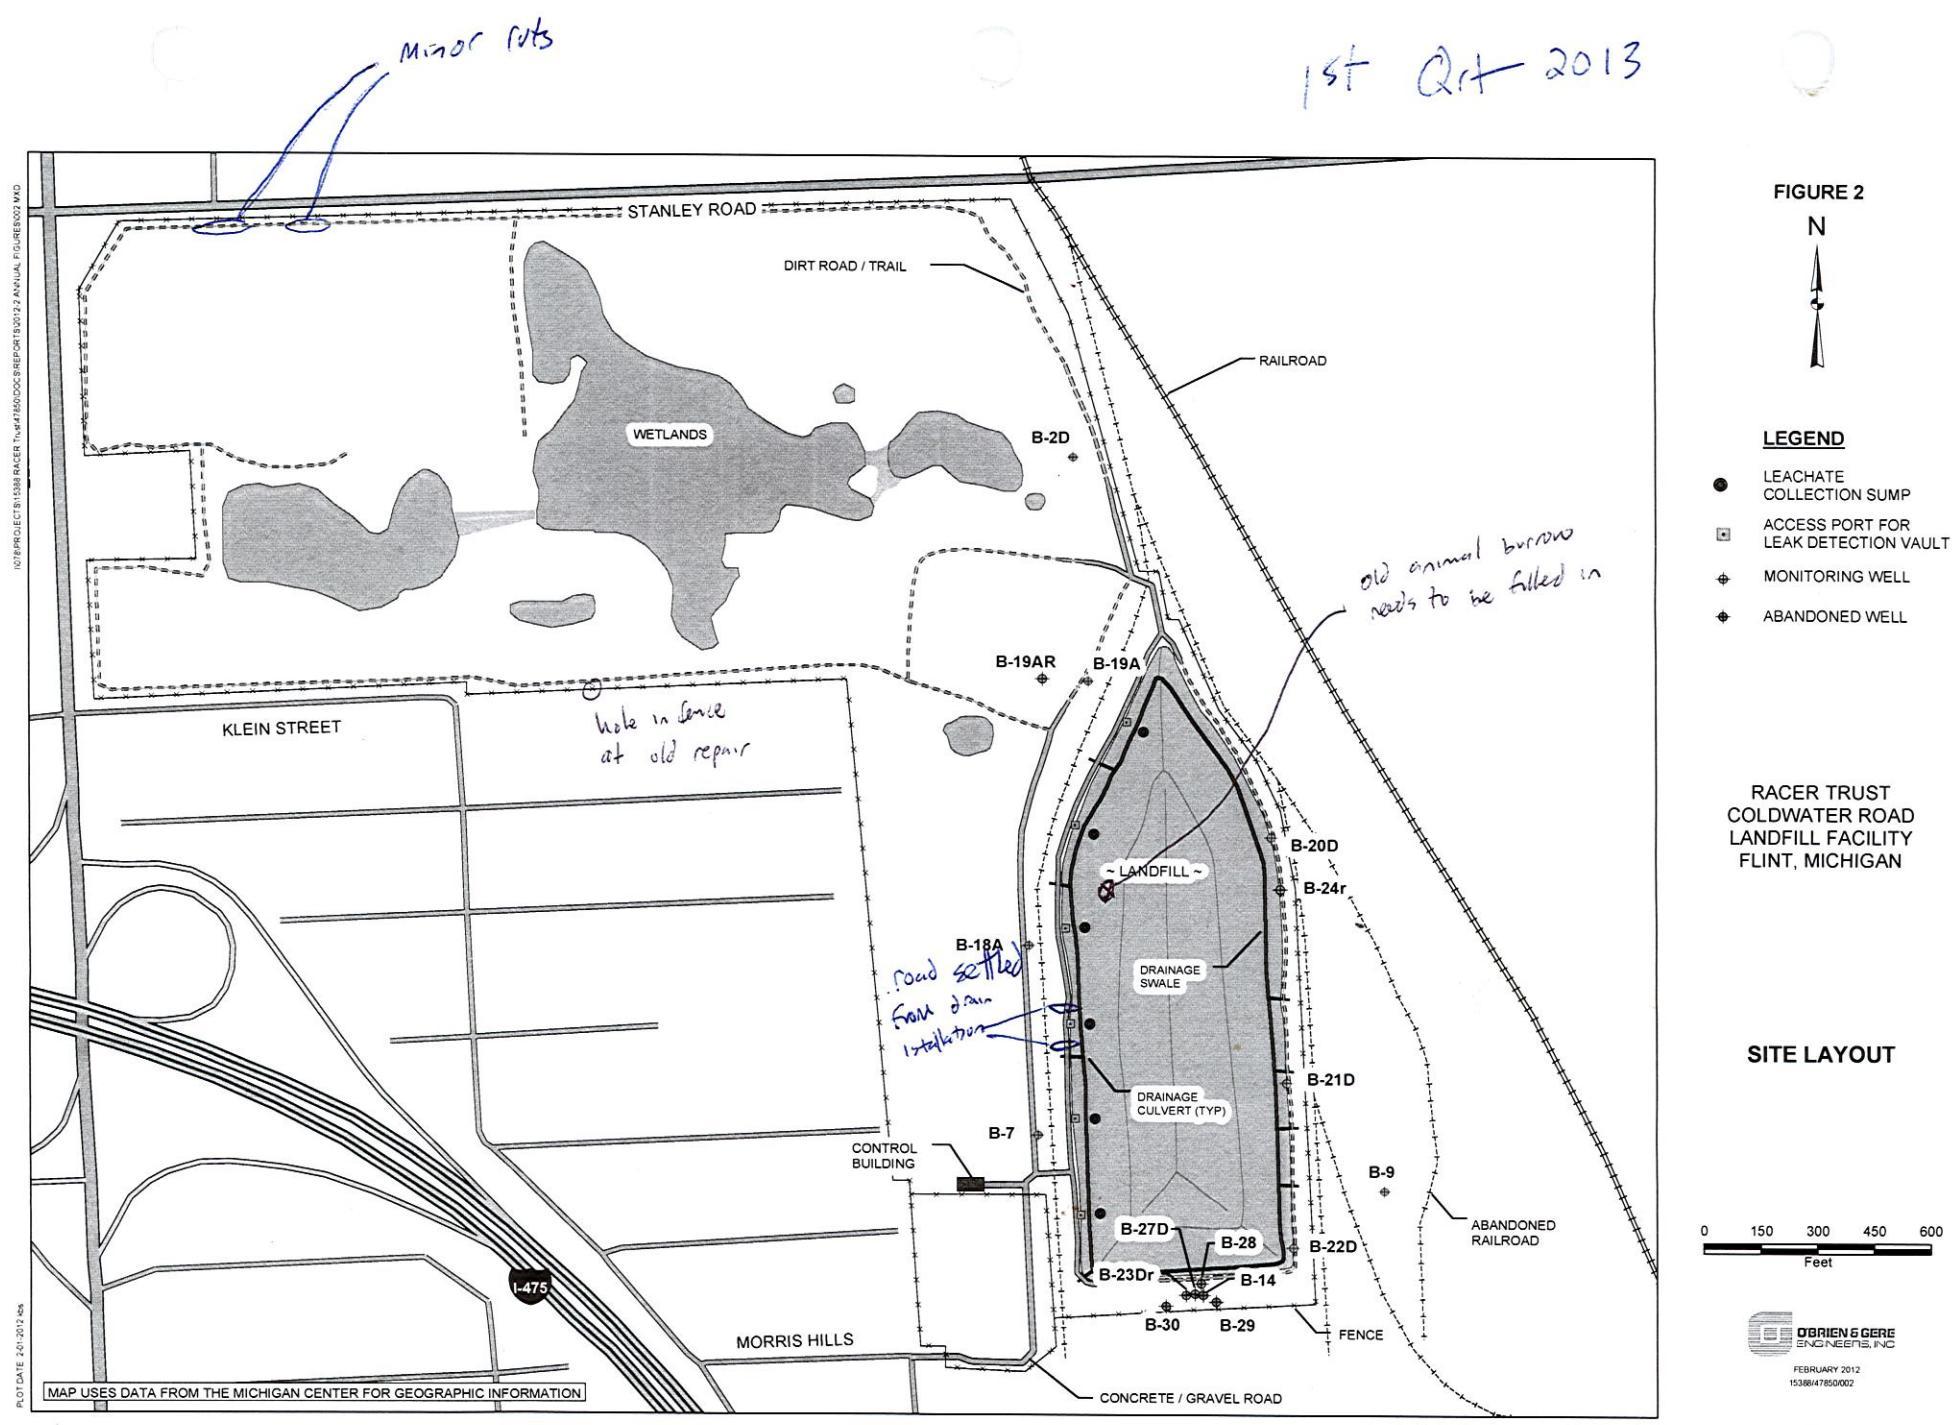
woody plants were located throughout plants will be remained once the ground were located number of the woody landfil CAP. The MAG mured

Area	Any damage present?	Signs of unauthorized entry?	Broken or damaged locks on gates?	"Tresspassing Prohibited" and "Private Property" Signs Posted?
Fences along north property line	N°.	μυ	۲Ŋ	Yes
Fences along south property line	NU	د در	No	445
Fences along west property line	the in fuce at previous relait tocution	Na	Nø	Ye S
Fences along east property line	N ŷ	Nэ	No	4e S

PaimAlert system down for repor

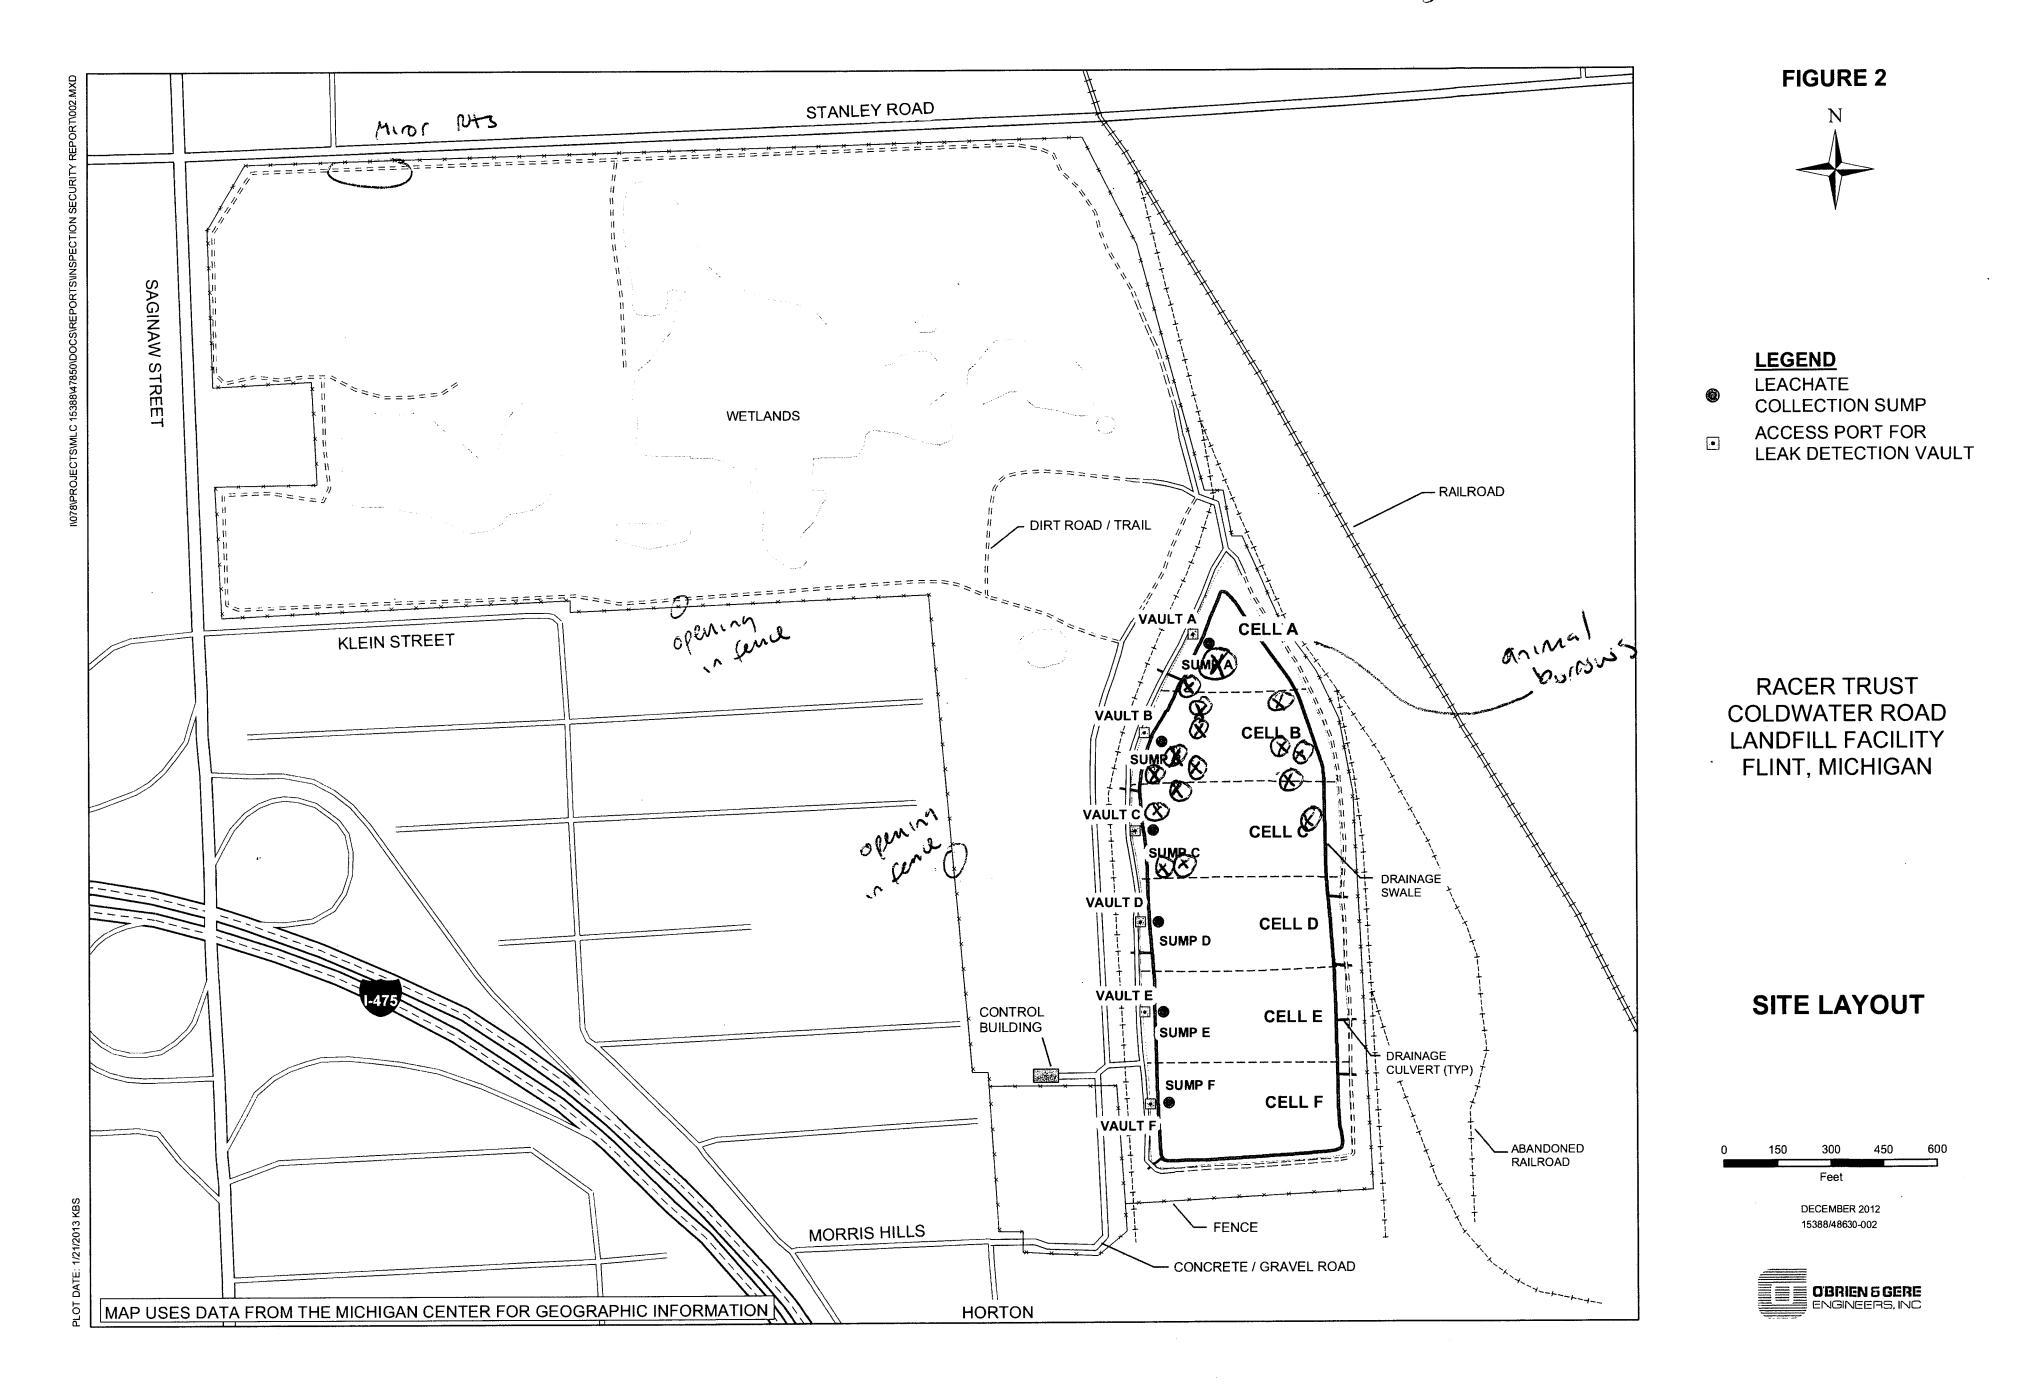
Area of Inspection	Animal Burrows?	Soil Erosion	Slope Failures?	Ponding?	Washouts?	Liner damage or exposure?	If yes to any, describe issue, location, and actions taken
Cell A	No	No	No	No	No	No	
Cell B	405	No	No	No	N٥	No	burrow west side inline w/ sump / set trip
Cell C	No	ŅΟ	No	No	No	No	
Cell D	No	No	yo	No	No	No	prior to inspection low areas where armins were enstalled where filled in and seeded
Cell E	No	No	No	No	No	No	
Cell F	yes	NO	No	N٥	No	NO	l burrow Southside near petitious burrow Set trap
Berms	NO	No	No	NO	NO	NO

Cell	Areas with sparse vegetation present?	Deep-rooted plants present?	Areas around building and equipment mowed?	Access roads mowed and in good condition?
А	NONE	NONE	Yes	Yes
В	NONE	NONE		
С	NONE	None		
D	Areas where installed draws were installed has sparse veg	None		
Е	Nomé	NONE		
F	NONE	IN CLUSTERS ON top of cap < 5"		
Berms	NONE	NONE in clust	s V	V

6/20/13 2nd Qrt 2013 wet w/ rots FIGURE 2 STANLEY ROAD N DIRT ROAD / TRAIL RAILROAD 0 LEGEND WETLANDS B-2D + LEACHATE COLLECTION SUMP 0 Wet ACCESS PORT FOR LEAK DETECTION VAULT ٠ w MONITORING WELL wet w/ nots ABANDONED WELL 0 clusters plants B-19AR , B-19A KLEIN STREET Animal Burrow / RACER TRUST COLDWATER ROAD LANDFILL FACILITY B-20D TM set FLINT, MICHIGAN deer Carcass ~ LANDFILL ~ B-24p \$ B-18A DRAINAGE SWALE filled in 10w meas SITE LAYOUT Seeded 4 B-21D DRAINAGE CULVERT (TYP) B-7 R H H H CONTROL BUILDING B-9 + ++ ABANDONED B-27D 150 300 450 600 RAILROAD B-28 B-22D B-23D - B-14 X te 475 Annal Burrow Trap Set B-29 B-30 OBRIEN 5 GERE FENCE MORRIS HILLS JULY 2012 15388/48630/002 MAP USES DATA FROM THE MICHIGAN CENTER FOR GEOGRAPHIC INFORMATION - CONCRETE / GRAVEL ROAD clusters of woody plants es"

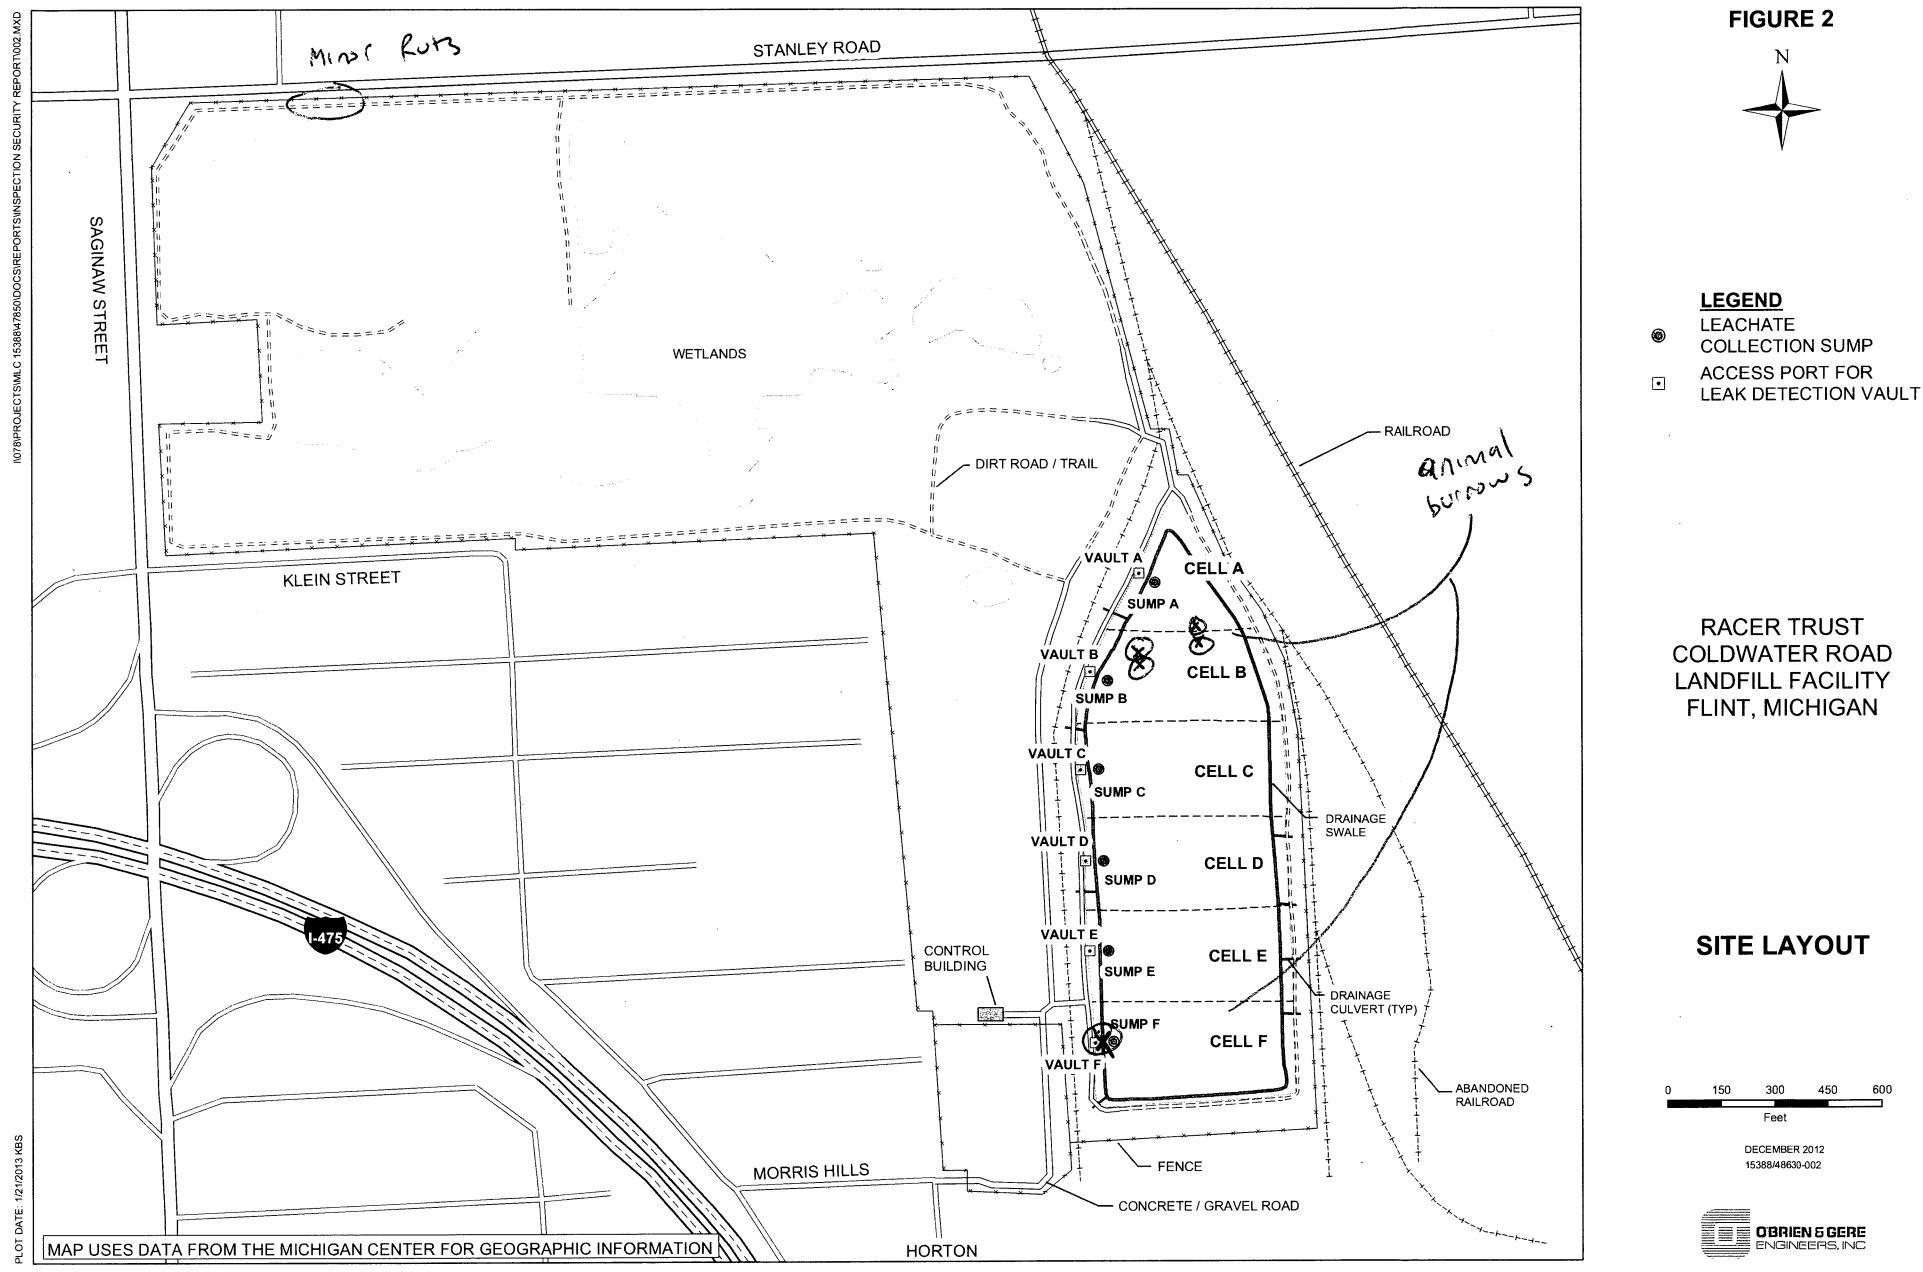
318 Q17 2013

Area of Inspection	Animal Burrows?	Soil Erosion	Slope Failures?	Ponding?	Washouts?	Liner damage or exposure?	If yes to any, describe issue, location, and actions taken
Cell A	Yes	N0	NO	N0	No	No	
Cell B	Yes	No	No	No	N٥	N٥	
Cell C	Yes	No	No	No	No	No	
Cell D	N٥	No	No	No	Nº	N٥	
Cell E	No	No	No	No	No	N٥	
Cell F	No	N٥	No	No	No	No	
Berms	No	No	No	N ð	NO	N٥	
Woody Pla	nt Removal	Activities	<u> </u>	<u>.</u>	<u>]</u>	<u>k. – –</u>	· · · · · · · · · · · · · · · · · · ·

Cell	Areas with sparse vegetation present?	Deep-rooted plants present?	Areas around building and equipment mowed?	Access roads mowed and in good condition?
A	NINE .	Areas of Woody Blants	No	Not Moved Grass High in Areas
В	NoNE	Areas of Wood 1 Plants	{	
С	NoNE	Areas of woods plants		
D	None	NONE		
E	NUNE	NONE		
F	NONE	NoNe		
Berms	None	NoNe

Area	Any damage present?	Signs of unauthorized entry?	Broken or damaged locks on gates?	"Tresspassing Prohibited" and "Private Property" Signs Posted?
Fences along north property line	N٥	NO	уо	
Fences along south property line	No	No	No	
Fences along west property line	2 openings in fince @ provides openings	N٥	No	
Fences along east property line	NO	No	No
