PCB Area #20 – Former Oil Interceptor #2 TSCA Deed Restriction

RACER Buick City Site, Flint, Michigan

EXECUTIVE SUMMARY

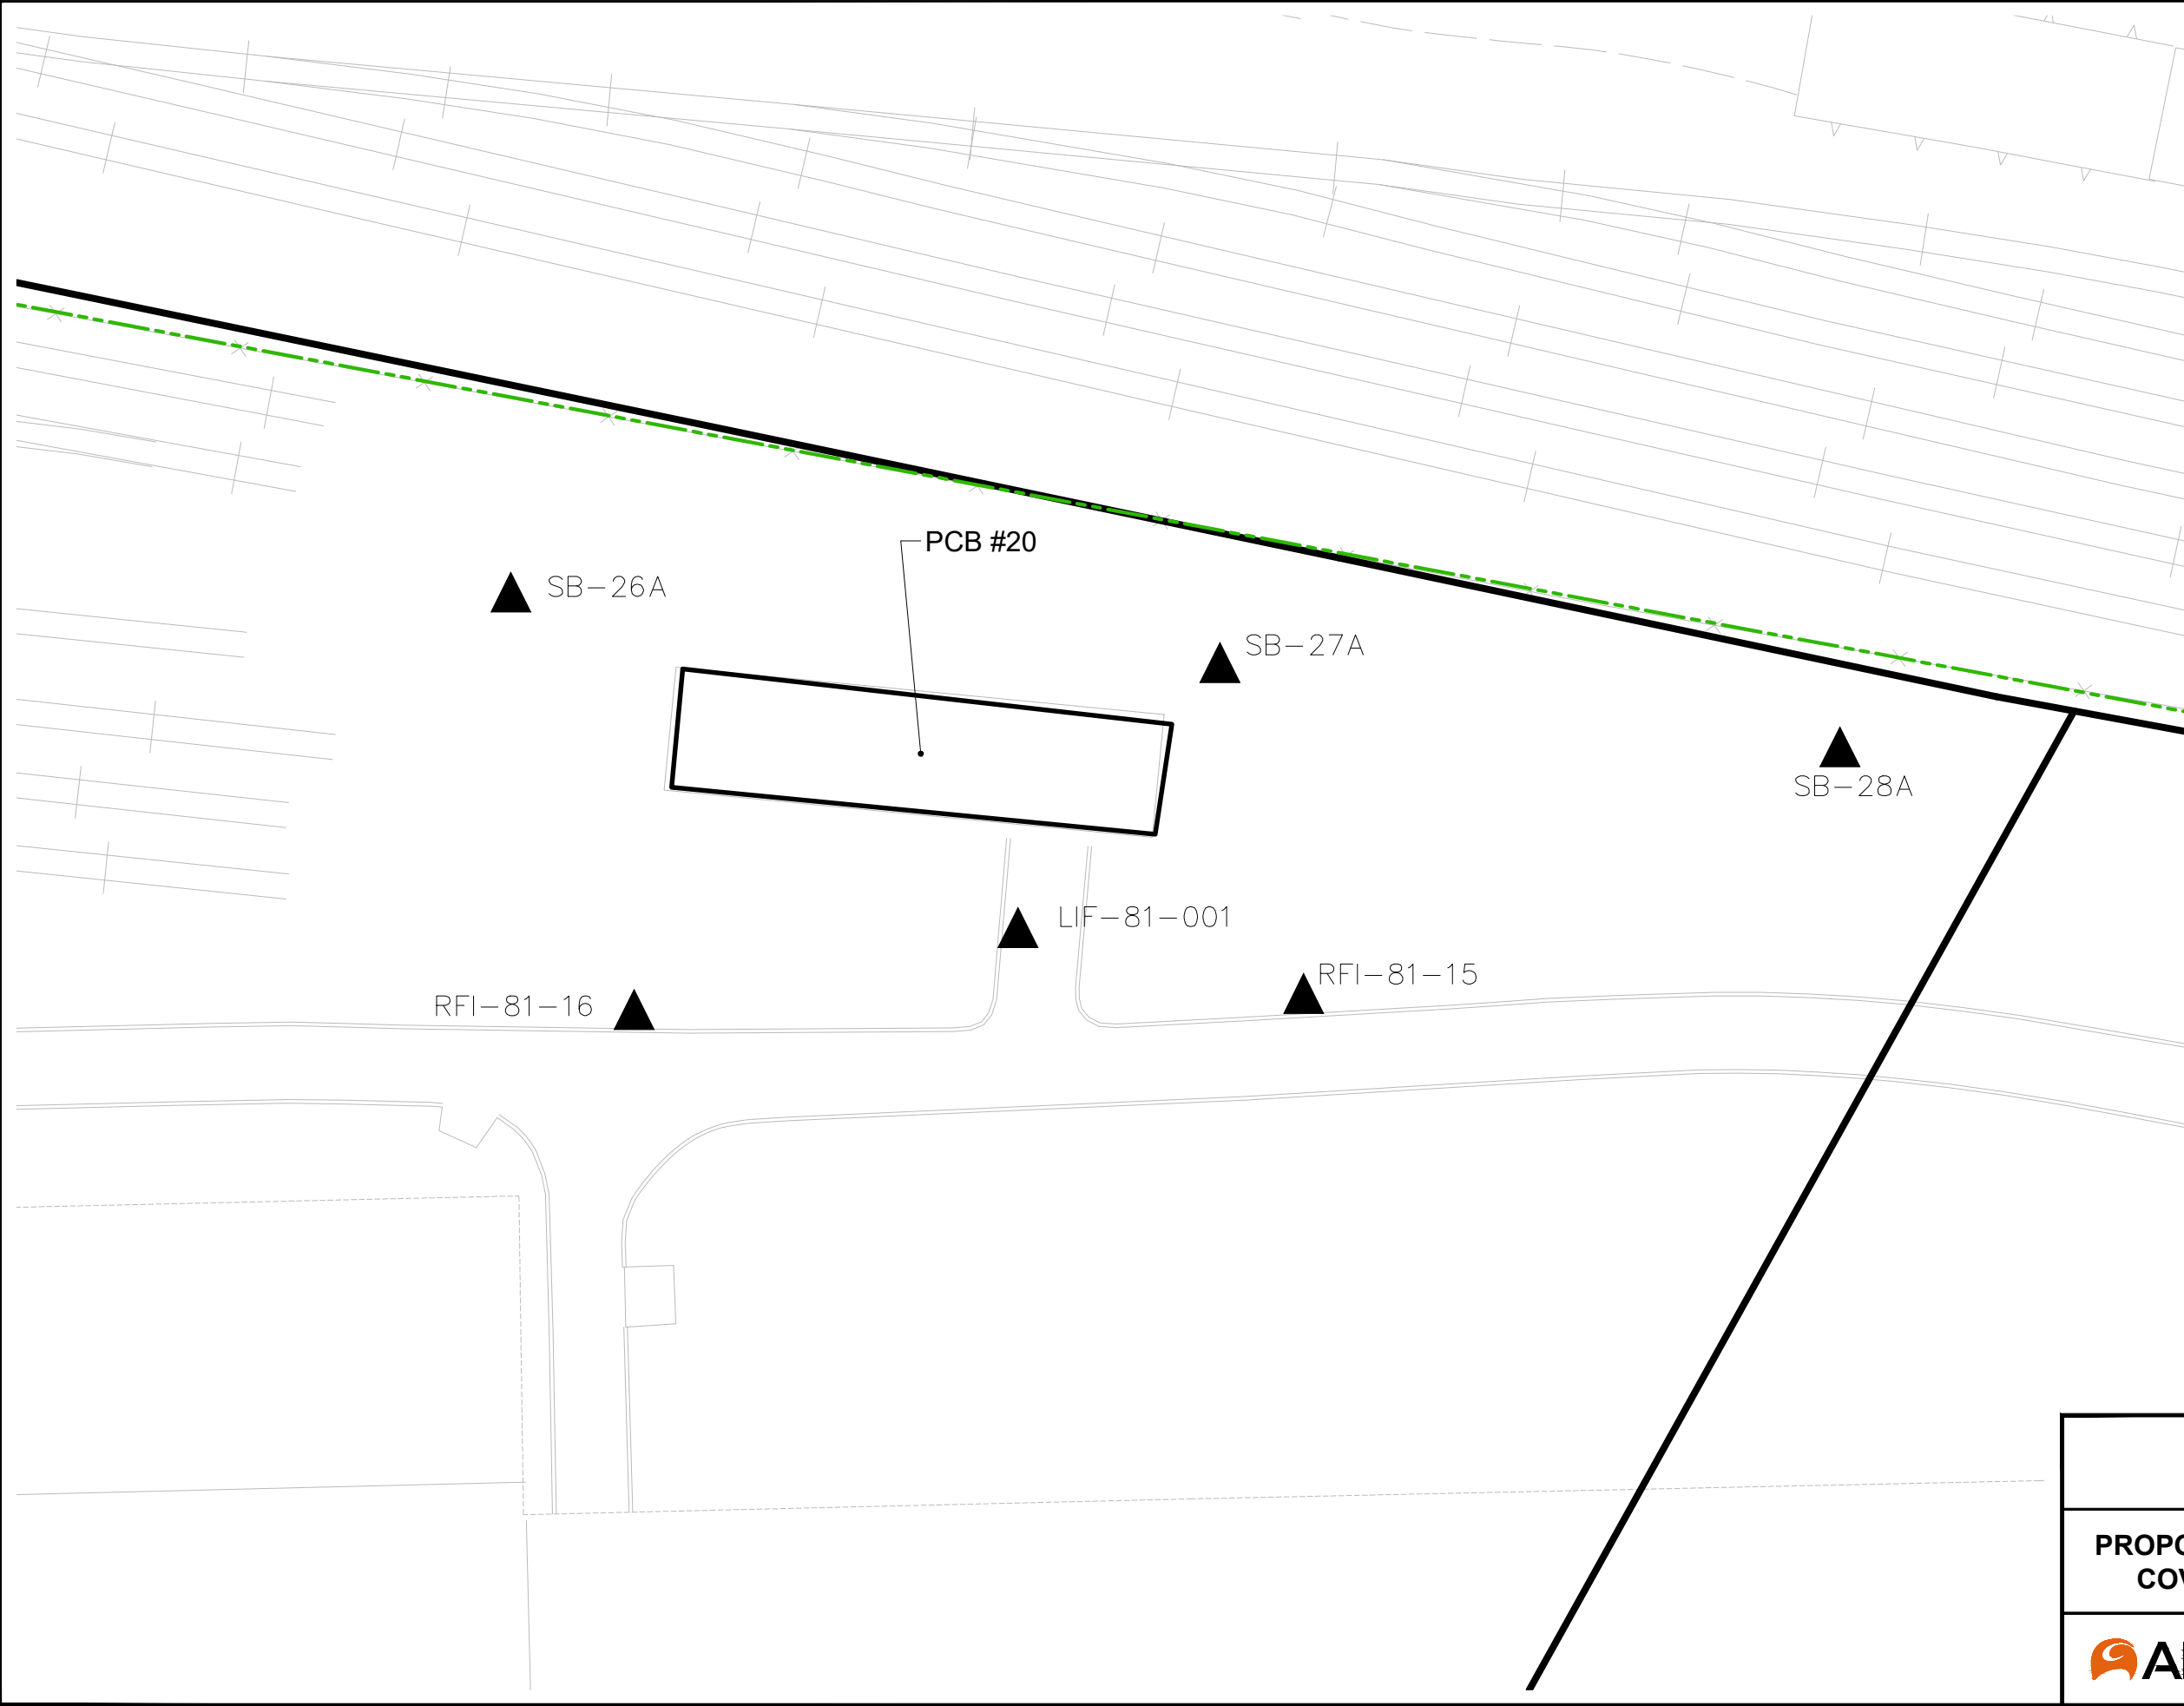
ARCADIS <small>Design & Consultancy for natural and built assets</small>	FIGURE 4

RACER TRUST BUICK CITY FLINT, MICHIGAN	
PROPOSED EXTENT OF RESTRICTIVE COVENANT FOR PCB AREA #20

At PCB Area #20, PCBs were detected at concentrations up to 24 ug/100cm² from the wipe samples collected from remaining Oil Interceptor #2 structure. The proposed area to be restricted is the footprint of the Oil Interceptor #2 structure, shown on **Figure 4**. No evidence of PCB impacts has been identified outside of the structure. Based on available data a **low occupancy deed restriction** is being requested for PCB Area #20.

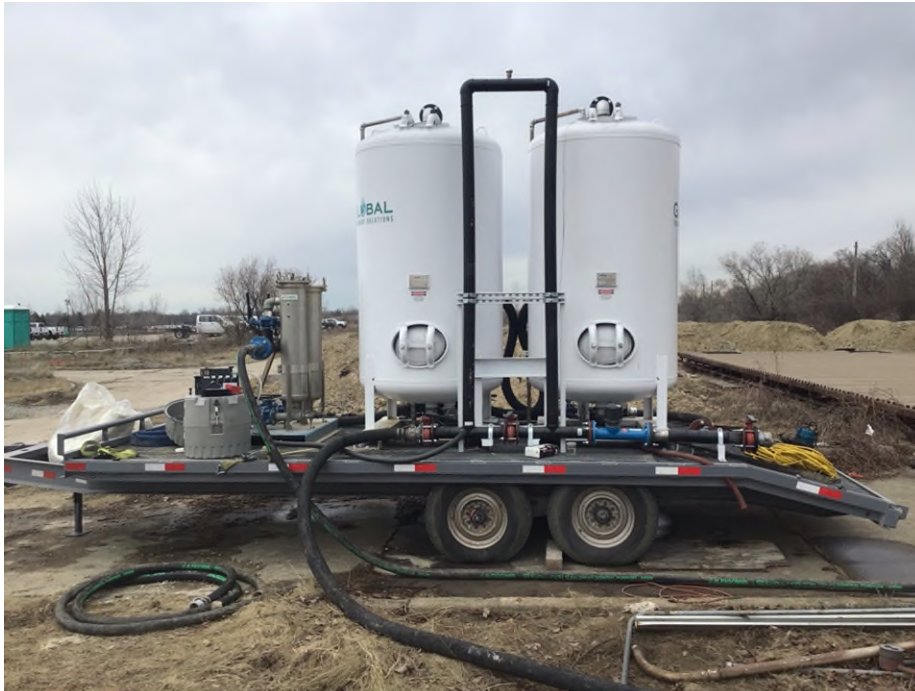
PHOTOGRAPH: 1

Global Water Treatment System consisting of inline GAC vessels and dual bag filter housing units. ISCO sampling device shown towards front of the trailer mounted system.

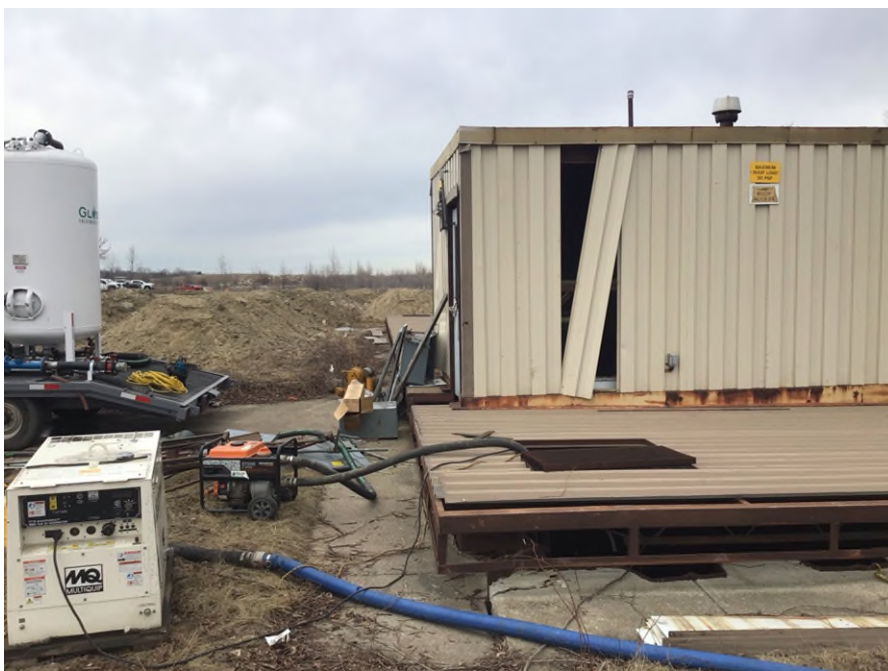
PHOTOGRAPH: 2

2" submersible pump and generator installed near SW corner of Interceptor #2

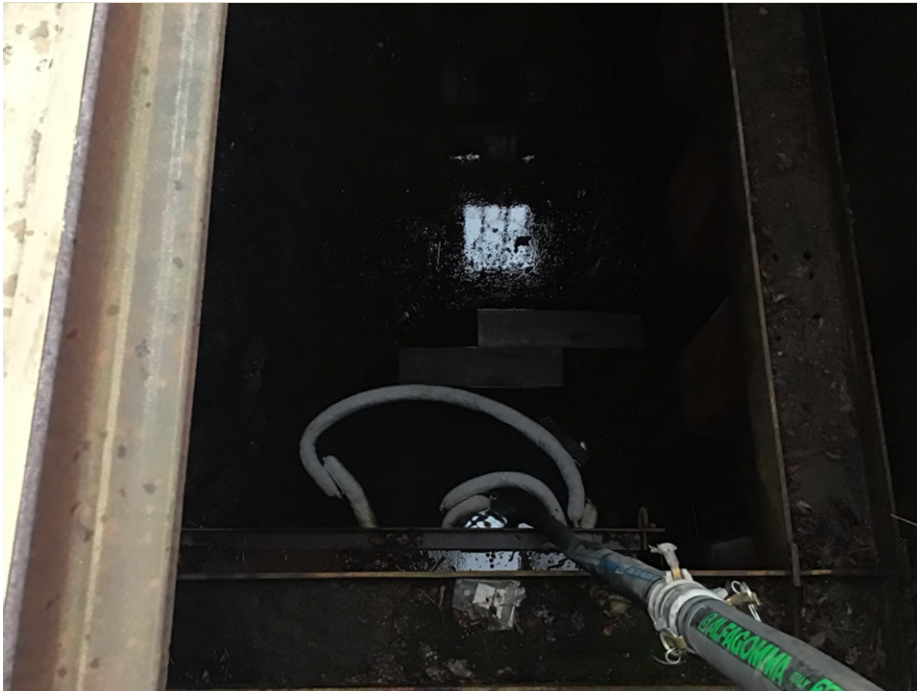
PHOTOGRAPH: 3

View from atop structure at intake location when the treatment system was shut down due to trickle flow water level

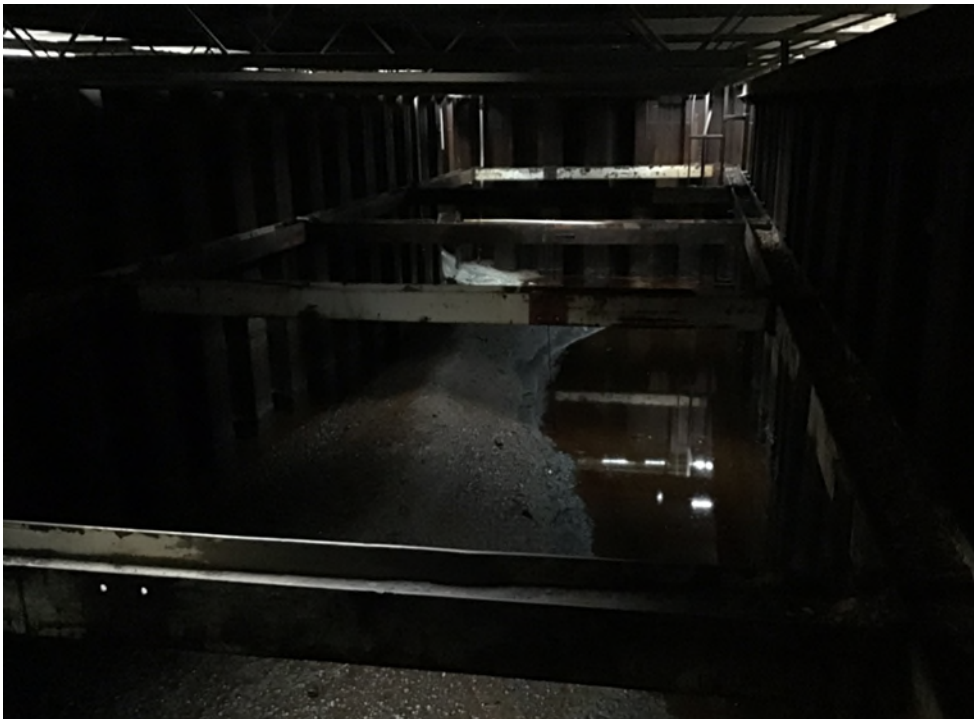
PHOTOGRAPH: 4

View from within the structure of sediment and ponding water

- Prior to backfill, the sediment remaining in the interceptor structure was regraded to an approximate two-foot thickness across the bottom of the structure.

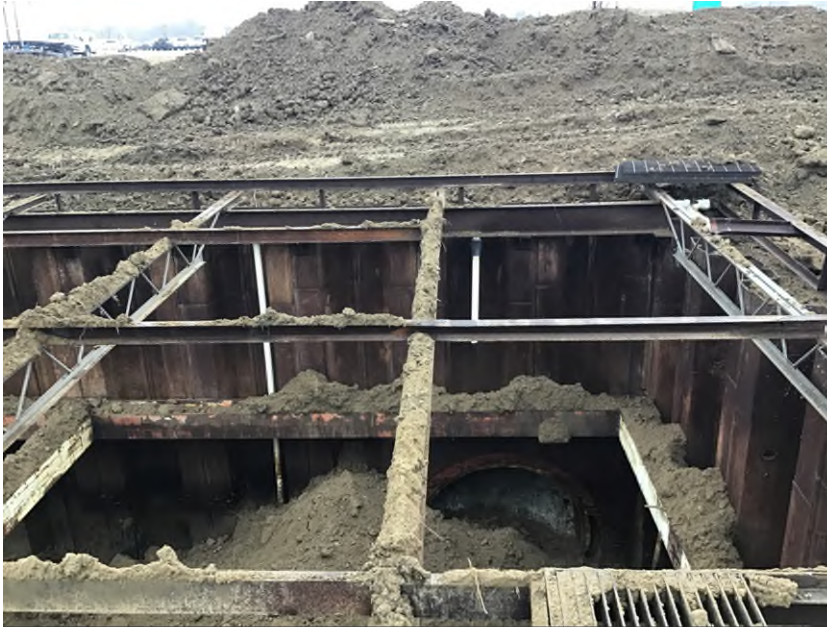
PHOTOGRAPH: 6

Observe a 12" dia. line entering the subsurface structure from the NE corner at a depth of ~10' below top of the sheet pile wall.

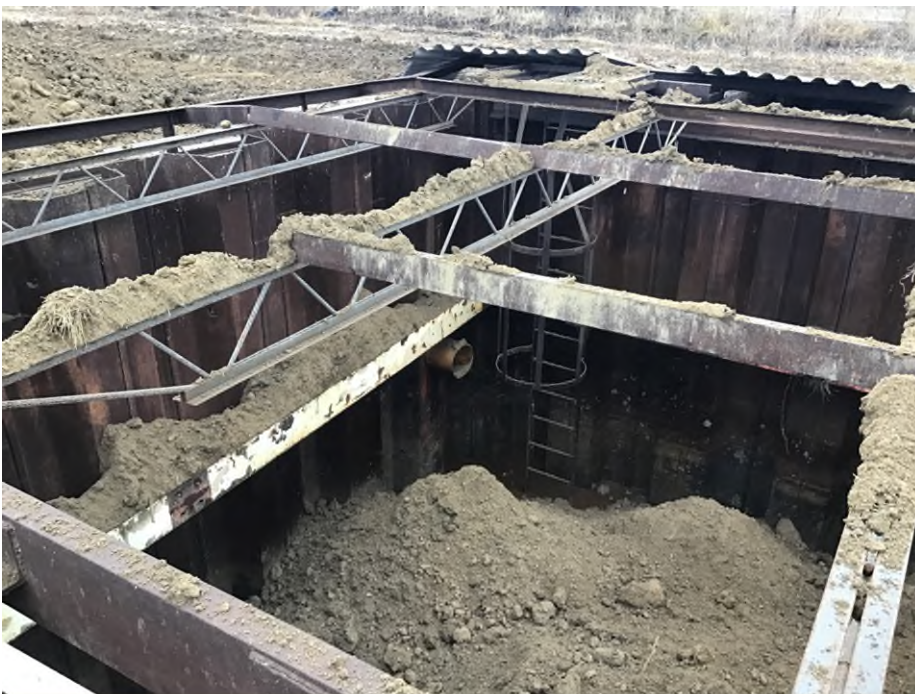
PHOTOGRAPH: 7

Contents from within the above grade structure removed prior to building demo.

- The internal components of the oil interceptor which included an above grade building and an open stairwell to a lower-level catwalk were removed for offsite disposal.

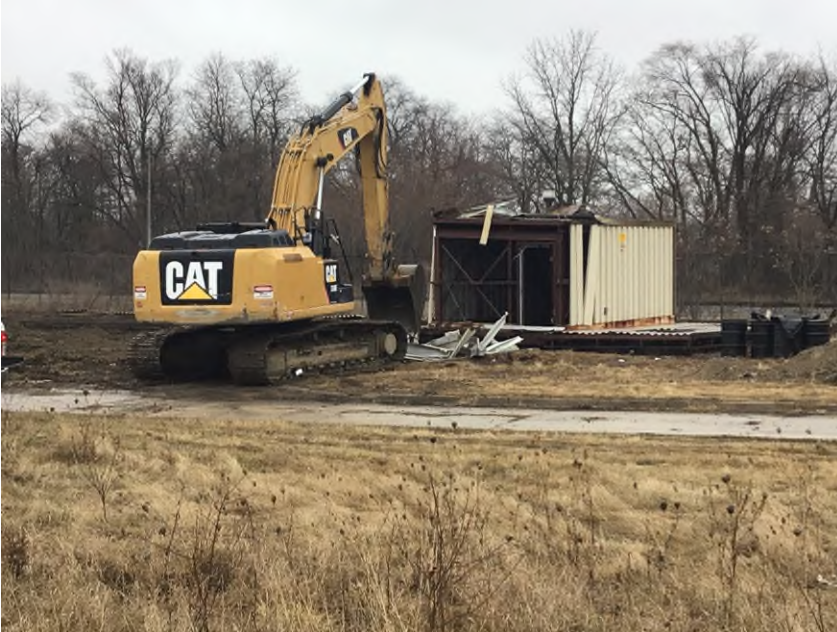
PHOTOGRAPH: 8

Above grade building structure post demo.

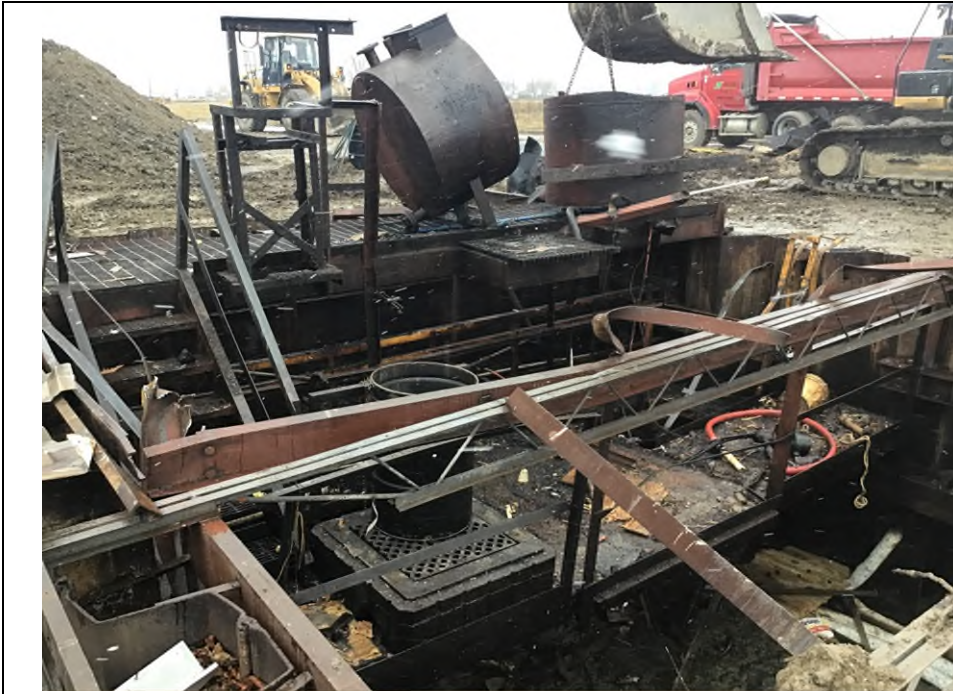
PHOTOGRAPH: 9

Removal of components from within the interior structure of the interceptor building

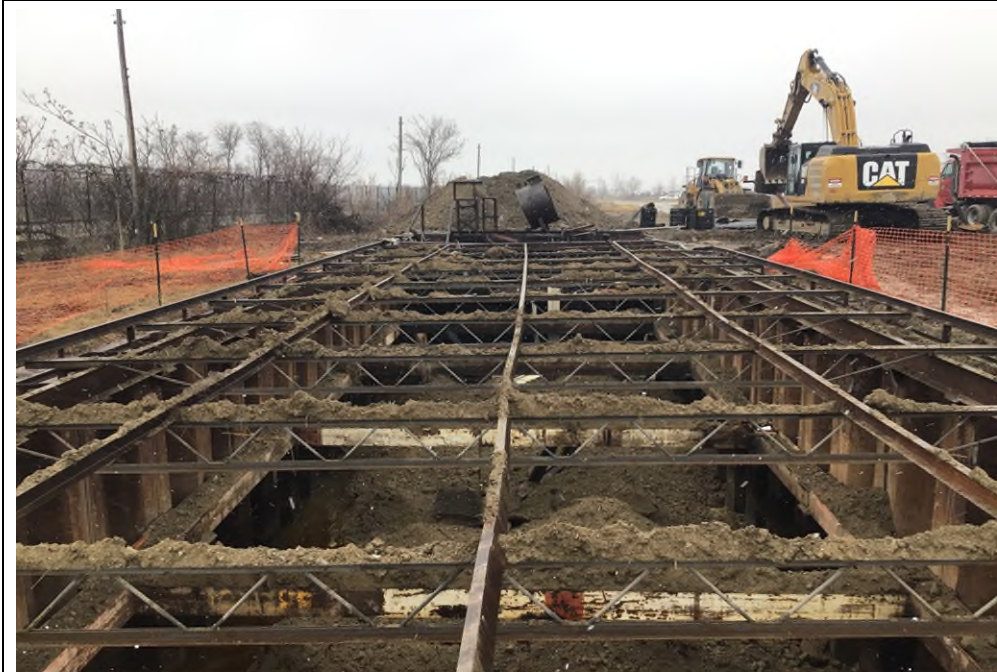
PHOTOGRAPH: 10

Removal of components from within the interior structure of the interceptor building

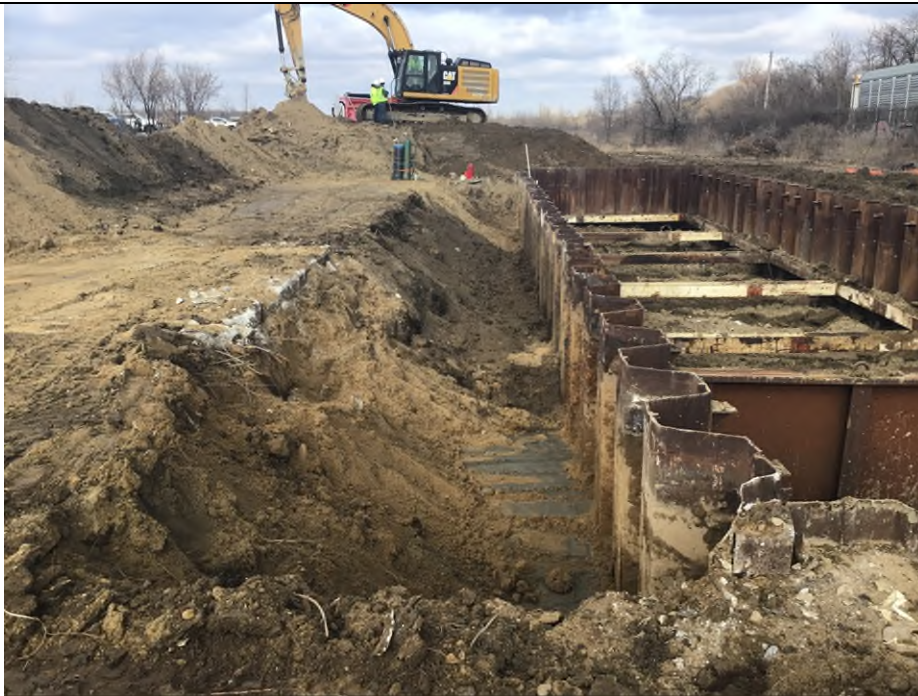
PHOTOGRAPH: 11

Contractor has completed excavation of soil along the West side of the structure to accommodate sheet pile wall removal after piles have been cut w/welding torch

- Existing soils along the perimeter of the interceptor were removed to a depth of five and a half feet. Soils were temporarily stockpiled for reuse.
- The sheet pile sidewalls of the interceptor were cut at five feet below grade, removed for offsite disposal.

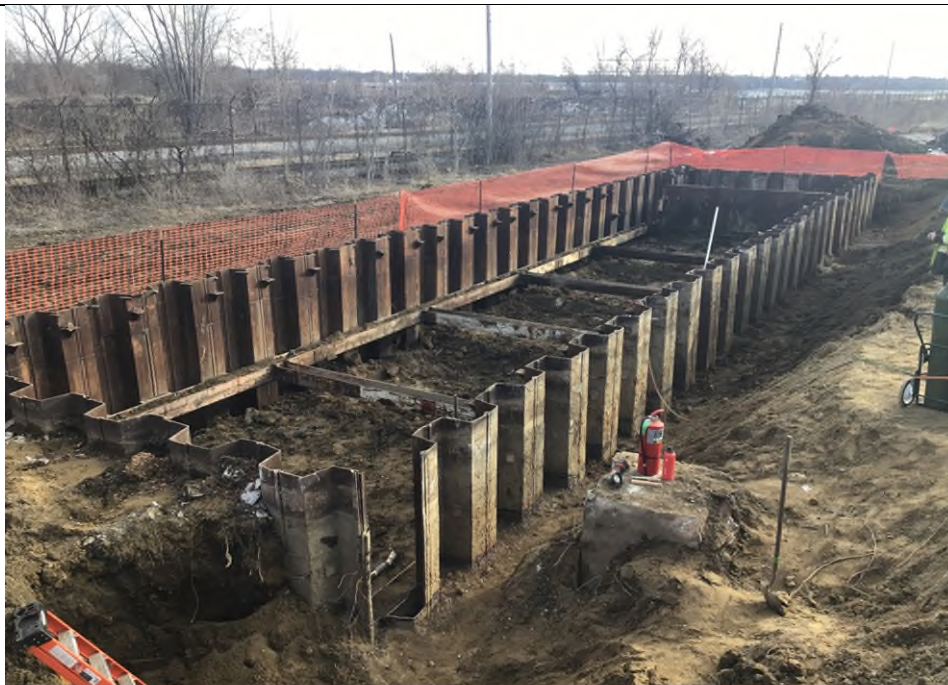
PHOTOGRAPH: 12

Overview of Interceptor sheet pile wall and horizontal I-beam supports that remain in place

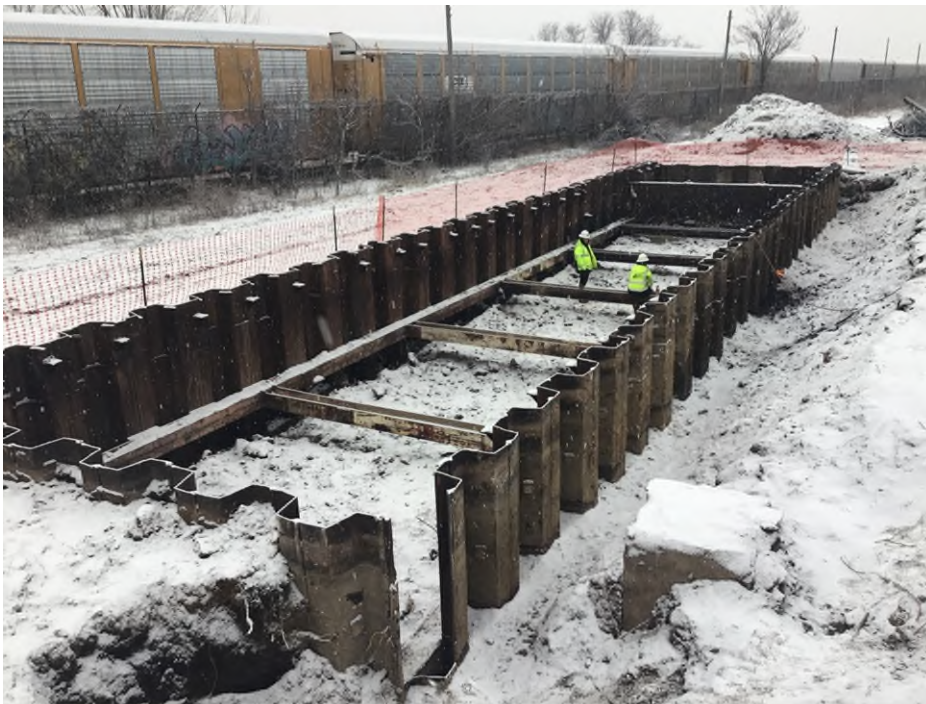
PHOTOGRAPH: 13

Contractor cutting sheet pile with welding torch prior to removal

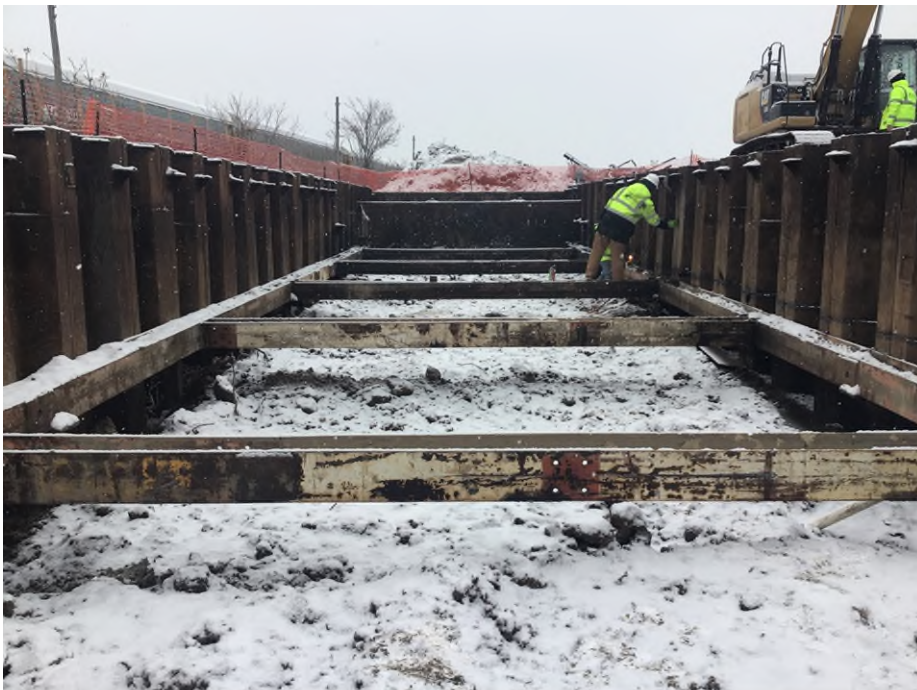
PHOTOGRAPH: 14

Structural bracing remains in place while sheet pile is cut

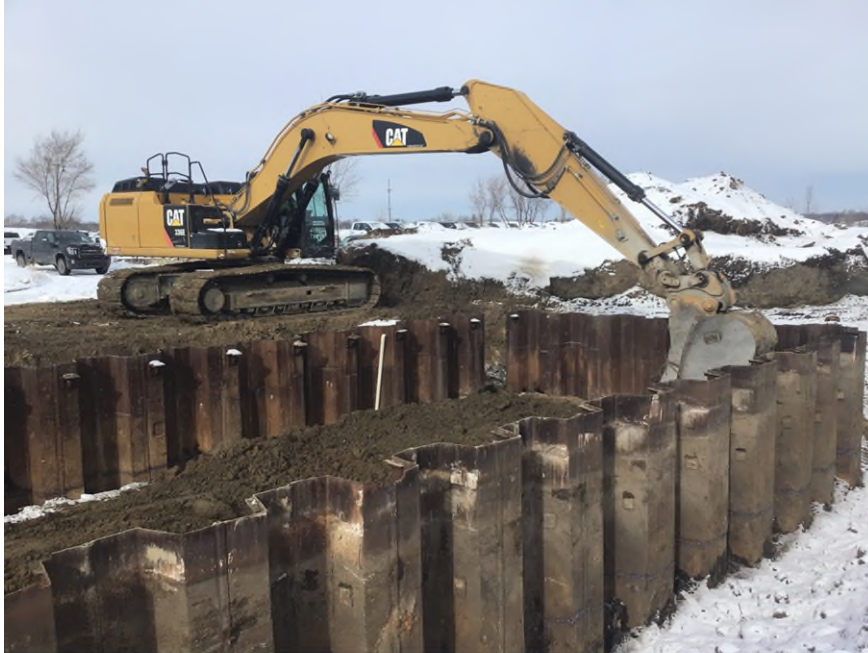
PHOTOGRAPH: 15

Contractor placing material within the interceptor during backfill and compaction.

- Imported fill material was placed in 12" loose lifts and compacted to approximately seven feet below final grade.
- Surface wipe samples were collected from six locations on the interior sheet pile walls of the interceptor structure at a depth of 7 feet below ground surface. One sample did not detect PCBs and the remaining 5 samples detect PCBs at concentrations ranging from 3 to 24 ug/100cm².

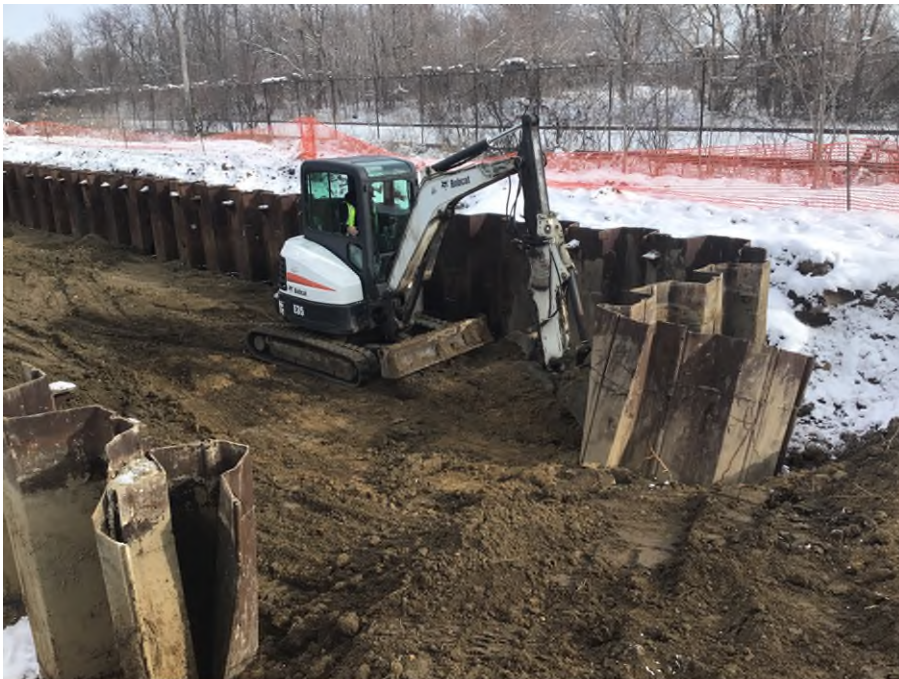
PHOTOGRAPH: 16

Contractor utilizing mini excavator to grade and compact soil around structural bracing.

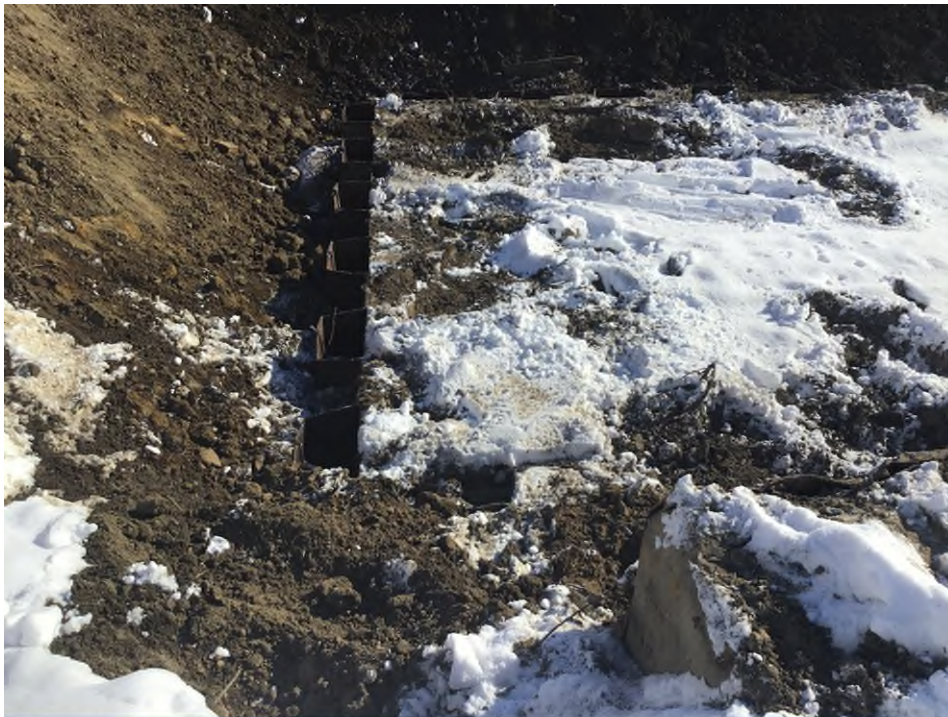
PHOTOGRAPH: 17

The upper 5ft of the 4 sided sheet pile wall structure have been removed

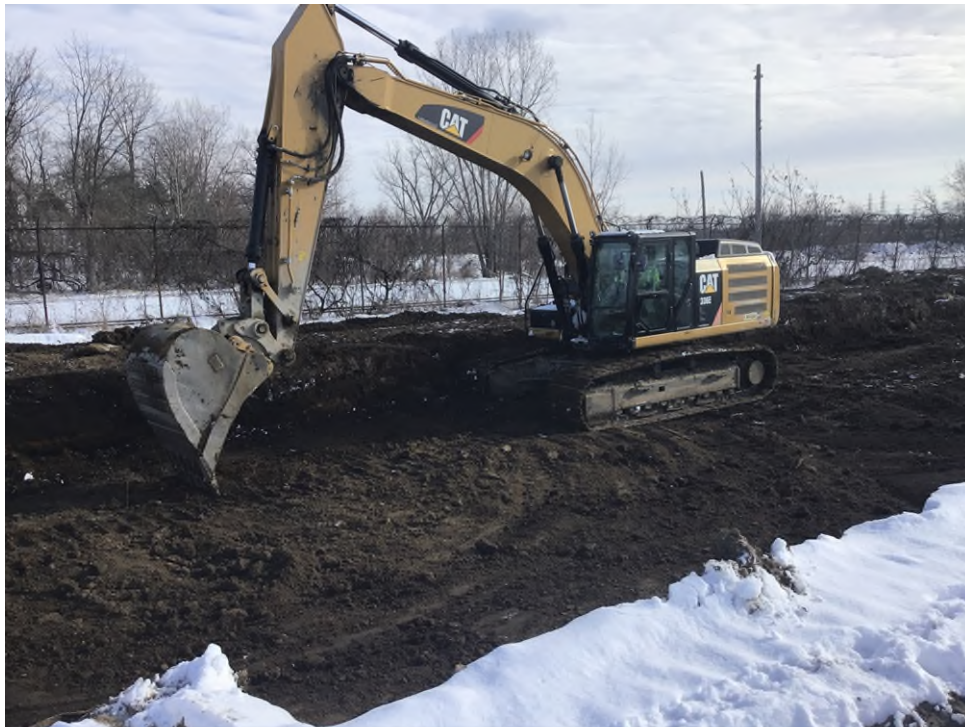
PHOTOGRAPH: 18

Contractor placing, grading, compacting clay soil 6" above the top of the cut sheet pile wall

- Imported fill material was placed six inches above the top of the remaining embedded sheet pile structure across the excavation area and then compacted with a roller.

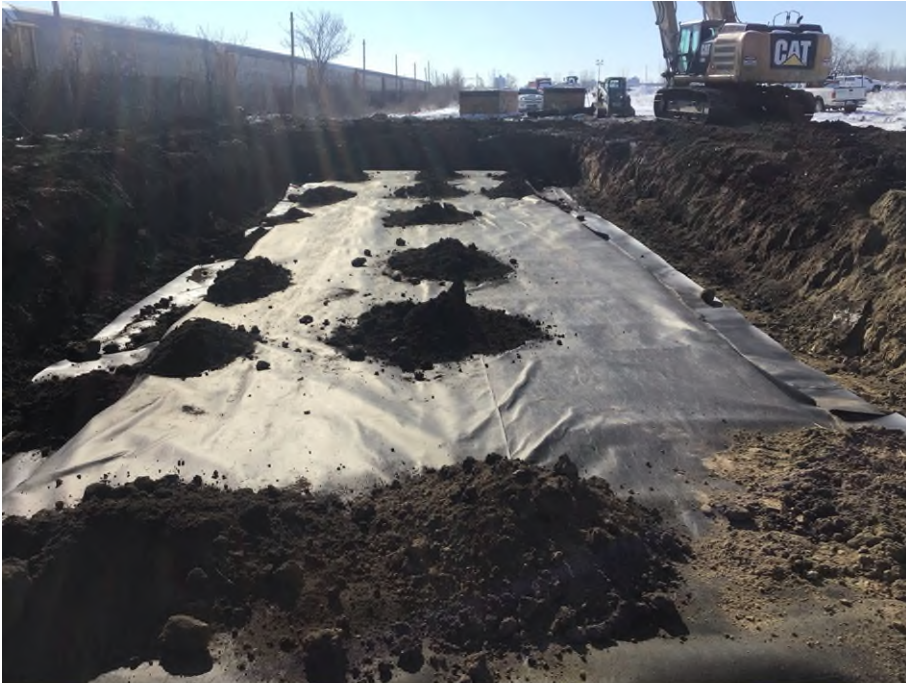
PHOTOGRAPH: 19

Backfill above liner system

- An additional layer of 6oz nonwoven geotextile was placed atop of the clay (one foot above the top of the liner) to act as a demarcation layer.
- Imported fill material was placed in 12" loose lifts and compacted with a roller to surface grade.

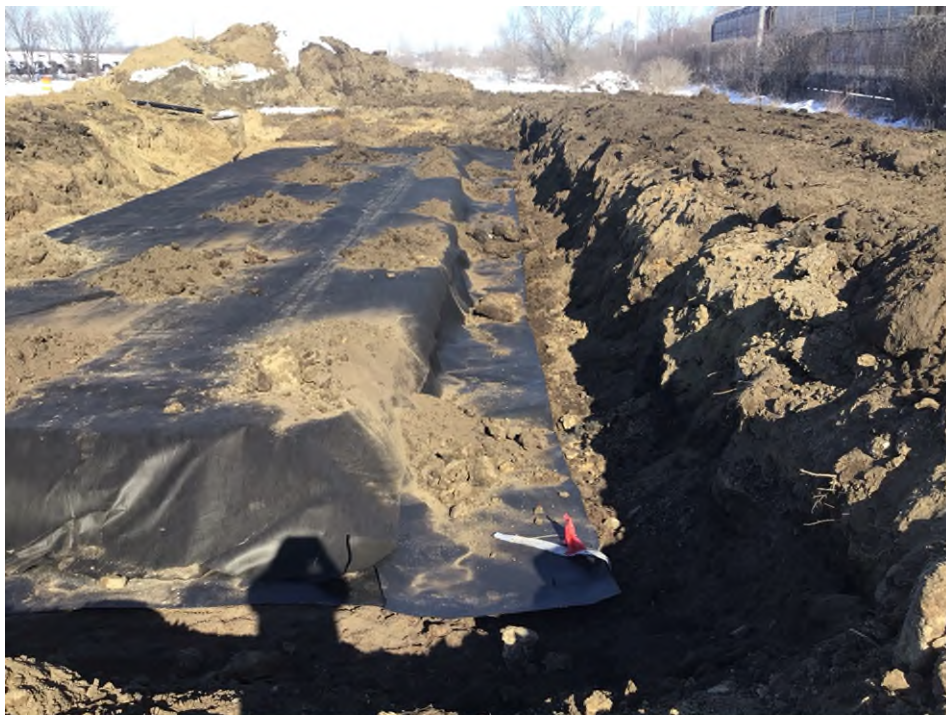
PHOTOGRAPH: 20

Backfill above liner system

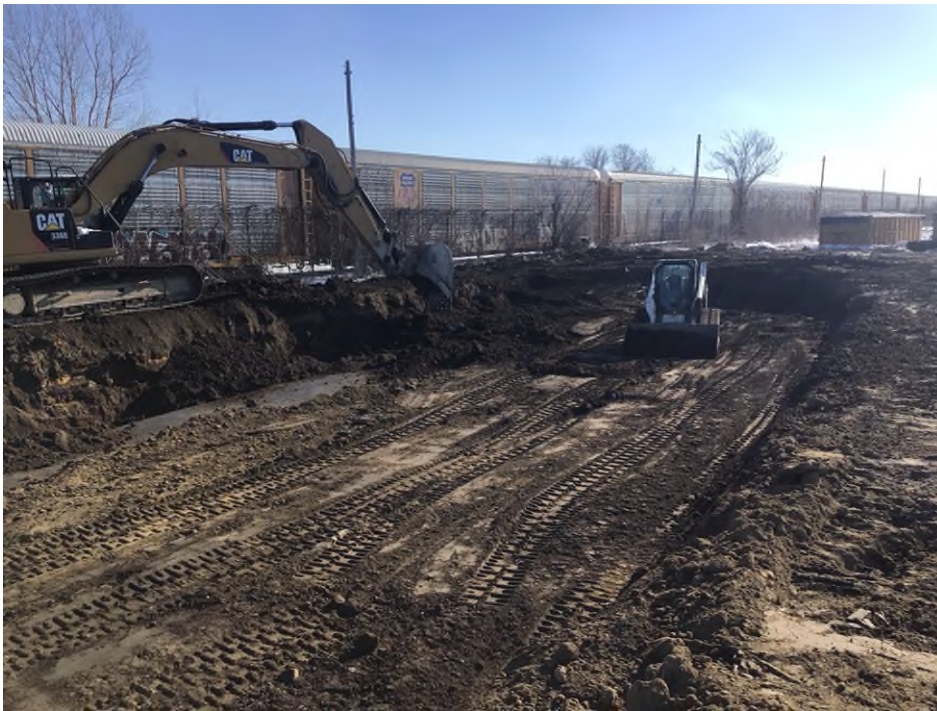
PHOTOGRAPH: 21

Backfill and grading above liner system

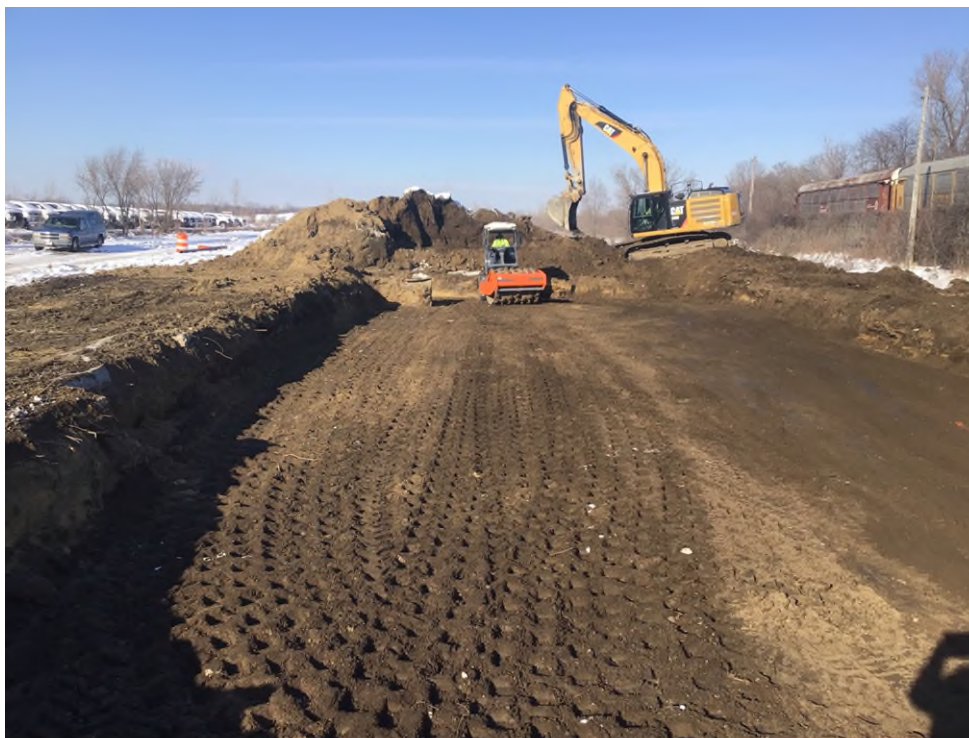
PHOTOGRAPH: 22

Compaction of 12" loose lifts during backfill

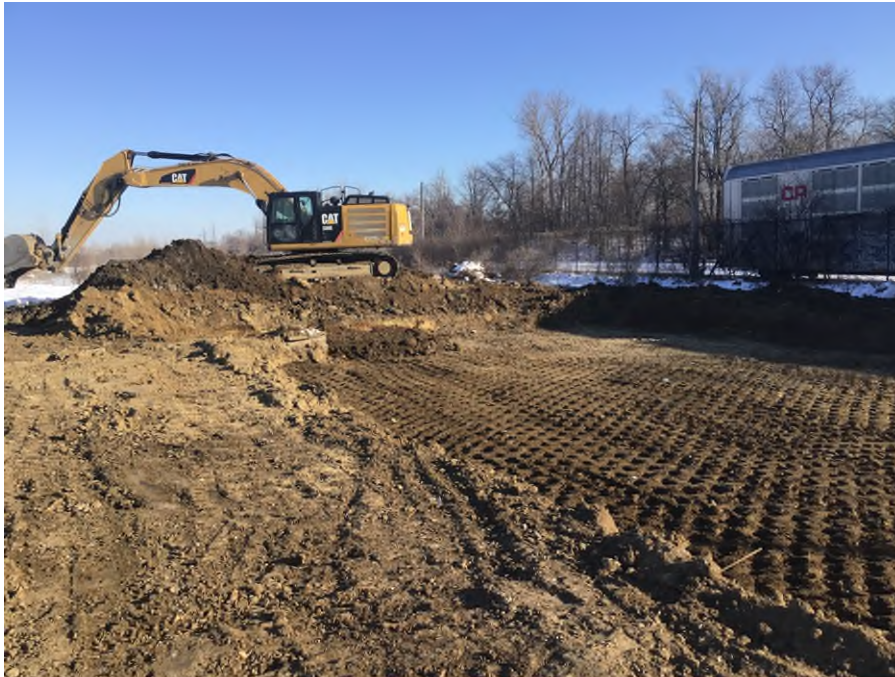
PHOTOGRAPH: 23

Following placement and grading of 12" lift, contractor utilizing Compactor with sheep's foot Pad front roller
