Memorandum

May 29, 2019

Subject: **RACER Nodular Industrial Land - Response to U.S. EPA Comments from April 4, 2019 Site Meeting**

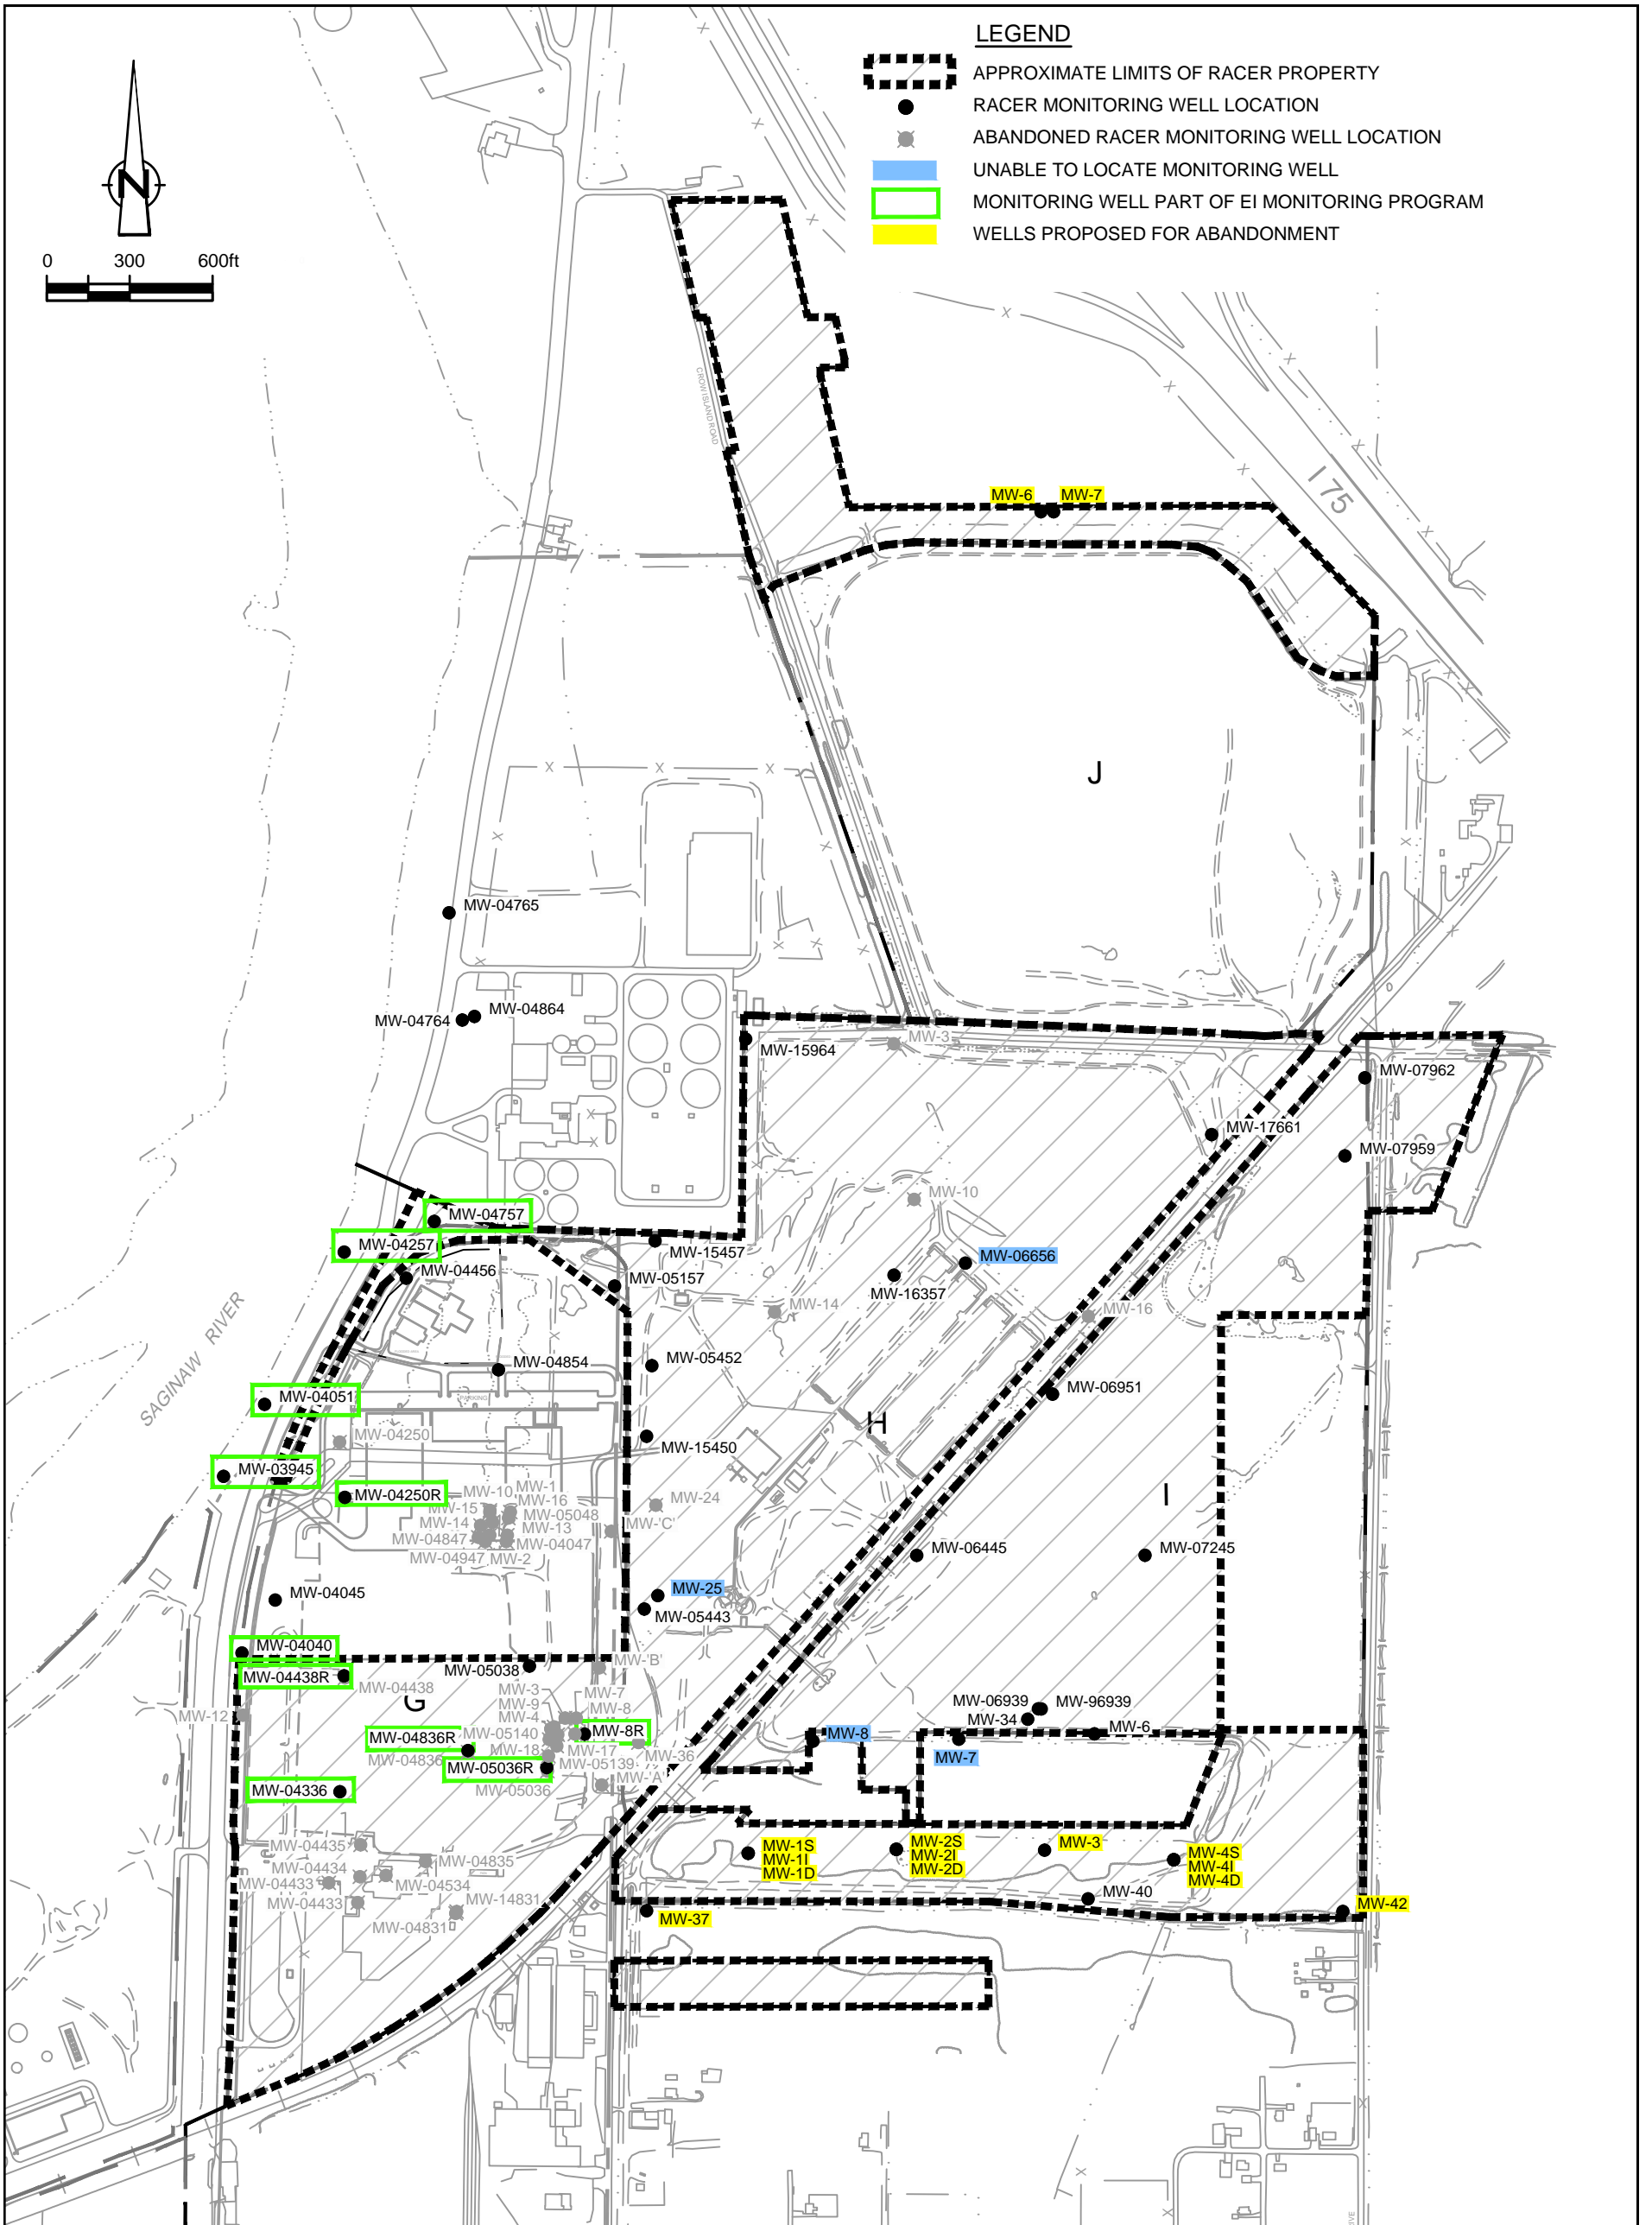
figure 2
 MONITORING WELLS
 SAGINAW NODULAR INDUSTRIAL LAND
 Saginaw, Michigan

The following monitoring wells are located on the property south of the clay pile: MW-37, MW-1S, 1I, 1D, MW-2S, 2I, 2D, MW-3, MW-40, MW-4S, 4I, 4D, and MW-42. These wells are shown on Figure 2.

Based on the lack of historical operations in this area, review of available groundwater data, and lack of potential risk/exposure to groundwater in this area, GHD recommends that all the wells be abandoned.

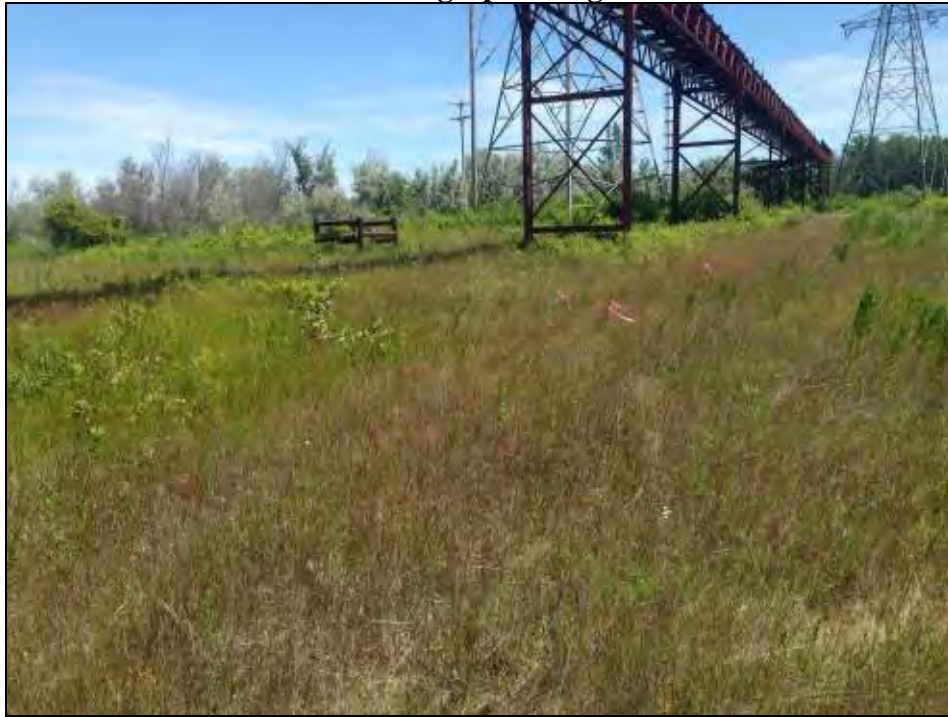
Photo 1

The Racer Trust property is a 38.86-acre site that was a former industrial facility that was demolished roughly 10-15 years ago and left fallow.

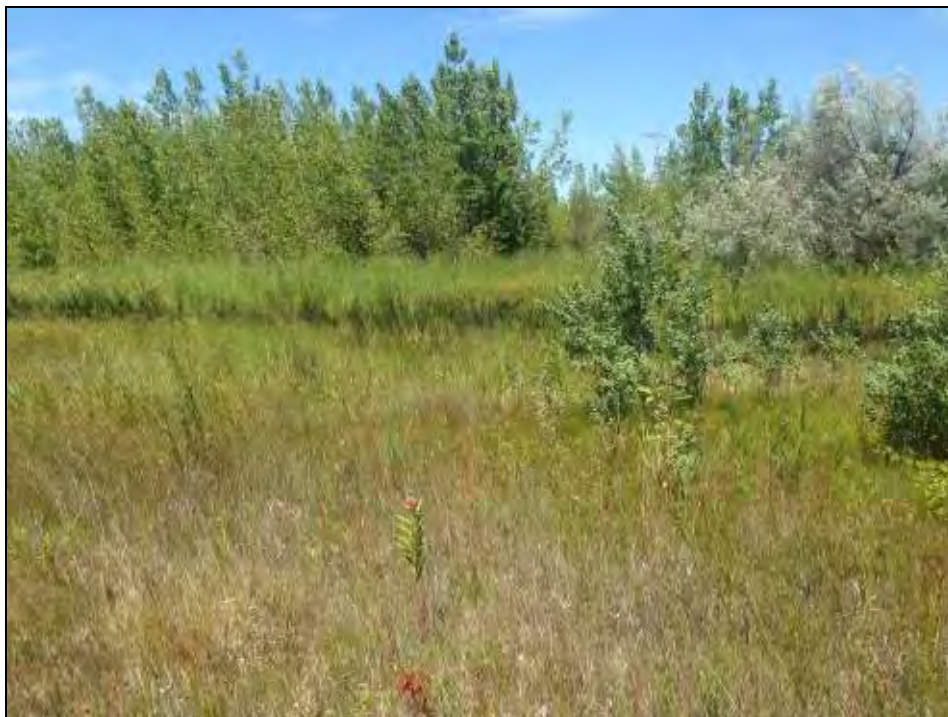
Photo 2

This disturbed property is dominated by pioneer species such as cottonwood, willow, and Russian olive.

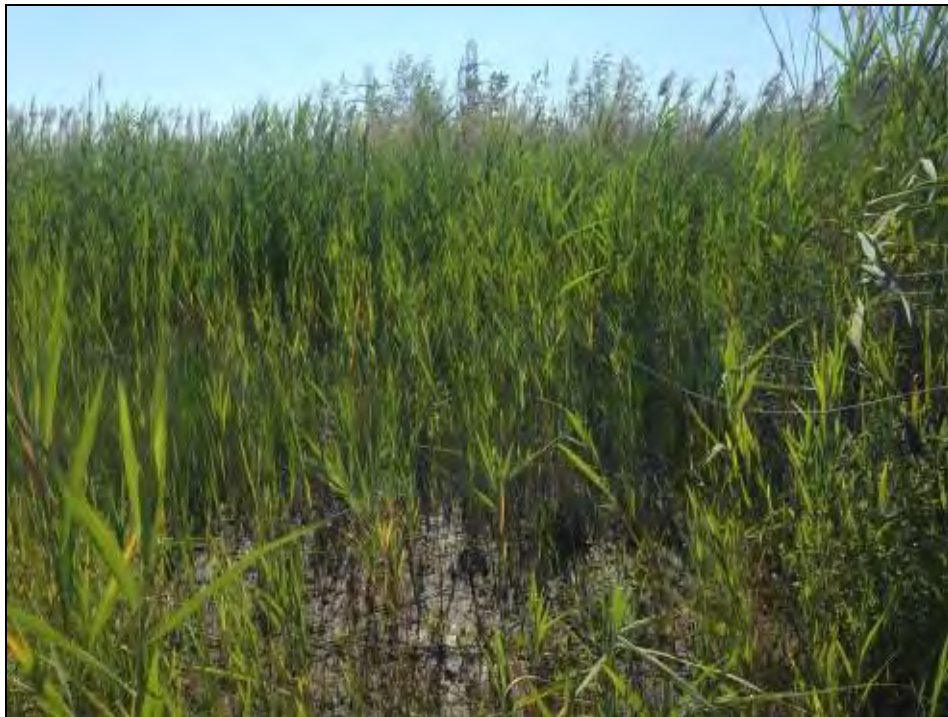
Photo 4

Wetland A, located on the north side of the access drive, is dominated by Phragmites (although other species are present throughout).

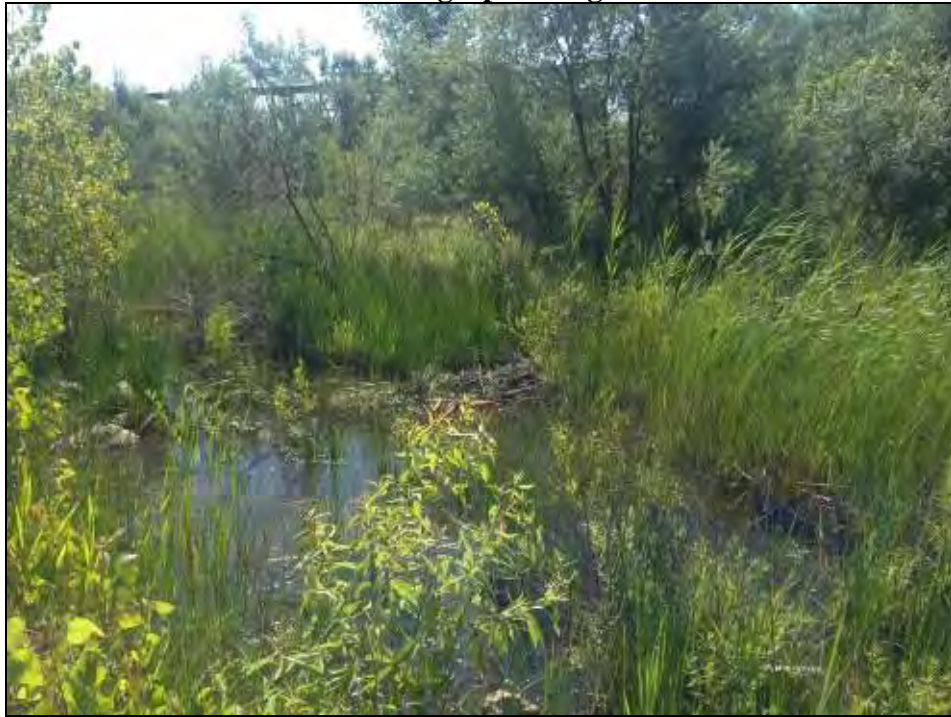
Photo 5

View facing south showing Wetland B, a large (~7⁺ acre) scrub-shrub wetland. This wetland is likely regulated by the MDEQ.

It is Niswander Environmental's professional opinion that Wetland B is regulated by the MDEQ due to the fact that it is greater than 5 acres in size. The remaining four wetlands are less than 5 acres in size, and are hydrologically isolated. However, since the MDEQ has the final regulatory authority, we recommend that a Pre-Application Meeting with the MDEQ be held prior to moving forward with any potential development. A MDEQ Part 303 Permit will be necessary if impacts to regulated wetland are proposed.

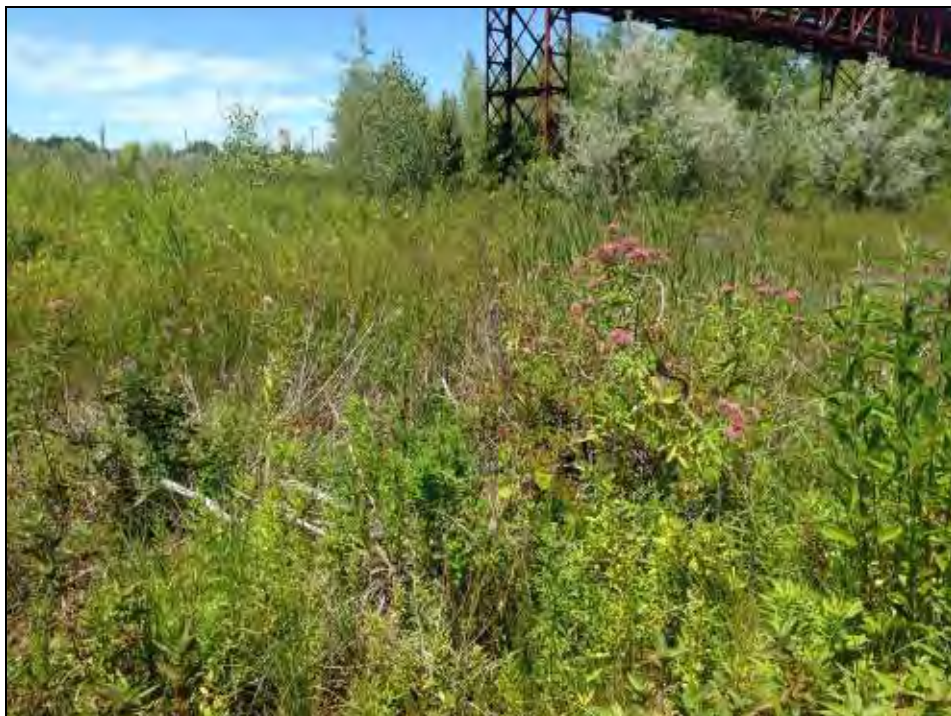
Photo 6

The southern portion of Wetland B is comprised primarily of meadow species as opposed to woody species that dominate further north.

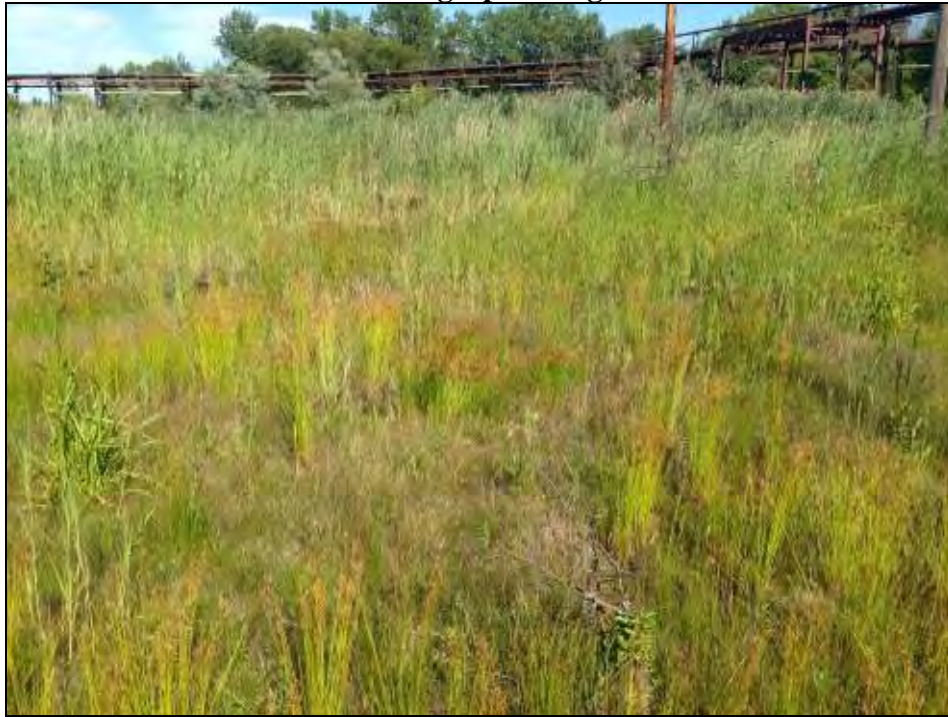
Photo 7

Wetland D, located in the northeast portion of the property, is primarily an emergent wetland dominated by Phragmites, cattail, sedge, and rush.

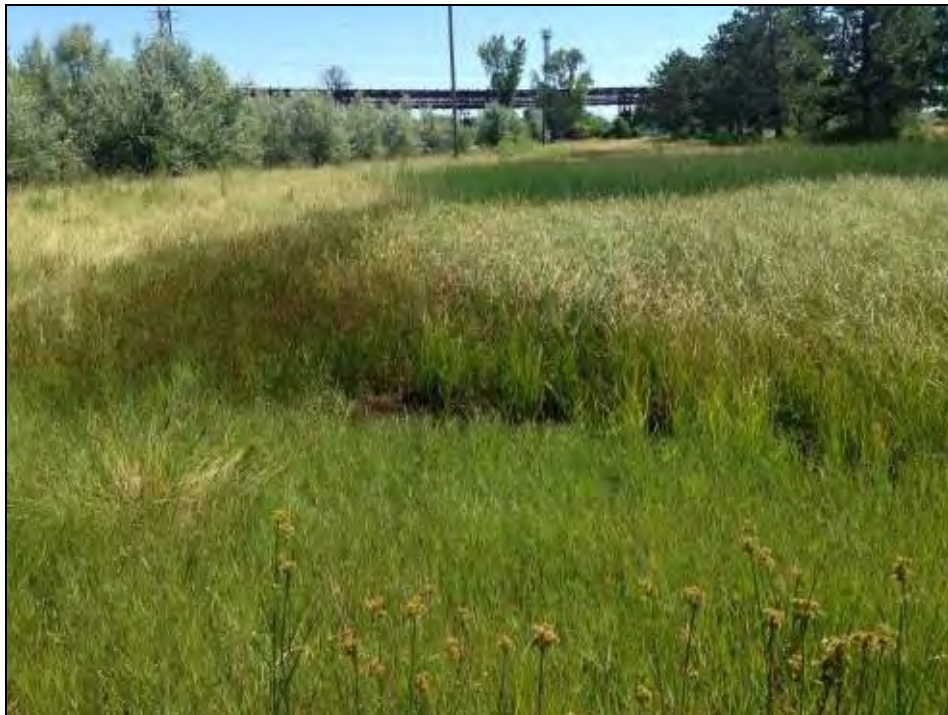
Photo 8

Wetland C is a small, isolated emergent wetland located along Veterans Memorial Highway.

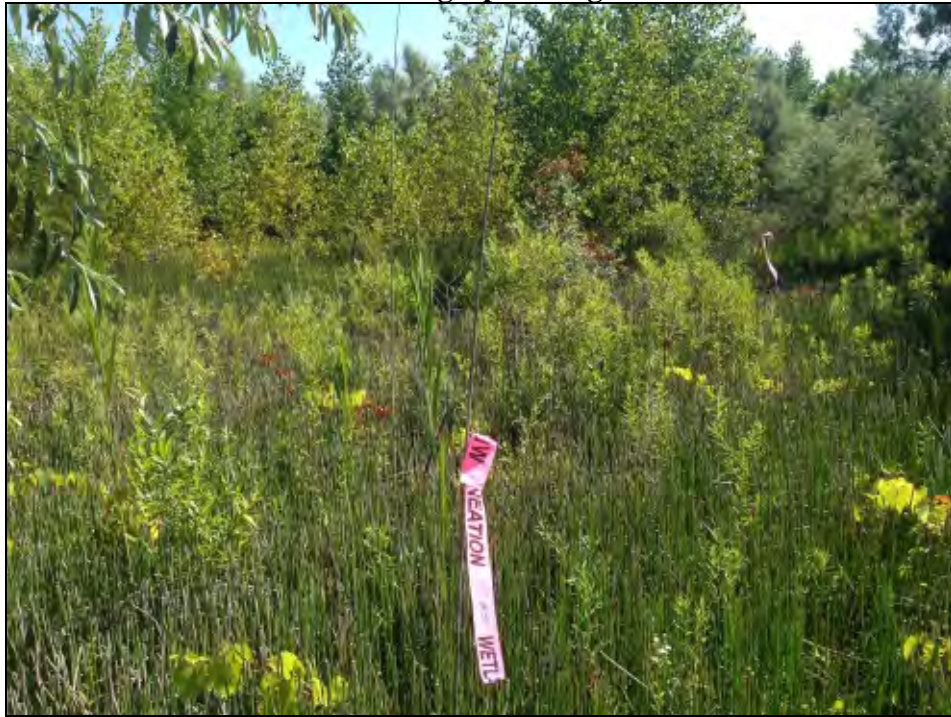
Photo 9

View facing north showing the scrub-shrub portion of Wetland E. This wetland contains both meadow and scrub-shrub characteristics, and is very diverse.

Wetland E is a small (~1 ac) wetland located in the northwest portion of the Property, beginning just north of the access drive (Figure 1). Like the other on-site wetlands, this wetland is disturbed but is becoming more naturalized as the years pass. Most of the wetland is classified as scrub-shrub due to the abundance of sapling cottonwood, but other portions are more open and resemble a meadow (Photos 9 and 10; Photographic Log). While no single species truly dominates, the most abundant plants within this wetland include cottonwood, sandbar willow, purple loosestrife, scouring rush, vervain, late goldenrod, slender-fragrant goldenrod, and riverbank grape (*Vitis riparia*).

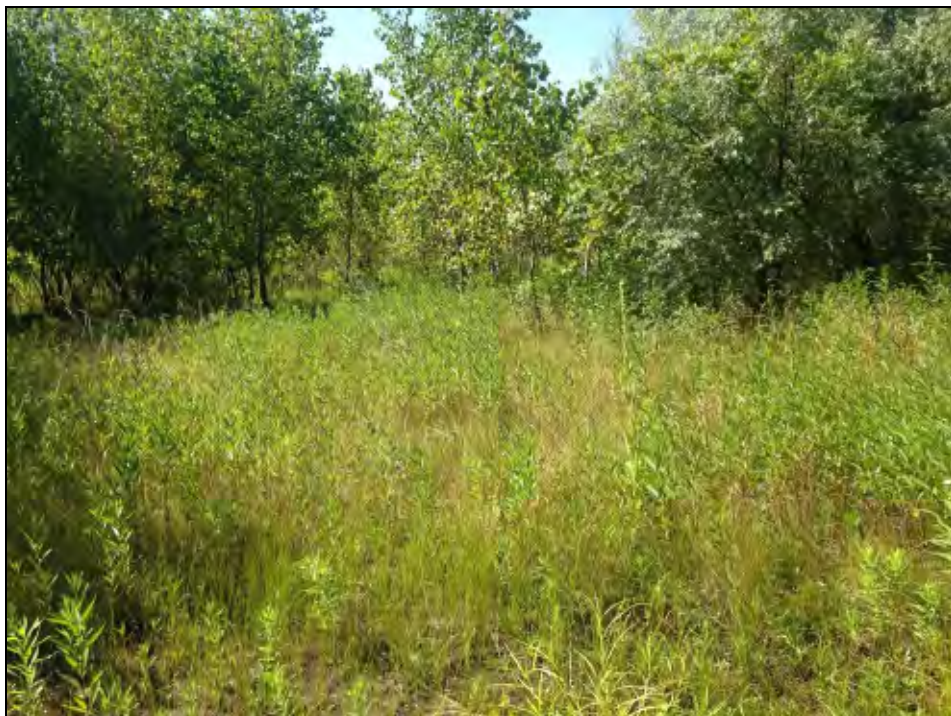
Photo 10

Pockets of open meadow are common throughout Wetland E. These areas contain an abundance of sedges, rushes and wildflowers such as vervain, goldenrod, milkweed, and aster.

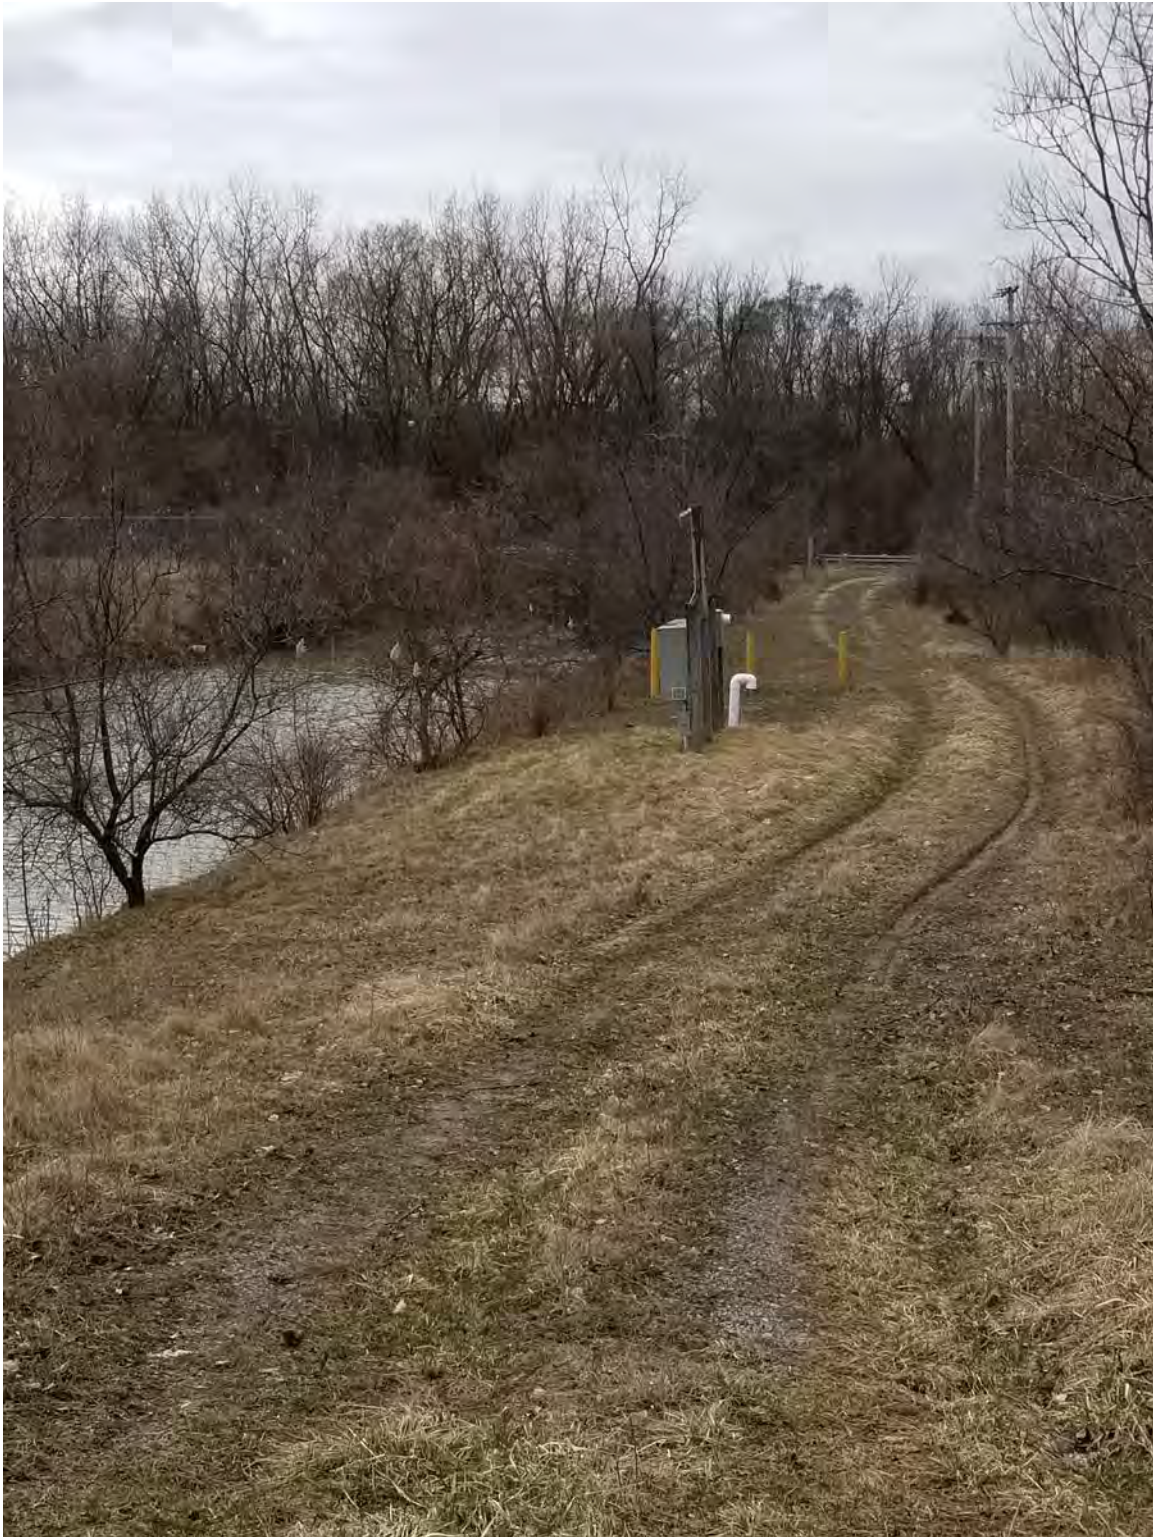
- Steve noted the presence of an electrical panel and what appeared to be pumps associated with the Crow Island Landfill (Photo 1)
- Steve also noted two wells (MW-6 and MW-7) associated with the GM Landfill (Photos 2 and 3). Figure 2 shows the locations of wells that are present to the north of the GM Landfill. GM no longer uses monitoring wells MW-6 and MW-7 as part of the monitoring associated with the GM Landfill. No data is available for MW-6 and MW-7. Given RACER does not have any responsibility for the GM Landfill, there is no data for these wells, there is no current use for the wells, and a lack of potential risk/exposure to groundwater in this area
- U.S. EPA's approval to abandon these wells is requested.

Photo 1 – View of Gauge Drain and electrical panel for pump station for Crow Island Landfill , west towards the Saginaw River 04-11-2019

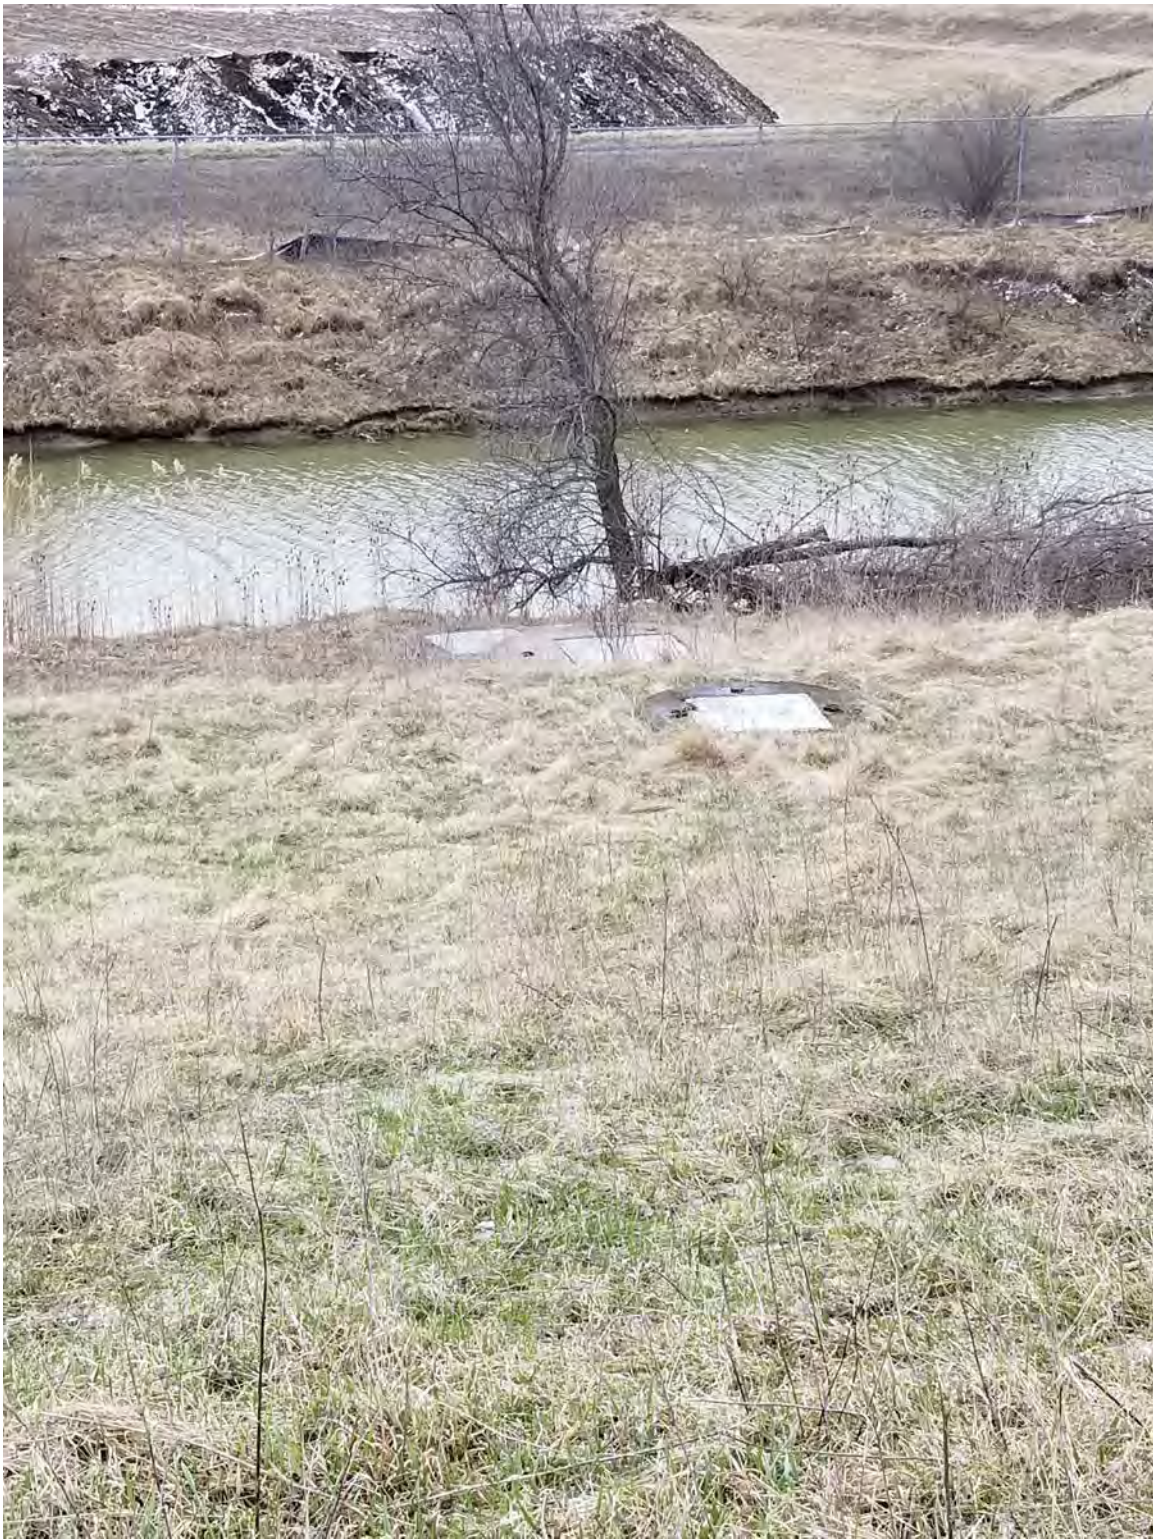
Photo 2 – View of Gauge Drain, south looking towards GM Landfill 04-11-2019

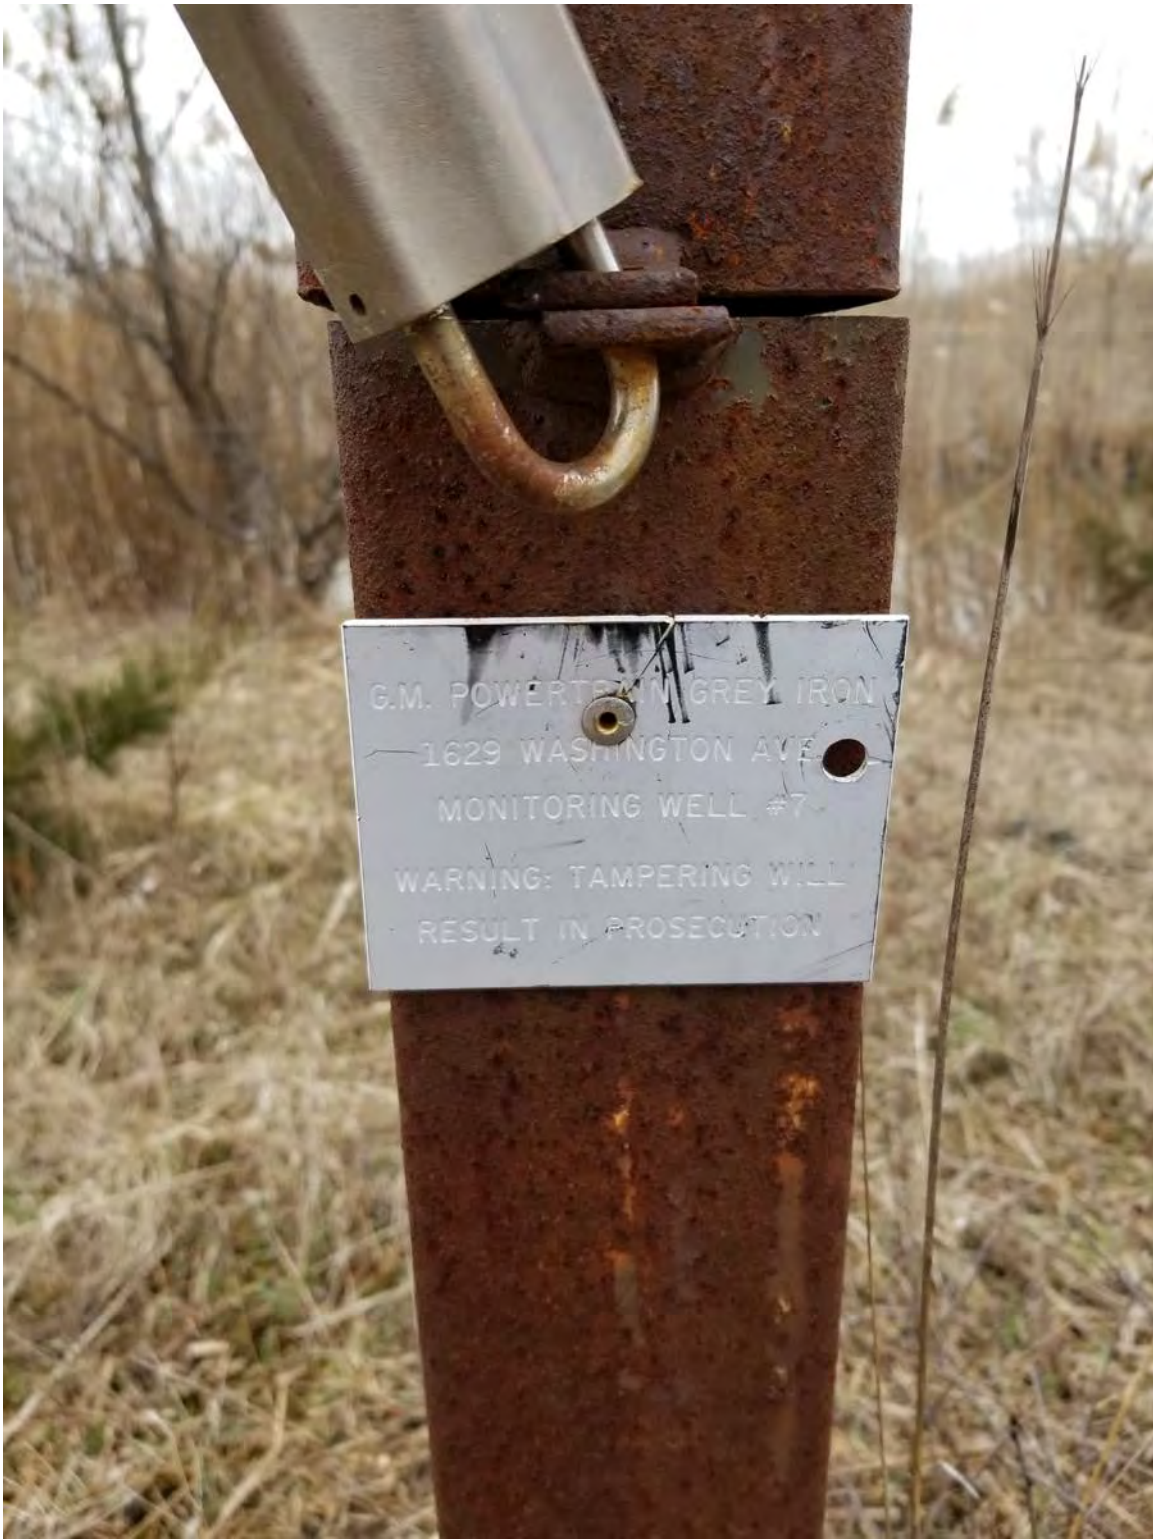
Photo 3 – GM Landfill monitoring well (MW-7) 04-11-2019

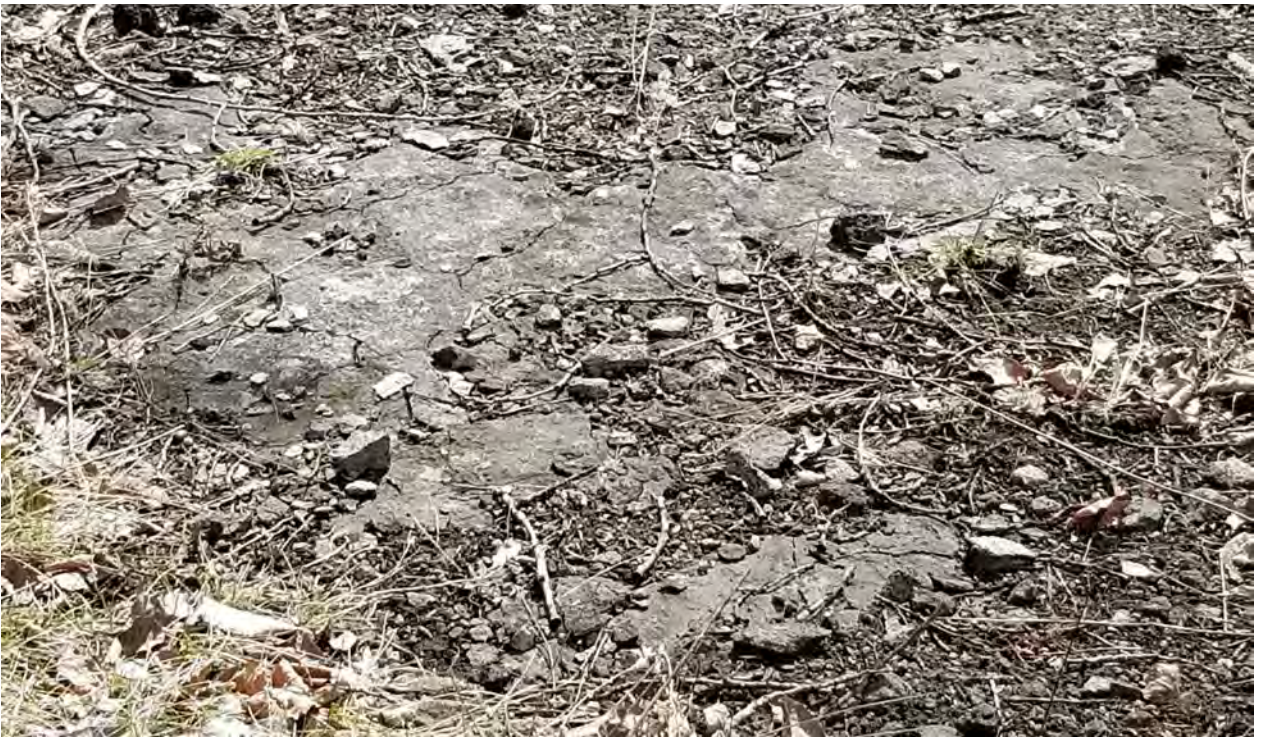
- In general the two areas are heavily vegetated and there is also miscellaneous trash/debris
- There was evidence of some historical GMC operations (two areas of slag) on the northern of these two parcels (Photos 4 and 5). Figure 3 shows the approximate size of the slag areas. Area 1 is approximately 750 square feet and Area 2 is 12,000 square feet.
- A brief sampling scope of work will be submitted separately for the two areas of slag

Photo 4 – Close up of slag area 04-11-2019

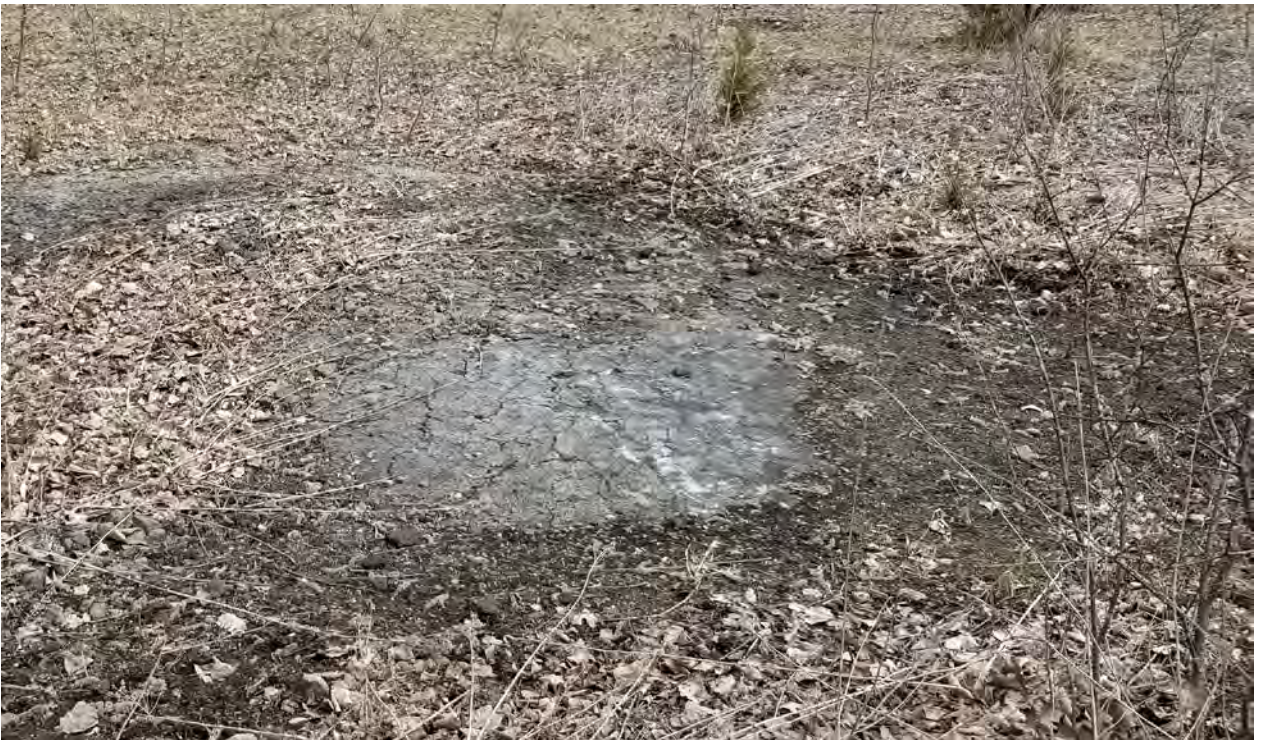
Photo 5 – Slag area 04-11-2019
