WDNR BRRTS CASE # 02 - 54 - 556700 WDNR SITE NAME : Former GM Training Center

1. Site Name: Former Janesville Training Center  
Street Address: 1405 S. Jackson Street  
City/Zip Code: Janesville, 53546
2. BRRTS #: 02-54-556700
3. DNR FID #: \_\_\_\_\_ PECFA Claim#: \_\_\_\_\_

## Site Summary

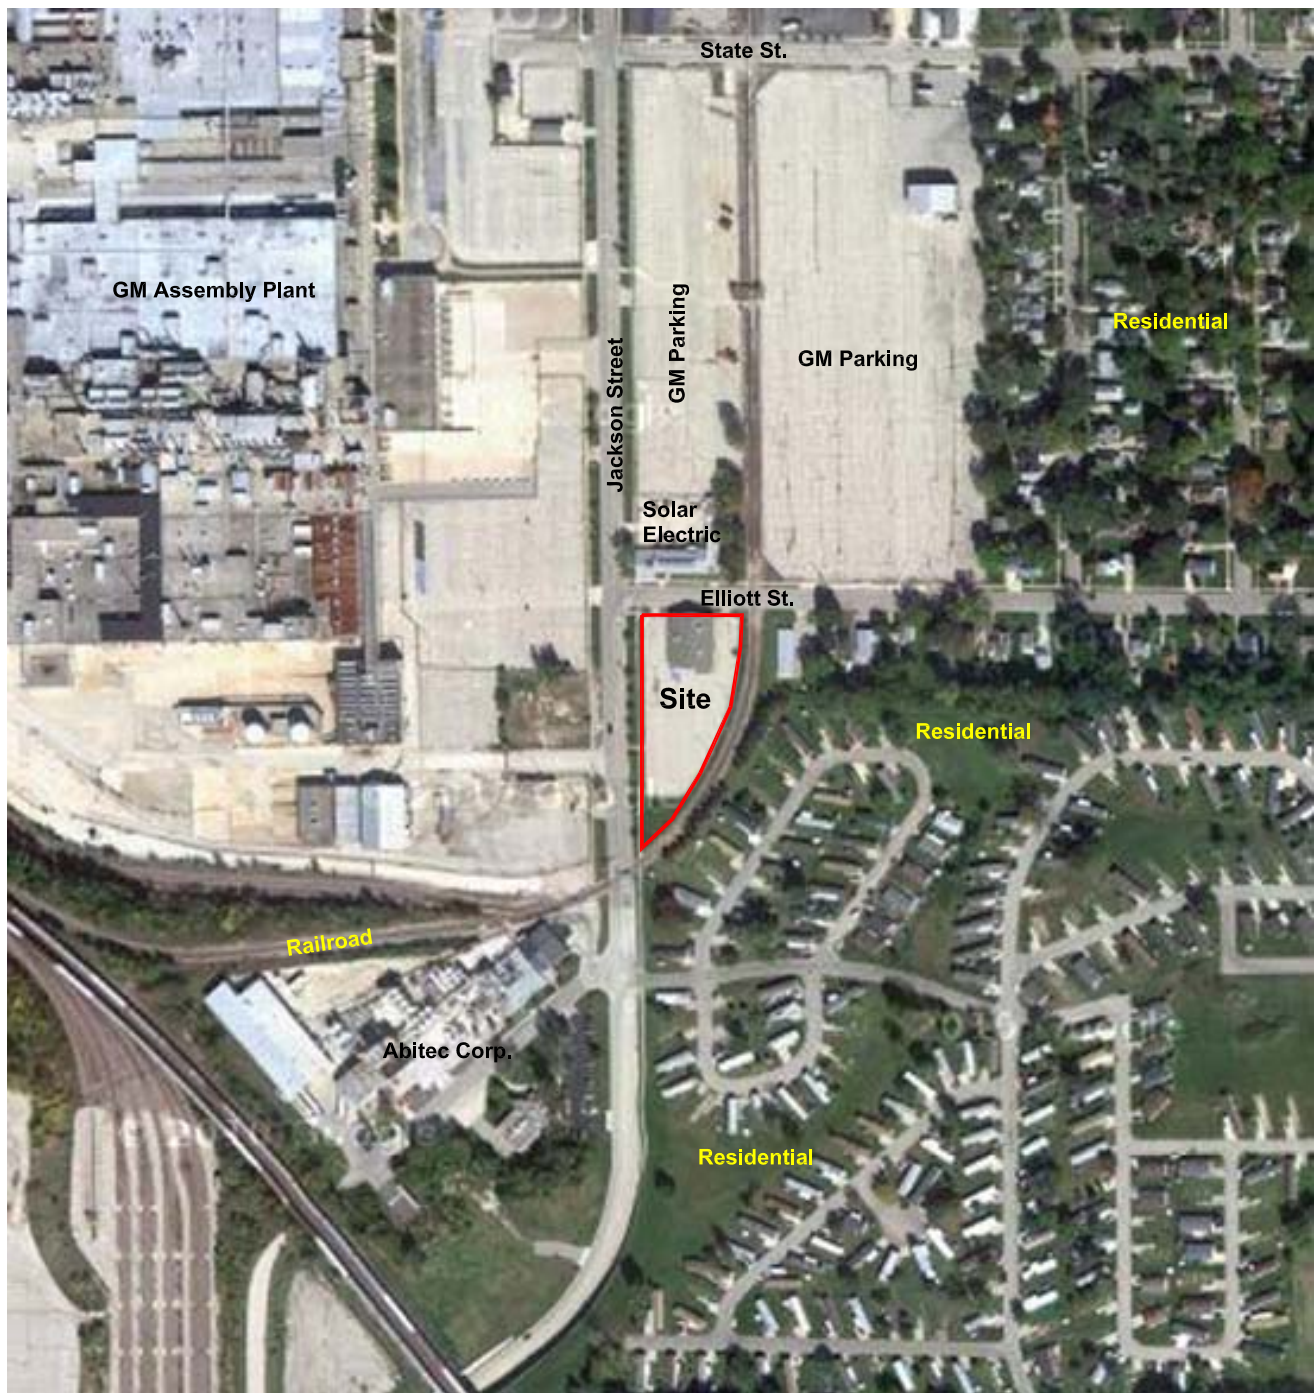
Figure 2

The Site is situated in a mixed industrial/residential area of Janesville (Figure 2). Land to the west and northwest is occupied by a large General Motors assembly plant, and land to the north is occupied by paved parking lots for the plant, with a small business (Solar Electric Energy) situated at the northeastern corner of the intersection of Jackson and Elliot. Land to the east and southeast is occupied by residential neighborhoods, and land to the southwest is occupied by Abitec Corporation. A single railroad track is immediately adjacent to the eastern side of the Site. The Site is largely asphalt paved and has one building on its northern side. One area of grassy land is situated at the southern tip of the Site, and the paved area is completely enclosed in chain link fence. The building is an approximately 9,300 square-foot, single-story slab-on-grade structure that is divided into several rooms. It has one bay door on its eastern side and a bump-out addition on its southern side (Figure 3). The Site is serviced by municipal water and sewer systems along with electrical and natural gas utilities, all of which enter the site off of Jackson Street to the west.

### Site Vicinity Map
