AMENDMENT TO
POST-CLOSURE PLAN FOR RACER ELYRIA

by
Haley & Aldrich, Inc.
Cleveland, Ohio

for
RACER Trust
Detroit, Michigan

File No. 129862
February 2021

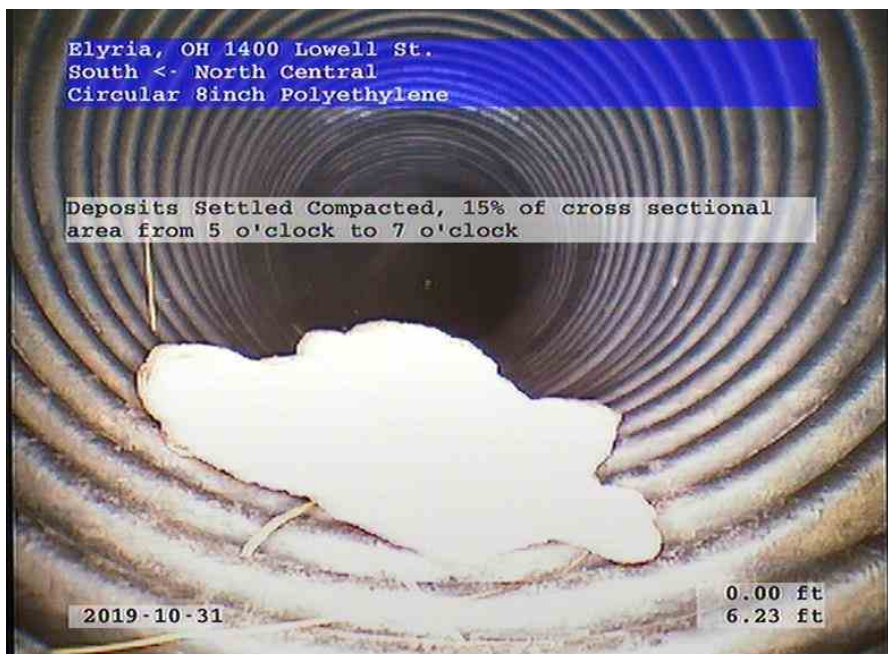
South-North Central_f308c9af-d8ca-474b-aba3-ebc824385c99_20191031_084411_735.jpg,
00:01:02, 6.23ft
Deposits Settled Compacted, 15% of cross sectional area from 5 o'clock to 7 o'clock

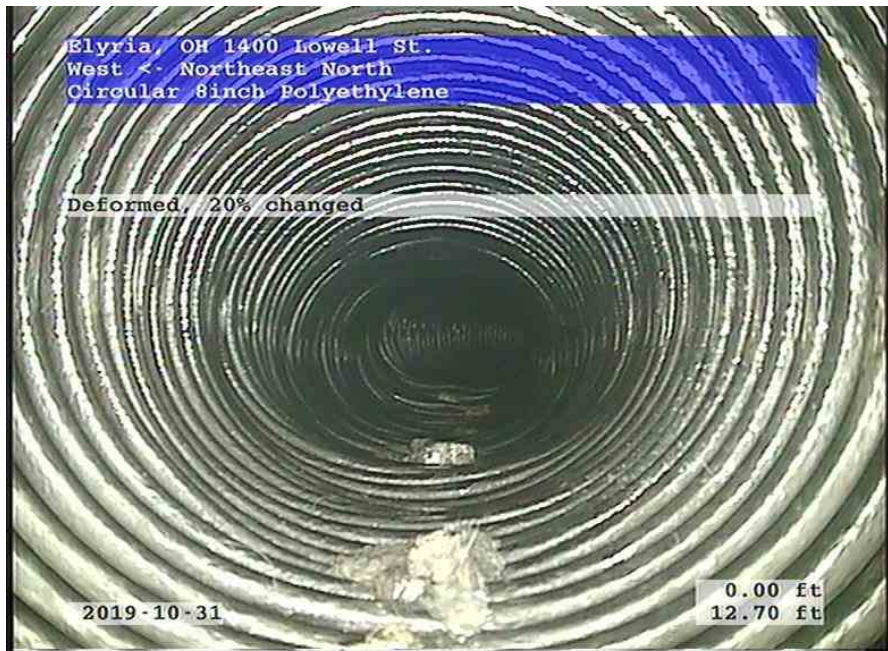
West-Northeast North_ea25ff16-b098-4eea-8c57-f587963d3b40_20191031_093015_990.jpg,
00:01:01, 12.70ft
Deformed, 20% changed

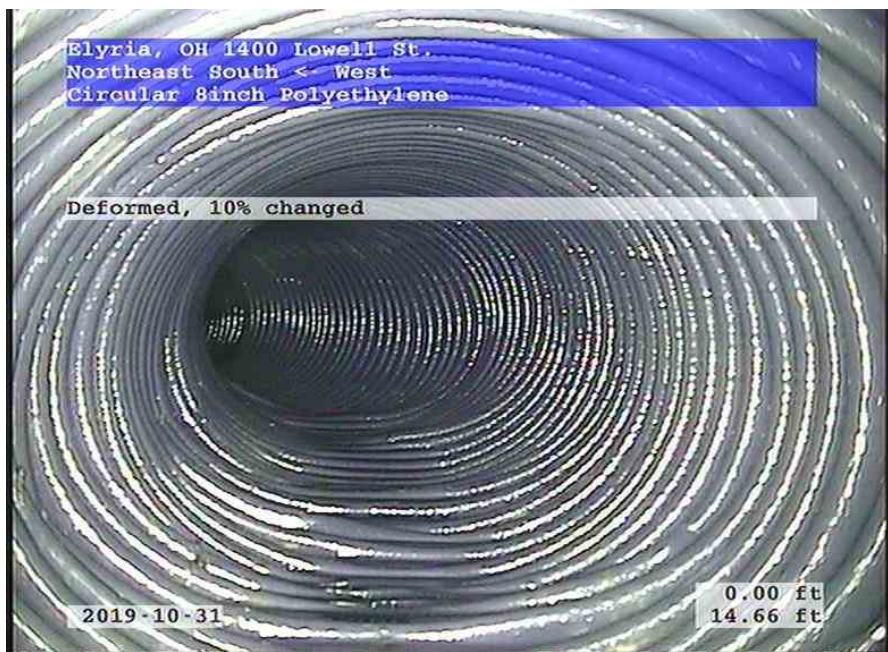
Northeast South-West_6fe19efa-8ec1-4be9-aece-1d6a736e9005_20191031_112953_725.jpg,
00:01:02, 14.66ft
Deformed, 10% changed

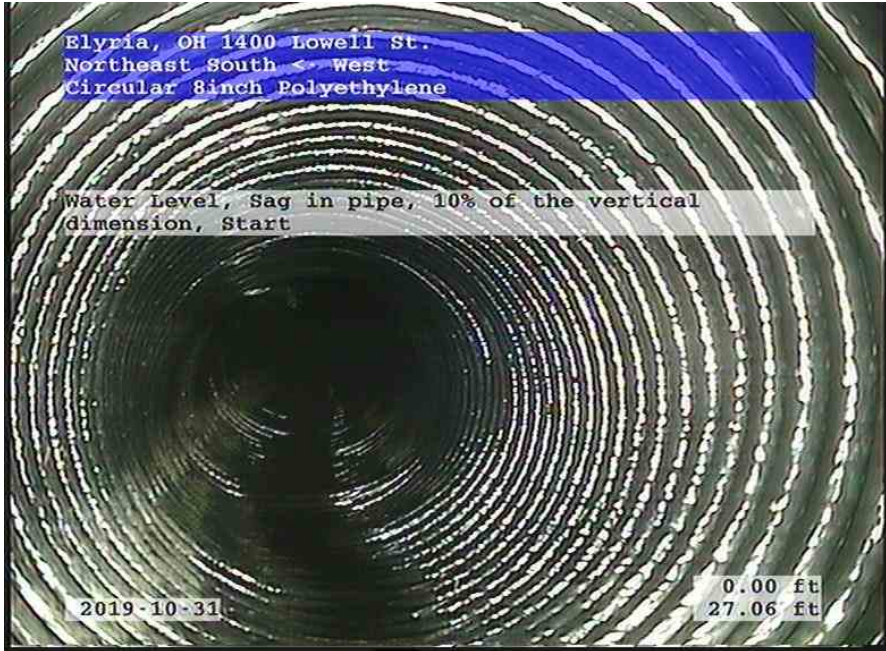
Northeast
South-West_e304673e-9e59-473b-b8bb-c309b0a34e4b_20191031_113052_767.jpg,
00:01:53, 27.06ft
Water Level, Sag in pipe, 10% of the vertical dimension, Start

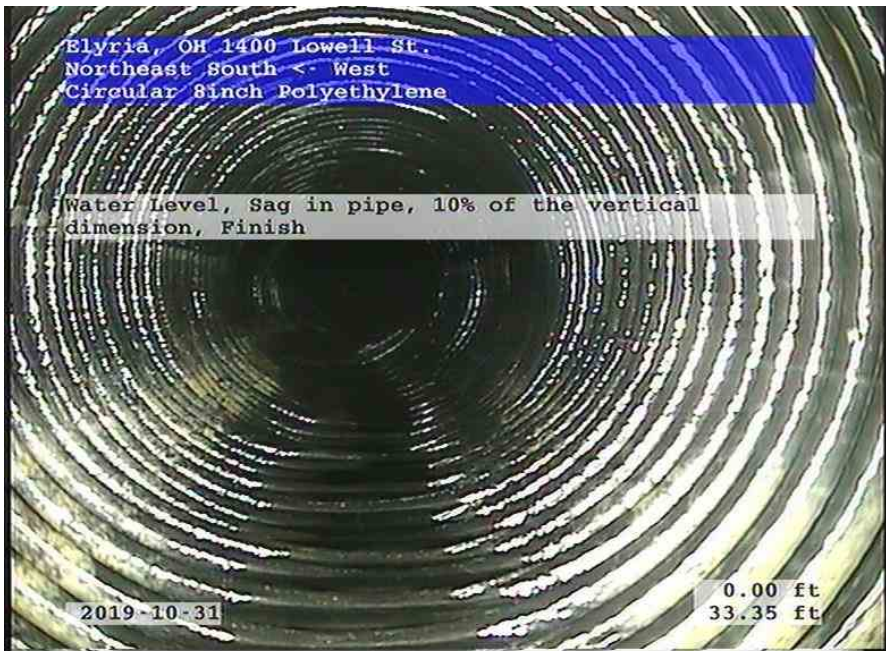
Northeast South-West_2e4c4a35-28a4-4f6f-bd51-1c9a6e7f14ea_20191031_113112_308.jpg,
00:02:10, 33.35ft
Water Level, Sag in pipe, 10% of the vertical dimension, Finish

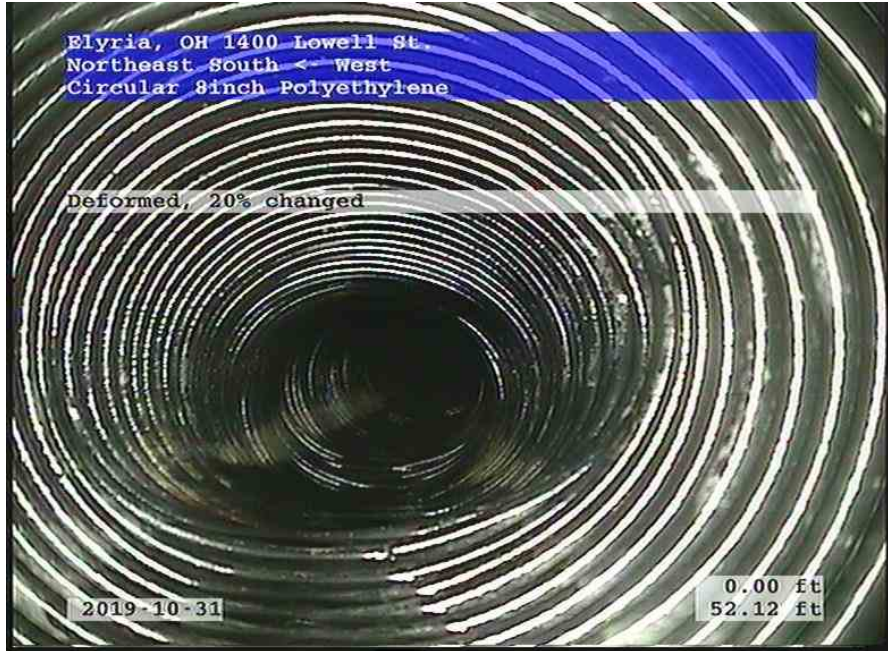
Northeast
South-West_422ca95e-543a-4013-95e4-56cdb3db73fe_20191031_113158_561.jpg,
00:02:49, 52.12ft
Deformed, 20% changed

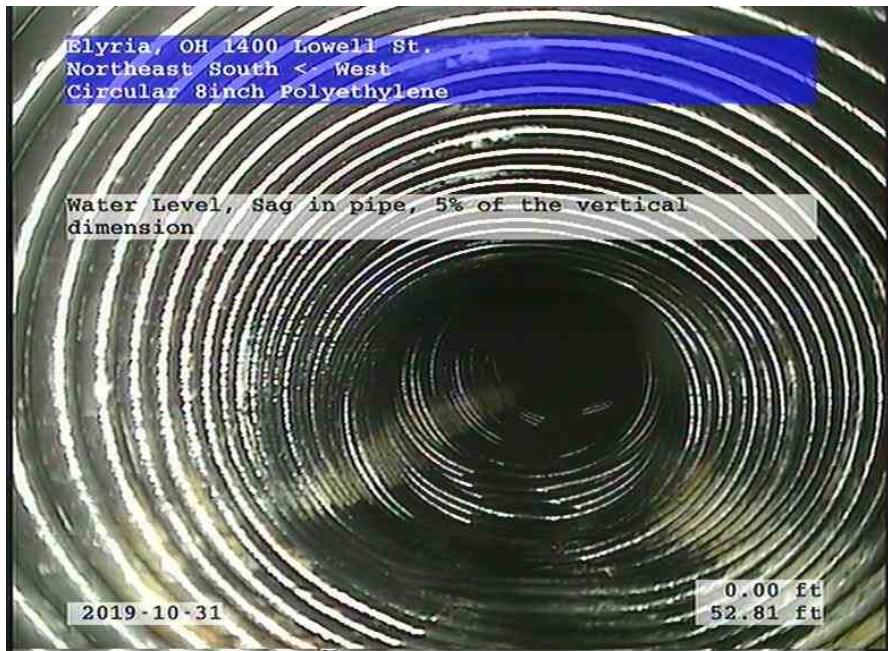
Northeast South-West_bdfccd14-7ccc-4f71-950a-f52a4c11683f_20191031_113611_977.jpg,
00:04:59, 52.81ft
Water Level, Sag in pipe, 5% of the vertical dimension

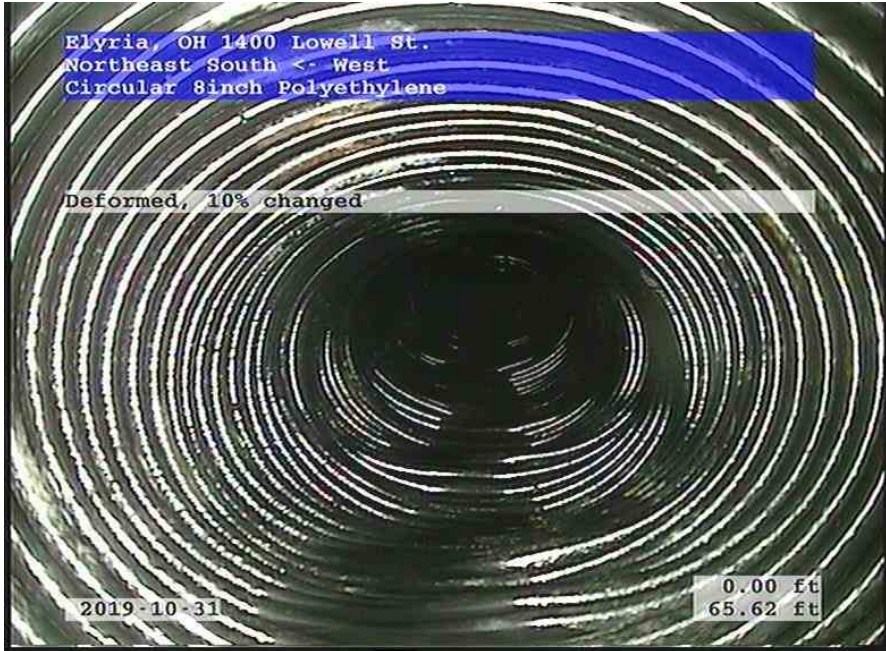
Northeast South-West_aa356f1d-fcf7-4984-8772-1995aa87e02d_20191031_113643_578.jpg,
00:05:25, 65.62ft
Deformed, 10% changed

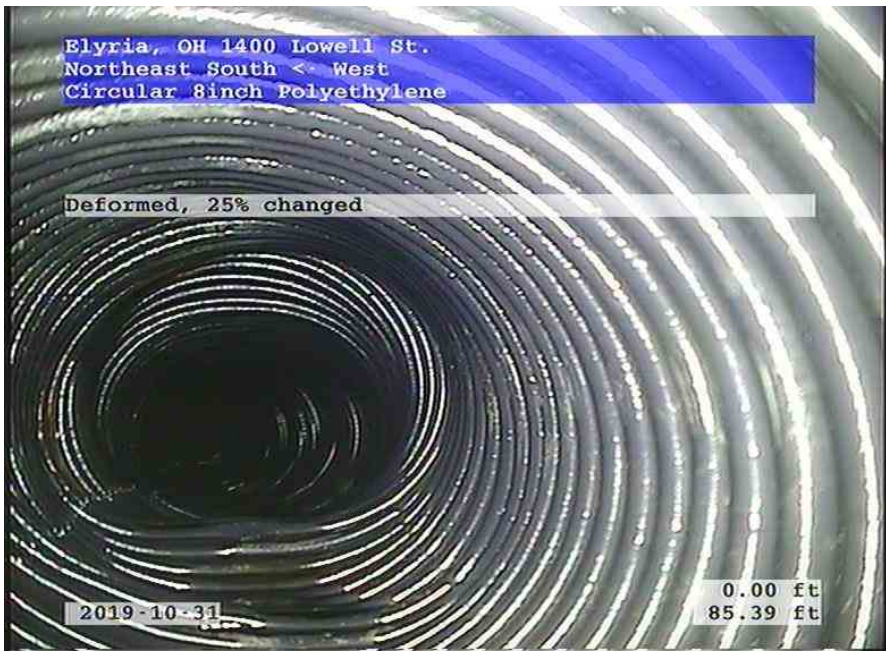
Northeast South-West_2db5c6e7-97ec-4ee7-af13-d6e21f47bca3_20191031_113749_102.jpg,
00:06:19, 85.39ft
Deformed, 25% changed

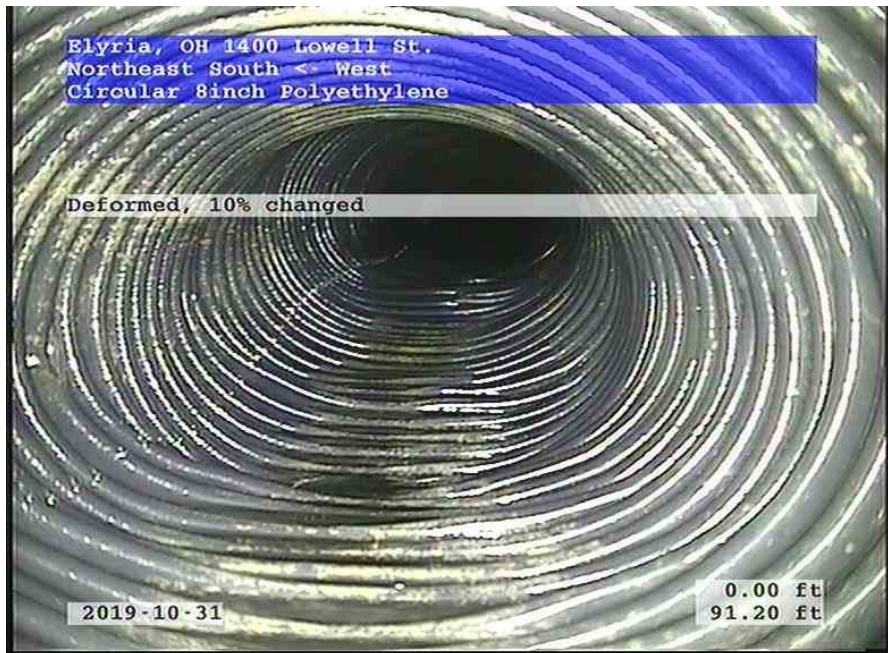
Northeast
South-West_dd7d2c25-056c-4399-8c91-92227aa3ac84_20191031_113817_524.jpg,
00:06:41, 91.20ft
Deformed, 10% changed

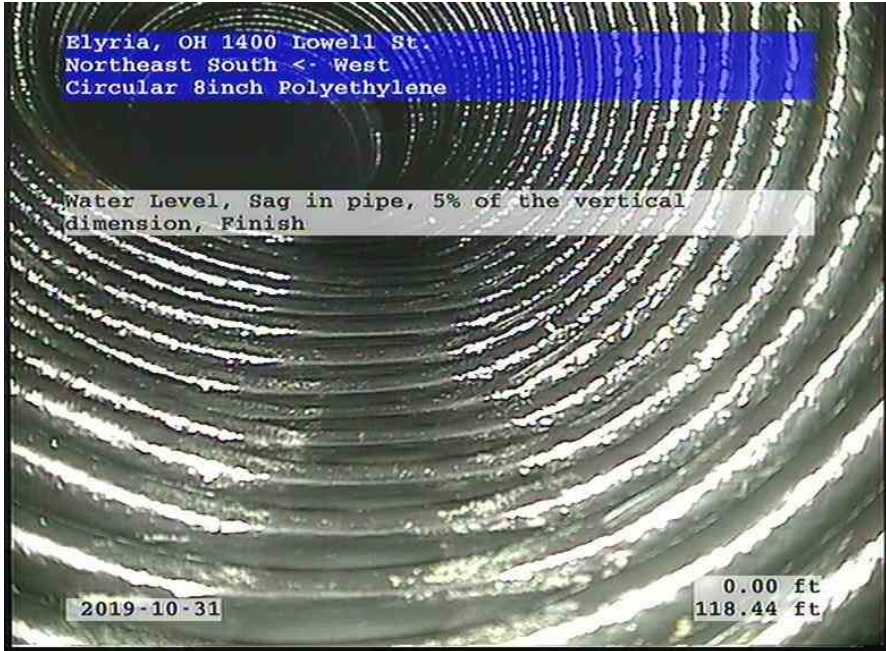
Northeast
 South-West_509edd4d-809f-4033-9c34-7d29da566b2a_20191031_113959_803.jpg,
 00:08:12, 118.44ft
 Water Level, Sag in pipe, 5% of the vertical dimension, Finish

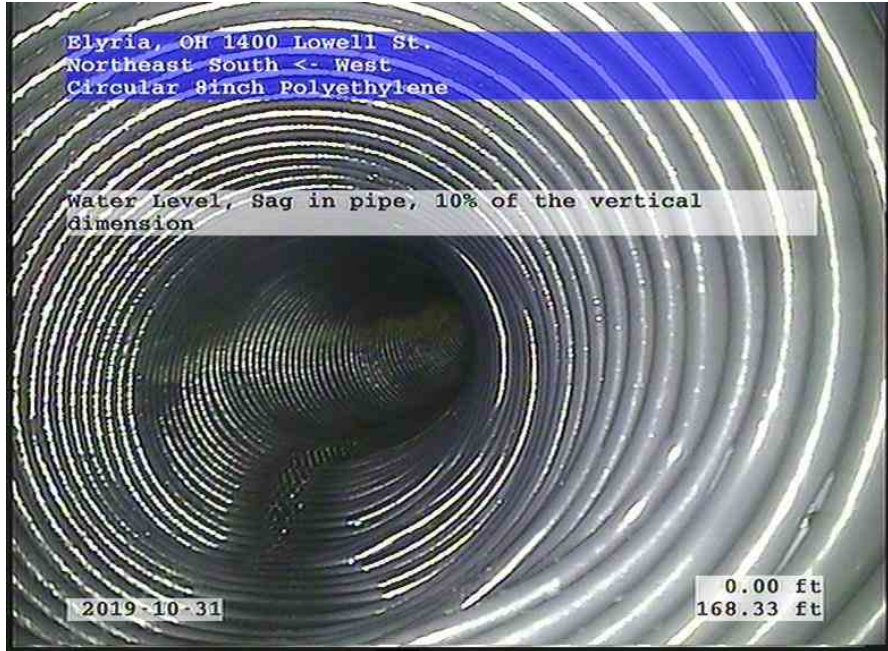
Northeast South-West_0d537fca-6a77-4f99-97fb-28a14a518e16_20191031_120305_701.jpg,
00:11:19, 168.33ft
Water Level, Sag in pipe, 10% of the vertical dimension

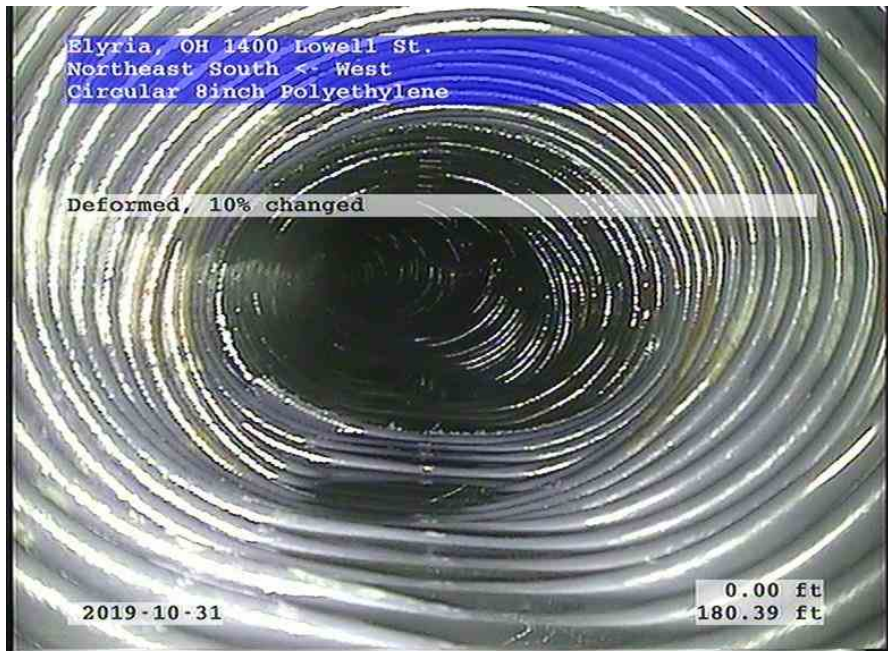
Northeast South-West_67315583-e9cb-4c1a-ba94-af5bcdb1adb9_20191031_120335_474.jpg,
00:11:41, 180.39ft
Deformed, 10% changed

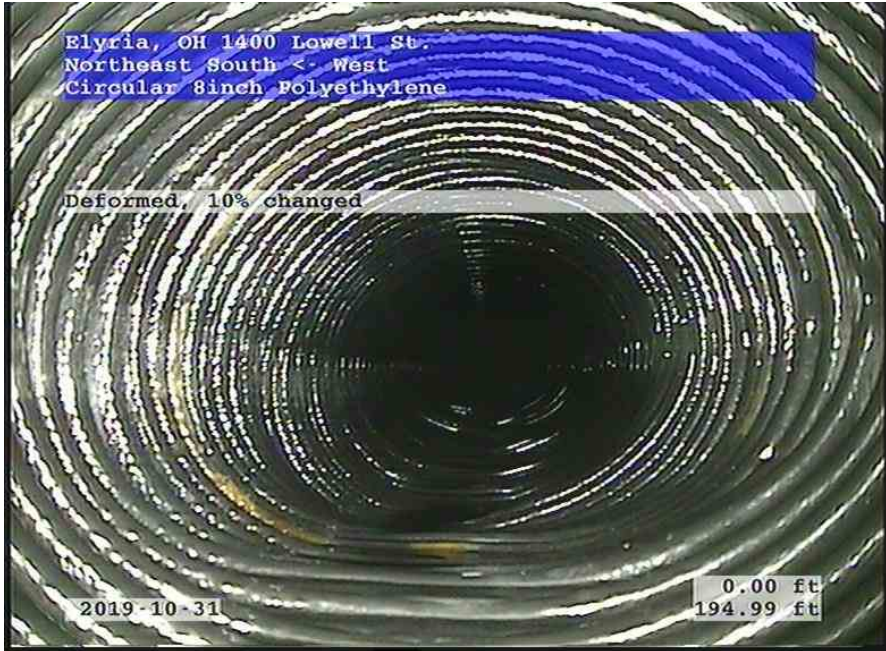
Northeast South-West_b9c4ef06-2f18-43e8-8cd0-aba396c9e2c9_20191031_120419_104.jpg,
00:12:18, 194.99ft
Deformed, 10% changed

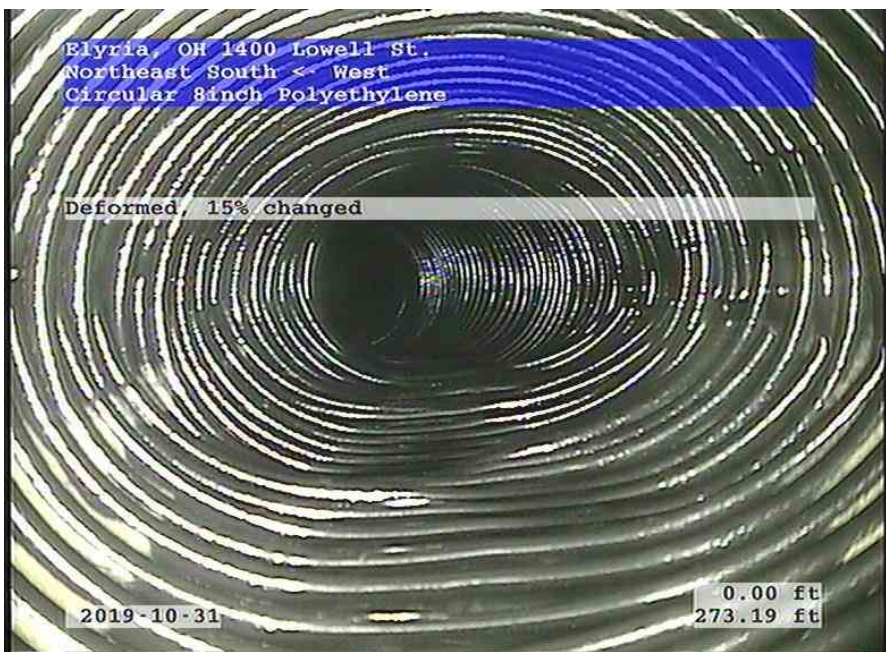
Northeast South-West_9ff89f61-c22a-42dd-bba2-445bafa6dd6a_20191031_120722_269.jpg,
00:15:13, 273.19ft
Deformed, 15% changed

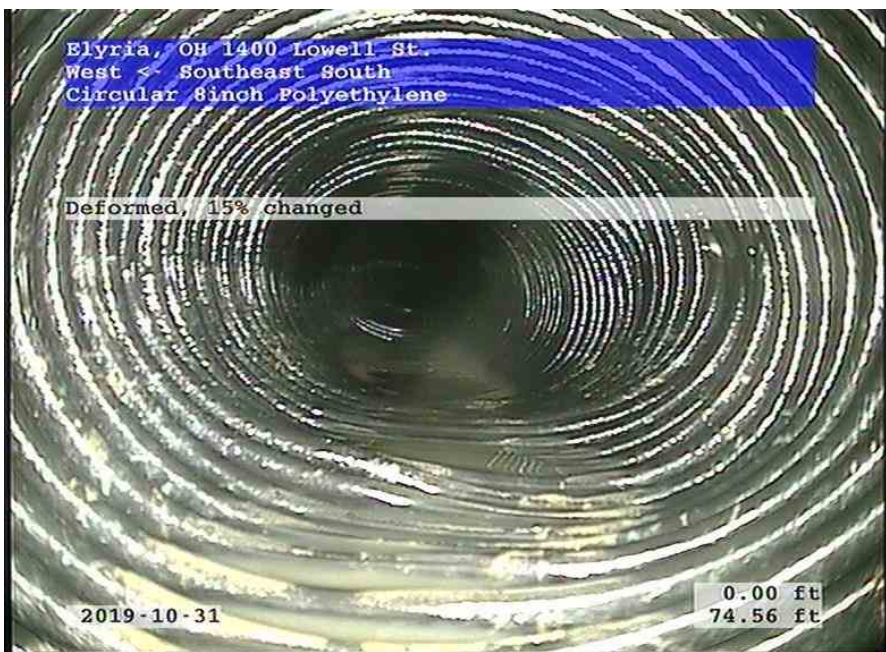
West-Southeast
South_32430ced-19bf-4dd5-9cd0-6c8bad2eebde_20191031_140408_990.jpg, 00:02:47,
74.56ft
Deformed, 15% changed

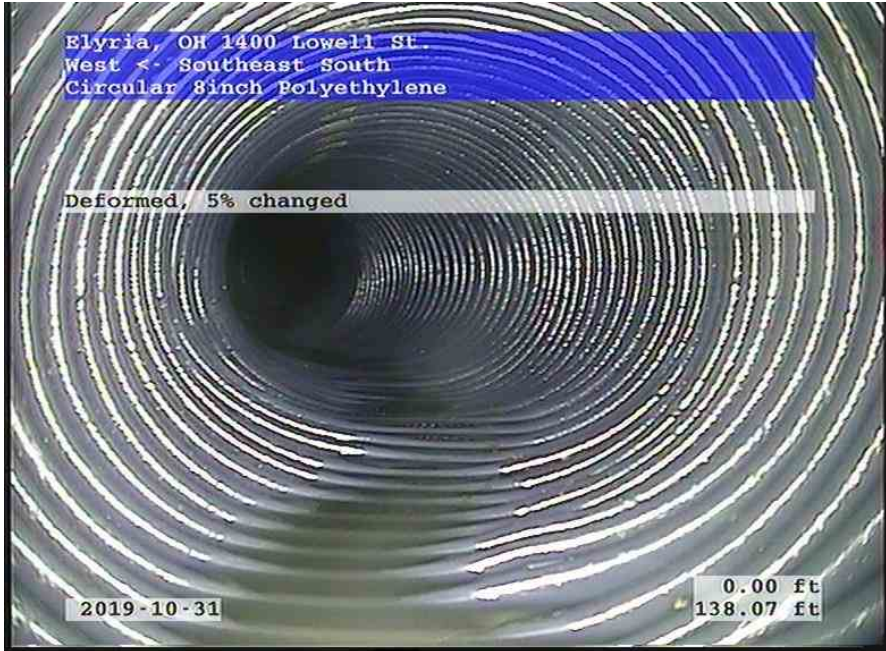
West-Southeast
South_41aa186b-aec3-4d42-b9fb-3a5abe04f946_20191031_140653_230.jpg, 00:05:16,
138.07ft
Deformed, 5% changed

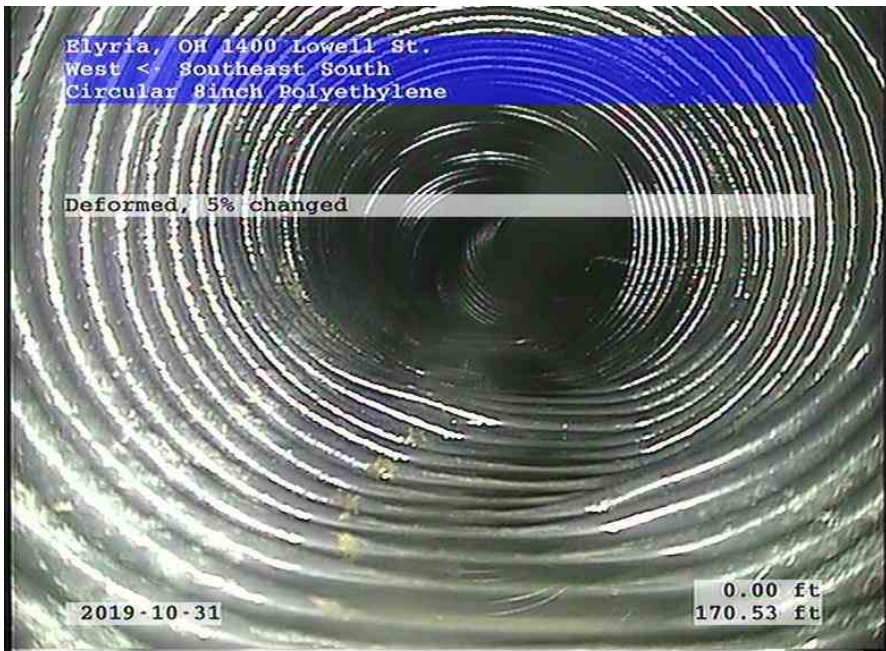
West-Southeast
South_71c2953e-9455-4af4-8cbe-fc0991096e07_20191031_140830_860.jpg, 00:06:40,
170.53ft
Deformed, 5% changed

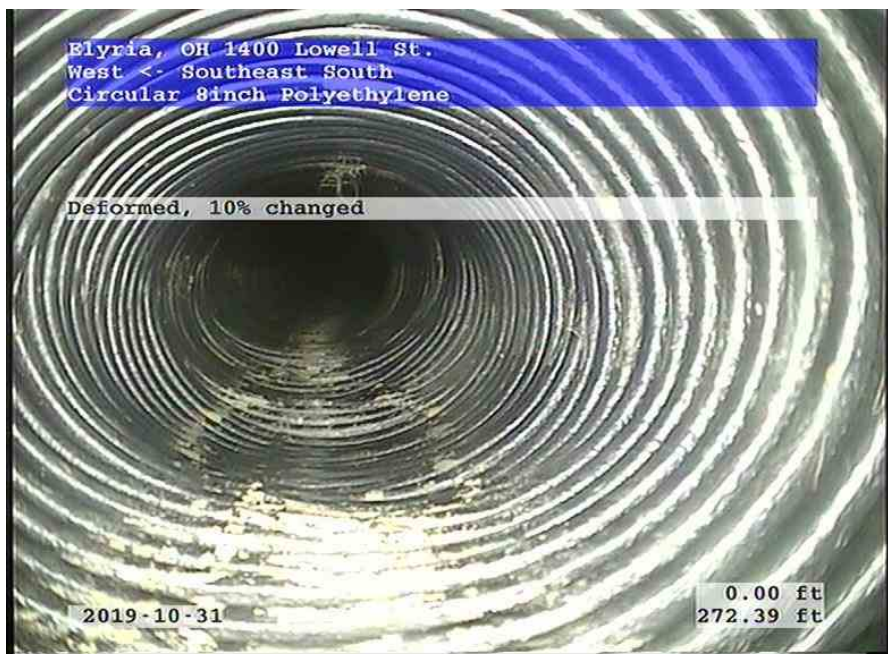
West-Southeast South_2d315e9f-a5bb-4dca-98aa-99c6c583b048_20191031_141551_960.jpg, 00:12:32,
272.39ft
Deformed, 10% changed

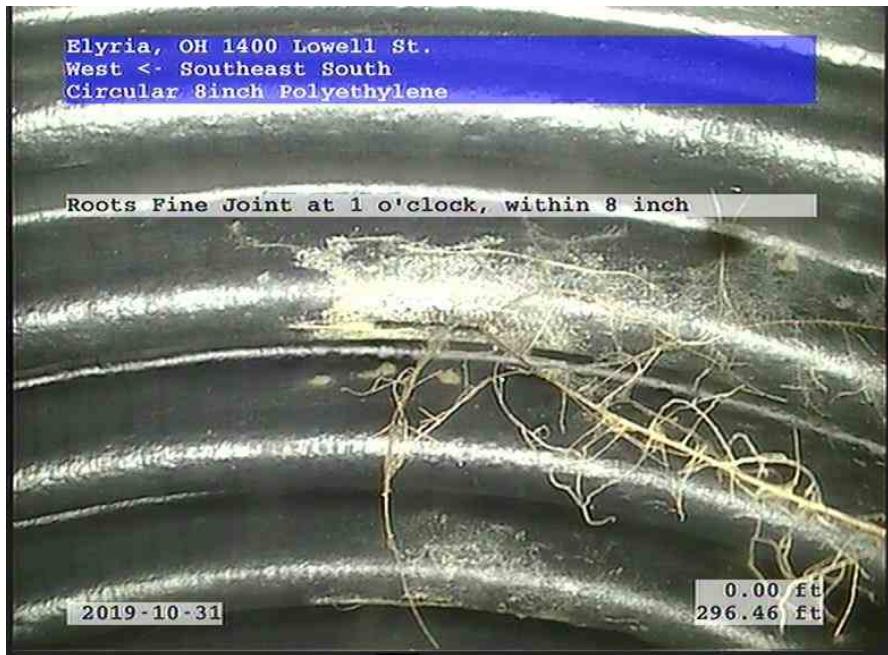
West-Southeast South_e4338f6d-811d-4af8-90f2-807dd0e63c27_20191031_141716_390.jpg,
00:13:36, 296.46ft
Roots Fine Joint at 1 o'clock, within 8 inch

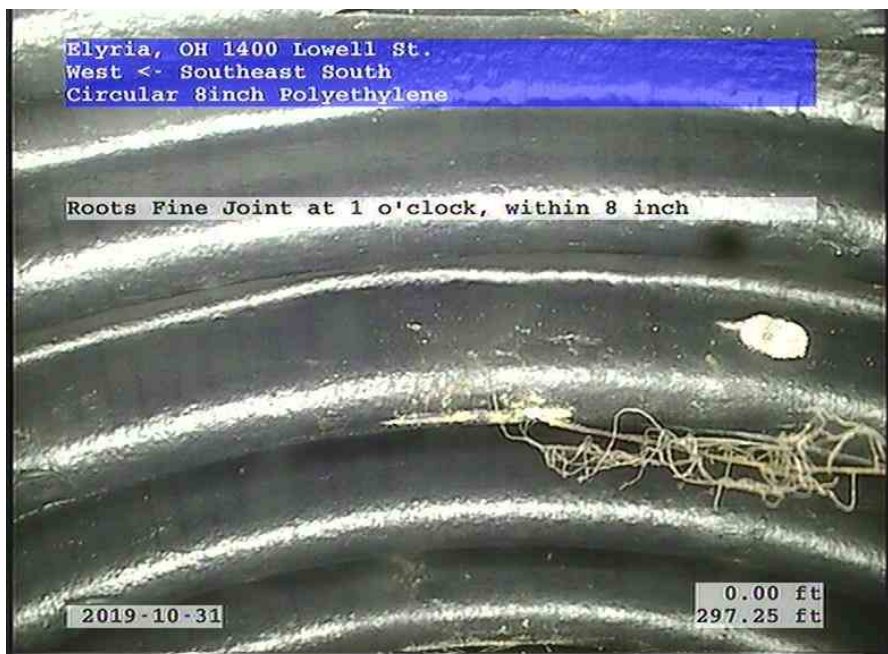
West-Southeast South_f8e9557f-df8f-4bc6-9183-5d22718265db_20191031_141747_650.jpg,
00:13:56, 297.25ft
Roots Fine Joint at 1 o'clock, within 8 inch

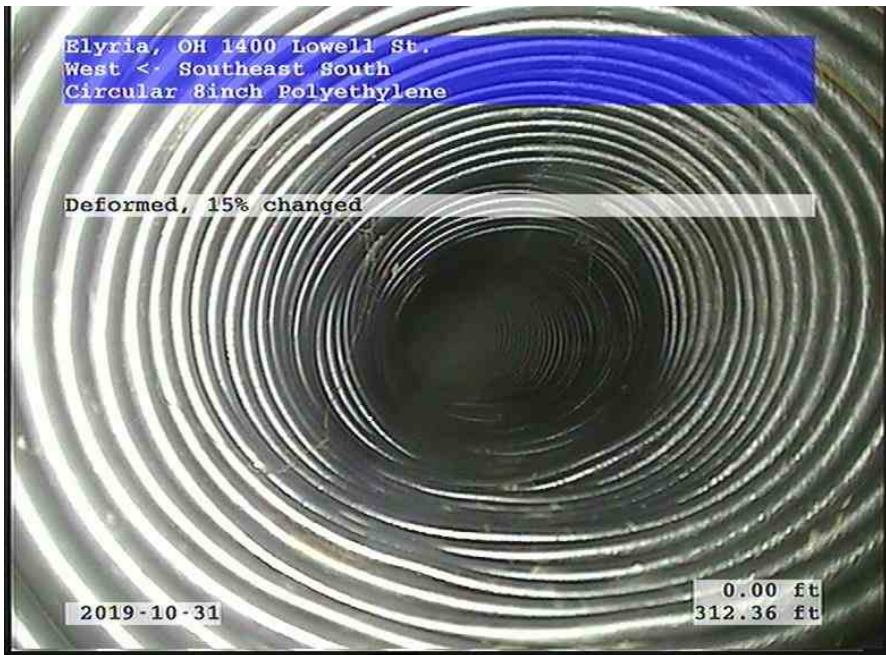
West-Southeast South_73ab21b1-84d7-48a4-a55e-2ec7e4af2375_20191031_141911_940.jpg, 00:15:07, 312.36ft
Deformed, 15% changed

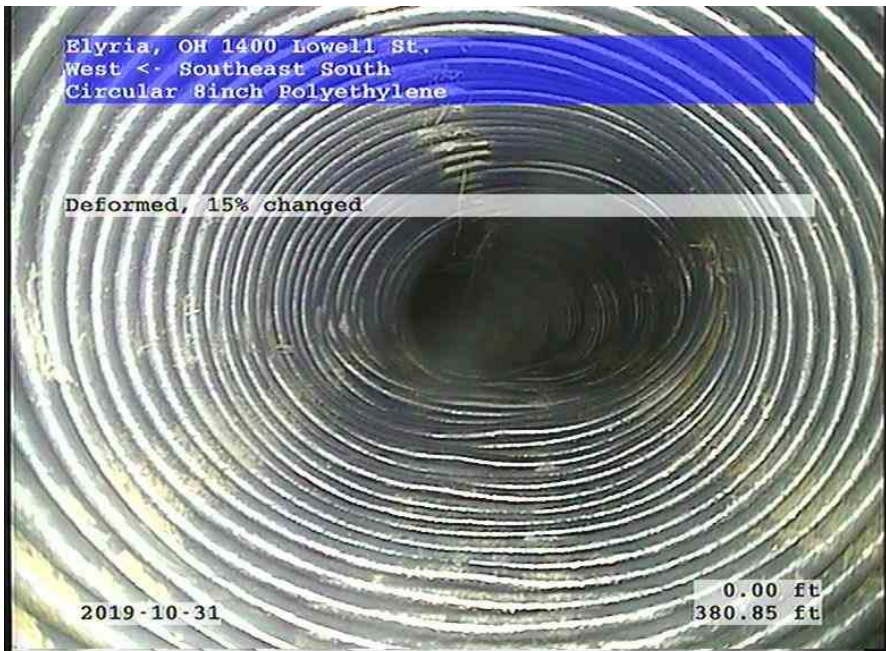
West-Southeast South_febf1650-48dd-463d-8493-c4e3bf3bba6_20191031_142242_390.jpg, 00:18:29, 380.85ft
Deformed, 15% changed

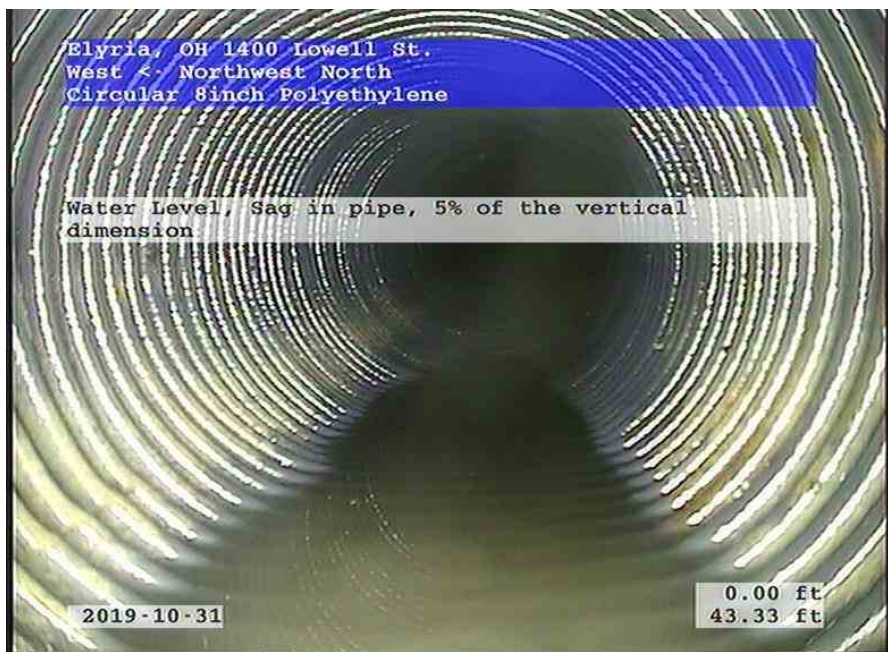
West-Northwest North_fb35bbfa-4ef4-4e11-8a5c-fd901d9f234b_20191031_164703_919.jpg,
00:01:51, 43.33ft
Water Level, Sag in pipe, 5% of the vertical dimension

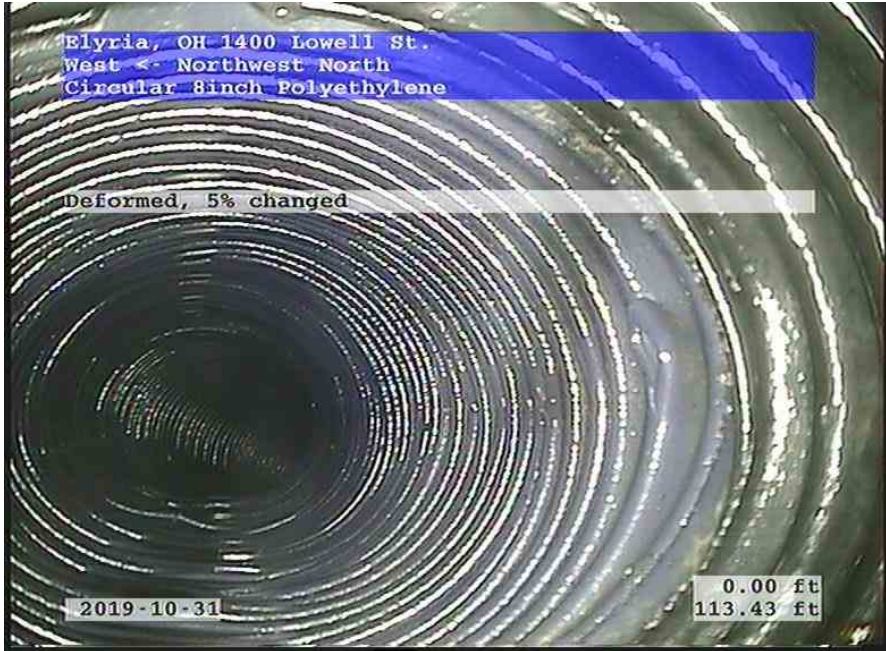
West-Northwest
North_a5e83abd-640c-48b3-85dc-1658b2f65cc1_20191031_164933_745.jpg, 00:04:13,
113.43ft
Deformed, 5% changed

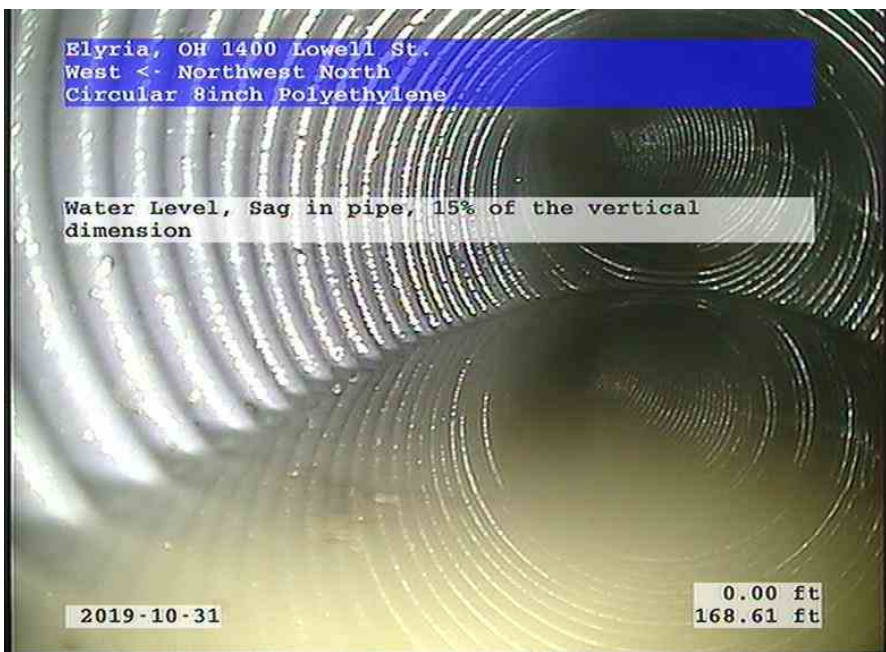
West-Northwest
North_f02b48c5-eb0e-464b-b8e1-710315b35063_20191031_165051_248.jpg, 00:05:24,
168.61ft
Water Level, Sag in pipe, 15% of the vertical dimension

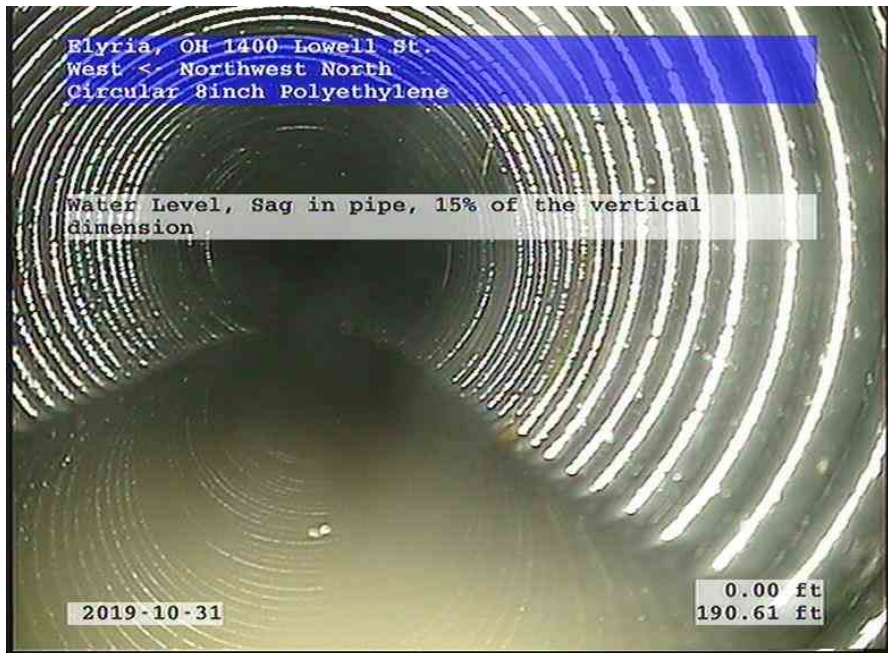
West-Northwest
North_ca734e12-2f34-4ed3-a41a-3430a3983c3d_20191031_165127_672.jpg, 00:05:54,
190.61ft
Water Level, Sag in pipe, 15% of the vertical dimension

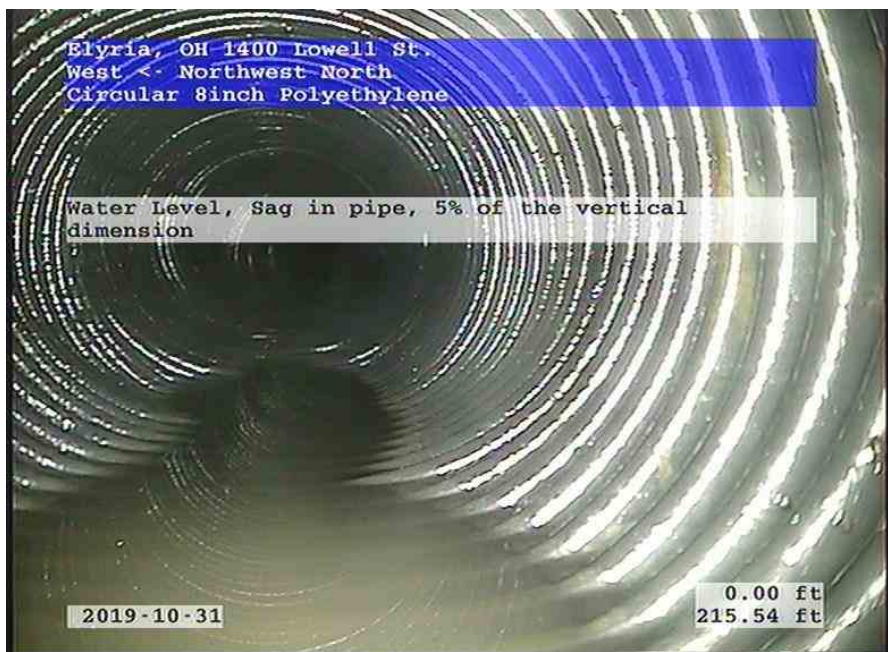
West-Northwest
North_c74a3a49-e418-4e00-b0e2-92986ead7913_20191031_165209_892.jpg, 00:06:31,
215.54ft
Water Level, Sag in pipe, 5% of the vertical dimension

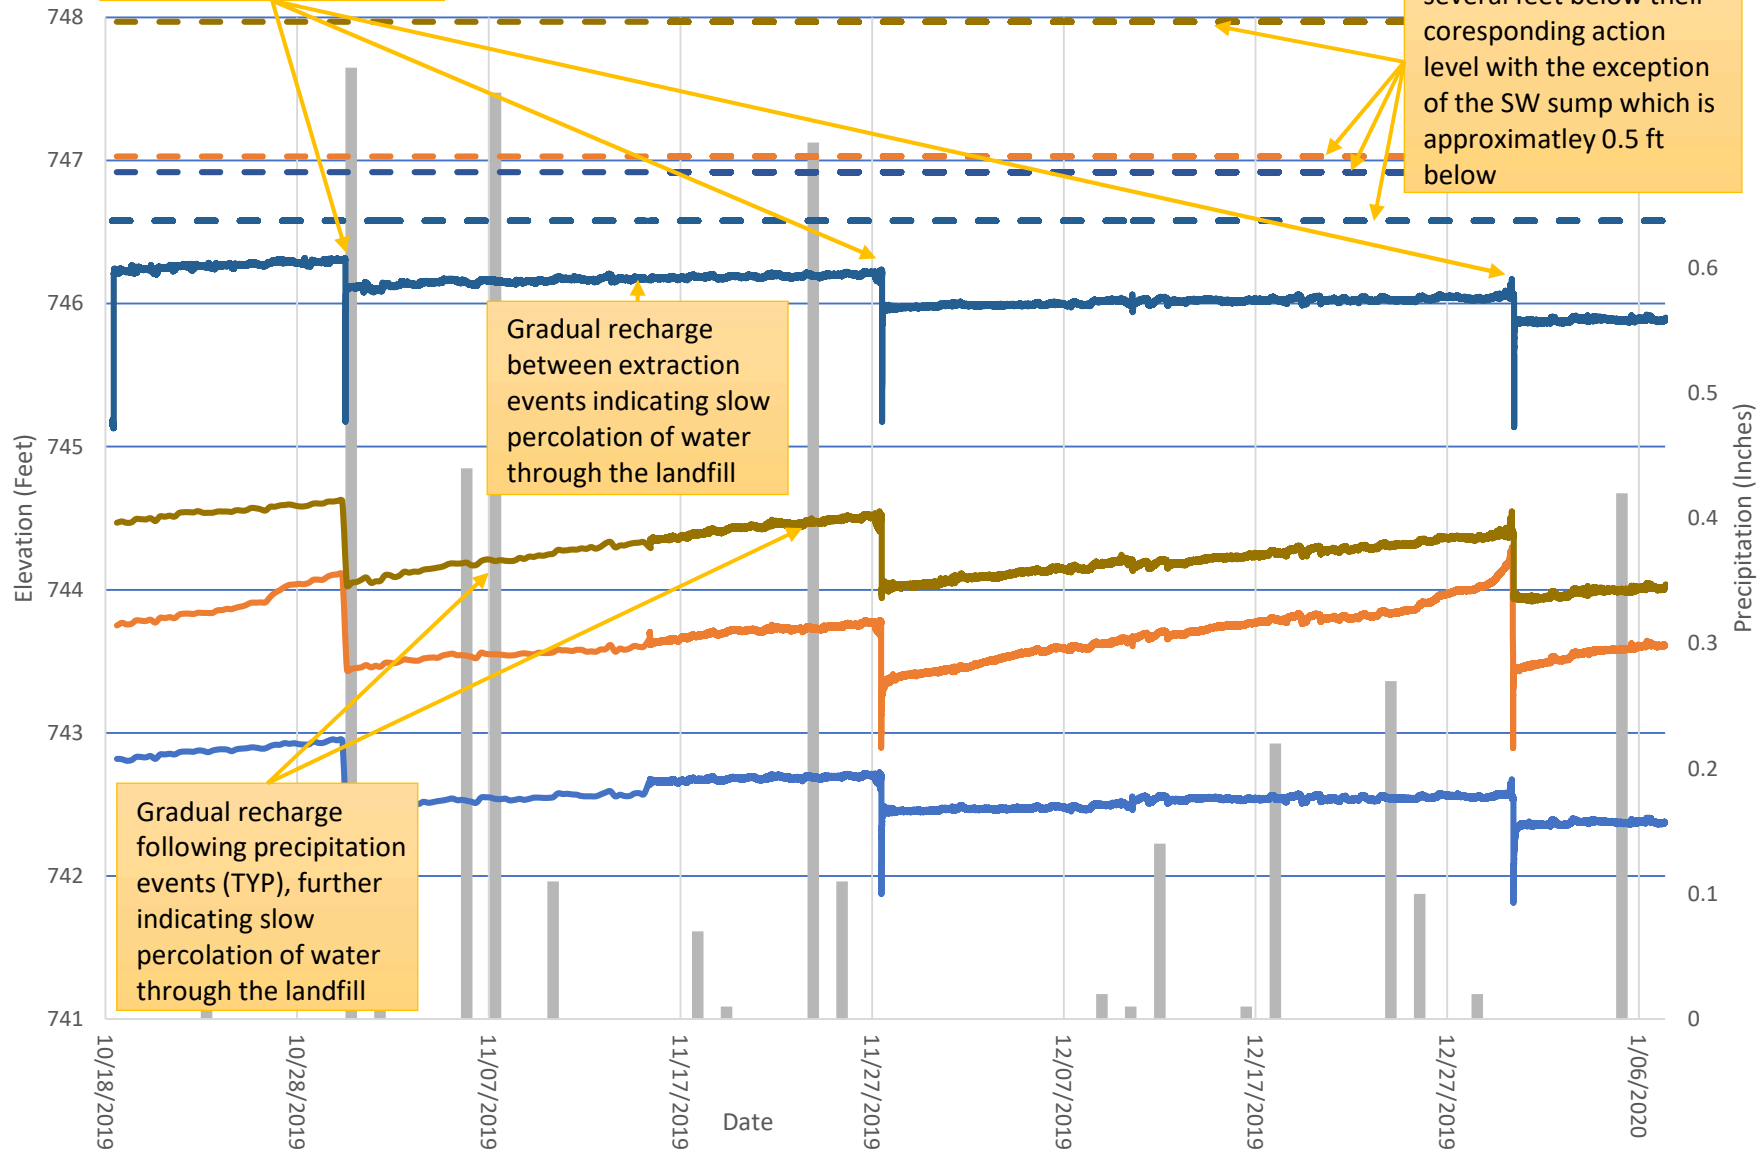
ATTACHMENT B - PRIMARY SUMPS AND PRECIPITATION

Sump water levels are several feet below their corresponding action level with the exception of the SW sump which is approximately 0.5 ft below
