**PRELIMINARY ASSESSMENT/
VISUAL SITE INSPECTION**

**GENERAL MOTORS CORPORATION (GM)
POWERTRAIN DIVISION
ROMULUS ENGINE OPERATIONS
(Formerly GM Chevrolet-Pontiac-Canada
Group, Romulus Engine Operations)
Romulus, Michigan
MID 000 809 905**

FINAL REPORT

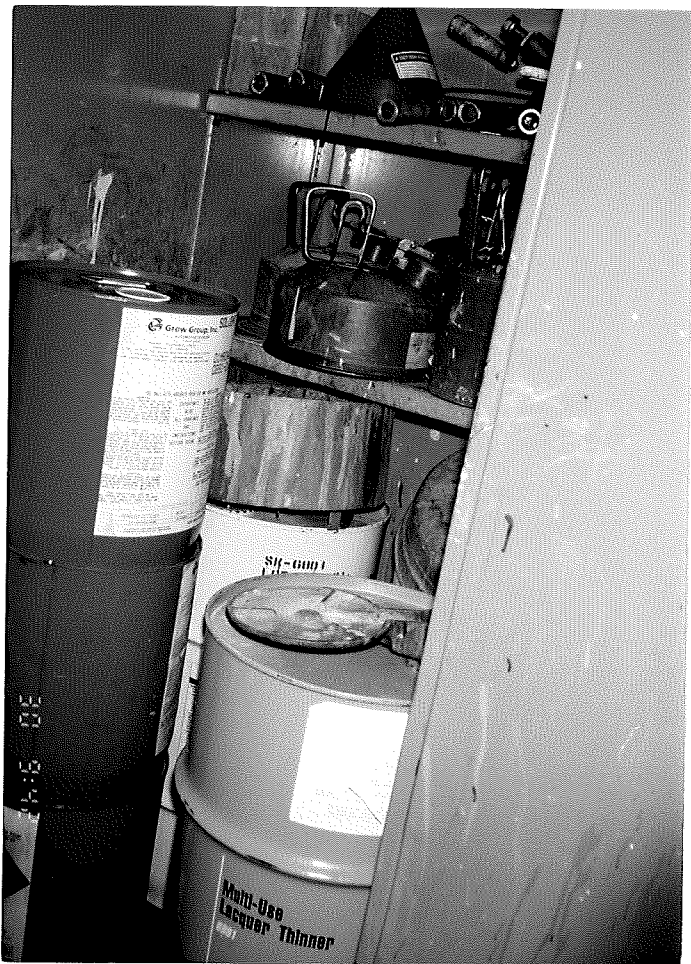
<-
Photograph No. 1
Location: SWMU 1
Orientation: Southeast
Date: 01/30/92
Description: This photograph shows one flammable storage cabinet containing spent solvent, solvent product, and maintenance equipment.

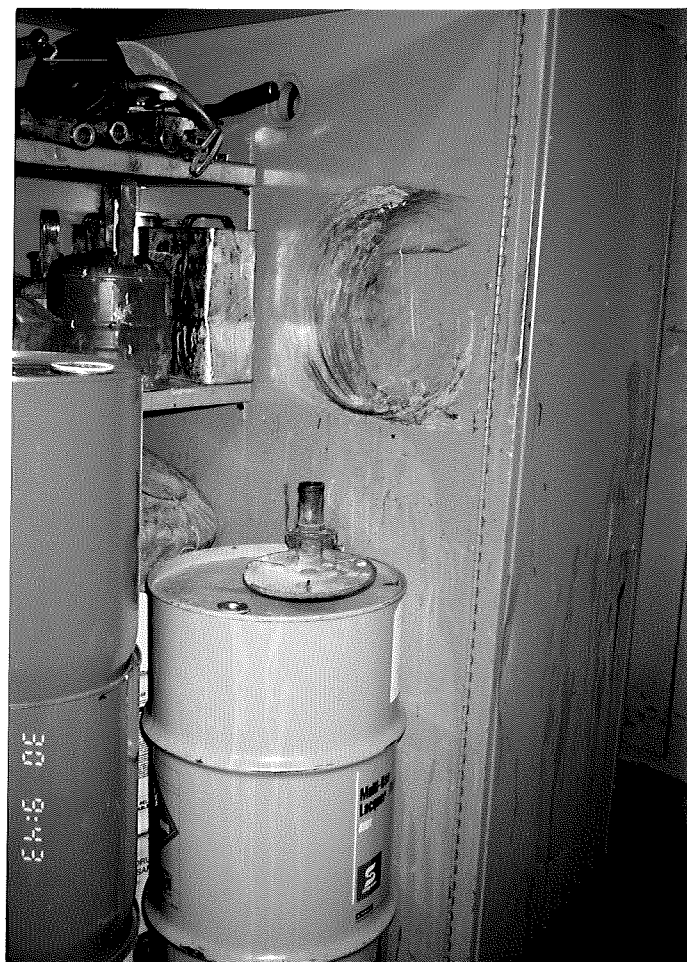
->
Photograph No. 2
Location: SWMU 1
Orientation: Southwest
Date: 01/30/92
Description: This photograph shows the second flammable storage cabinet containing spent solvent, solvent product, and maintenance equipment.

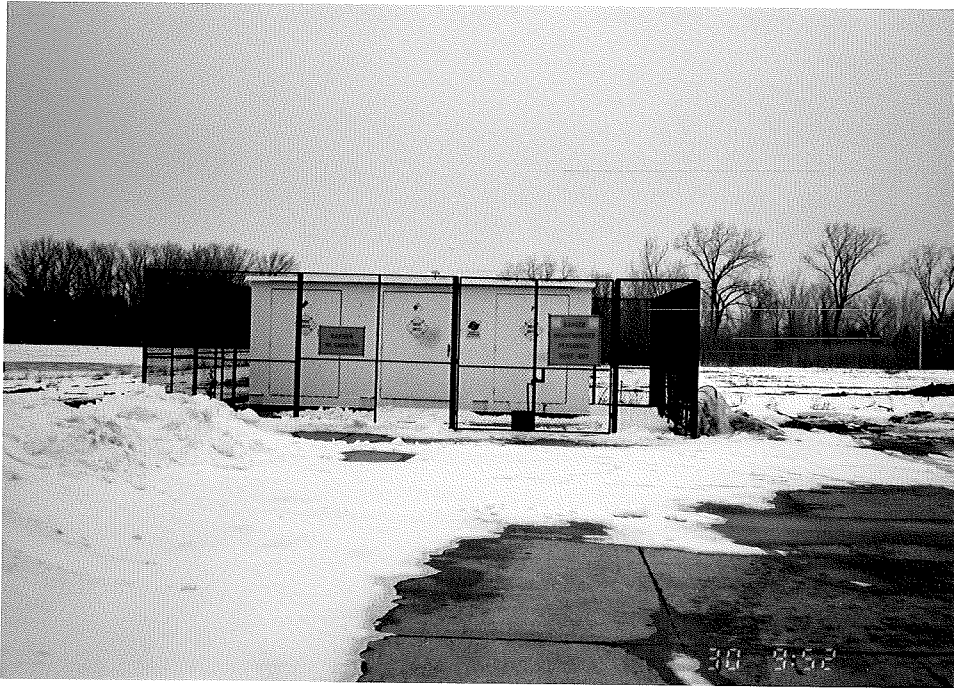
Location: SWMU 2
Date: 01/30/92

Photograph No. 3
Orientation: North
Description: This photograph shows the HWSA shed.

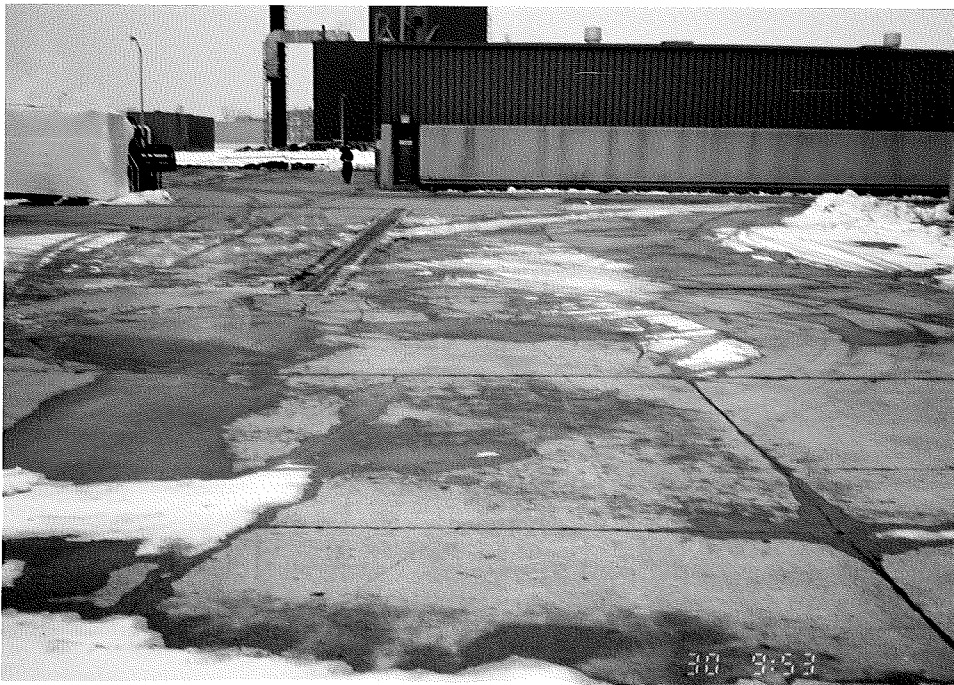
Location: SWMU 2
Date: 01/30/92

Unit Description: The Hazardous Waste Storage Area is located outside in the north central area of the facility. The unit was used to store hazardous waste in drums. Currently, the unit accumulates nonhazardous paint sludge and spent filters in gondolas (see Photographs No. 12 and 13). The unit measures 100 feet by 107 feet and consists of a concrete slab with a metal storage shed on the northwest corner. The storage shed measures about 5 feet high by 10 feet wide by 25 feet long. It is surrounded by a 6-foot-high security fence and warning signs (see Photograph No. 3). The unit has a steel grate covered drainage trench that extends from the center to the east border and up to the northeastern corner (see Photograph No. 4).

Photograph No. 4
Orientation: East
Description: This photograph shows the HWSA, including the central drainage trench.

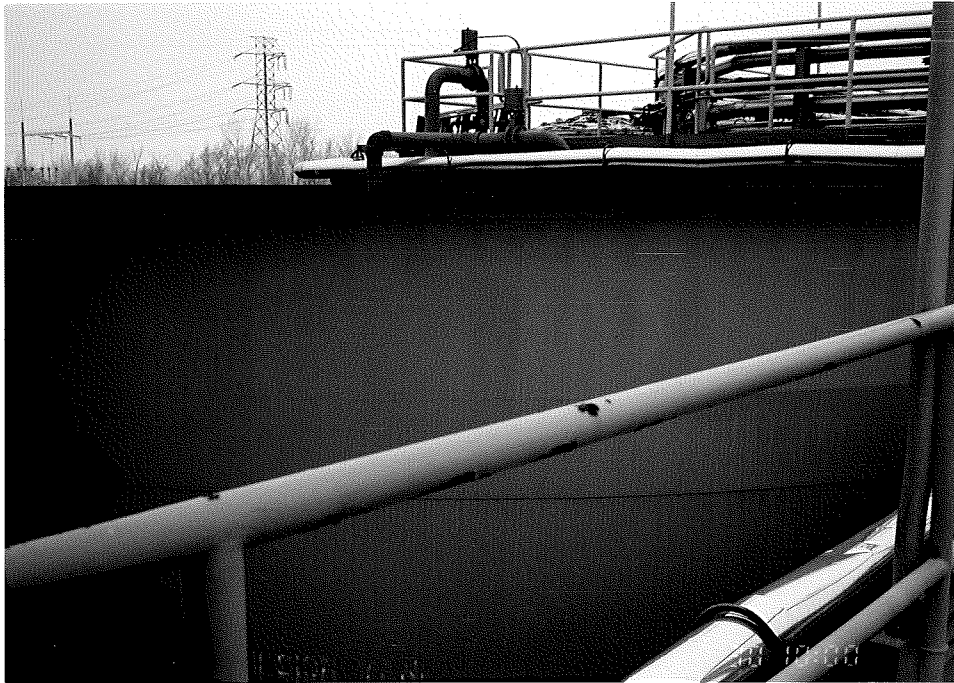
Location: SWMU 5
Date: 01/30/92

Photograph No. 5
Orientation: North
Description: This photograph shows an emulsion AST at the WTP.

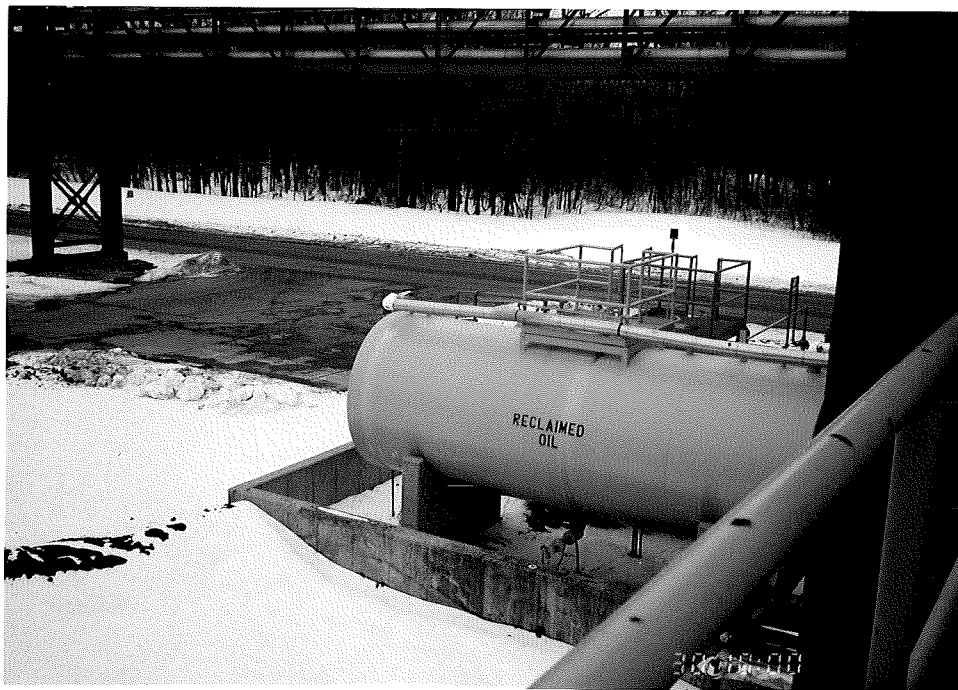
Location: SWMU 5
Date: 01/30/92

Photograph No. 6
Orientation: Southeast
Description: This photograph shows the reclaimed oil AST at the WTP.

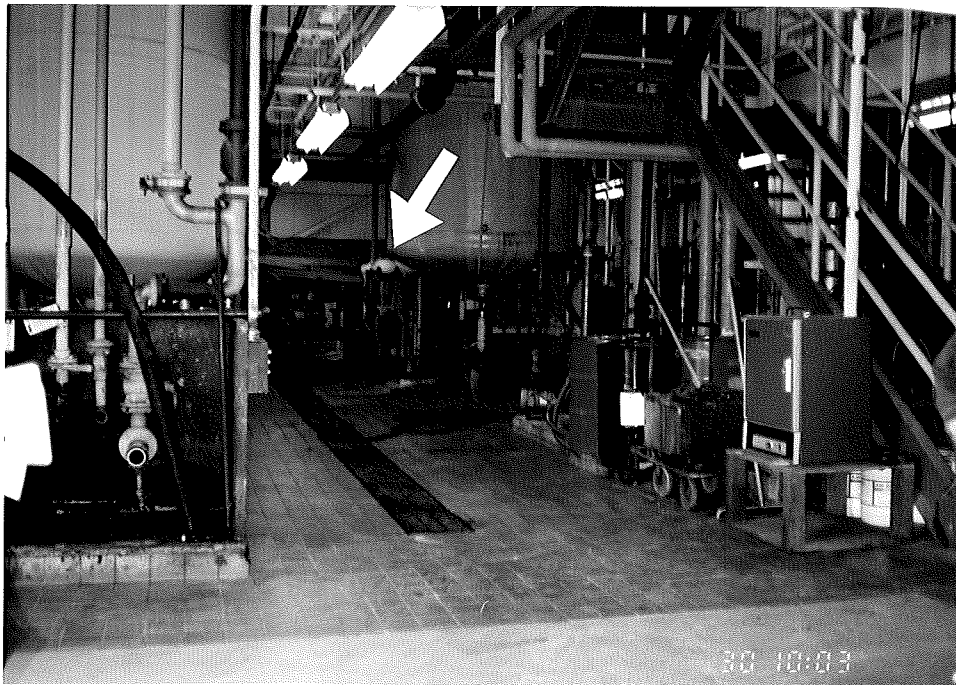
Photograph No. 8

PRC observed no cracks or staining on the floors or berms surrounding the ASTs. Minor staining was observed on all ASTs. Moderate staining and exterior paint deterioration was evident on one AST (see Photograph No. 10). One small flocculation unit was observed foaming over and draining into the floor trench (note arrow in Photograph No. 8). Snow cover obscured the ground surrounding the outdoor ASTs.

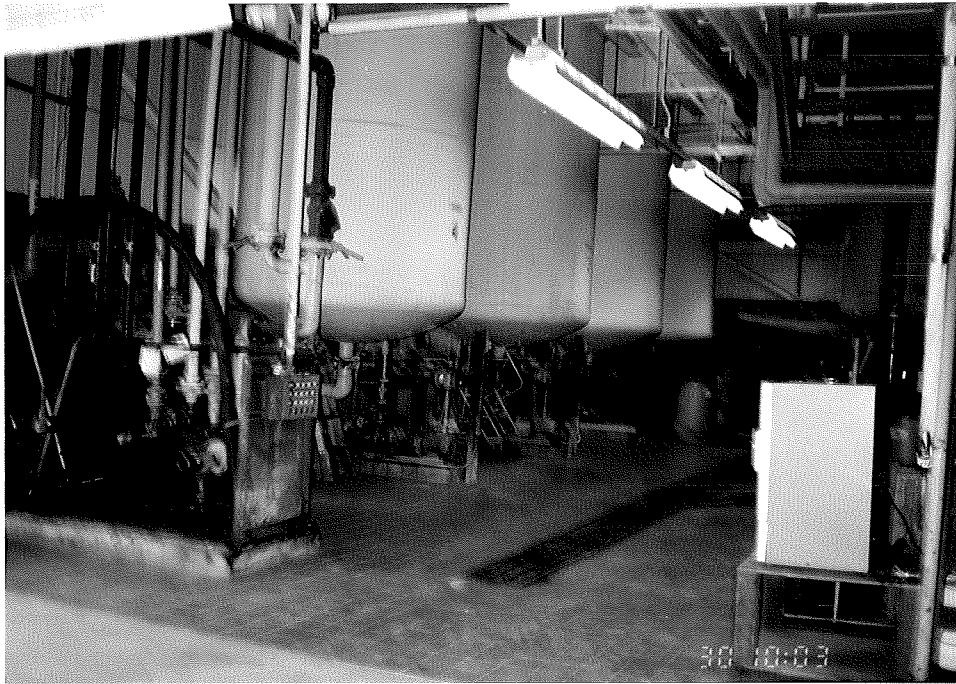
Location: SWMU 5
Date: 01/30/92

Photograph No. 9
Orientation: Northwest
Description: This photograph shows the cooker ASTs in the WTP from the first floor.

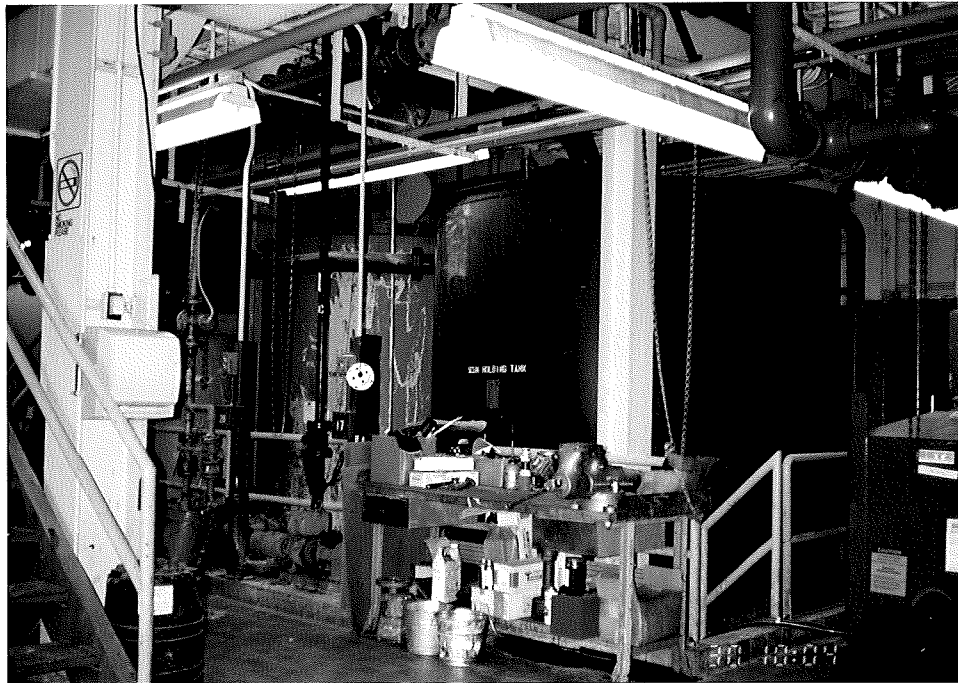
Location: SWMU 5
Date: 01/30/92

Description: This photograph shows the scum holding AST and a work bench on the lower level of the WTP; note staining and paint deterioration on the scum holding AST.

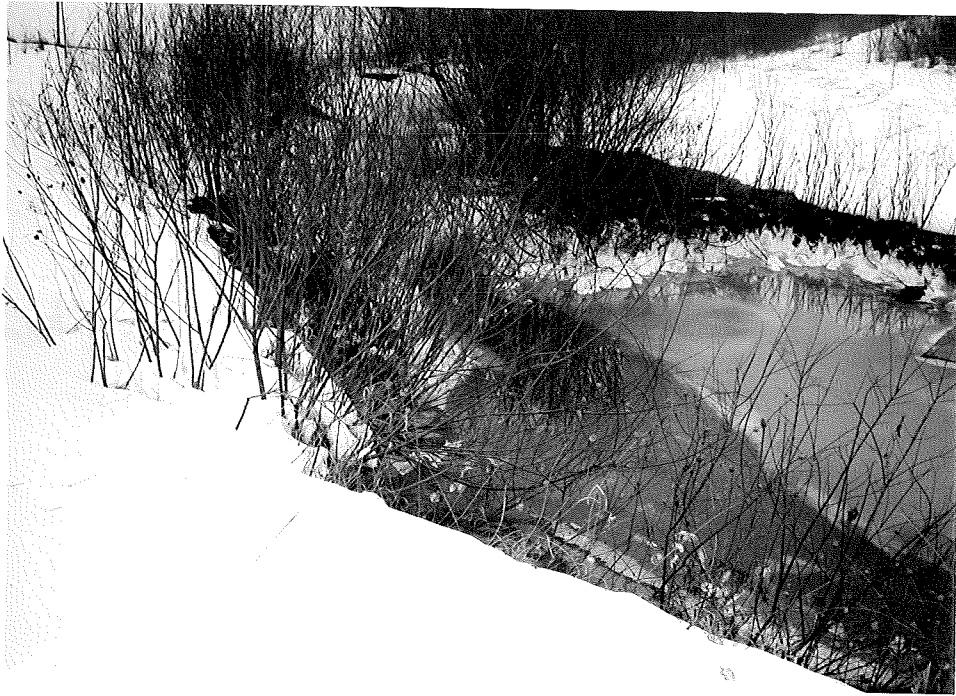
Photograph No. 11

Location: NPDES Outfall

Date: 01/30/92

Surface water drainage at the facility is to the west toward McClaughrey Drain. A set of storm sewer drainage ditches channel surface runoff to two storm water retention ponds. The retention ponds discharge to McClaughrey Drain through an outfall (see Photograph No. 11) just beyond the northwest corner of the facility. The facility discharges runoff under a NPDES permit. The NPDES permit expired October 1, 1991. However, the facility has submitted a renewal application, and MDNR is allowing the facility to operate under the expired permit until the new permit is approved (MDNR, 1991c).

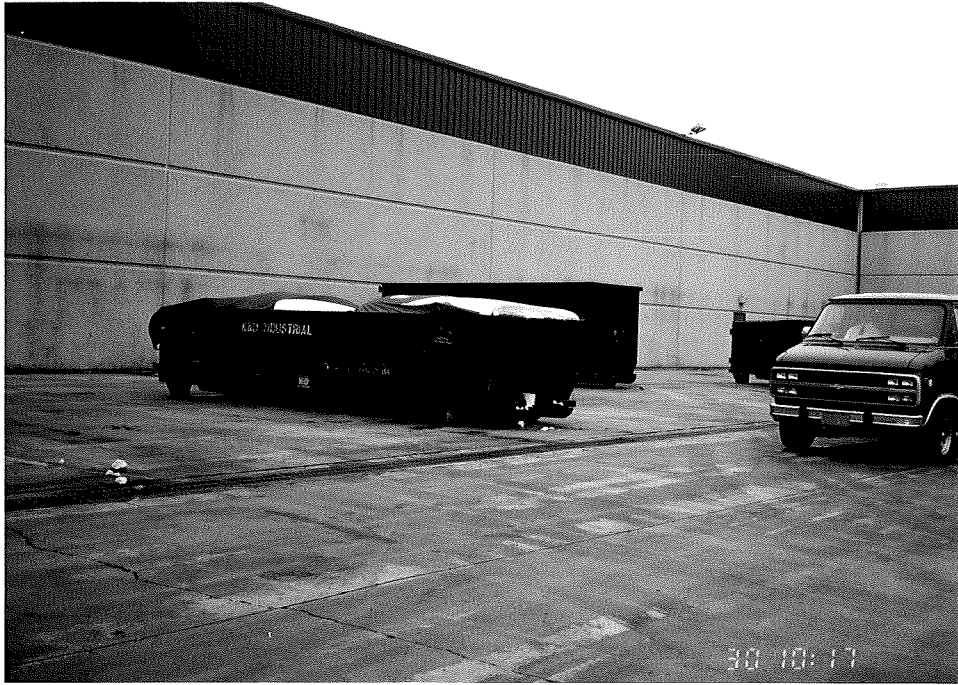
Photograph No. 13

Description: This photograph shows the paint sludge gondola at the HWSA (SWMU 2).

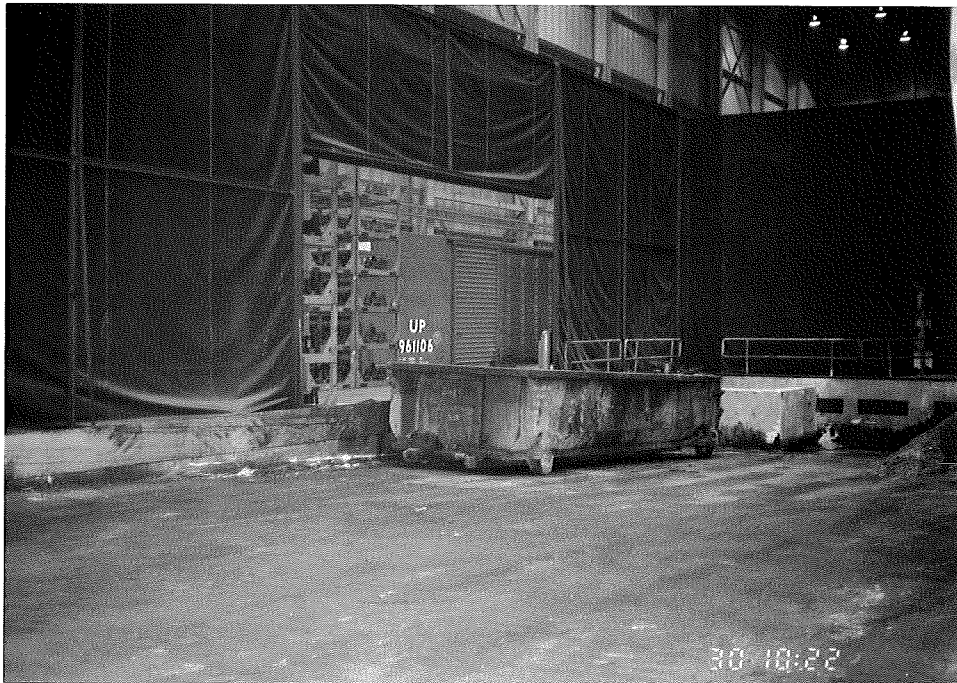
Photograph No. 14

Description: This photograph shows the Grinding Sludge and Refuse Gondola and the sloping concrete floor.

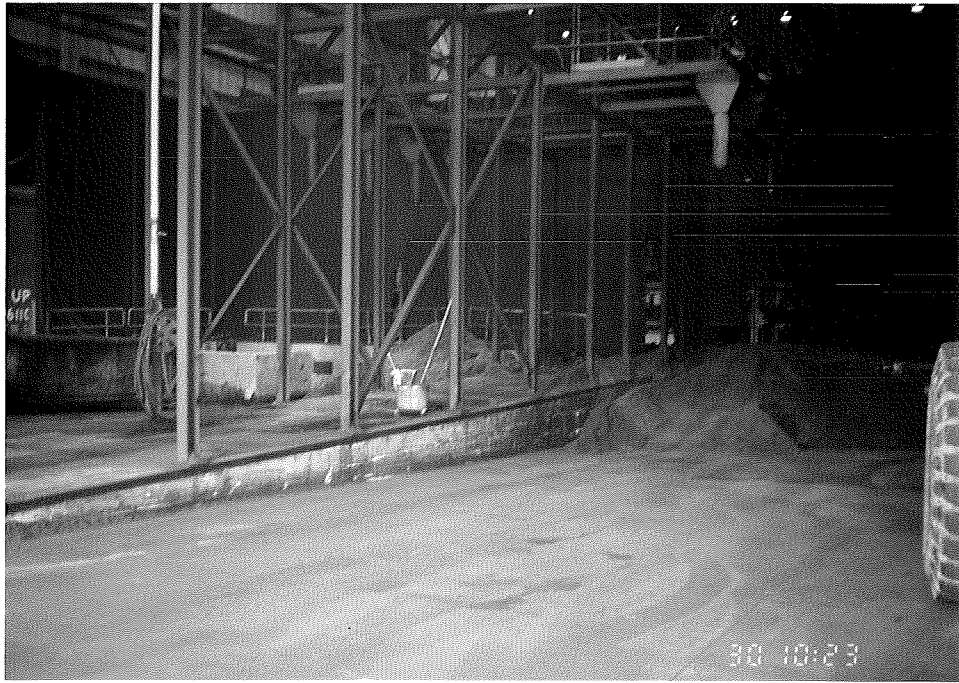
Photograph No. 15

Observations: The unit contained two piles of about 4 cubic yards each of iron and steel scrap during the VSI. No cracks were evident on the floors. Dusty wheel tracks extended from the piles of scrap.

Description: This photograph shows the Iron and Steel Scrap Accumulation piles and a portion of the berm. SWMU 3 is visible at the left edge of the photograph.

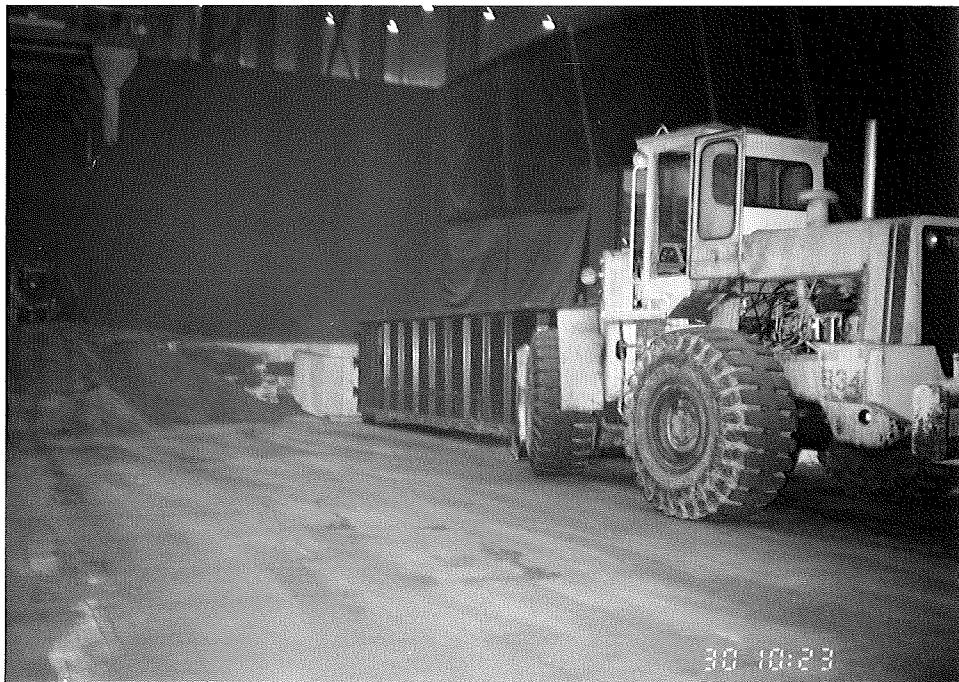
Photograph No. 16

Location: SWMUs 4 and 6

The Aluminum Scrap Gondola is located in the northeast center of the facility; inside Warehouse G in a high bay area. The unit accumulates aluminum scrap from the cutting processes. The unit is an open steel gondola that measures about 6 feet wide by 5 feet high by 15 feet long (see Photograph No. 16). The area has no floor drains.
