**AIR PERMIT WAIVER  
QUARTERLY MONITORING REPORT  
FOURTH QUARTER 2017**

**FORMER GENERAL MOTORS PLANT  
801 BOXWOOD ROAD, WILMINGTON, DELAWARE**

**DE-1149 Operable Unit 4**

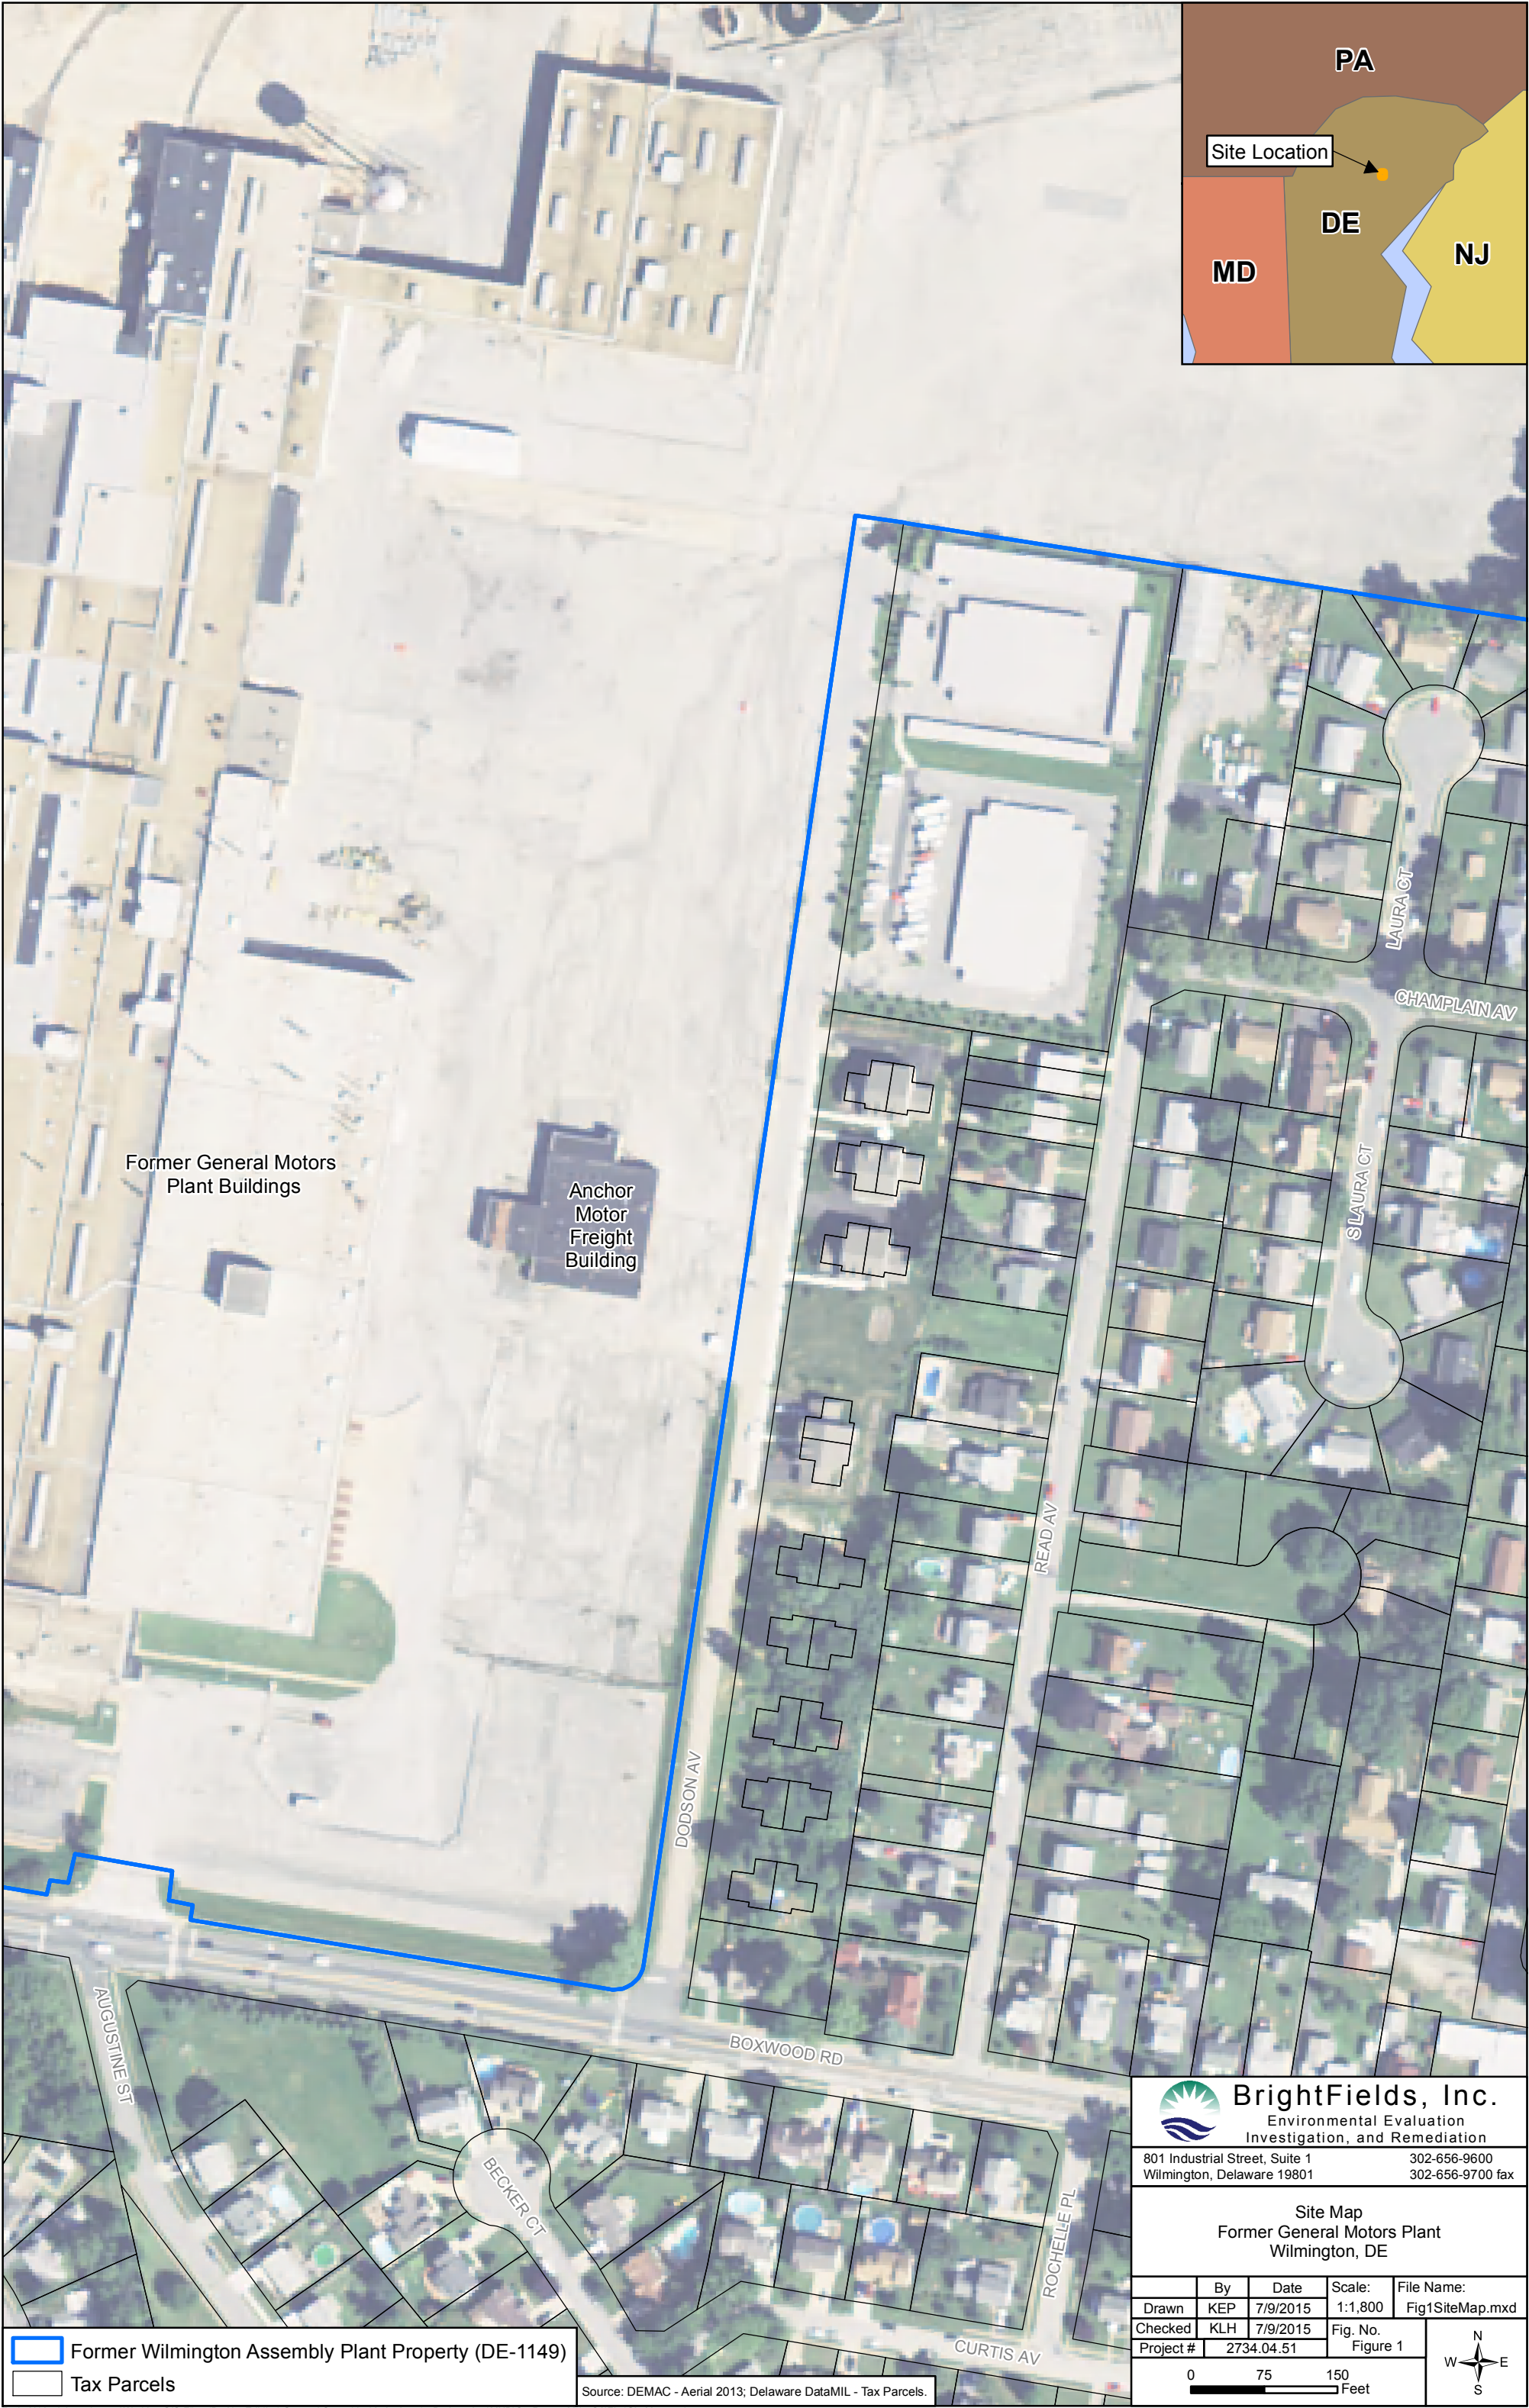
| Project # | 2734.04.51 | | Figure 1 | |

Site Map  
Former General Motors Plant  
Wilmington, DE

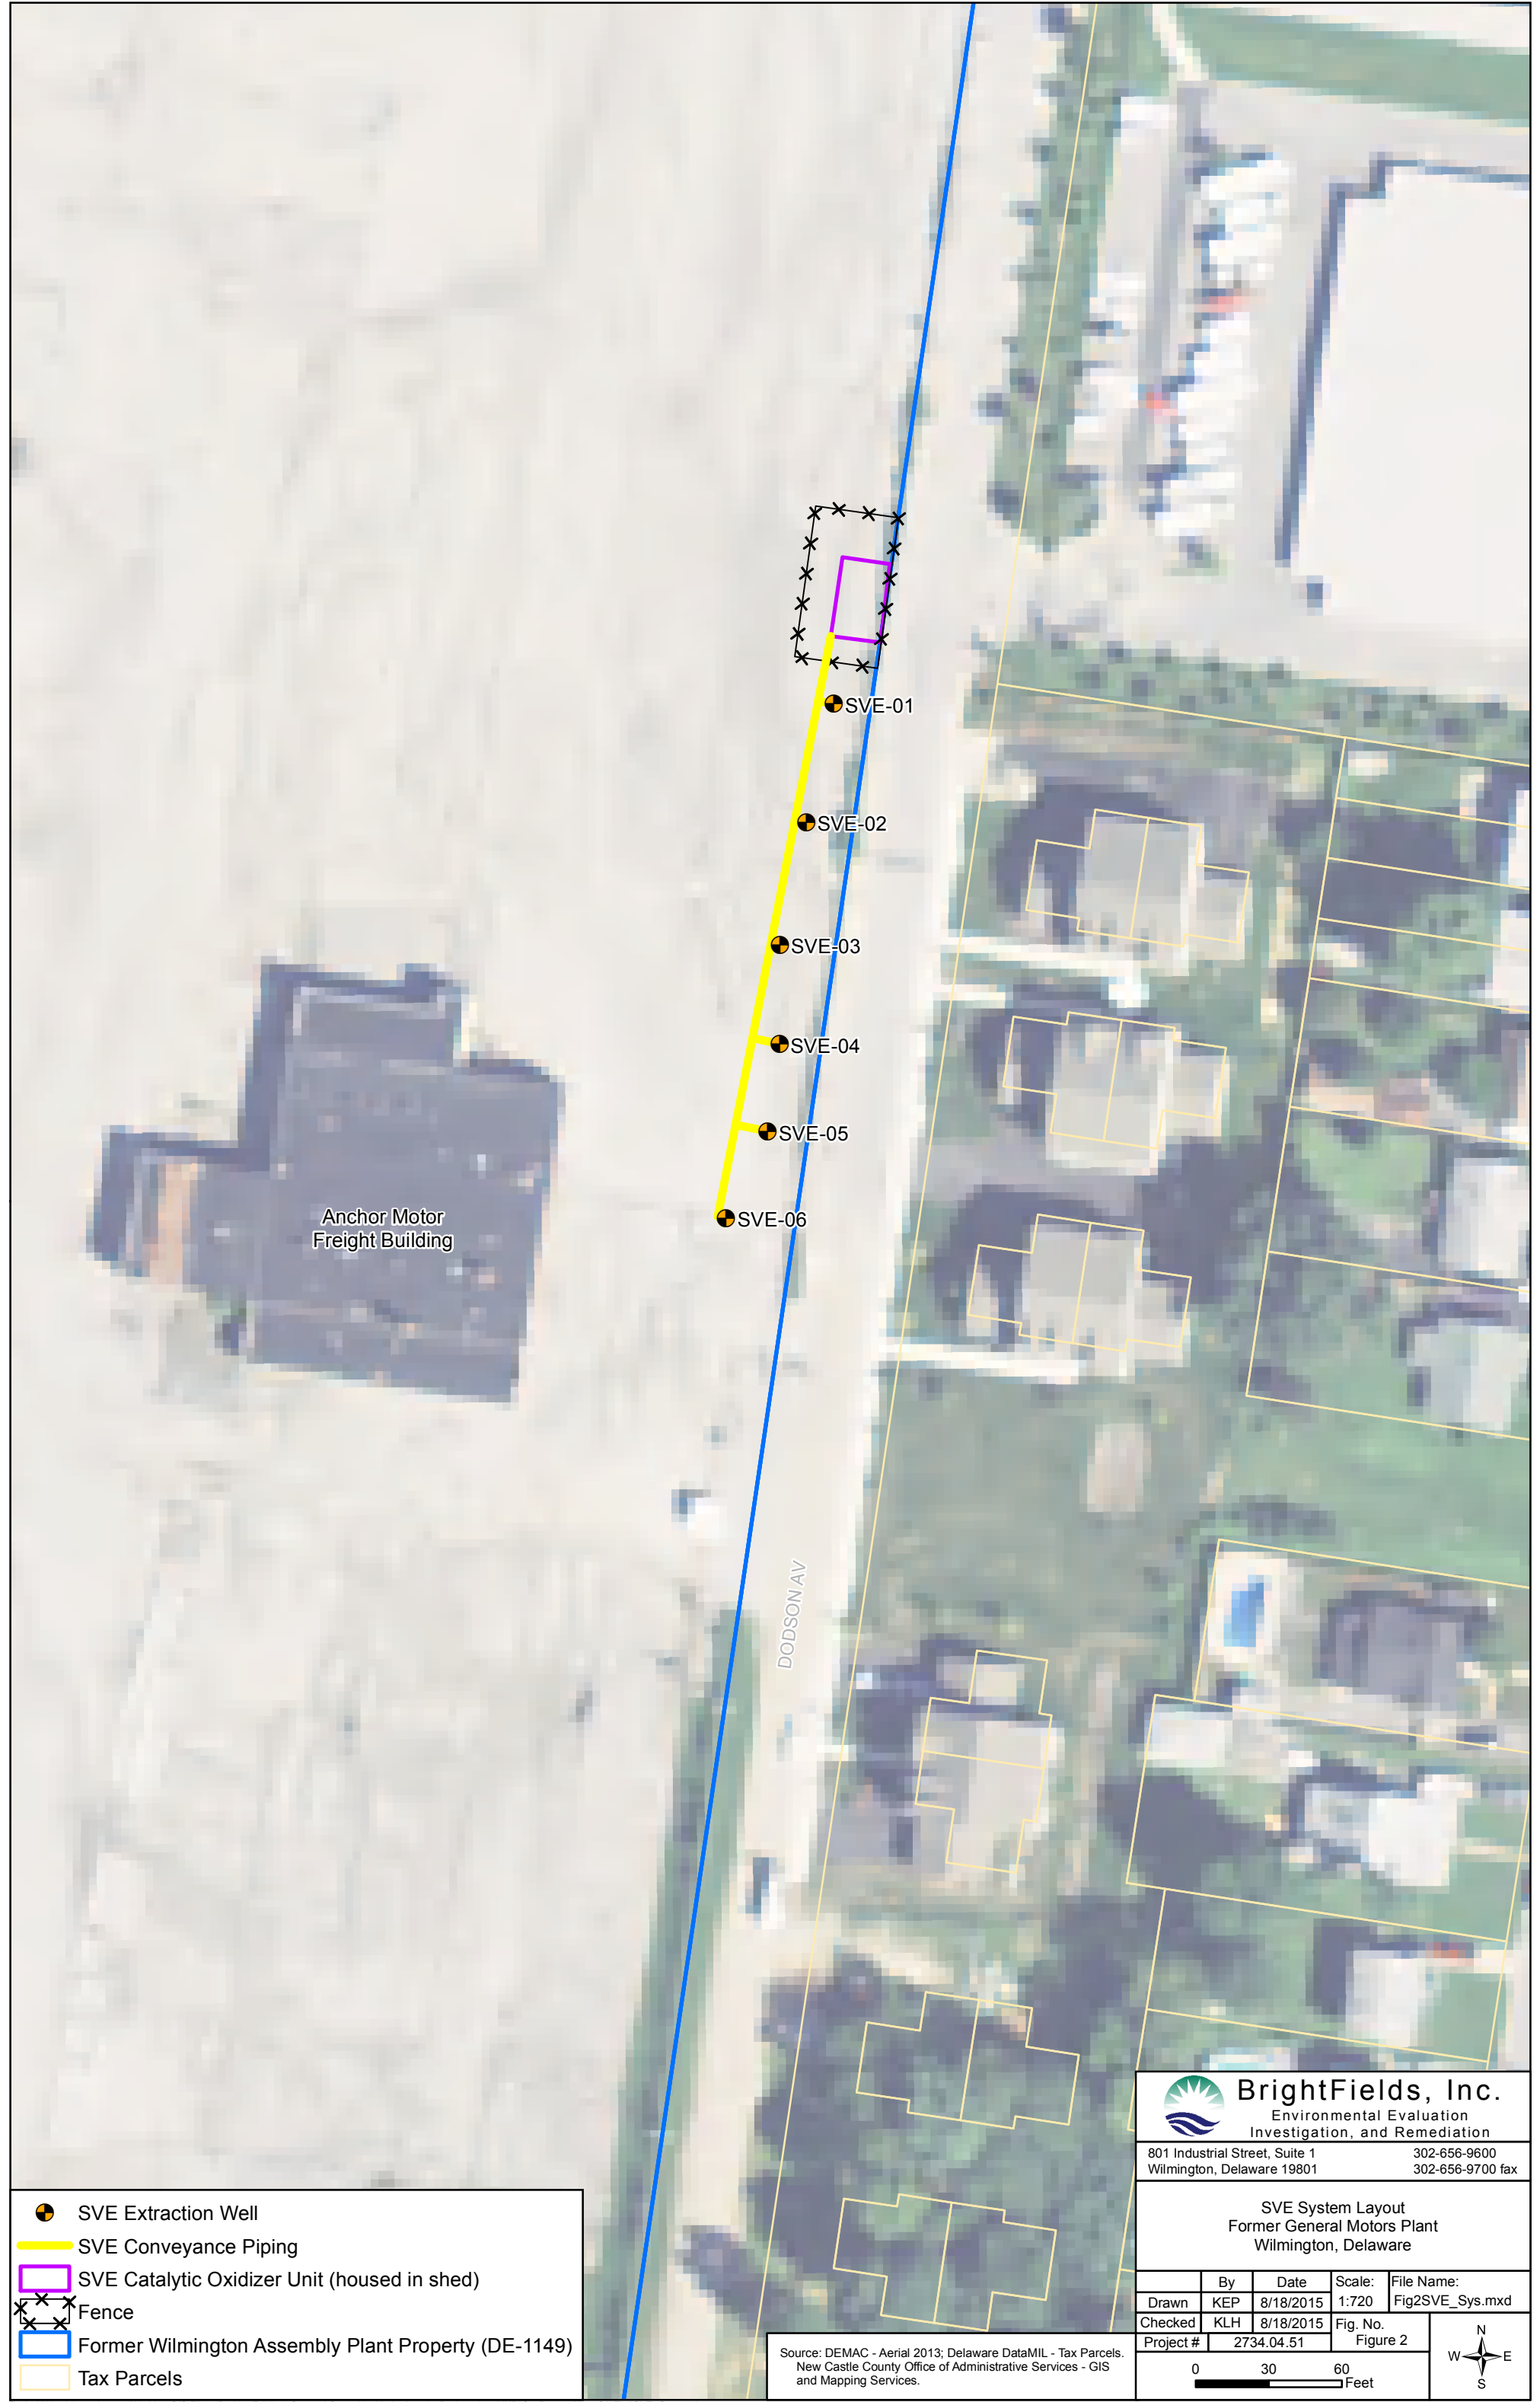
| Project # | 2734.04.51 | Figure 2 | | |

The remediation system consists of a Falco 300 Catalytic Oxidizer with a 15-horsepower (hp) regenerative blower. The blower is capable of extracting 295 standard cubic feet per minute (scfm) of vapor flow at 60-inches of water vacuum. The blower is connected to extraction wells SVE-01 through SVE-06 (Figure 2).

SVE System Layout  
Former General Motors Plant  
Wilmington, Delaware
