**WETLAND DELINEATION**

**PROPOSED DEVELOPMENT SITE  
RACER SITE 11110  
95.2 ACRE PROPERTY  
1400 LOWELL STREET  
ELYRIA, OHIO 44035**

**CARDNO ATC JOB NUMBER 008.75528.0001**

**JUNE 13, 2014**

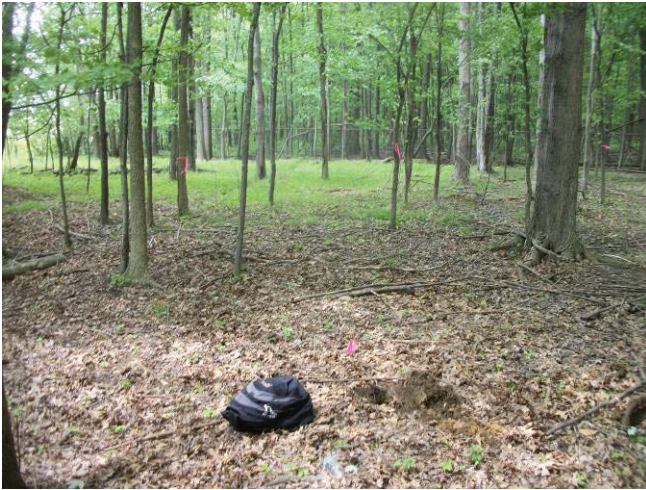
Photo 1: DP-1 (upland point) looking west into Wetland A.

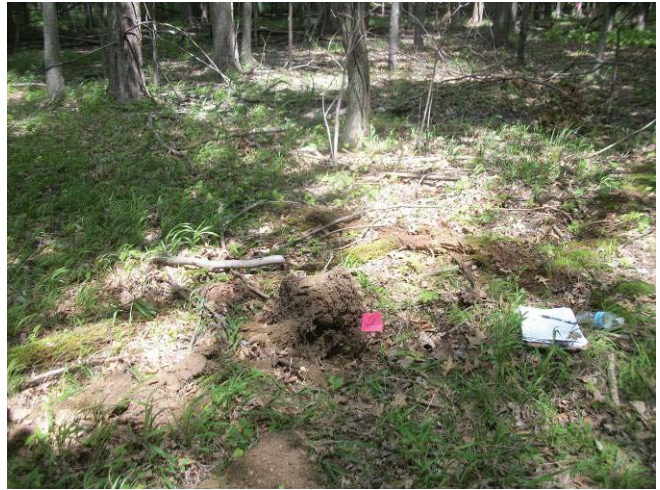
Wetland A is forested wetland consisting of an irregular depression located on the western portion of the property. Primary indicators of hydrology were observed including evidence of seasonal inundation. Soils were documented as hydric soils. All three diagnostic environmental characteristics of a wetland were present at data point DP-2. Wetlands A1, A2, and A3 are linear

Photo 2: Wetland A (DP-2)

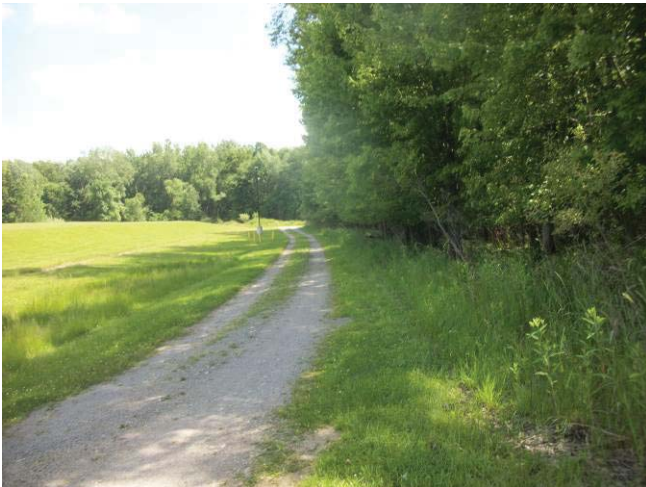
Photo 3: Former RCRA Landfill looking south (wetland A2 to left and A to right).

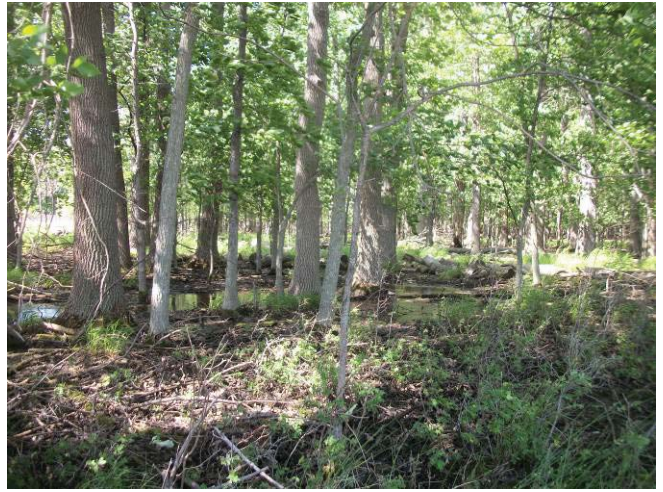
Wetland B is a large forested wetland complex containing mosaic habitat that is >90% wetland. Wetland B is located within and along the edges of a gravel roadway along the east, west, and southern property boundaries. Primary indicators of hydrology were observed including evidence of seasonal inundation. Soils at these locations were documented as hydric soils. All three diagnostic environmental characteristics of a wetland are present at the data points collected within these areas (DP-14 and DP-17). Two (2) areas mapped on the NWI are located within Wetland B. Wetland B2 is a linear wetland apparently constructed as a drainage ditch consisting of forested and scrub-shrub vegetation and is hydrologically connected to Wetland B.

Photo 8: Wetland B looking north.

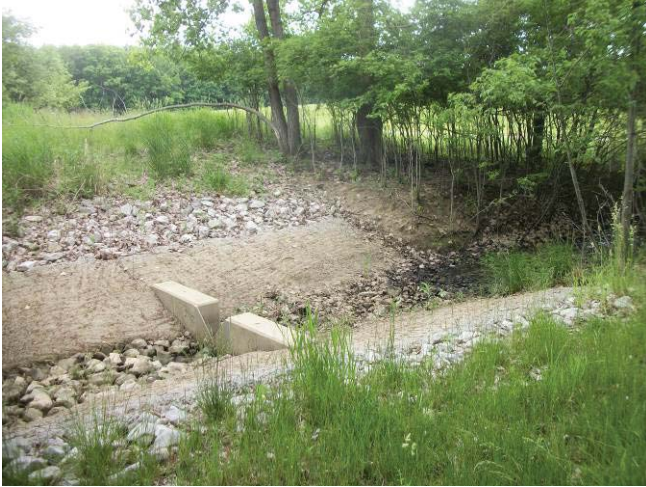
Photo 13: Storm water management weir on the western side of property in wetland B2.

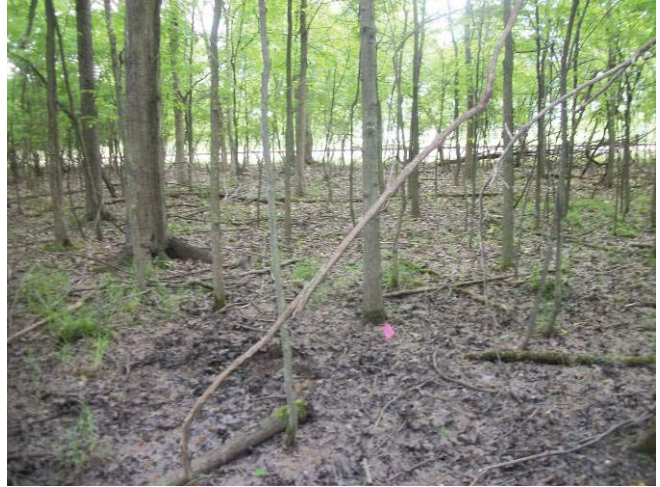
Wetland C is a forested wetland surrounded by gravel roads and a railroad spur. Primary indicators of hydrology were observed including evidence of seasonal inundation. Soils were documented as hydric soils. All three diagnostic environmental characteristics of a wetland are present at DP-3.

Photo 14: Wetland C (DP-3) looking northeast.

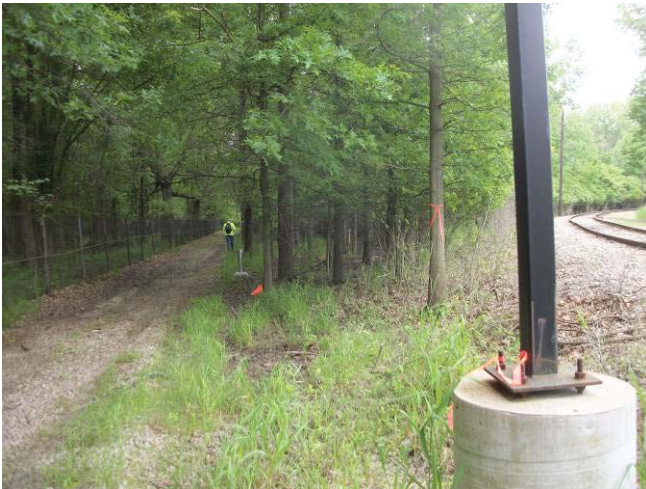
Photo 15: Wetland C looking south.

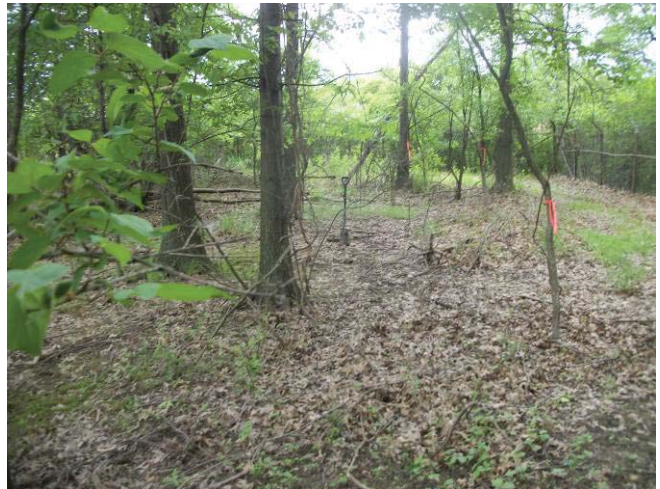
Wetland E is a forested/scrub-shrub wetland located in an irregular depression on the northeast corner of the property. Primary indicators of hydrology were observed including evidence of seasonal inundation. Soils were documented as hydric soils. All three diagnostic environmental characteristics of a wetland are present at DP-4.

Photo 16: Wetland E (DP-4) looking north.

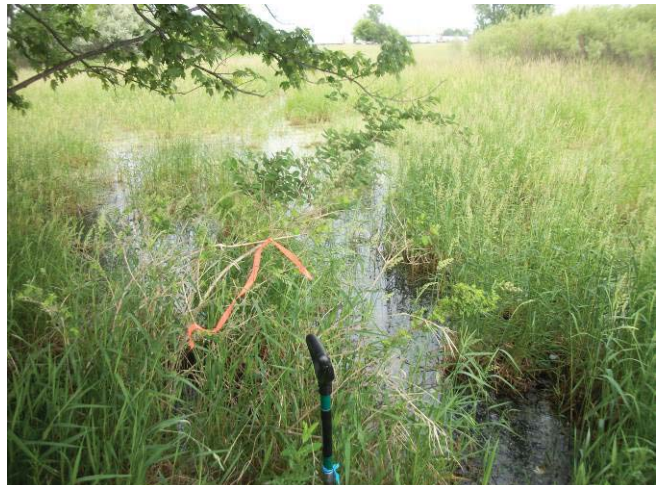
Photo 18: Wetland F looking west.

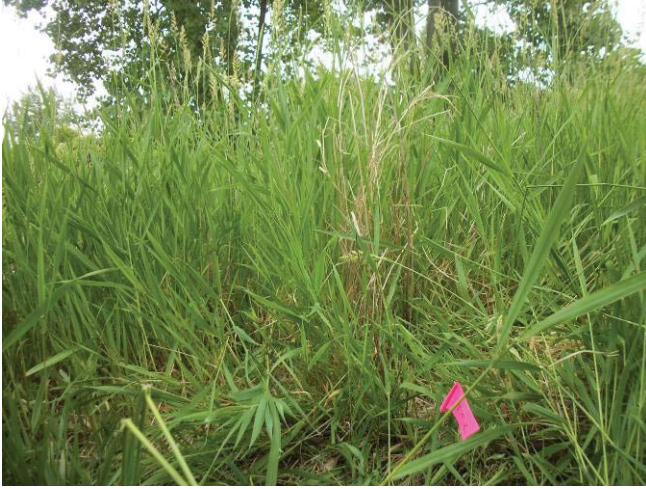
Wetland F is an emergent/scrub-shrub wetland located in an irregular depression along the north property boundary, south of a gravel roadway. Vegetation observed consisted of primarily herbaceous and scrub-shrub, and saplings. Primary indicators of hydrology were observed including evidence of seasonal inundation. Soils were documented as hydric soils. All three diagnostic environmental characteristics of a wetland are present at DP-6.

Photo 19: Wetland F (DP-6) looking east.

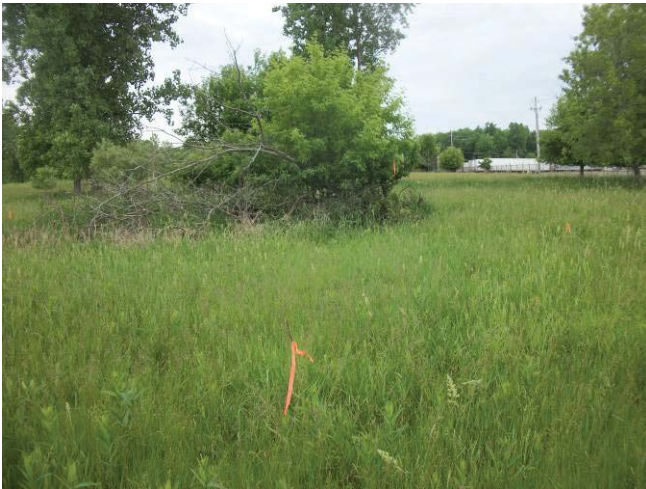
Wetlands G is forested/scrub-shrub wetland located in an irregular depression on the northwest portion of the property. Primary indicators of hydrology were observed including evidence of seasonal inundation. Soils were documented as hydric soils. All three diagnostic environmental characteristics of a wetland are present at DP-8.

Photo 21: Wetland G (DP-8) looking south.

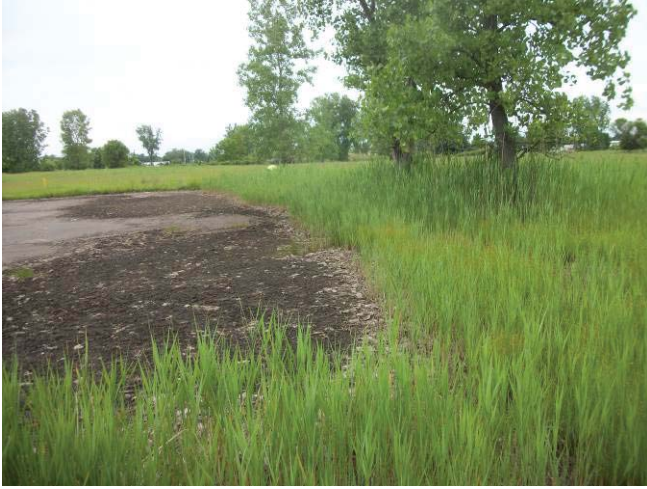
Photo 25: Wetland H looking north.

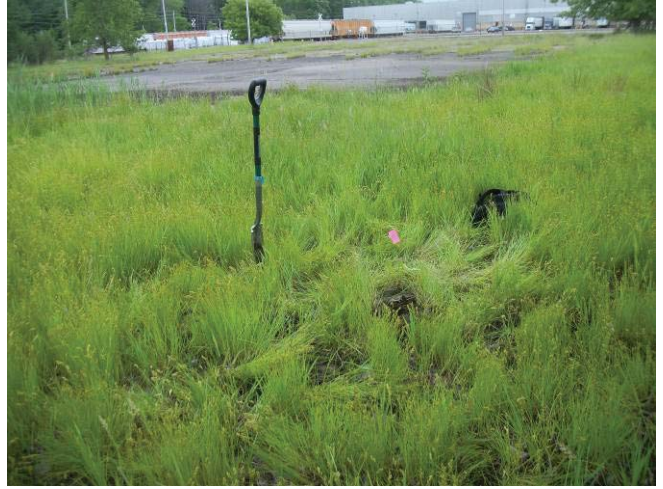
Wetland H is an emergent wetland surrounding a concrete storage pad and connected to a linear wetland along a rail spur on the west-central portion of the property. Primary indicators of hydrology were observed including evidence of seasonal inundation. Soils were documented as hydric soils. All three diagnostic environmental characteristics of a wetland are present at DP-10.

Photo 26: Wetland H (DP-10).

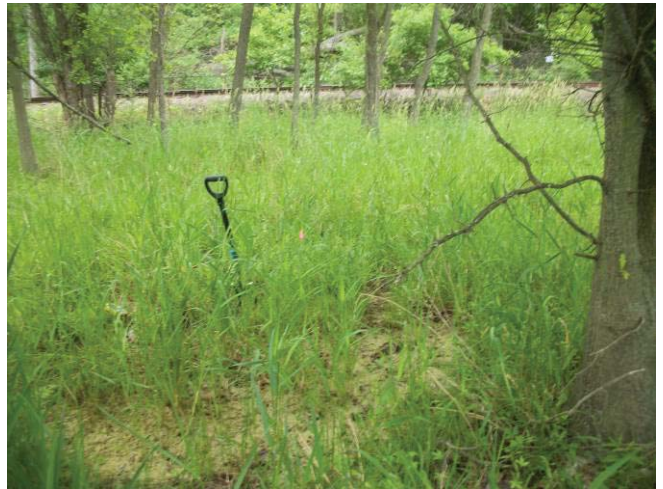
Wetlands D is a linear emergent wetland primarily located in the depressions parallel to a rail spur. These wetlands consist of herbaceous and scrub-shrub habitats. Primary indicators of hydrology were observed including evidence of seasonal inundation. Soils were documented as hydric soils. All three diagnostic environmental characteristics of a wetland are present at DP-12.

Photo 28: Wetland D (DP-12) looking south.

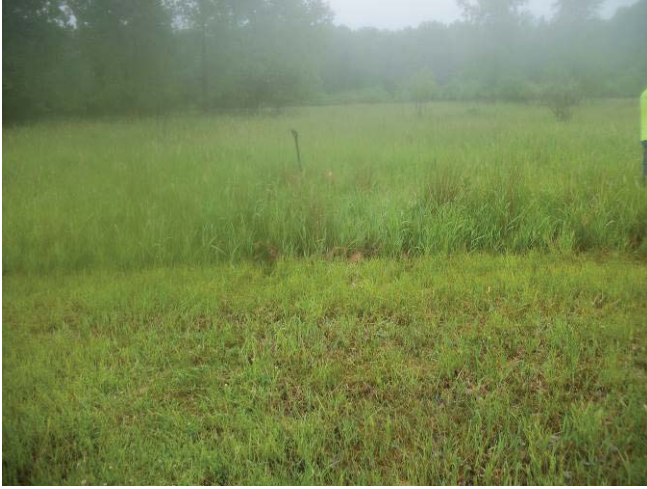
Wetland I is an emergent wetland located in an irregular depression in the middle of an open field near Wetland B and consists of herbaceous and scrub-shrub habitats. Primary indicators of hydrology were observed including evidence of seasonal inundation. Soils were documented as hydric soils. All three diagnostic environmental characteristics of a wetland are present at DP-15.

Photo 31: Wetland I (DP-15) looking west.

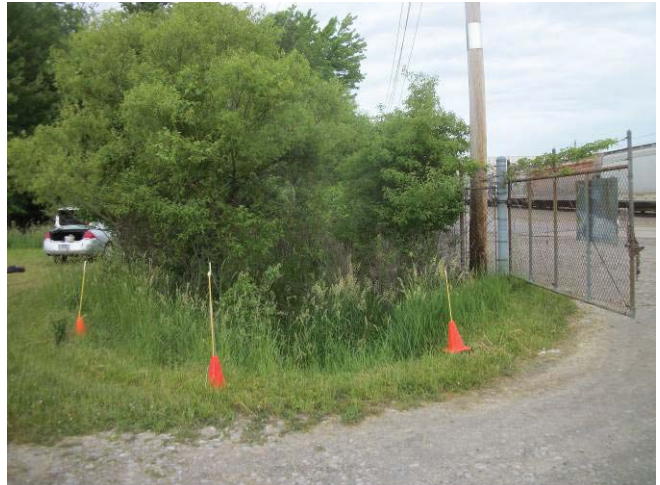
Photo 36 Wetland A1 looking west

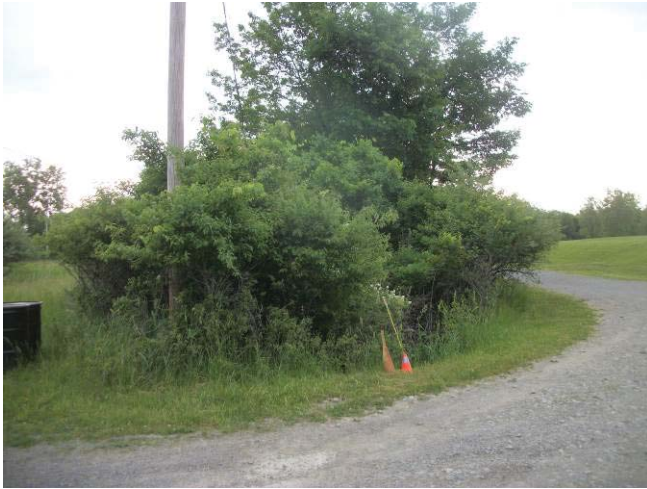
Photo 37: Wetland A1 looming east.

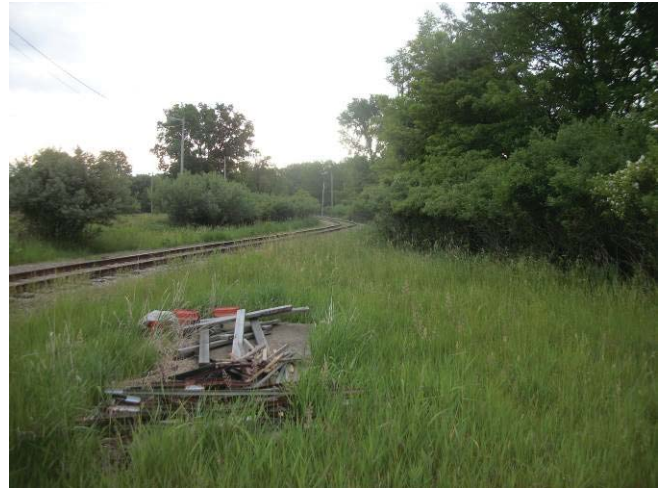
Photo 38: Wetland A3 left of RR looking east
