RE: Annual Landfill Cap Inspection  
**Linden Road Landfill**, Flint Township, Genesee County, Michigan  
Site ID No. 25000016  
FILE: 15388/51437 Docs

*APPENDIX A*  
*October 22, 2014*  
*Inspection Report*

**Operation and Maintenance Periodic Inspection Report  
Linden Road Site  
Flint Township, Michigan**

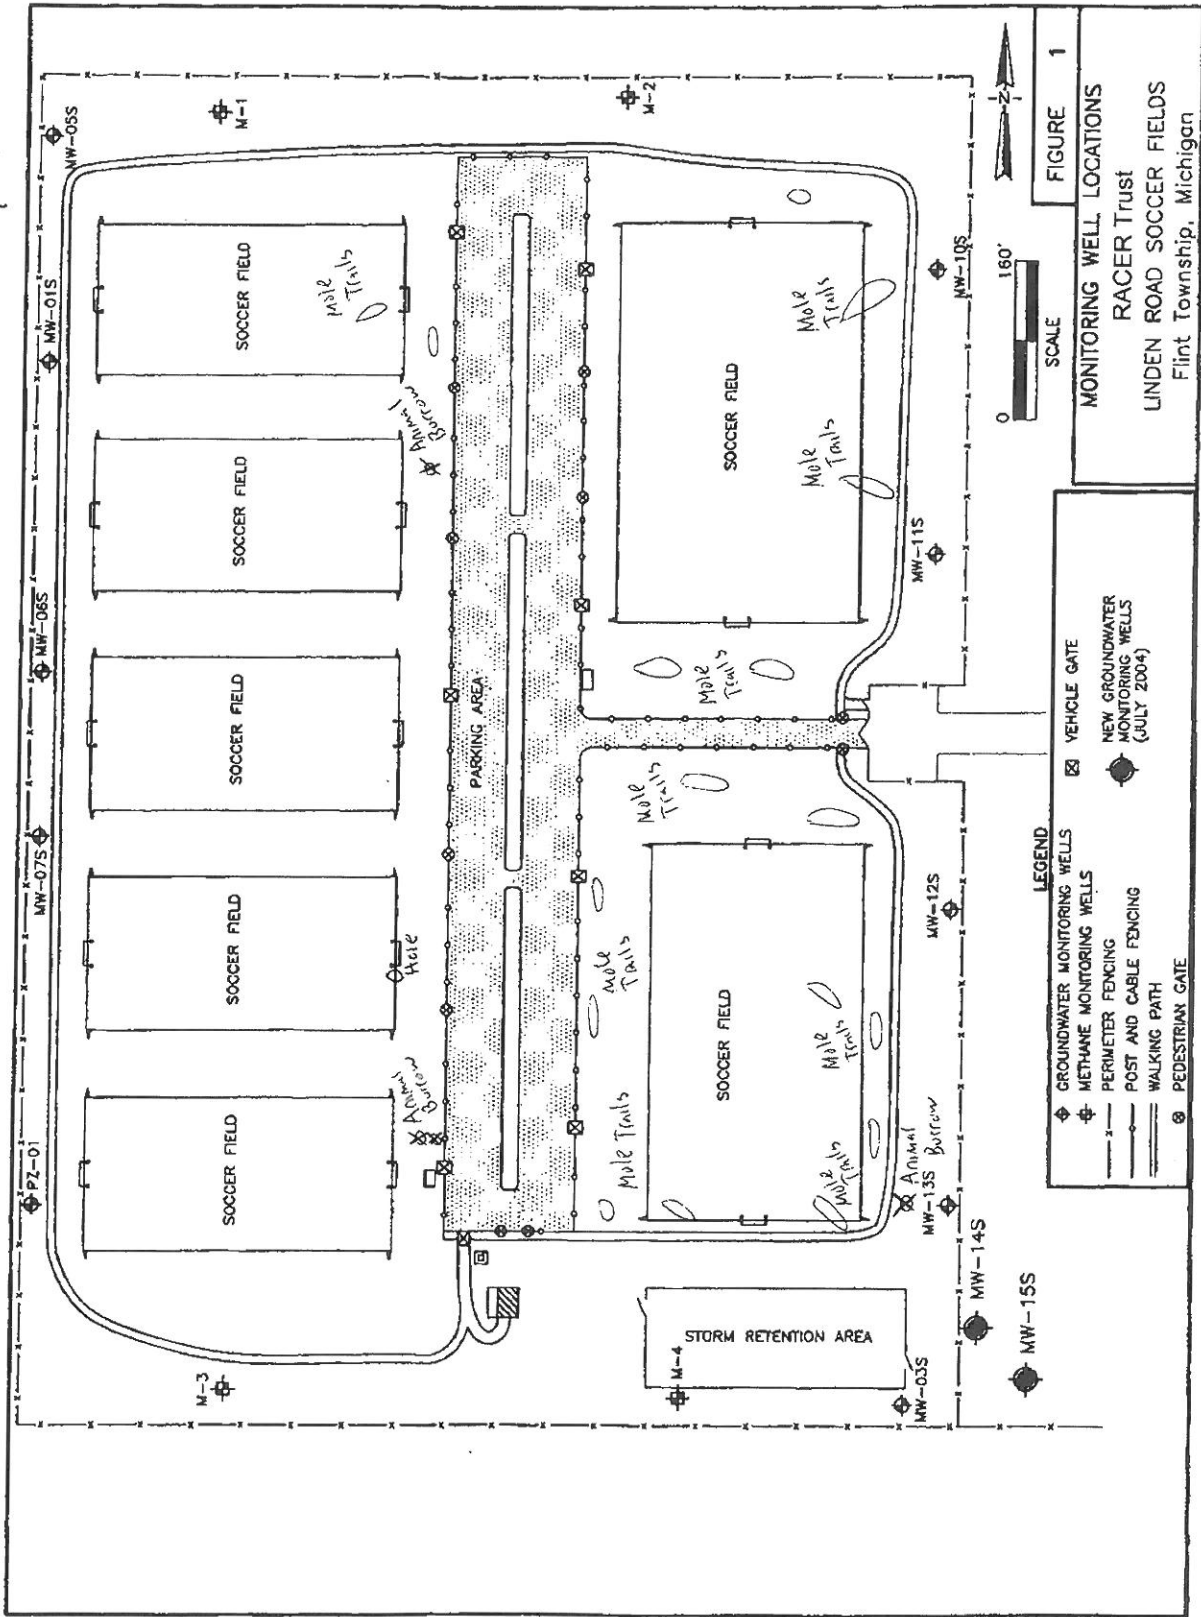
**FIGURE 1**  
**MONITORING WELL LOCATIONS**  
**RACER TRUST**  
**LINDEN ROAD SOCCER FIELDS**  
 Flint Township, Michigan

Summary of Deficiencies and/or Corrective Actions: A number of mole trails were identified along the outside of the east soccer fields (see map), 3 animal burrows were located and traps should be set. Burrows are near fields and care should be taken to mark traps. 1 hole was located and should be filled in.

As noted in the report, burrowing animals appear to have caused a few holes in the landfill cap and moles have made tunnels in several areas. O'Brien & Gere plans to work with the AYSO to set traps in order to control the moles and burrowing animals. Otherwise, the landfill cap is in good condition.
