**PHASE I ENVIRONMENTAL SITE ASSESSMENT  
VACANT PARCEL  
6560 CASS AVENUE  
DETROIT, MICHIGAN 48202**

**ENCORE**

**DATE: NOVEMBER 15, 2002**

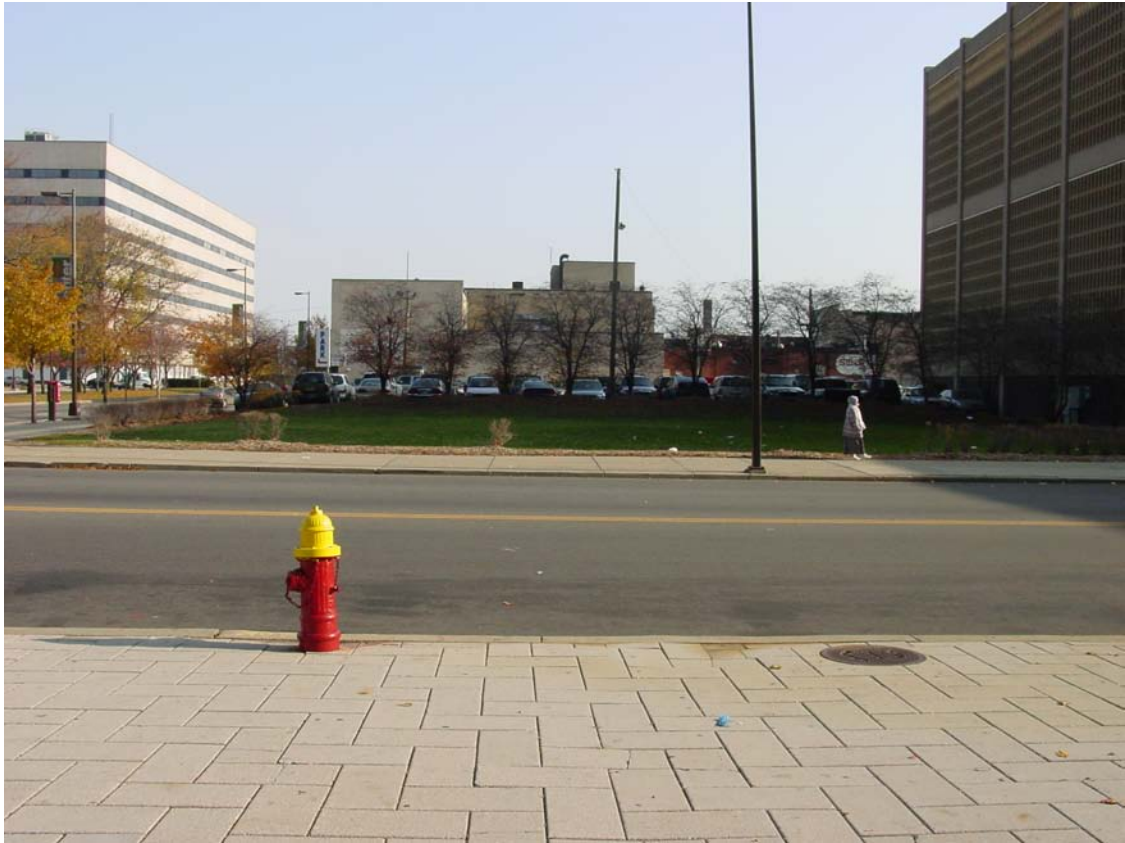
**Photograph 1. View of the Site, facing east/northeast. The Site is primarily grass lawn, lined with shrubs on the west, and north sides, and lined with trees on the east and south sides. Cass Street is in the forefront. The parking garage is to the right. Pal Parking is beyond the Site and tree line. West Grand Boulevard is on the left.**

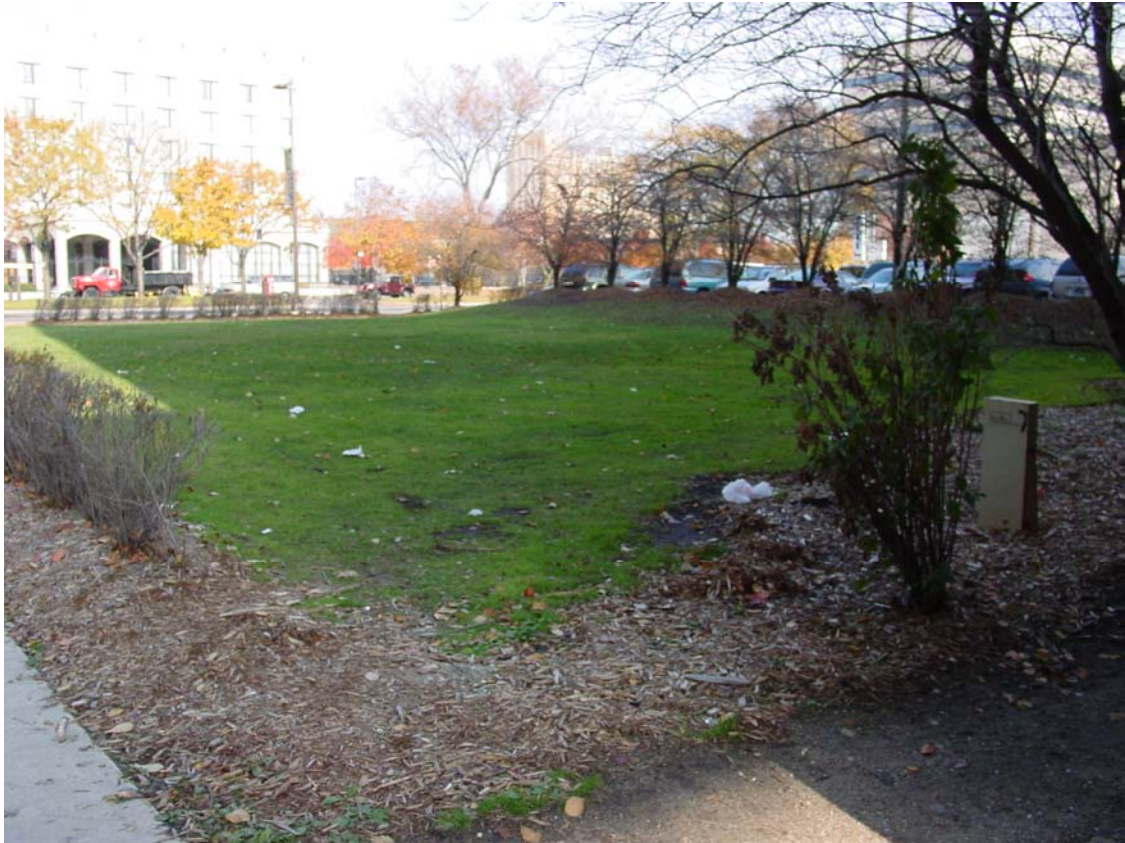
**Photograph 2. View of the Site, facing north. An irrigation system control box is in the right forefront. Pal Parking is in the right background, and the Hotel St. Regis is in the left background behind West Grand Boulevard.**

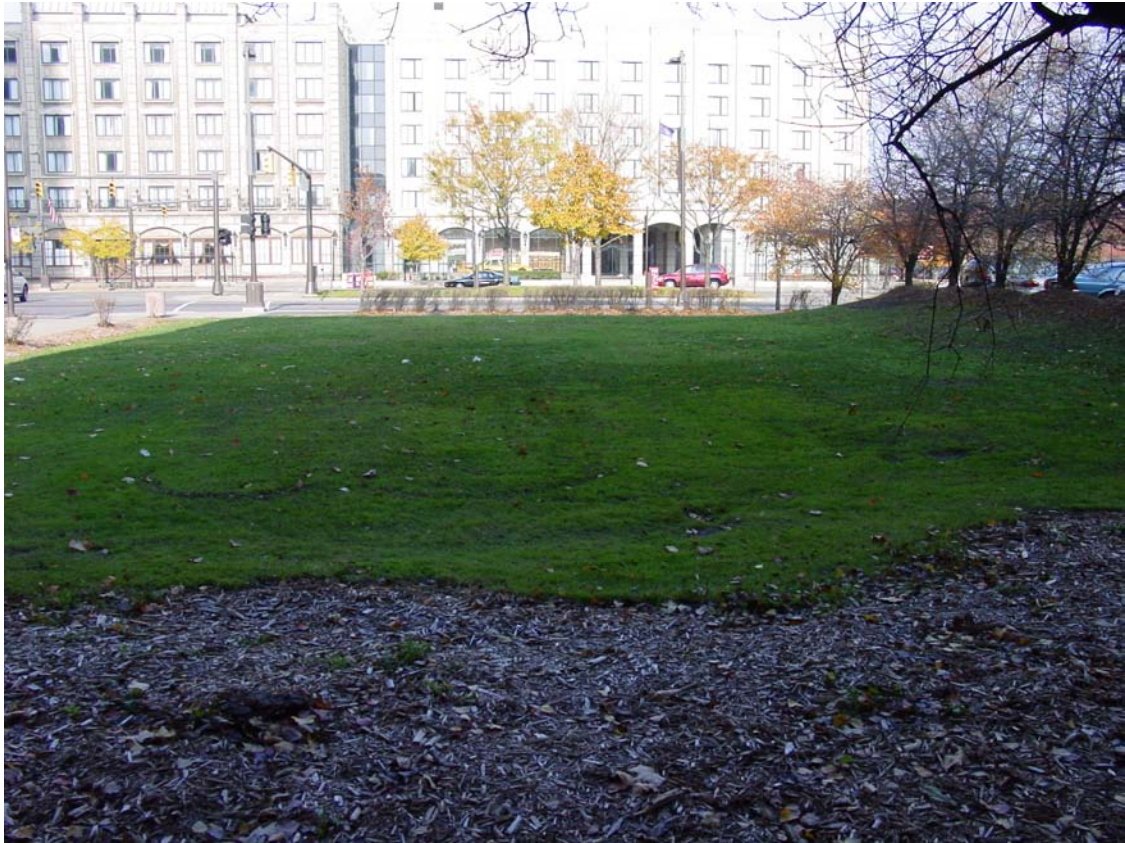
**Photograph 3. View of the Site, facing north/northwest. The Site Hotel St. Regis is in the background behind West Grand Boulevard.**

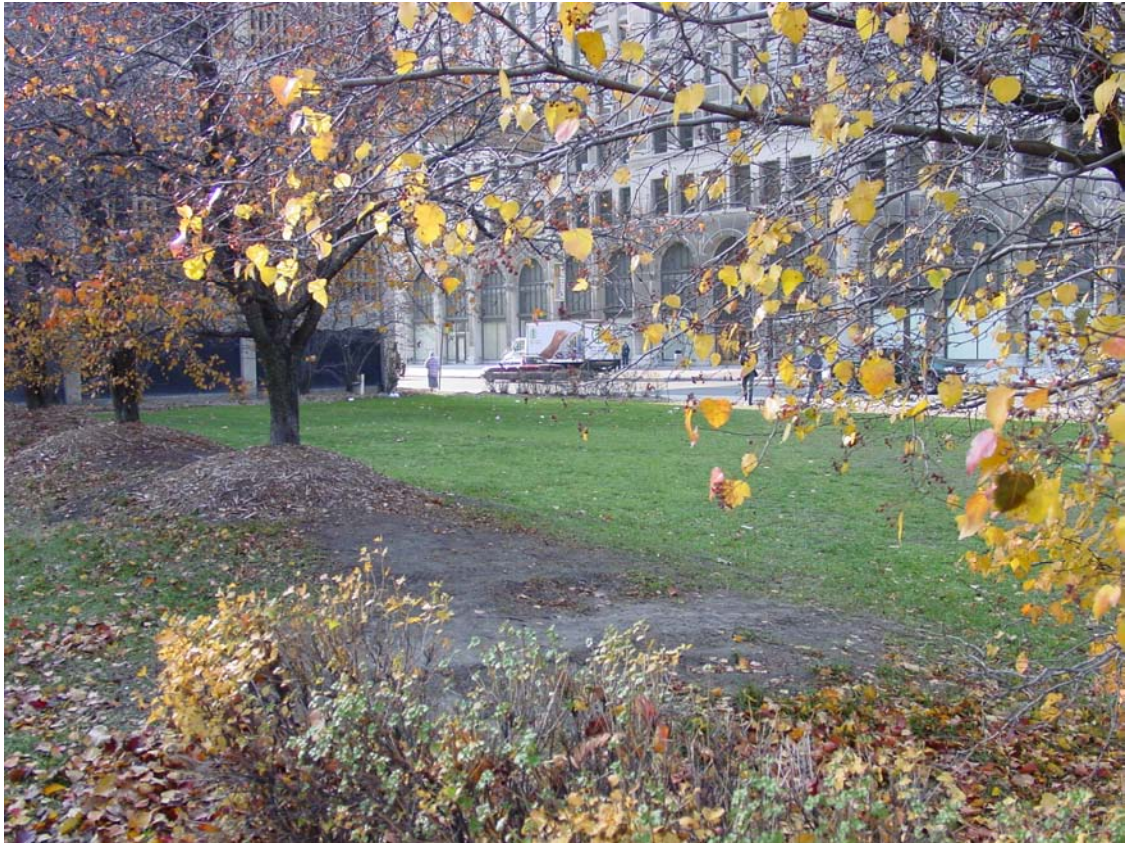
**Photograph 4. A view of the Site, facing south. The treeline is in the forefront. The parking garage is in the left background, and the Cadillac Place building is in the center and right background.**
