**CLOSURE REPORT  
ENAMEL STORAGE PIT AND PIPELINE**

**GENERAL MOTORS CORPORATION  
FORMER GM-LEEDS ASSEMBLY PLANT  
KANSAS CITY, MISSOURI**

**FEBRUARY 1995**

**Burns & McDonnell Waste Consultants, Incorporated  
Engineers—Scientists—Geologists  
Overland Park, Kansas**

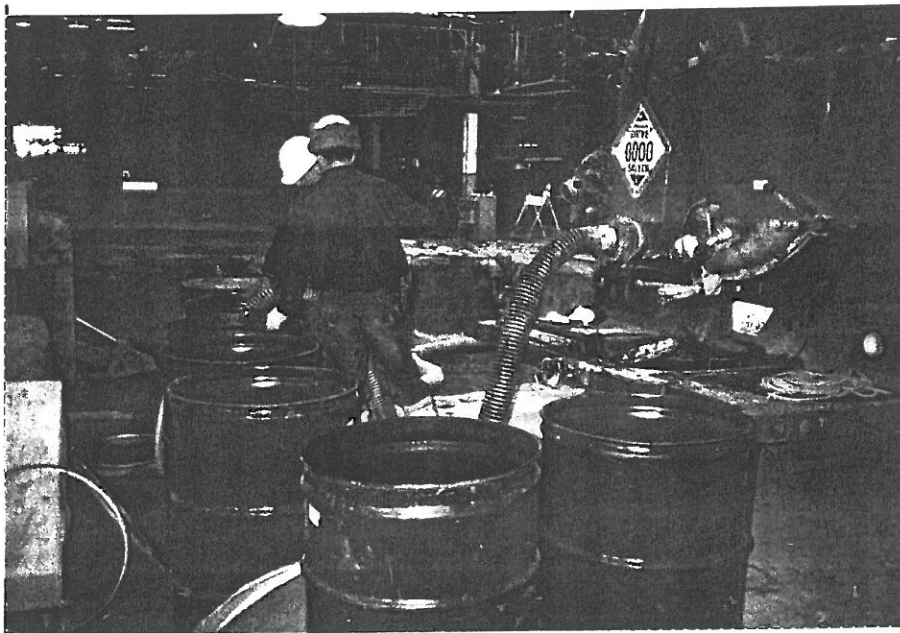
PHOTO 6 - LIQUID REMOVED FROM TANK BEING TRANSFERRED TO  
55-GALLON DRUMS

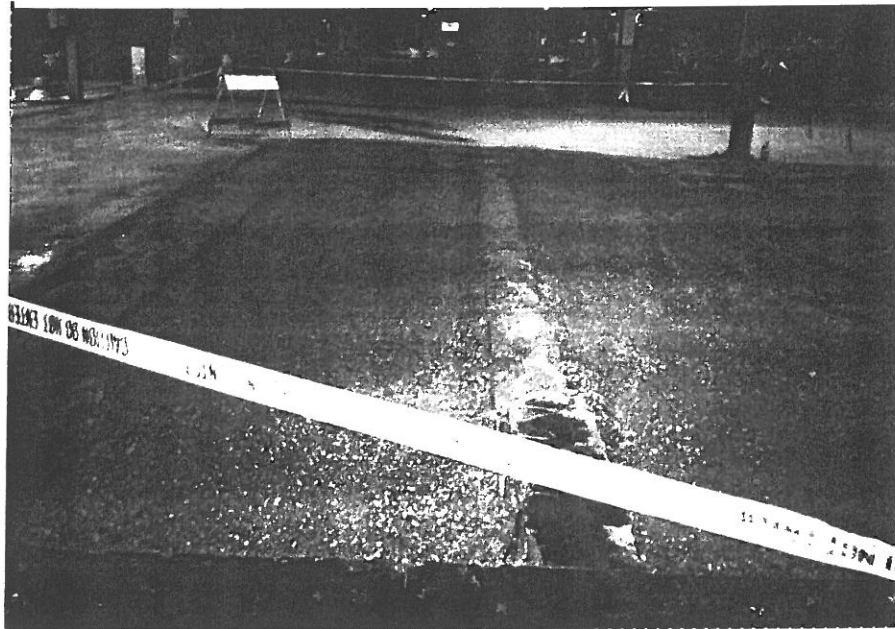
CCE began filling the ESP with granular backfill on January 14, 1993. They completed backfilling the ESP on January 15, 1993 (Photo 14).

PHOTO 14 - ESP BACKFILLED WITH CRUSHED ROCK

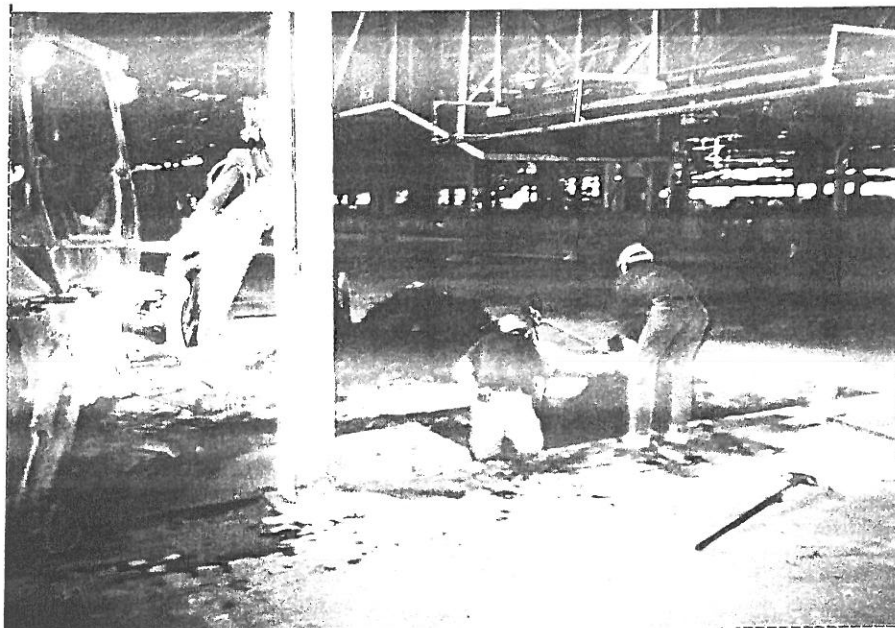
PHOTO 15 - WORKERS ATTEMPTING TO LOCATE KEROSENE PIPE  
WEST OF THE ESP
