**PHASE I ENVIRONMENTAL SITE ASSESSMENT
75.69 ACRES VACANT LAND (PARCEL C)
NORTHWEST CORNER OF ECORSE ROAD AND DENTON ROAD
VAN BUREN TOWNSHIP, MICHIGAN 48111**

GENERAL MOTORS WORLDWIDE REAL ESTATE

ENCORE ENVIRONMENTAL CONSORTIUM, LLC

DATE: FEBRUARY 13, 2007

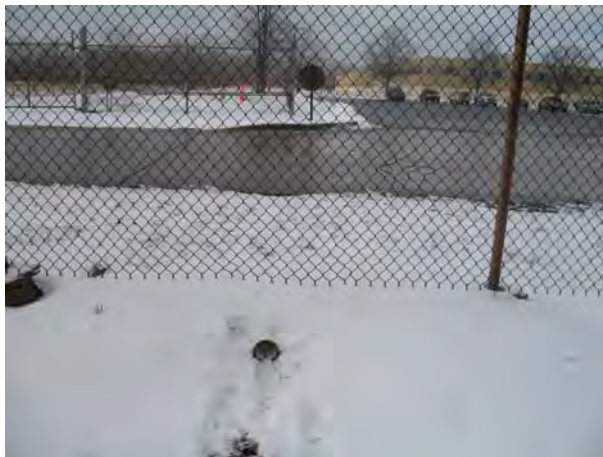
Photograph 3. View of a polyvinyl chloride discharge pipe located along the western boundary of the Site, adjacent to the General Motors SPO facility.

- During the Site reconnaissance, EEC observed five polyvinyl chloride (PVC) stormwater discharge drainage pipes along the western boundary of the Site. The stormwater discharge drainage pipes appeared to discharge directly onto the ground on the western boundary of the Site. EEC also observed several storm drains at the adjacent GM SPO Warehouse parking lot. The storm drains at the adjacent GM SPO Warehouse are likely connected to the onsite PVC stormwater discharge drainage pipes. When occupied over time, parking lot areas represent a common source of automotive fluids. Since the western boundary of the Site receives drainage (a.k.a. runoff) from the parking lot areas, the potential for impact exists. Therefore, the discharge location of the PVC drainage pipes along the western boundary of the Site represents a REC.

During the Site reconnaissance, EEC observed five polyvinyl chloride (PVC) stormwater discharge drainage pipes along the western boundary of the Site. The stormwater discharge drainage pipes appeared to discharge directly onto the ground on the western boundary of the Site. EEC also observed several storm drains at the adjacent GM SPO Warehouse parking lot. The storm drains at the adjacent GM SPO Warehouse are likely connected to the onsite PVC stormwater discharge drainage pipes. When occupied over time, parking lot areas represent a common source of automotive fluids. Since the western boundary of the Site receives drainage (a.k.a. runoff) from the parking lot areas, the potential for impact exists. Therefore, the discharge location of the PVC drainage pipes along the western boundary of the Site represents a REC.

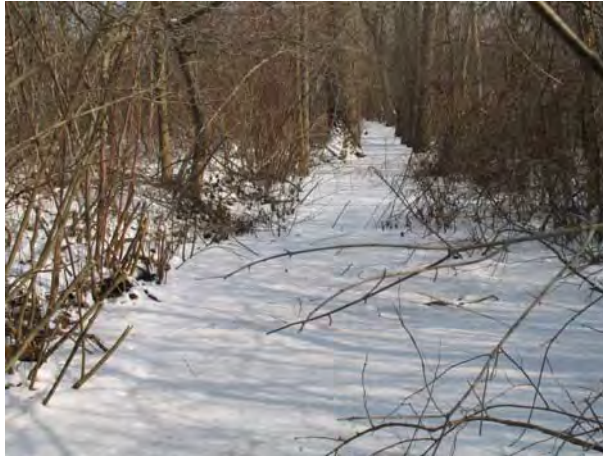
Photograph 4. View of the Old Smith Drain located on the southern portion of the Site, facing east.

EEC observed sections of the Old Ayer Drain and Old Smith Drain across the northern and southern portions of the Site, respectively. The Old Ayer Drain and Old Smith Drain are not depicted as regulated wetland areas in the EDR report. Inundated areas were also observed on the eastern portion of the Site. In addition, EEC observed wetland-type vegetation (i.e., cattails and grasses) in these portions of the Site. The EDR report indicated that the Site did not contain State of Michigan listed wetlands. However, EEC observed wetland delineation flags in the vicinities of the Old Ayers Drain, Old Smith Drain and the inundated areas on the eastern portion of the Site. Based on EEC's observations during the Site reconnaissance and the presence of wetland delineation flags, the Site may contain regulated wetland areas, which represents an other environmental issue.

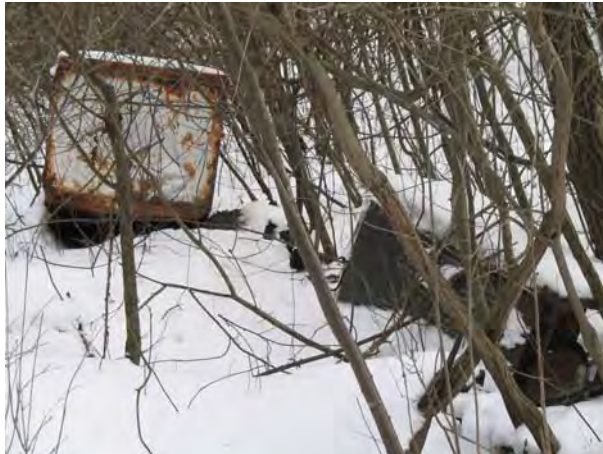
Photograph 5. View of debris including two refrigerators located in the western portion of the Site.

Interviews with Site personnel and review of historical references did not indicate disposal of solid waste below the ground surface at the Site. EEC observed solid waste in piles aboveground sporadically throughout the Site. In addition to the ASTs and drums identified as RECs (refer to Sections 2.1.4 and 2.1.7, respectively), EEC also observed used tires, general garbage, building construction materials (e.g., concrete, wood, metal, shingles), household appliances (e.g., washer, dryer), furniture (e.g., bedspring), plastic and metal piping, hazardous material containers, scrap metal, and numerous unidentifiable items. The presence of large quantities of solid waste disposed of aboveground at the Site represents an other environmental issue.

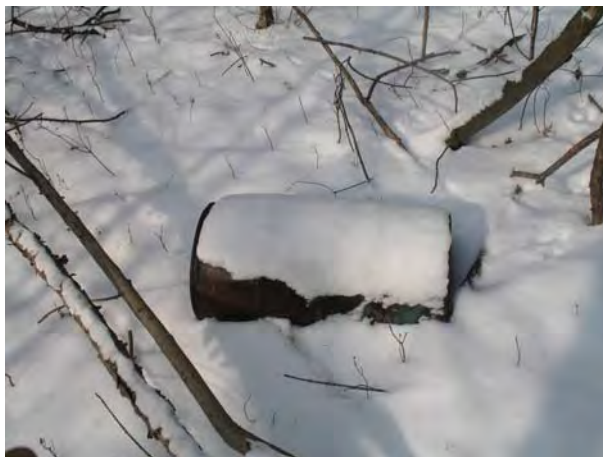
Photograph 6. View of an empty 30-gallon drum located in the western portion of the Site.

- During the Site reconnaissance, EEC observed three 30-gallon drums and one 55-gallon drum in the western portion of the Site. The drums were observed to be rusted and in poor structural

condition. EEC did not observe labels on the drums. Several of the drums appeared to be empty or filled with snow/ice. Evidence of spills/releases was not observed in the vicinities of the drums during the Site reconnaissance. However, the presence of four abandoned drums at the Site represents a REC.

EEC observed evidence of petroleum product containers discarded aboveground in the eastern and western portions of the Site. In addition to the abandoned ASTs described in Section 2.1.4, EEC observed three 30-gallon drums and one 55-gallon drum in the western portion of the Site. The drums were observed to be rusted and in poor structural condition. EEC did not observe labels on the drums. Several of the drums appeared to be empty or filled with snow/ice. Evidence of spills/releases was not observed in the vicinities of the drums during the Site reconnaissance. However, the presence of four abandoned drums at the Site represents a REC.

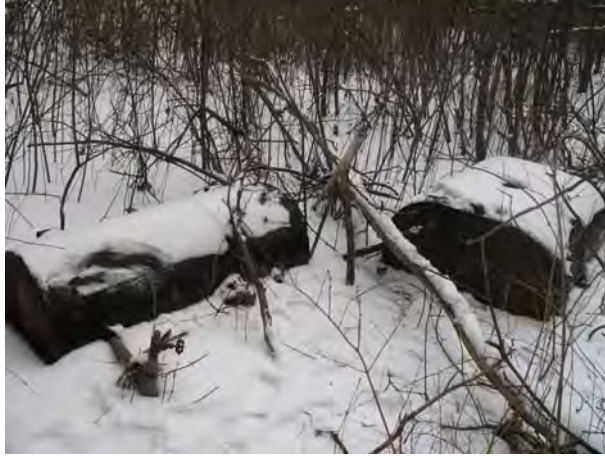
Photograph 7. View of one empty approximate 300-gallon AST and one empty approximate 500-gallon AST located in the eastern portion of the Site.

No records of Site ASTs were listed in the EDR database report. However, during the Site reconnaissance, EEC observed one abandoned 500-gallon ASTs and two abandoned 300-gallon ASTs. The ASTs were observed lying on the ground on the eastern portion of the Site, near the locations of former onsite residences. The ASTs were observed to be rusted and in poor structural condition. EEC did not observe product in the ASTs. The 500-gallon AST was labeled "Automatic Detroit". EEC did not observe labels on the 300-gallon ASTs. It is unknown if the ASTs were used at the location of observation in association with the former residences (constructed between 1940 and 1960), or otherwise

if the ASTs were discarded on the ground. Evidence of spills/releases was not observed in the vicinities of the ASTs during the Site reconnaissance. However, the presence of three abandoned ASTs at the Site represents a REC. No other environmental issues were noted in association with ASTs.

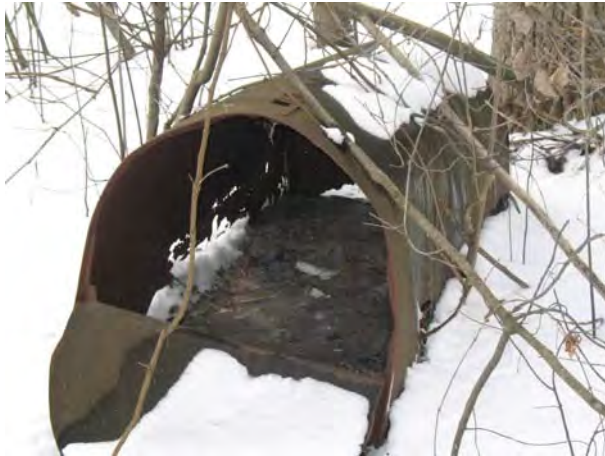
Photograph 8. View of an empty approximate 300-gallon AST located in the eastern portion of the Site.

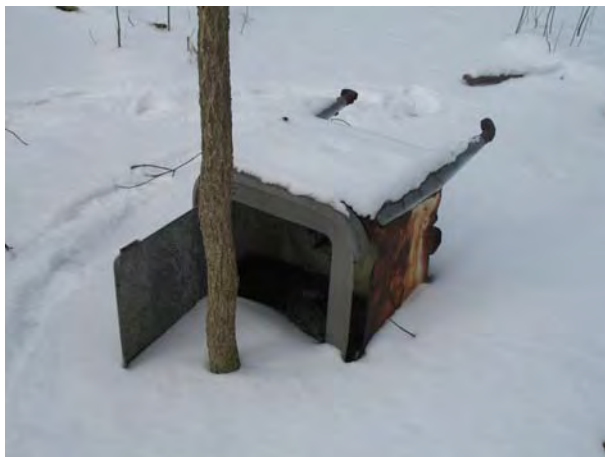
Photograph 9. View of debris located in the western portion of the Site.

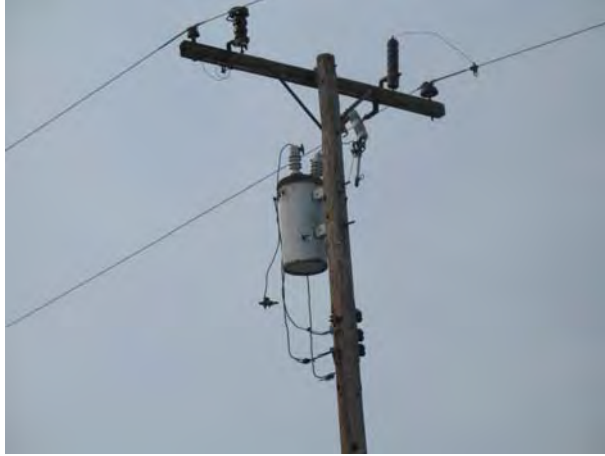
Photograph 10. View of a pole-mounted transformer located in the southeastern portion of the Site.

Site personnel did not have knowledge of PCB-containing materials formerly or currently present at the Site. During the Site reconnaissance, EEC observed three pole-mounted electrical transformers in the eastern portion of the Site. EEC did not observe PCB labels on the transformers. The transformers appeared to be in good condition at the time of Site reconnaissance with no visible evidence of leaks or staining. According to the Site personnel the transformers are owned by DTE Energy. Since the pole-mounted transformers are the property of DTE Energy, liabilities pertaining to spills, leaks, or fires should rest with them. No RECs or other environmental issues were noted in association with potential PCB-containing materials.

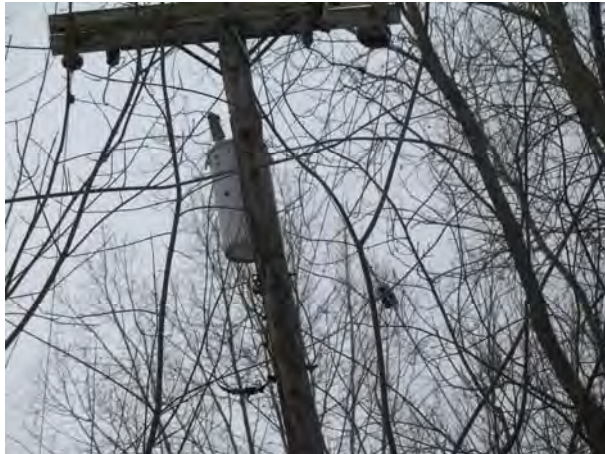
Photograph 11. View of a pole-mounted transformer located in the eastern portion of the Site.
