**JURISDICTIONAL WATERS DELINEATION – FINAL**

**Coldwater Road Landfill  
Mt. Morris, Genesee County, Michigan**

**Racer Trust**

December 10, 2018

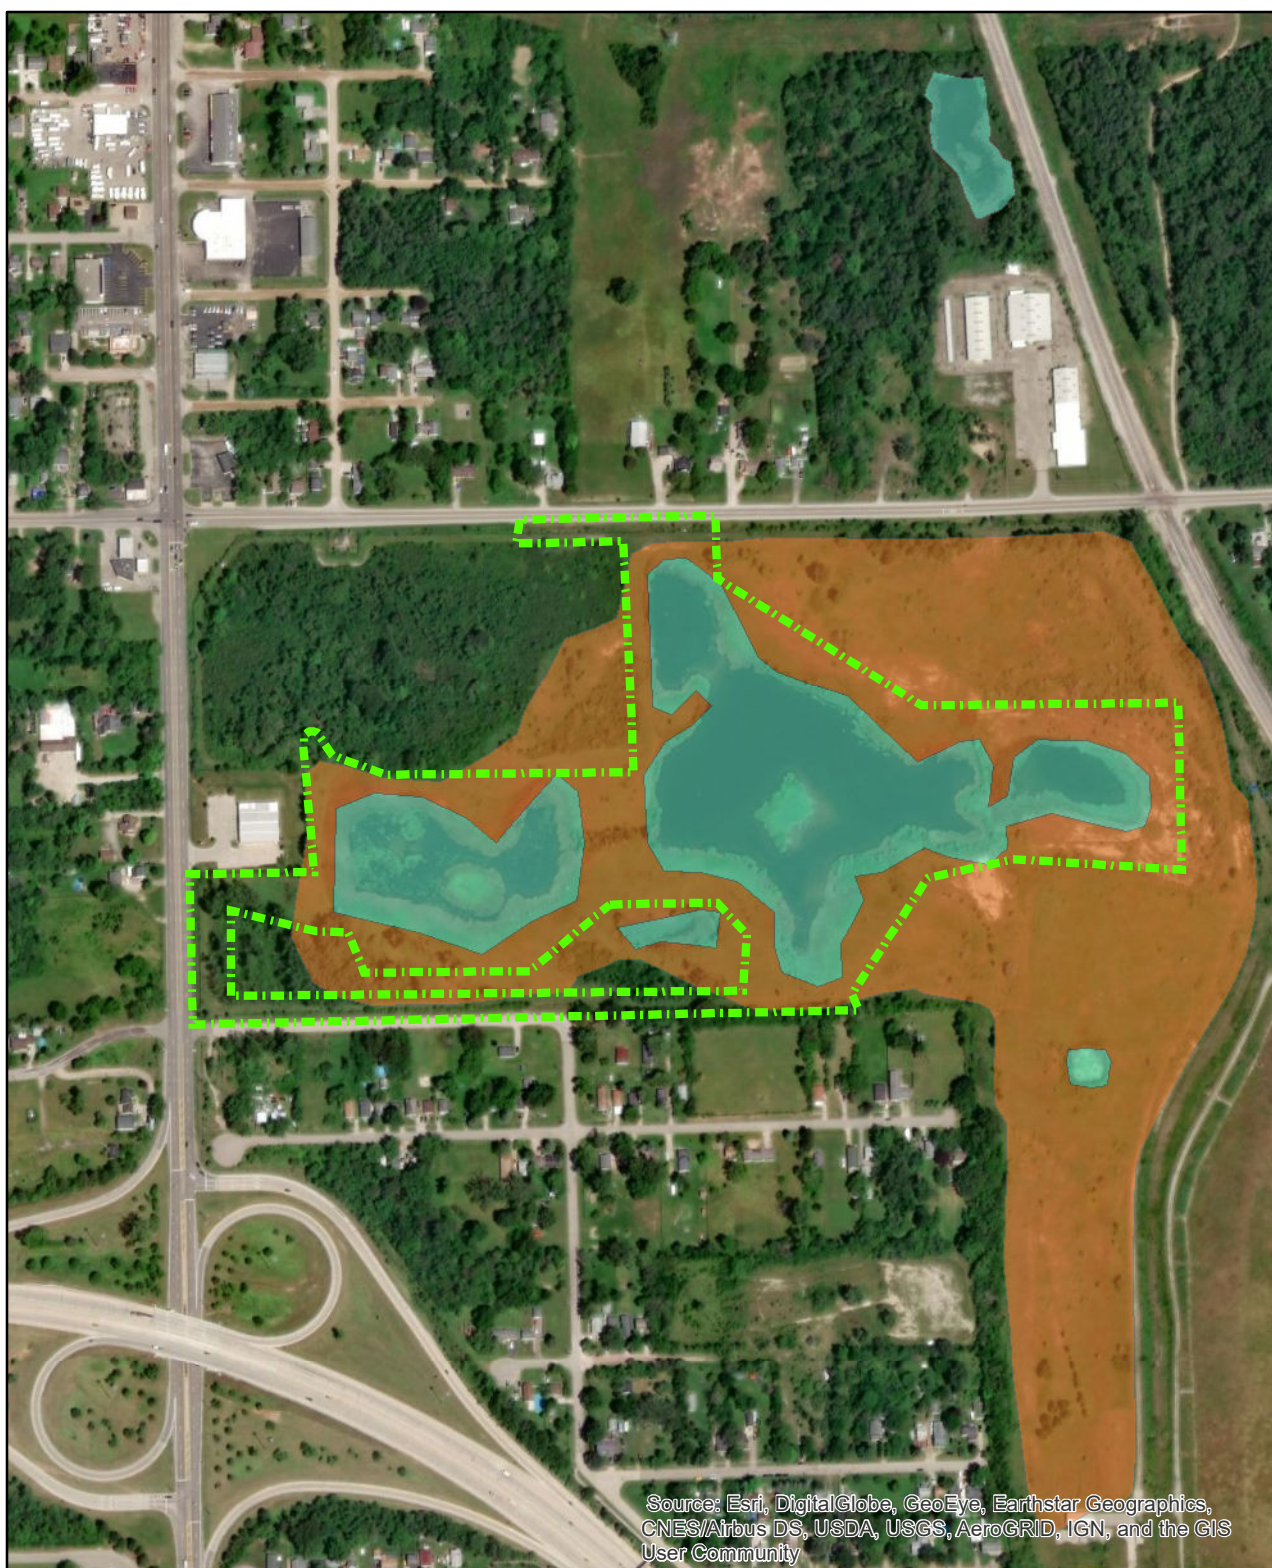
C:\Users\RodriaA\OneDrive - O'Brien & Gere Limited\GIS\_Other\_Offices\Chicago\68545\_FIG3\_Coldwater\_NWI.mxd

The U.S. Fish & Wildlife Service (USFWS, 2018) NWI map ([Figure 3](#)) shows two Freshwater ponds within the Site, surrounded by freshwater emergent wetlands. Both ponds are part of the remediation of former waste water treatment activities and were likely constructed in upland areas.

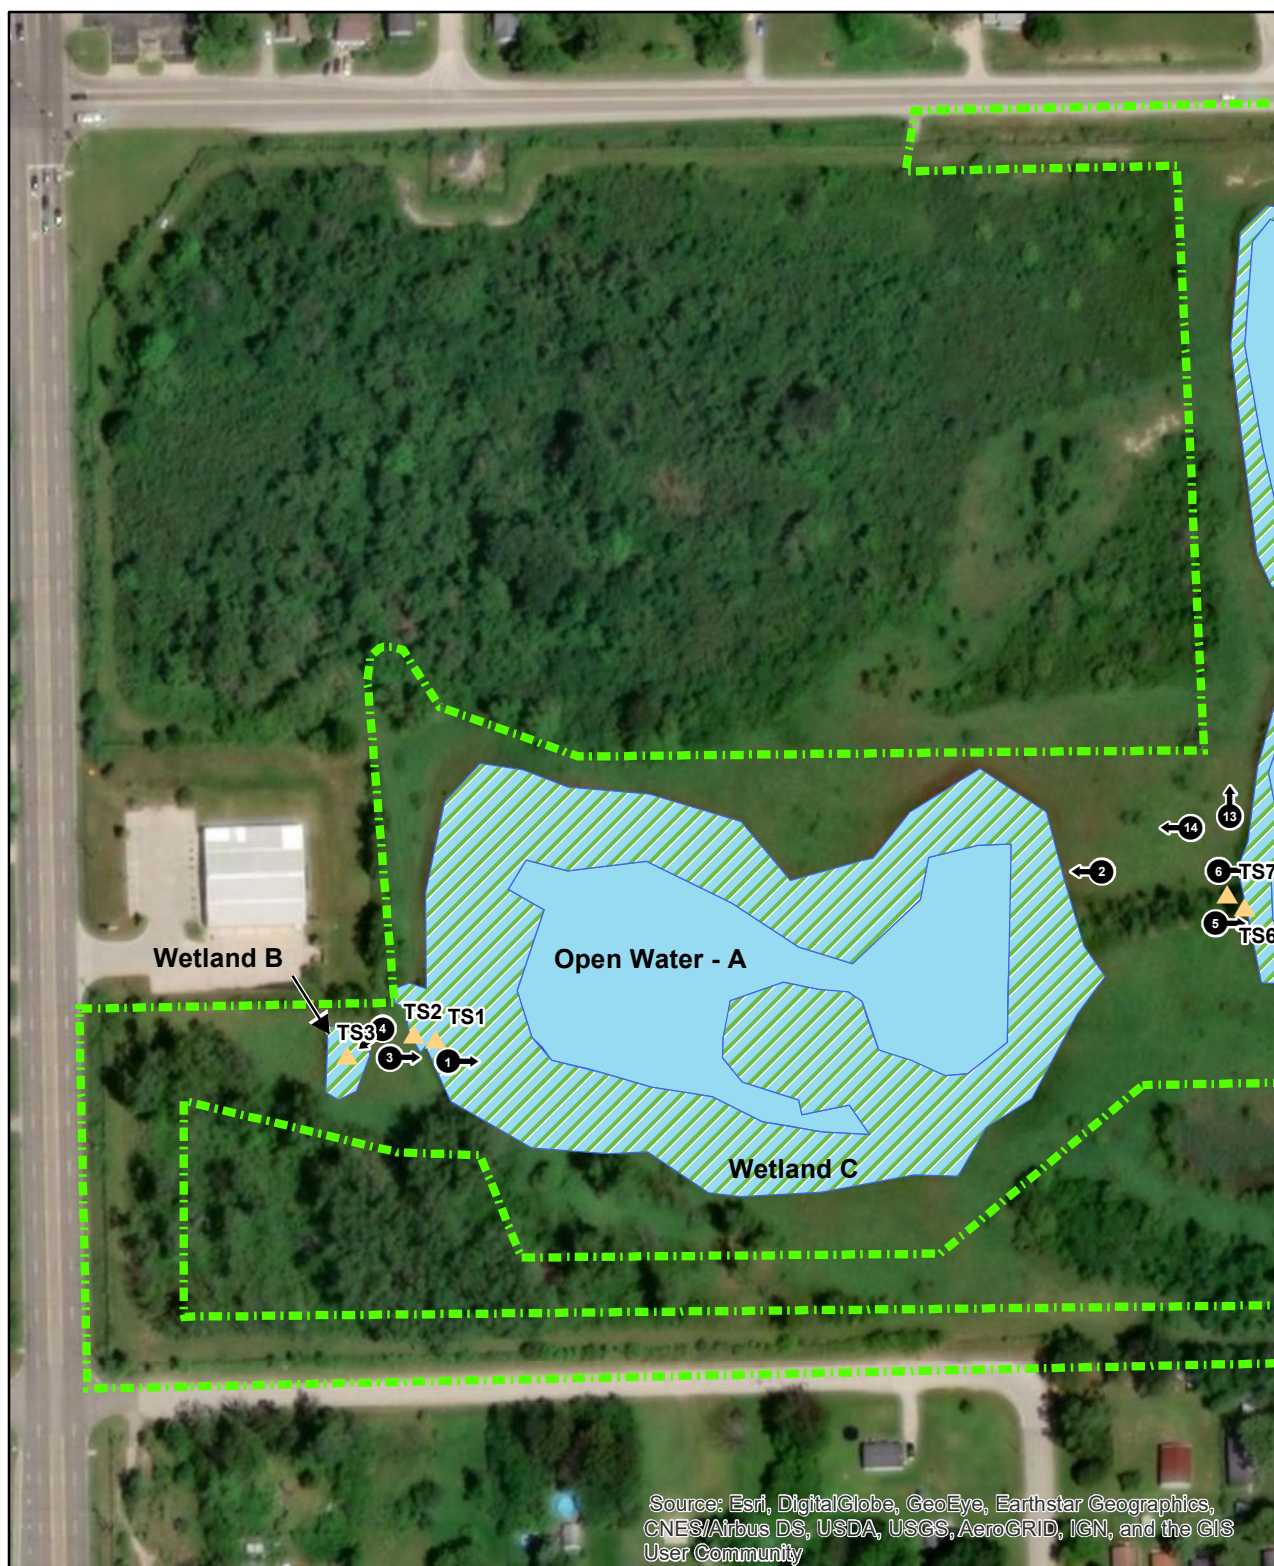
C:\Users\RodriaA\OneDrive - O'Brien & Gere Limited\GIS\_Other\_Offices\Chicago\68545\_Fig4\_Coldwater.mxd

wetland boundaries and wetland sample plots are presented on the Wetland Location Map included herein as **Figure 4**.

The wetland boundary and sample plot flagging locations were surveyed by the field biologists using a hand-held Trimble Global Positioning System (GPS) unit and subsequent post processing of the raw data. The post-processed GPS data represent sub-meter accuracy. Boundaries of the wetland community that were inaccessible to OBG biologists were flagged and a GPS location was taken at the nearest practicable location with a noted observation of an approximate distance and cardinal direction to the wetland boundary. Post-processing of flagged wetland boundaries included adjusting the GPS locations which were noted as inaccessible to OBG biologists during the field survey by using the field observations and high resolution aerial photographs from July 2017 and 2018 to map an accurate wetland boundary. Post-processing of the representative photographs and boundaries of delineated wetland areas are presented in [Appendix E](#) and [Figure 4](#).

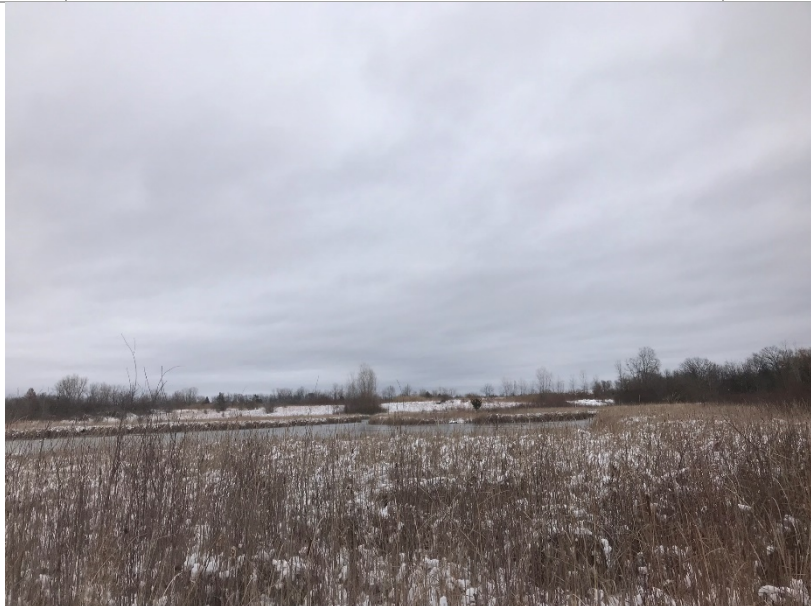
| <b>PHOTO NO.</b><br>1 | <b>DATE:</b><br>11/28/2018 | | |

| <b>DESCRIPTION</b><br>View of Palustrine Open Water Feature (POW) A and Wetland C.<br><br>Photo taken facing east.<br><br>Photo credit: A. Rodrian | | | |

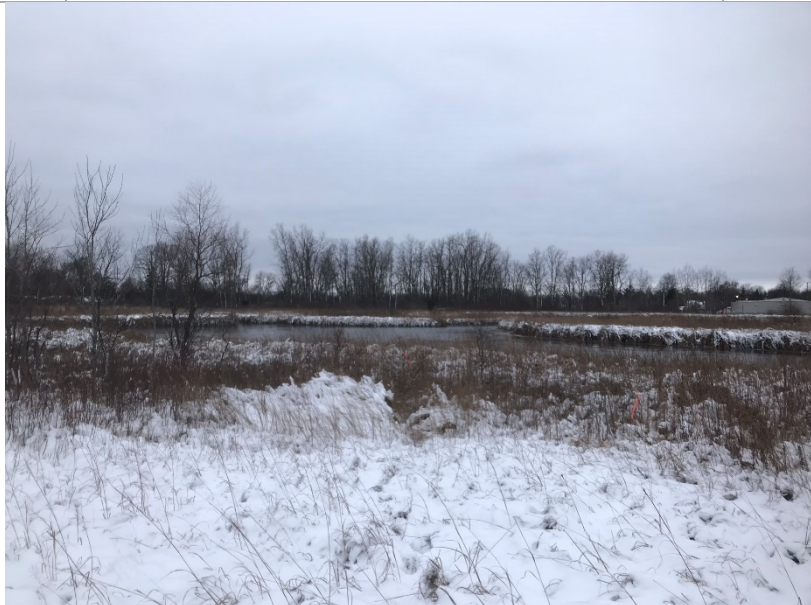
| <b>PHOTO NO.</b><br>2 | <b>DATE:</b><br>11/28/2018 | | |

| <b>DESCRIPTION</b><br>View of Palustrine Open Water Feature (POW) A and Wetland C.<br><br>Photo taken facing west.<br><br>Photo credit: A. Rodrian | | | |

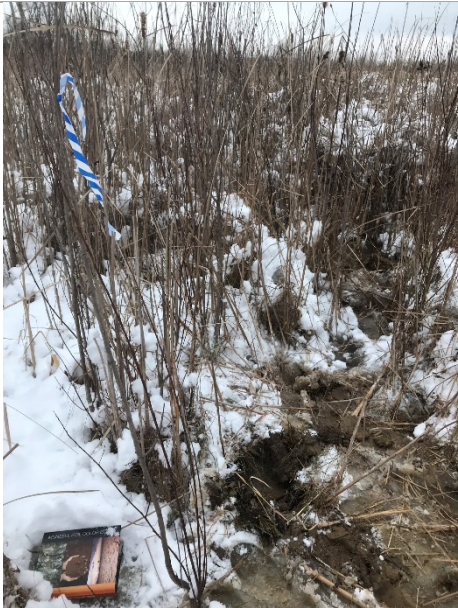
| <b>PHOTO NO.</b><br>3 | <b>DATE:</b><br>11/28/2018 | | | |

| <b>DESCRIPTION</b><br>View of Test Site (TS) 1 for Wetland C.<br><br>Photo taken facing west.<br><br>Photo credit: A. Rodrian | | | | |

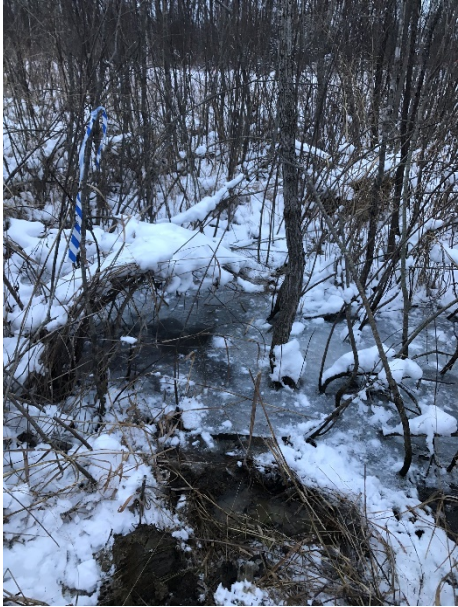
| <b>PHOTO NO.</b><br>4 | <b>DATE:</b><br>11/28/2018 | | | |

| <b>DESCRIPTION</b><br>View of Test Site 3 for Wetland B.<br><br>Photo taken facing southeast.<br><br>Photo credit: A. Rodrian | | | | |

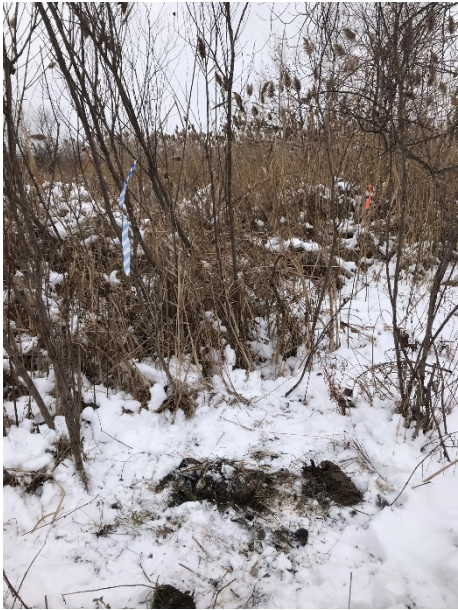
| <b>PHOTO NO.</b><br>5 | <b>DATE:</b><br>11/29/2018 | | |

| <b>DESCRIPTION</b><br>View of Test Site 6 for Wetland D.<br><br>Photo taken facing east.<br><br>Photo credit: A. Rodrian | | | |

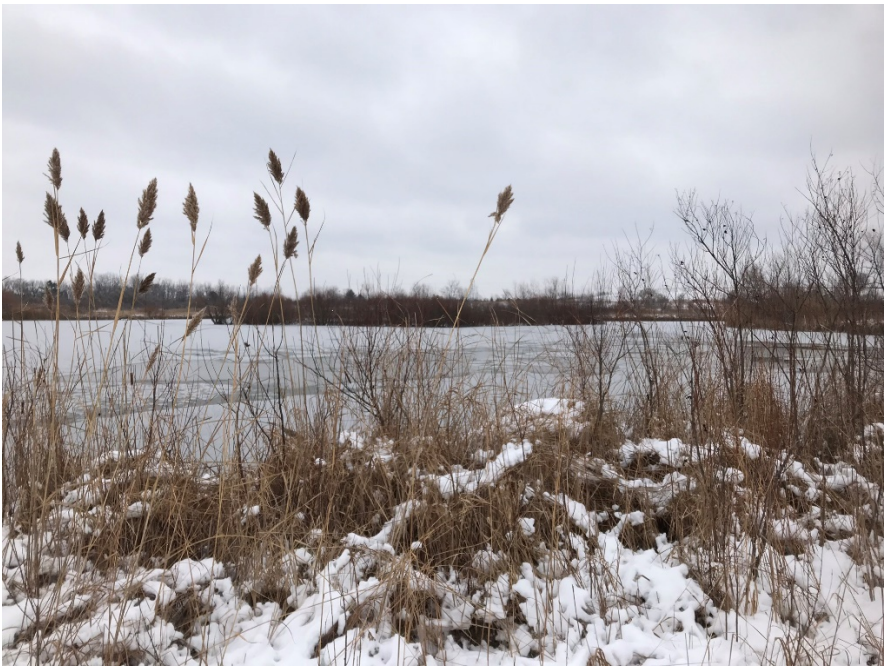
| <b>PHOTO NO.</b><br>6 | <b>DATE:</b><br>11/29/2018 | | |

| <b>DESCRIPTION</b><br>View of POW G and Wetland E.<br><br>Photo taken facing east.<br><br>Photo credit: A. Rodrian | | | |

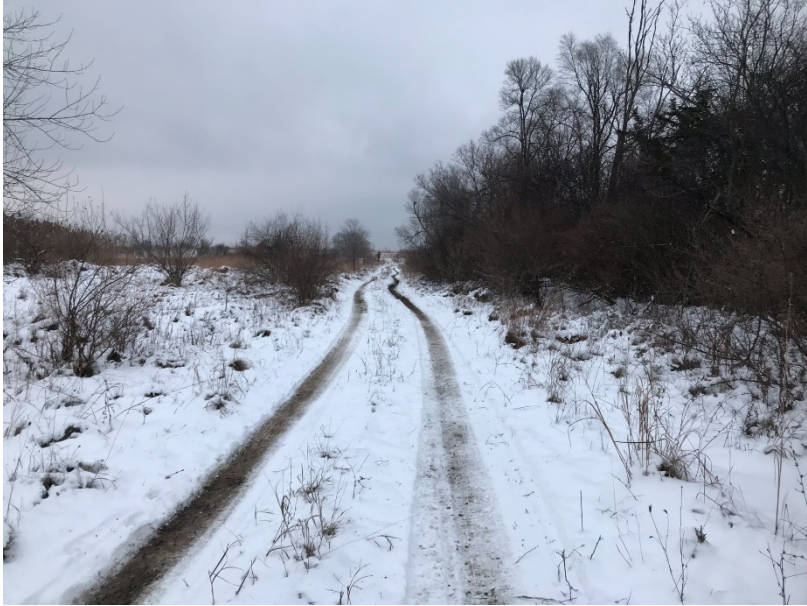
| <b>Photo No.</b><br>7 | <b>Date:</b><br>11/29/2018 | | |

| <b>Description</b><br>Representative view of upland area and existing gravel road south of Wetland D.<br><br>Photo taken facing east.<br><br>Photo credit: A. Rodrian | | | |

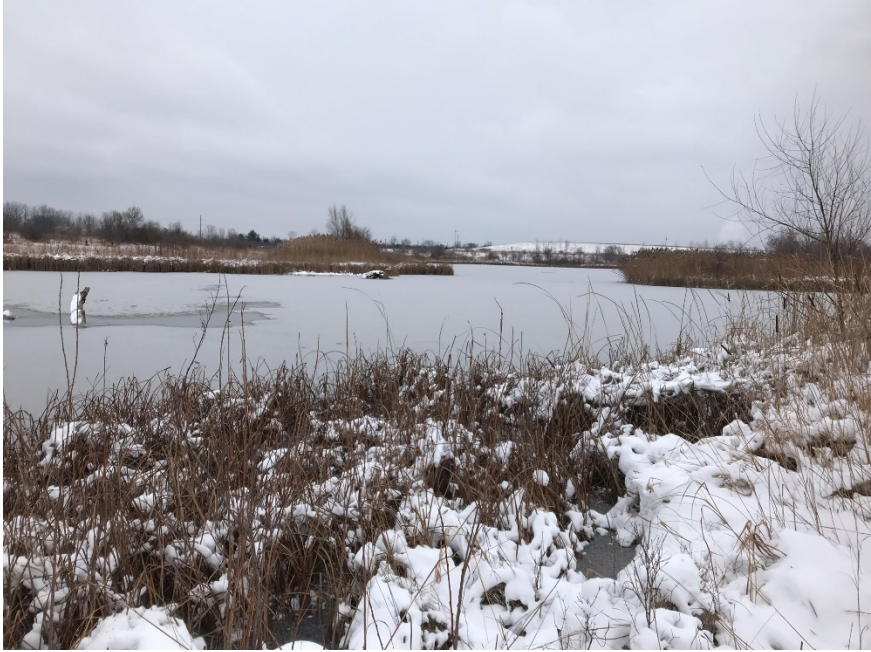
| <b>Photo No.</b><br>8 | <b>Date:</b><br>11/29/2018 | | |

| <b>Description</b><br>Representative view of Wetland D and POW G.<br><br>Photo taken facing north.<br><br>Photo credit: A. Rodrian | | | |

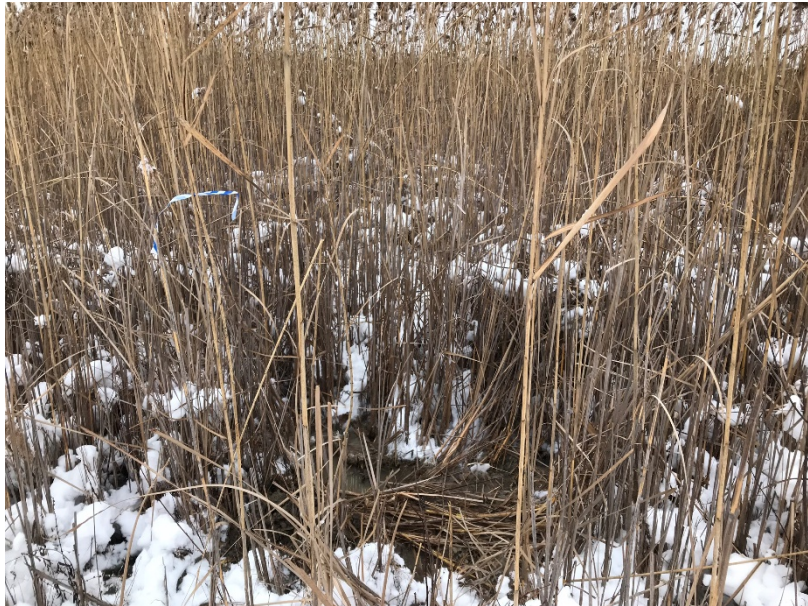
| <b>Photo No.</b><br>9 | <b>Date:</b><br>11/29/2018 | | |

| <b>Description</b><br><br>View of Test Site 4 for Wetland D.<br><br>Photo taken facing east.<br><br>Photo credit: A. Rodrian | | | |

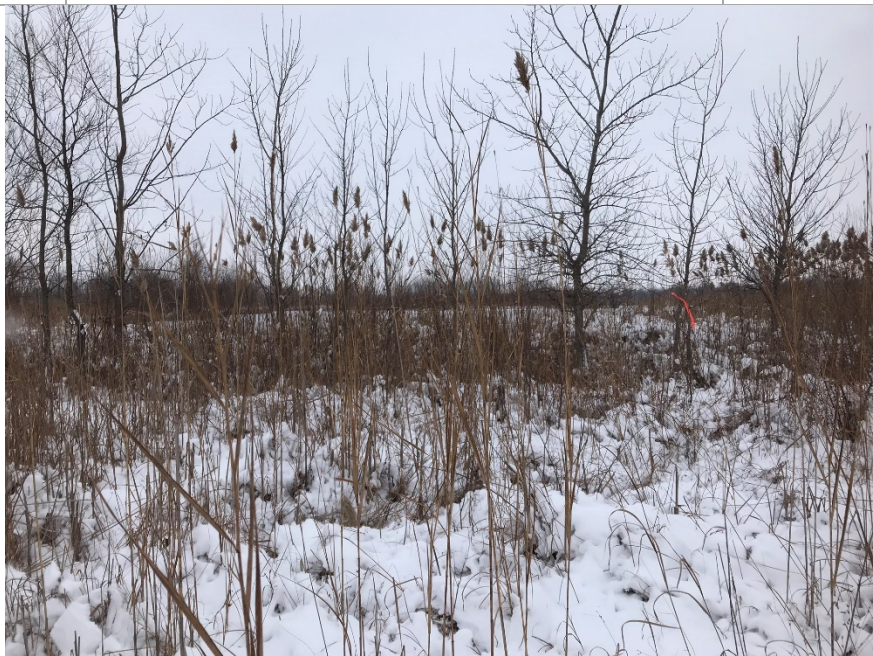
| <b>Photo No.</b><br>10 | <b>Date:</b><br>11/29/2018 | | |

| <b>Description</b><br><br>Representative view of Wetland D and POW G.<br><br>Photo taken facing west.<br><br>Photo credit: A. Rodrian | | | |

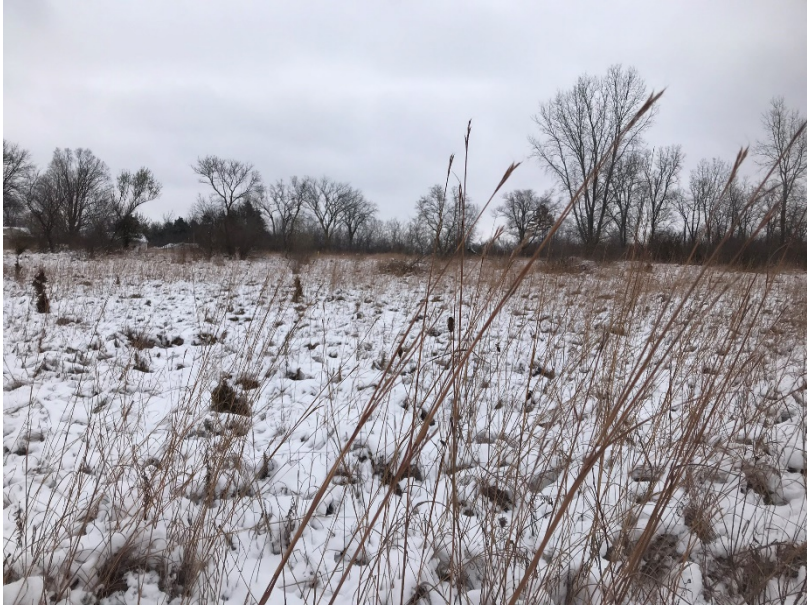
| <b>Photo No.</b><br>11 | <b>Date:</b><br>11/29/2018 | | |

| <b>Description</b><br><br>Representative view of upland area at edge of Wetland D.<br><br>Photo taken facing north.<br><br>Photo credit: A. Rodrian | | | |

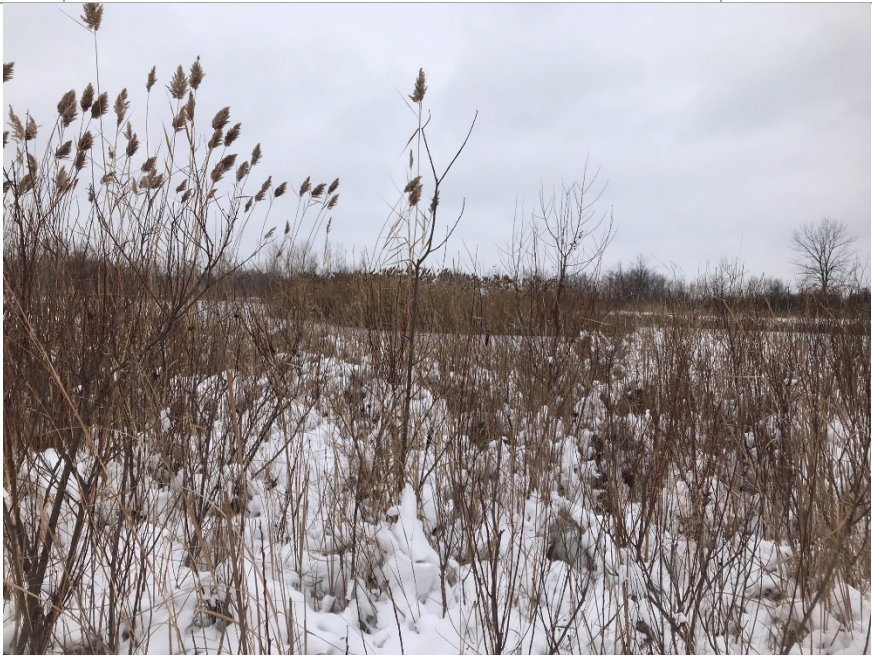
| <b>Photo No.</b><br>12 | <b>Date:</b><br>11/29/2018 | | |

| <b>Description</b><br><br>Representative view of Wetland D, Wetland E and POW G.<br><br>Photo taken facing south.<br><br>Photo credit: A. Rodrian | | | |

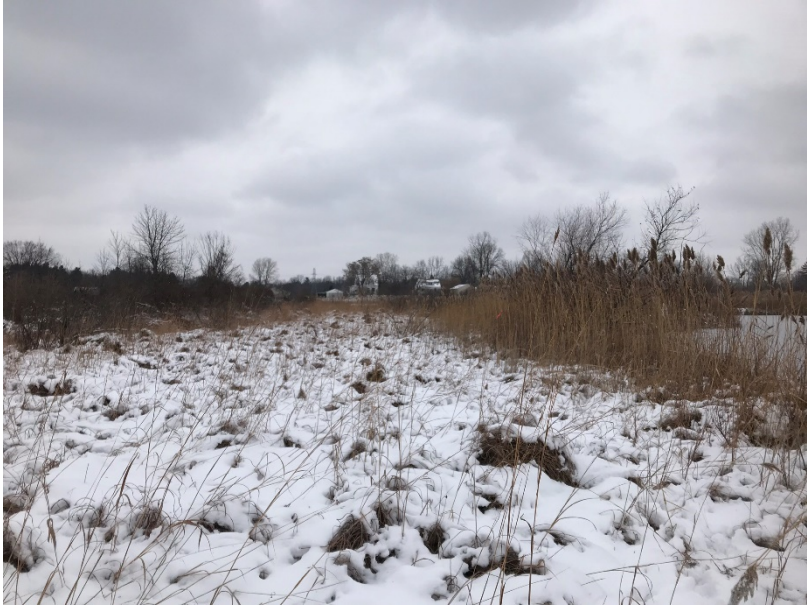
| <b>Photo No.</b><br>13 | <b>Date:</b><br>11/29/2018 | | |

| <b>Description</b><br><br>Representative view of upland area and constructed berm on western edge of Wetland D.<br><br>Photo taken facing north.<br><br>Photo credit: A. Rodrian | | | |

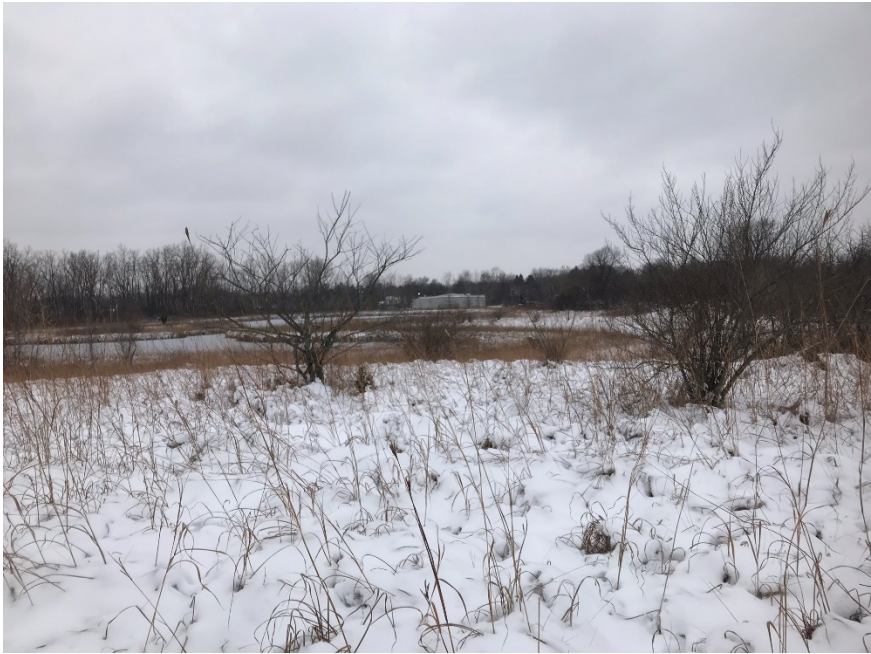
| <b>Photo No.</b><br>14 | <b>Date:</b><br>11/29/2018 | | |

| <b>Description</b><br><br>Representative view of Wetland C and POW A. Representative view of upland berm area between Wetlands C and Wetland D.<br><br>Photo taken facing west.<br><br>Photo credit: A. Rodrian | | | |
