RACER Pontiac North Campus – RW-08-14 Shutdown Request

Arcadis of Michigan, LLC (Arcadis) prepared this memorandum on behalf of Revitalizing Auto Communities Environmental Response (RACER) Trust for the Pontiac North Campus Site (Site) located in Pontiac, Michigan (**Figure 1**). The purpose of this memorandum is to request shutdown of RW-08-14 light non-aqueous phase liquid (LNAPL) recovery system operation activities based on the results of additional LNAPL transmissivity testing activities.

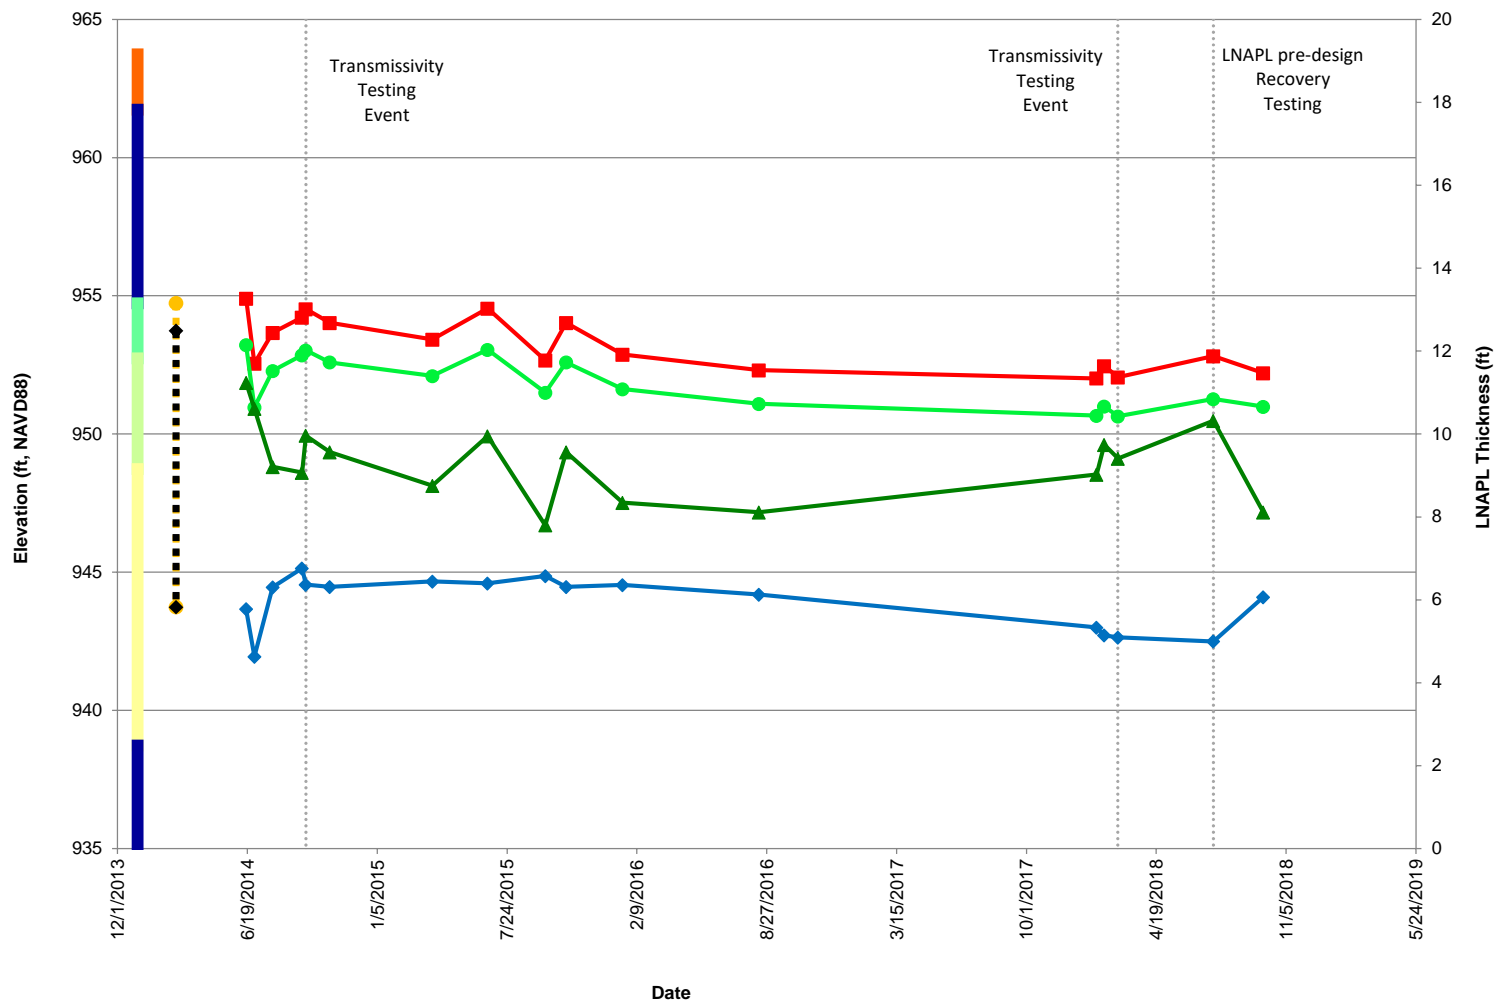
RACER - Pontiac North Campus Pontiac, Michigan	
SB-08-14 LNAPL HYDROGRAPH	
	FIGURE 1

- Air-NAPL Interface
- Potentiometric Surface (Corrected Groundwater Surface)
- ◆ NAPL-Water Interface
- Sand and Gravel
- Silty Sand
- Clay
- Fine Sand
- Medium Sand
- Filter Pack
- ◆ Screened Interval
- NAPL Thickness

Attachment 1 for hydrographs for original well SB-08-14 and recovery well RW-08-14 to show the relationship between fluid levels over time.

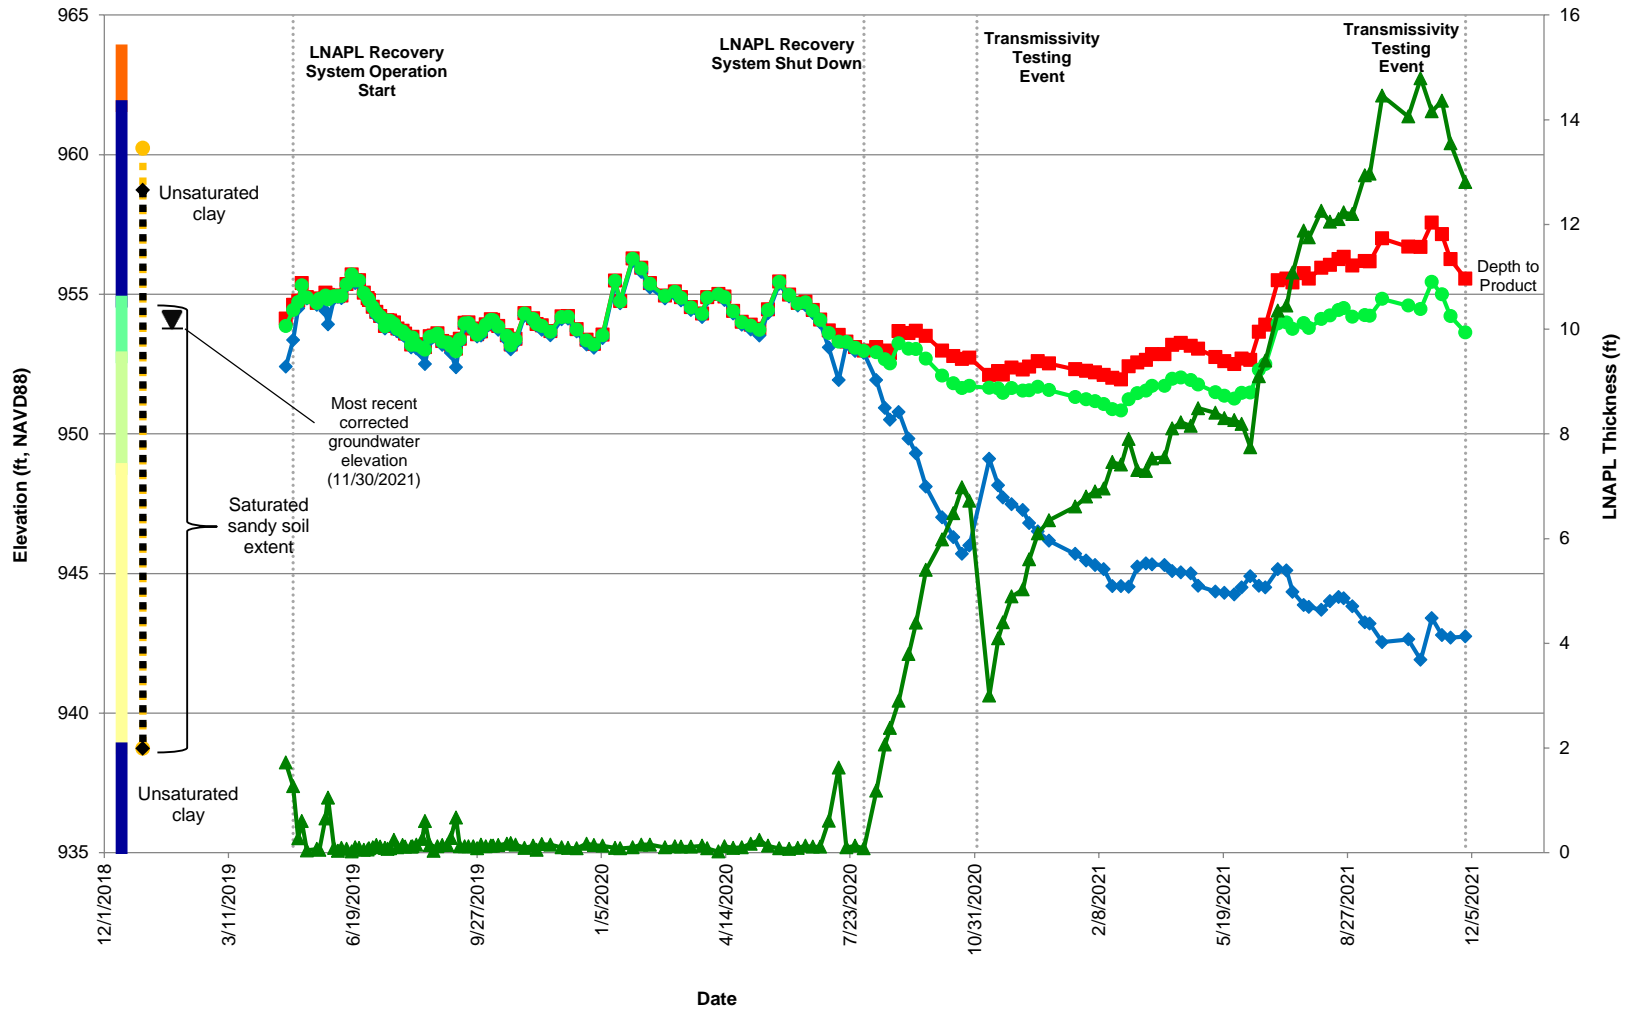
RACER - Pontiac North Campus Pontiac, Michigan	
RW-08-14 LNAPL HYDROGRAPH	
ARCADIS	FIGURE 2

Note: Fluid level elevations based on estimated top of casing elevation for original well SB-08-14.

Diagnostic properties of confined conditions are observed in wells where both the apparent LNAPL thickness in the wells increases as the air-LNAPL interface and the corrected groundwater potentiometric surface increase. This trend is best observed in RW-08-14 in 2021 after the skimming system had been shut down and the LNAPL interfaces were stabilizing following the transmissivity testing in 2020. The fluid level pattern over time appears to be consistent with a mobile LNAPL interval near 943 to 945 feet above mean sea level filling upward into the well. This interval was identified based on the observation that the LNAPL-water interface (blue line; **Figure 2 in Attachment 1**) remains relatively constant between this elevation range during mid to late 2021 when fluid levels were equilibrating. With fluctuating fluid levels over time and exaggerated LNAPL thickness, we are seeing a large smear zone vertically with thin, mobile LNAPL intervals within. This interpretation is further supported by intermittent laser-induced fluorescence (LIF) response with depth in adjacent borings (Cross-section B-B'; Appendix A to the Draft Corrective Actions Summary of Activities Report [Arcadis 2021b]).

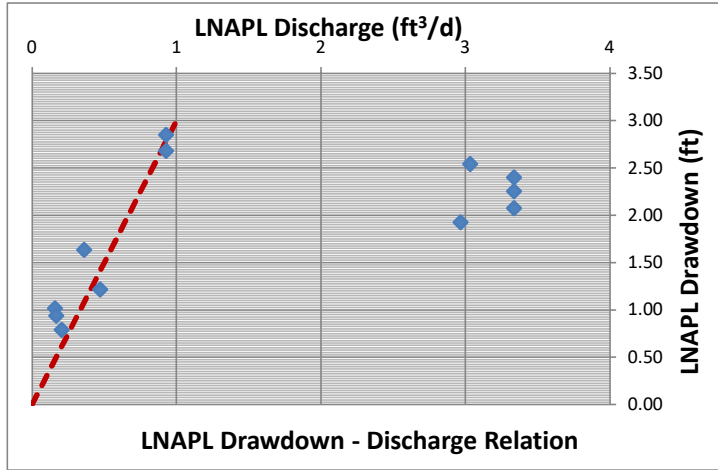
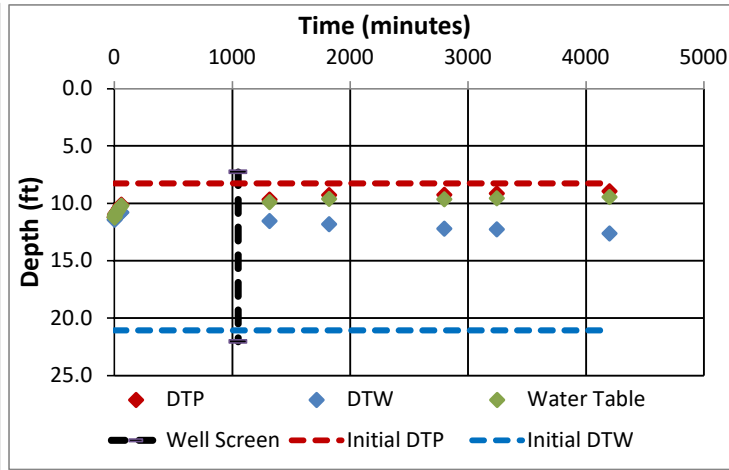
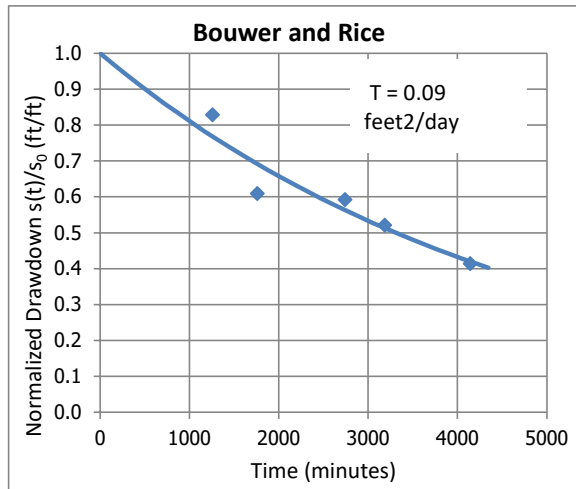
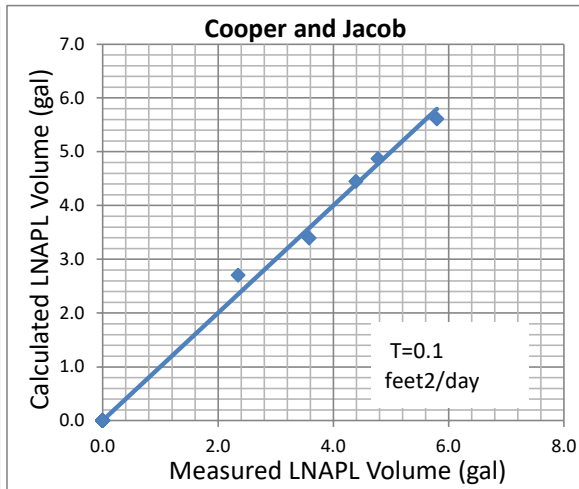
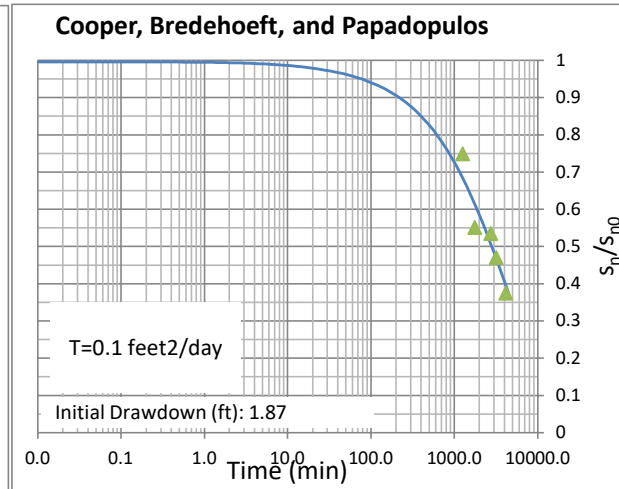
RW-08-14 Transmissivity Test Output Charts

Abbreviations:
 d = day
 DTP = depth to product
 DTW = depth to water
 ft = feet
 LNAPL = light non-aqueous phase liquid
 s = drawdown
 T = LNAPL transmissivity

Using a bailer, field staff evacuated LNAPL from the well, a total of approximately 23 gallons, and monitored LNAPL and water depths periodically over the next three days. LNAPL thickness recovered to 3.67 feet by the end of the monitoring period. The total LNAPL recovery was approximately 29% over almost 3 days. Transmissivity was estimated in the range of 0.09-0.1 ft²/day depending on the analytical drawdown solution with an average of 0.1 ft²/day; refer to the Transmissivity Test Output Charts included in **Attachment 3**. This transmissivity falls below the EGLE lower limit LNAPL transmissivity value of 0.5 ft²/day and verifies previous results indicating that removal activities continue to remain not feasible at this location. A summary of the November 2021 data is presented in **Table 2**.
