CERTIFICATION OF LAGOON CLOSURE REPORT

**GENERAL MOTORS
HARRISON RADIATOR DIVISION FACILITY
MORAINES, OHIO**

**AUGUST 10, 2001
REF. NO. 12611 (5)**

**Prepared by:
Conestoga-Rovers
& Associates**

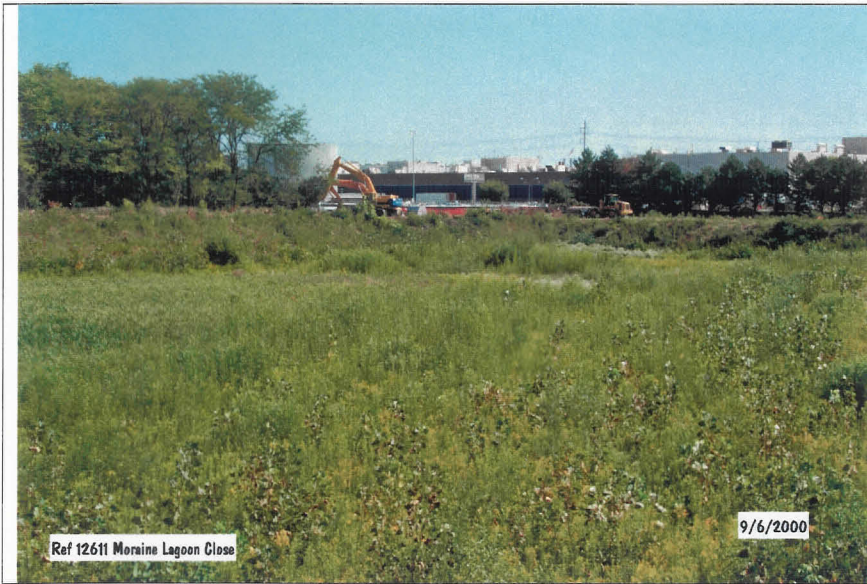
Photograph No. 1
Initial Site Conditions - South Lagoon - Secondary Basin
Looking northeast prior to grubbing.

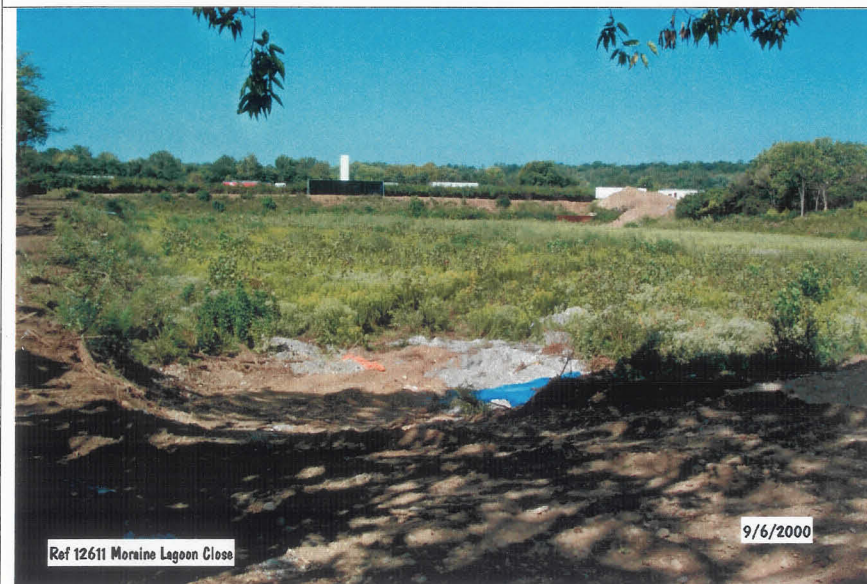
Photograph No. 2
Initial Site Conditions - South Lagoon - Secondary Basin
Looking northwest prior to grubbing.

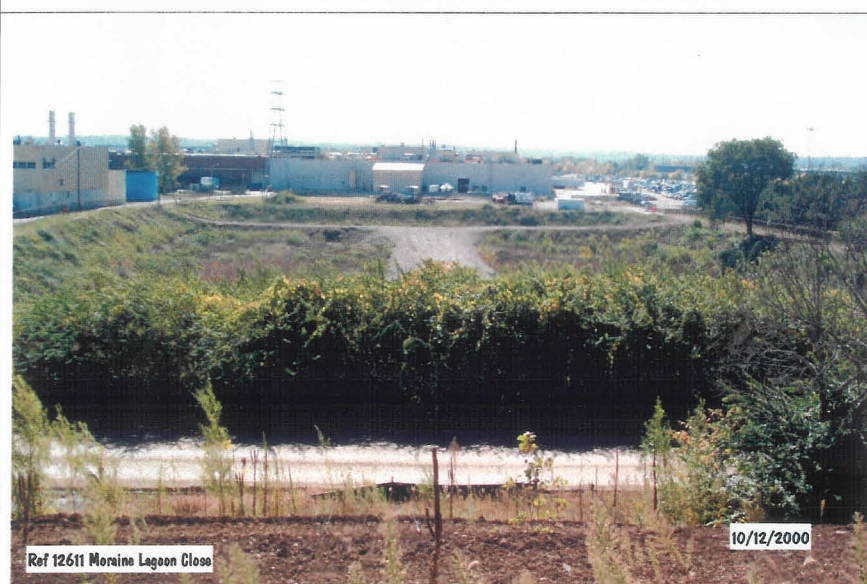
Photograph No. 3
Initial Site Conditions - North Lagoon
Looking south from the top of soil stockpile.

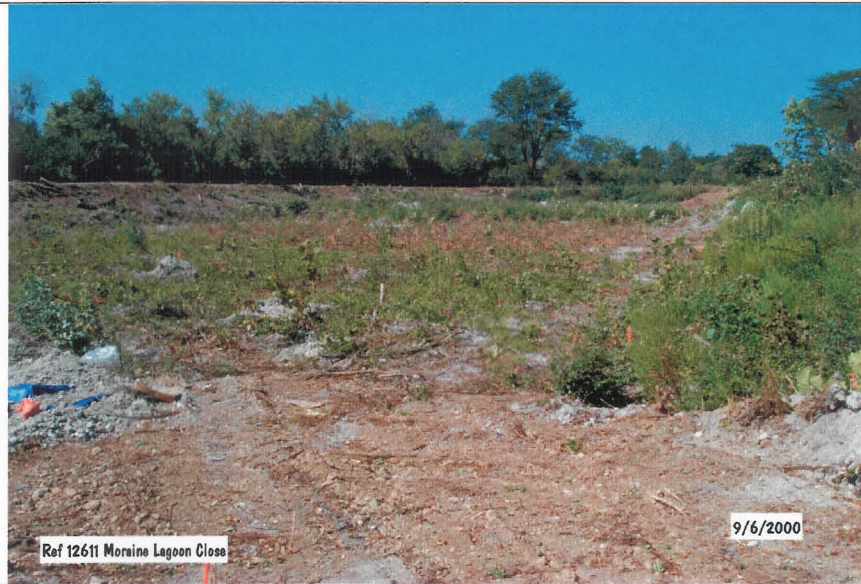
Photograph No. 4

South Lagoon – Sludge Drying Basin After Excavation

Looking southwest after leveling.

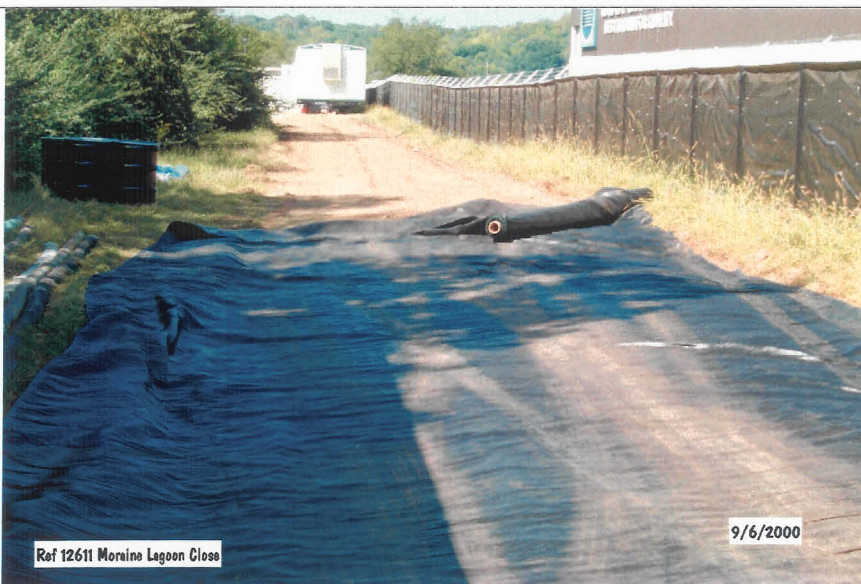
Photograph No. 6

South Lagoon – Upgrading Roads

Installing fabric to upgrade existing access roads.

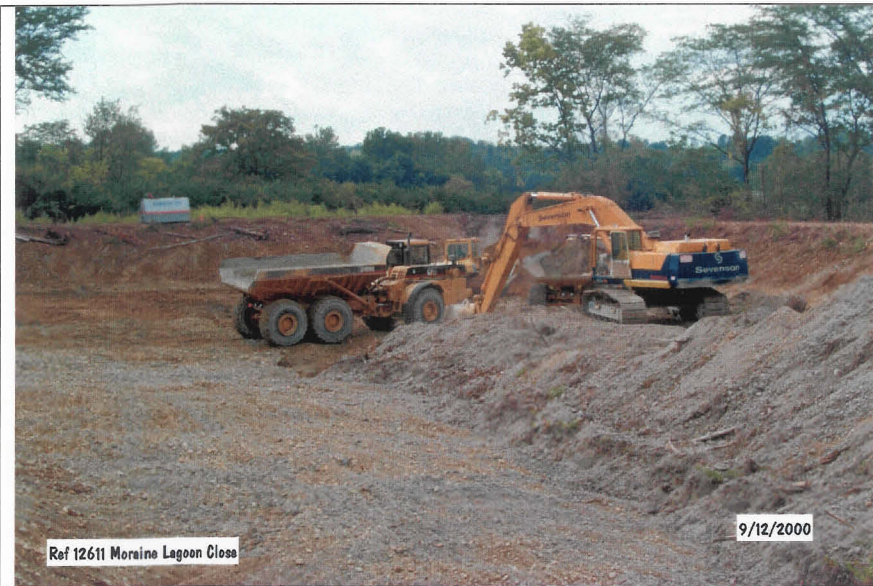
Photograph No. 7
 Sludge Transfer - South Lagoon - Sludge Drying Basin

Loading dry sludge into off-road truck for transfer to secondary basin of South Lagoon.

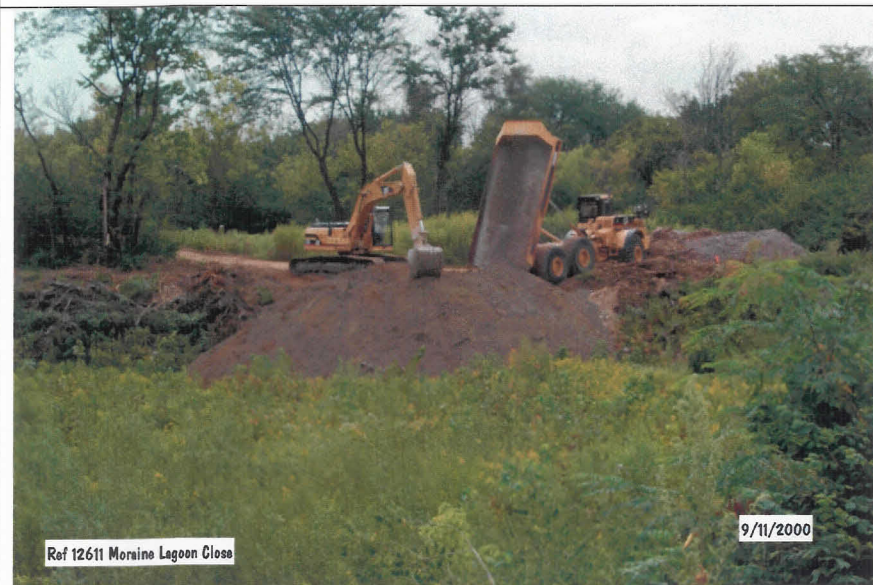
Photograph No. 8
 Sludge Transfer - South Lagoon - Secondary Basin.

Transferring of dry sludge from sludge drying basin to southwest corner of secondary basin of South Lagoon. Looking south from northwest corner.

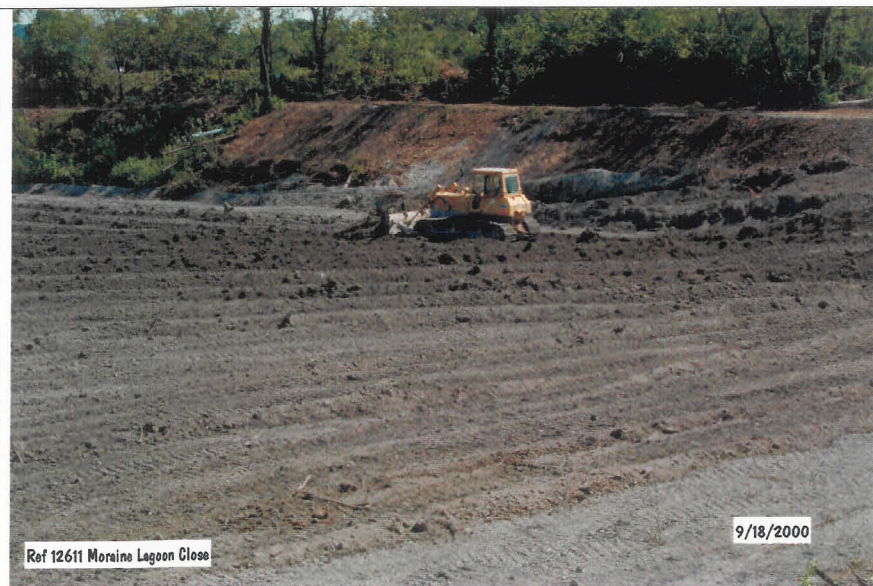
Photograph No. 9
 Sludge Transfer - South Lagoon - Secondary Basin

Spreading transferred dry sludge overtop of existing sludge. Looking southeast from west bank.

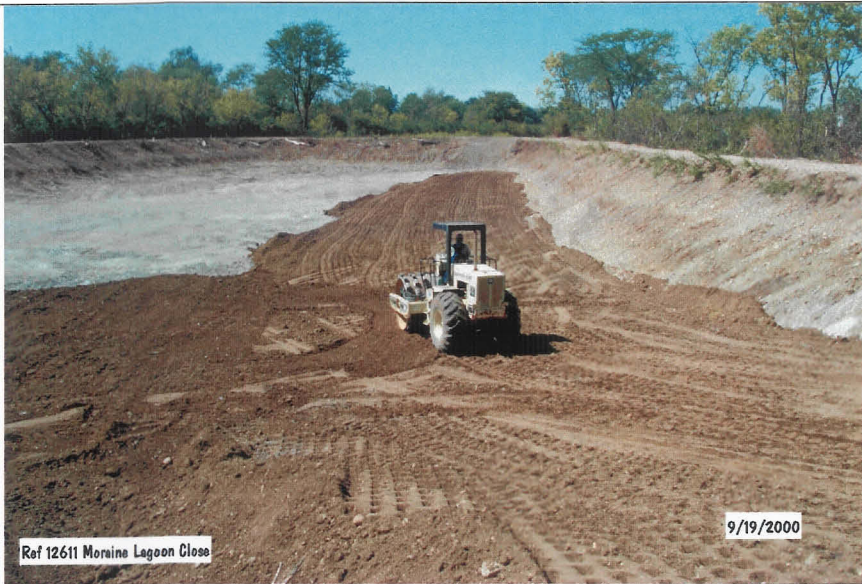
Photograph No. 10

Backfilling - South Lagoon -
Sludge Drying Basin

Placing first lift of soil in
emptied basin. Looking west
from northeast corner.

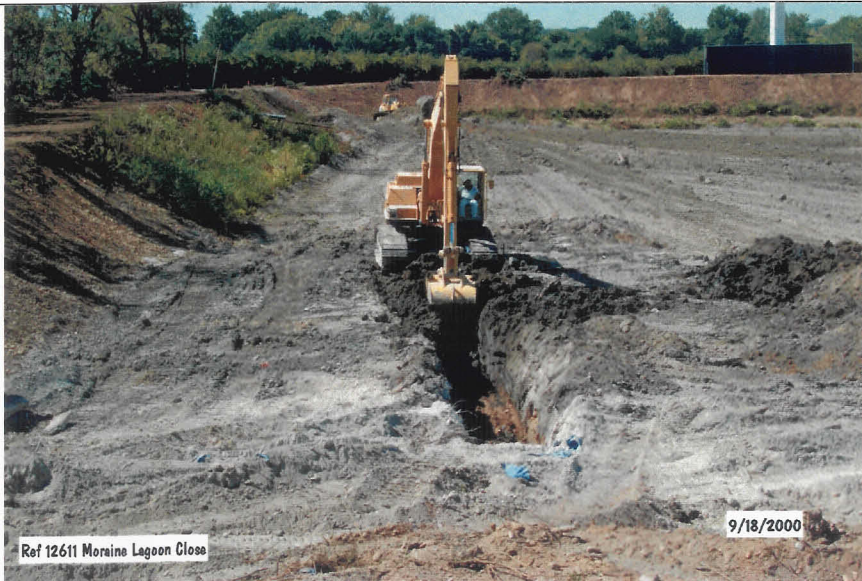
Photograph No. 11

Solidifying Sludge - South
Lagoon - Secondary Basin

Preparing trench for visqueen
pocket and CKD delivery.
Looking west from southeast
corner.

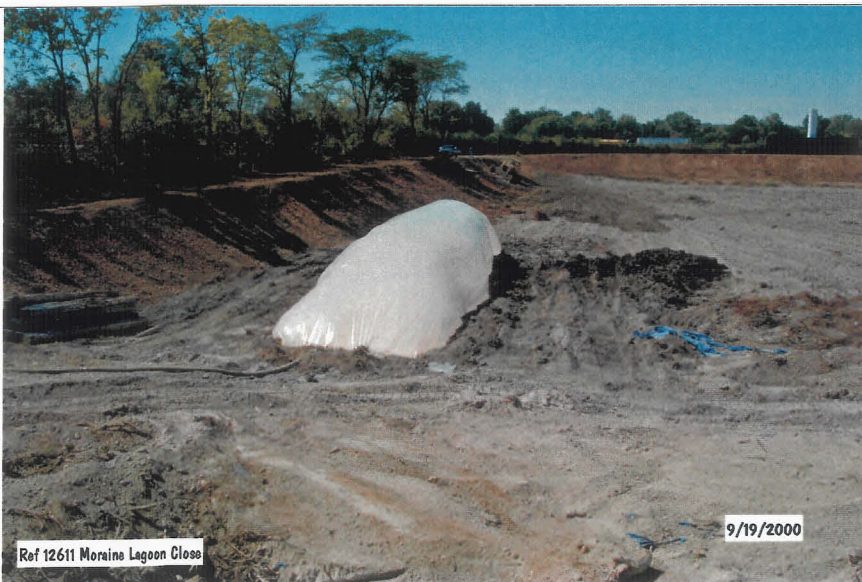
Photograph No. 12

Solidifying Sludge - South
Lagoon - Secondary Basin

Unloading CKD into visqueen
pocket. Looking west from
southeast corner.

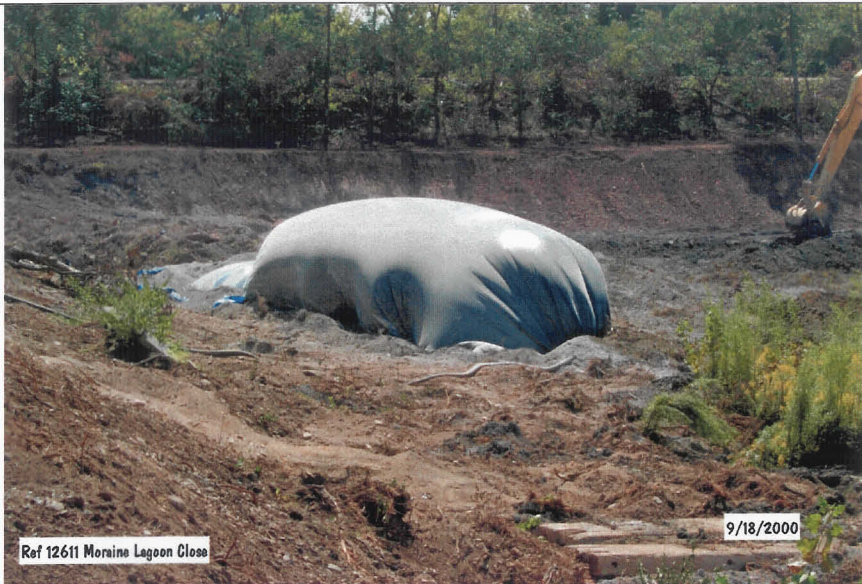
Photograph No. 13
Solidifying Sludge - South Lagoon - Secondary Basin
Unloading CKD into visqueen pocket. Looking at southeast corner from east bank.

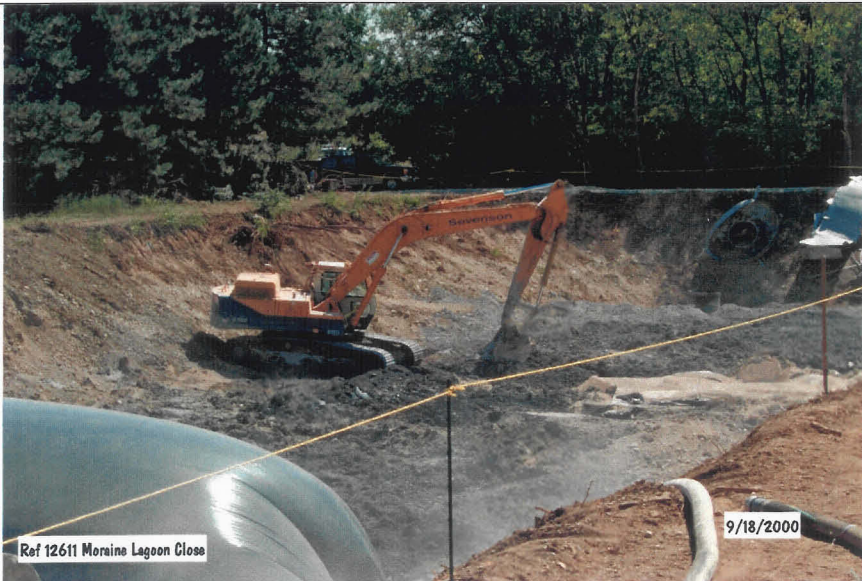
Photograph No. 14
Solidifying Sludge - South Lagoon - Primary Basin
Mixing sludge with CKD. Looking southeast from west bank.

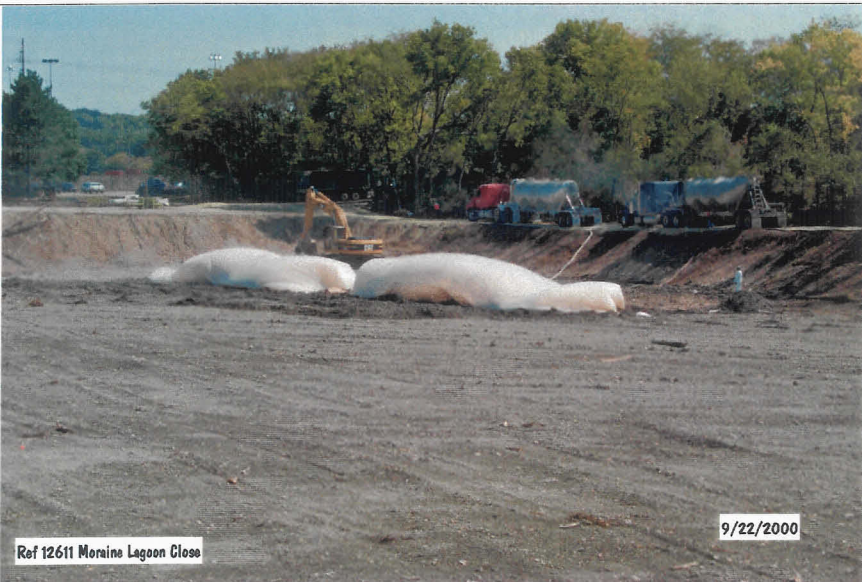
Photograph No. 15
Solidifying Sludge - South Lagoon - Secondary Basin
Unloading CKD into visqueen pockets. Looking southeast from west bank.

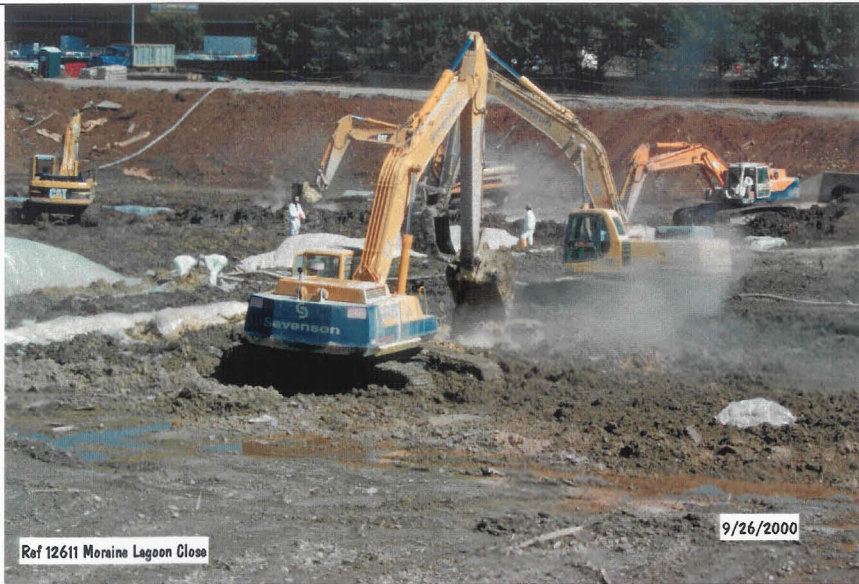
Photograph No. 16
 Solidifying Sludge - South Lagoon - Secondary Basin

Mixing soil and CKD with sludge. Looking northeast from south bank.

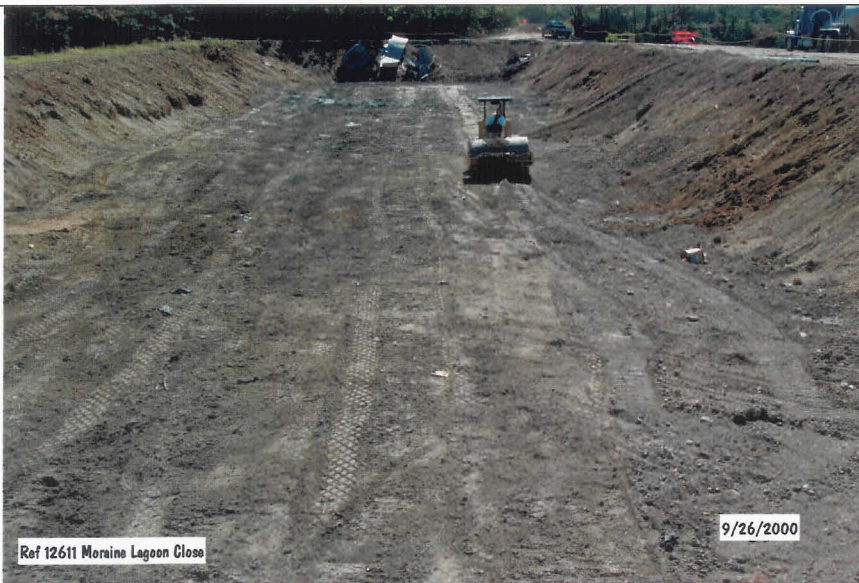
Photograph No. 17
 Solidifying Sludge - South Lagoon - Primary Basin

Proof rolling solidified sludge prior to backfilling. Looking south from north bank.

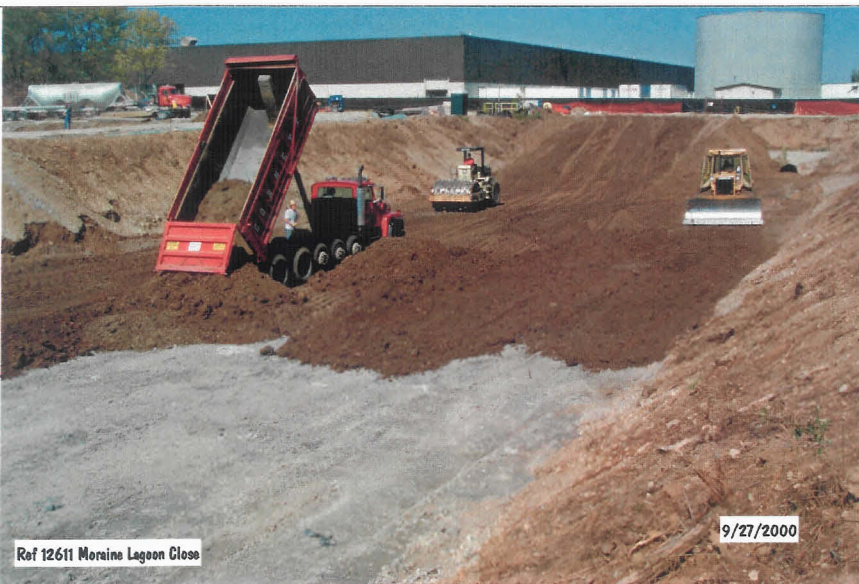
Photograph No. 18
 Solidifying Sludge - South Lagoon - Primary Basin

Placing first lift of soil on solidified sludge. Looking northwest from southeast corner.

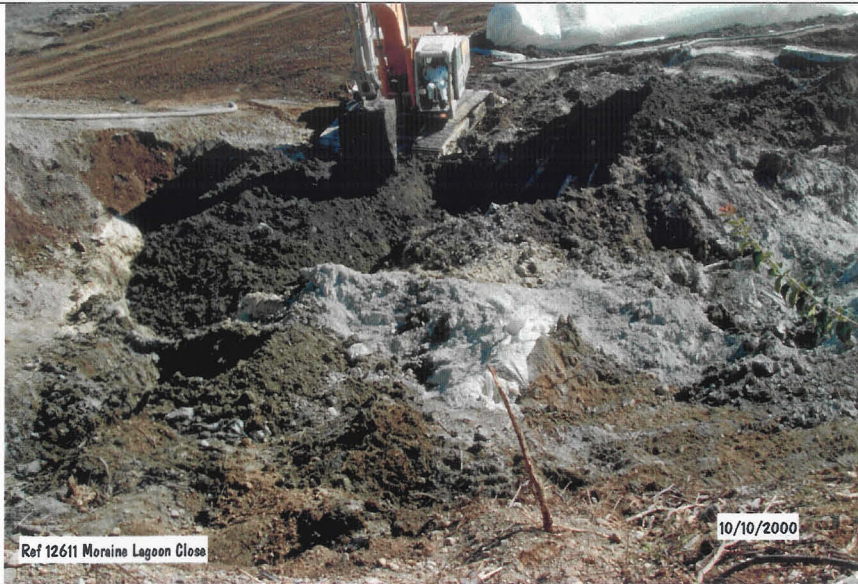
Photograph No. 19
Solidifying Sludge - South Lagoon - Secondary Basin

Mixing soil and CKD with sludge. Looking southeast from north west corner.

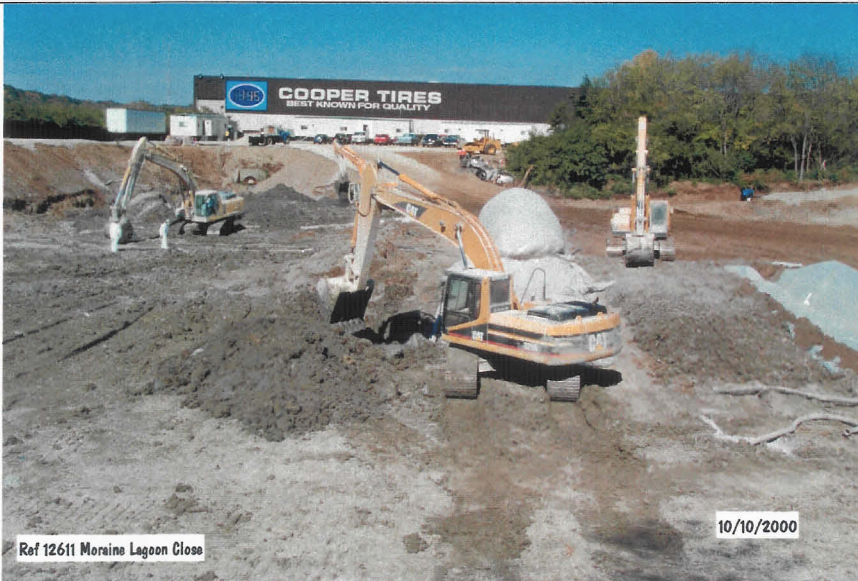
Photograph No. 20
Solidifying Sludge - South Lagoon - Secondary Basin

Mixing soil and CKD with sludge. Looking northwest from south bank.

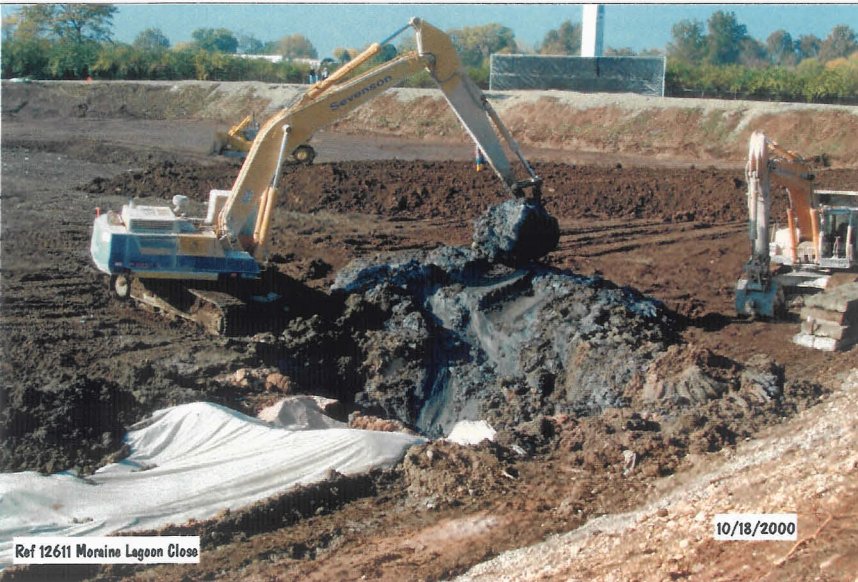
Photograph No. 21
Solidifying Sludge - South Lagoon - Secondary Basin

Mixing soil and Portland cement with sludge. Looking southwest from north bank.

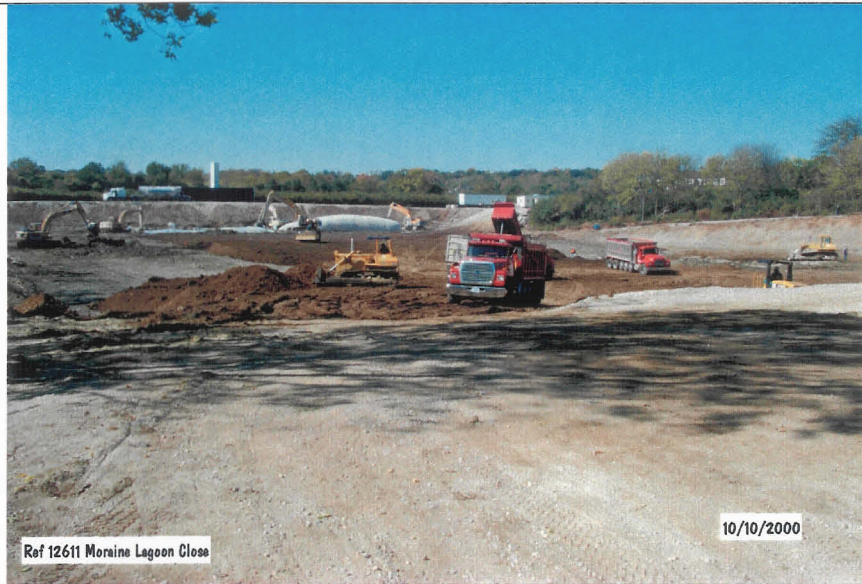
Photograph No. 22

Backfilling - South Lagoon - Secondary Basin

Backfilling operation in foreground. Mixing soil and CKD with sludge in background. Looking northwest from southeast corner.

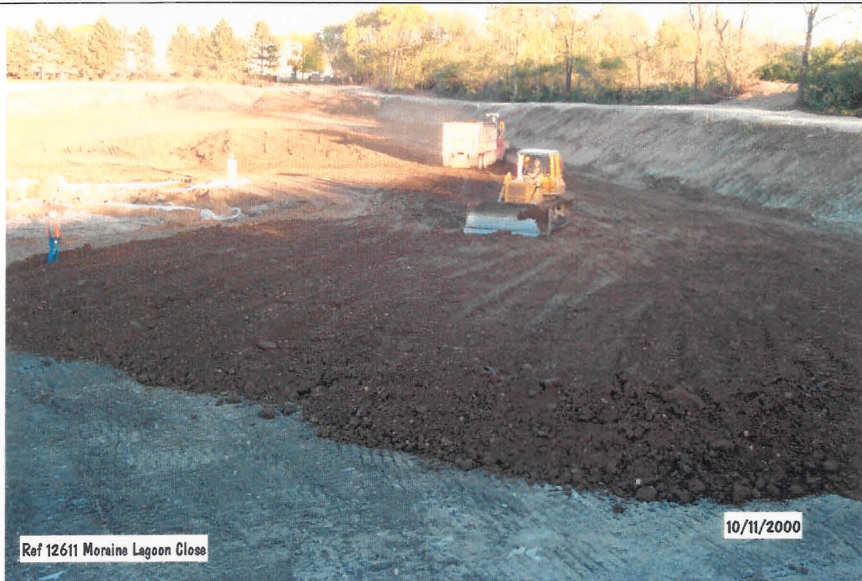
Photograph No. 23

Backfilling - South Lagoon - Secondary Basin

Backfilling soil on top of solidified sludge. Looking southeast from west bank.

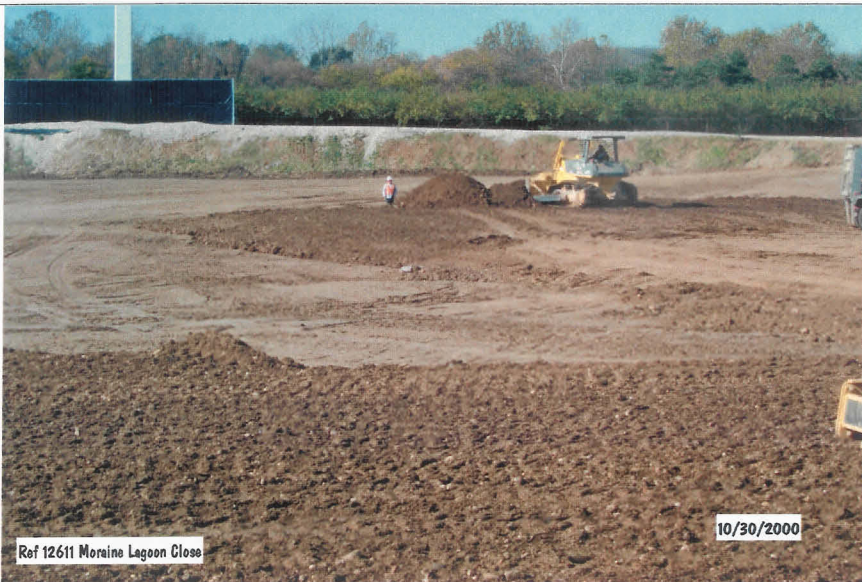
Photograph No. 24

Backfilling - South Lagoon - Secondary Basin

Backfilling operation. Looking west from east bank.

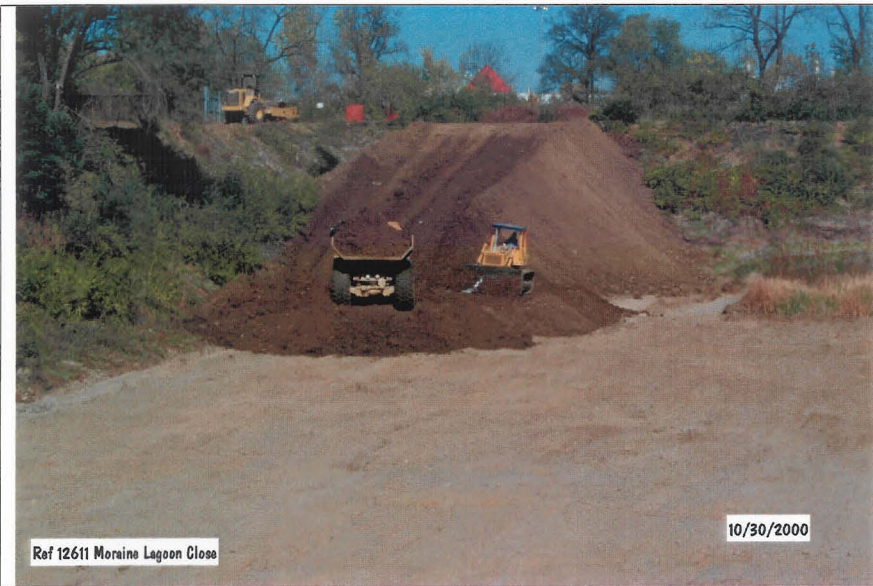
Photograph No. 25

Backfilling - North Lagoon - Secondary Basin

Backfilling west side after sludge was transferred to east side. Looking north from south bank.

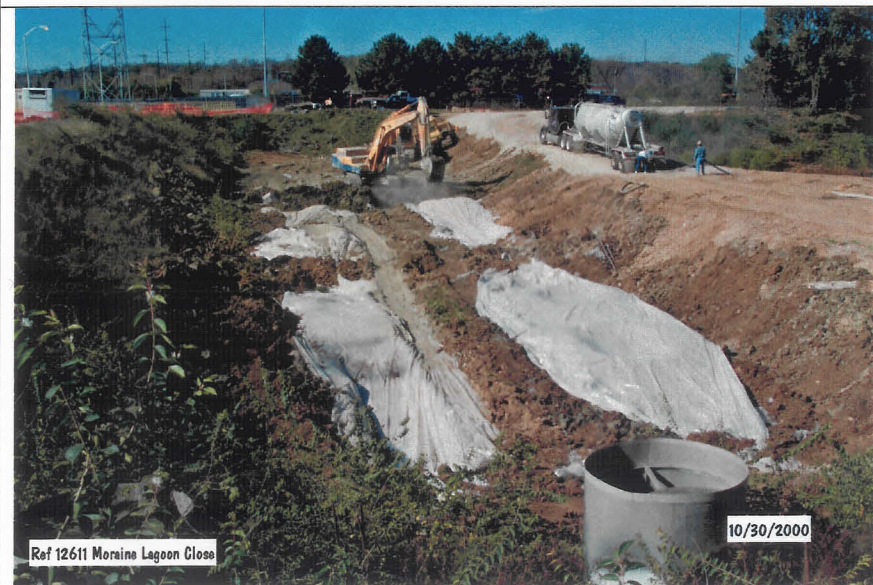
Photograph No. 26

Solidifying Sludge - North Lagoon - Primary Basin

Mixing soil and Portland cement with sludge. Looking west from east bank.

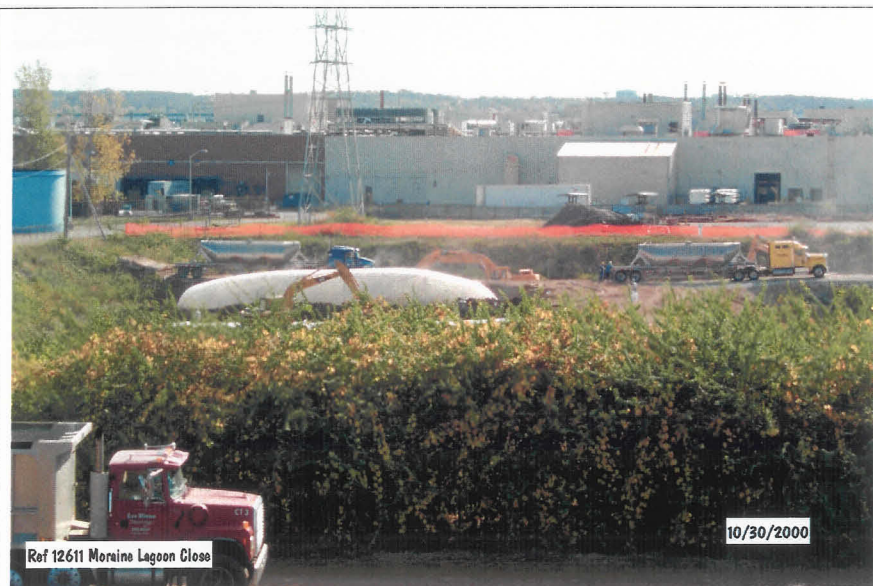
Photograph No. 27

Solidifying Sludge - North Lagoon - Primary Basin

Mixing soil and Portland cement with sludge. Looking south from north stockpile.

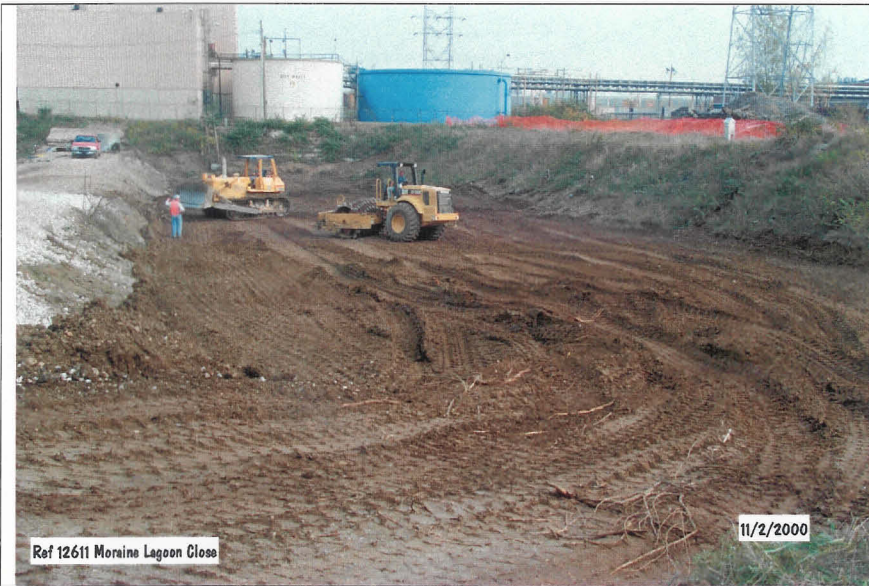
Photograph No. 28

Backfilling - North Lagoon - Primary Basin

Backfilling operation.
Looking east from west bank.

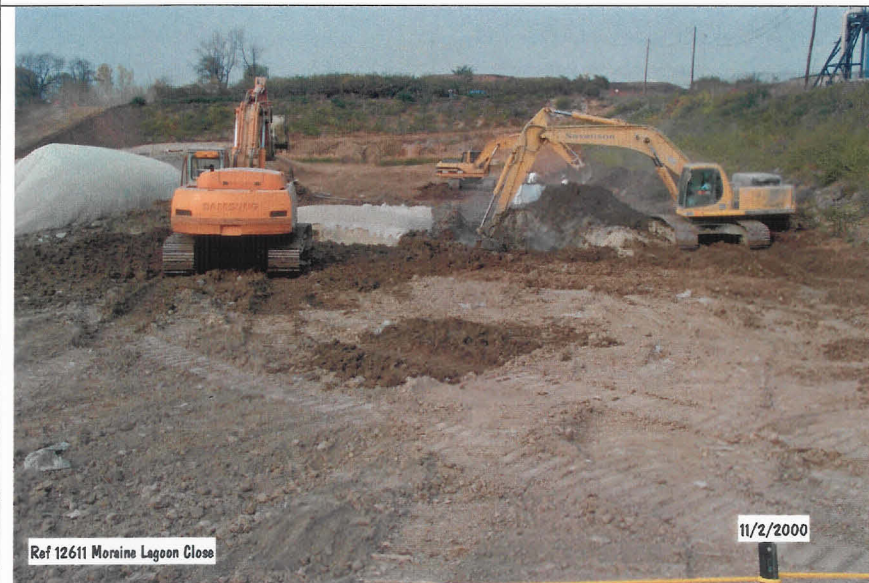
Photograph No. 29

Solidifying Sludge - North Lagoon - Secondary Basin

Mixing soil and Portland cement with sludge. Looking north from south bank.

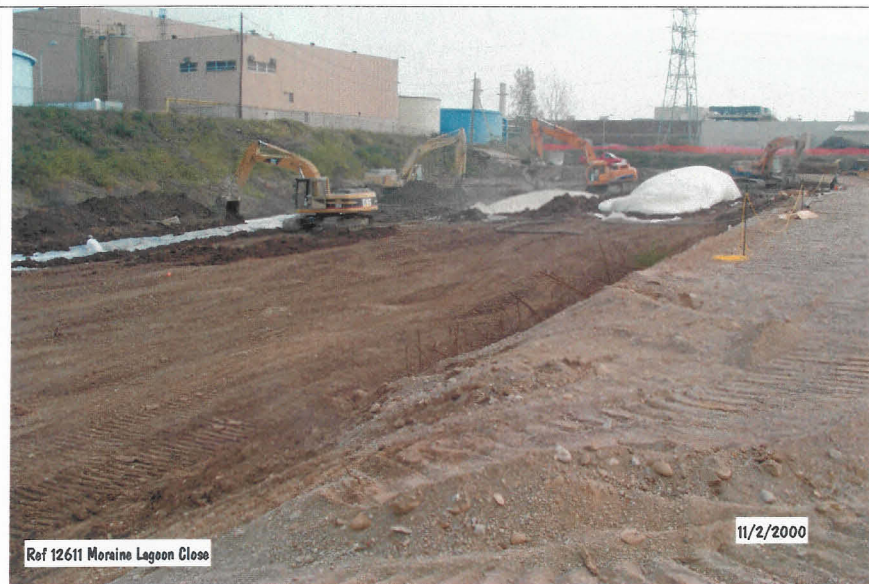
Photograph No. 30

Solidifying Sludge - North Lagoon - Secondary Basin

Mixing soil and Portland cement with sludge. Looking southeast from center berm.

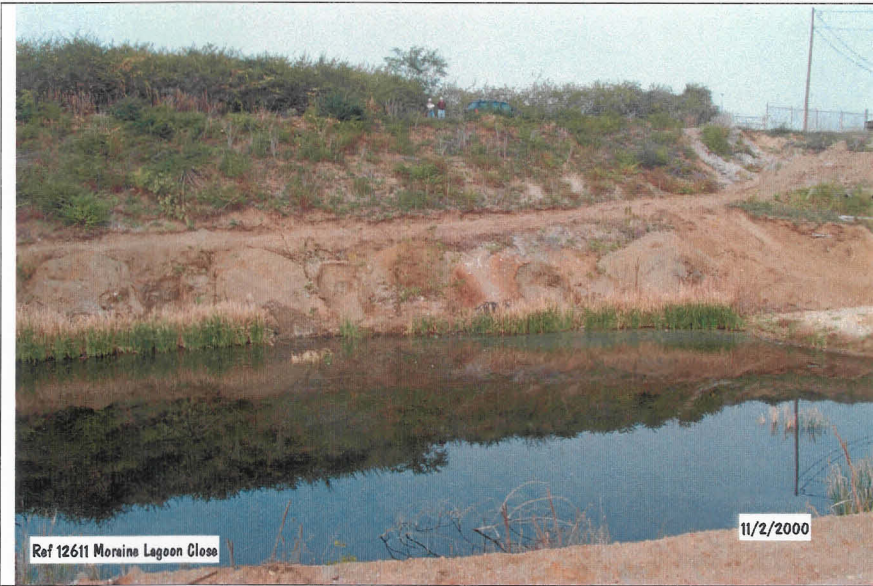
Photograph No. 31
 Poned Area - North Lagoon -
 Secondary Basin

Poned area at north end.
 Looking north from center
 berm.

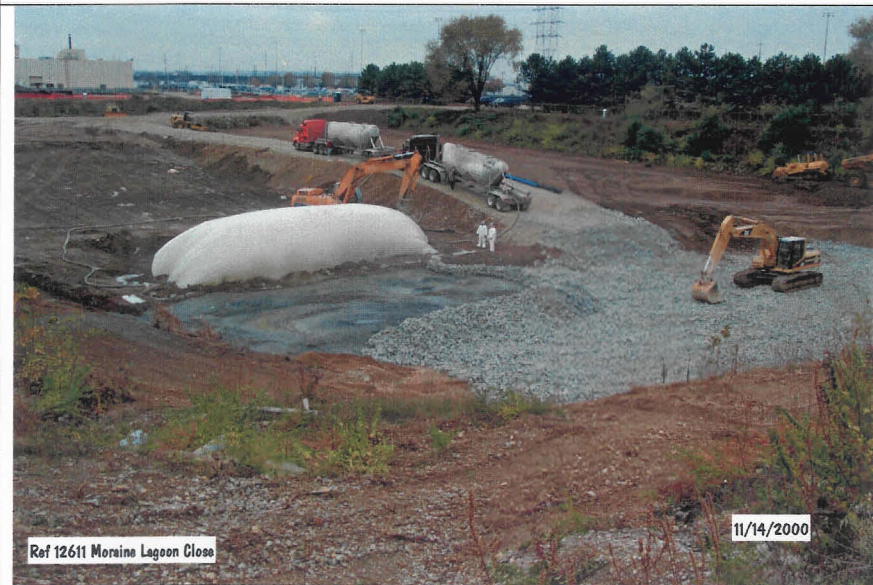
Photograph No. 32
 Solidifying Sludge - North
 Lagoon – Secondary Basin

Unloading Portland cement
 into visqueen pocket after
 sludge has been displaced
 using rip rap rock. Looking
 southwest from northeast
 bank.

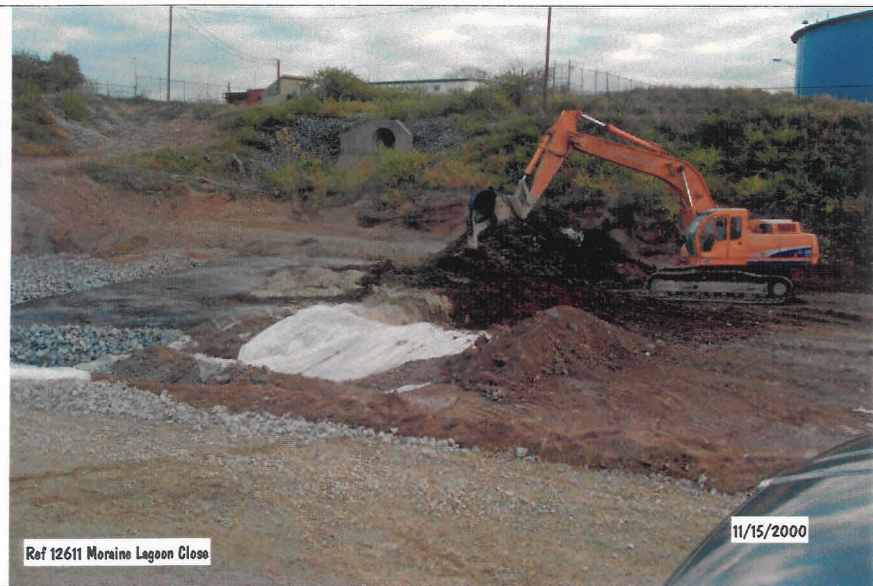
Photograph No. 33
 Solidifying Sludge - North
 Lagoon – Secondary Basin

Mixing Portland cement with
 sludge. Looking northeast
 from center berm.

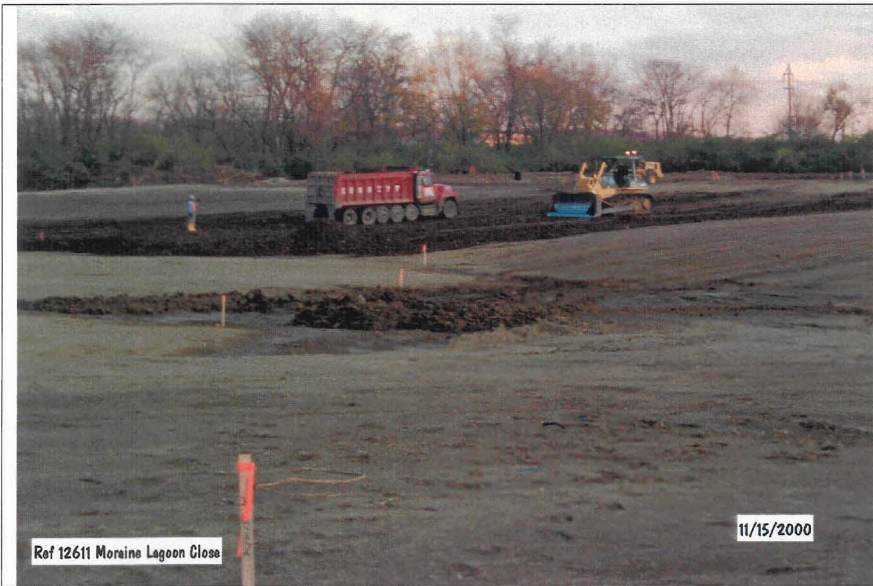
Photograph No. 34

Backfilling - South Lagoon -
Secondary Basin

Backfilling operation.
Looking southeast from north
west corner.

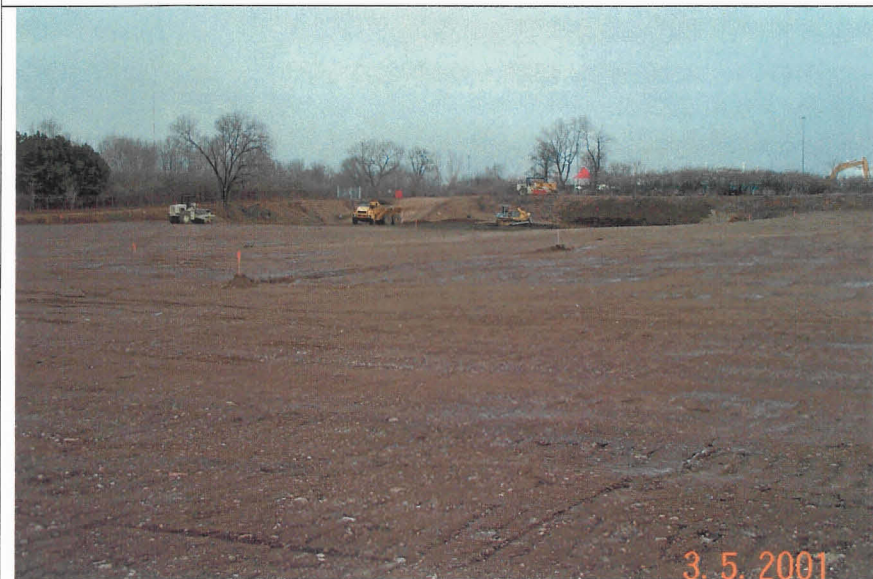
Photograph No. 35

Backfilling - North Lagoon -
Secondary Basin

Backfilling operation.
Looking north from south
bank.

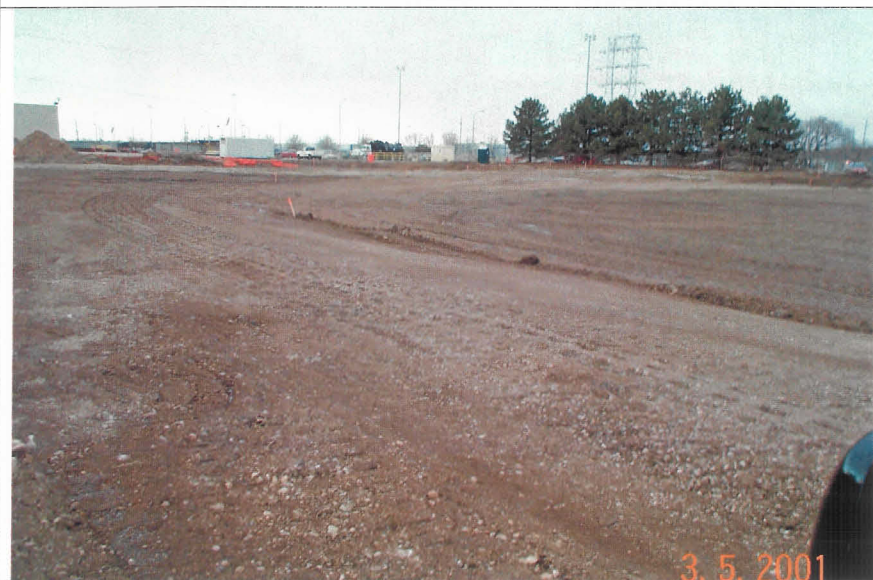
Photograph No. 36

Backfilling - North Lagoon -
Secondary Basin

Backfilled to subgrade.
Looking southwest from north
end.

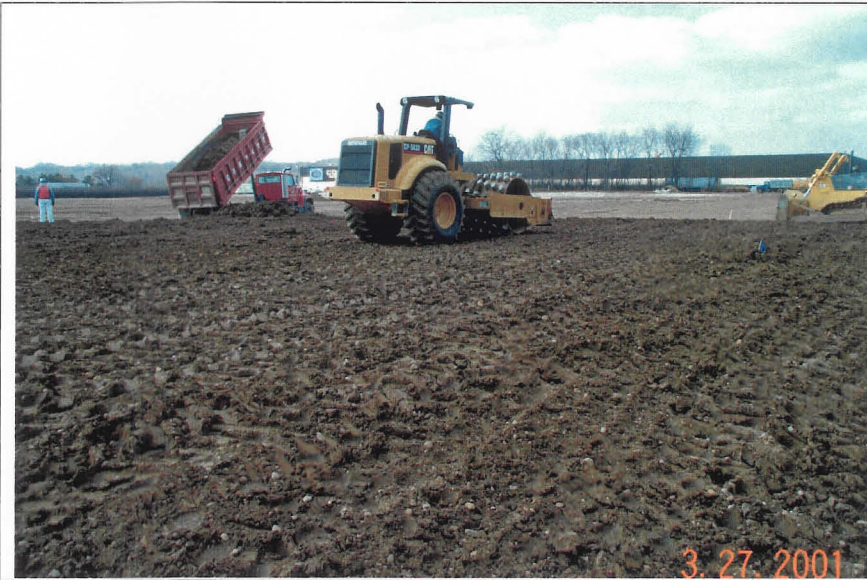
Photograph No. 37

Installing Cover - South Lagoon - Secondary Basin

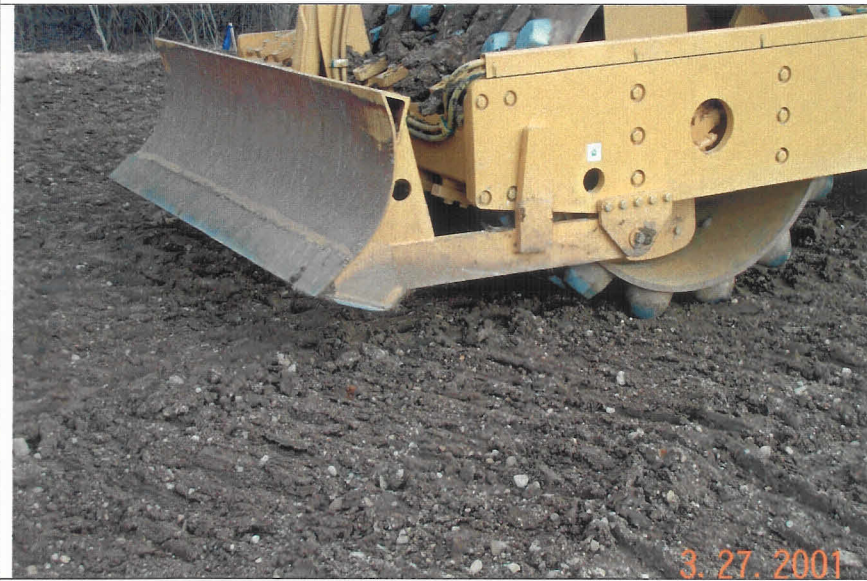
Installation of clay cover. Looking north from southeast corner.

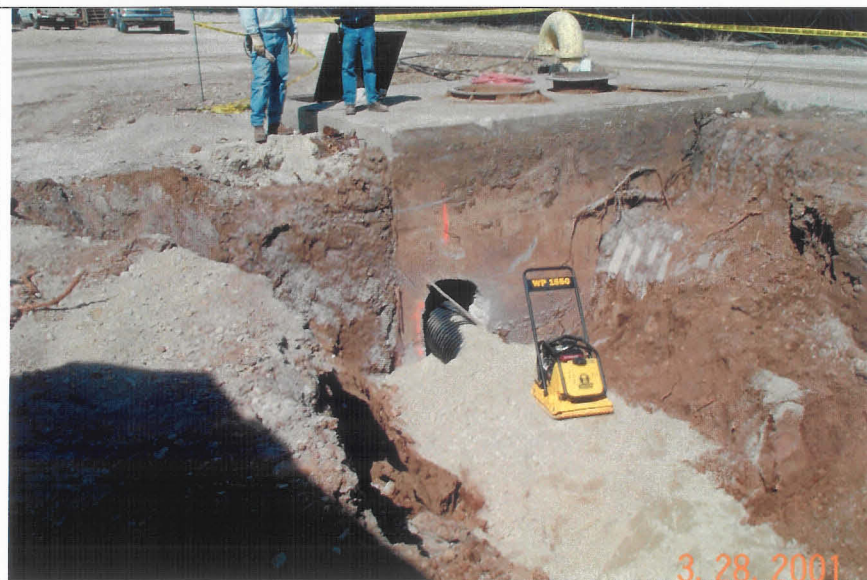
Photograph No. 38

Installing Cover - South Lagoon - Secondary Basin

Installation of clay cover. Southeast corner.

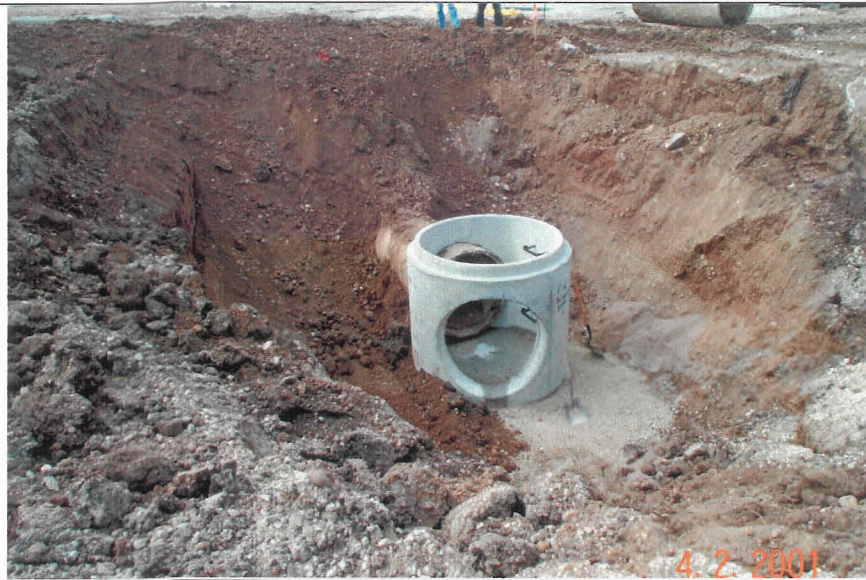
Photograph No. 39

Drainage Pipe Tie-in - South Lagoon

New drainage pipe tie in to existing concrete junction chamber. Northeast corner of the Site. Looking at east face of junction chamber.

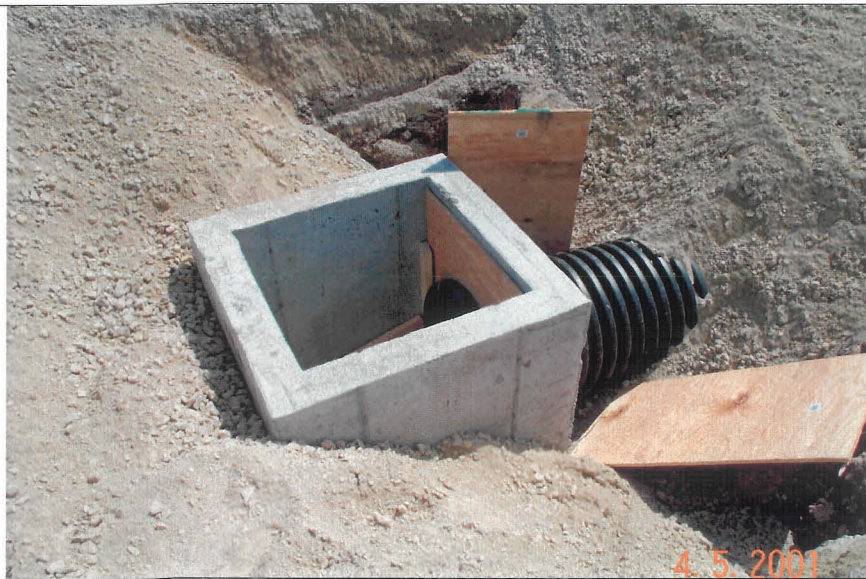
Photograph No. 40

Manhole - North Lagoon

New transition manhole between yet to be installed new drain pipe and existing previously abandoned concrete drain line. Looking southwest.

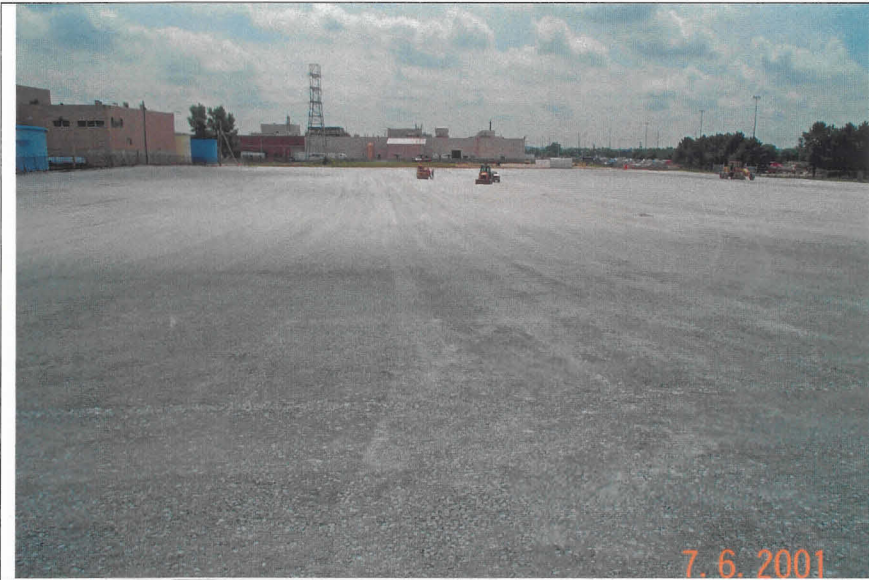
Photograph No. 42

Backfilling - North Lagoon

Backfilled to subgrade. Base sections for new catchbasins are installed, as is connecting drain pipe. Looking south from north end.

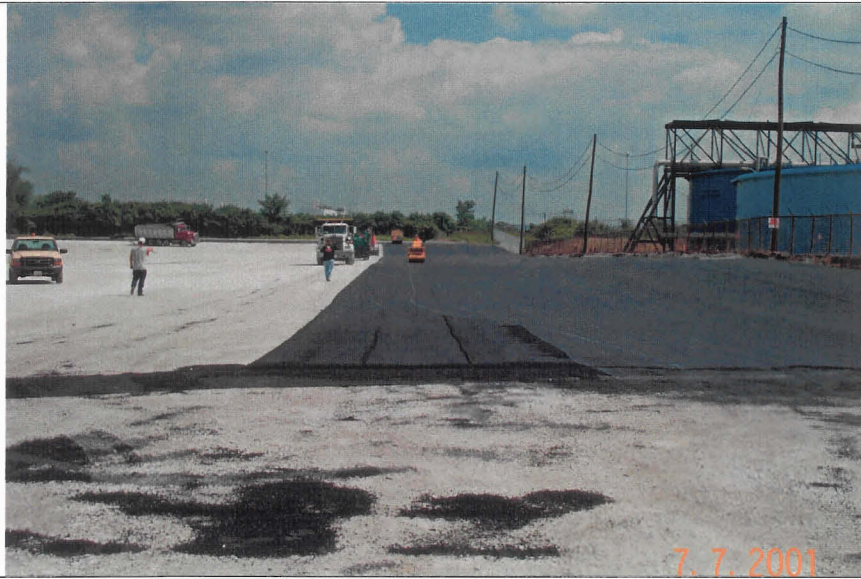
Photograph No. 43
Installing Cover - North Lagoon
Prepared sub base prior to installation of asphalt.
Looking south from north end.
