CERTIFICATION OF LAGOON CLOSURE REPORT

**GENERAL MOTORS
HARRISON RADIATOR DIVISION FACILITY
MORAINES, OHIO**

**AUGUST 10, 2001
REF. NO. 12611 (5)**

**Prepared by:
Conestoga-Rovers
& Associates**

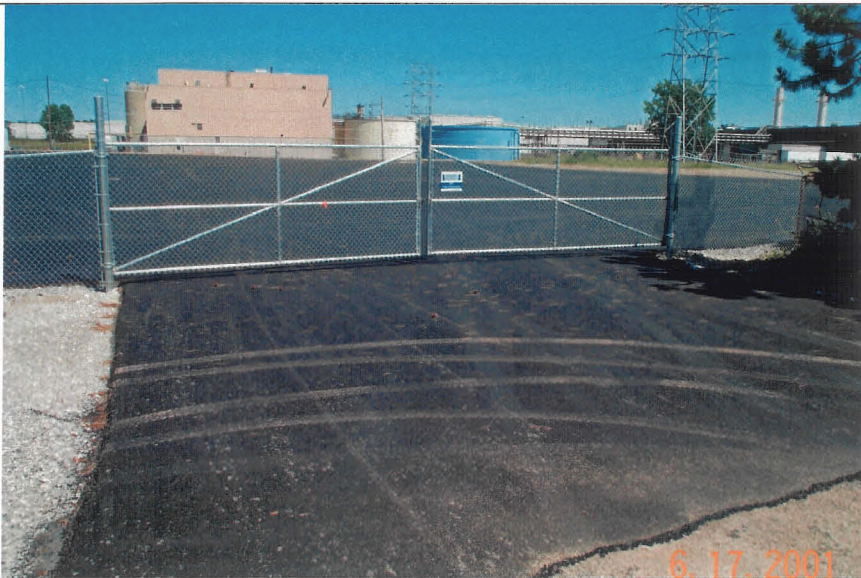
Photograph No. 44
Installing Cover - North Lagoon
Placement of initial lift of asphalt pavement on prepared sub base. Looking north along east side.
