RE: *Quarterly Status Report –April 2014 – June 2014*
Coldwater Road Landfill
1245 East Coldwater Road, Flint, MI
MID 005 356 860

In accordance with requirements of the approved Post-Closure Care Plan, we are providing you with this Quarterly Status Report for the second quarter 2014.

**2ND QUARTER 2014
BURROW LOCATION
MAP**

COLDWATER RD LANDFILL – ANIMAL BURROW PHOTO LOG

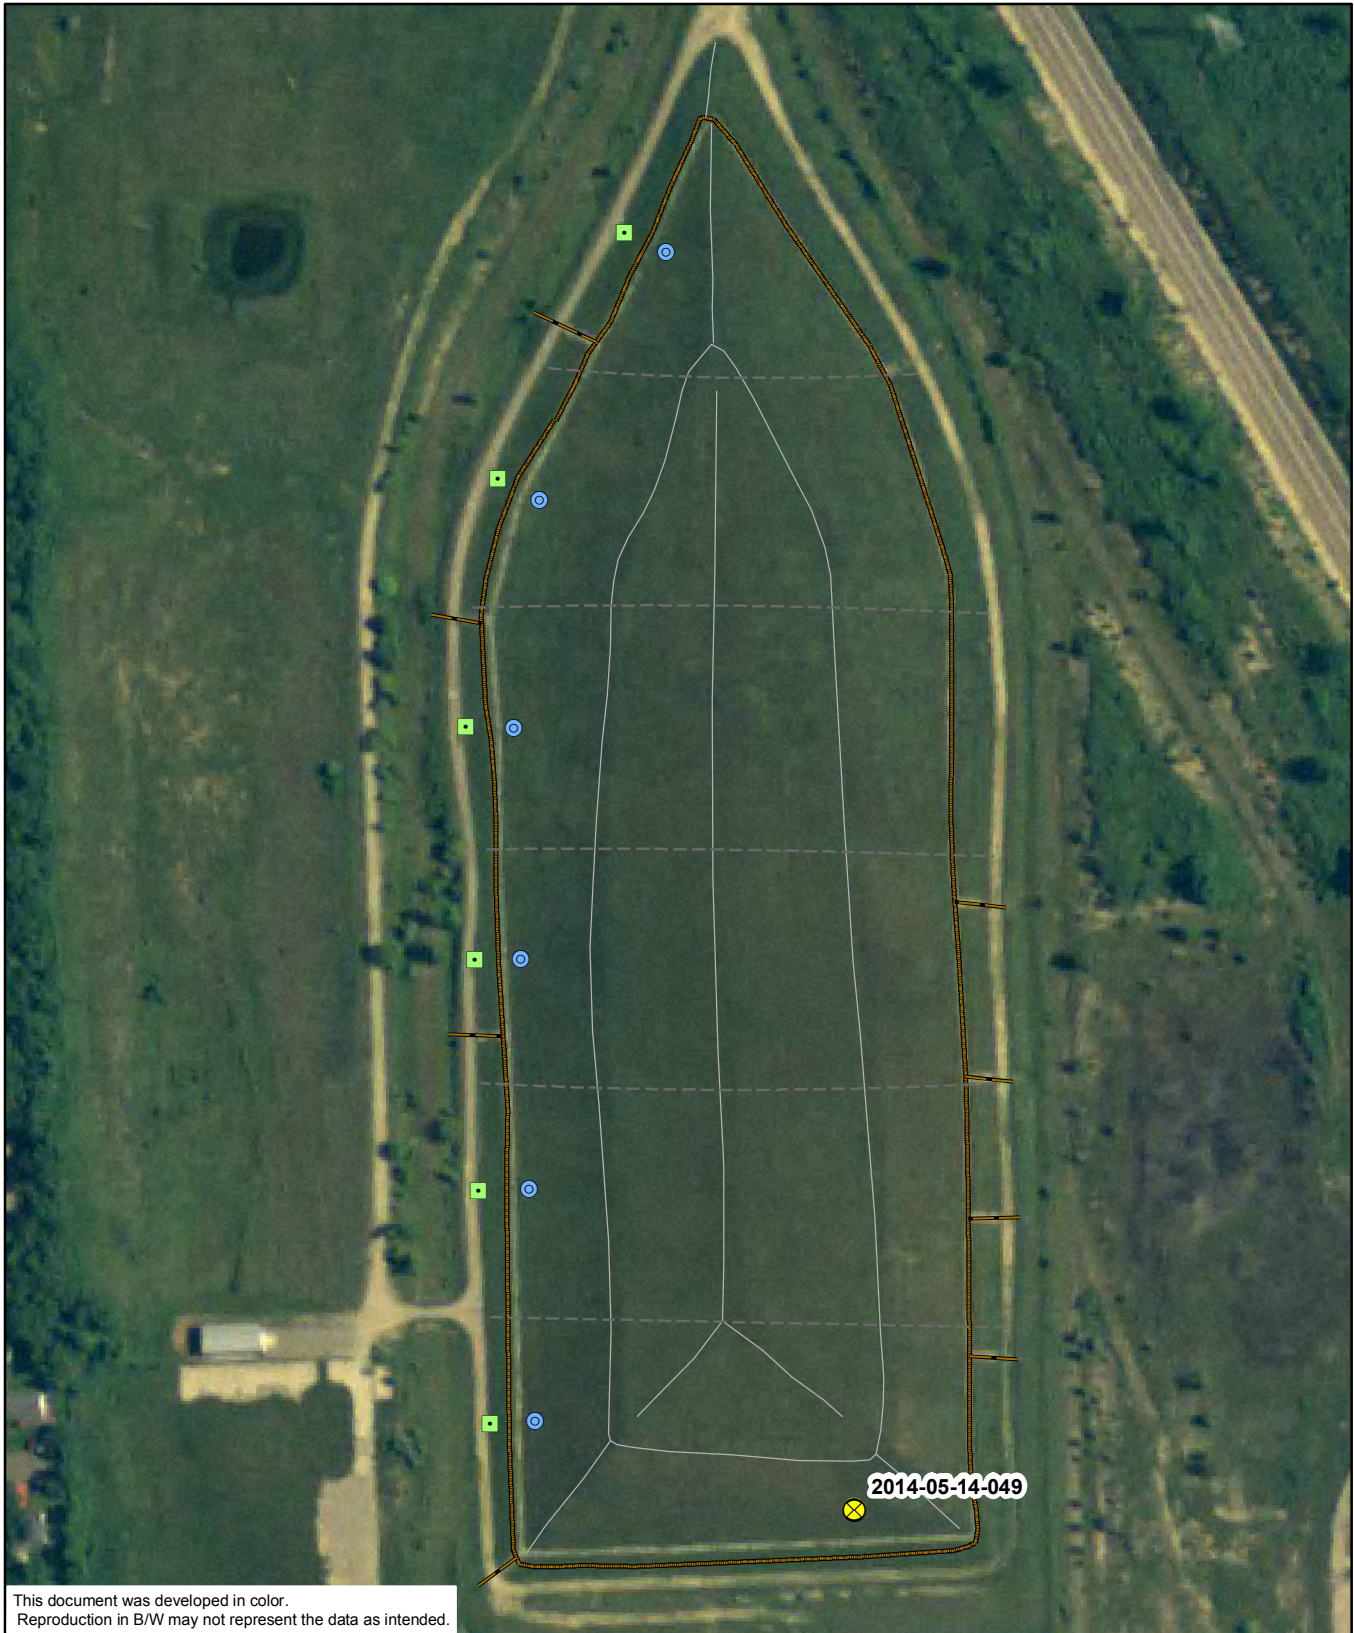
- » Observed one active burrow on March 20, 2014 and set trap. The animal burrow was closed and backfilled on May 14, 2014. See attached figure for animal burrow locations and photo log for detailed information concerning animal burrow activities for this quarter.

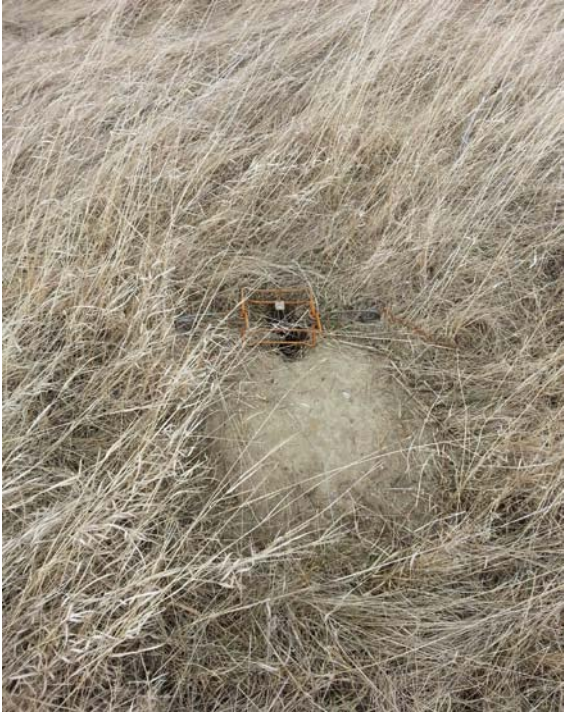
LOCATION: F4 – Middle of Slope		APPROX. LENGTH: 2 ft	APPROX. DEPTH: 1 ft	APPROX. DIAMETER: 6 inch
DATE FOUND: 3/20/2014	DATE CLOSED: 5/14/14

NOTES: ID: 2014-05-14-049 PRE repair photo of burrow. Trap set up for 7 weeks. Trapped skunk. No signs of liner damage.				
LOCATION: F4 – Middle of Slope		APPROX. LENGTH: 2 ft	APPROX. DEPTH: 1 ft	APPROX. DIAMETER: 6 inch
DATE FOUND: 3/20/2014	DATE CLOSED: 5/14/14
