**Drain Tile Removal - Summary Report  
Green Point Landfill – RACER Trust**

**Project Name:** Green Point Landfill – RACER Trust      **Date:** Tuesday, July 16, 2013  
**Project Location:** Saginaw, MI      **Project #:** B0050096.2013  
**Task:** Drain Tile Removal  
**Contractor:** Young's Environmental Cleanup, Inc.  
**Weather:** 80°F, sunny, hot, and humid

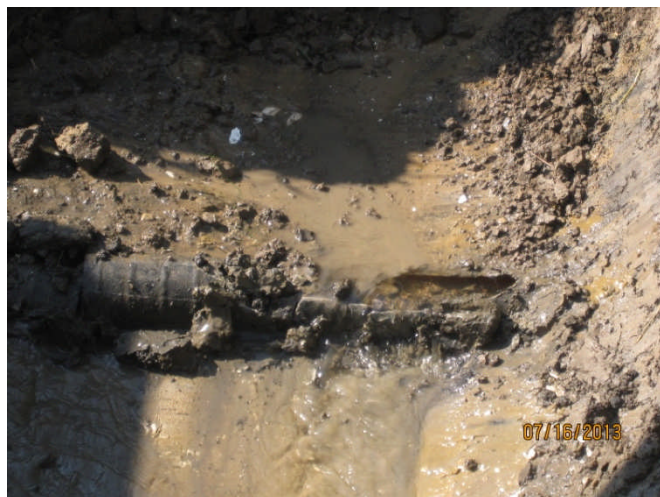
*View of drain tile at west end adjacent to fence line.*

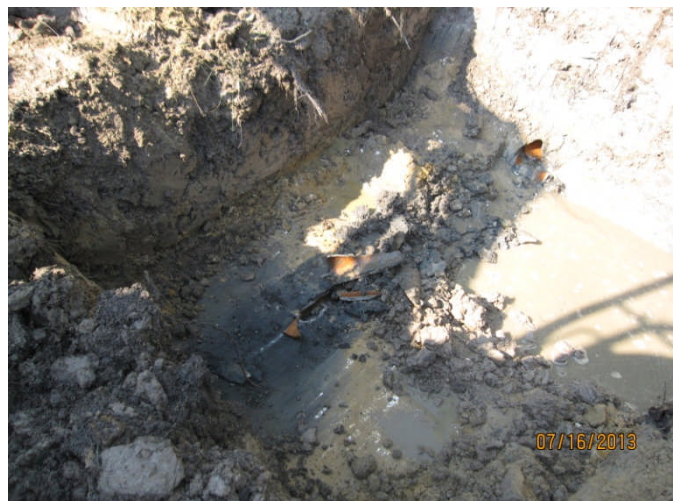
*View of drain tile section uncovered.*

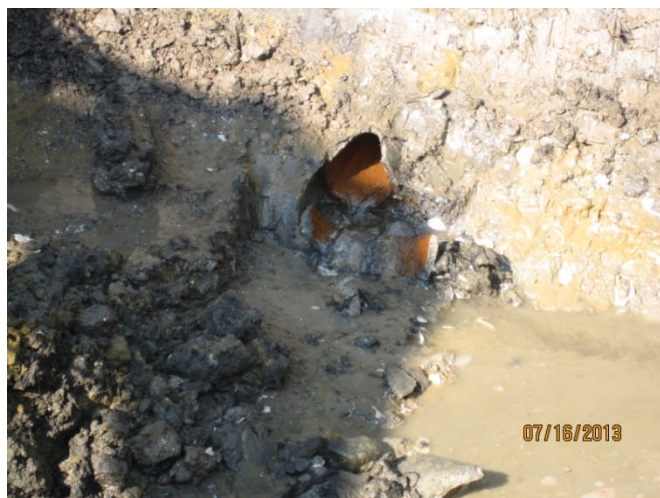
*View of west end of pipe opening adjacent to fence.*

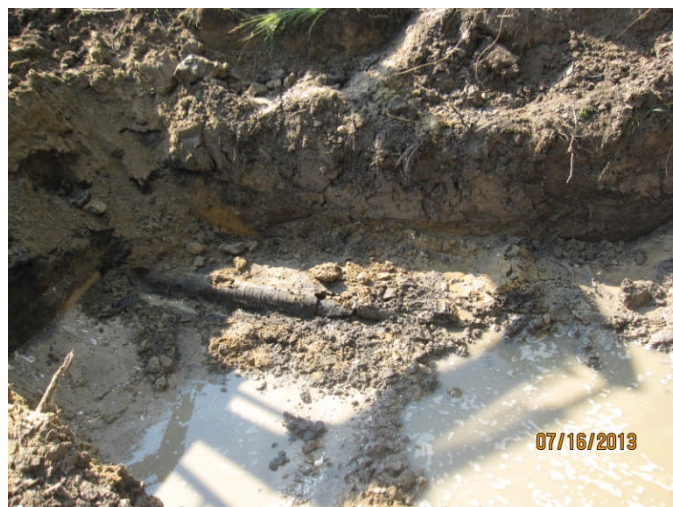
*View of tile sections uncovered at east end.*

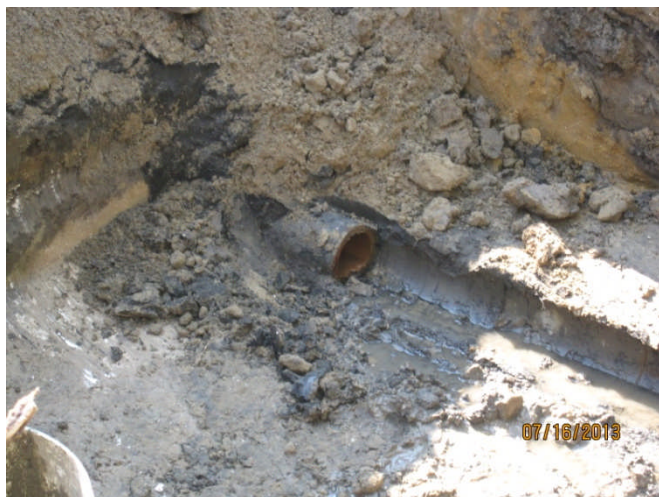
*View of east end of pipe opening.*

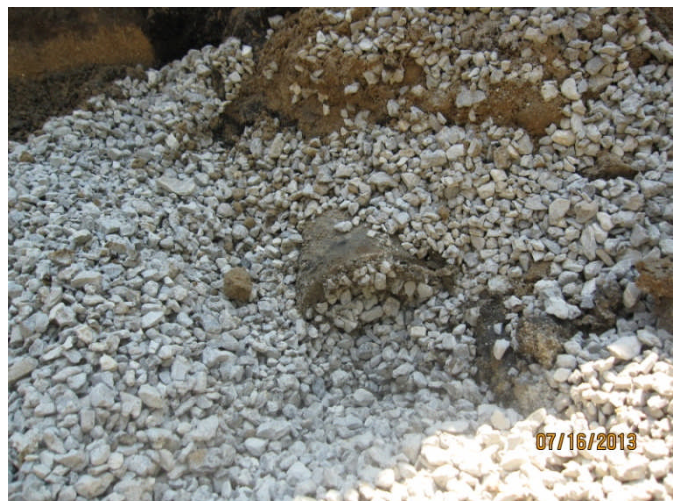
*Hydraulic cement and bentonite placed at east end of pipe.*

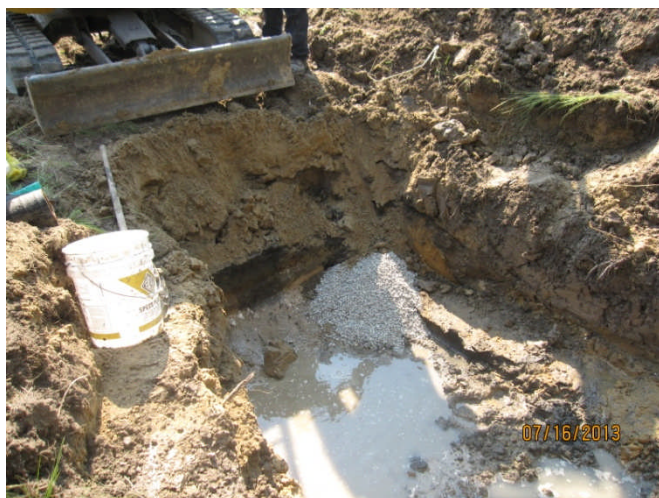
*View of bentonite placed on east end pipe.*

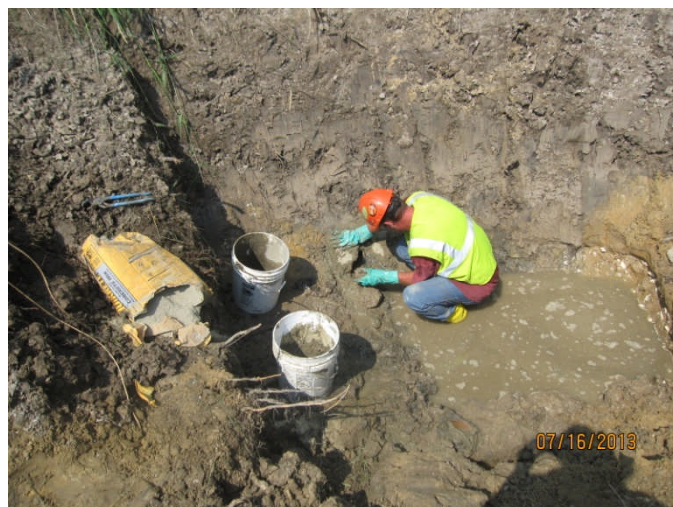
*YECI placing clay pieces inside of west end pipe opening to stop water flow.*

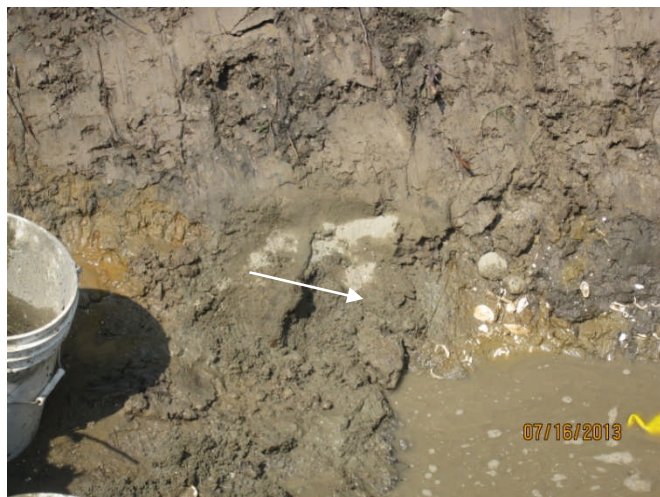
*Hydraulic cement placed over opening at west end (see arrow).*

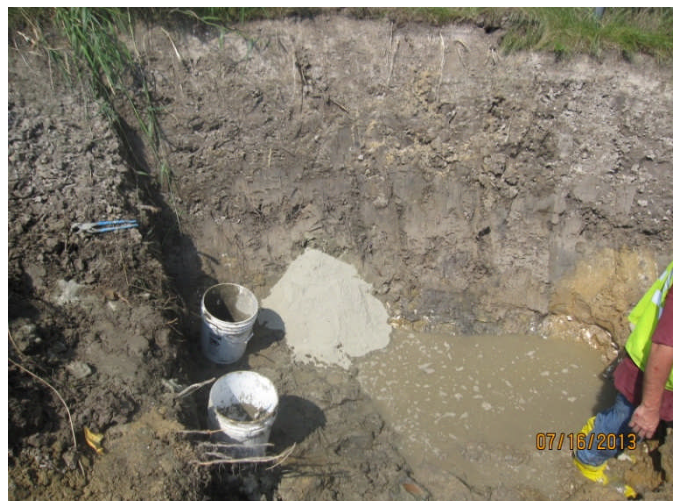
*Quick-crete placed over opening at west end.*

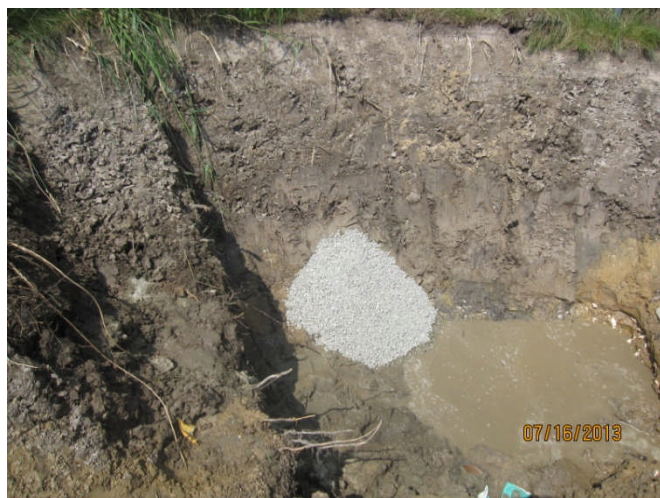
*View of bentonite placed over opening at west end.*

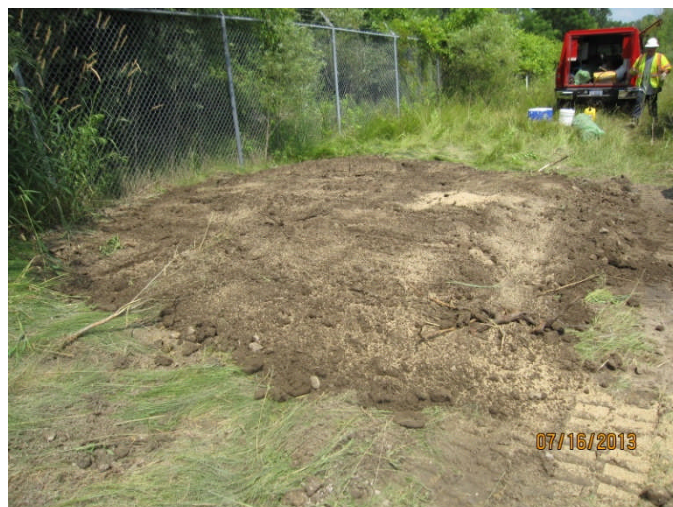
*Topsoil and seed placed at excavation by fence line.*

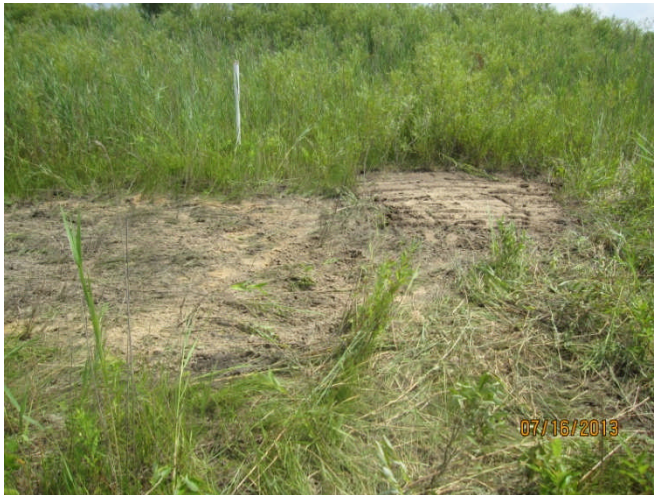
*Topsoil and seed placed at test excavation area.*

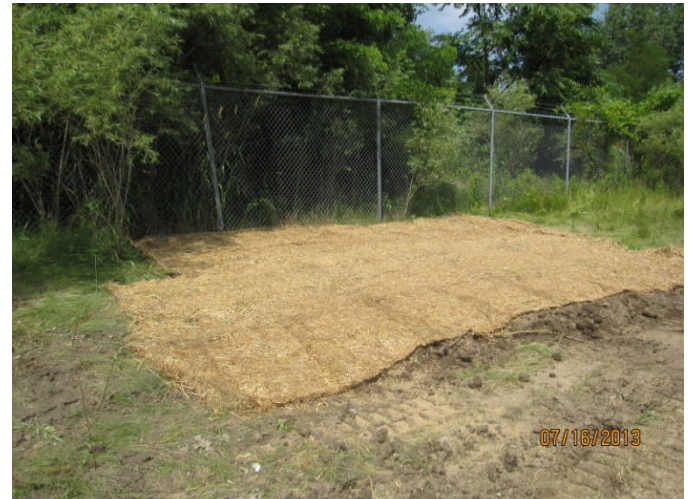
*Straw matting placed at excavation by fence line.*

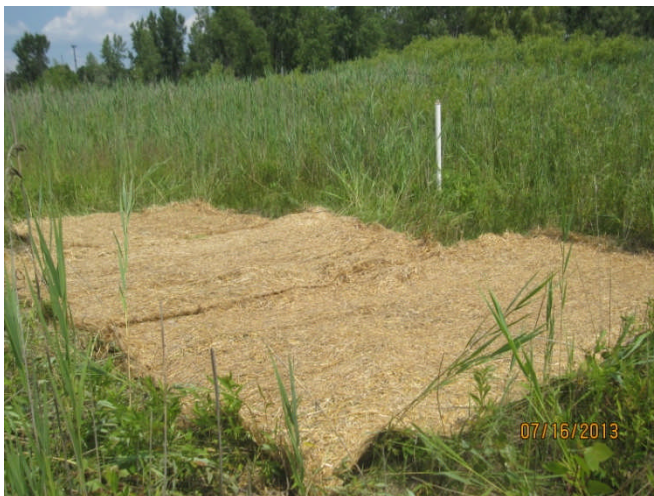
*Straw matting placed at test excavation area.*

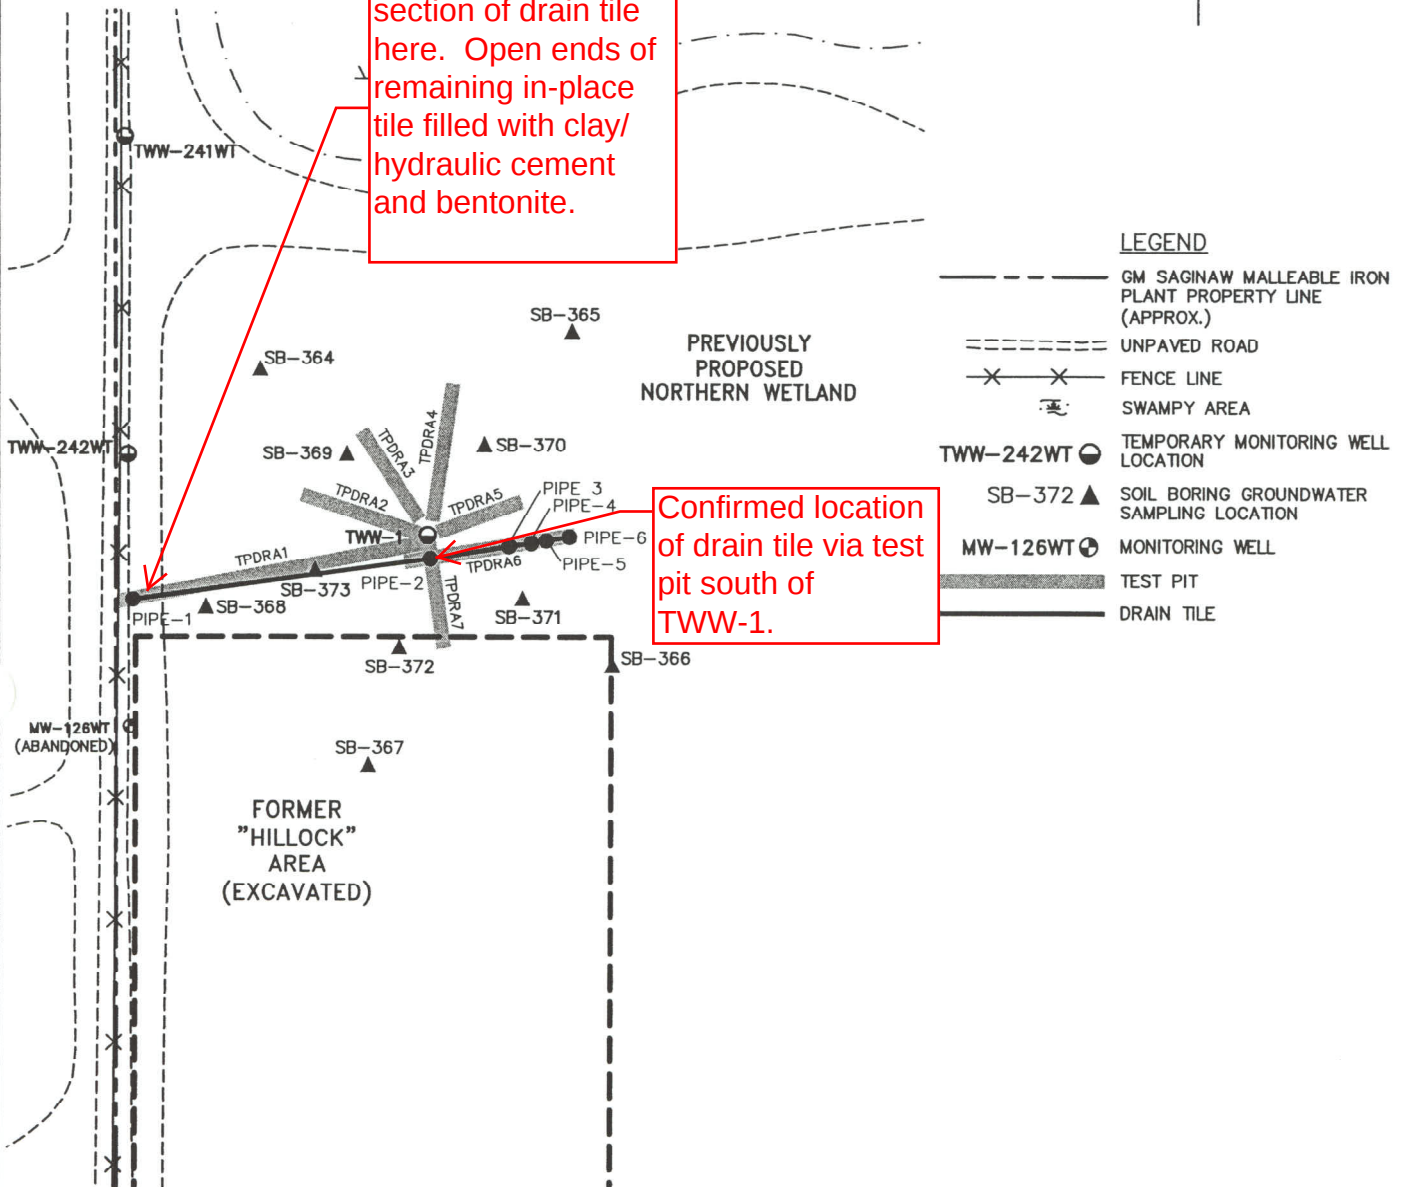
FIGURE  
**2-6**

Removed 10-foot section of drain tile here. Open ends of remaining in-place tile filled with clay/hydraulic cement and bentonite.

Confirmed location of drain tile via test pit south of TWW-1.

**DRA SUPPLEMENTAL MONITORING  
WELL, SOIL BORING, AND TEST PIT  
LOCATION MAP**

Additional notes from drain tile removal work completed on July 16, 2013.
