Subject: Semi-Annual Progress Report January 1, 2026 – June 30, 2026  
Revitalizing Auto Communities Environmental Response Trust  
Buick City Site, Flint, Michigan

Buick City - Volume 6

January 1, 2025 – December 31, 2025

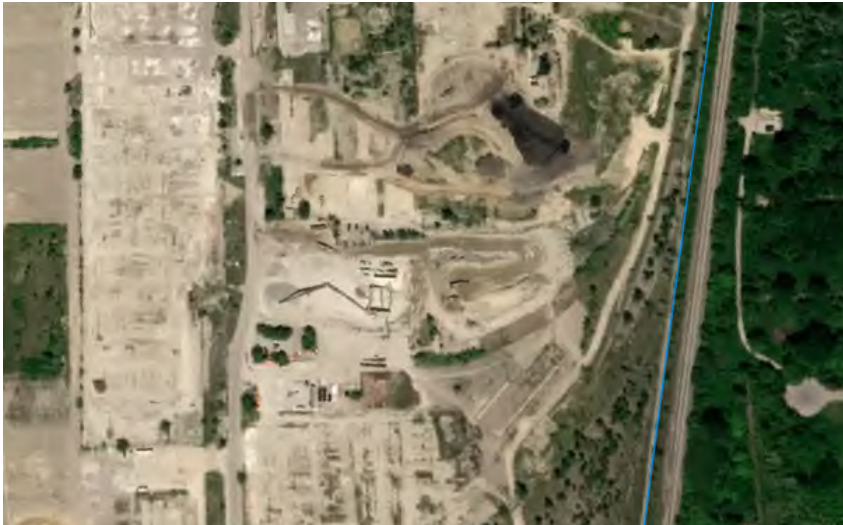
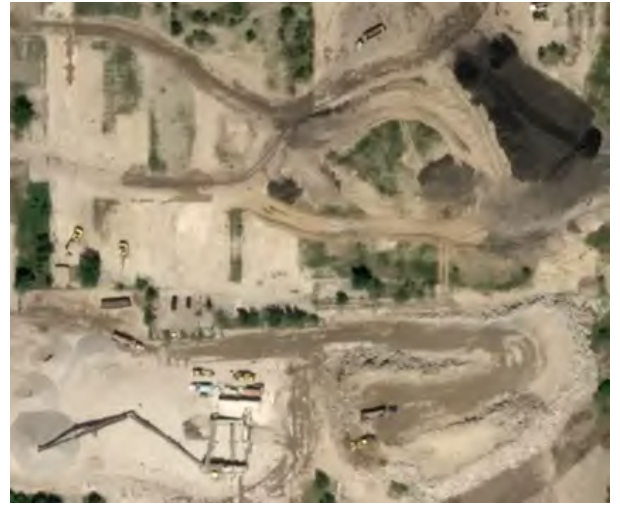
**Image 1 - 2:** May 24, 2024 - PN (High Res)

| AOI | Change Detection Scope | Commentary |
|---|---|---|
| Middle facility | Ongoing signs of excavation and soil stockpiling | Construction and stockpiling of soil visible in 2024 continues in 2025 along with active excavation in the middle facility. |

We can see new large piles of soil and / or gravel have appeared in 2025. More area appears to have been graded since 2024.

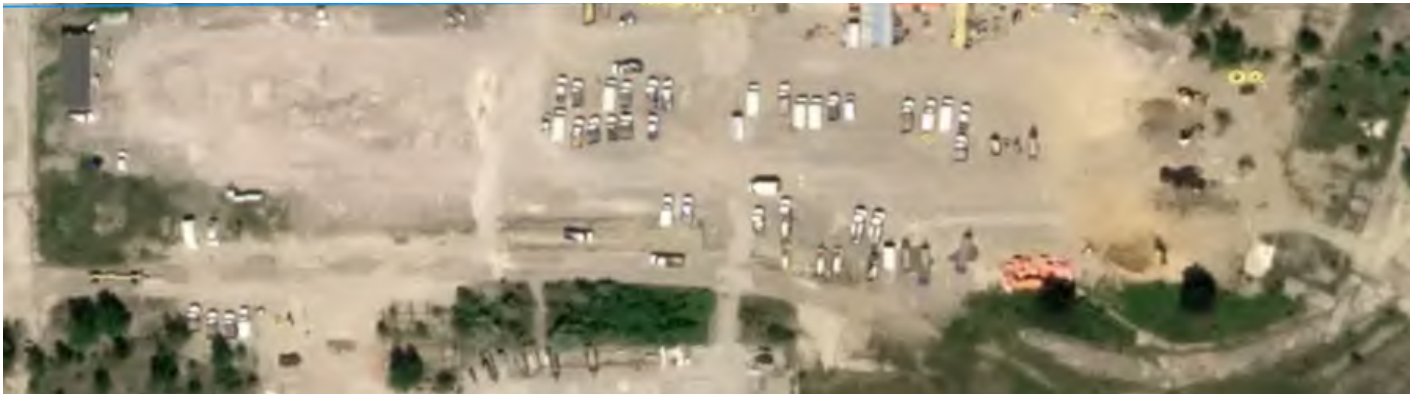
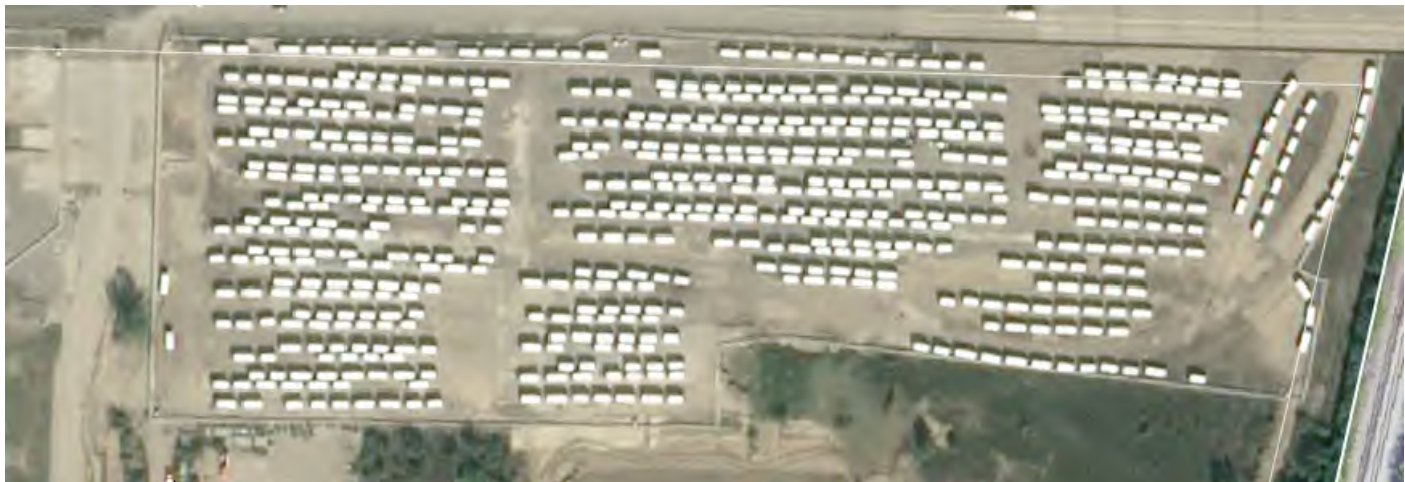
| AOI | Change Detection Scope | Commentary |
|---|---|---|
| Middle Facility | Increased usage | Vehicles and vegetation present in May 2024 have been replaced with large numbers of white objects. |

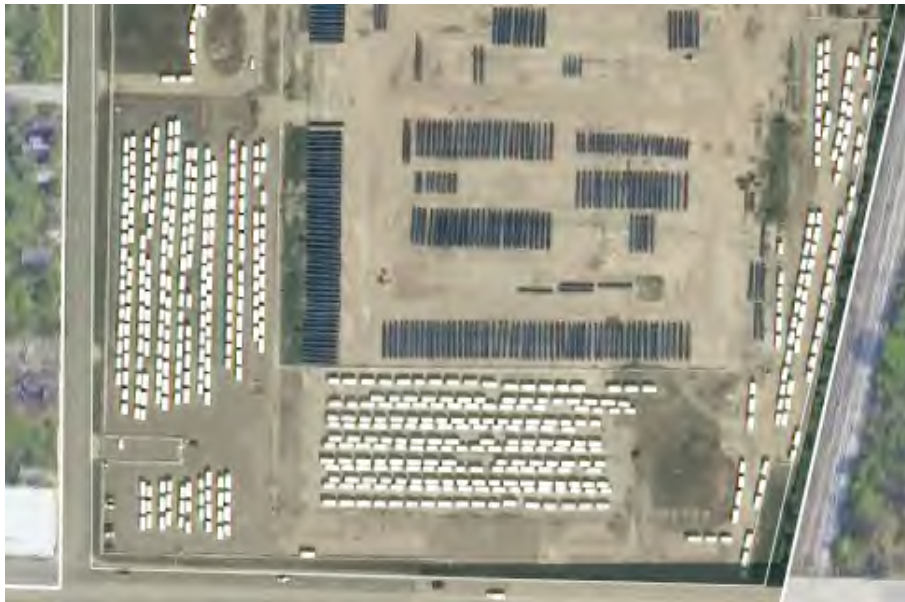
| AOI | Change Detection Scope | Commentary |
|---|---|---|
| North Facility | Increased usage | Vehicles and vegetation present in 2024 have been replaced with large numbers of white objects. These remain in October, and we see increasing numbers of the black objects in October as well. |

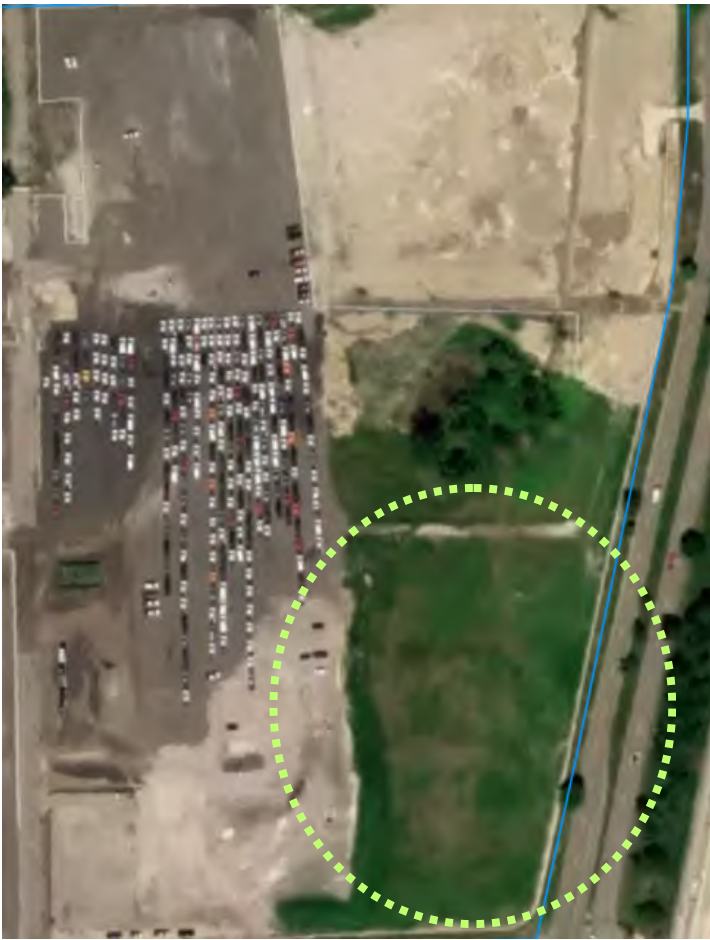
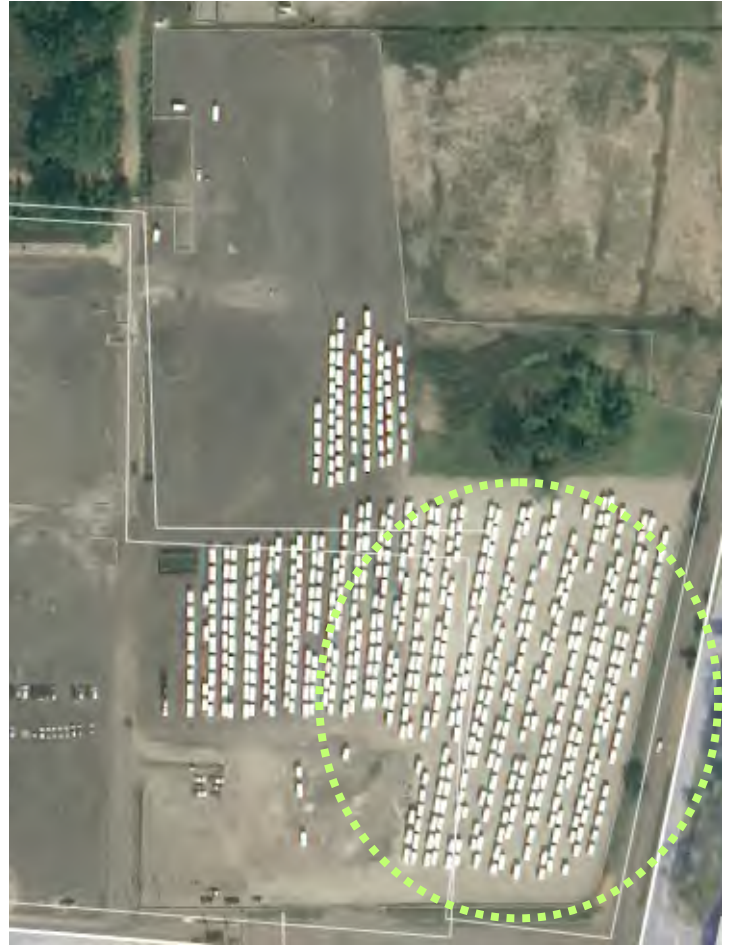
| AOI | Change Detection Scope | Commentary |
|---|---|---|
| Vegetation area | Evidence of new construction or excavation | Evidence of extensive grading and vegetation clearing |

We can see that this vegetated area has been removed, graded and is now used to store additional objects. The cars visible to the left on the May 2024 image have also been removed and replaced with white objects.

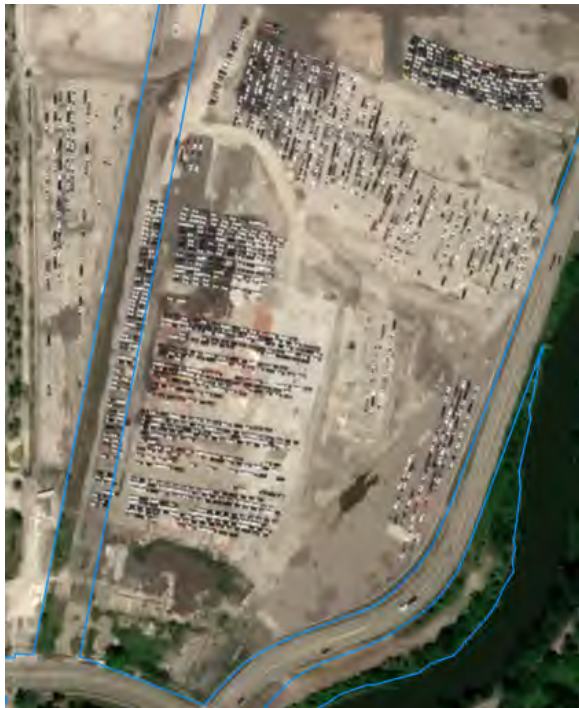
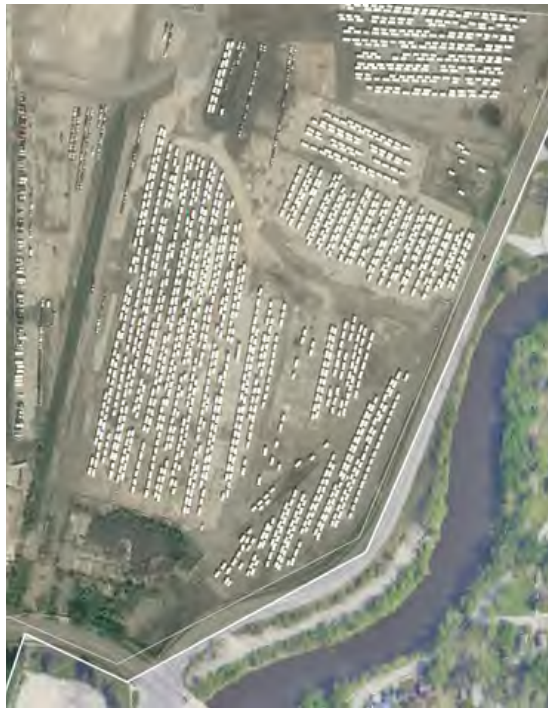
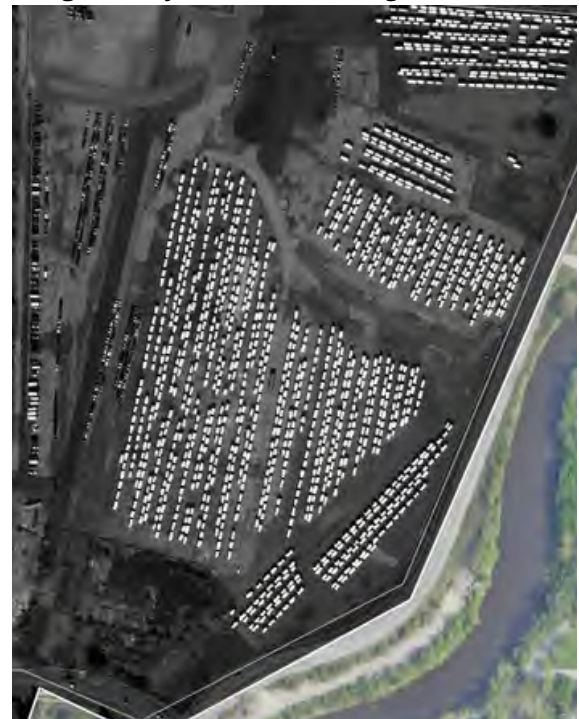
| AOI | Change Detection Scope | Commentary |
|---|---|---|
| S. Construction area | Evidence of increased parking lot usage for storage | We can see cars in this area have been replaced by the same white objects visible in other AOI |

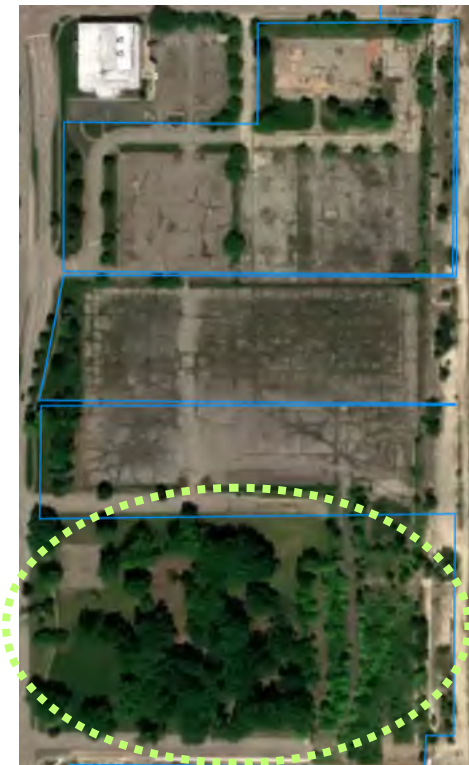
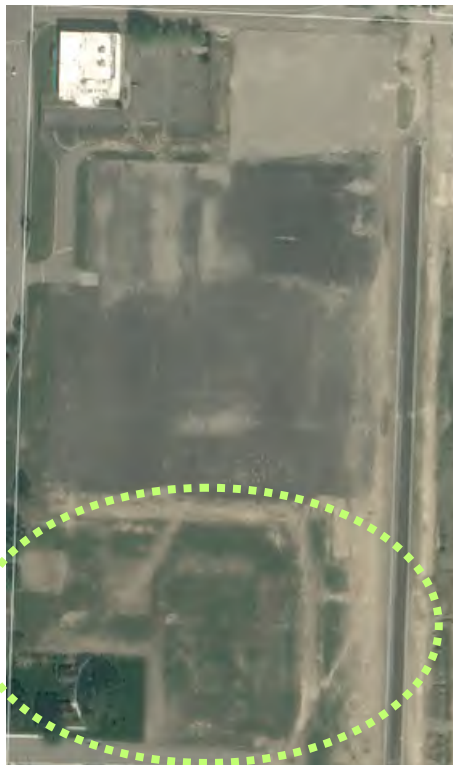
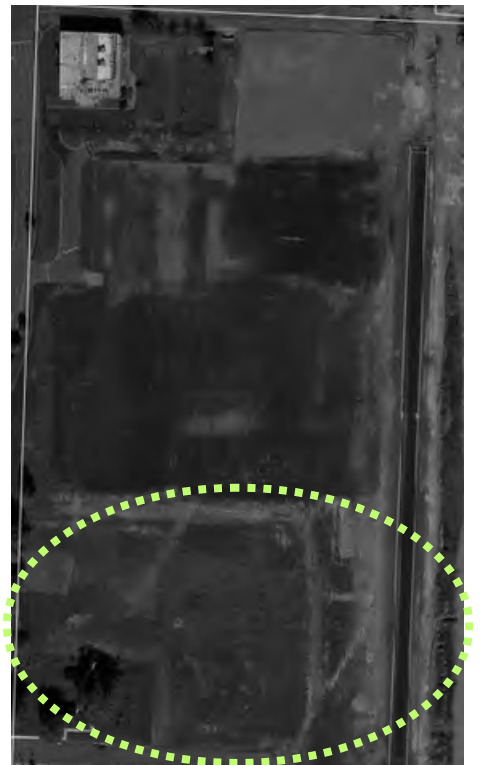
| AOI | Change Detection Scope | Commentary |
|---|---|---|
| S. Construction area | Evidence of extensive vegetation removal | We can see the large patch of trees and vegetation in the lower left of the May 2024 image has been mostly removed in images from Fall 2025. |

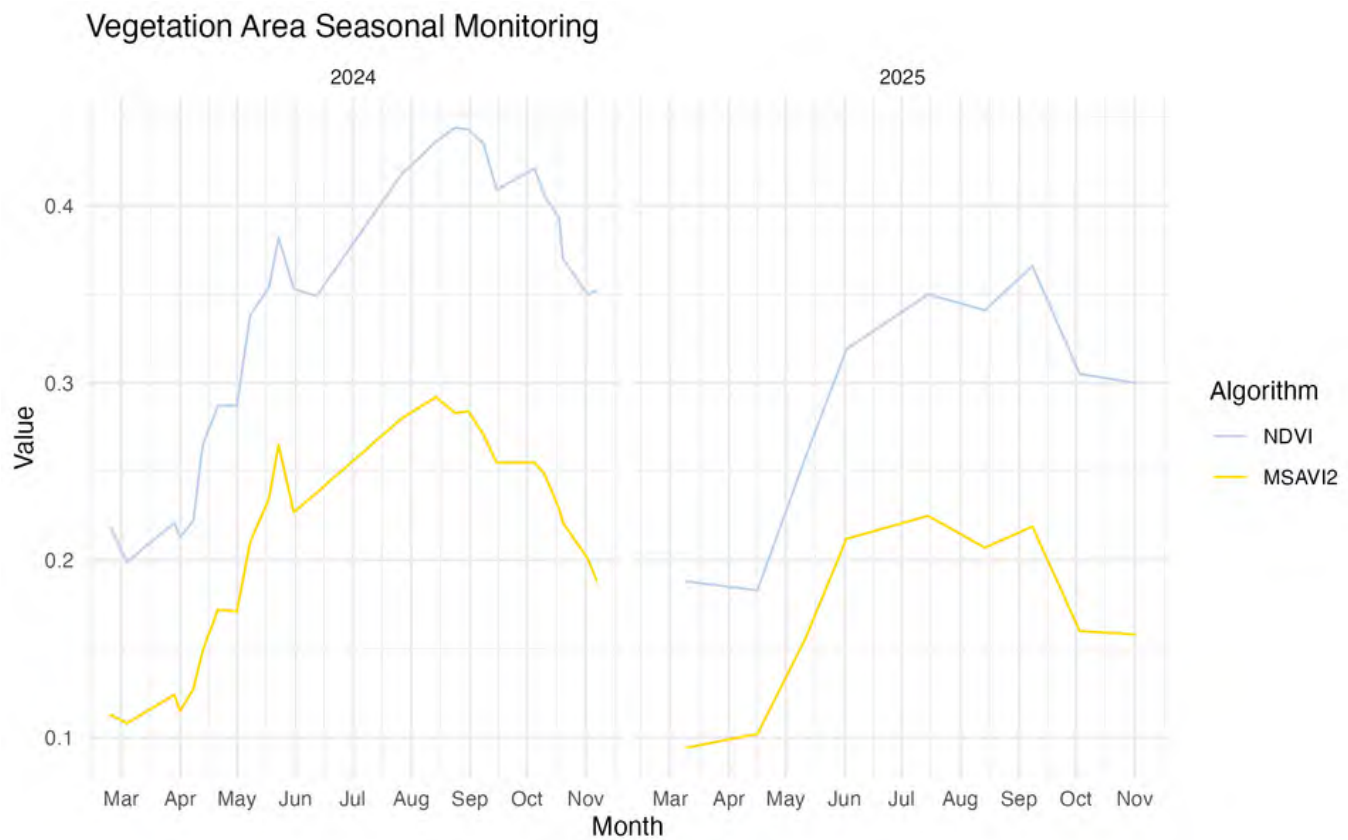
| AOI | Change Detection Scope | Commentary |
|---|---|---|
| Vegetation area | Vegetation monitoring | Vegetation monitoring can provide us with additional information on how vegetation areas are (or aren't) being maintained. We see that compared to 2024, values have shifted down for the entire year. This likely reflects the vegetation removal that we can see in various AOIs above. |
