**AIR PERMIT WAIVER  
QUARTERLY MONITORING REPORT  
SECOND QUARTER 2016**

**FORMER GENERAL MOTORS PLANT  
801 BOXWOOD ROAD, WILMINGTON, DELAWARE**

**DE-1149 Operable Unit 4**

## QUARTERLY MONITORING REPORT

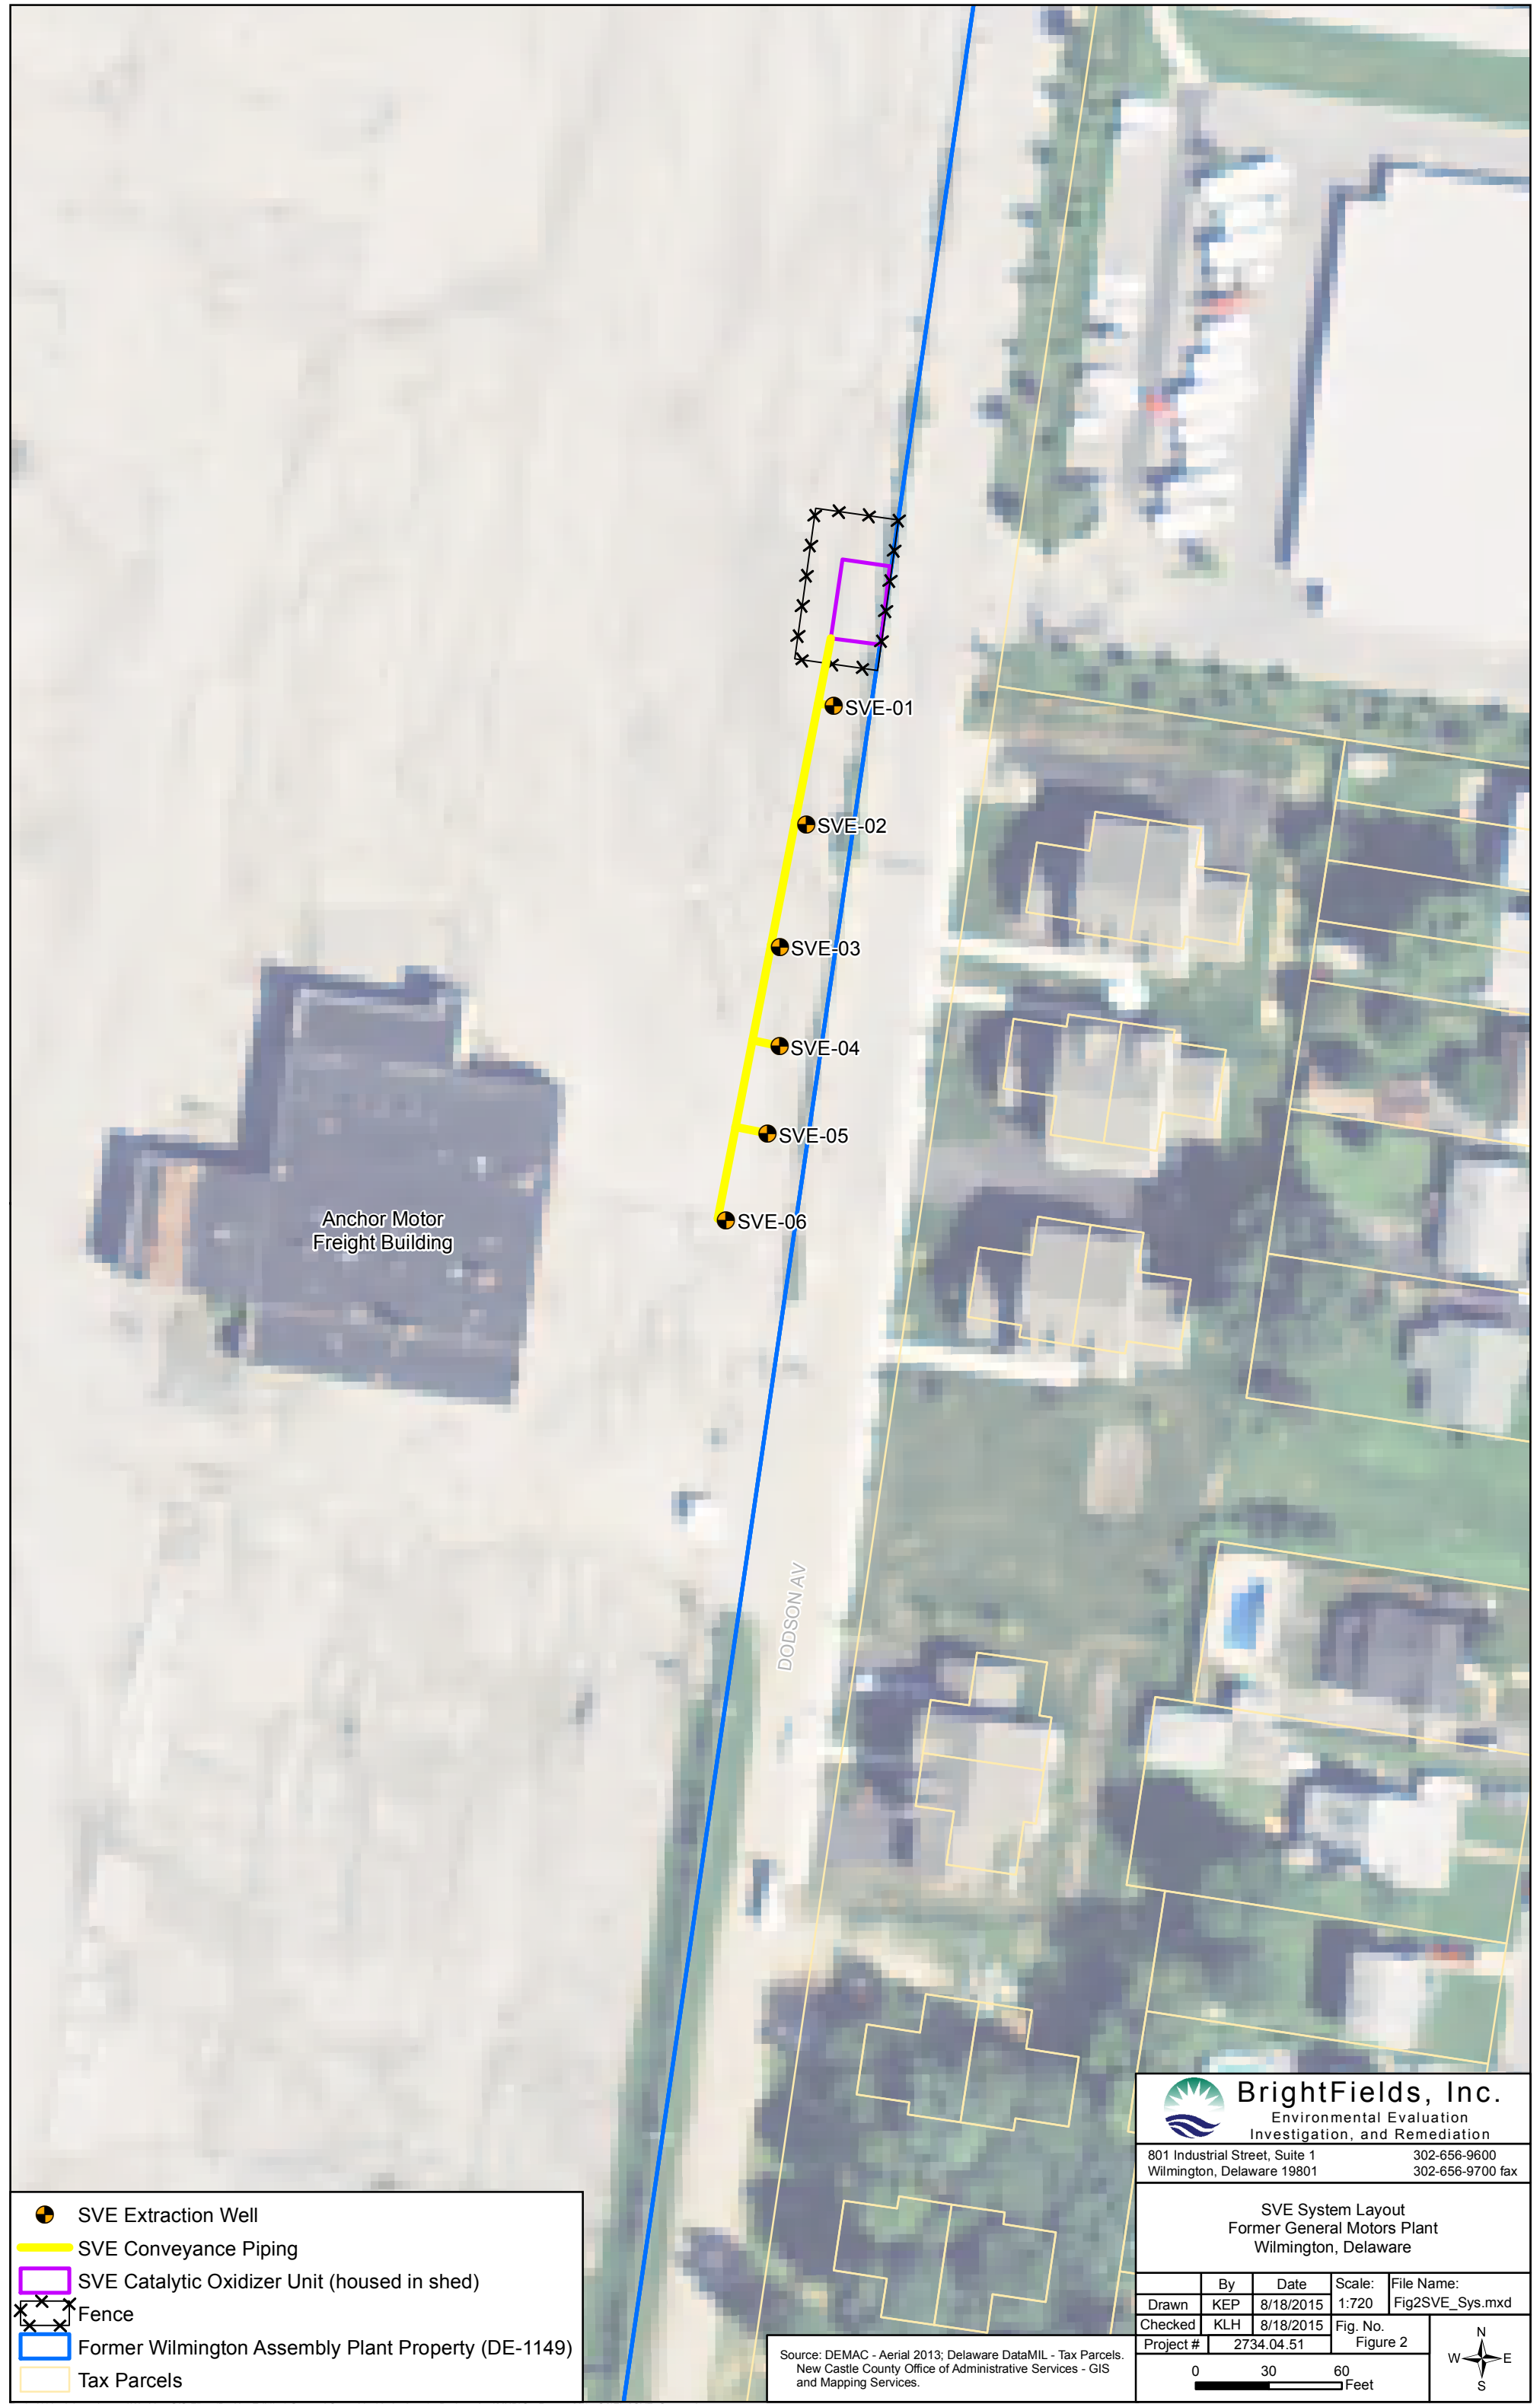
SVE System Layout  
Former General Motors Plant  
Wilmington, Delaware

SVE Extraction Well

SVE Conveyance Piping

SVE Catalytic Oxidizer Unit (housed in shed)

The remediation system consists of a Falco 300 Catalytic Oxidizer with a 15-horsepower (hp) regenerative blower. The blower is capable of extracting 295 standard cubic feet per minute (scfm) of vapor flow at 60-inches of water vacuum. The blower is connected to extraction wells SVE-01 through SVE-06 (Figure 2).
