# LNAPL STATUS

## RACER Malleable Iron Industrial Land

Review with MDEQ  
November 7, 2014

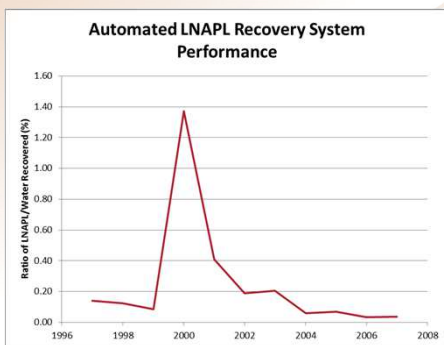
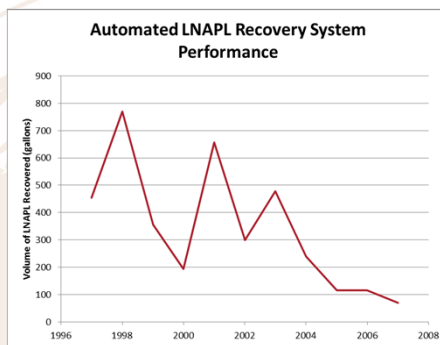
## Annual LNAPL Recovery Performance

- Recovery of LNAPL has been performed by various methods since 1995
  - Automated recovery system efficiency decreased significantly prior to water table submerging screens post-demolition (ratio of LNAPL recovered/water recovered decreased from high of 0.01 in 2000 to 0.0004 in 2006 and 2007)
