**RESOURCE CONSERVATION AND RECOVERY ACT
CURRENT CONDITIONS SUMMARY**

**FORMER GM ROMULUS ENGINEERING CENTER
37350 ECORSE ROAD
ROMULUS, MICHIGAN
USEPA ID #MID000809905**

**Haley & Aldrich of Michigan, Inc.
Ann Arbor, Michigan**

**File No. 37515-003
30 December 2011**

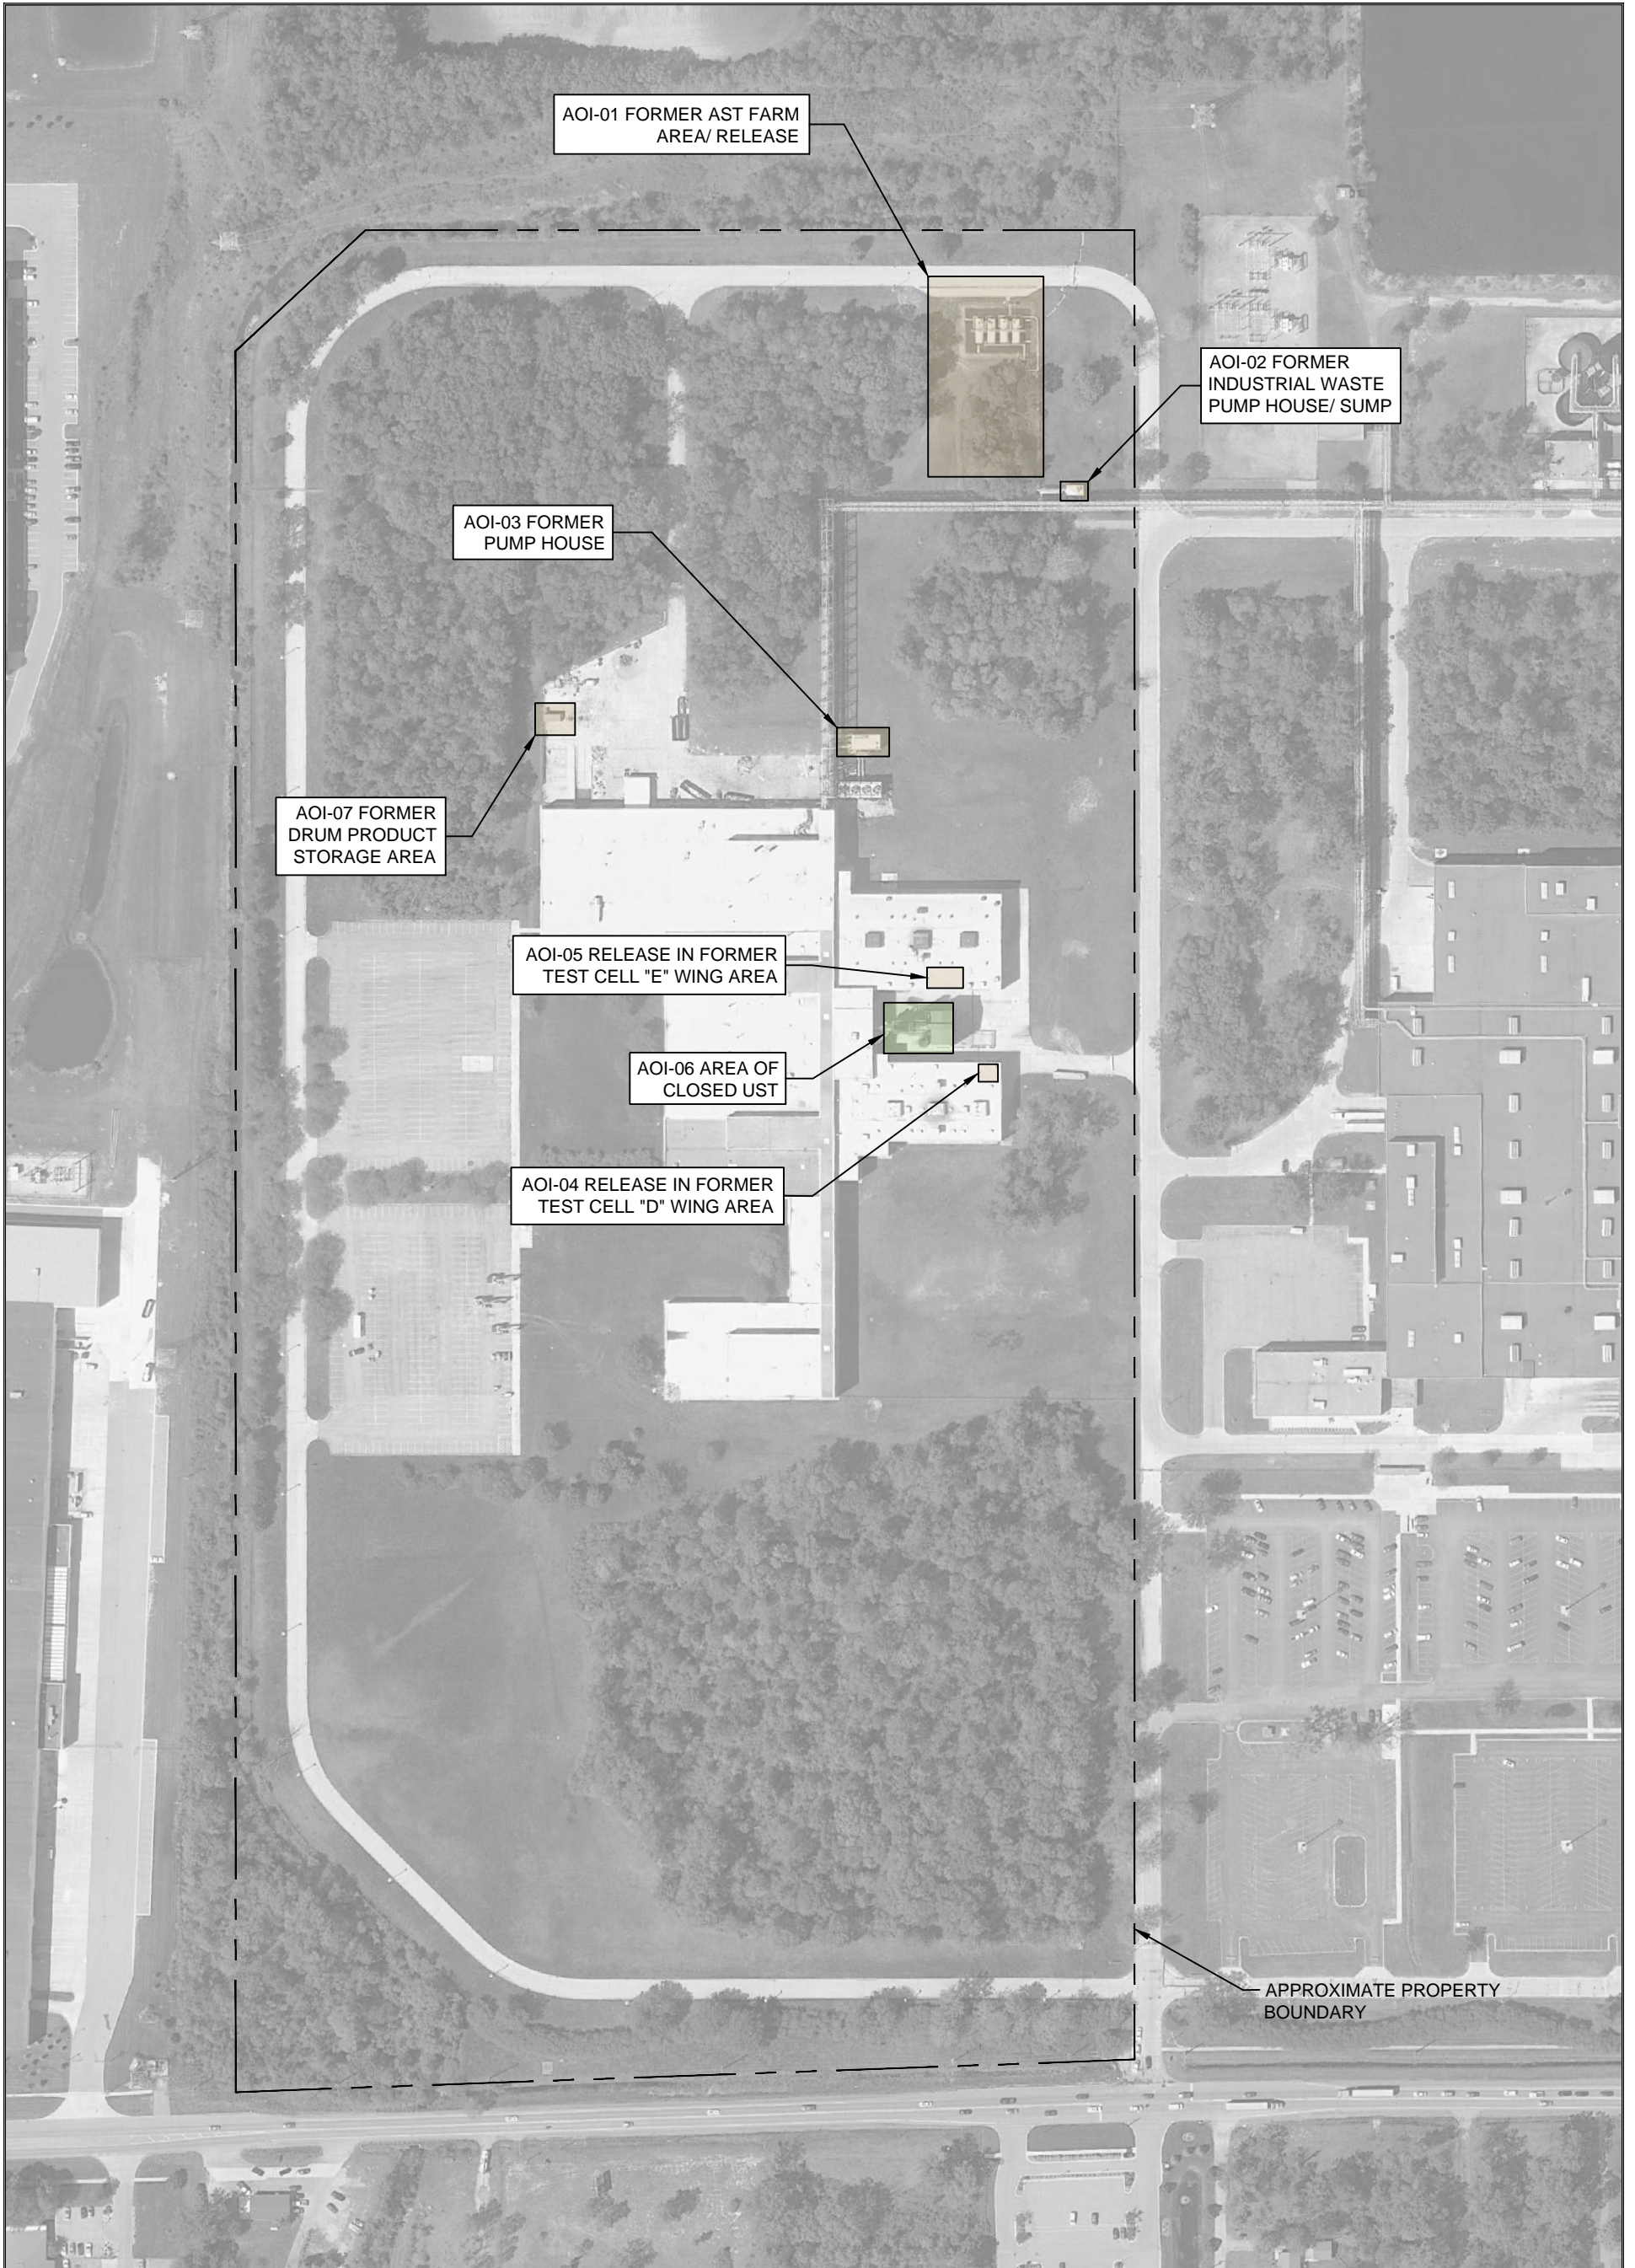
FIGURE 3

AOI-01 FORMER AST FARM
AREA/ RELEASE

AOI-02 FORMER
INDUSTRIAL WASTE
PUMP HOUSE/ SUMP

AOI-03 FORMER
PUMP HOUSE

AOI-07 FORMER
DRUM PRODUCT
STORAGE AREA

AOI-05 RELEASE IN FORMER
TEST CELL "E" WING AREA

AOI-06 AREA OF
CLOSED UST

AOI-04 RELEASE IN FORMER
TEST CELL "D" WING AREA

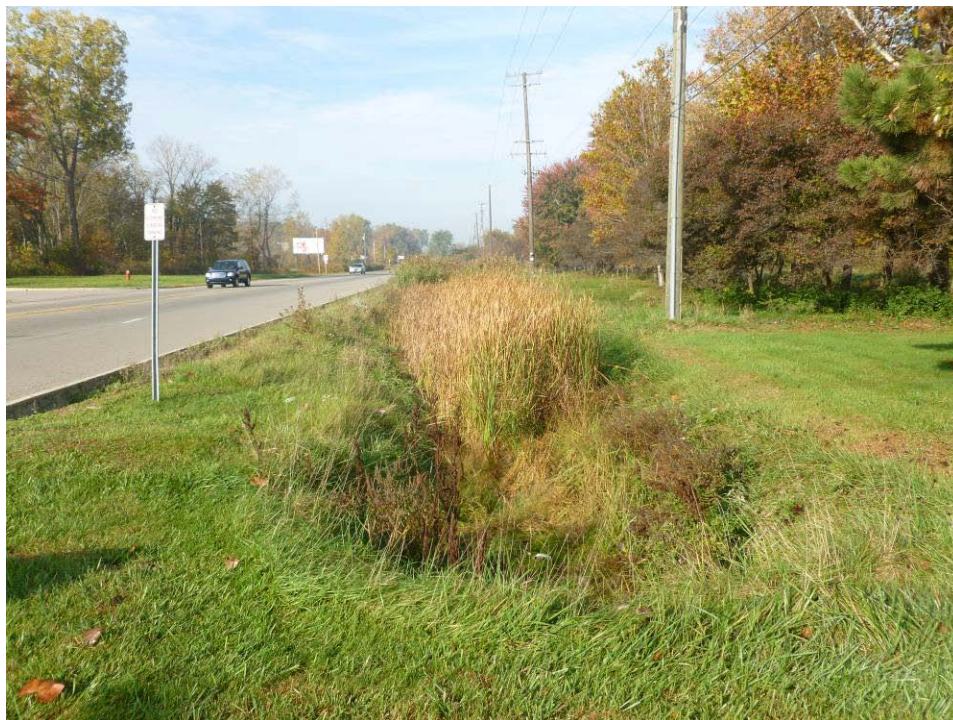
Photograph 2. Swale located on north side of Ecorse Road, south of Site access road. Photo taken facing west.

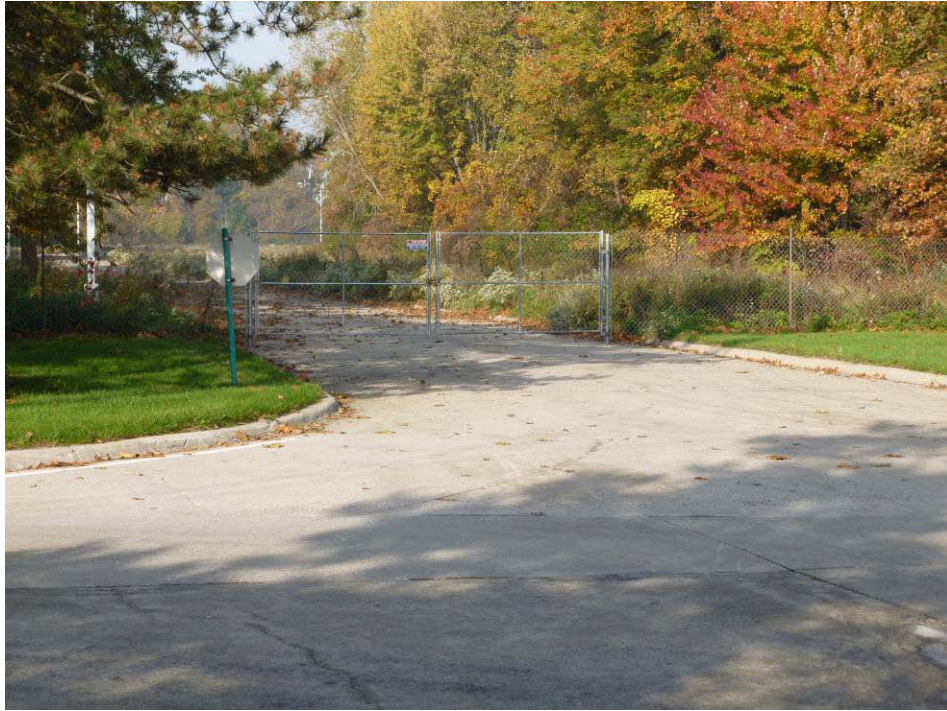
Photograph 3. Entrance to access road to Site. Gates are maintained locked to deter unauthorized entry. Photo taken facing west.

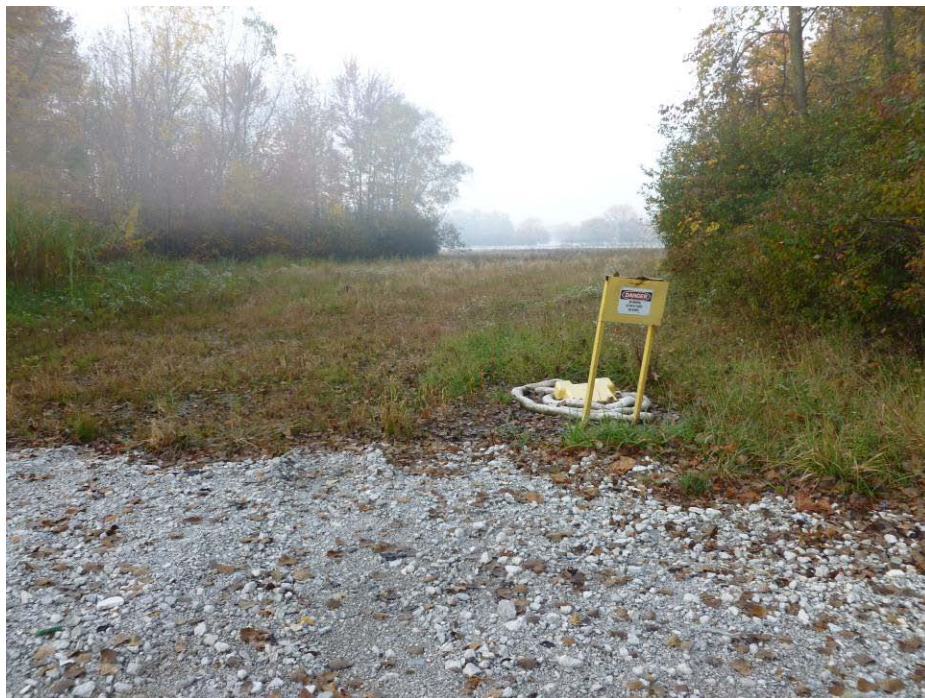
Photograph 8. (AOI-01) Photo taken at northeastern area of Site, facing south. Gravel is present in former AST area.

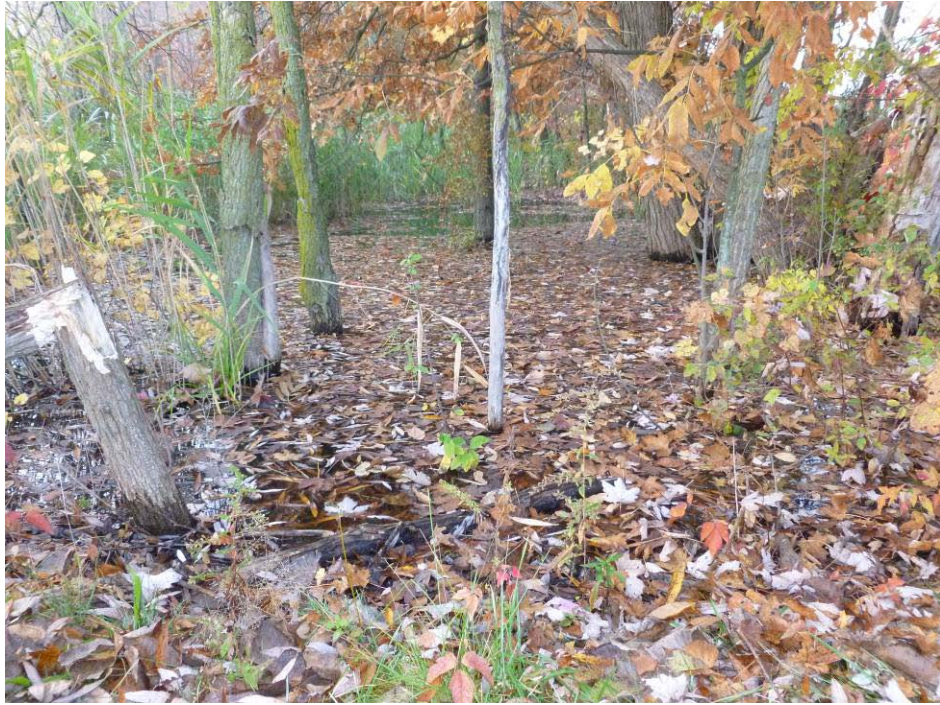
Photograph 9. (AOI-01) Area identified by facility personnel as wetland, northeast area of Site, located immediately south of former AST area. Photo taken facing southeast.

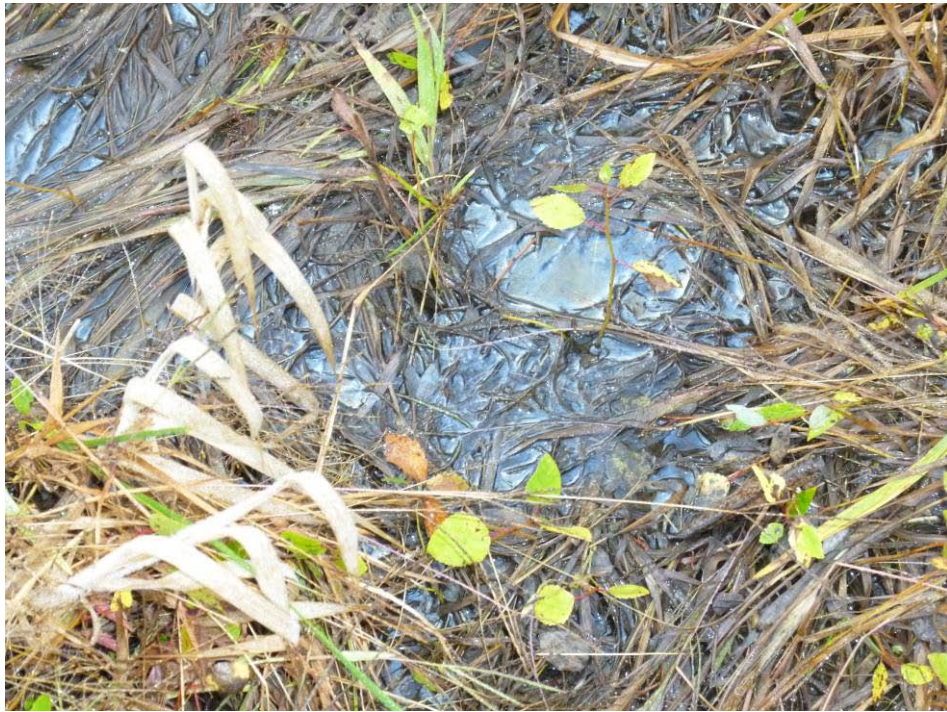
Photograph 10. (AOI-01) Close-up of sheen observed in “wetland area” located south of former AST area. Sheen had no noticeable petroleum odor. Sheen was friable and is believed to be associated with biological degradation of organic matter.

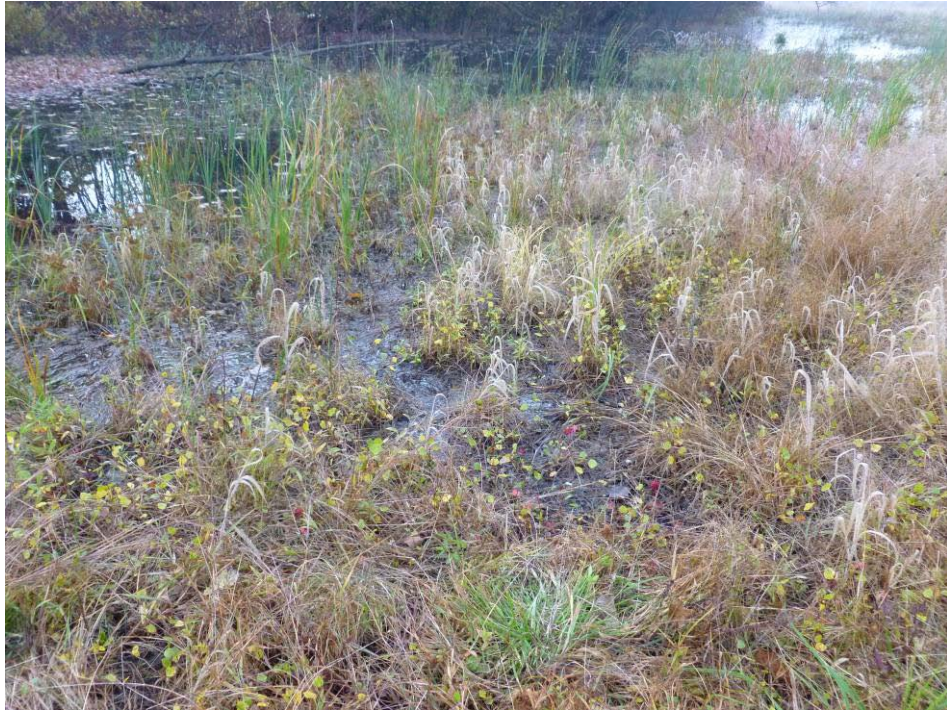
Photograph 11. (AOI-01) "Wetland area" south of former AST area. Photo taken facing north.

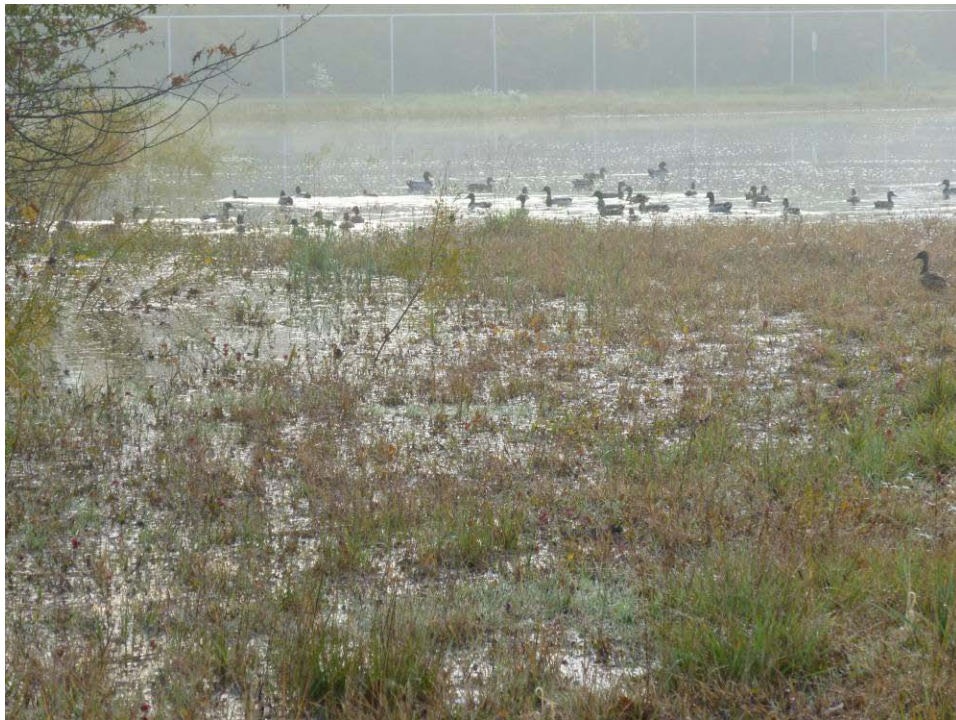
Photograph 12. Photo taken in northeastern area of Site, facing eastern property boundary (note fence in background). Standing water in former lawn area north of former facility structure.

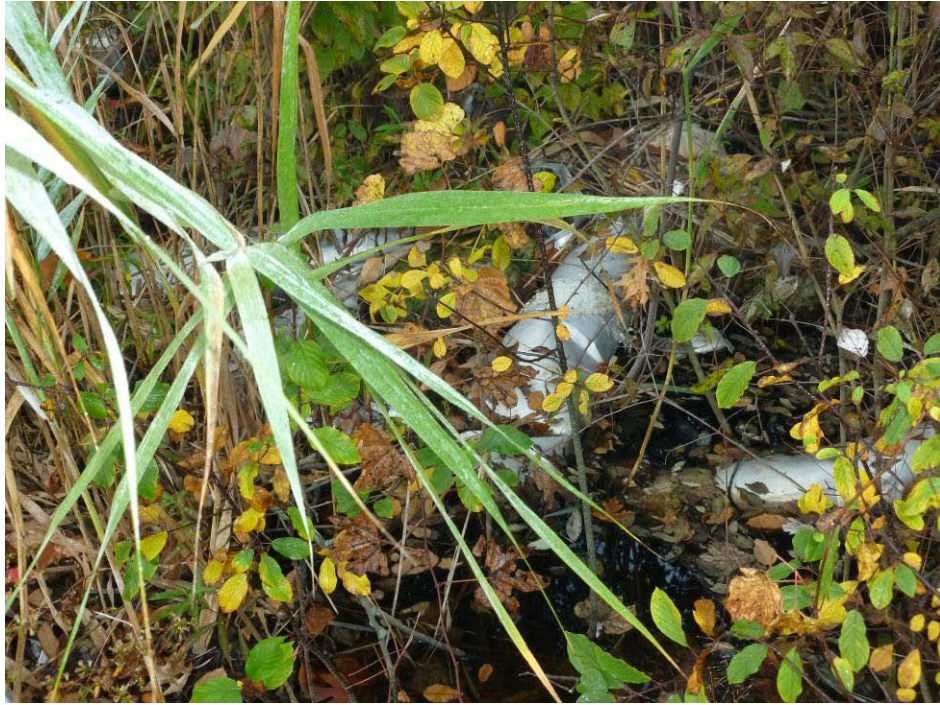
Photograph 13. (AOI-01) Sections of pipe observed crossing “wetland area” located south of former AST area.

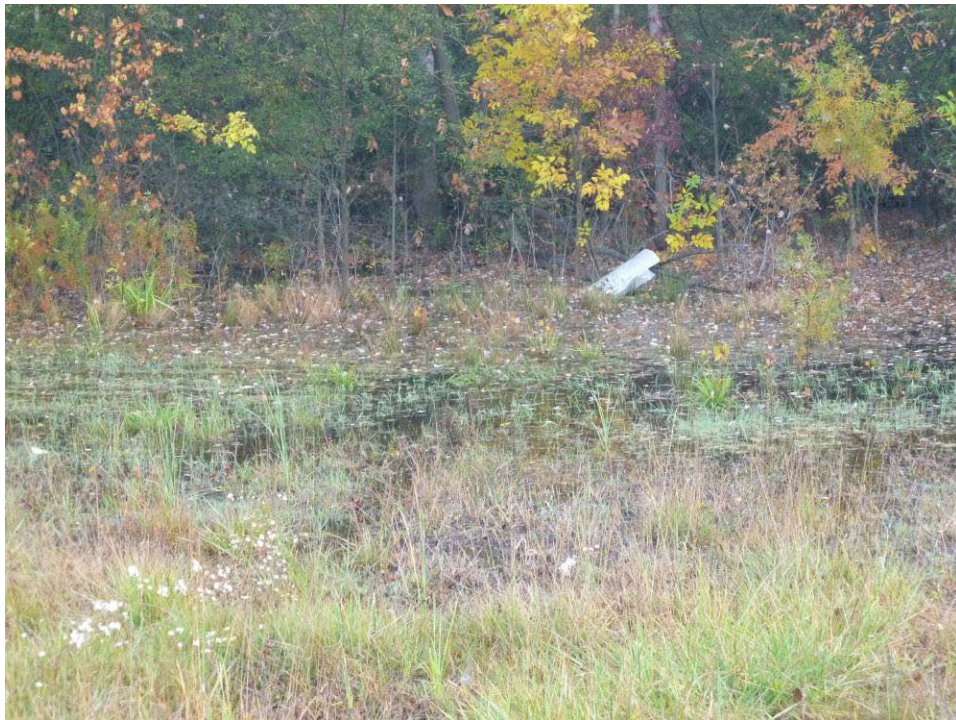
Photograph 14. (AOI-01) Section of pipe observed in “wetland area” located south of former AST farm. Photo taken at northern edge of wetland area, facing south.

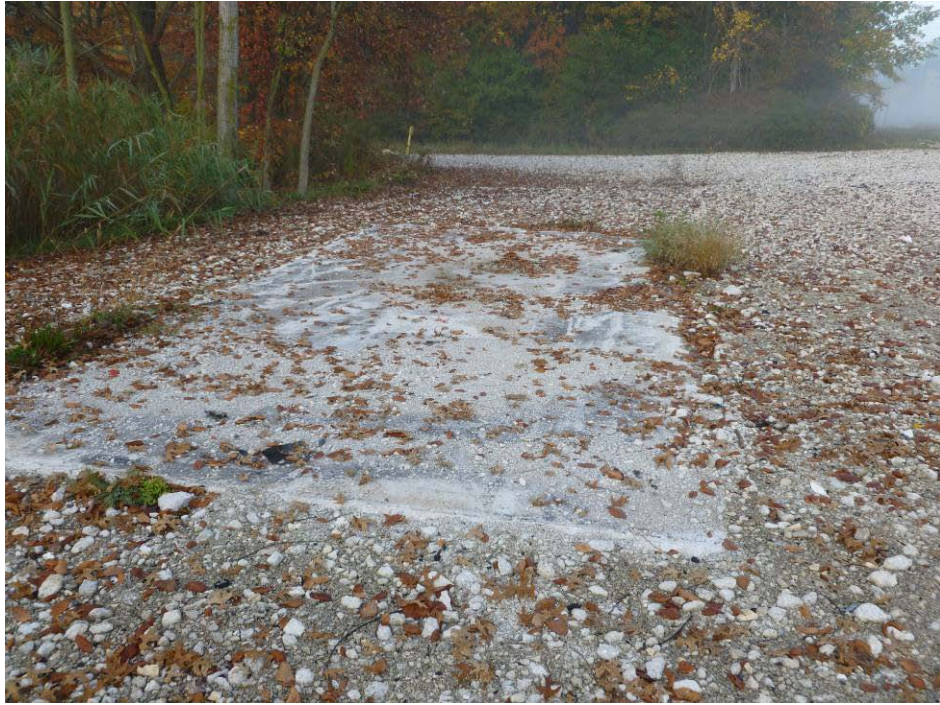
Photograph 15. (AOI-01) Pump pad concrete pad, located southeast of AST area. Photo taken facing west.

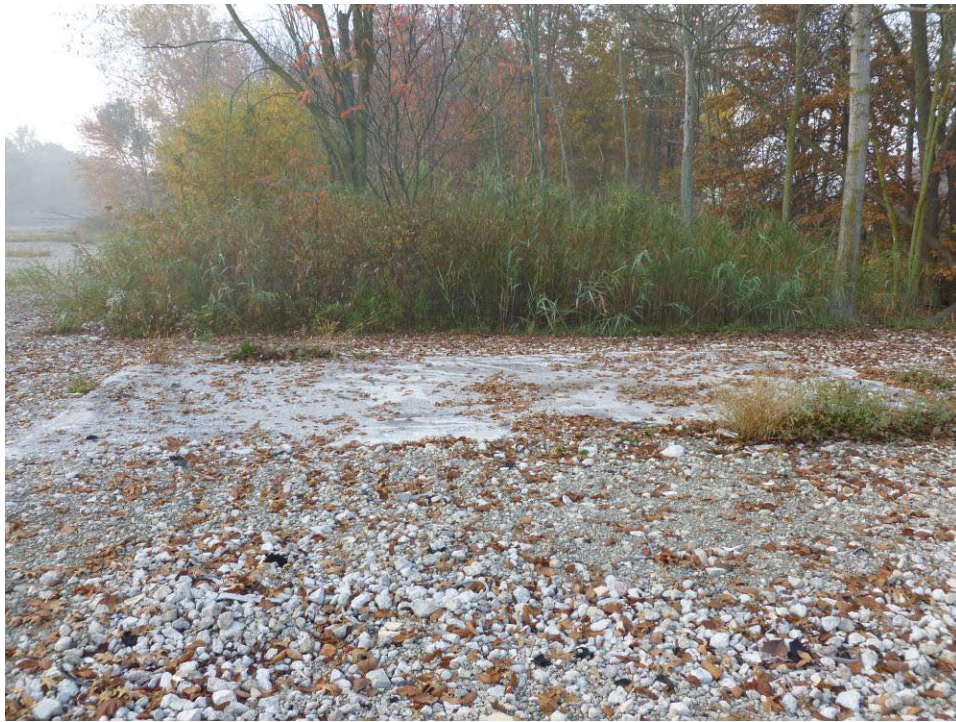
Photograph 16. (AOI-01) Pump pad concrete pad, located southeast of AST area. Photo taken facing east.

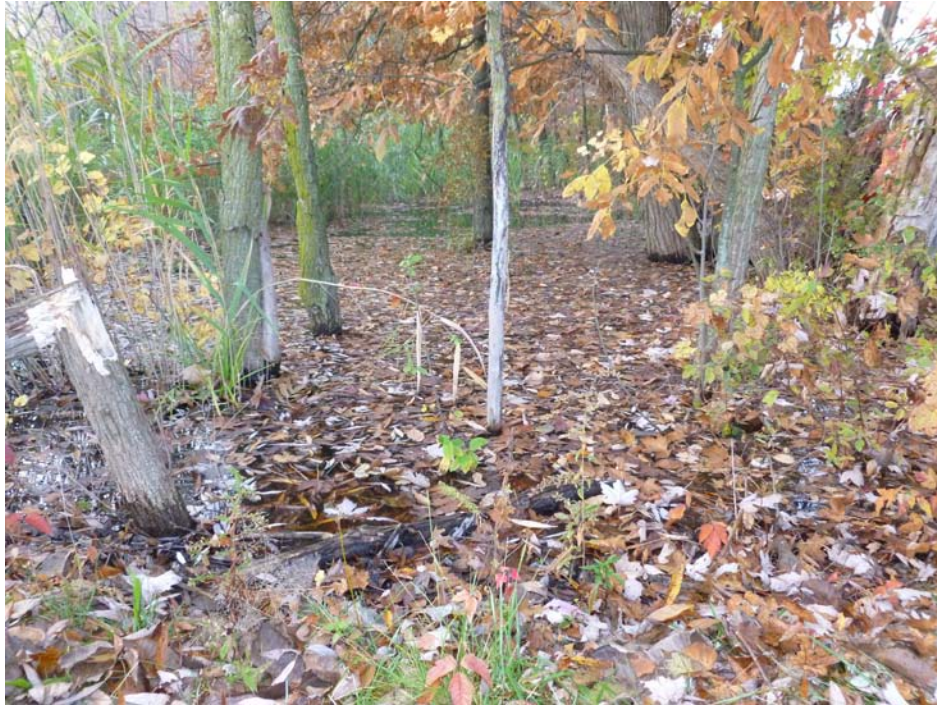
Photograph 17. Photo taken facing east at location of former overhead trestle to GMPT.

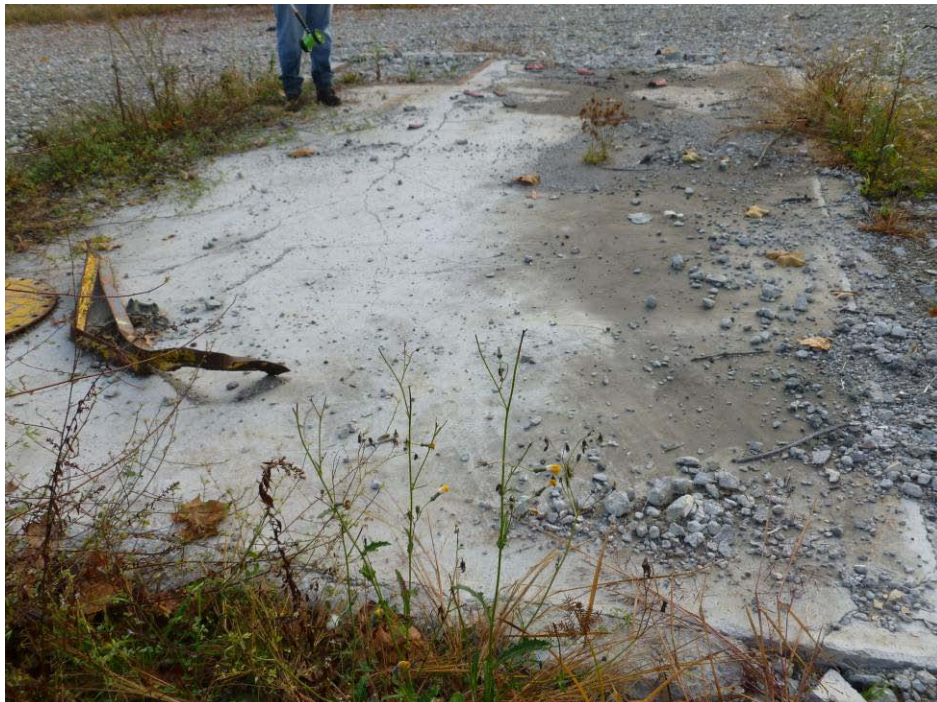
Photograph 18. (AOI-02) Concrete pad at former industrial waste pump house. Note staining on concrete. Photo taken from southwest edge of feature, facing east.

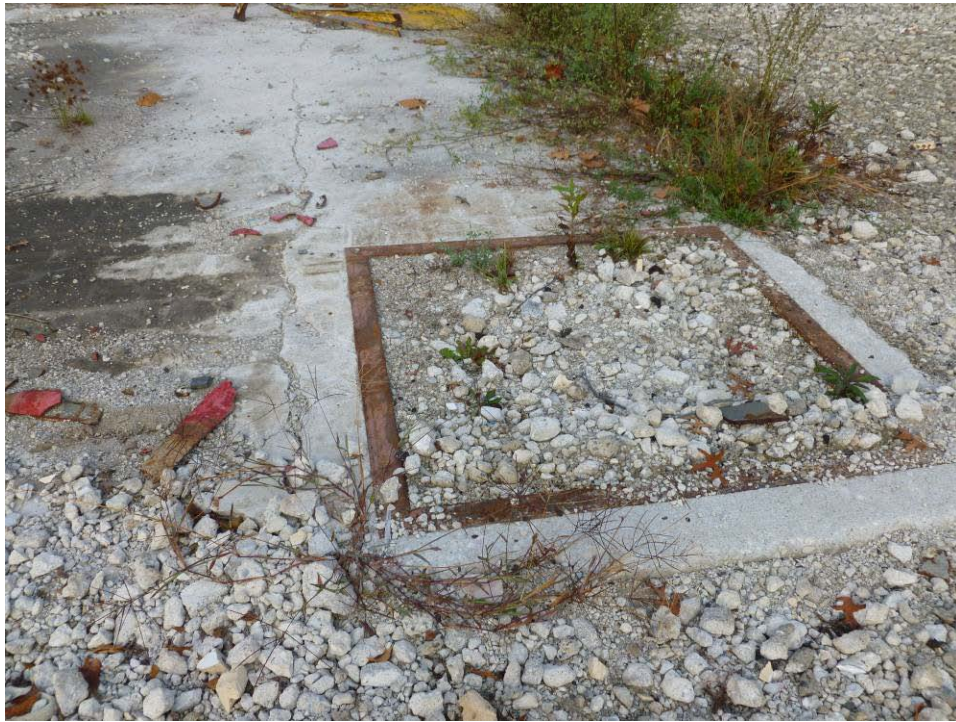
Photograph 19. (AOI-02) Concrete pad at former industrial waste pump house. Note staining on concrete and sump feature. Photo taken from northeast edge of feature, facing west. Red colored objects appear to be metal fragments of a former hydrant.

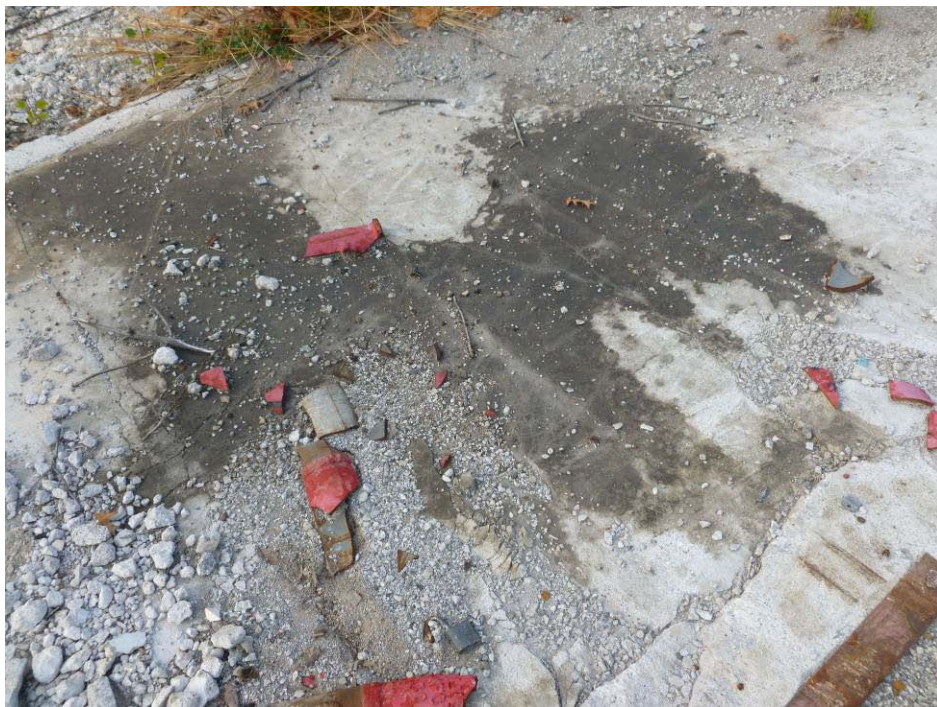
Photograph 20 (AOI-02) Close-up of staining on concrete pad at former industrial waste pump house.

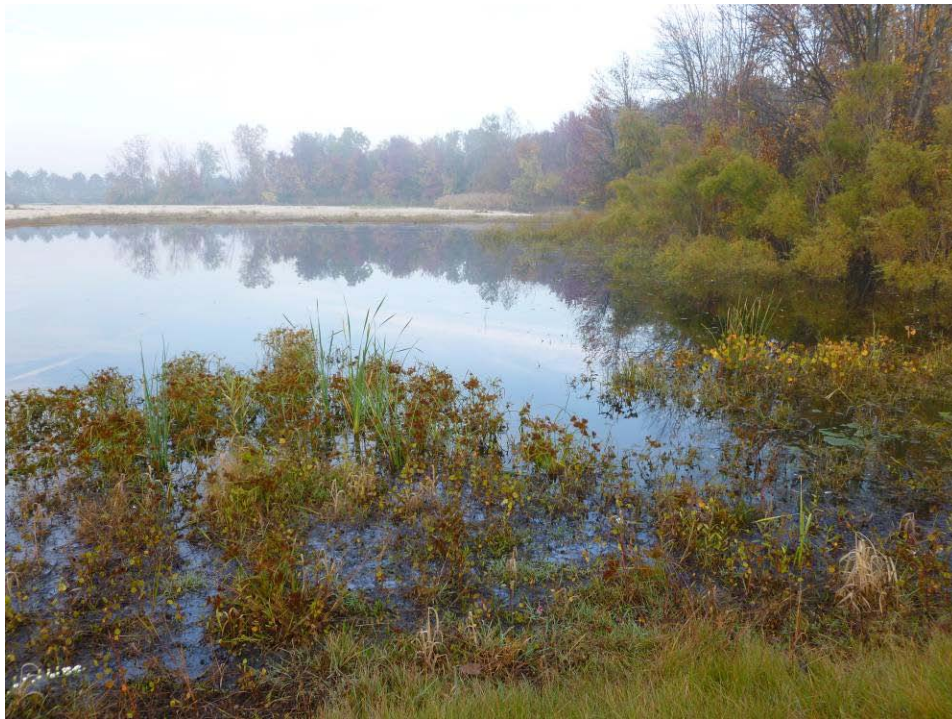
Photograph 21. Standing water and vegetation that has developed in place of former lawn/grassy area (as observed in aerial photos) located north of former Test Cell "E" Wing. Photo taken facing west, toward former vehicle test garage.

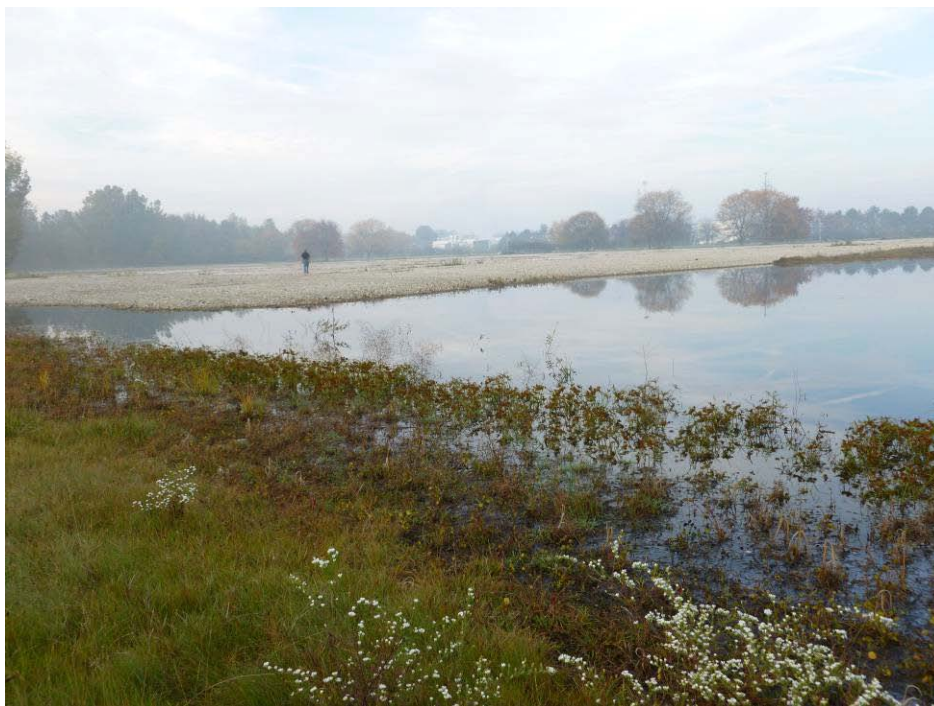
Photograph 22. Standing water and vegetation that has developed in former lawn/grassy area, located north of former Test Cell "E" Wing. Photo taken facing southwest.

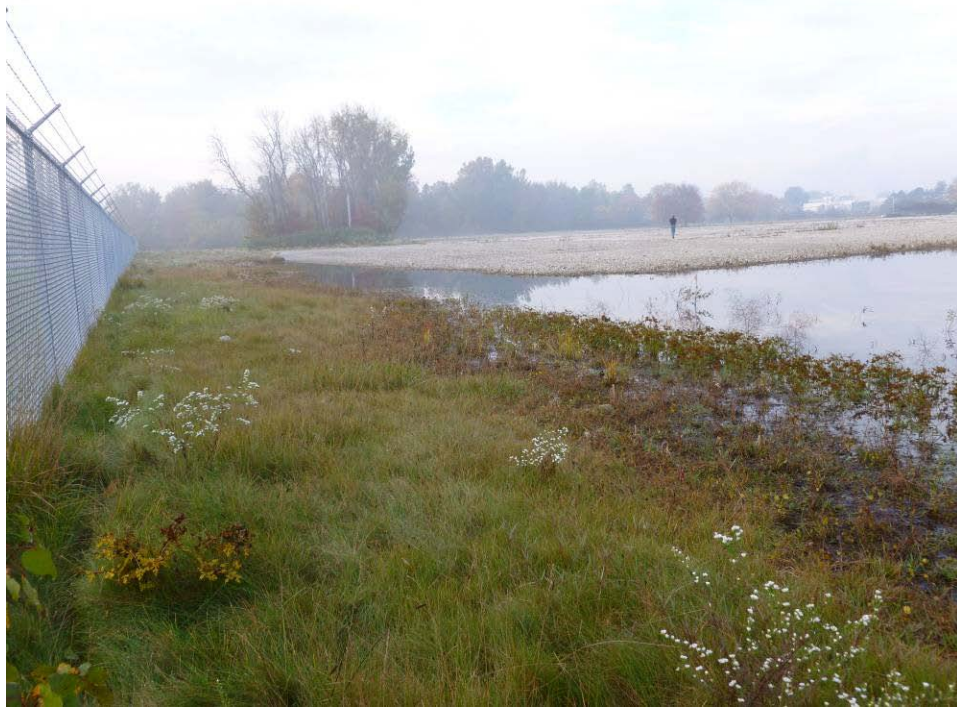
Photograph 23. Standing water and vegetation that has developed in former lawn/grassy area, located north of former east entrance to facility. Photo taken facing south.

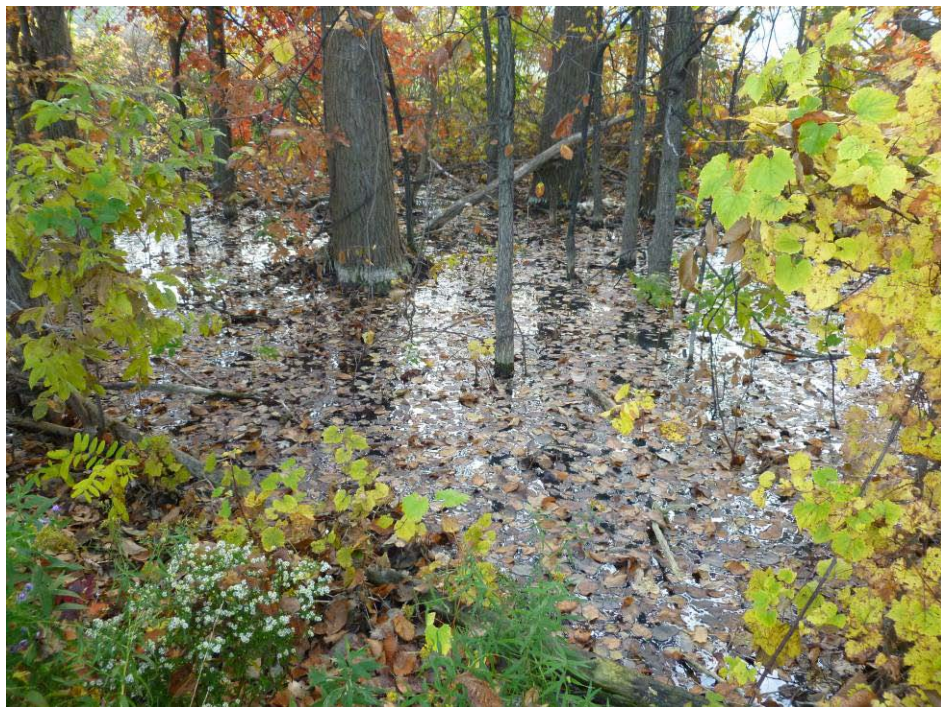
Photograph 24. Standing water in wooded area located immediately south of former Test Cell "D" Wing.

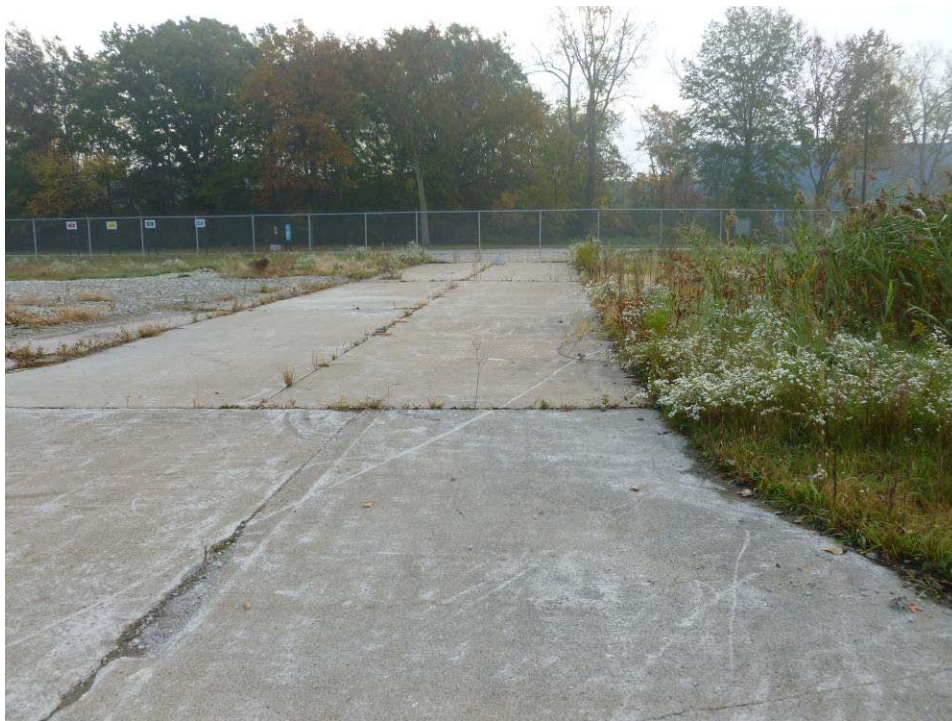
Photograph 25. (AOI-06) Access to east area of facility, leading to area of baghouse, cold test trailer and closed UST. Photo taken facing east.

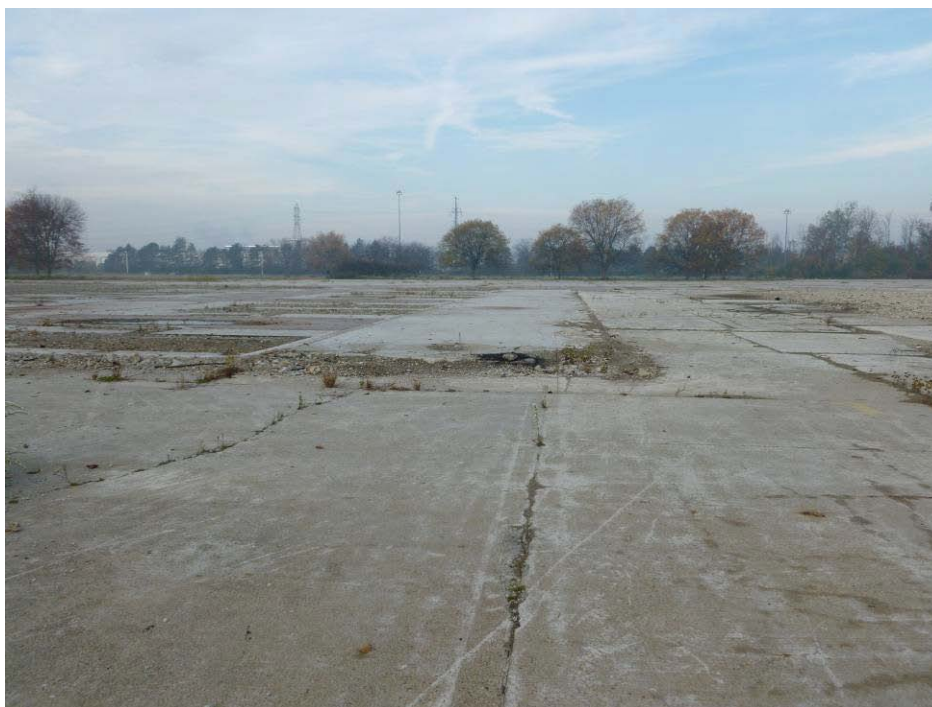
Photograph 26. Concrete footprint of former facility. Photo taken facing west from area approximately central to "D" and "E" Test Cell Wings.

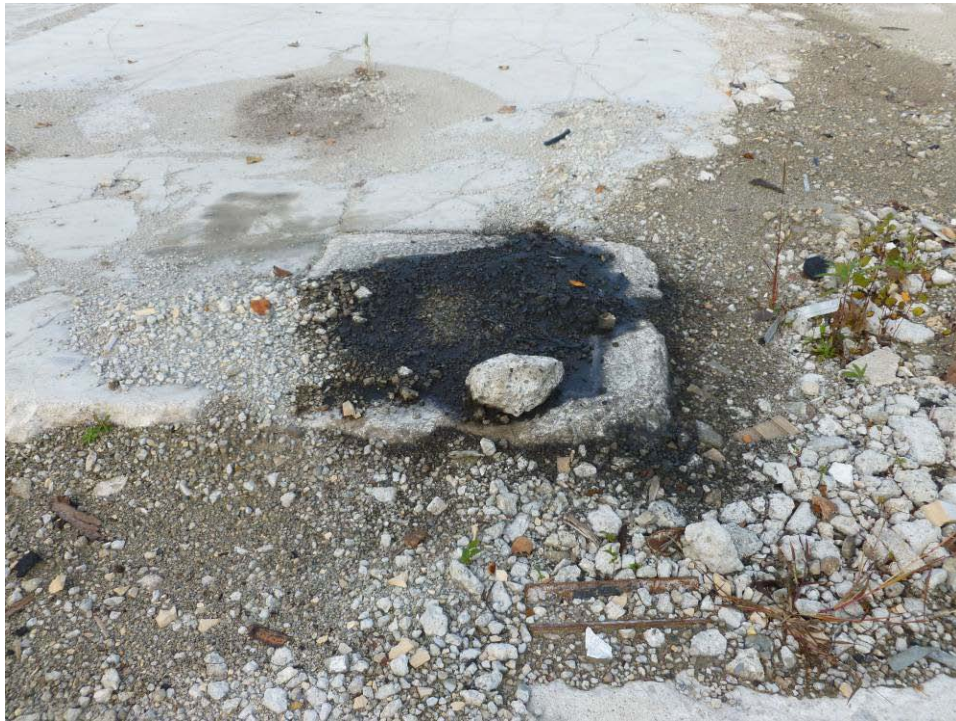
Photograph 27. (AOI-04) Dark, oily staining observed on concrete in eastern portion of former facility. Location believed to be outside of southeast corner of Test Cell "D" Wing. Material may be associated with building demolition or post-demolition activities.

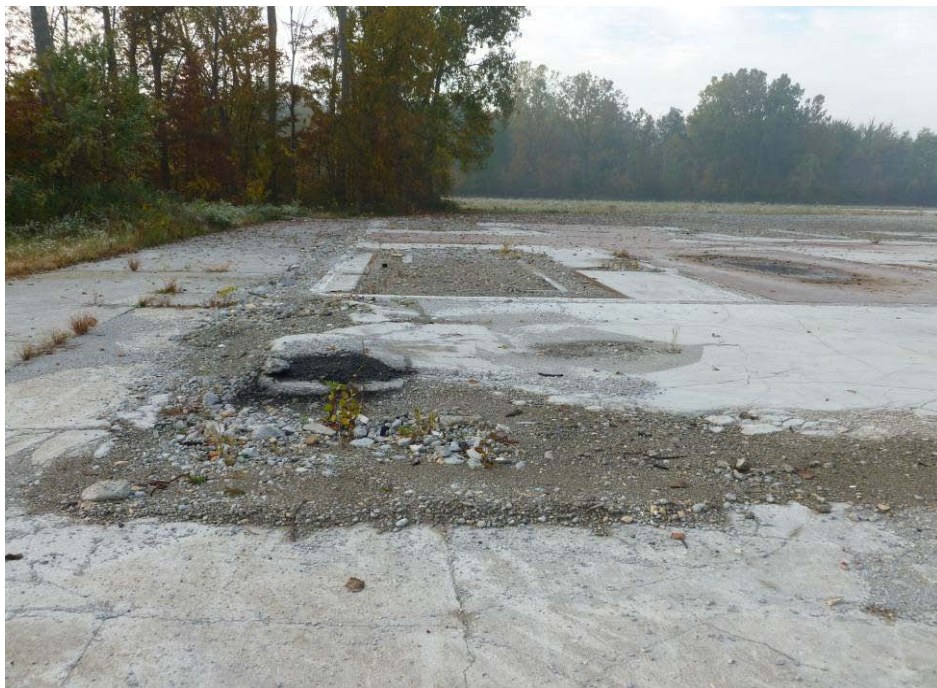
Photograph 28. (AOI-04) Note dark, oil staining on concrete in eastern portion of former facility. Photo taken facing south. Location believed to be outside of southeast corner of Test Cell "D" Wing.

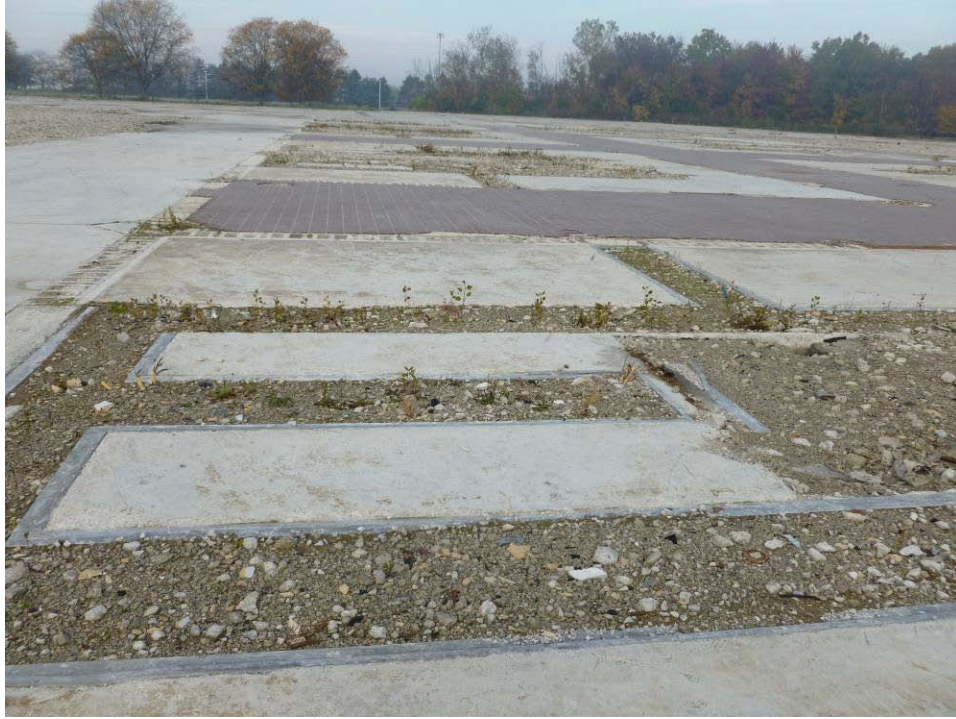
Photograph 29. Concrete tile features in footprint of former facility. Areas believed to be former dynamometer testing areas and tiled aisles, Test Cell "E" Wing. Photo taken near eastern area of former facility, facing west.

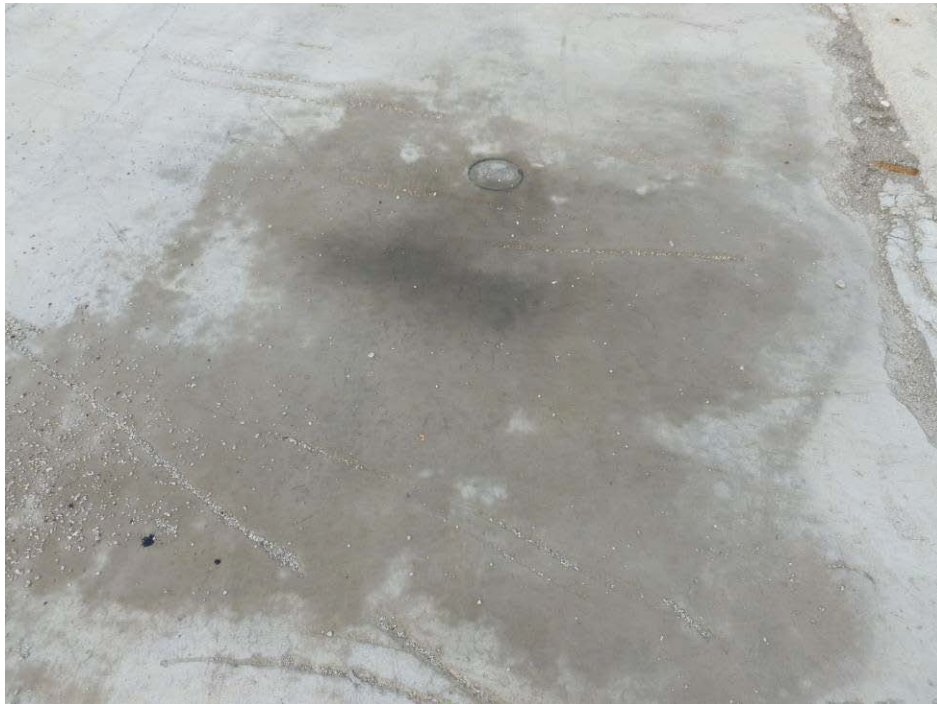
Photograph 30. Light staining observed on concrete in footprint of former facility.

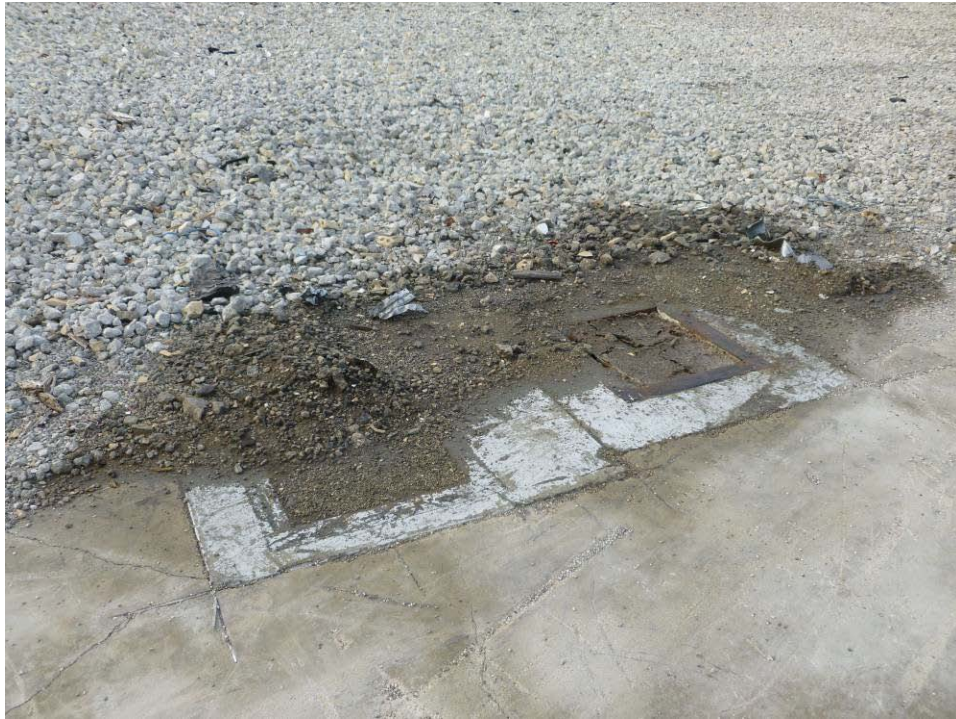
Photograph 31. (AOI-05) Staining observed on concrete and gravel in footprint of former facility. Location believed to be northeast area of Test Cell "E" Wing.

03	Former Pump House	Northeast area of Site	Site walk /Facility drawings	Feature identified on Site Plan as pump house. Use of pump house unknown; possibly associated with oil or fuel conveyance. Area of former pump house pad was covered by standing water at time of Site reconnaissance and could not be observed.	Dimensions unknown. Area inaccessible at time of Site reconnaissance.	25	Diesel fuel, oils	Yes
04	Evidence of Release in Test Cell "D" Wing Area	Southeast test cell	Site walk	Area of dark staining and oily residue observed on concrete and gravel near northeast corner of former Test Cell "D" Wing. Staining may be associated with demolition or subsequent activities.	4x4	27, 28	Fuel, oil	Yes
05	Evidence of Release in Test Cell "E" Wing Area	Northeast test cell	Site walk	Staining observed on concrete and gravel near southwest area of the Test Cell "E" Wing. Staining may be associated with demolition or subsequent activities.	6x4	31, 32	Fuel, oil	Yes
